**SUBJECT: Hydrogeologic Investigation Report (HIR) Addendum  
Furlong Fault Groundwater Study  
New Hope Crushed Stone  
SMP No. 7974SM3  
Solebury Township, Bucks County, PA  
ERG Project No. 011012.009**

# Hydrogeologic Investigation Report Addendum

## Furlong Fault Groundwater Study

New Hope Crushed Stone  
SMP No. 7974SM3  
Phillips Mill Road  
Solebury Township, Bucks County, Pennsylvania

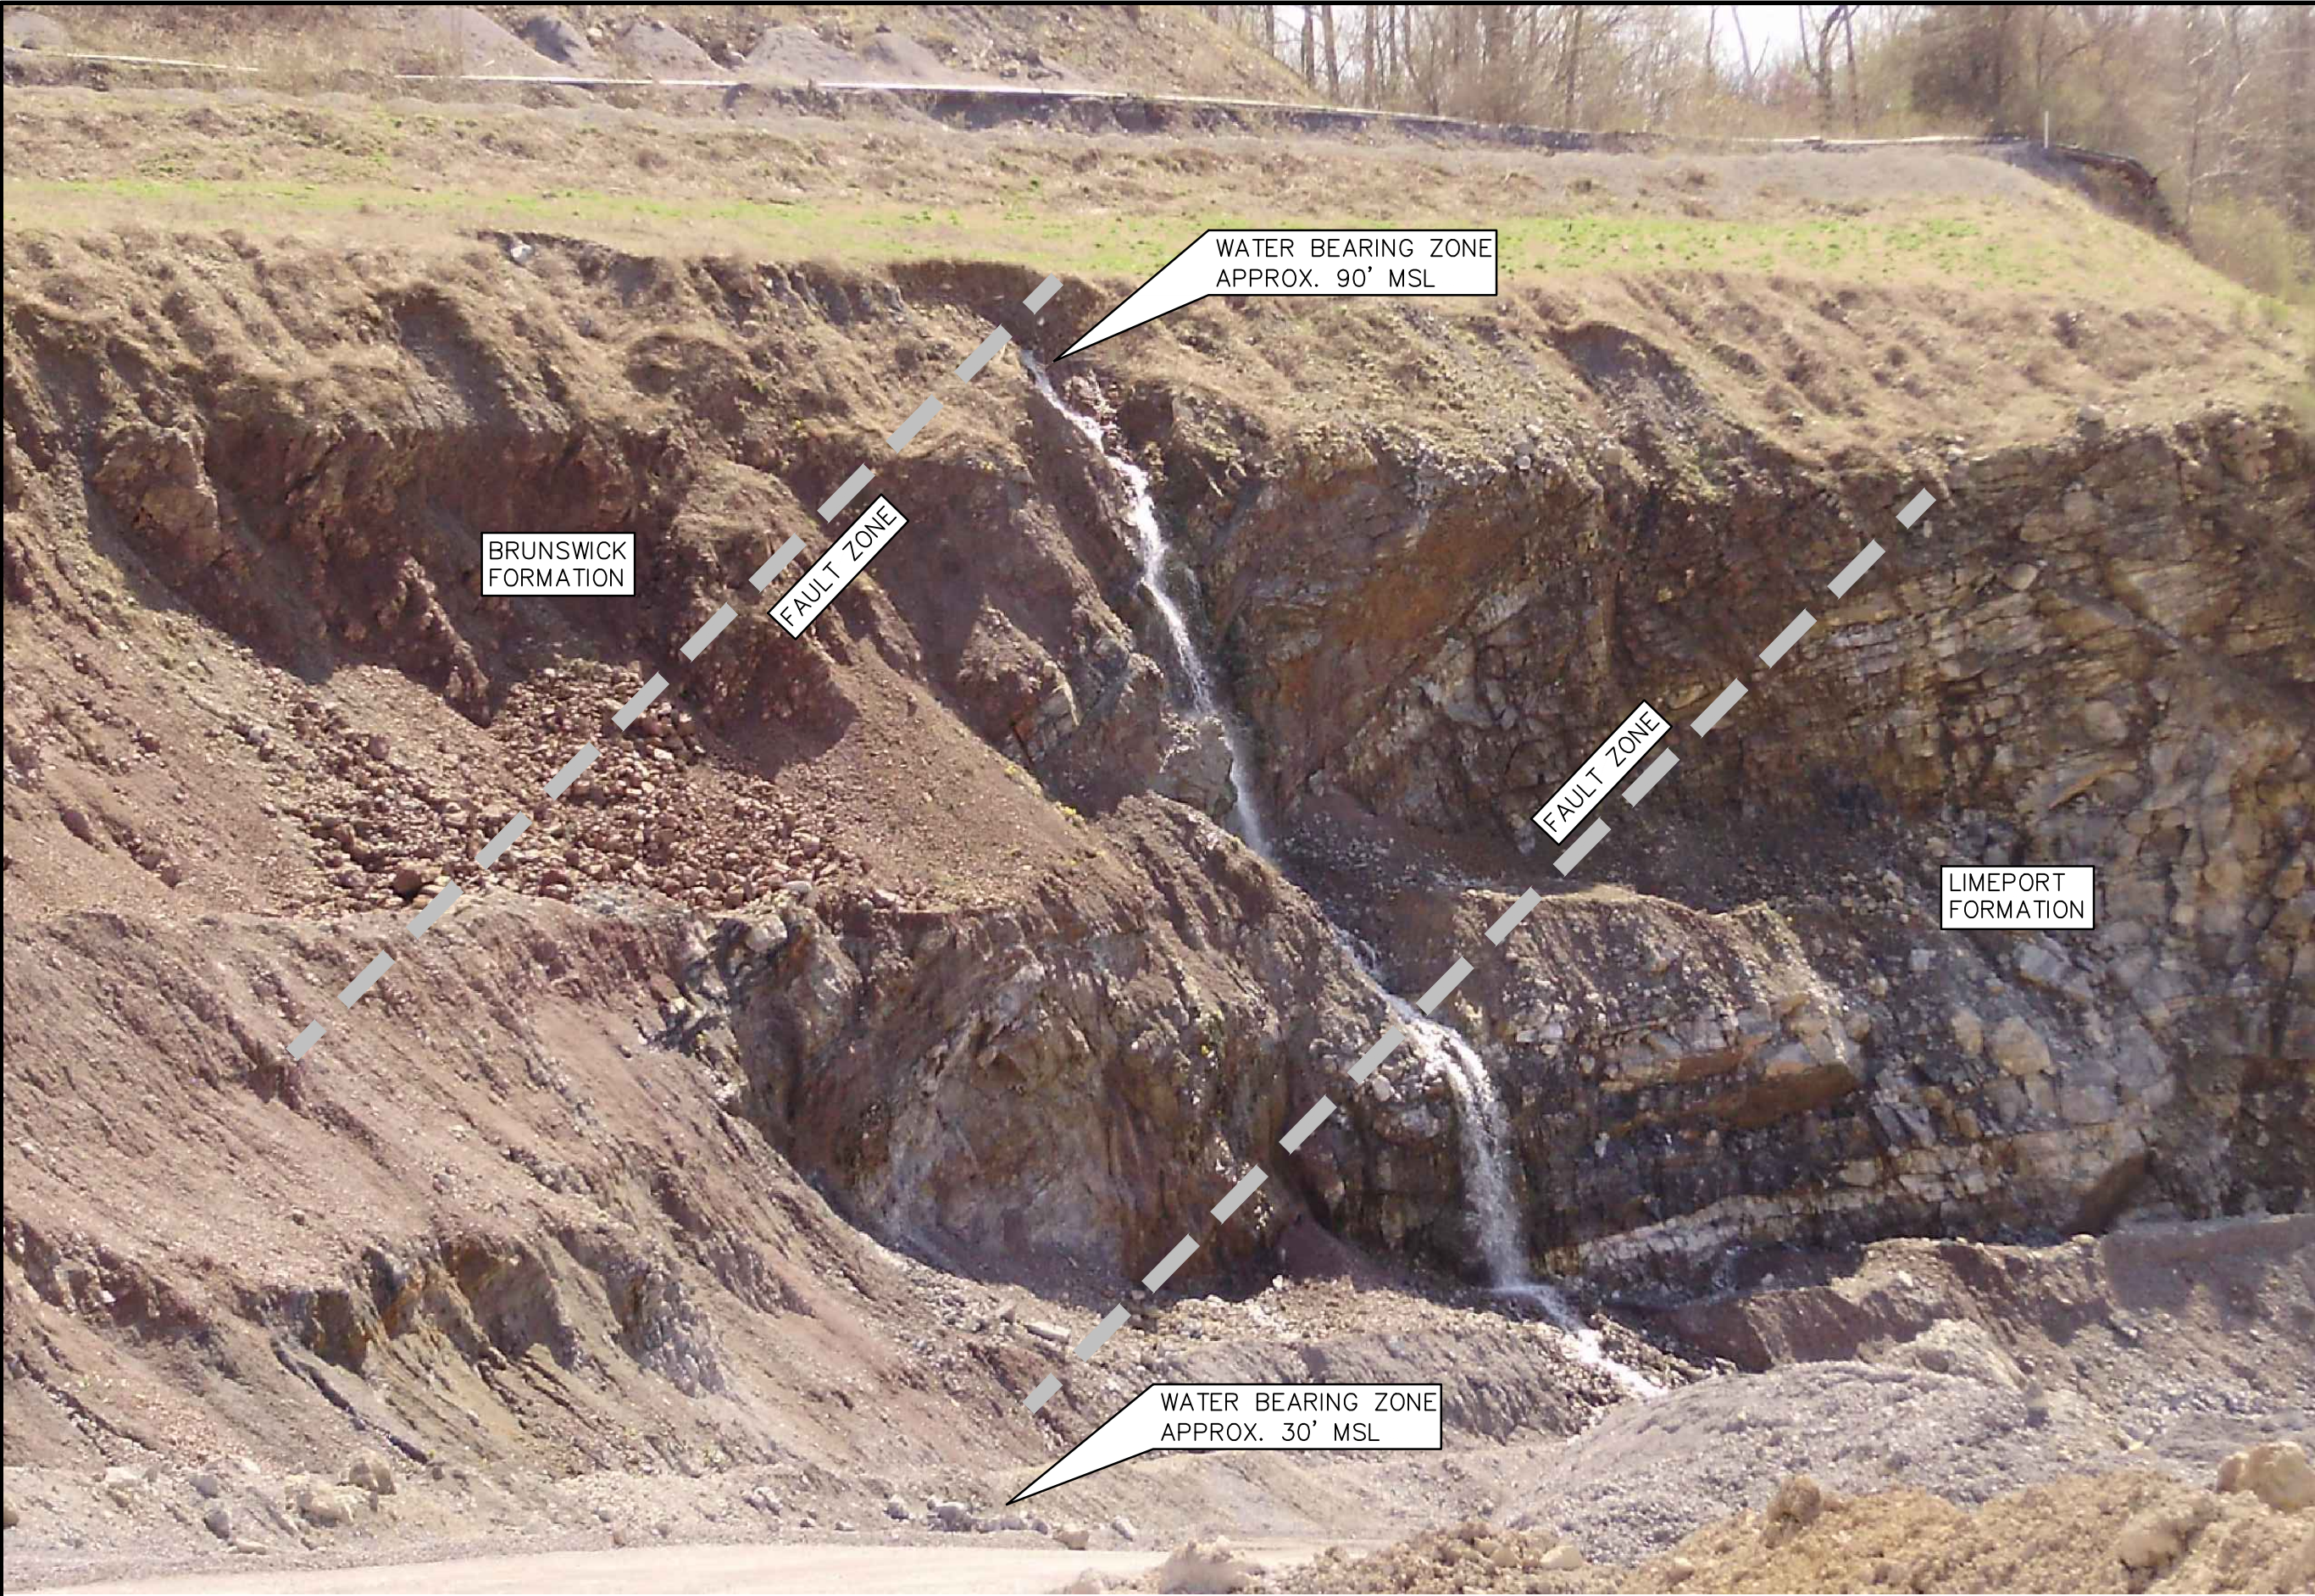
| FIGURE 2<br>FURLONG FAULT EXPOSURE ALONG SOUTH<br>WALL OF QUARRY | | | | 2010 SITE WORK<br>SOLEBURY TOWNSHIP, BUCKS COUNTY, PA |

Modifications of the Quarry pit initiated in 2008 and completed by December 2008 exposed a section of the Fault within the pit. A photograph of this exposure is included in Figure 2. The blocky characteristic geology of the Allentown/Limeport Formation is shown on the right (western) portion of the outcrop. The red shale of the Brunswick Formation dominates the left (eastern) portion of the outcrop. The Fault zone is highly deformed and occurs near the center of the outcrop. Two (2) water bearing zones are observed in this area of the Pit. The first water bearing zone daylights along the high wall, at an elevation of approximately 90' msl and flows from a fracture within the Fault zone. Flow from this zone fluctuates greatly depending on precipitation. In periods of wet weather, flow cascades down the side of the wall; however, during dry weather no flow is apparent. The second water bearing zone occurs at the base of the highwall (approximately 30' msl) approximately 100 feet east of water bearing zone 1. Additionally, the area between these two water bearing zones is characterized by several small seeps. Flow from these zones was collected in a channel constructed alongside the haul road and was monitored from March 5, 2010 to April 13, 2010 (See Section 3.2.1). Flow was gauged with a global flow probe by measuring stage and water velocity at multiple points across the swale and then using the data to calculate flow.

SOURCE: PHOTO TAKEN BY ERG ON 4/2/2010

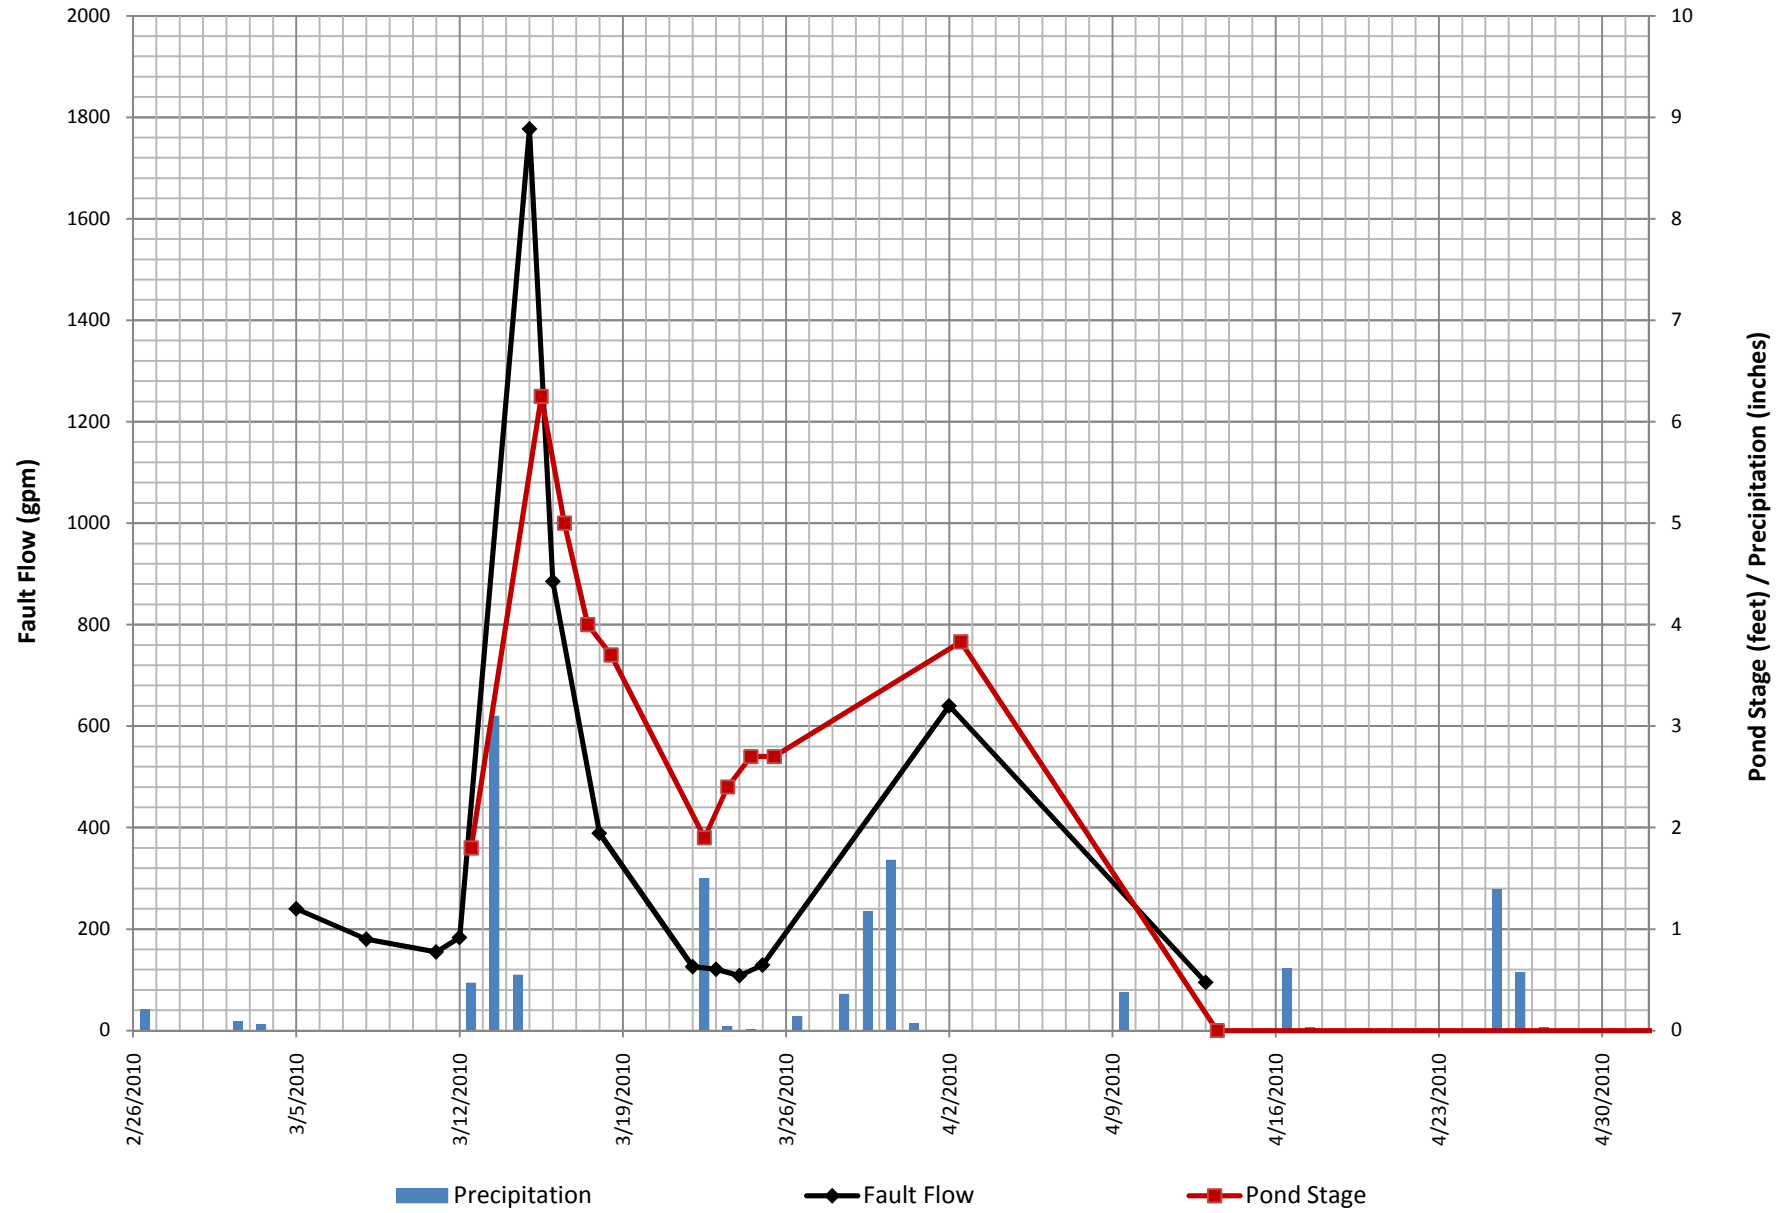
Figure 3. Pond and Fault Hydrograph

A hydrograph presenting the Pond and Fault flow data (Tables 2 and 3) measured during the testing period is shown in Figure 3. The hydrograph shows that there is a positive correlation between the pond stage, Fault flow discharge to the Quarry, and precipitation. After a precipitation event, pond stage rises as does the Fault flow rate as measured at the Quarry monitoring location (see Drawing E-067). The data indicates that the shallow expression of the Fault in the area of the Quarry is recharged by the pond and additional surface water runoff collected during precipitation events. Following storm events, the flow of the Fault resumes a typical baseflow recession.

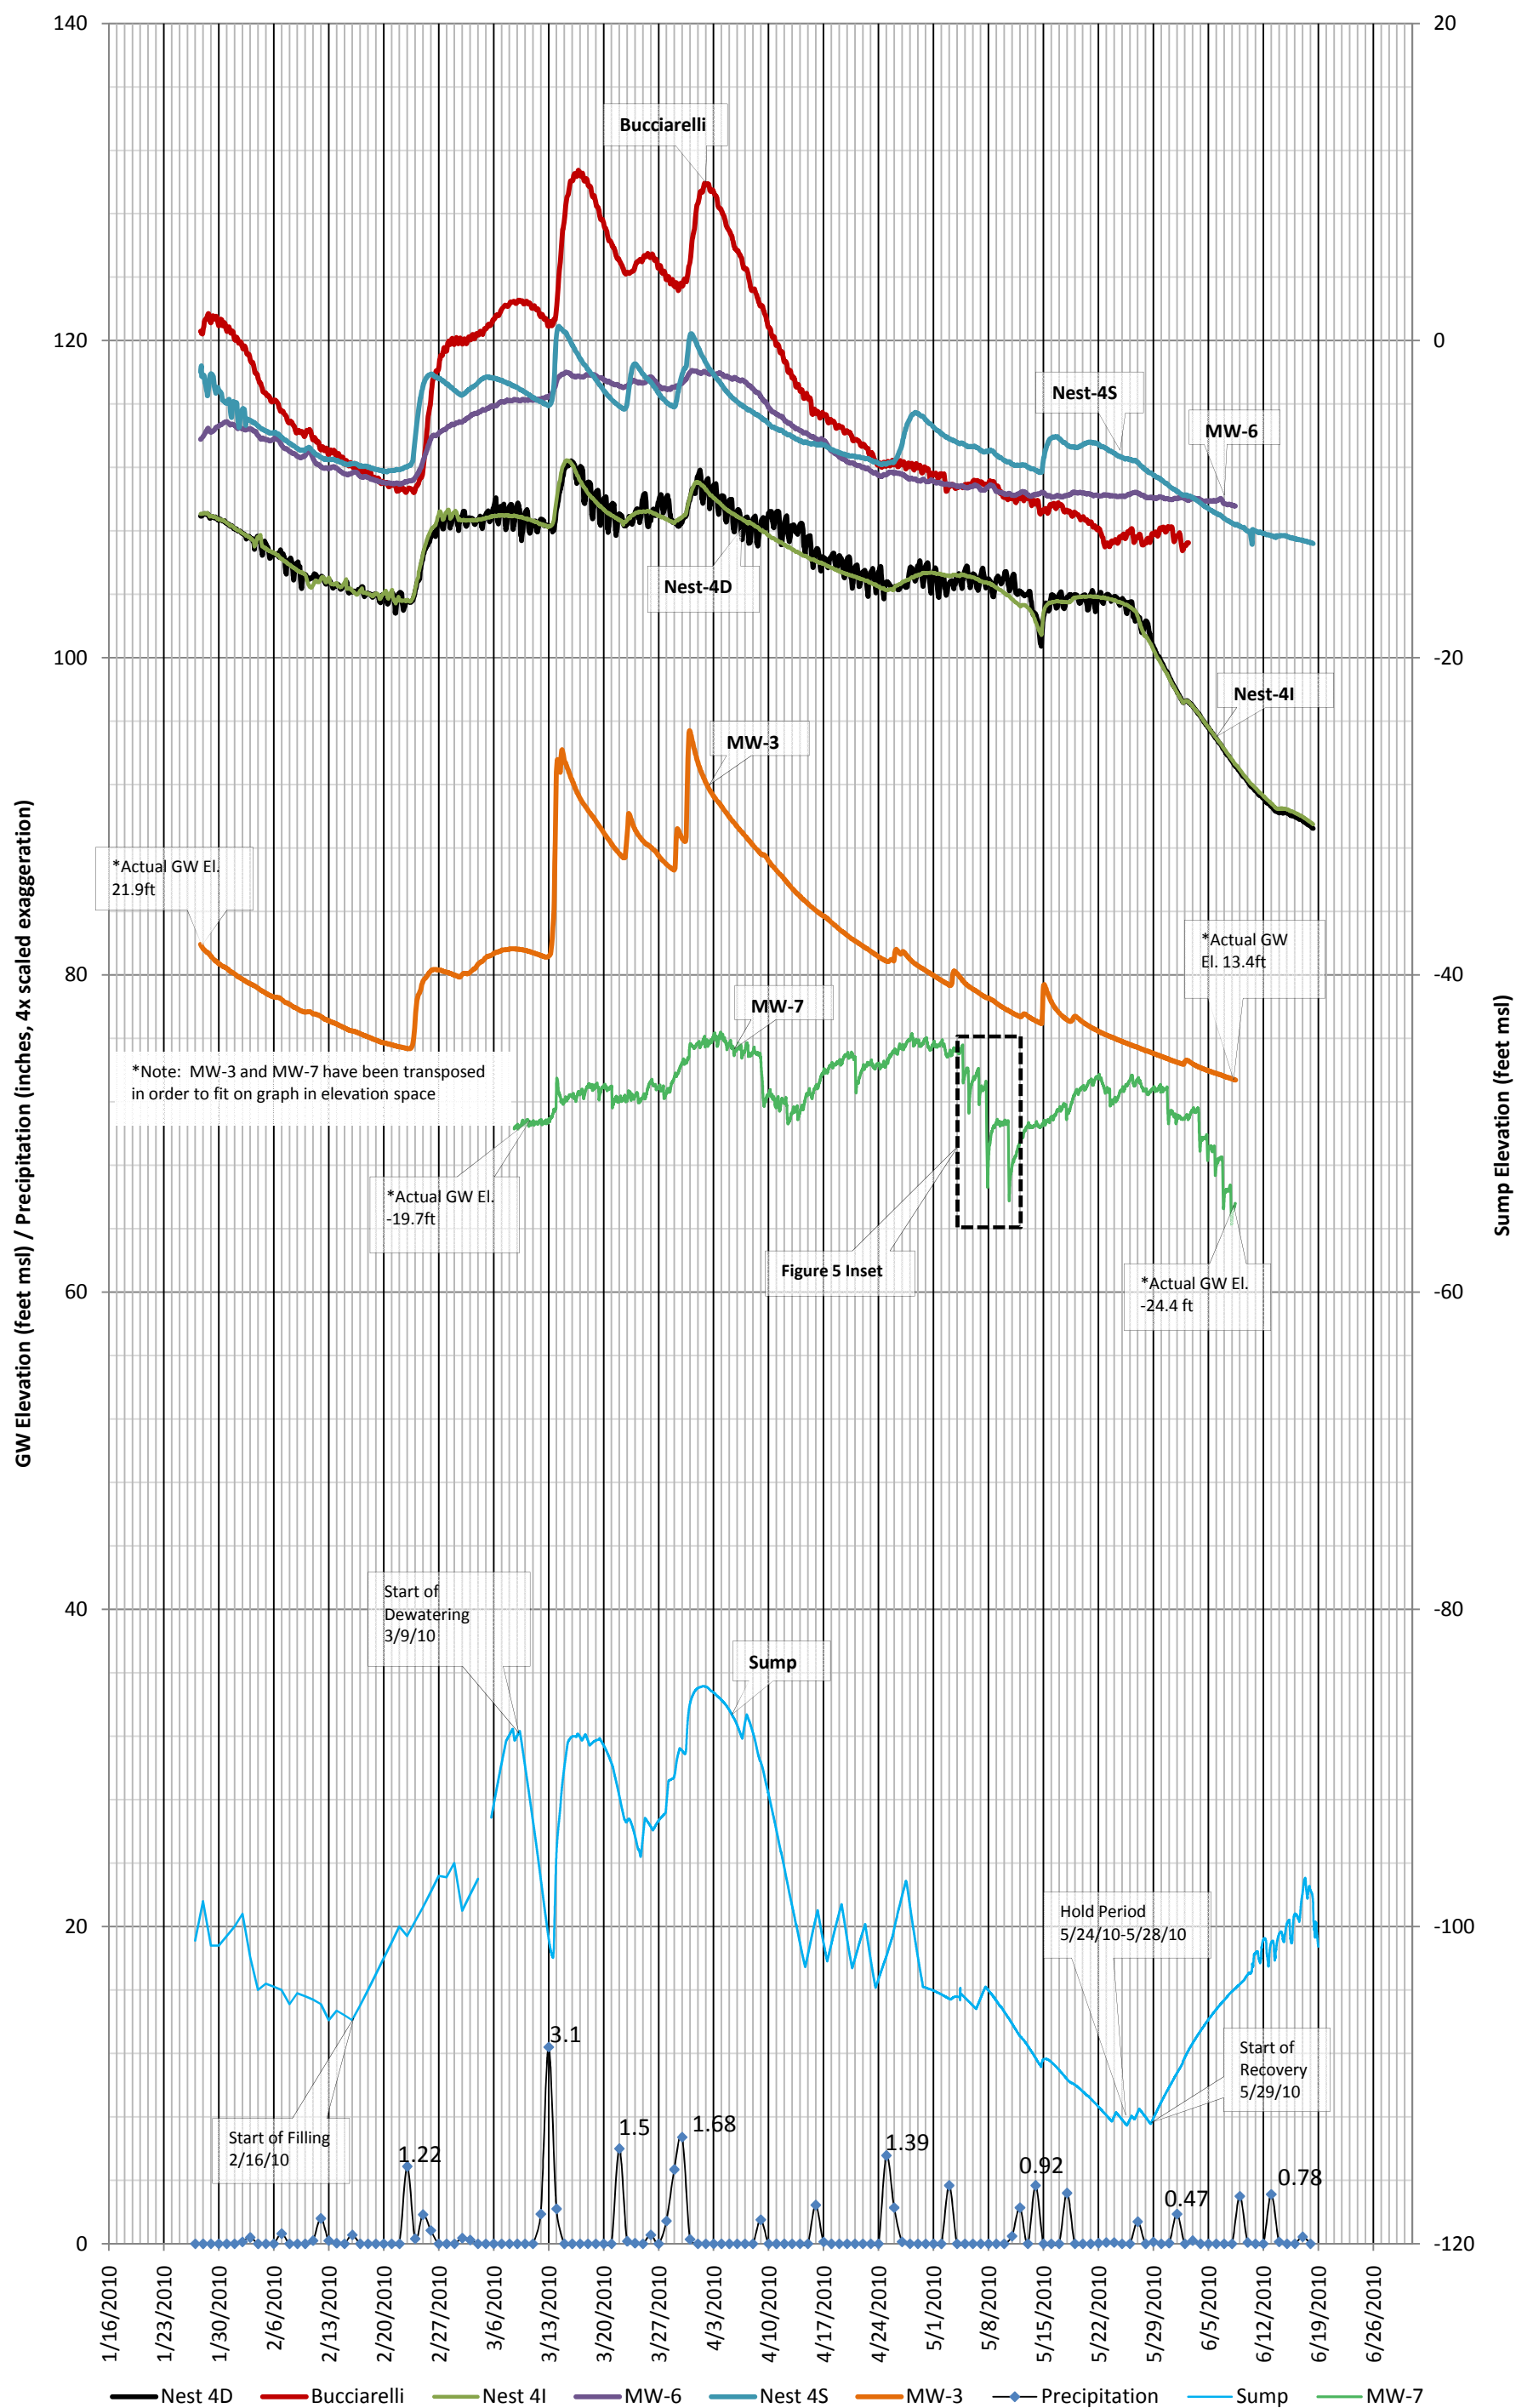
Figure 4. Monitoring Wells and Sump Hydrograph

Figure 4 is a hydrograph of the test monitoring wells shown in elevation space with callouts marking test dates. Groundwater levels within the monitoring wells were evaluated for spatial and temporal trends, specifically for deflections from Sump dewatering. The monitoring wells do not show deflections based on Sump dewatering (see Table 1 for Sump pumping schedule). Rather water levels respond to precipitation events and are unaffected by Sump dewatering. As shown, water levels began their seasonal decline during the growing season as in response to decreased precipitation recharge. Separate hydrographs were prepared for MW-7 (Figure 5) and Well Nest-4 (Figure 6) to show these levels in more detail.

It is demonstrated from the hydrographs (Figures 4 and 6) that groundwater levels in Well Nest-4 are approximately 200 hundred feet above the level of the Sump. Furthermore, the average water level is similar to the level indicated on the 1992 water table map of the area, prepared by USGS (Open-File report 93-28) and on groundwater contour maps for the Basin prepared and submitted quarterly by ERG.

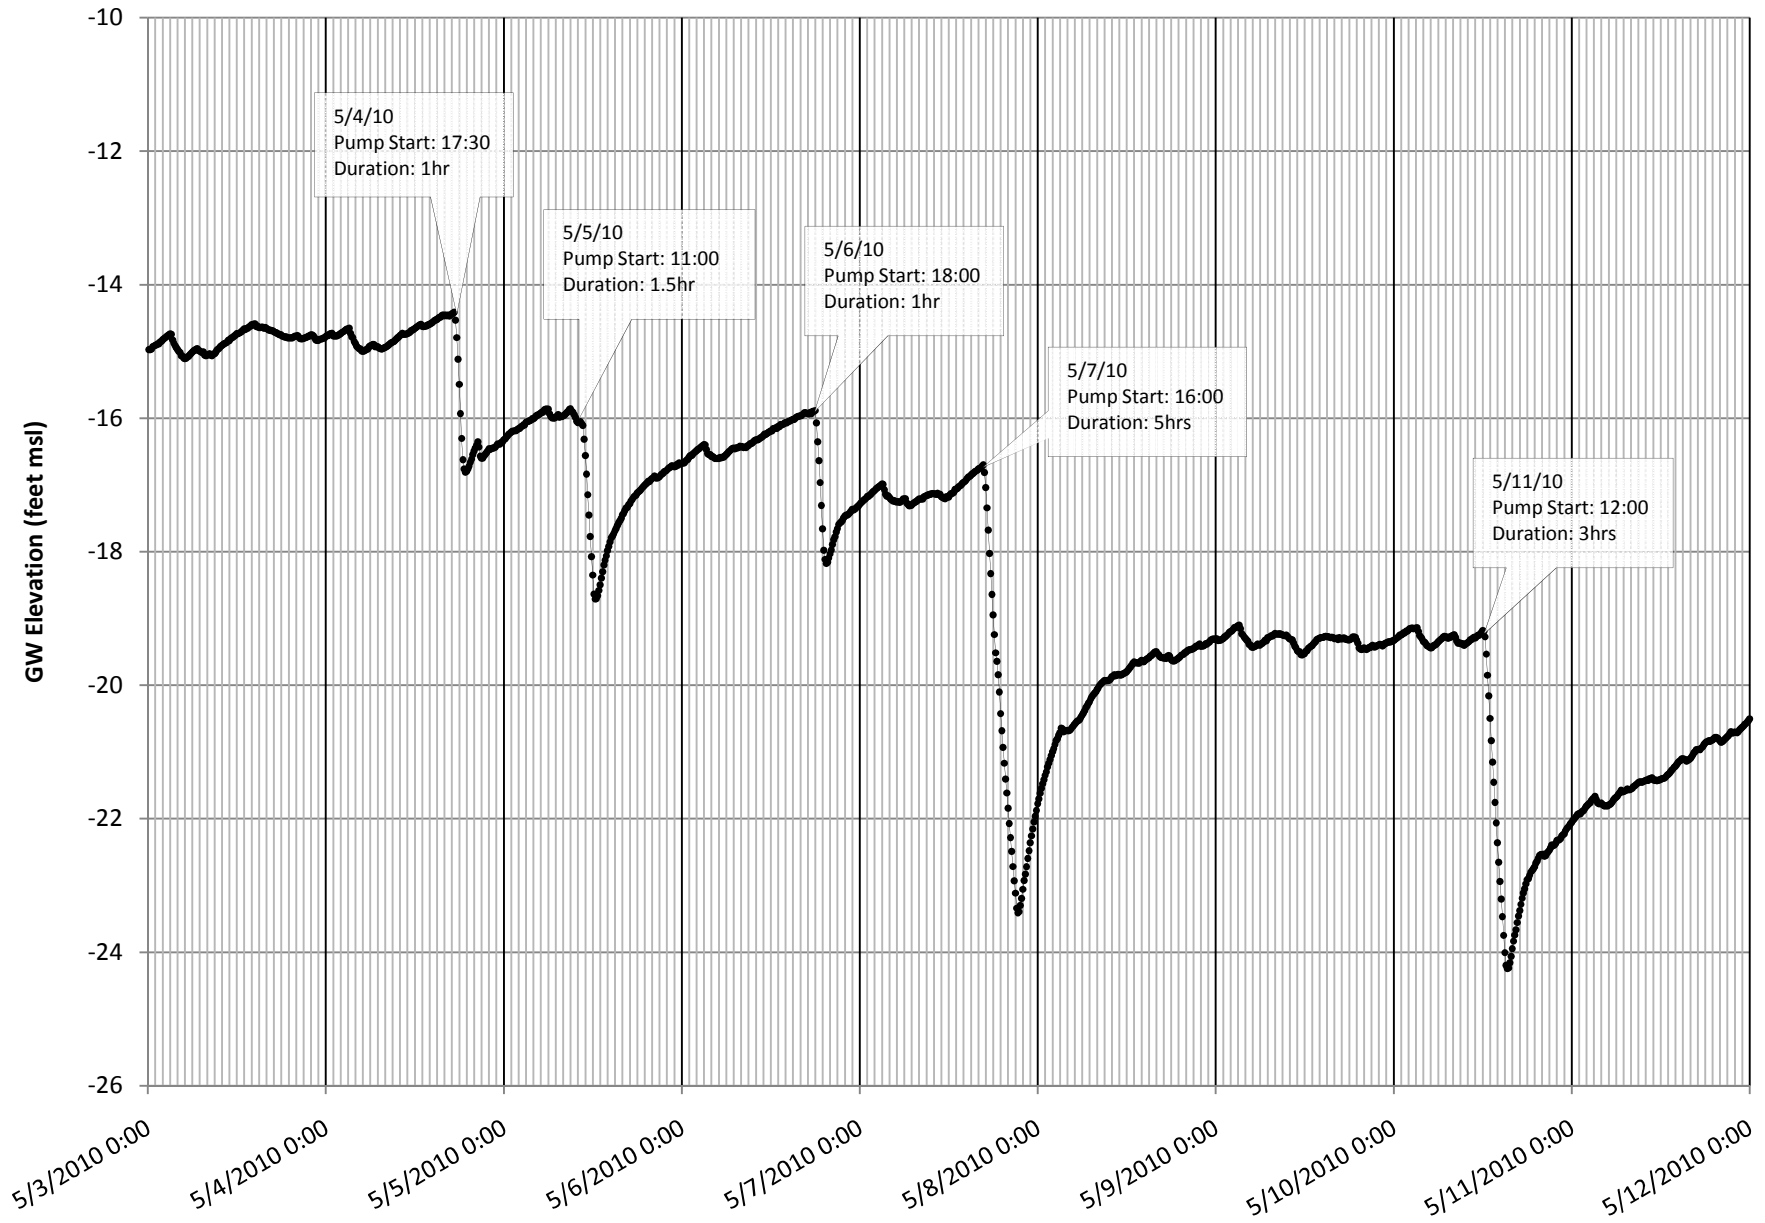
Figure 5. MW-7 (5/3/10 - 5/12/10)

The water level in MW-7 is affected by routine pumping of a water source other than the Quarry Sump, as demonstrated by comparison of the Figure 5 hydrograph with the Sump pumping schedule presented on Table 1. Figure 5 shows the water level in MW-7 from Monday, May 3 through Wednesday May 12. Several pumping cycles are evident (a very pronounced cycle corresponding to longer pumping time and higher drawdown and a less pronounced cycle corresponding to short duration and low drawdown.) Pumping start times (as indicated by the start of drawdown) and durations are indicated to be: 17:30 for 1 hour (Tuesday, 5/4), 11:00 for 1.5 hours (Wednesday, 5/5), 18:00 for 1 hour (Thursday, 5/6), and 16:00 for 5 hours (Friday 5/7), 12:00 for 3 hours (Tuesday, 5/11). Also evident is a short pumping cycle starting at 3 AM. By contrast, Quarry dewatering pumping through May 6 was continuous with 2 electric submersible pumps. On May 6 one of the subs was turned off at 11:30 AM and then restarted at 7:00 AM on May 7. These pumps ran continuously until the start of the recovery period (May 26) when one of the subs was shut-off during the hold period. Based on comparison of the Quarry Sump pumping schedule and the drawdown presented on Figure 5, MW-7 was not affected by Quarry Sump dewatering.

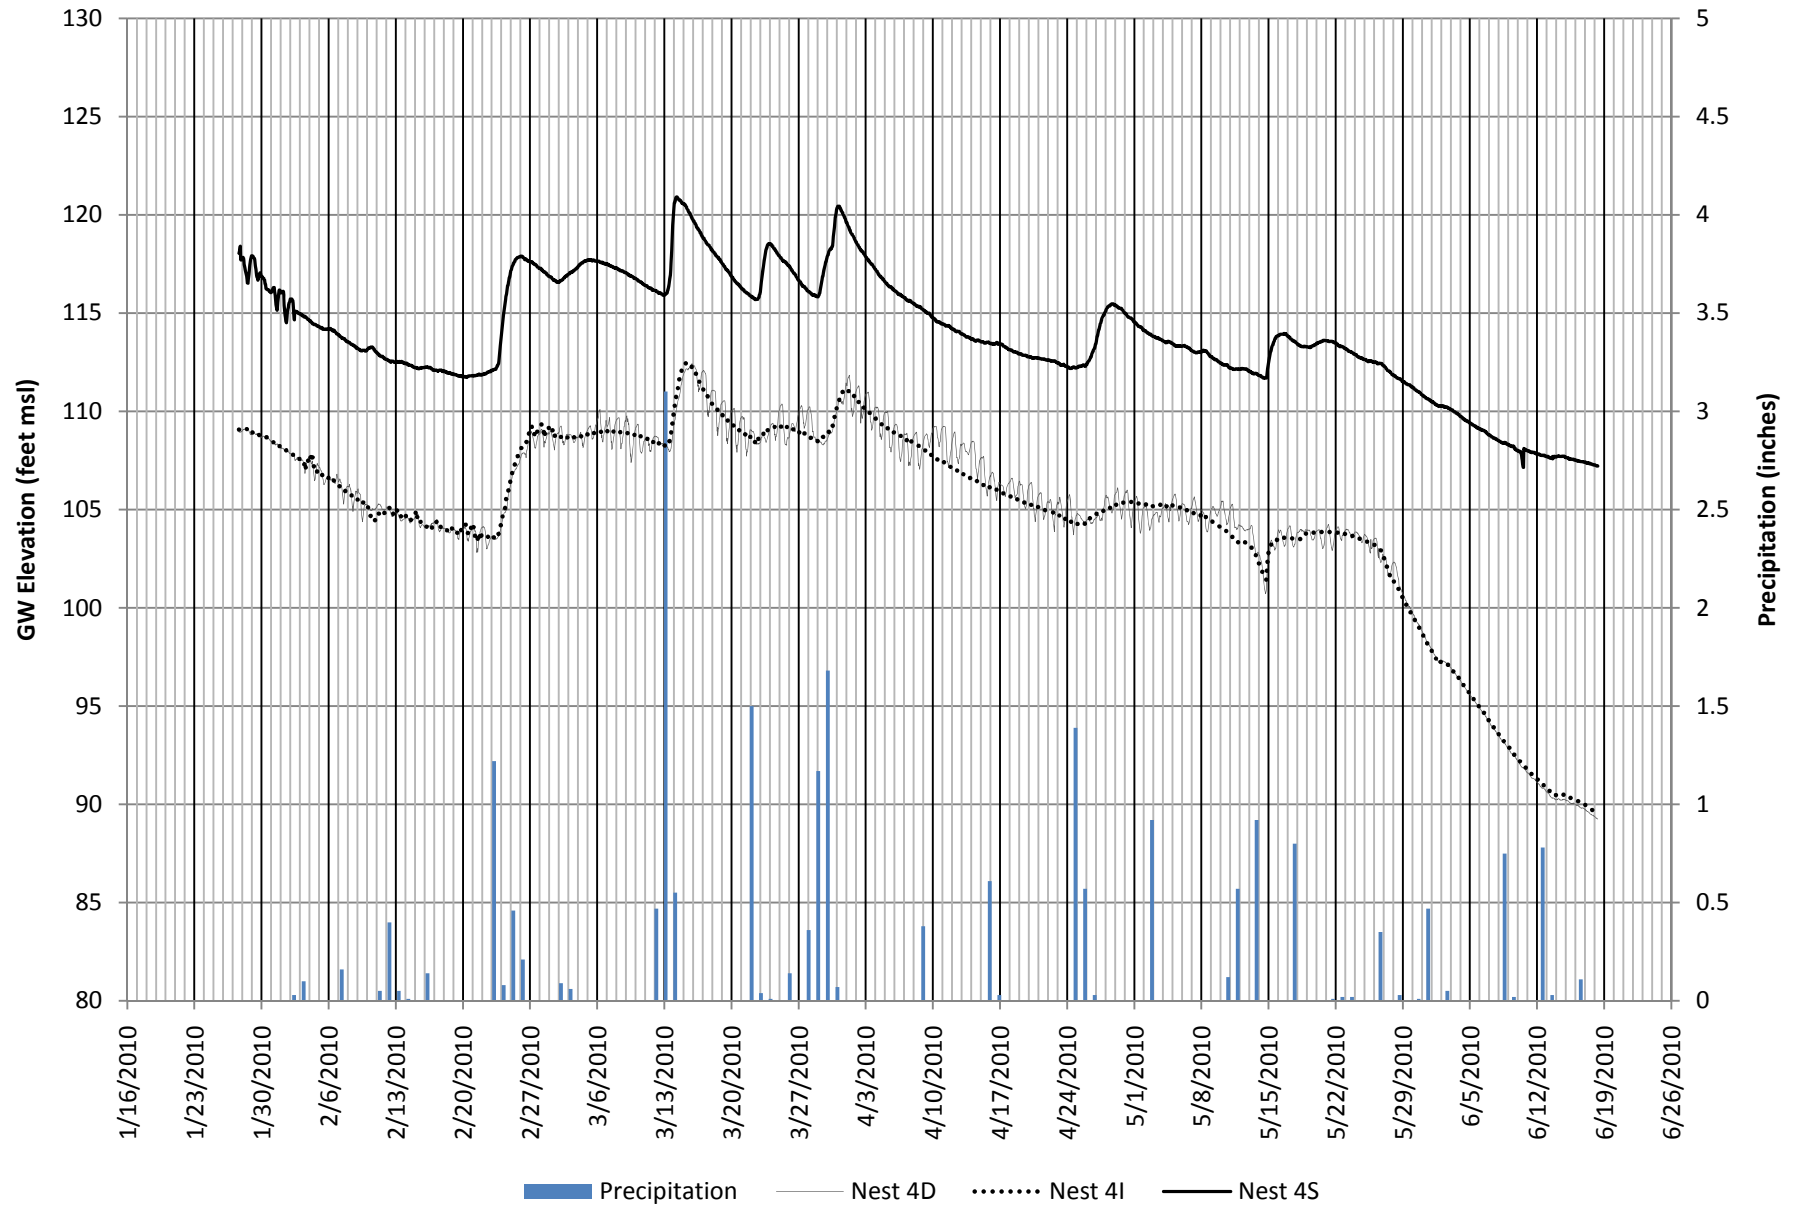
Figure 6. Well Nest-4 Hydrograph

It is apparent from the hydrographs that Well Nest-4I and Well Nest-4D demonstrate very similar water levels in terms of both elevation and temporal variation indicating that they are part of the same hydrogeologic unit. Both wells tested with a moderately high to high hydraulic conductivity indicating a connected fracture network. Well Nest-4S, completed within the Brunswick, has a higher water level but trends much like the deeper Nest wells. Based on the higher water level in Well Nest-4S, a downward vertical gradient exists between the shallow and deeper wells which indicates leakage from the Brunswick Formation into the Fault system.

In addition, Well Nest-4I and 4D exhibit a boundary condition in effect at approximately 104 feet msl where the trend of the groundwater recession takes a steeper slope. This boundary condition is demonstrated in the data as occurring on May 13, 2010. This was subsequently evaluated for pumping effects from Sump dewatering and was found to have no connection to pumping from the Sump. Subsequent recharge resulted in recovery of the water level to 104 feet msl for a period of several days; however, the water level soon resumed the steep downward trend after declining below 104 feet msl.

The elevation of 104 feet msl corresponds to the approximate bottom of the Pond and tributary system located near the Fault. Therefore, the shallow expression of the Fault is connected to the Pond system, and the Pond system provides recharge to the Fault until becoming depleted. Flow measured along the Fault clearly demonstrates a connection to surface water recharge given the measured surges corresponding with precipitation. Following depletion of the Pond storage, the water level in the Fault undergoes recession as the Fault comes into equilibrium with groundwater baseflow from the south and discharge to the Quarry.

The declining water level is significant and indicates that baseflow along the Fault is not sufficient to recharge the Fault system in the absence of recharge from the shallow pond system. Therefore it is demonstrated that the Fault system is not pulling large amounts of water from the south, otherwise neither the water level within the Fault nor the measured discharge from the Fault into the Quarry would decrease so dramatically. The hydrograph data shows that the Fault in the area of the Quarry responds to a local and shallow water system connected to the recharge/discharge of the Pond and tributary system. Deeper high volume flow along the Fault is not indicated in the data and further is not observed in the Quarry.

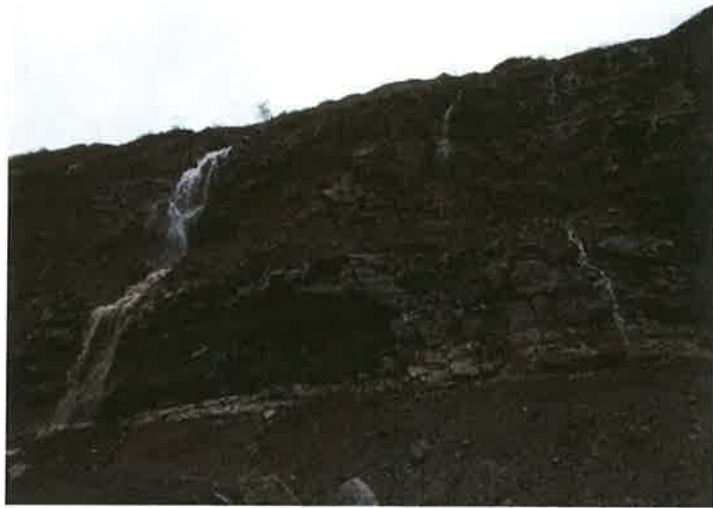
Fault zone (looking up from base of highwall)

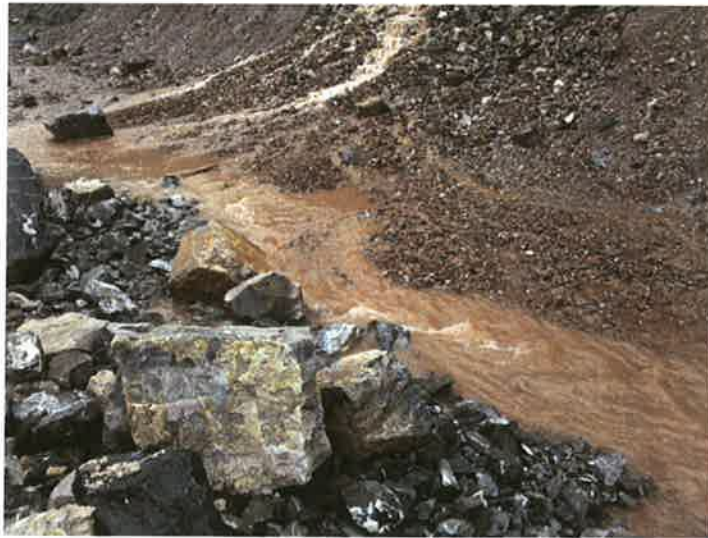
Fault zone swale (looking Northeast or "upstream")

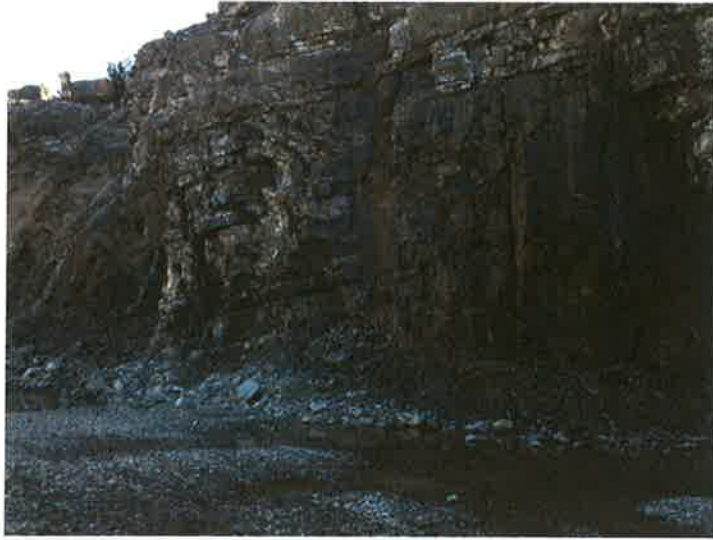
Southeast Wall (behind sump transducer, wall very wet)

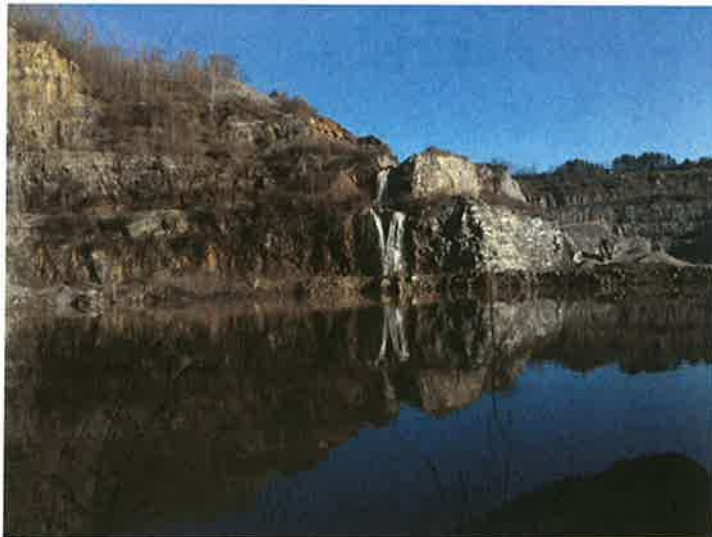
Looking North across sump to Primrose Creek outflow on west wall

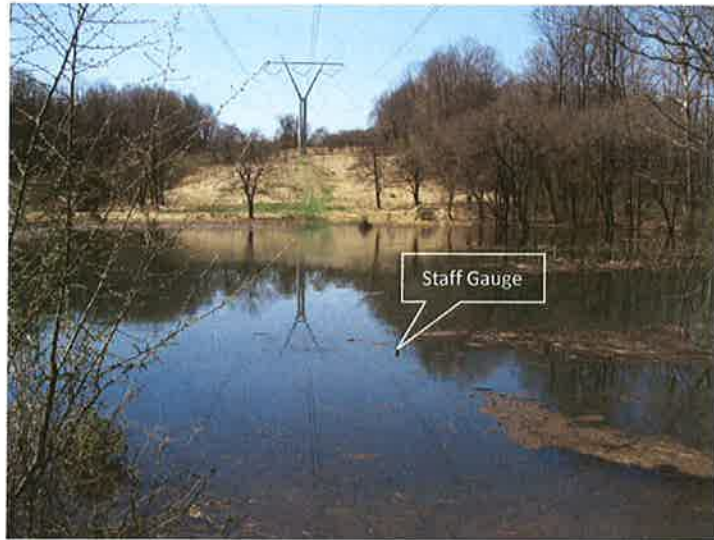
Pond (with staff gauge nearly completely submerged, looking west)

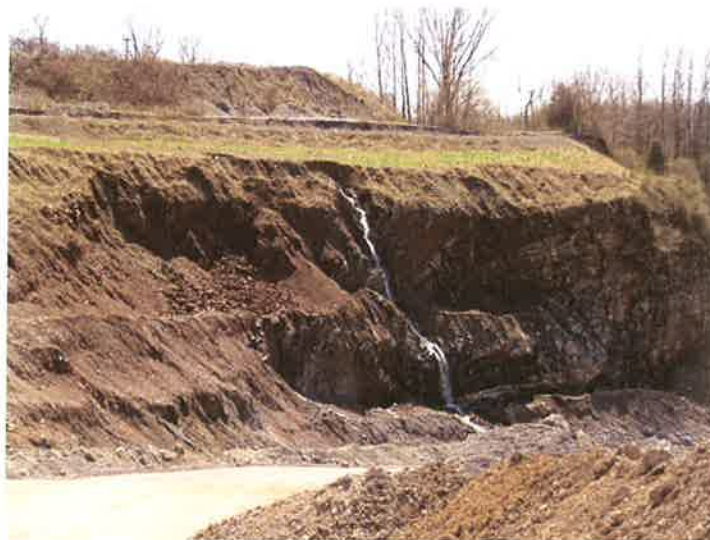
Attachment F includes photographs of the Quarry at different monitoring locations showing seeps, and other water bearing features throughout the period of this study. Beginning with photographs from March 2010, the Quarry is shown to be receiving water through the shallow expression of the Fault zone through: 1) water cascading from a water bearing zone at approximately 90 feet msl entering the channel; and 2) water bearing zones observed along the base of the highwall. During March the Sump was infilling and being pumped to prevent overflow to the Quarry floor and maintain flow to the Primrose Creek. The April 2, 2010 photograph of the Pond shows the large amount of surface water that collects in the area along the Fault. A corresponding photograph from April 2, 2010 shows the Pond water draining and cascading down the south wall of the Quarry through the previously identified water bearing zone.

Fault Zone (south wall, with water cascading)

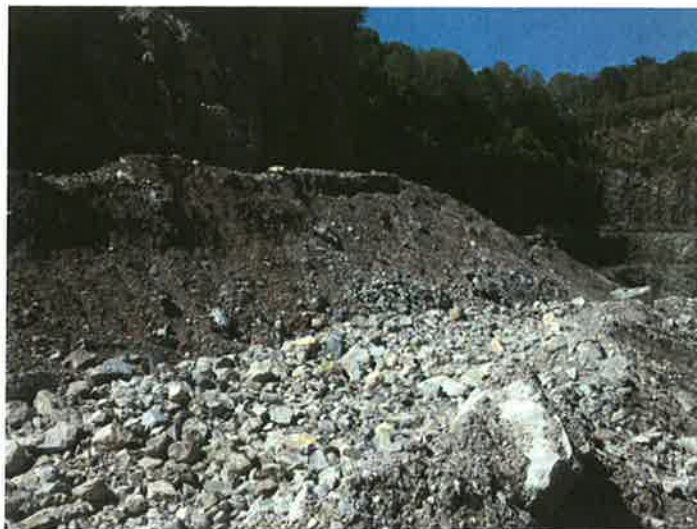
Fault Zone swale – filled with rock (looking southwest)

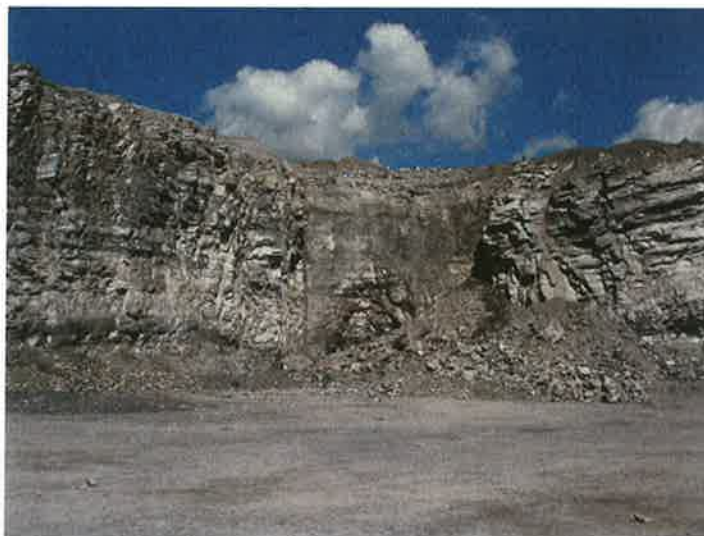
Seep (photo taken from pit floor, looking east)

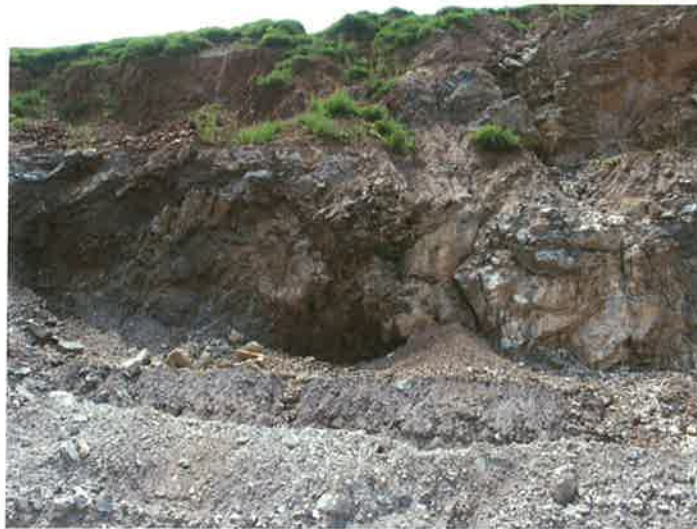
Photographs from May indicated drier conditions. Photographs taken on May 27<sup>th</sup> and 28<sup>th</sup> show the Quarry during the low hold period, when the water has drained from the Pond (due to low precipitation / low recharge conditions). Corresponding, there is no flow cascading down the south wall at the Fault zone. Photographs from May 25<sup>th</sup> and May 28<sup>th</sup> show two areas of groundwater seepage into the Quarry—at an area on the east wall and on the south wall behind the Sump transducer. These seeps are likely related to the Fault. During this time the Primrose Creek

Fault zone (south wall, dry)

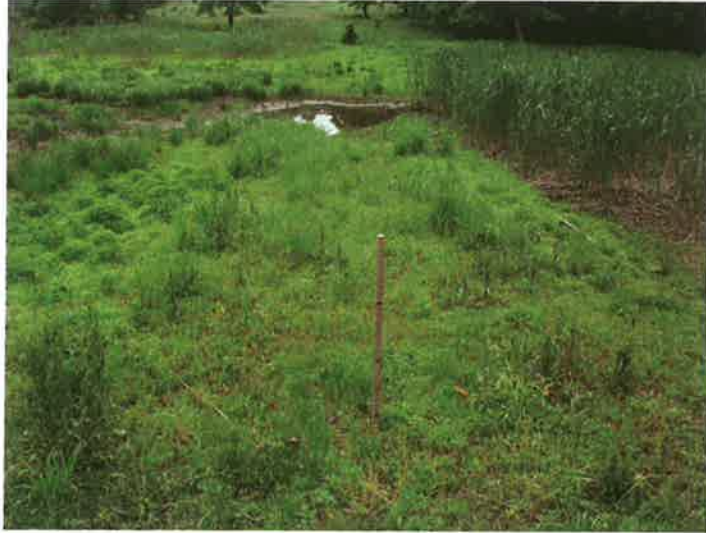
Pond area (with staff gauge, looking west)

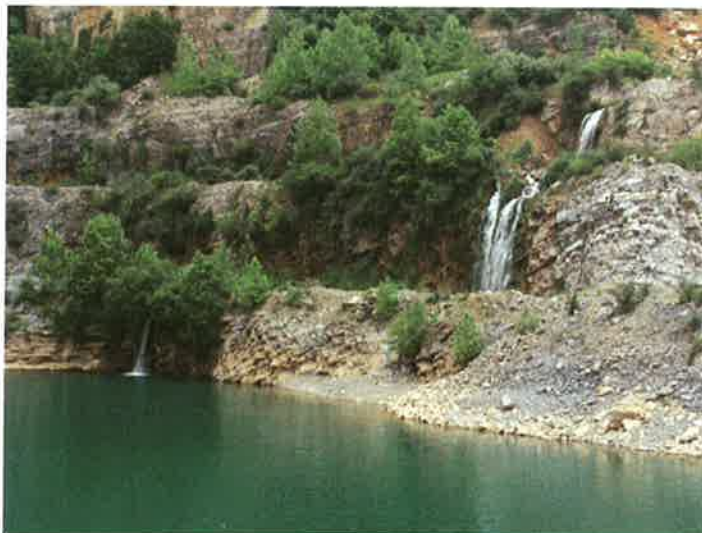
Based on the field observation and direct measurements taken at these locations, flows were calculated. At the culvert located in the northwest corner of the Sump, flow from the Primrose Creek Valley was measured on May 25, 26, 27, and 28 (averaged 1.14 MGD). The measured 1.14 MGD underestimates the total flow from this feature as a portion of flow leaks directly to the Sump through fractures in the swale (see last photo from 5/28/2010). The total flow is conservatively estimated at 1.3 MGD. Seeps located on the west, northwest, east, and southeast walls are estimated to flow 0.05 MGD. The flow associated with the Fault Zone water bearing zone is calculated below.

Culvert (northwest corner of sump); Primrose Creek outflow on west wall
