ANSONVILLE EAST
Abandoned Mine Reclamation Project
Contract No. OSM 17(4433)101.1

FACT SHEET 1 of 2

Pre-Construction

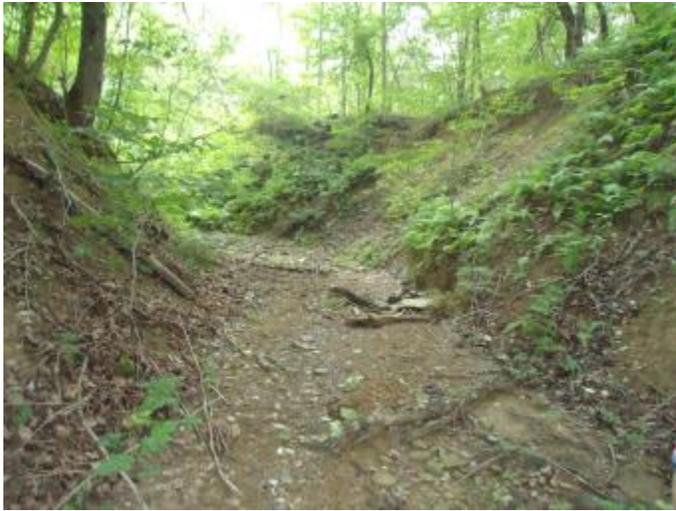
View of Potts Run Stream Channel located on the SW area of the project.

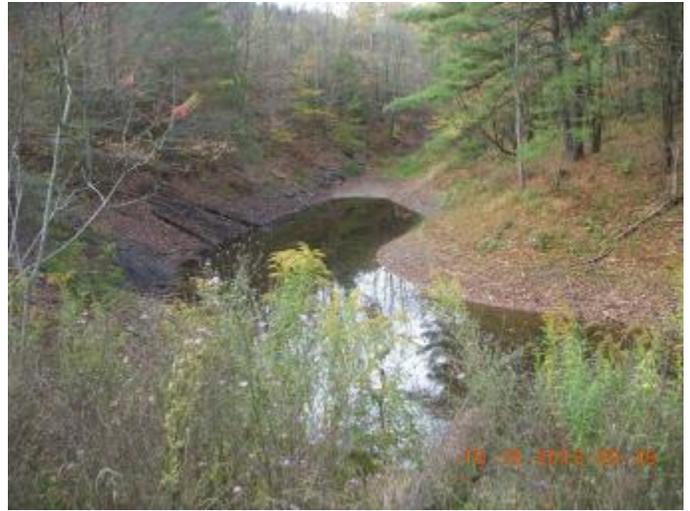
View looking SW from SR 729.

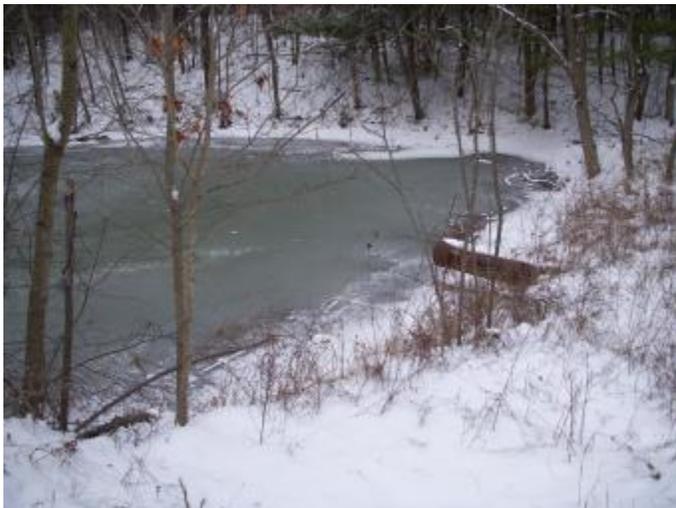
View of drainage pipe from roadway swale along SR 729.

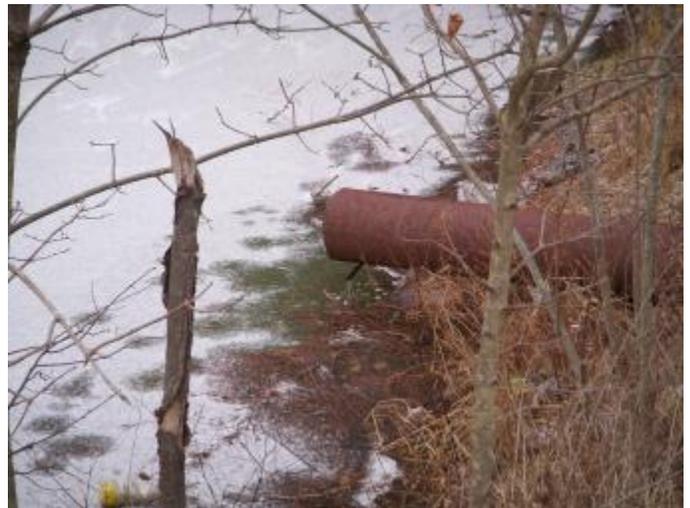
Close-up of water level below pipe from roadway swale.

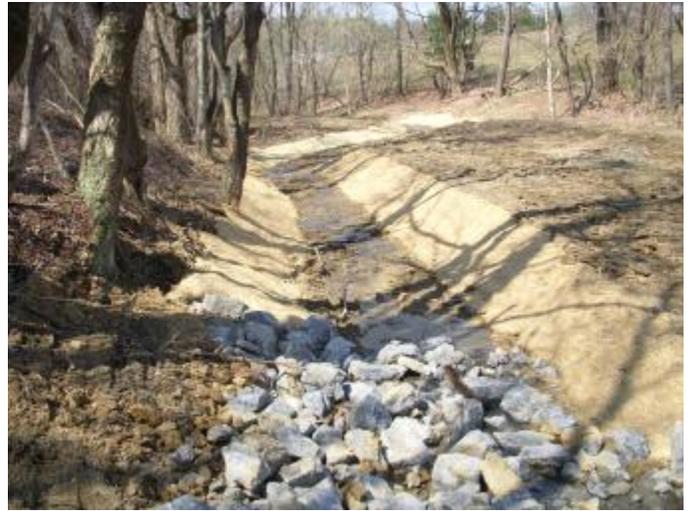
Pott's Run Stream channel work at SW end of job.

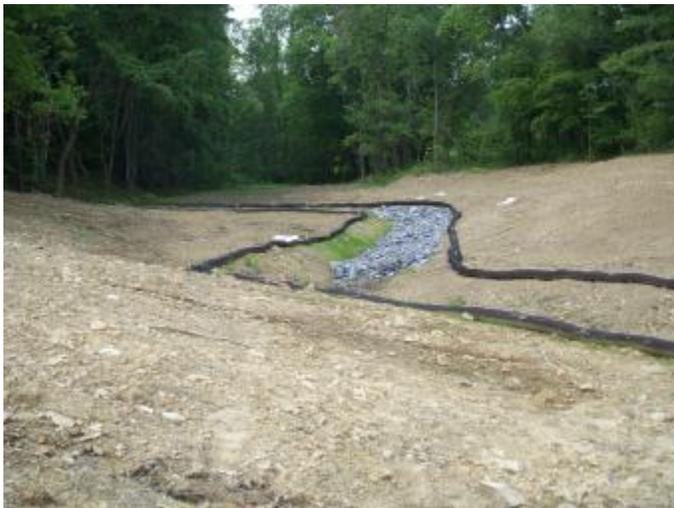
Looking SW from center of project.

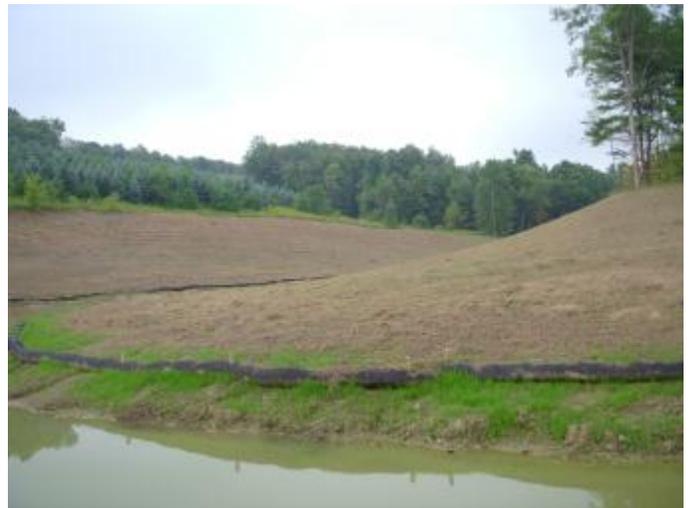
View looking SW from SR 729.
