THE MONONGAHELA SOUTH NO. 1 DANGEROUS HIGHWALL RECLAMATION PROJECT, CITY OF MONONGAHELA, PENNSYLVANIA₁

Abstract. The Pennsylvania Abandoned Mine Land Program completed the Monongahela South project in 2005. The project involved the stabilization of a dangerous and deteriorating highwall that threatened a church and school in the City of Monongahela, Washington County. A portion of the highwall was stabilized by cutting the slope back and included the incidental extraction of coal. Construction of a soldier pile and lagging retaining wall stabilized the remainder of the highwall. The highwall was typically 40 feet high and the hillside immediately above the highwall was very steep with residential streets and homes located just above the top of the slope. Differential weathering on the exposed highwall had caused treacherous rock overhangs that eventually would break off and fall onto the driveway located behind the church and school. Several automobiles were severely damaged by rock falls from the highwall during church services. The school at the site had been closed for several years due to the dangerous condition posed by the highwall.

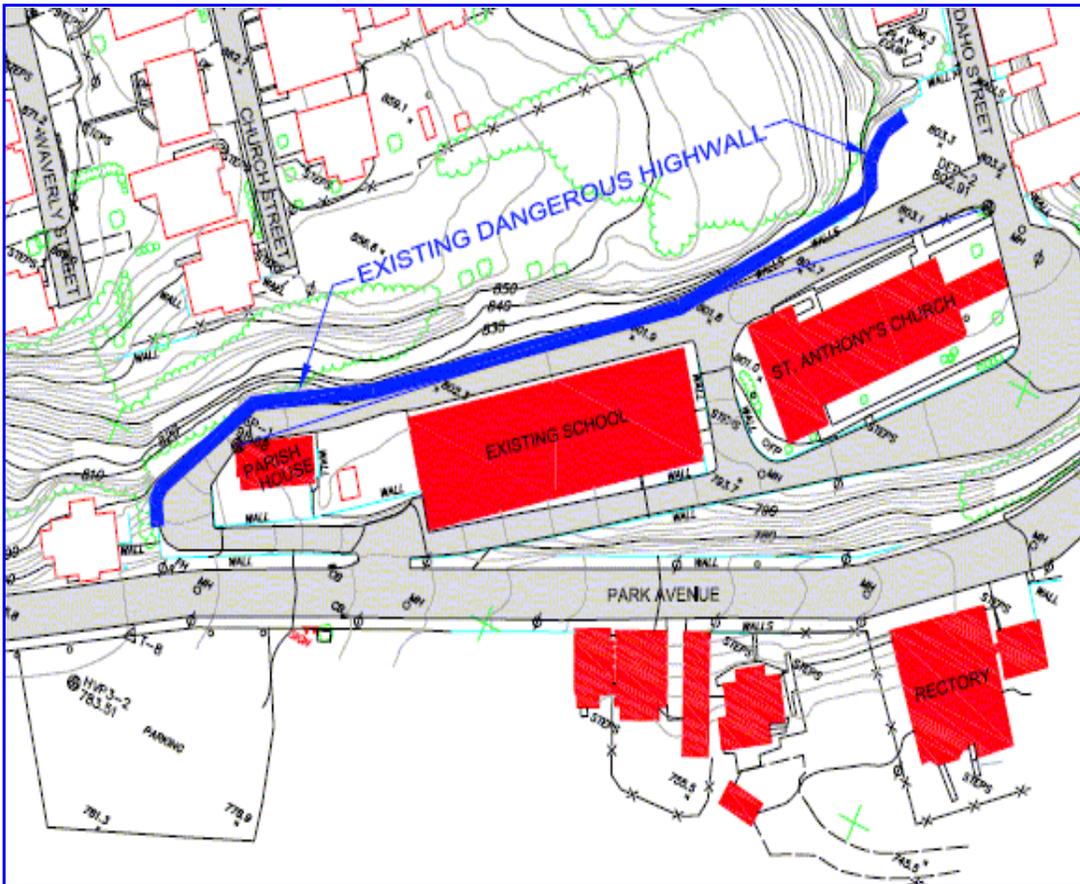
Figure 1. Project Site Plan.

along a driveway next to the church, parochial school, and a parish house. The highwall was typically 40 feet high with the following profile from bottom to top: approximately six feet of Pittsburgh coal; approximately 20 feet of sandy shale; approximately three to four feet of sandstone; and a soil mantle that varied in thickness. The hillside immediately above the highwall was very steep (approximately 1H:1V) with residential streets and homes located immediately at the top of the slope. Figure 1 shows the location of the highwall, church, parochial school, parish house, and other pertinent cultural features at the project site. The project site is included in AML Problem Area PA3803.

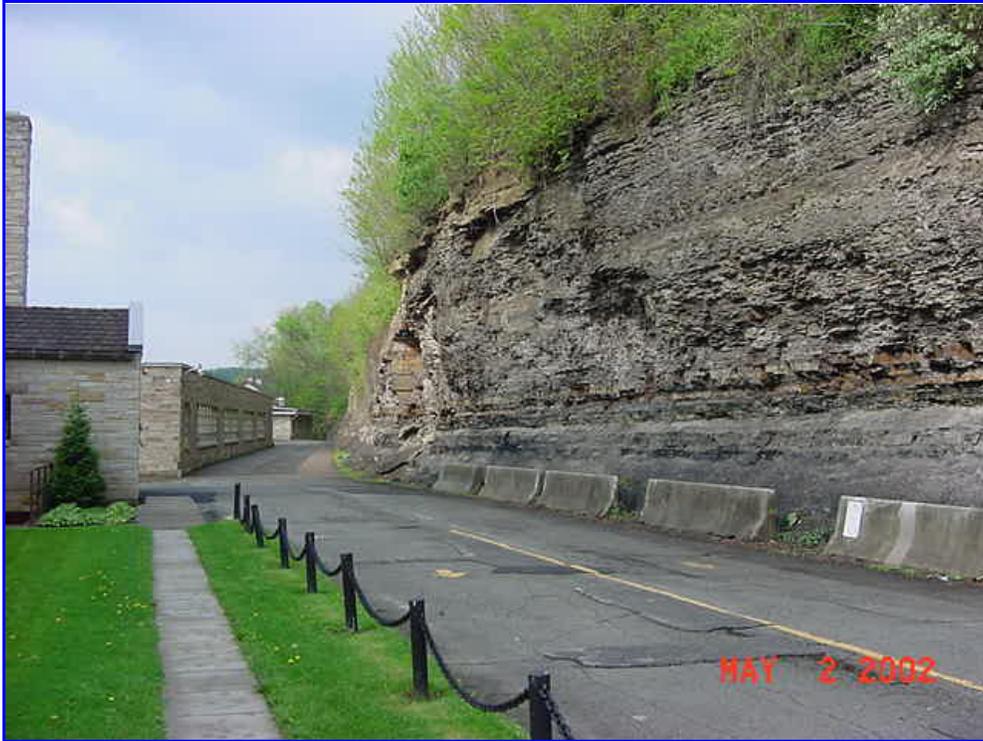
Figure 2. Dangerous highwall looking west with the church, school and parish house visible on left.

Differential weathering on the exposed highwall had caused the more competent sandstone layer near the top of the highwall to jut out from the less resistant underlying shale causing treacherous overhangs. A number of these overhangs eventually broke off and fell onto the driveway located behind the church and school. Several automobiles were severely damaged by rock falls from the highwall during church services. The school at the site had been closed for several years due to the dangerous condition posed by the highwall. In addition to the danger of falling rock the highwall posed to pedestrians and automobiles traveling along the driveway at the base, individuals walking along the top of the highwall were at risk of falling off the cliff.

Now that all reclamation work is completed, St. Anthony's Parish plans to reopen the school. A secondary benefit for the parish of cutting the highwall back was the widening of the driveway next to the church to provide an additional parking area. Figures 2 and 3 show photographs of the dangerous highwall prior to the reclamation project.

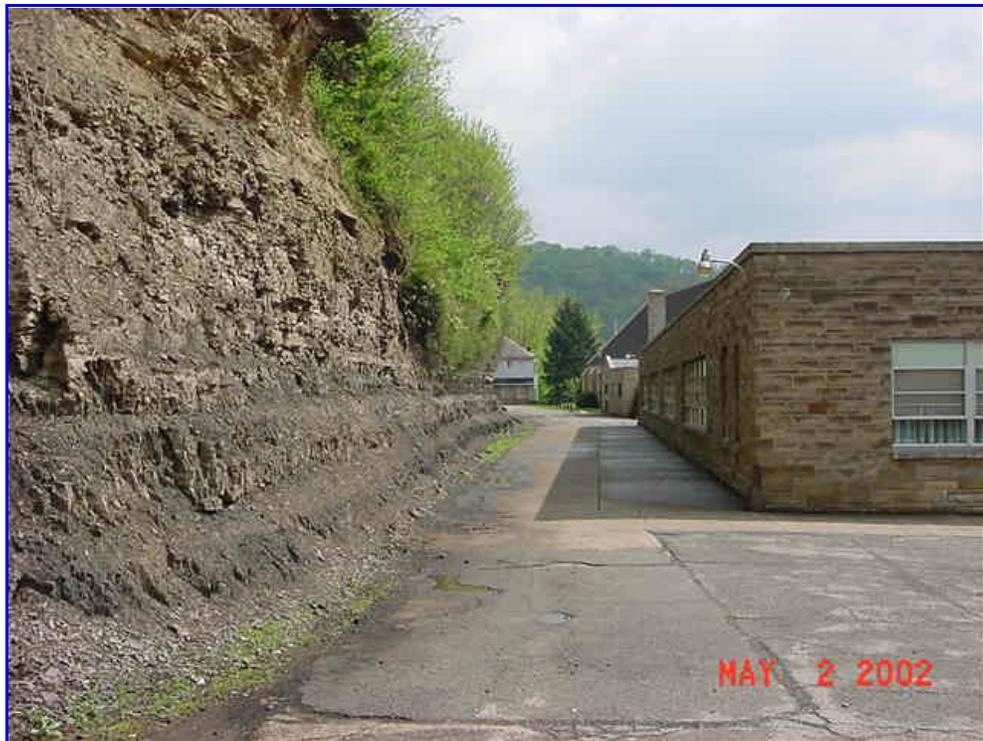
Figure 3. Dangerous highwall looking east with the school and church on right.

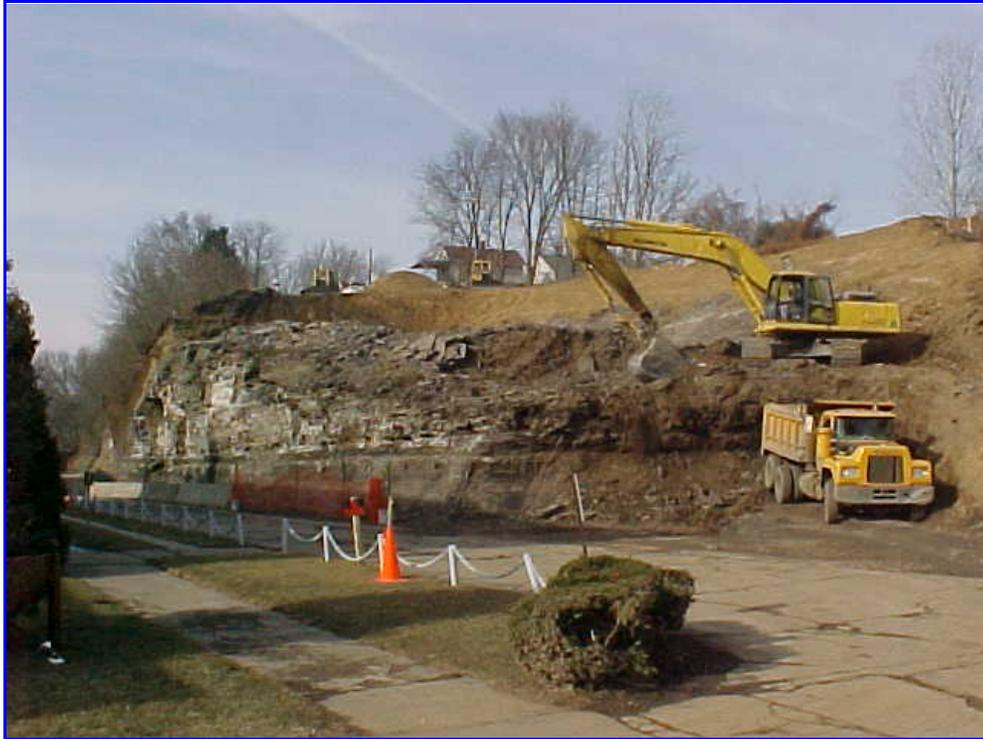
Figure 4. Initiation of the excavation work to reduce the slope of the highwall.

Construction was initiated in December of 2003 and a final inspection for the project was held on July 14, 2005. Work on the project began with cutting the slope back starting at the eastern end of the highwall. Figure 4 shows the initiation of slope reduction excavation. The original design estimated that 22,600 cubic yards of rock and soil would need to be excavated and disposed of to achieve the final grade. The actual quantity of rock and soil excavated and hauled to a spoil disposal area approximately one mile from the project site was 27,700 cubic yards. The cost of the additional excavation and disposal added approximately \$92,200 to the total contract amount.

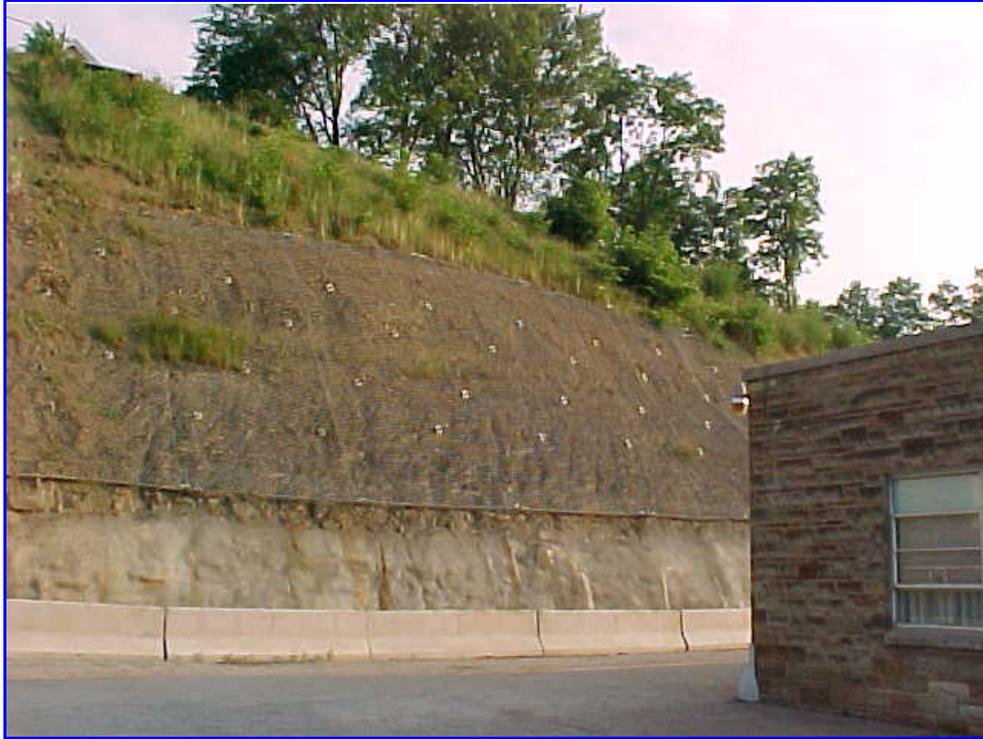
Figure 5. Finished cut slope with rock face support system adjacent to the school building.

The spoil disposal site was at a location where a sewer line installation project with a need for large quantities of fill material was underway. Spoil disposal was coordinated with the City of Monongahela and Carroll Township, the sponsors of the sewer line project. This coordination was beneficial for all parties involved, as removing and disposing of the excess fill from the project site was a major portion of the work at the project. Figure 5 shows an overview of the completed cut slope in relation to the church and school.

The exposed coal seam face remaining at the base of the final cut slope was covered with steel mesh and grouted with a fiberglass-reinforced grout material. The final rock face of the finished cut slope was covered with a rock face support system comprised of wire mesh fencing anchored into rock along the hillside. Figure 7 shows the fiberglass-reinforced grout being applied to the coal seam face.

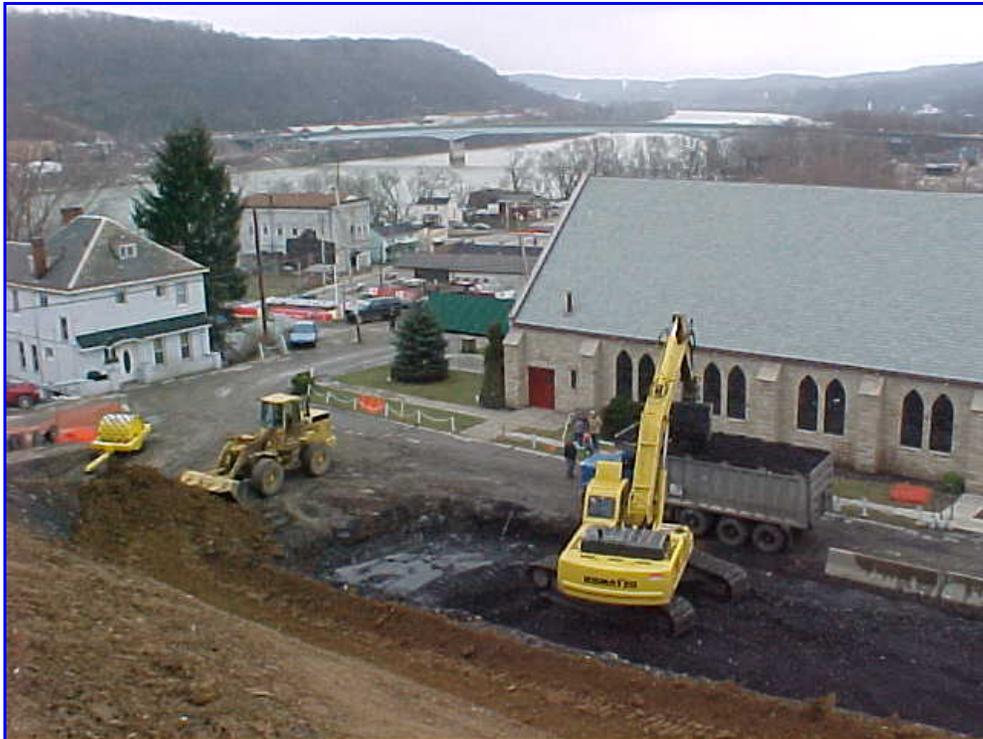
Figure 6. Incidental coal extraction during project construction.

By cutting back the hillside to eliminate the vertical highwall, a block of Pittsburgh Coal was uncovered. Approximately 1,956 tons of coal were removed from the project site and sold. Figure 6 shows the coal removal operation during project construction. During excavation of the final cut slope, a number of underground mine workings were intercepted resulting in four standing mine openings at the base of the final slope. The design called for pneumatic stowing of the opening to block access followed by horizontal drilling of the exposed coal seam face with injection of a cement grout to stabilize the old mine workings and prevent future problems due to mine subsidence. However, before all of the openings were stowed and grouted, one of the larger openings in the middle of the project area collapsed. This necessitated a design change to construct a small retaining wall and to grout the strata above the opening. The cost of the remedial work to stabilize the collapsed area was about \$44,000.

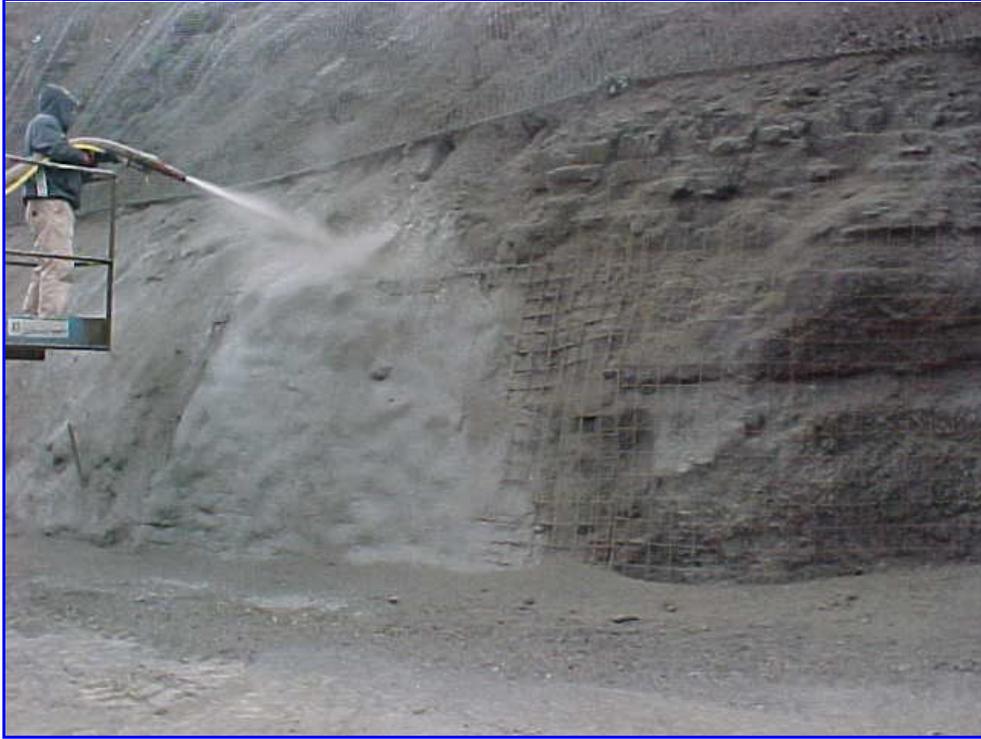
Figure 7. Fiberglass-reinforced grout being applied to the coal seam face.

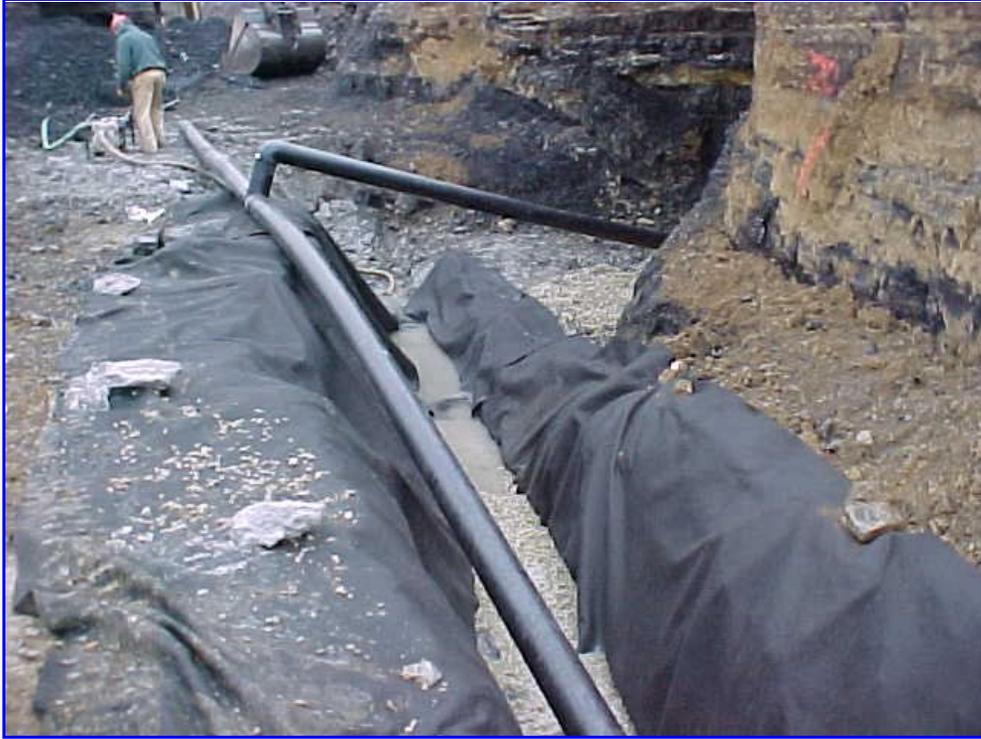
Figure 8. Mine drain being constructed near the base of the finished cut slope.

In order to effectively route stormwater runoff from the project site, a new storm drain had to be installed and tied to the municipal stormwater system located along Park Avenue. The existing municipal system was undersized and in a state of disrepair, so the PA-DEP partnered with the City of Monongahela to upgrade the facilities along Park Avenue. A new culvert had to be installed under Park Avenue to effectively route the water to Pigeon Creek, and the PA-DEP contractor, Alex E. Paris Contracting, Inc, performed this work. A small volume of mine water also drained from the mine entries located at the base of the final cut slope, and a mine drainage collection and conveyance system had to be constructed to route this water away from the finished church parking area. Figure 8 shows the mine drain being constructed near the base of the finished cut slope.

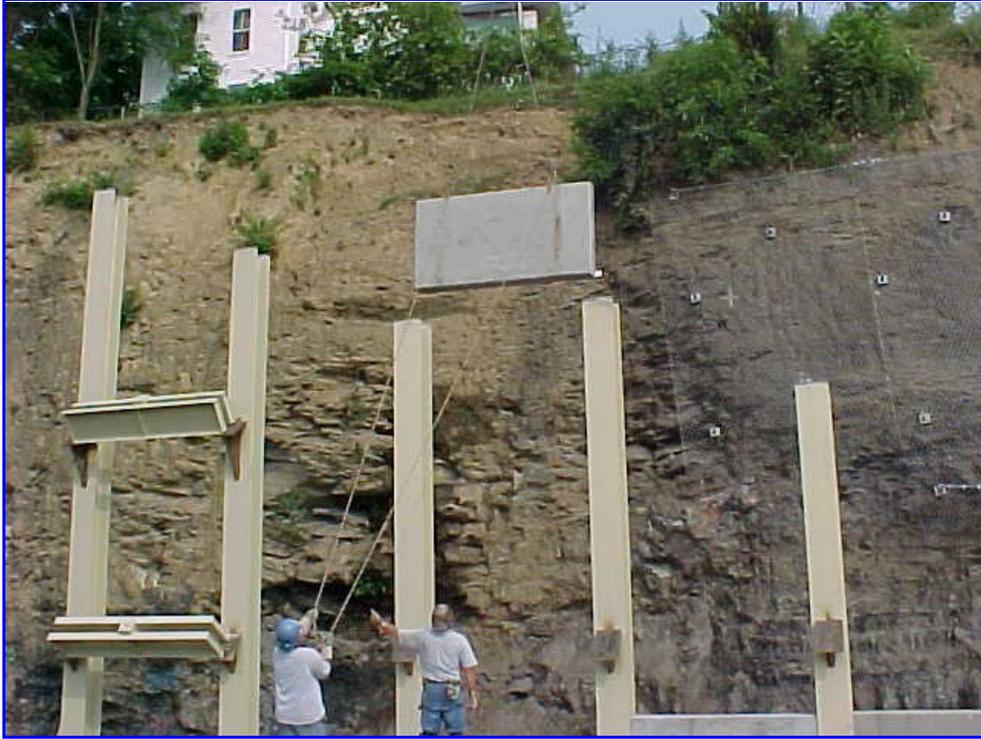
Figure 9. Soldier pile and lagging retaining wall under construction.

At the western end of the highwall a soldier pile and lagging retaining wall had to be constructed due to the proximity of a house above the highwall. During construction, the contractor proposed a modified retaining wall design to alleviate construction safety concerns and to facilitate construction of the retaining wall in the very tight working conditions. The modified wall design was approved by the Department and resulted in a construction cost savings of approximately \$25,000. In order to ensure that the final slope above the retaining wall was stable, micropiles were installed near the top of the final cut slope in the vicinity of Church Street and the nearest occupied house.

The micropiles were not included in the original project design, and the cost to install the micropiles was approximately \$104,000. In addition, a five-foot high security fence was installed along the top of the entire length of the finished cut slope. Figure 9 shows the retaining wall under construction, and Figure 10 shows the finished retaining wall and rock face support system near the west end of project site.

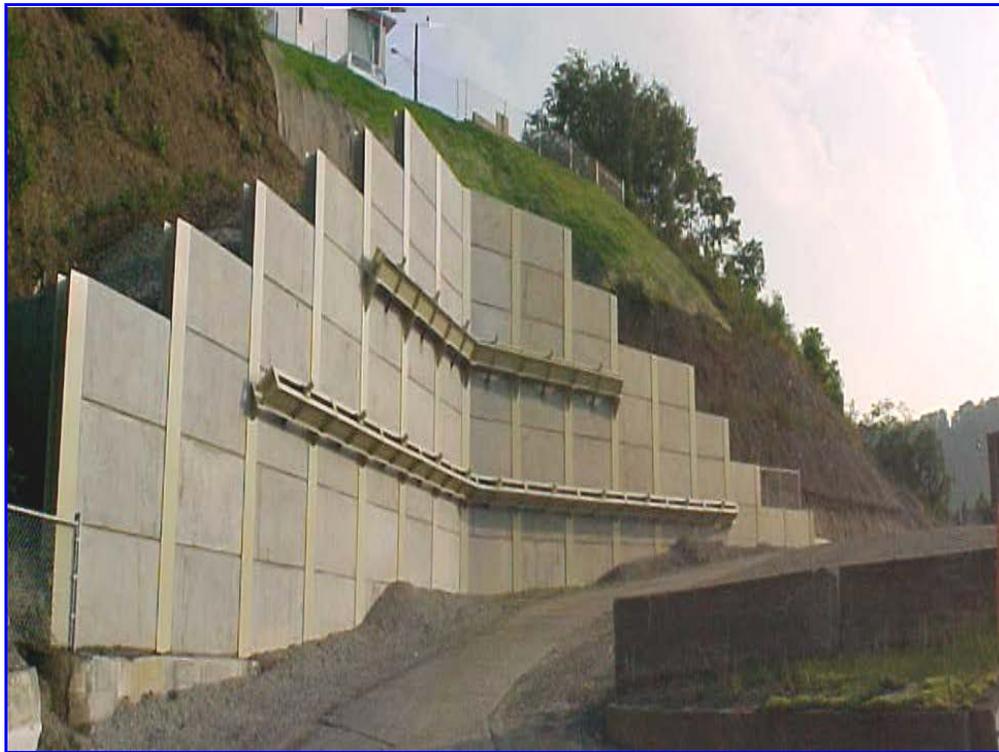
Figure 10. Completed retaining wall at west end of project site - the school is just visible on the right edge of photograph.

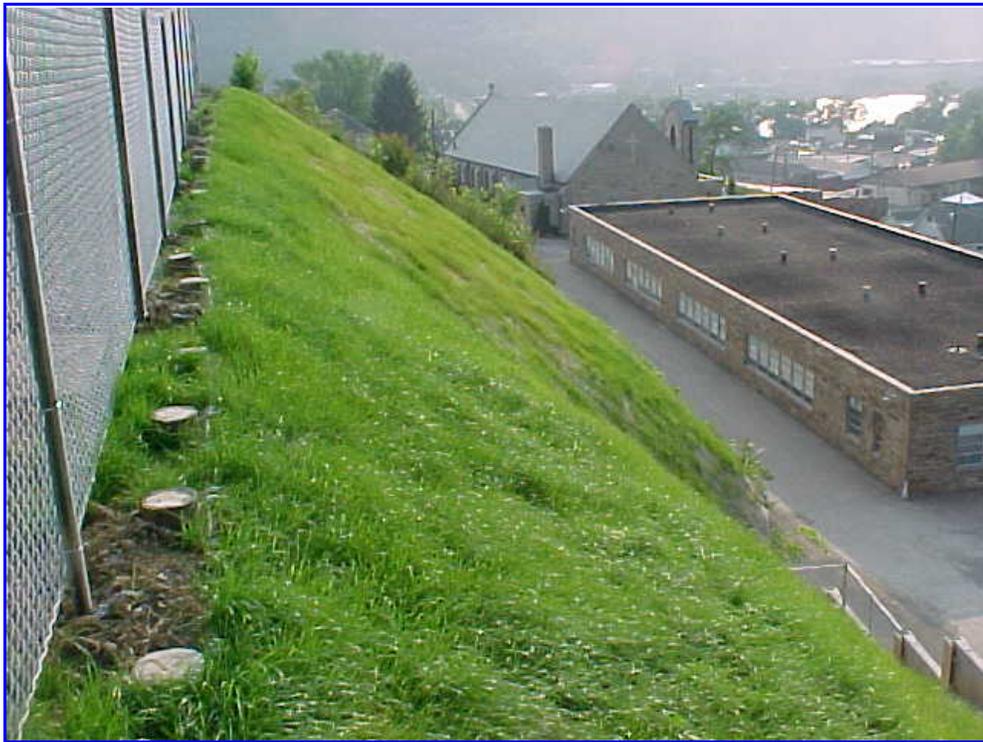
Figure 11. Reclaimed site from above with the school and church in background.

On July 6, 2005, a media event was held to showcase the project to the general public. Many parishioners attended to express their gratitude for the project. Mr. Ernest Gross, a lifelong member of the parish, had been working since 1985 to find a solution to this hazardous condition and was ecstatic about how the final project turned out. Mr. Paul Iurlano, property manager for the Diocese of Pittsburgh, also lauded the PA-DEP's efforts to reclaim the site. Father Joseph Feltz of St. Anthony's Parish expressed his deepest appreciation for the project. He indicated that the church plans to pave the parking area in the spring of 2006 and intended to take steps to put the school back in service. The church has already begun using the parochial school building to hold Sunday school classes. Figure 11 shows the finished project from above the reclaimed highwall with the church and school in the background.
