2014 Field Observations of Tennessee Gas Pipeline, Northeast Upgrade Project By Nicole Zenes, Delaware Riverkeeper Network

Preliminary Findings and Excerpt for FERC To Consider in Review of Atlantic Sunrise Pipeline

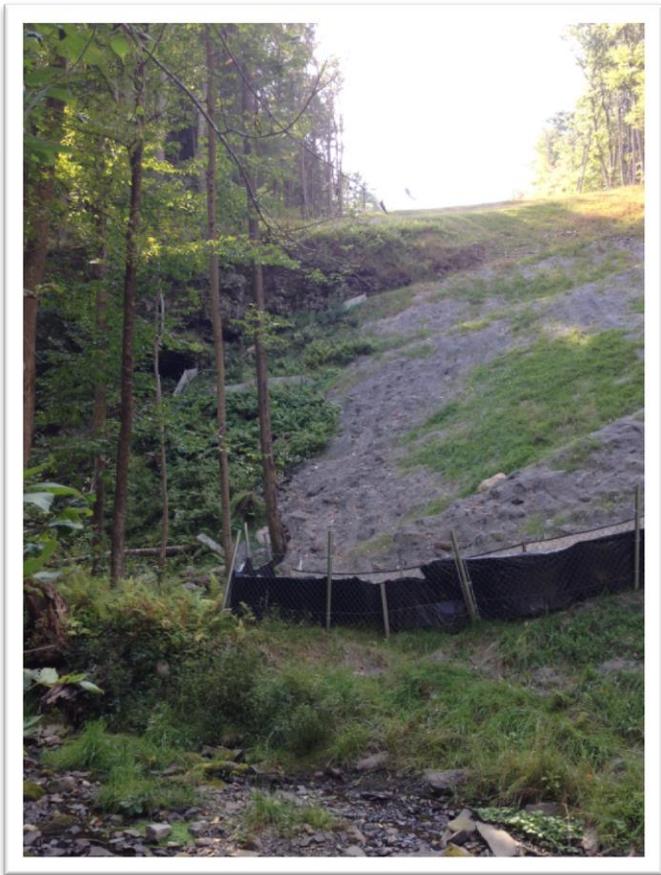
Of the sampled, the section of pipeline that was constructed over Cummins Hill and across Cummins Creek saw the most impact from erosion. The steep slopes that were cleared of mature trees still showed little sign of herbaceous growth on 7/11, 7/14, and 8/14, 2014 during field visits. The slope breakers on the ROW surrounding Cummins Creek were eroding along the perimeter. The water running down the slope breakers pushed the runoff to the side of the ROW creating gullies and stormwater runoff off the ROW and down into the stream. As a result of this erosion and increased stormwater runoff, sediment was observed in riffle habitat of Cummins Creek, which likely impaired aquatic life by smothering the habitat of these animals. This stormwater runoff and lack of regrowth indicates permanent soil compaction on the ROW. Similar locations along temporary work spaces and additional temporary work spaces also had sparse regrowth and soil compaction. The pipeline cut steep mature forested slopes, which has major implications for pollution to the receiving streams at the bottom of such steep slopes. FERC needs to address and evaluate these severe impacts that occur on steep slopes and the resultant pollution that can impact the adjacent streams downslope. Wind throw and damage to adjacent mature trees off the ROW was also observed during these field visits.

Sparse herbaceous growth, soil compaction, evidence of runoff and gullies, and sediment escaping the silt fences and traveling into adjacent Cummins Creek, an Exceptional Value Stream in Pike County, PA.

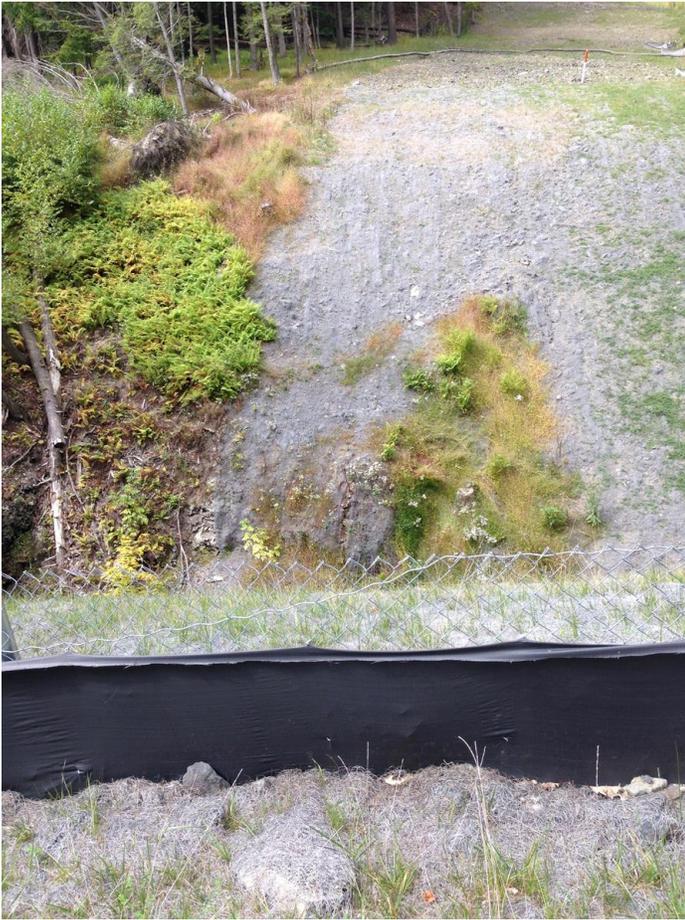
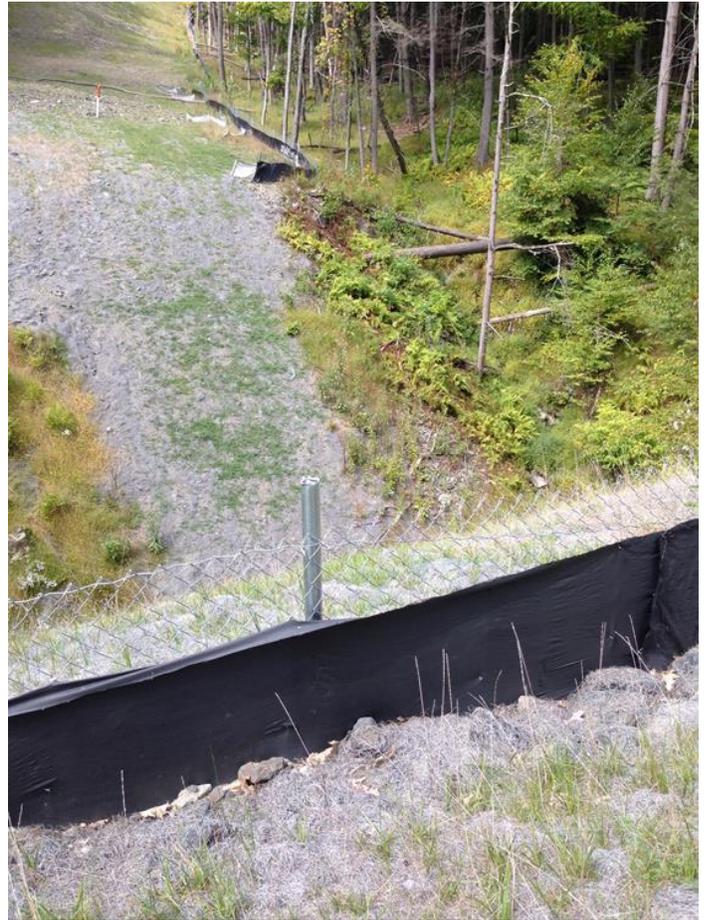
The steep slopes adjacent locally named Evergreen Stream (UNT to the Delaware River) were also bare during July and August field visits. There was erosion that could be clearly seen along the sides of the ROW here as well. There were uprooted trees from wind throw or erosion or both impacted off the ROW.

Conditions of steep slope adjacent Evergreen Stream, July and August 2014.

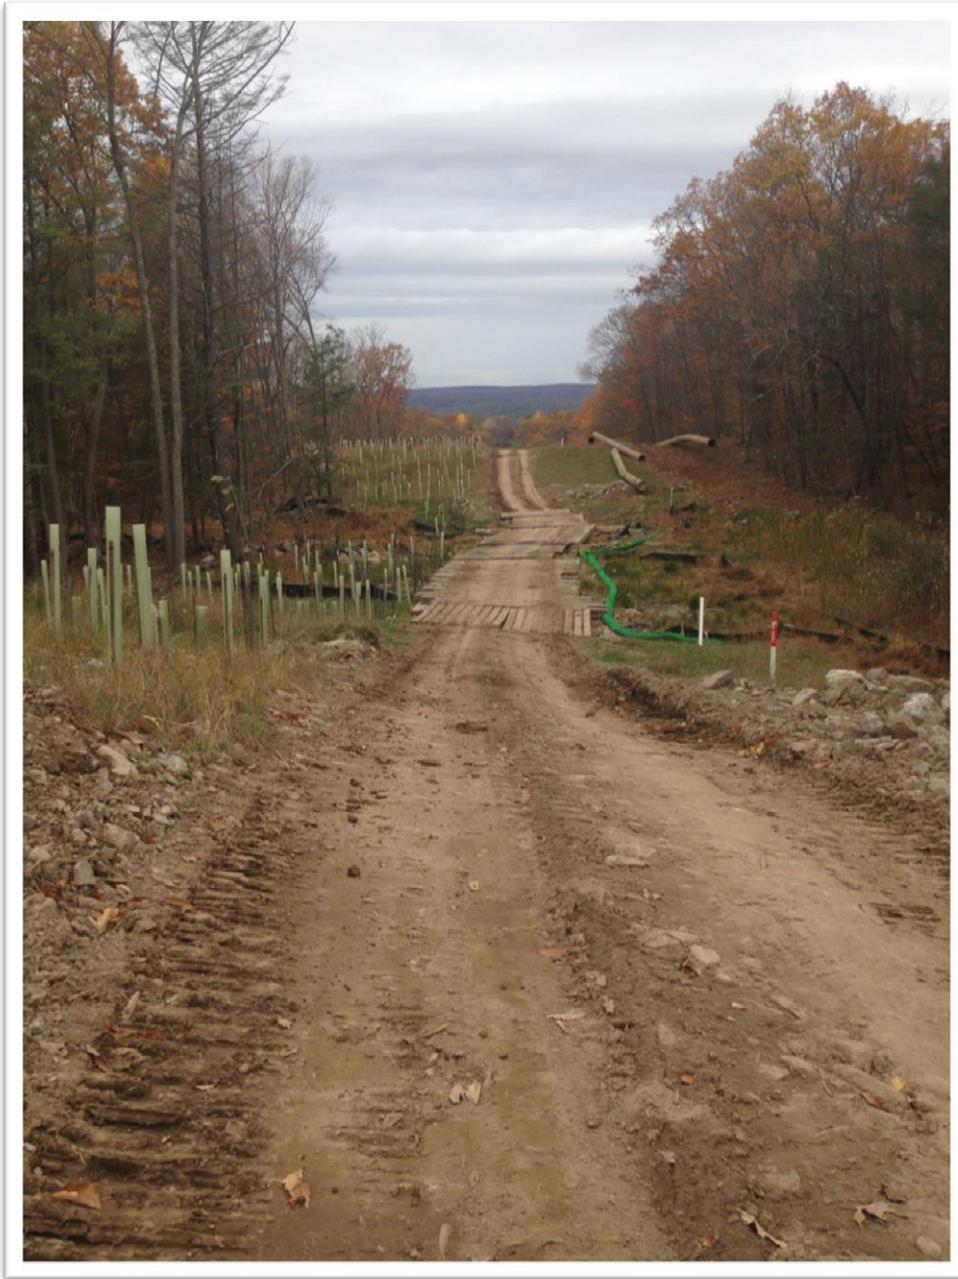
Lagging tree planting and remediation practices lead to repeated harm over several seasons. This picture was taken Summer of 2014 – almost a year after the new pipeline had been constructed and demonstrates repeated harm due to pipeline timelines and lagging efforts to restore the ROW shortly after its completion in November 2013.

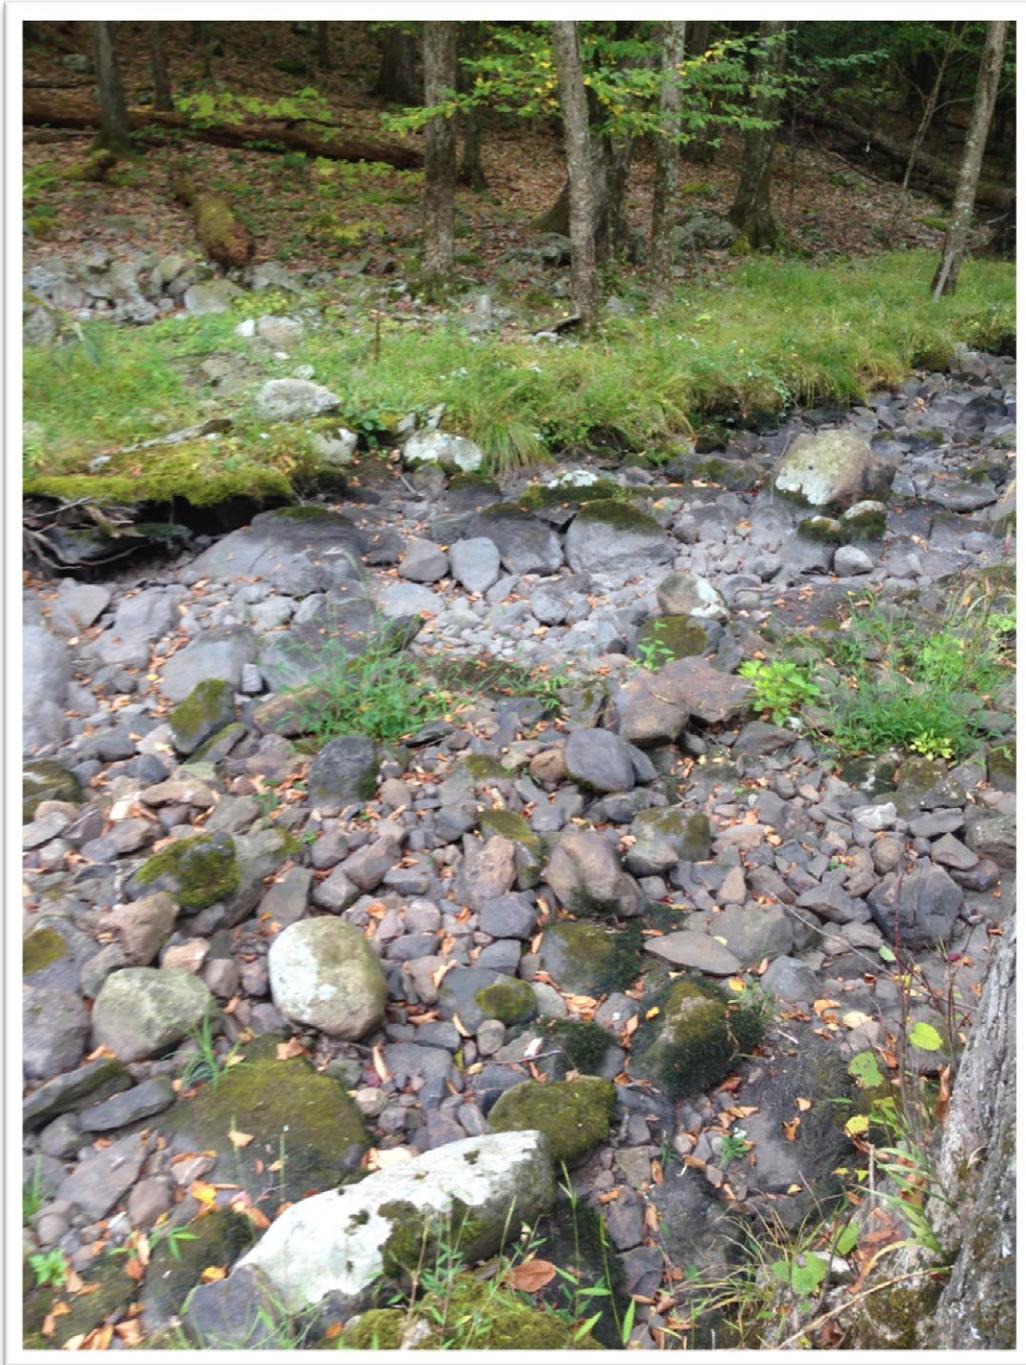
Streams S002 and S003 at High Point State Park were completely dry by July 23rd whereas on July 9th there was water present. Although rain was sparse in the summer, the streams crossed by the pipeline appeared to have extra impacts. This is most likely due to the slope breakers diverting the natural path of the runoff and the severe soil compaction that limited infiltration. The slope breakers diverted water into the woods where it eroded along the edge of the pipeline. I also documented low streams levels in S004 and S005 at High Point State Park. Herbaceous regrowth in this section was patchy and sparse leaving bare soil. The soil had been compacted to the point where the ground was solid dirt and that vegetation could not colonize. On August 2nd, 2014, I recorded that two streams on the pipeline section from Evergreen to Cummins Creek went dry both of which had been previously flowing. Also August 7th, 2014 observations included a stream drying up off of New Road as well, seen in the picture below.

Dry stream off of New Road along pipeline ROW.

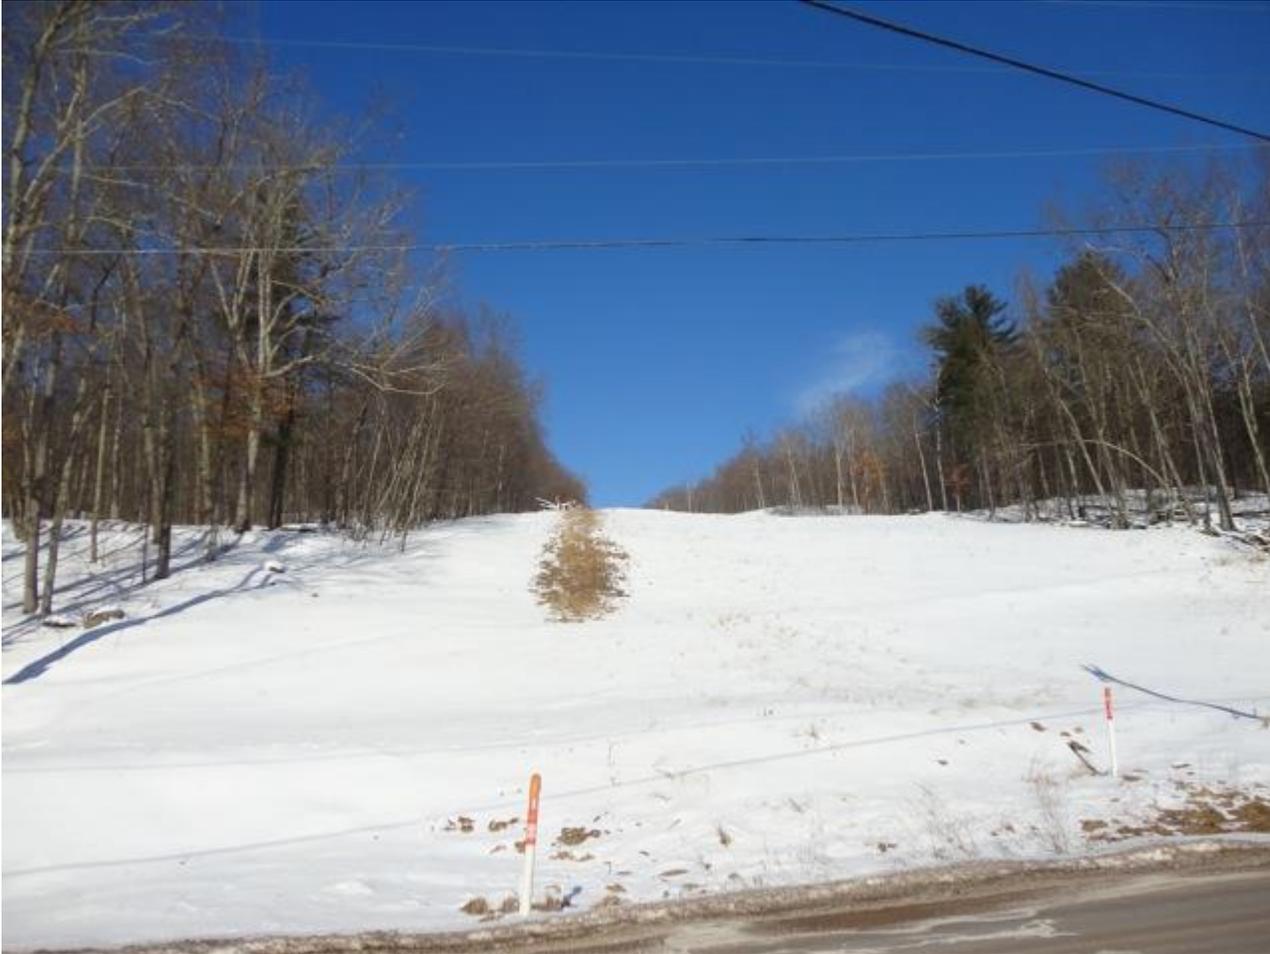
Various observers have noted melted snow over the buried pipelines even on very cold days. See the picture below taken west off of Rt 590 at the Lackawaxen River crossing 2-18-15 after a -12 degree day. The snow melt is over the new 30" pipeline which I suspect that the 24" line is now dependent from the 30" line. TGP now comes in and works on the older 24" line as maintenance projects which requires minimal approval usually under an existing PADEP permit and only gets reported the following May as I was told by David Hanobic FERC project manager NEUP.

Winter snow melt over 30 inch buried pipeline, February 18, 2015. Photo by J. Zenes

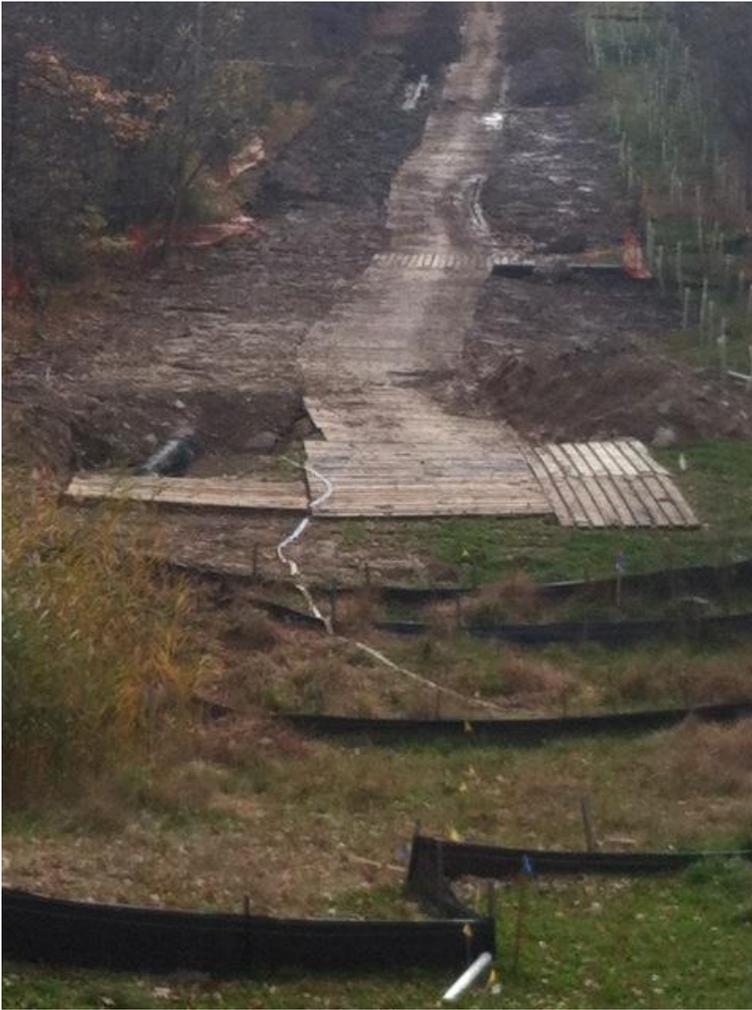
Maintenance work conducted by TGP on the old 24 inch line in the Fall, 2014. Photo by J. Zenes
