Re: Sunoco Pipeline LP – Pennsylvania Pipeline Project (Mariner East II)
Chapter 102 Permit No. ESG0100015001 – Major Modification
Revised Modification Request-Installation Method Change at PA Turnpike/280 HDD
Upper Uwchlan Township, Chester County, PA

PENNSYLVANIA PIPELINE PROJECT
CONSTRUCTION SPREAD 6

Aquatic Resources Report
0280 Reroute
Chester County, Pennsylvania

**Aquatic Resources Report
0280 Reroute
Chester County, Pennsylvania**

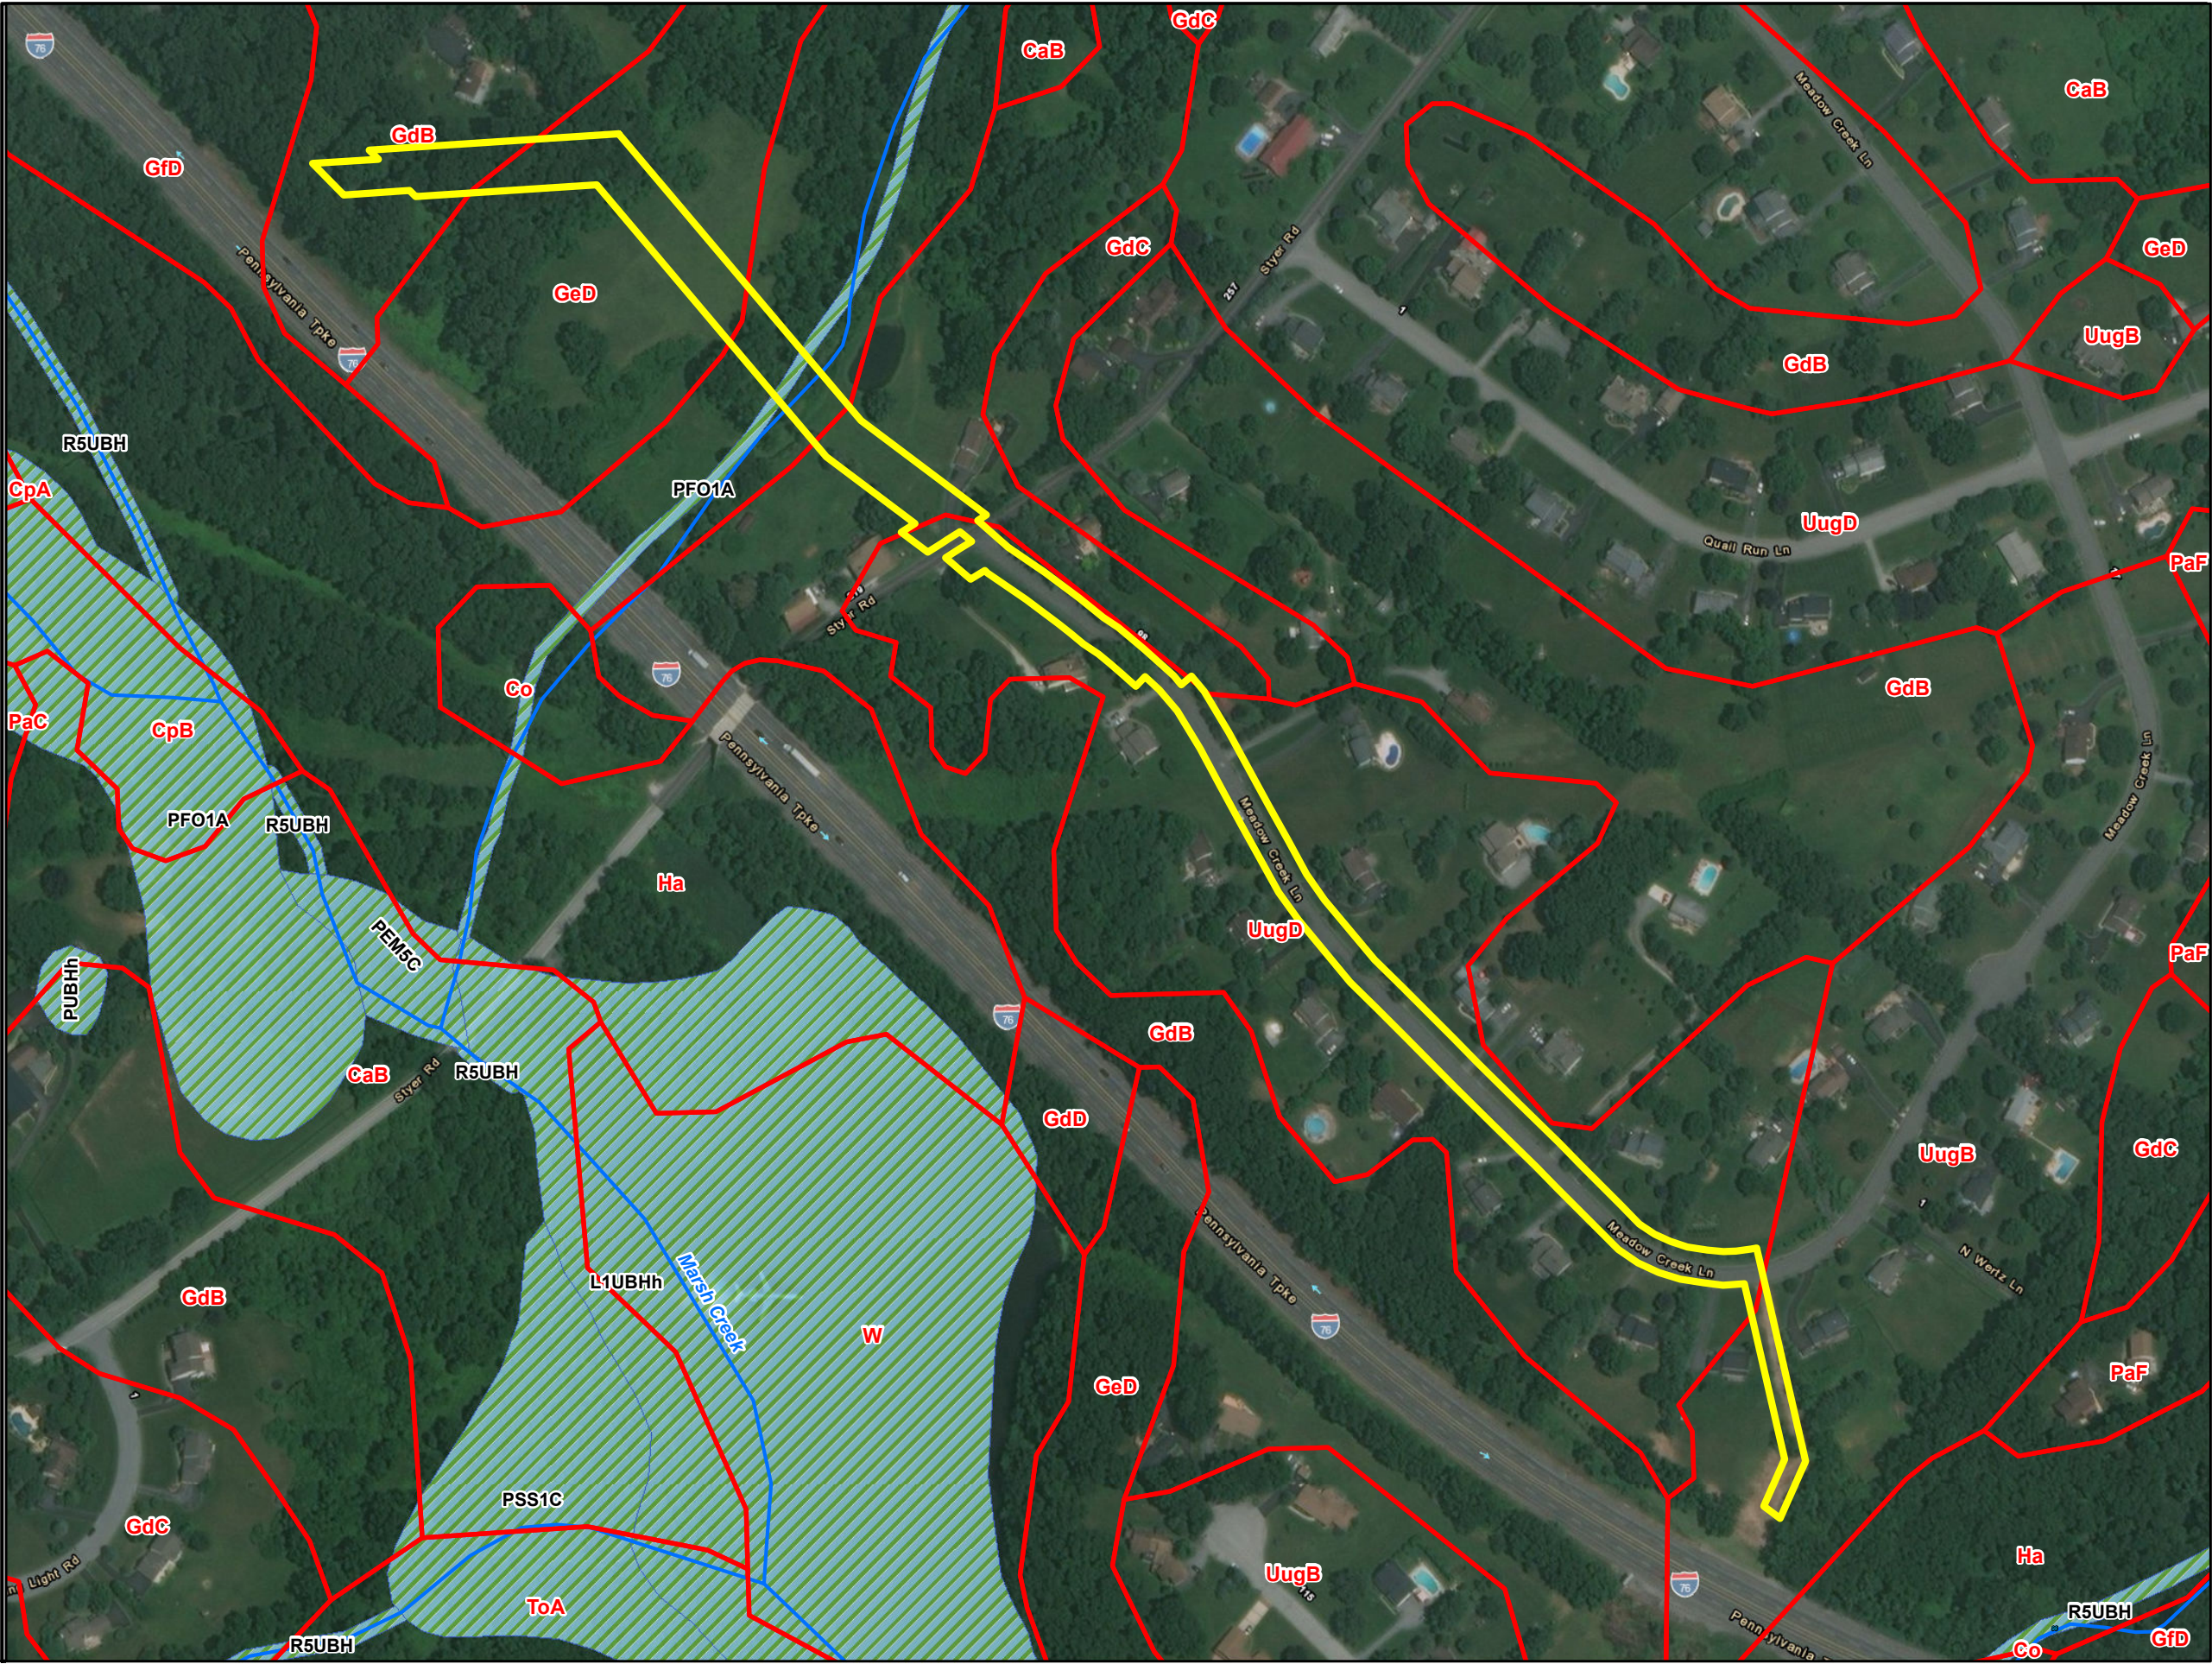
Figure 1. NWI Features and Soils on the Sunoco Pennsylvania Pipeline Project, Chester County, PA.
Sheet 1 of 1

Land use within the survey boundary is rural and consists of residential lawn, mowed field, scrub-shrub, woodlots, and several sparsely-concentrated residential homes. Land use in the general vicinity of the survey area is the same. Attachment A, Figure 1 provides an aerial basemap of the survey area.

A review of published and publicly available soils data for the survey area indicates that five (5) soils series are mapped within the survey boundary (Attachment A, Figure 1). Mapped soil series are summarized in Table 1 below.

One (1) USFWS mapped NWI feature was identified in the survey area. The NWI feature is classified as a temporary flooded, broad-leaved deciduous palustrine forested system (USFWS code PFO1A).

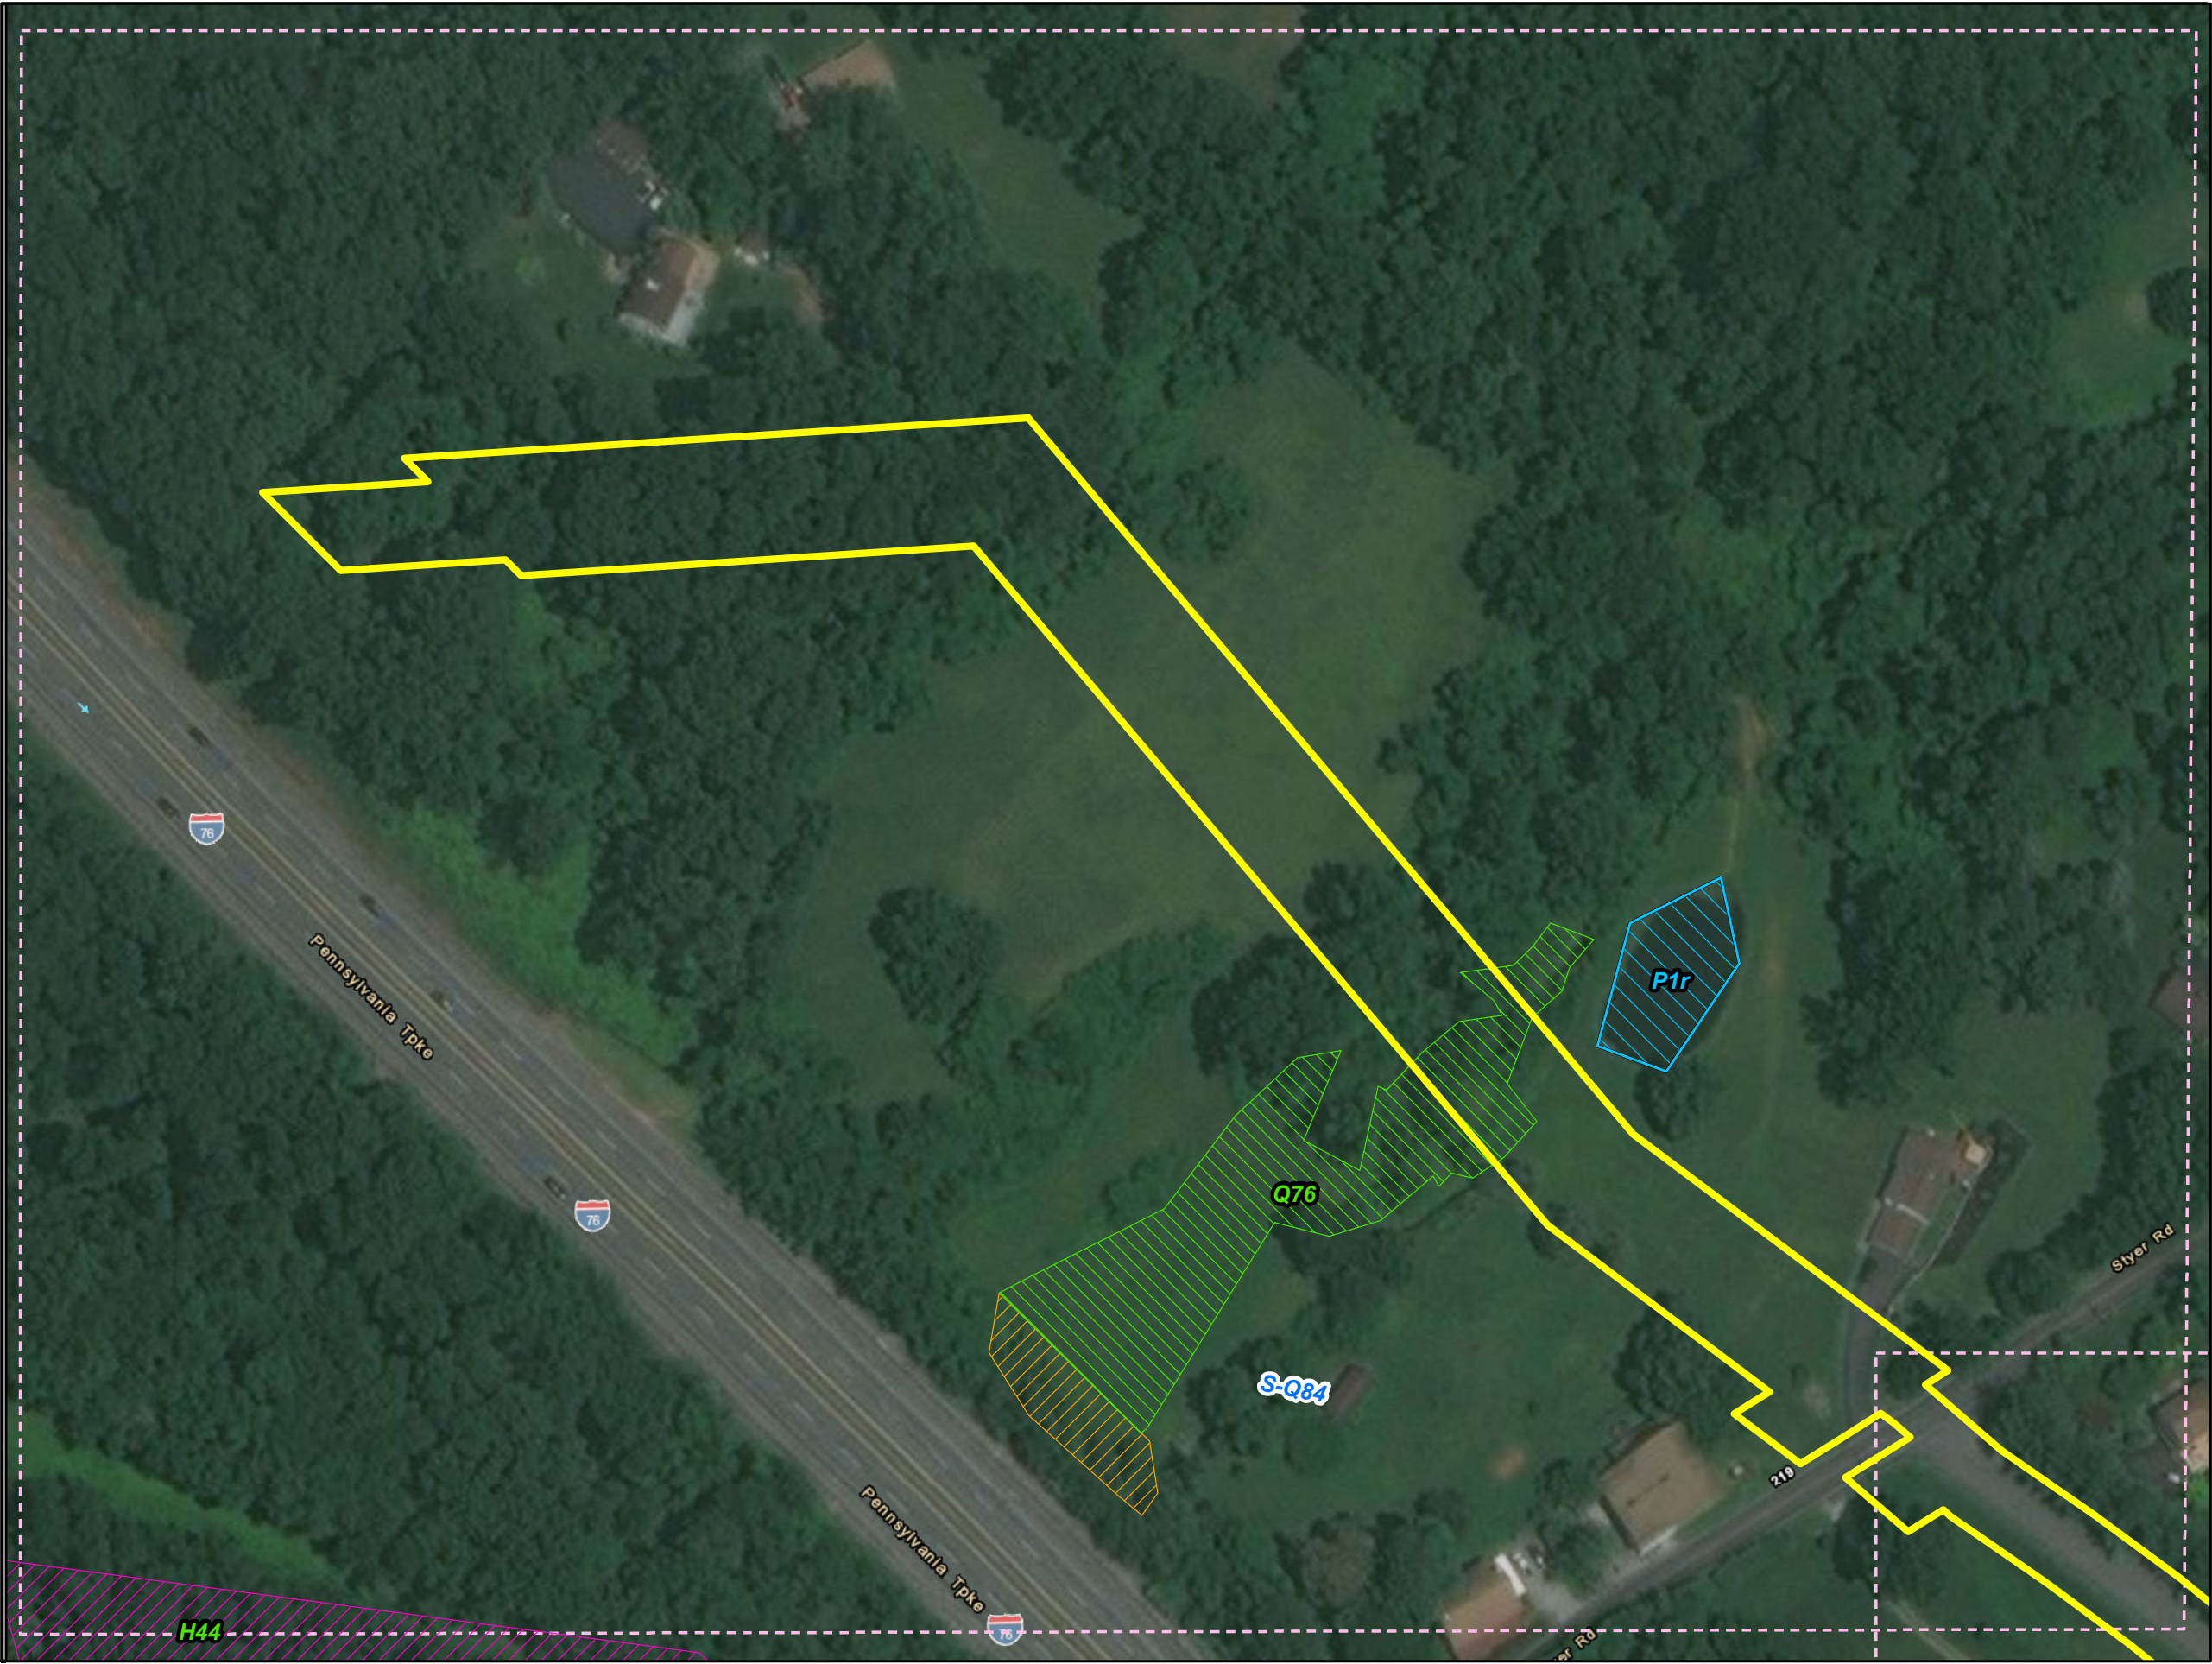
Figure 2. Delineated Aquatic Resources on the Sunoco Pennsylvania Pipeline Project, Chester County, PA.
Sheet 1 of 3

No new wetlands were identified within the survey corridor during survey efforts. One wetland, Q76, was extended from its modified (January 2019) delineation limits. The extension of wetland Q76 is a palustrine emergent wetland located in a narrow floodplain adjacent to stream S-Q83. The shrub area observed by USACE near wetland extension is located entirely in upland habitat. Though some hydrophytic vegetation was present in the understory vegetation, presence was observed to be below the thresholds required to meet USACE parameters for the hydric vegetation criteria of wetland delineation. Additionally, the shrub species themselves were not classified as hydrophytic. Hydrology indicators were identified inconsistently throughout the reevaluation areas, and where identified, the signature was generally weak. Specifically, some oxidized rhizospheres were identified in low concentrations. Soil cores were largely uniform in color and texture, lacking distinctive wetland characteristics such as redox concentrations or depletions noted in the delineated extension of wetland Q76.

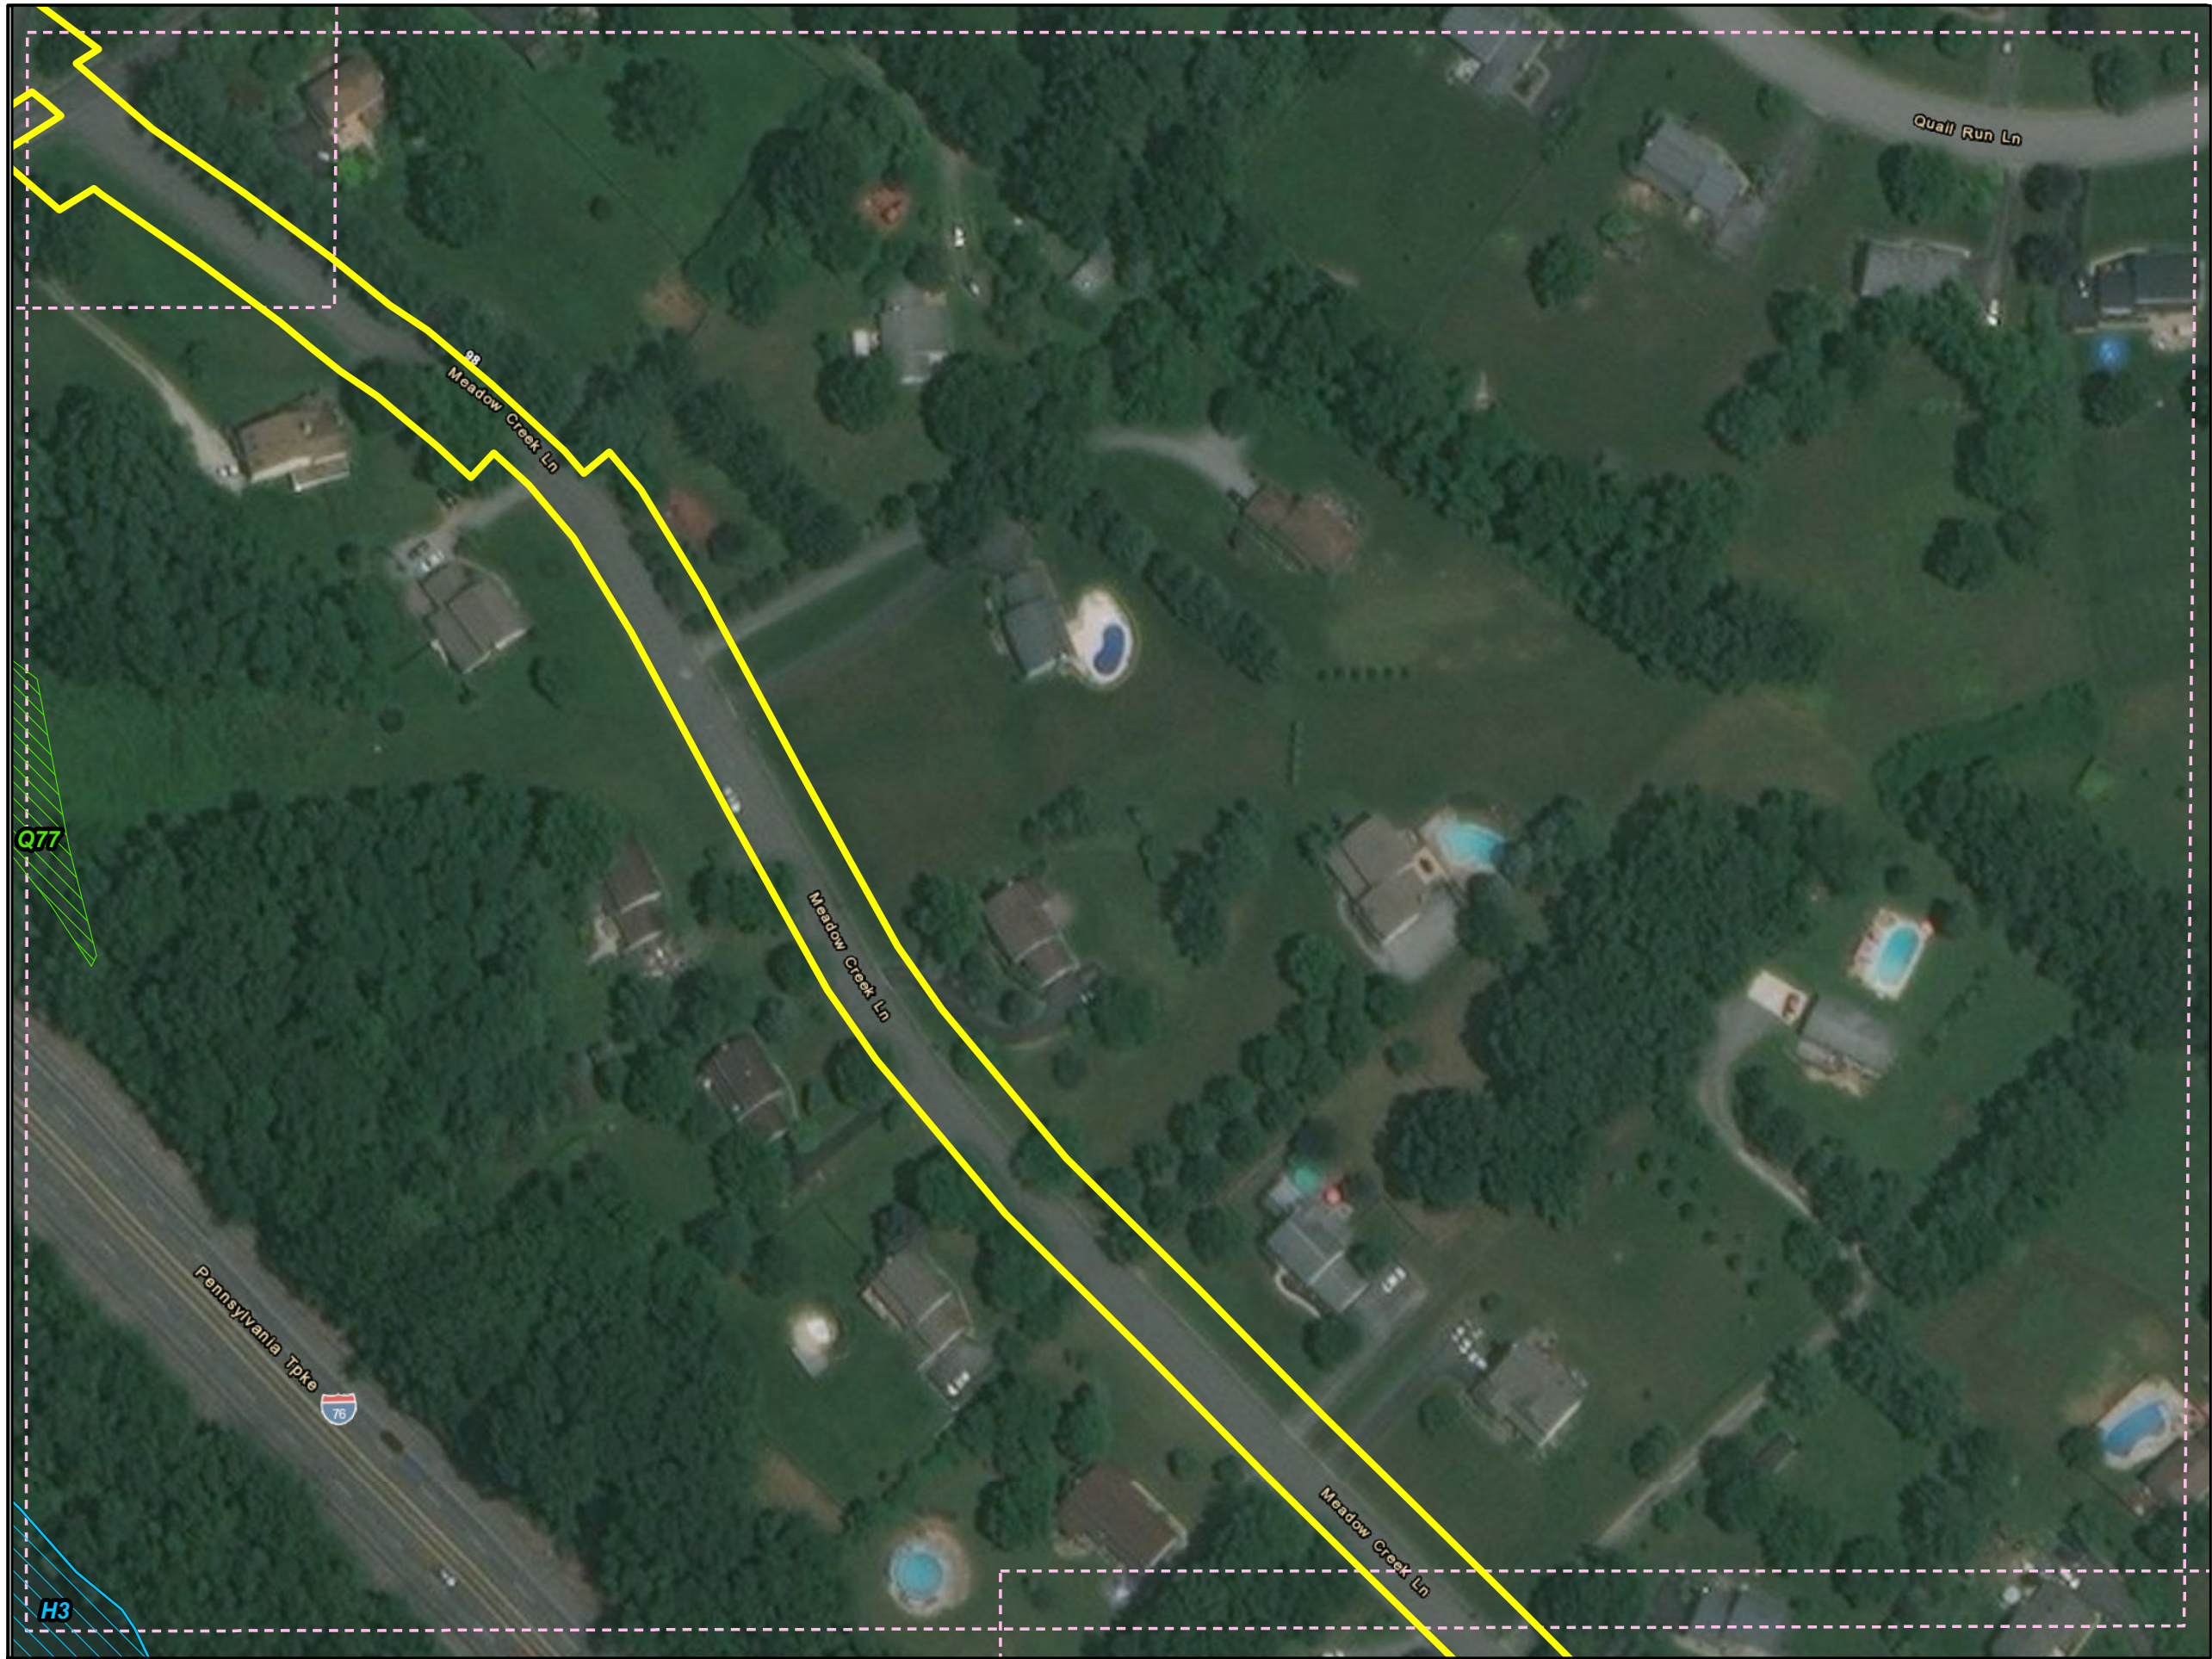
Figure 2. Delineated Aquatic Resources on the Sunoco Pennsylvania Pipeline Project, Chester County, PA.
Sheet 2 of 3

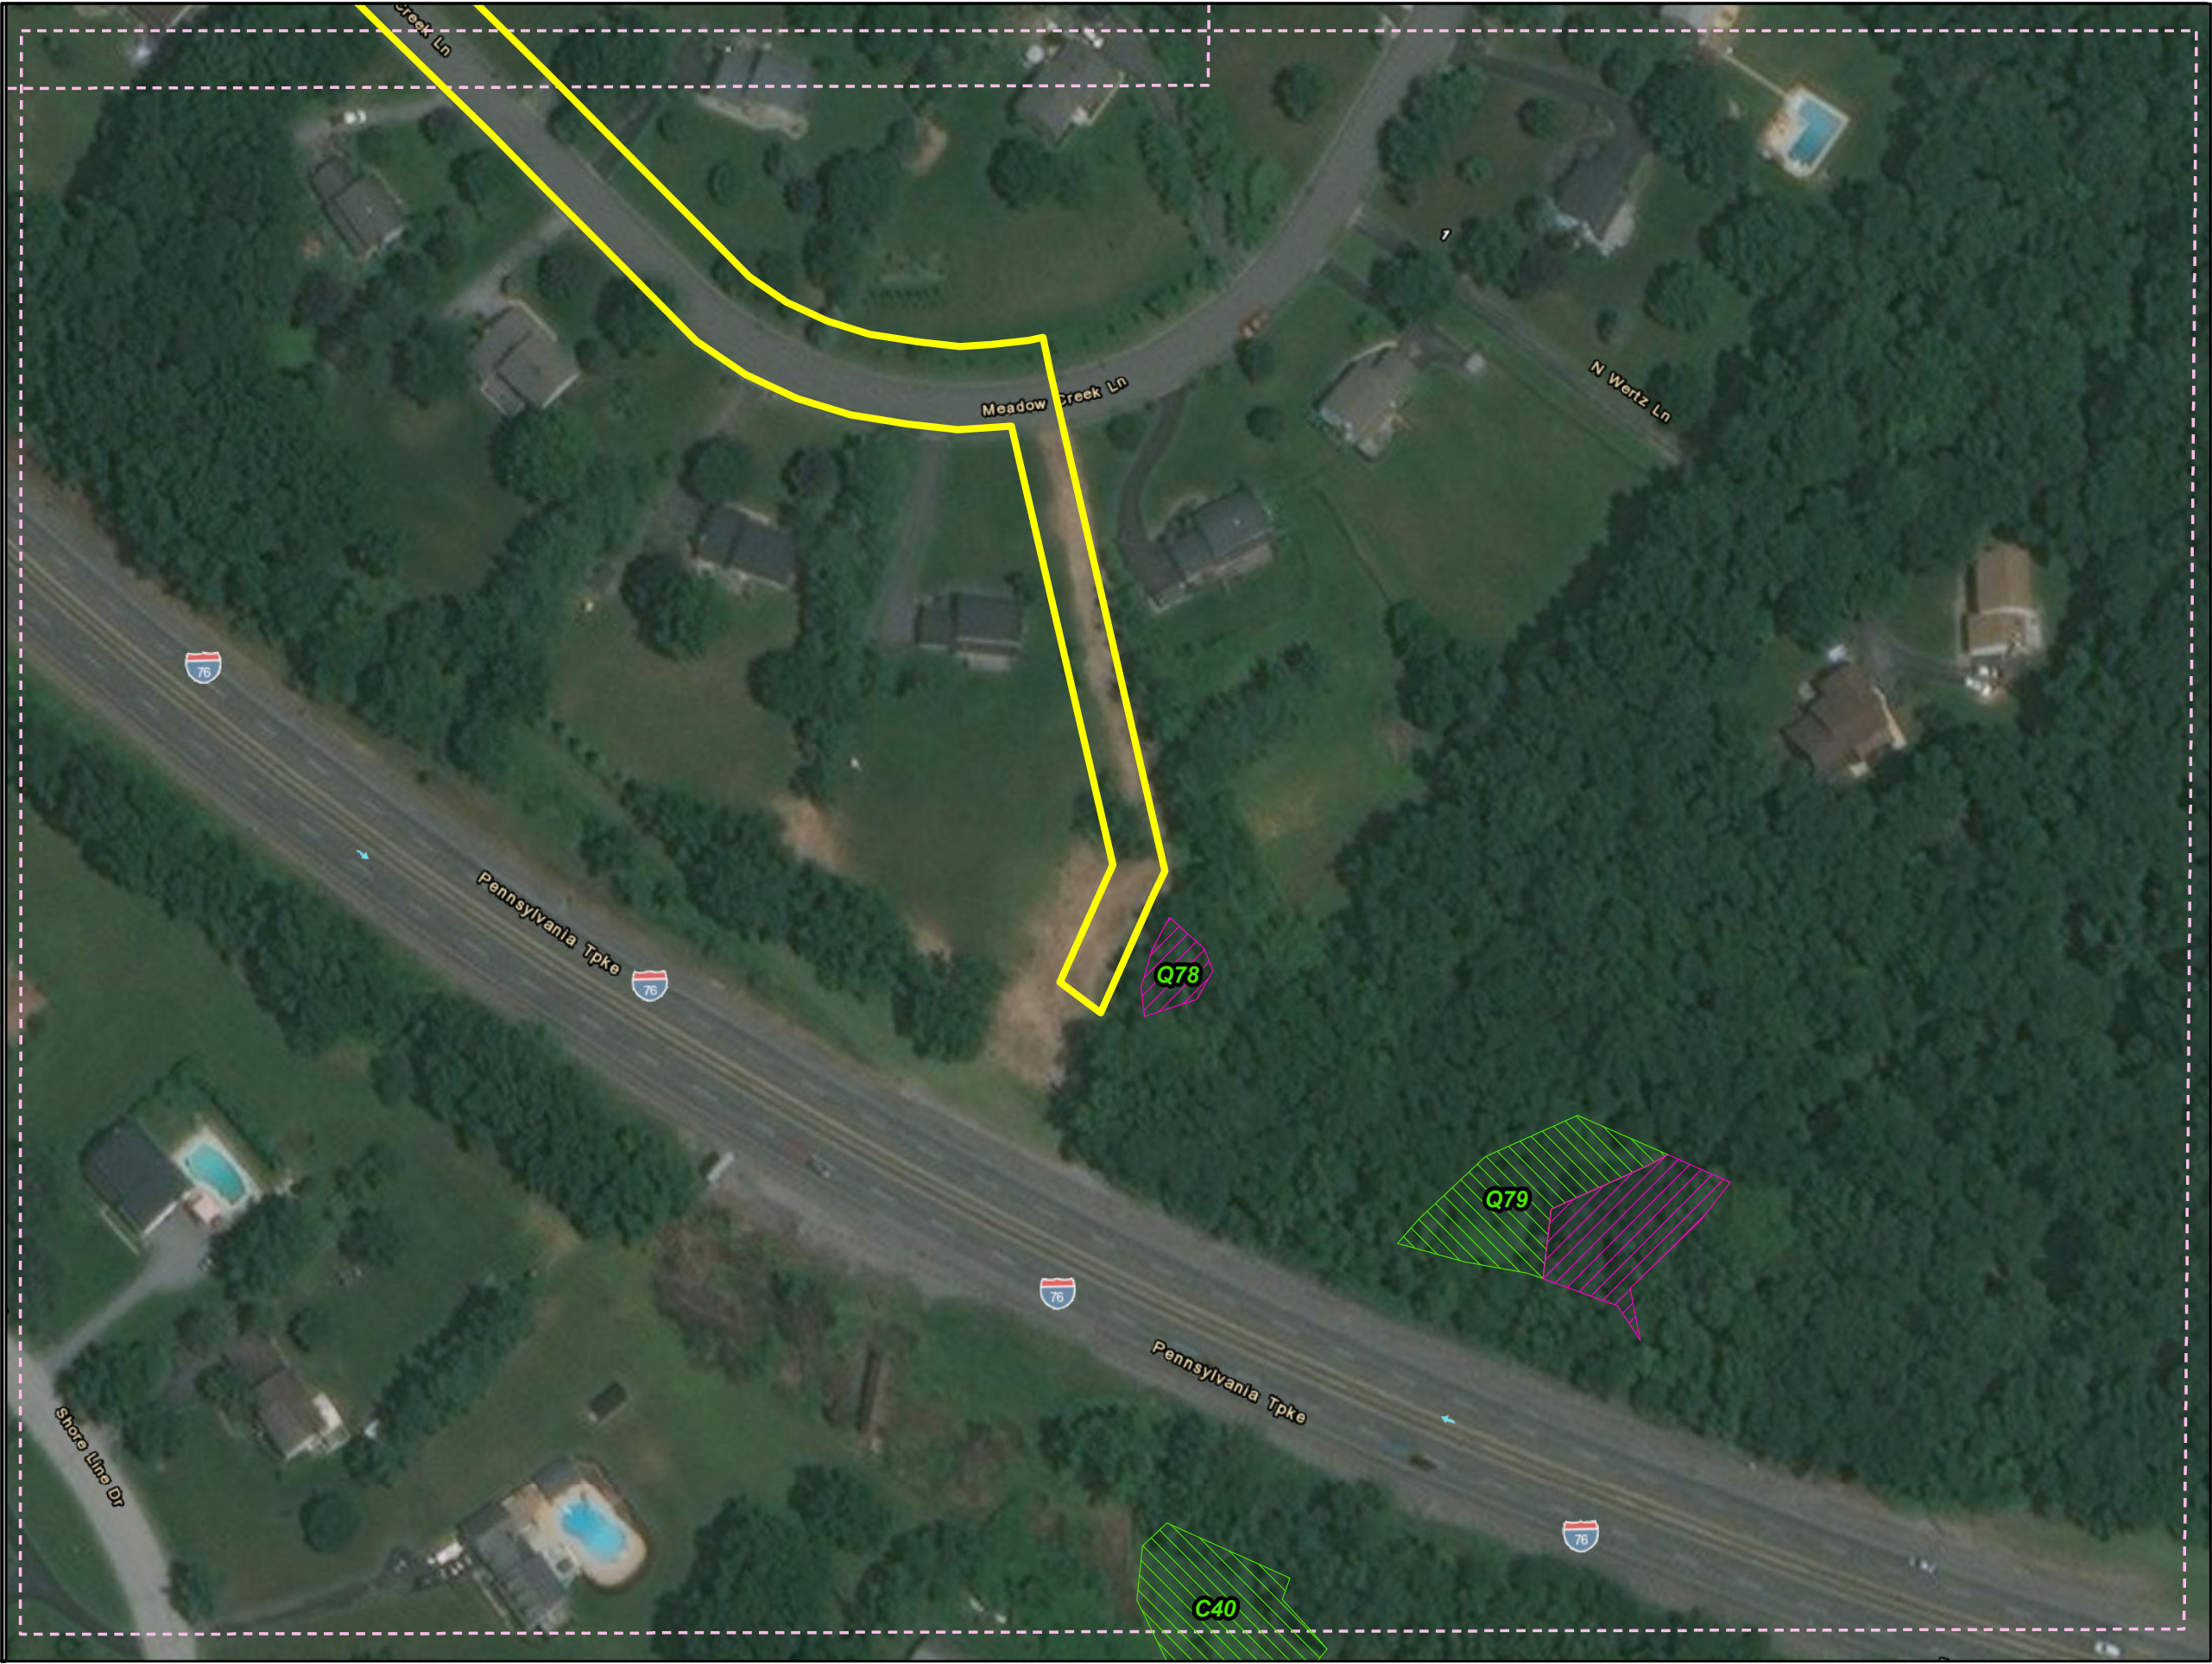
Figure 2. Delineated Aquatic Resources on the Sunoco Pennsylvania Pipeline Project, Chester County, PA.
Sheet 3 of 3

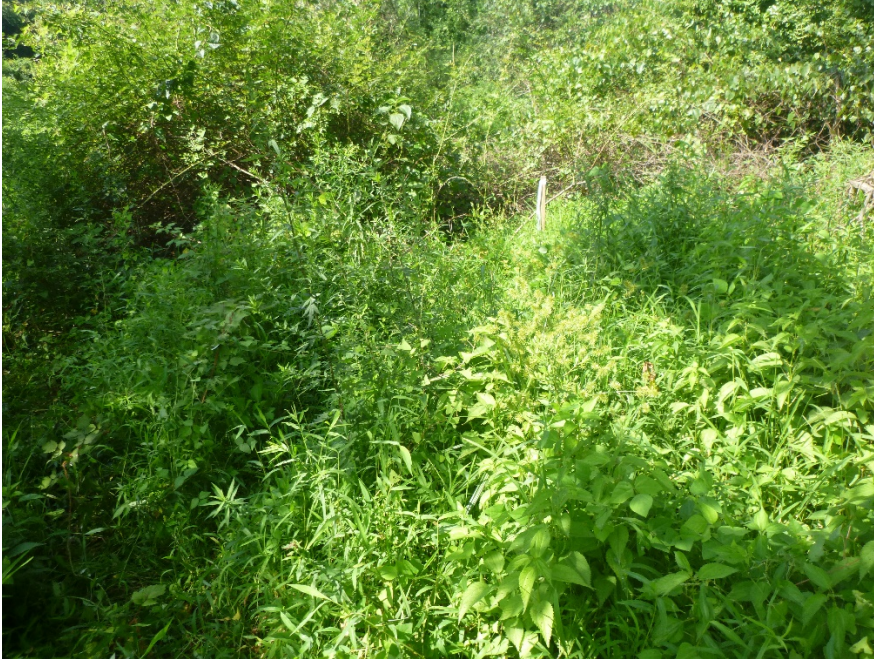
Photo No.: 1

Comments: Extension of wetland Q76 (PEM) – wetland sample point

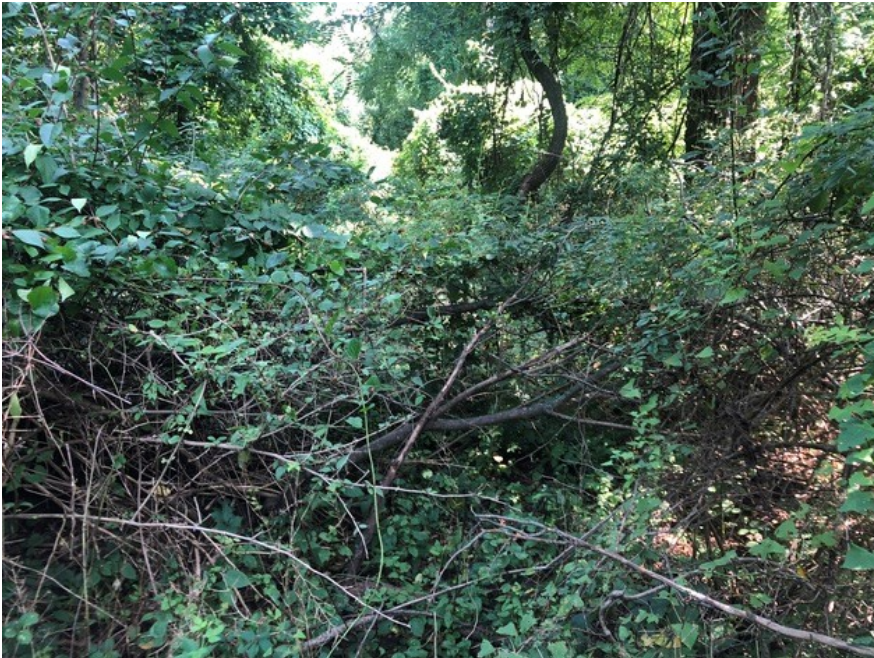
Photo No.: 2

Comments: Extension of wetland Q76 – upland sample point

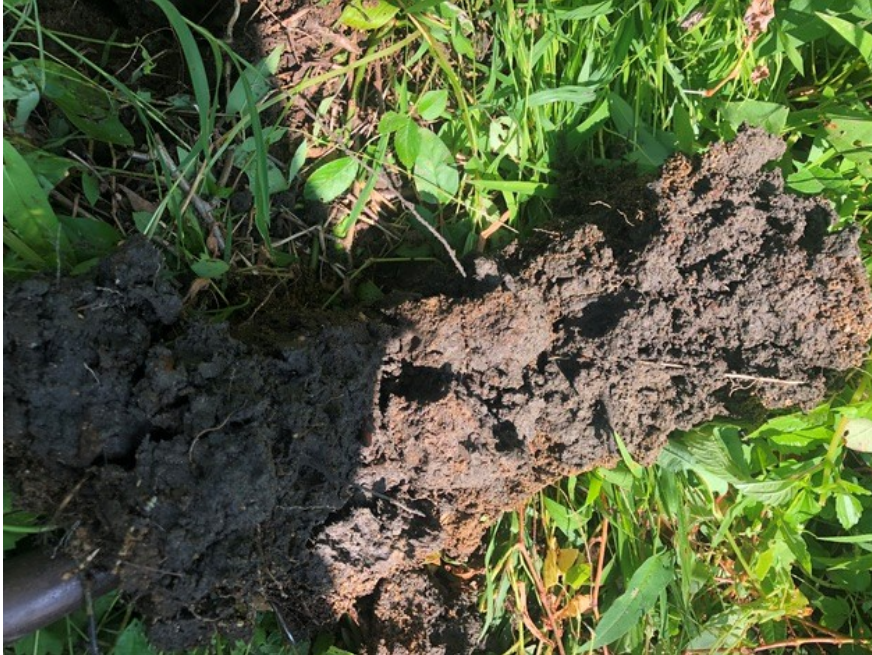
Photographer: G. McBrien
Date: 7/27/2019
Photo No.: 3
Direction: n/a

Comments: Soil profile for extension of wetland Q76 (PEM).
