TRIP REPORT OLD YORK ROAD EFRD SITE – INFILTRATION TESTING

1.0 PURPOSE

This Trip Report presents the field data and results of double-ring soil infiltration tests conducted to support the design of stormwater management systems at the Old York Road EFRD site located off Old York Road in Fairview Township, York County, Pennsylvania, as part of the Pennsylvania Pipeline Project (PPP) for Sunoco Pipeline, LP. Two shallow and two deep tests (IT-A and IT-B) were conducted at the site. The test locations are listed by coordinates (latitude and longitude) in Table 1 and shown on the attached figures.

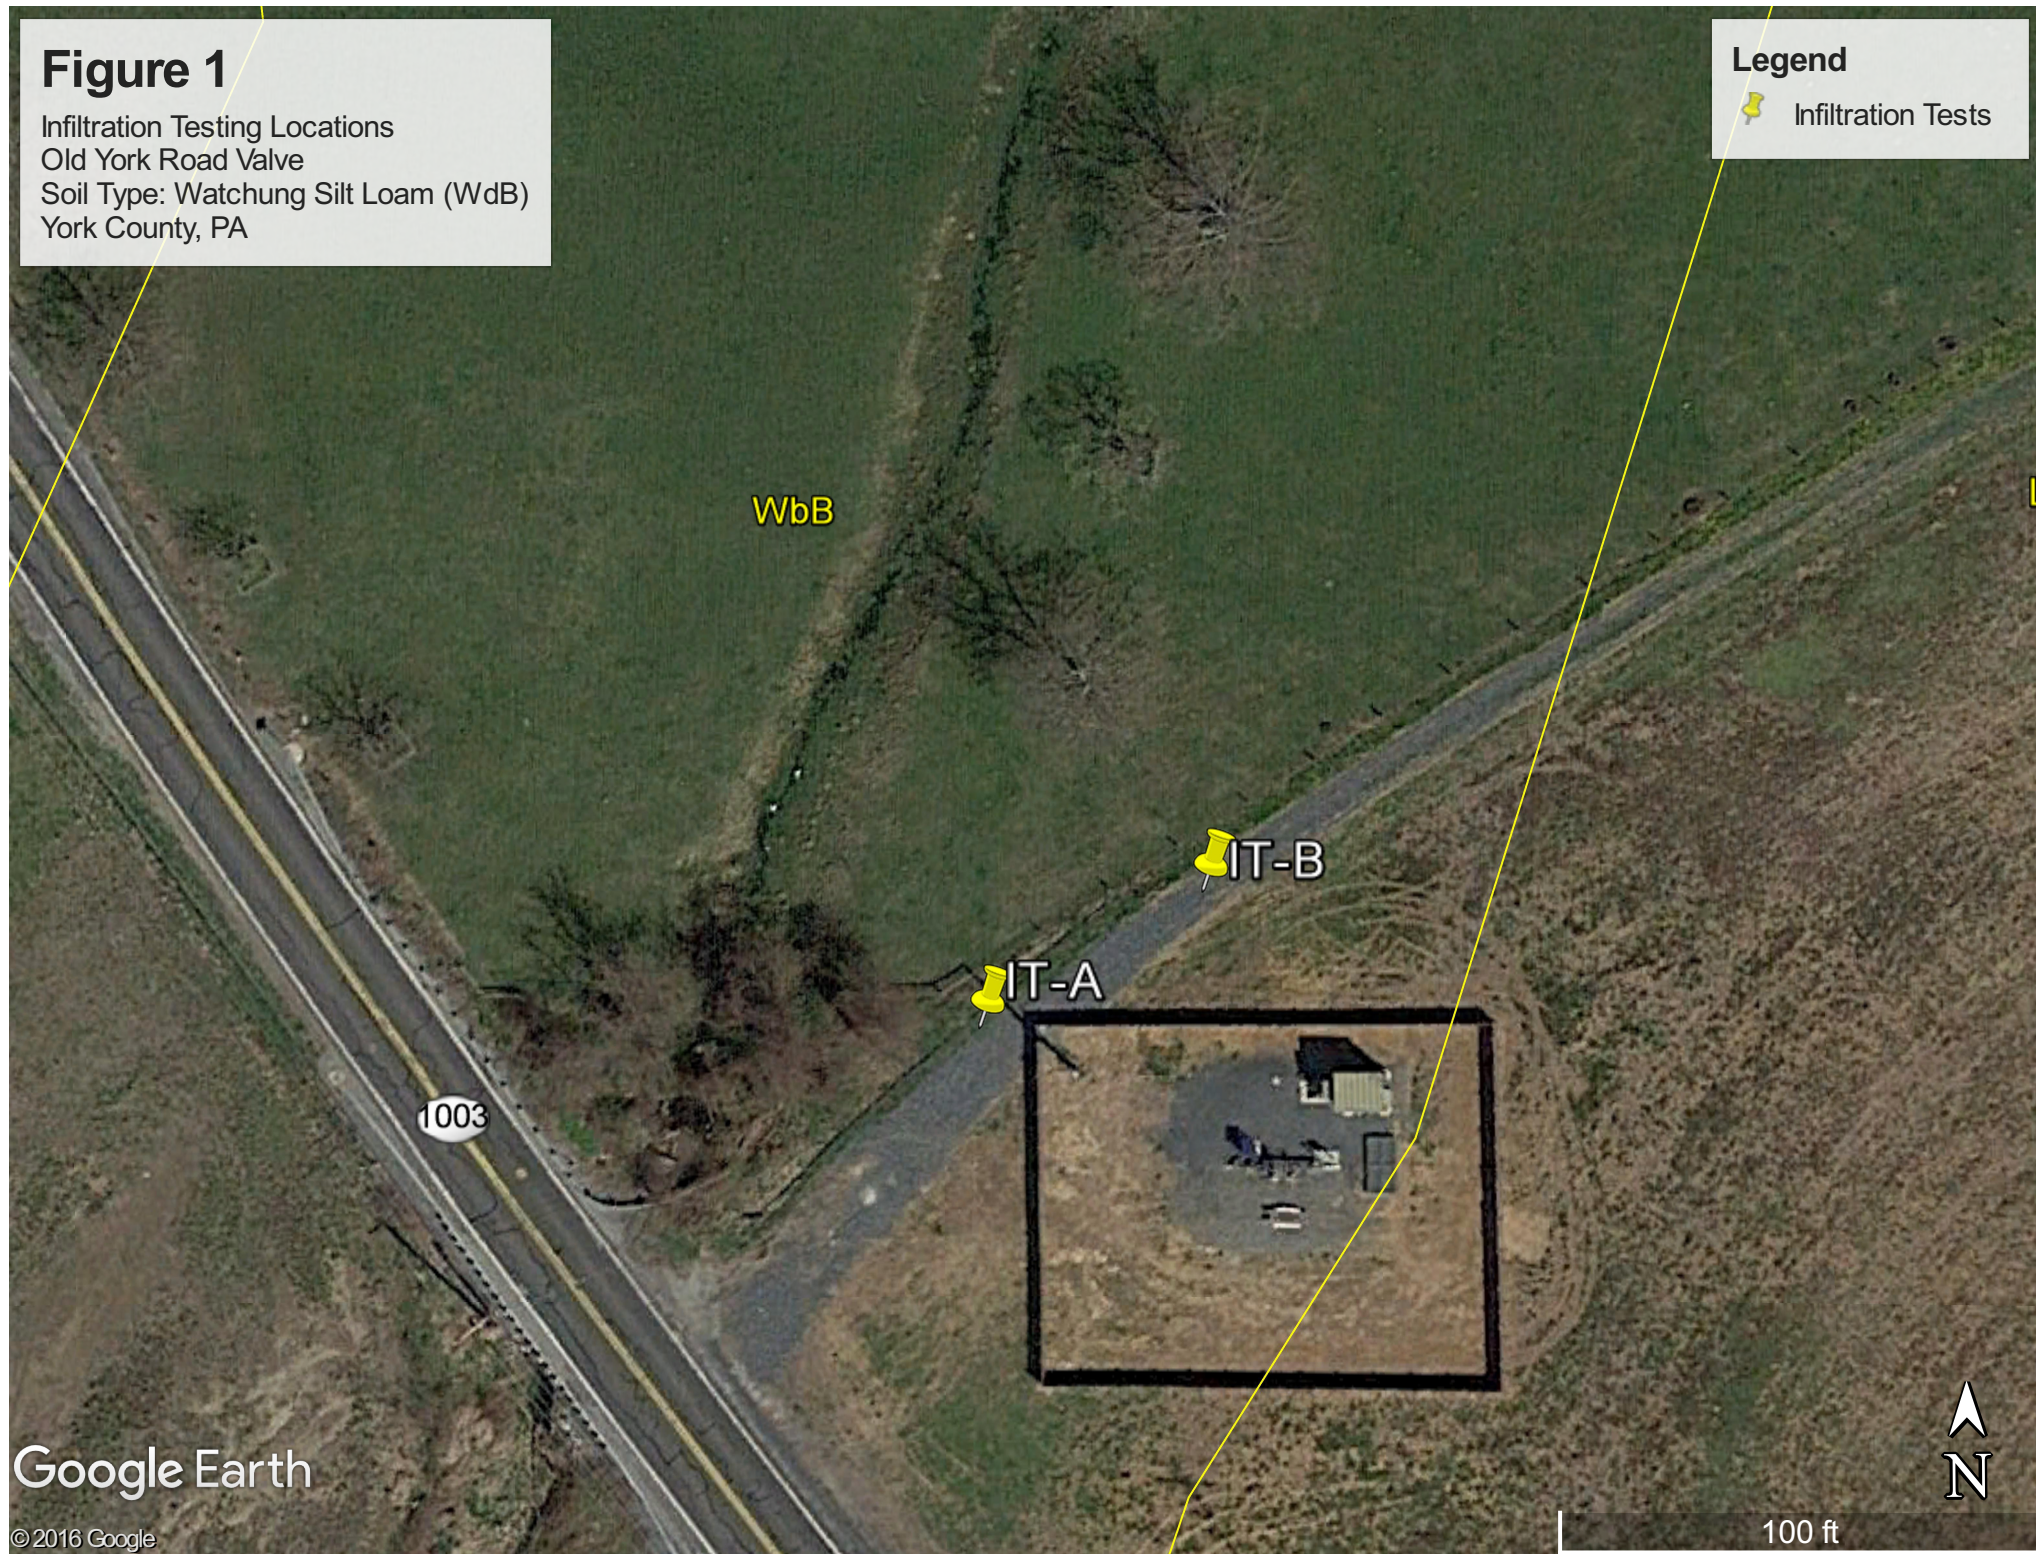
Figure 1

Infiltration Testing Locations
Old York Road Valve
Soil Type: Watchung Silt Loam (WdB)
York County, PA

According to United States Department of Agriculture Natural Resources Conservation Service Web Soil Survey data, the soil type for the test location is mapped as follows and shown on attached figure:

- Watchung Silt Loam, (WbB soil symbol). 0-8 percent slopes, extremely bouldery with very high runoff and poorly drained.
