**NATURAL RESOURCE CONCERNS
DURING FUTURE DEVELOPMENT
AT THE WOODLAWN TRACT
CONCORD TOWNSHIP, DELAWARE COUNTY
PENNSYLVANIA**

PREPARED FOR THE BEAVER VALLEY CONSERVANCY

**PREPARED BY SCHMID & CO., INC., CONSULTING ECOLOGISTS
MEDIA, PENNSYLVANIA**

NOVEMBER 2013

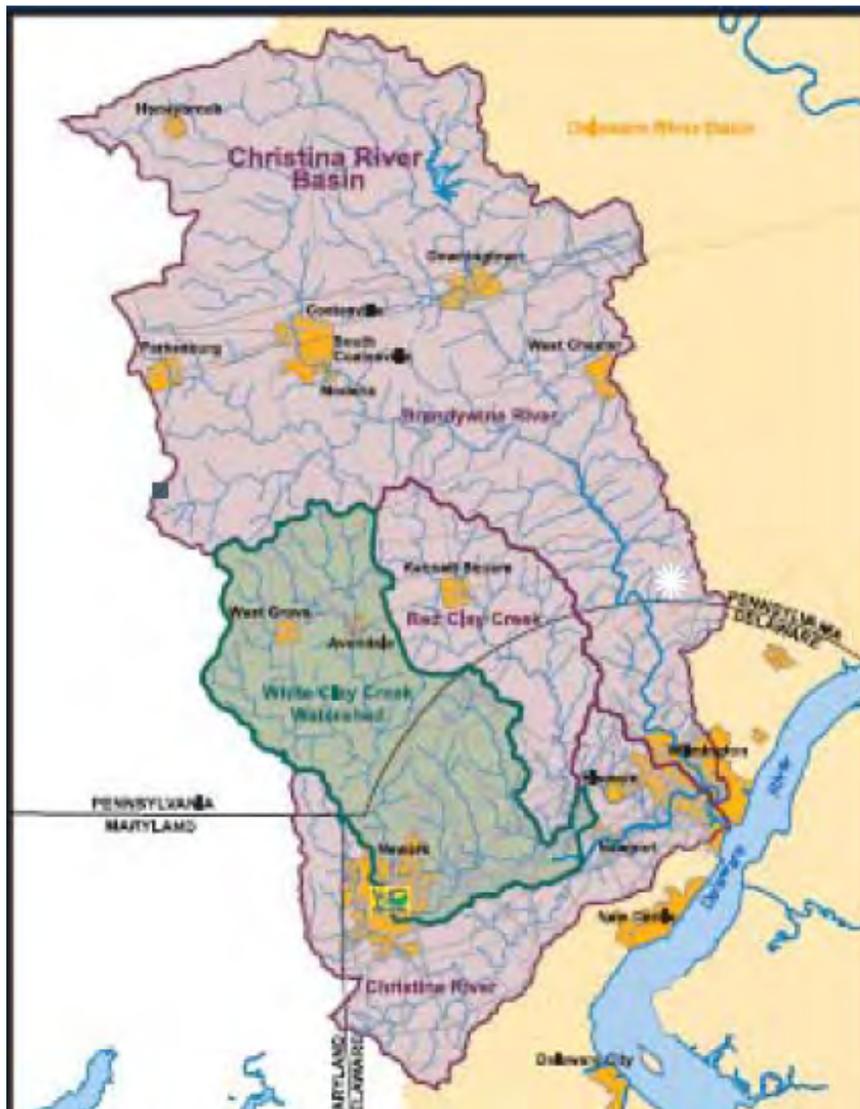
Figure 4. The subject property (white star) in the Brandywine and Christina River basins.

The subject property is about 8 miles north of downtown Wilmington, Delaware, and about 4 miles northwest of the Delaware River at Marcus Hook, Pennsylvania, and Claymont, Delaware (Figure 4). It extends westward about 1 mile from the places known as Elam and Johnsons Corner (Figure 2) on US Route 202 to the eastern limit of Chadds Ford Township. Its north-south dimensions from Smithbridge Road to the northern edge of New Castle County, Delaware, also are about 1 mile.

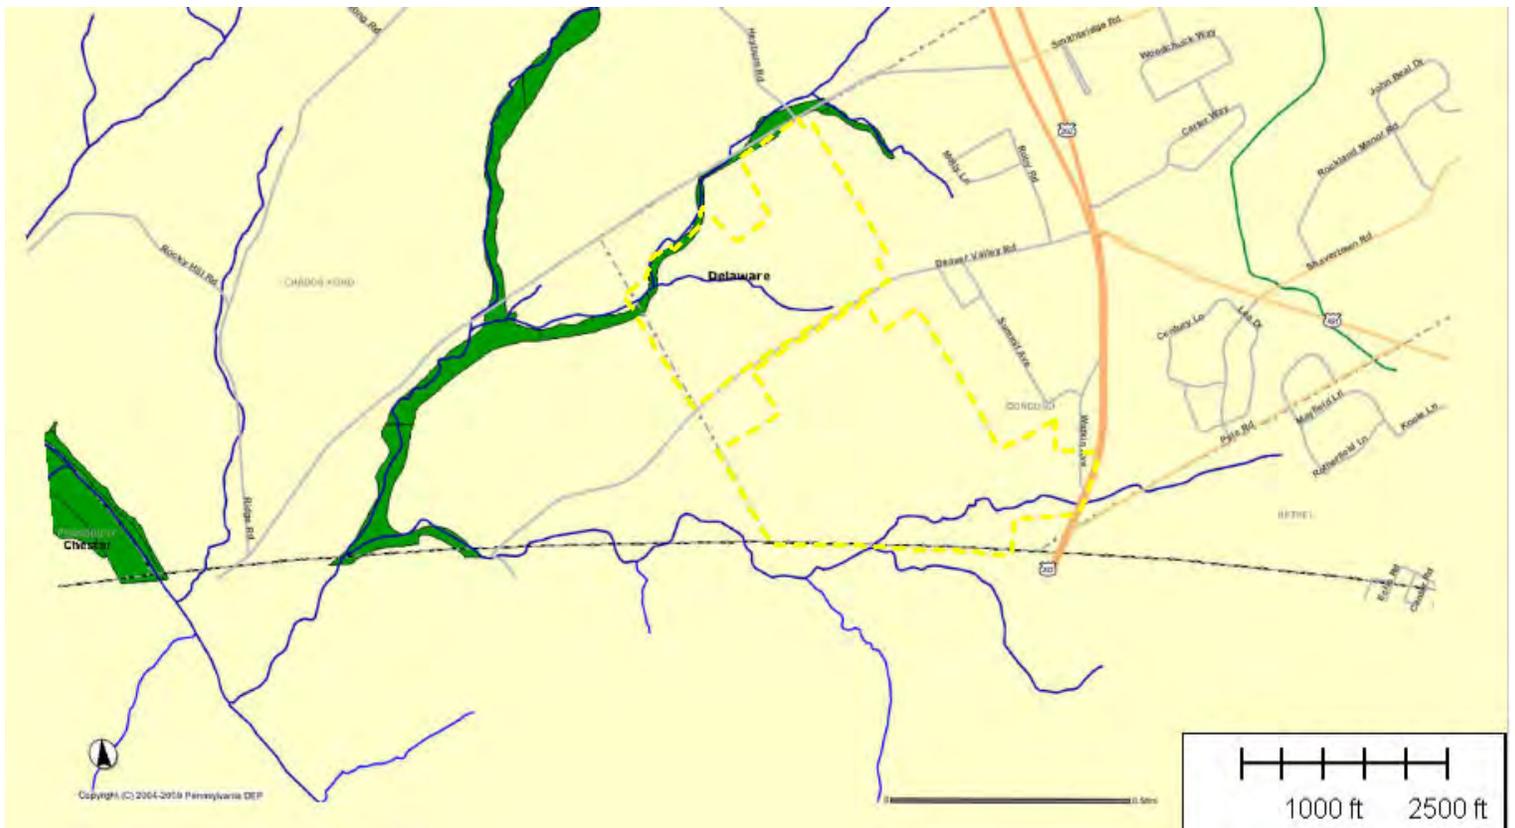
Figure 5. Streams (blue), streets (gray, orange, black), FEMA floodplains (green) and municipal boundaries (dot-dashed) on and near the subject property (yellow outline). Image from PADEP eMapPA. Brandywine Creek is at bottom left.

unnamed tributary on the right bank of the mainstem entirely within Chadds Ford Township. It, like the mainstem and the lowermost segment of the south branch, has a defined FEMA 100-year floodplain. All Pennsylvania streams not mapped by FEMA have a default floodway extending 50 feet horizontally from each bank. Unnamed tributaries joining the south branch of Beaver Run from Delaware are shown in Figure 5.

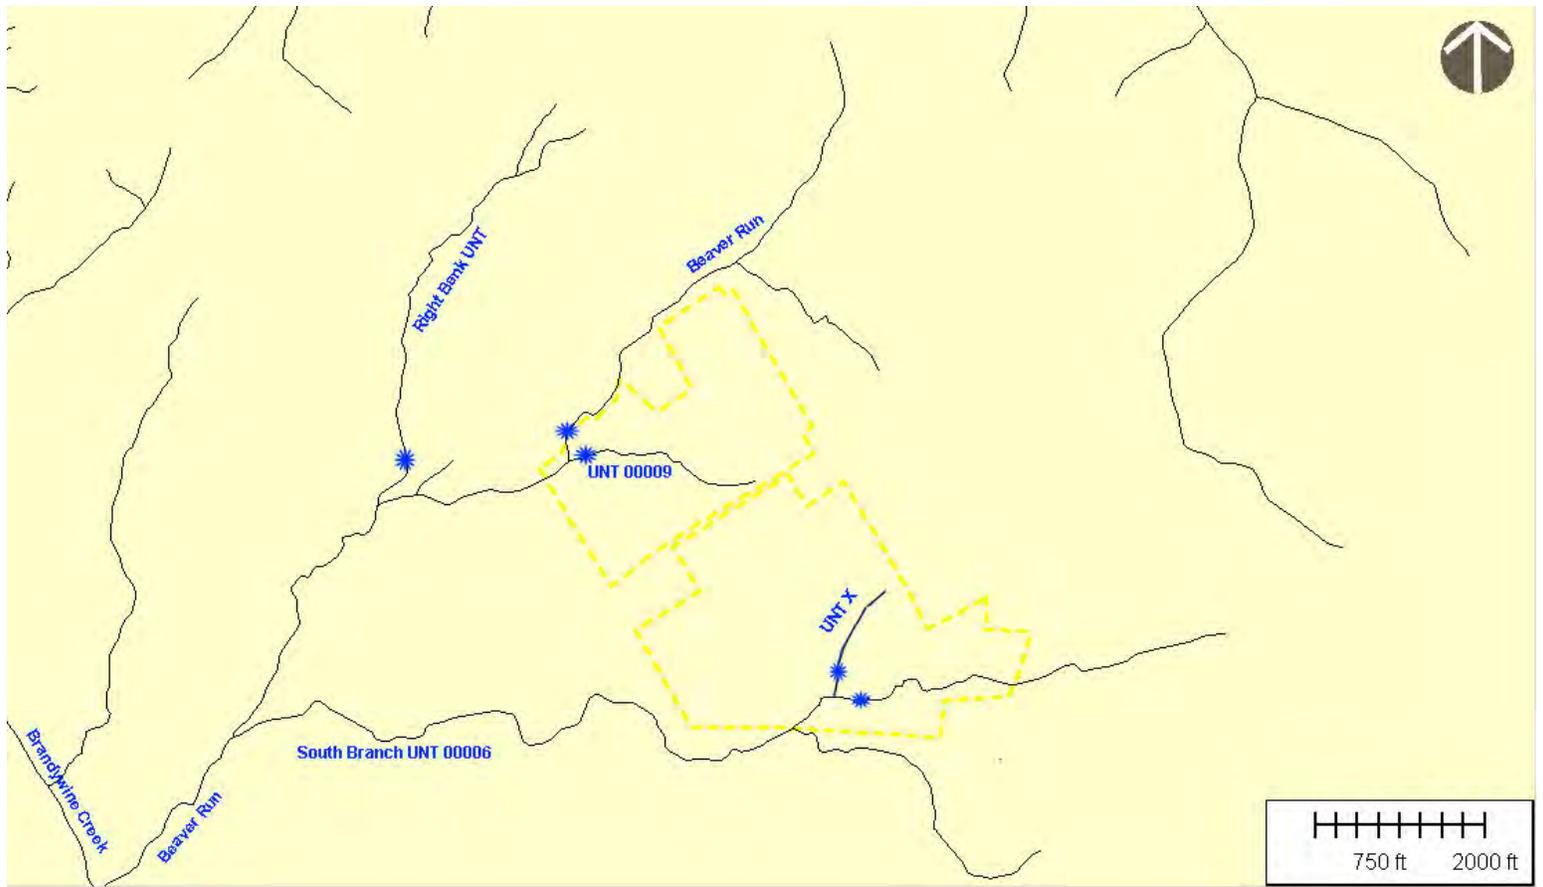
Figure 6. Streams (black) and May 2013 sampling stations (blue stars) at and near the subject property (yellow outline) in Concord Township, Delaware County, Pennsylvania. Features are from PADEP hydrographic maps, except for UNT X (added during 2013 field inspection). Some Delaware tributaries of Beaver Run are not shown on this drawing. Later figures show conditions at each sampling station on 7 May 2013.

Unnamed tributary 00006 of Beaver Run essentially comprises a south branch of that stream (Figure 6). It rises east of US Route 202 and flows westward almost parallel to the Delaware boundary along the southern edge of the property. UNT 00006 joins the Beaver Run mainstem west of the subject property a short distance upstream from the confluence with Brandywine Creek. Another unnamed tributary (UNT X), not recorded by the National Hydrography database, rises onsite along the eastern margin of the south tract and flows south across the petroleum pipeline right-of-way to join Tributary 00006. Unnamed tributary 00009 rises onsite south of Beaver Valley Road and joins the mainstem at the northwest corner of the property after flowing westward across the north tract. All of these streams are listed by 25 Pa. Code Chapter 93 as having warm water fishery (WWF) as their designated use. The PADEP eMapPA database shows

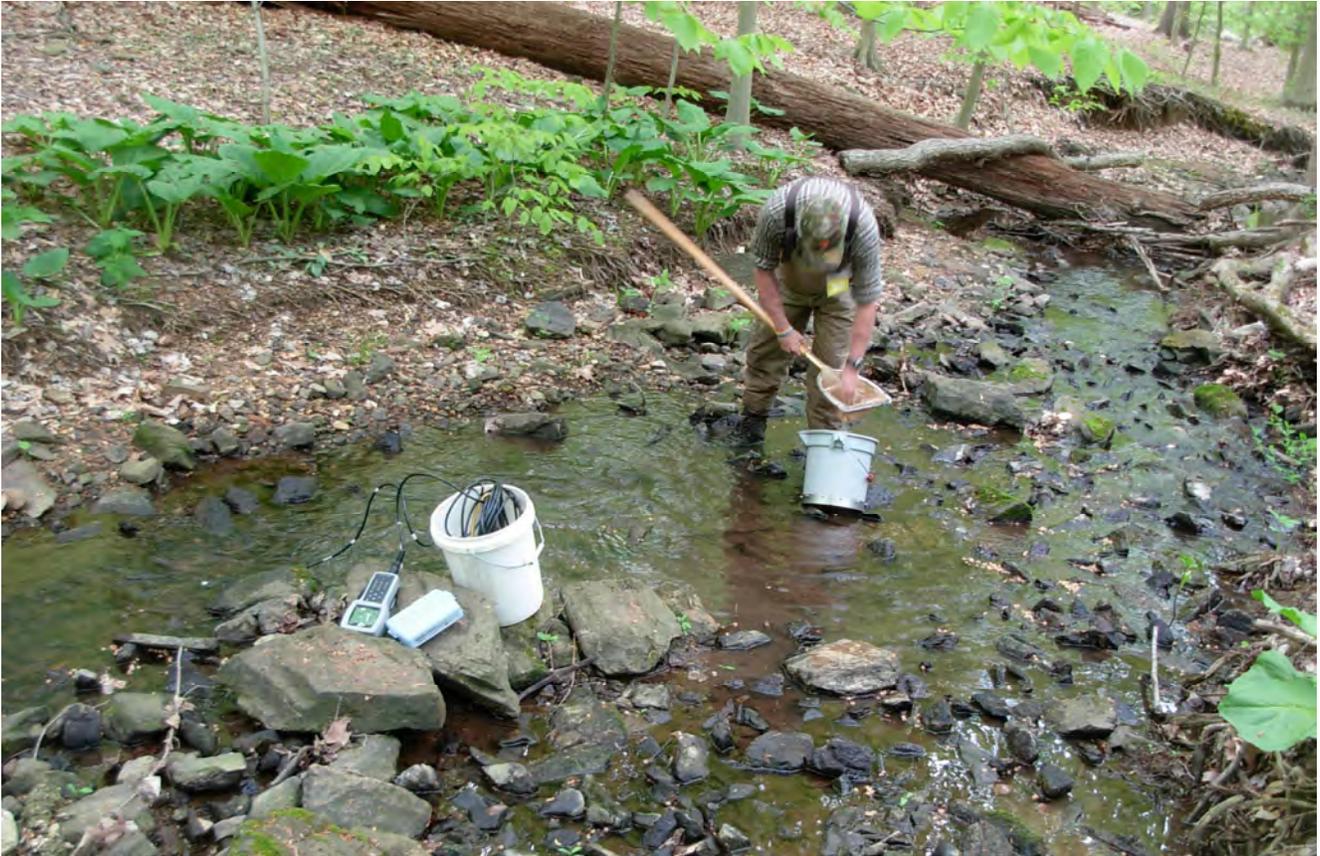
Figure 8. Sampling in South Branch Beaver Run (UNT 00006), 7 May 2013.

The stream samples reported here were collected and analyzed using the protocols of the Pennsylvania Department of Environmental Protection (2009) for comprehensive examination of stream quality and inclusion on Clean Water Act Section 303(d) lists of impaired streams. Six kicks covering 1 square meter each were composited using a 500 micron mesh D frame net (Figure 8). Flowing water habitat scores were recorded at each forested riffle using the 12 parameters specified by PADEP for freestone streams (2009). All of the recorded local habitat scores were considered excellent, ranging from 183 to 202 (Appendix 2). Habitat scores ranging from 192 to the theoretical maximum of 240 are optimal; 132 to 180, suboptimal. Tributary 00006 and offsite Right Bank Tributary were scored as optimal; the other three stations were in the suboptimal range.

Selected stream parameters also were measured (temperature, pH, specific conductance, dissolved oxygen, % dissolved oxygen, total dissolved solids, and total alkalinity, Appendix 2). A YSI Model 556 multimeter calibrated daily was used for most parameters. Alkalinity was determined by field titration using a Hach kit.

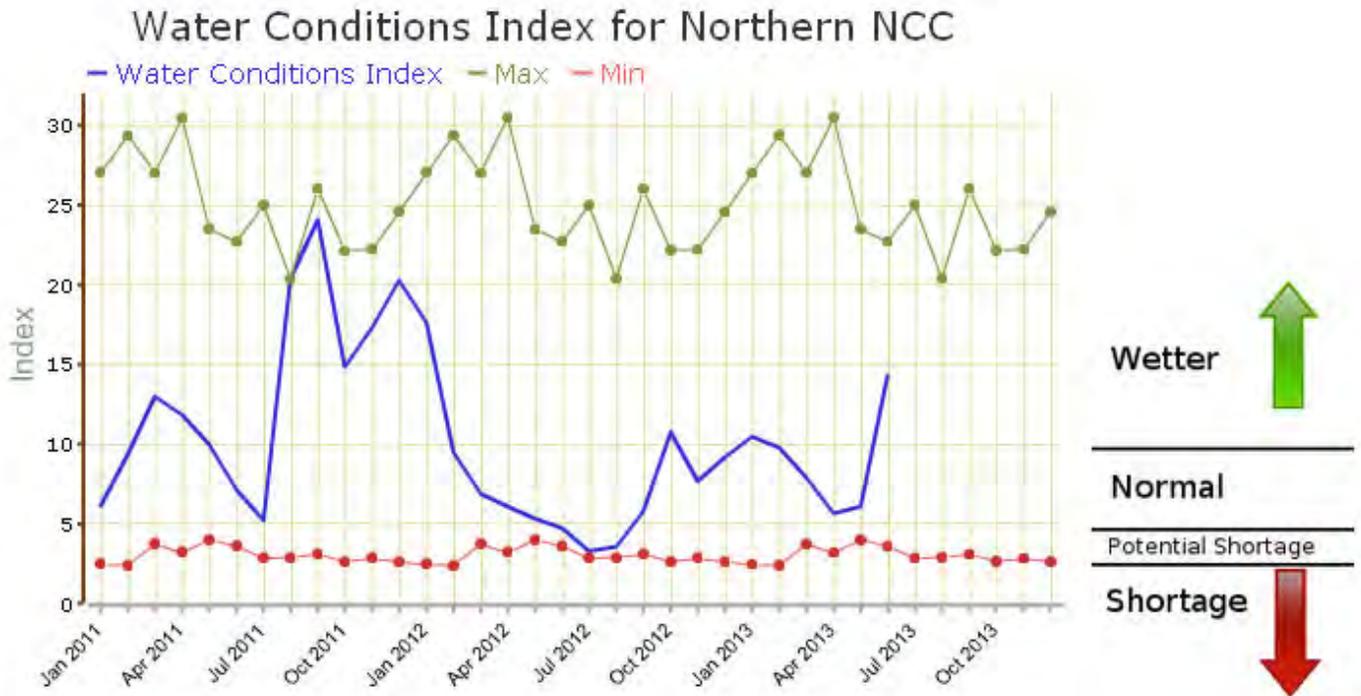
Figure 9. Water Conditions Index for northern New Castle County, Delaware, 2011-2013 (<http://www.dgs.udel.edu/water-conditions-summary-index-new-castle-county>). For May 2013 the actual index value (blue) was a “normal” 6.08; long-term recorded extremes for May range from 4 to 23.49. The index is based on cumulative precipitation for the preceding six months, the measured level in one groundwater observation well, the current monthly average flow in the Brandywine at Wilmington, and the year’s population estimate for New Castle County (Jordan & Woodruff 1982).

At the time of sampling water availability was deemed “normal” for the preceding six months, following a dry spring and summer in 2012 (Figure 9). The clear, cold water with discharges from springs supported a diverse population of aquatic macroinvertebrates in streams in and near the site of the proposed development at the time of field sampling on 7 May 2013. The number of kinds of macroinvertebrates identified ranged from 24 to 31 at each of the stations in samples of 212 to 240 individuals representing 16.4 to 25% of the total collected individuals. Sixty-five taxa (mostly genera) of macroinvertebrates were identified from the samples: 11 of mayflies, 10 of stoneflies, 12 of caddisflies, 11 of true flies, 3 of dragonflies, 10 of beetles, 2 kinds of crustaceans, 1 kind each of mollusc, acarid, flatworm, earthworm, hydra, and nematode (Appendix 1).

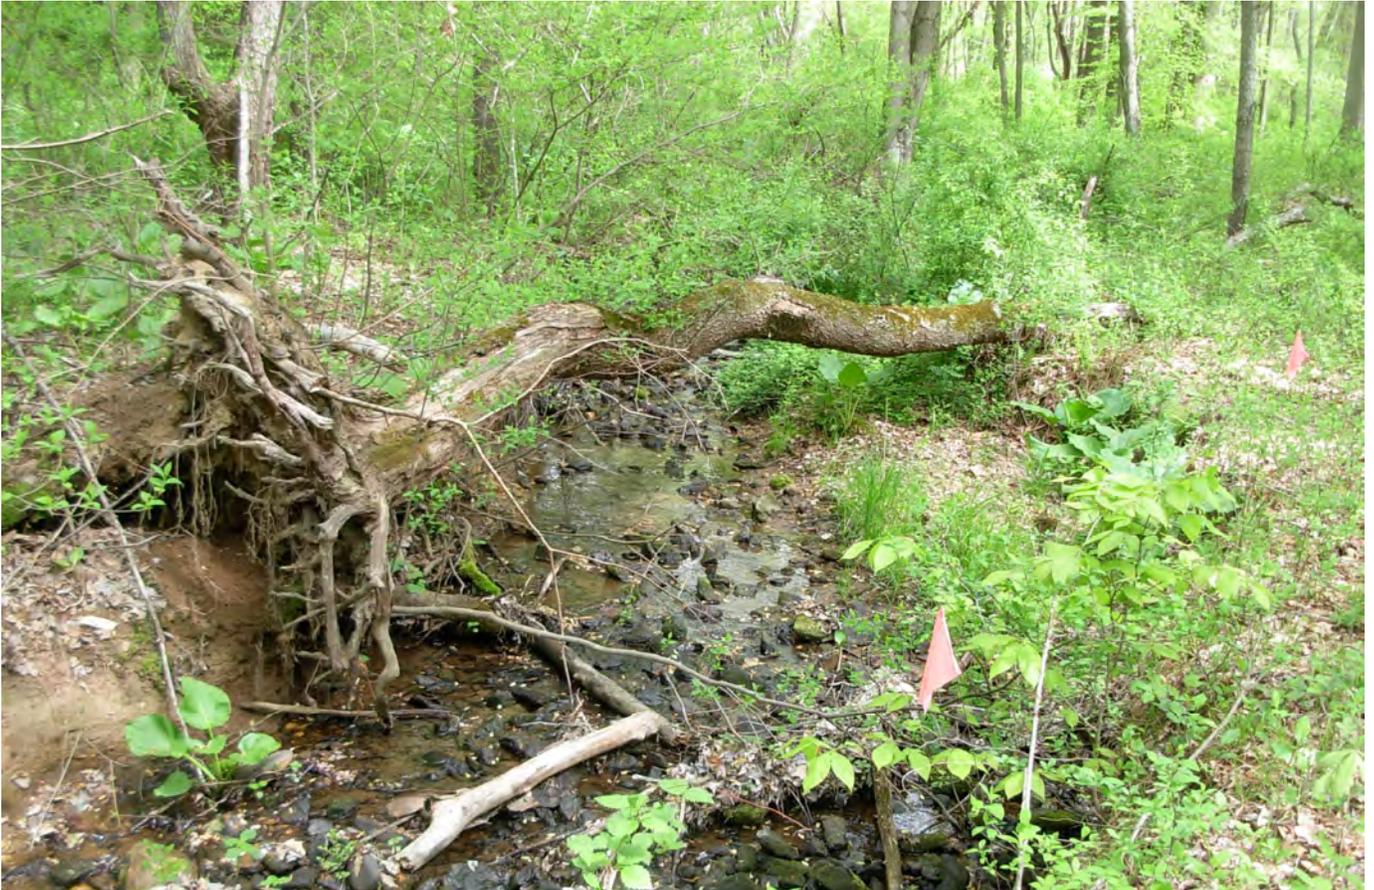
Figure 10. Sampling station at UNT X, Beaver Run watershed, Concord Township, Delaware County PA, 7 May 2013.

mere warm water fisheries. The Beaver Run mainstem (51.8) and South Branch Tributary 00006 (48.8) are non-attaining, confirming the listing of the latter stream on the Delaware 2010 Clean Water Act Section 303(d) list. Photographs were taken to record conditions at each sampling station on 7 May 2013 (Figures 10-13, 16-21).

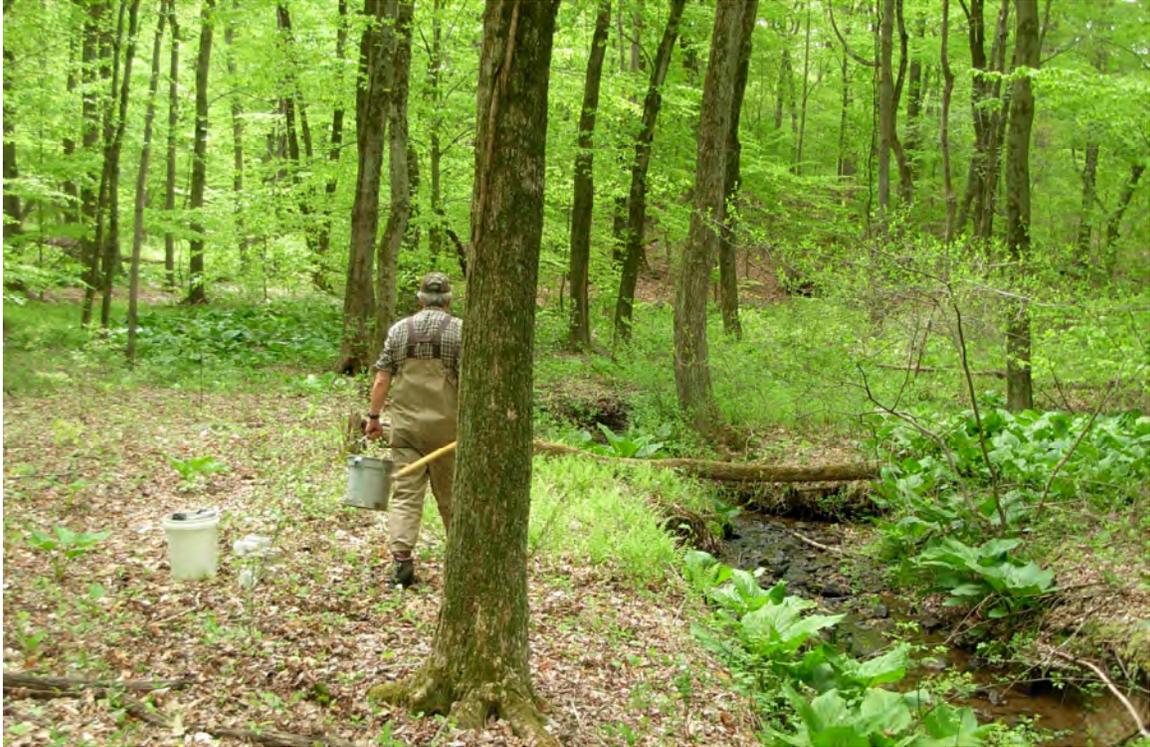
Figure 11. View downstream toward confluence below sampling station on UNT X, Beaver Run watershed, Concord Township, Delaware County PA, 7 May 2013.

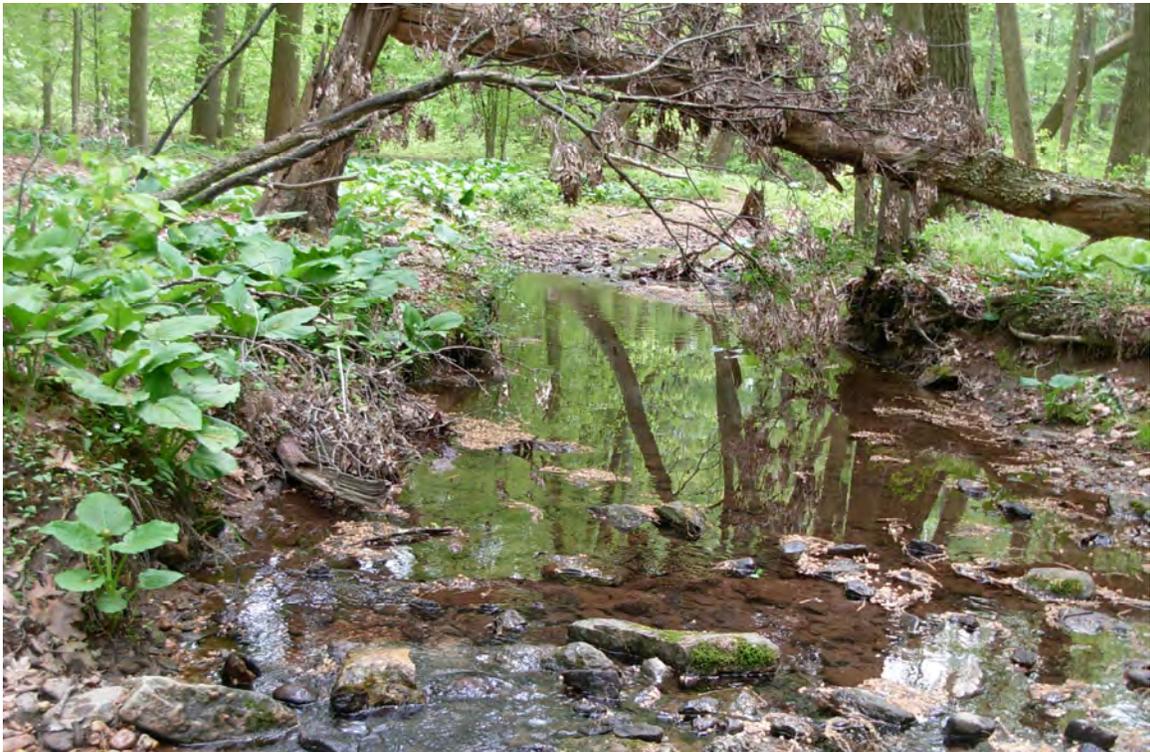
Figure 12. View upstream at sampling station on South Branch UNT 00006, Beaver Run watershed, Concord Township, Delaware County PA, 7 May 2013.

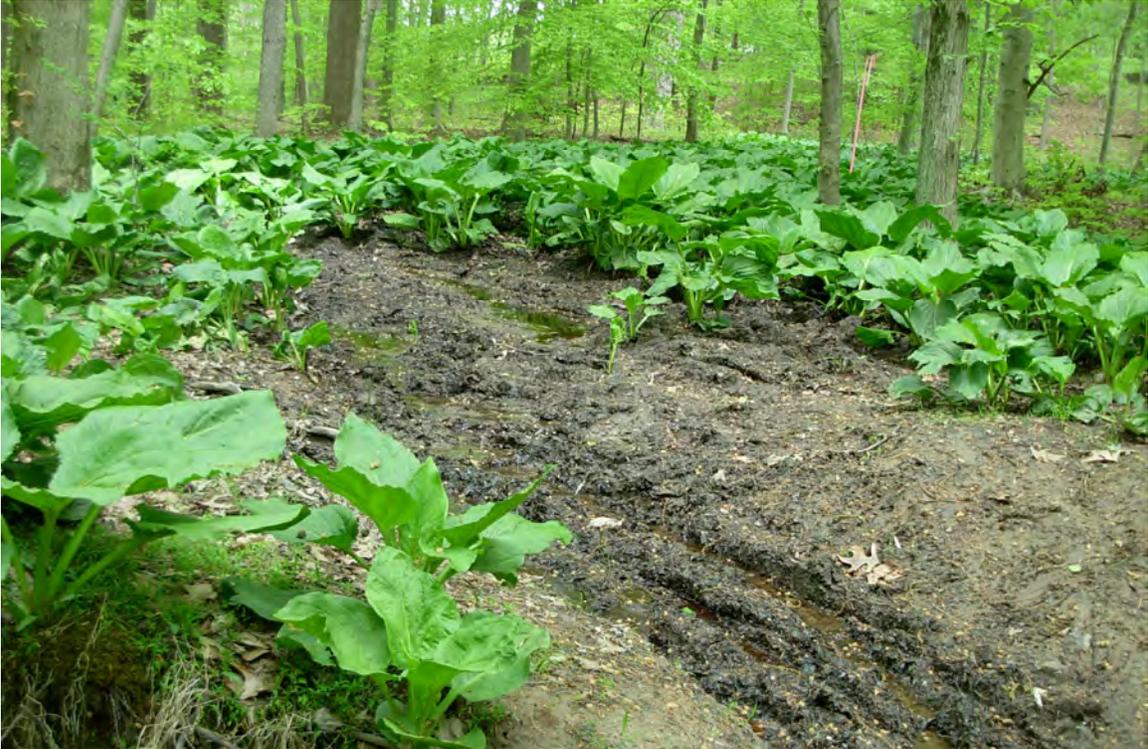
Figure 13. Seep flowing from springfed wetland into South Branch UNT 00006, Beaver Run watershed, Concord Township, Delaware County PA, 7 May 2013.

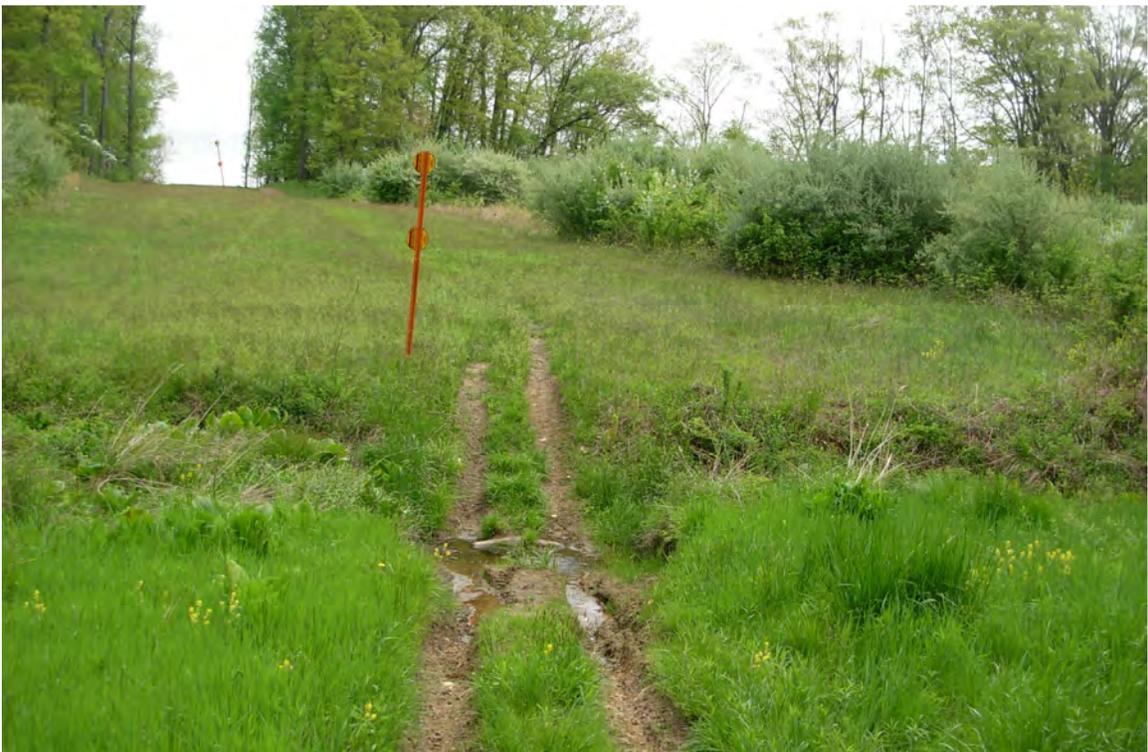
Figure 14. UNT X flows left to right across pipeline right-of-way, Beaver Run watershed, Concord Township, Delaware County PA, 7 May 2013. View east-southeast.

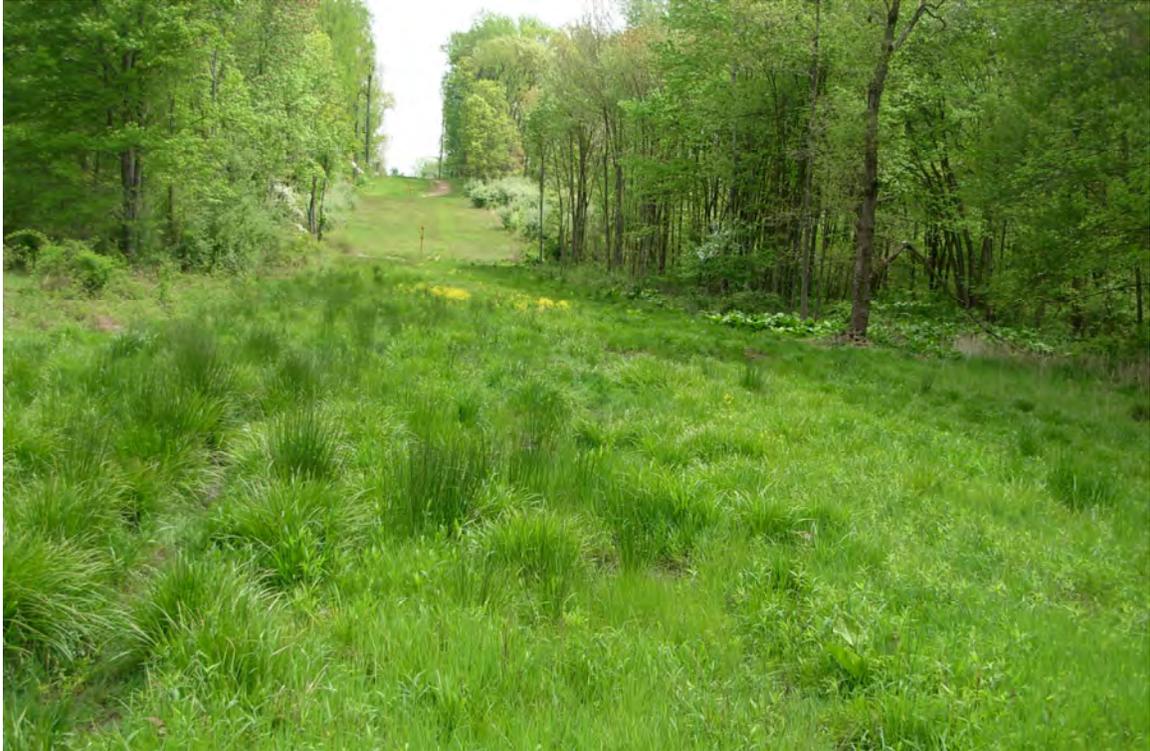
Figure 15. View east across palustrine emergent wetland in pipeline ROW, Beaver Run watershed, Concord Township, Delaware County PA, 7 May 2013.

The pipeline corridor is clear of trees and shrubs, and it appears as a pale line crossing the southern tract in Figure 3. Some of it contains palustrine emergent wetlands (Figure 15).

The species of concern at this site all require open conditions such as those found along the pipeline R.O.W. Maintaining the pipeline R.O.W. by annual, late season mowing, rather than summer mowing or herbicide use, will allow these species to persist (1998 update). [See Figure 15 above.]

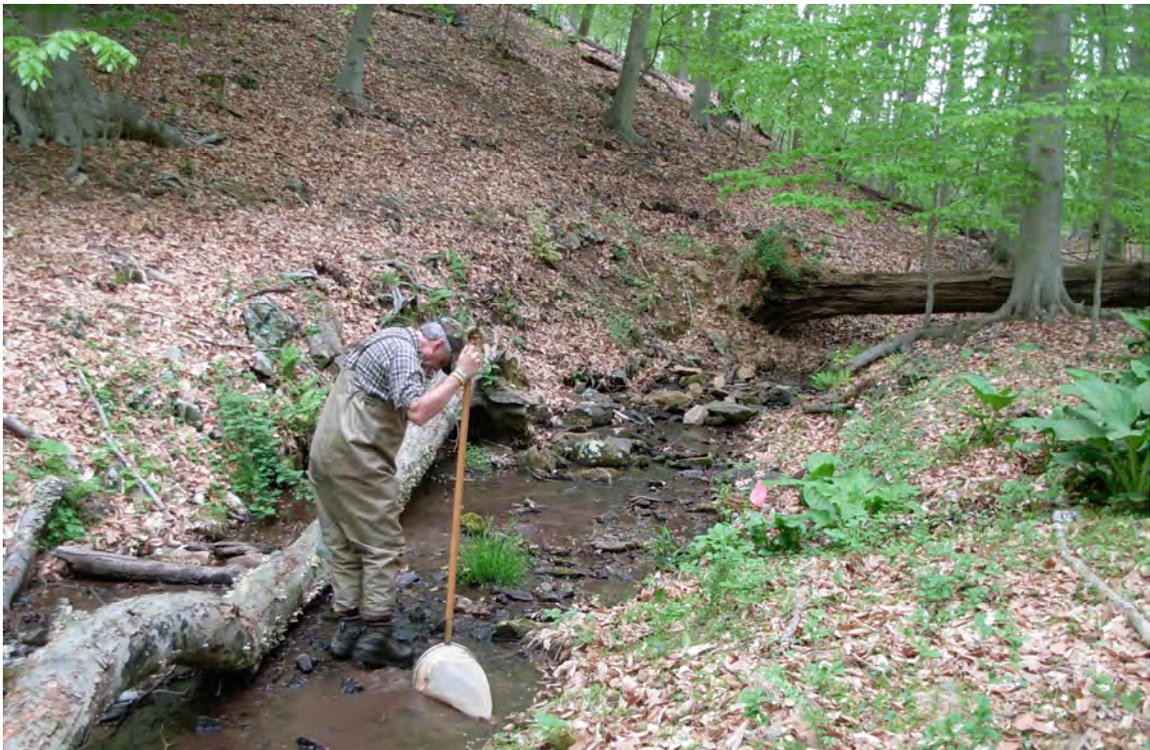
Figure 16. Sampling near mouth of UNT 00009, Beaver Run watershed, Concord Township, Delaware County PA, 7 May 2013.

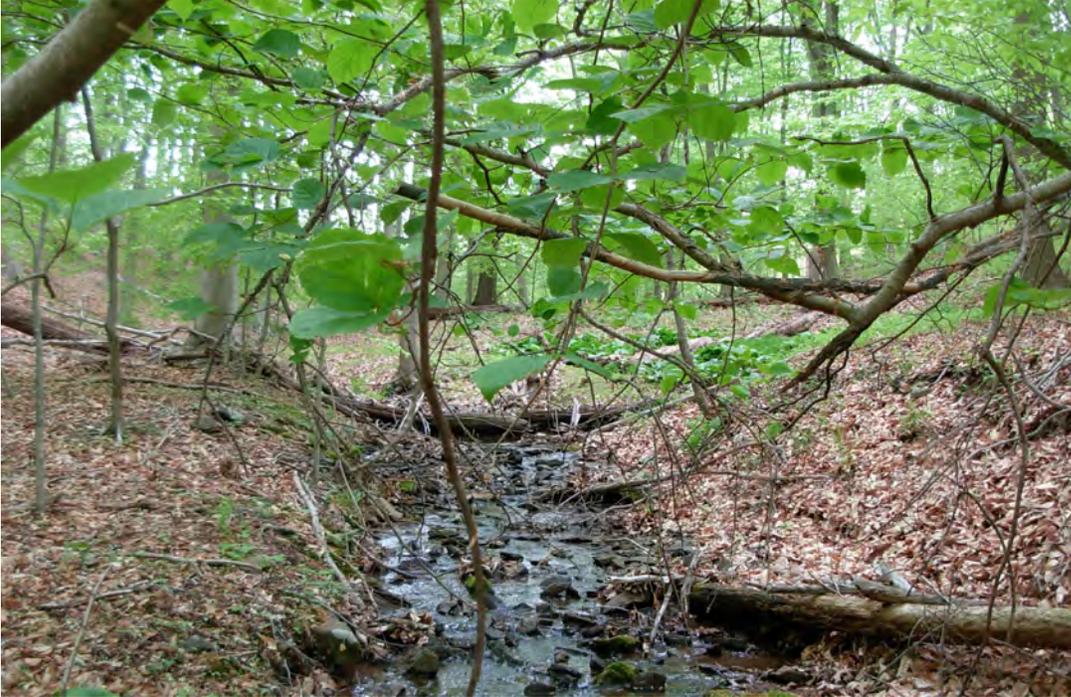
Figure 17. View upstream from sampling station in UNT 00009, Beaver Run watershed, Concord Township, Delaware County PA, 7 May 2013.

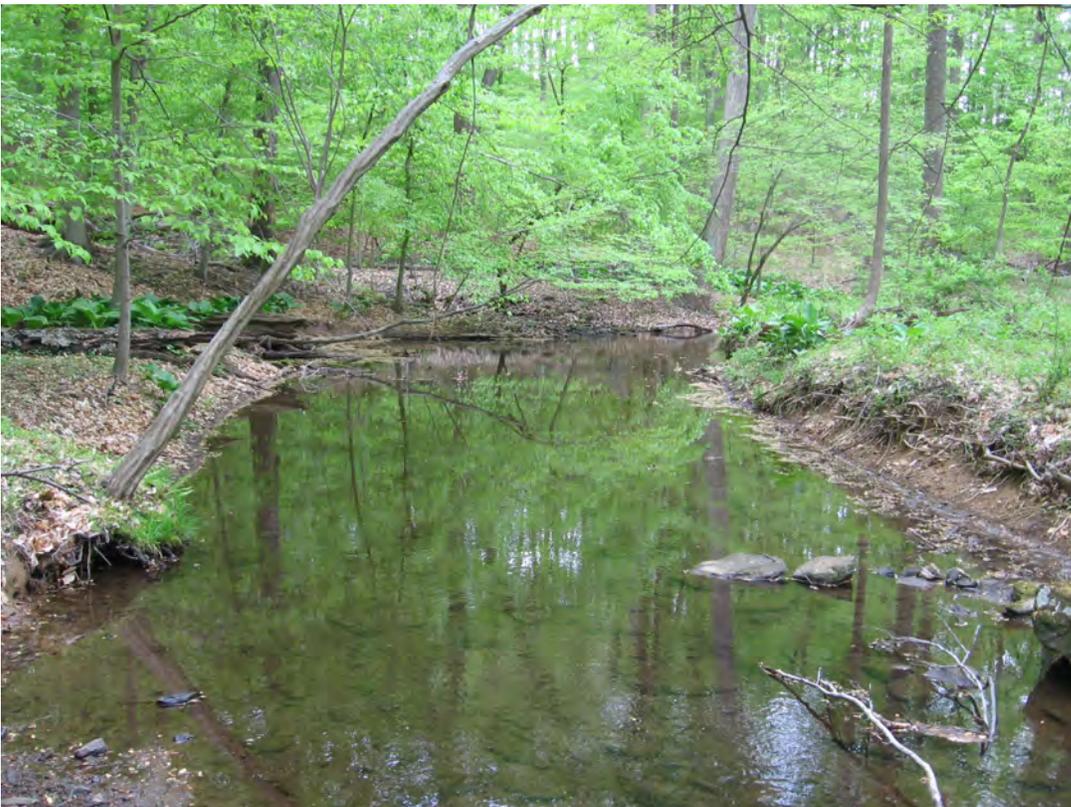
Figure 18. Confluence of UNT 00009 (left distance) with mainstem Beaver Run, Concord Township, Delaware County PA, 7 May 2013. View downstream.

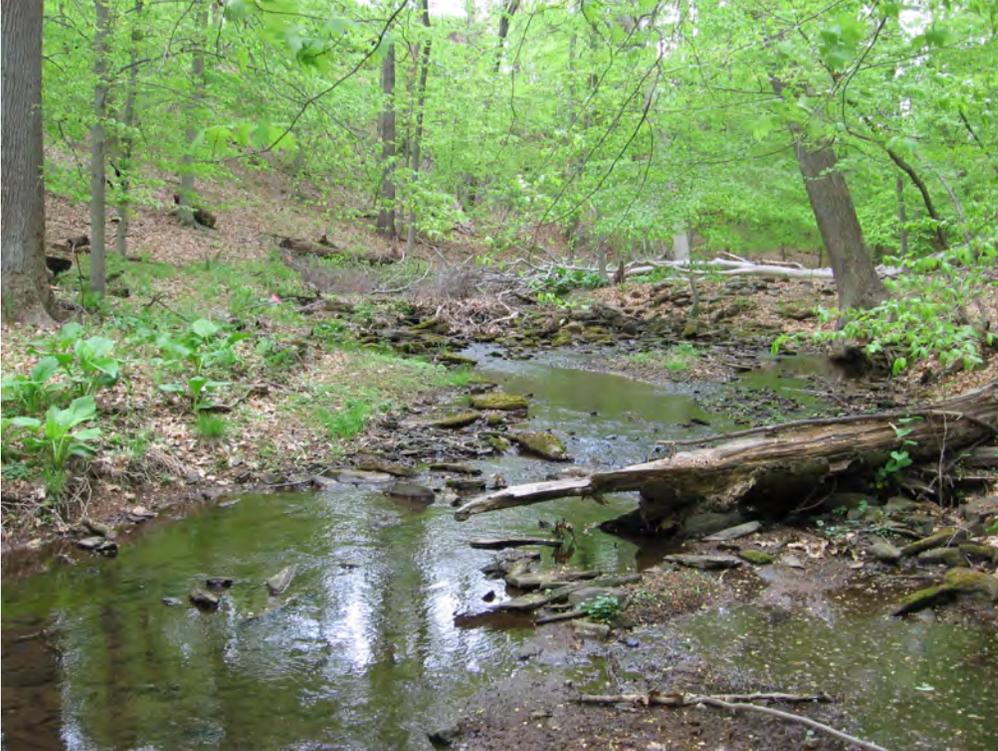
Figure 19. View upstream from sampling station, mainstem Beaver Run, Concord Township, Delaware County PA, 7 May 2013.

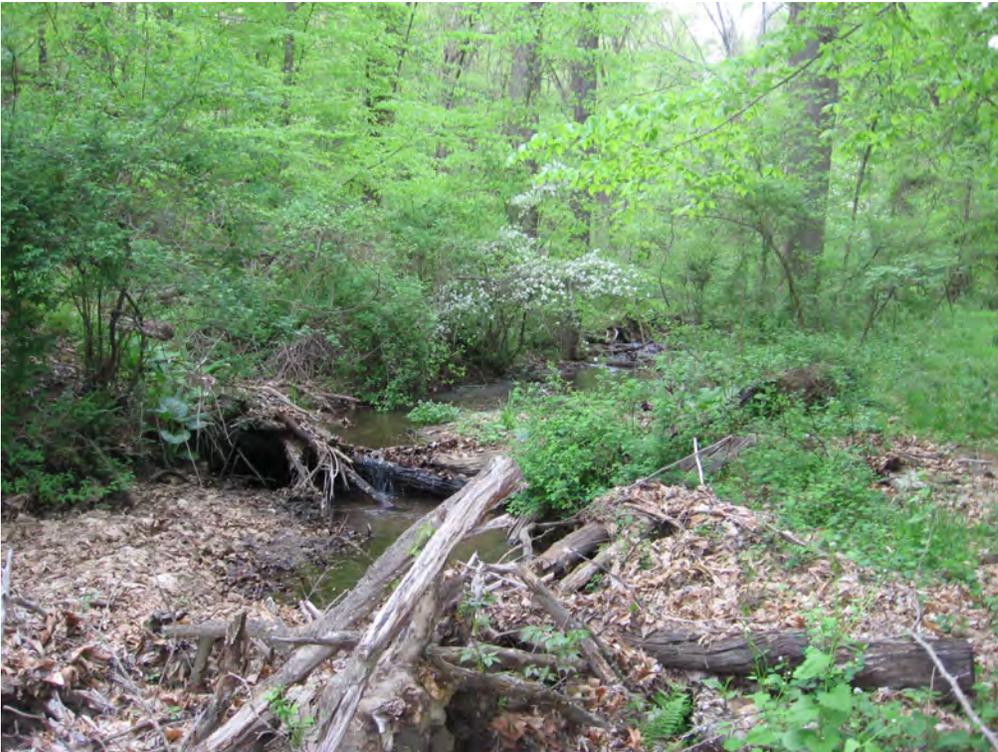
Figure 20. Sampling station on right bank mainstem tributary to Beaver Run, Chadds Ford Township, Delaware County PA, 7 May 2013.

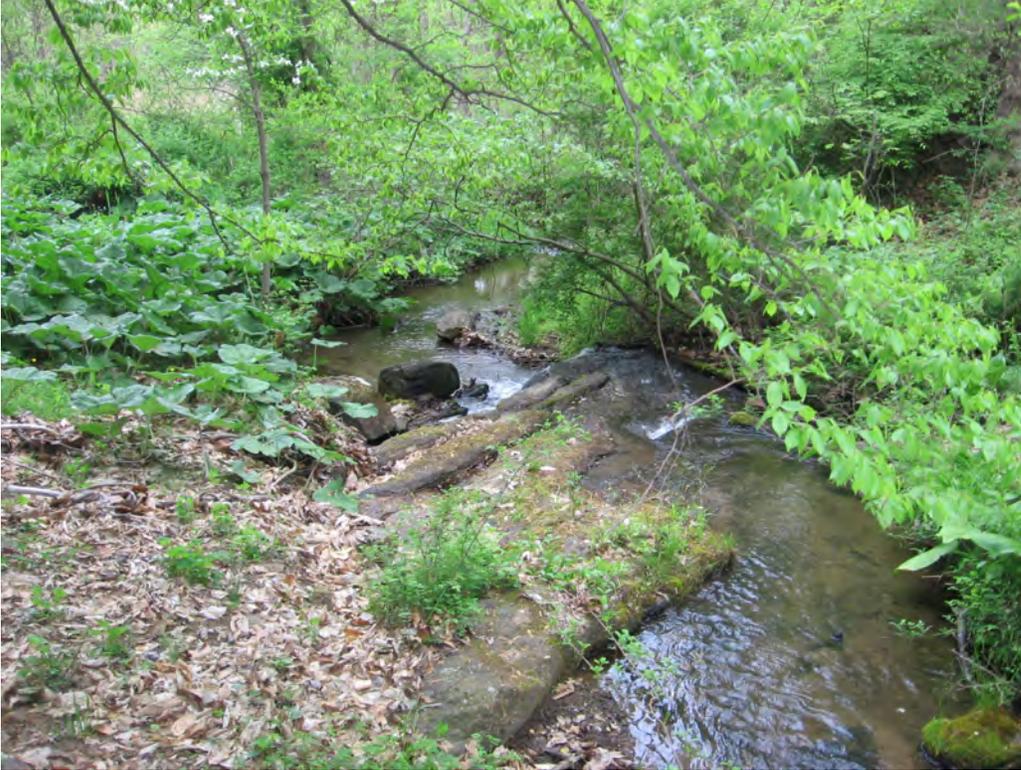
Figure 21. View downstream from sampling station toward old mill pond (left background) on right bank tributary to Beaver Run, Chadds Ford Township, Delaware County PA, 7 May 2013. Trout were observed here.

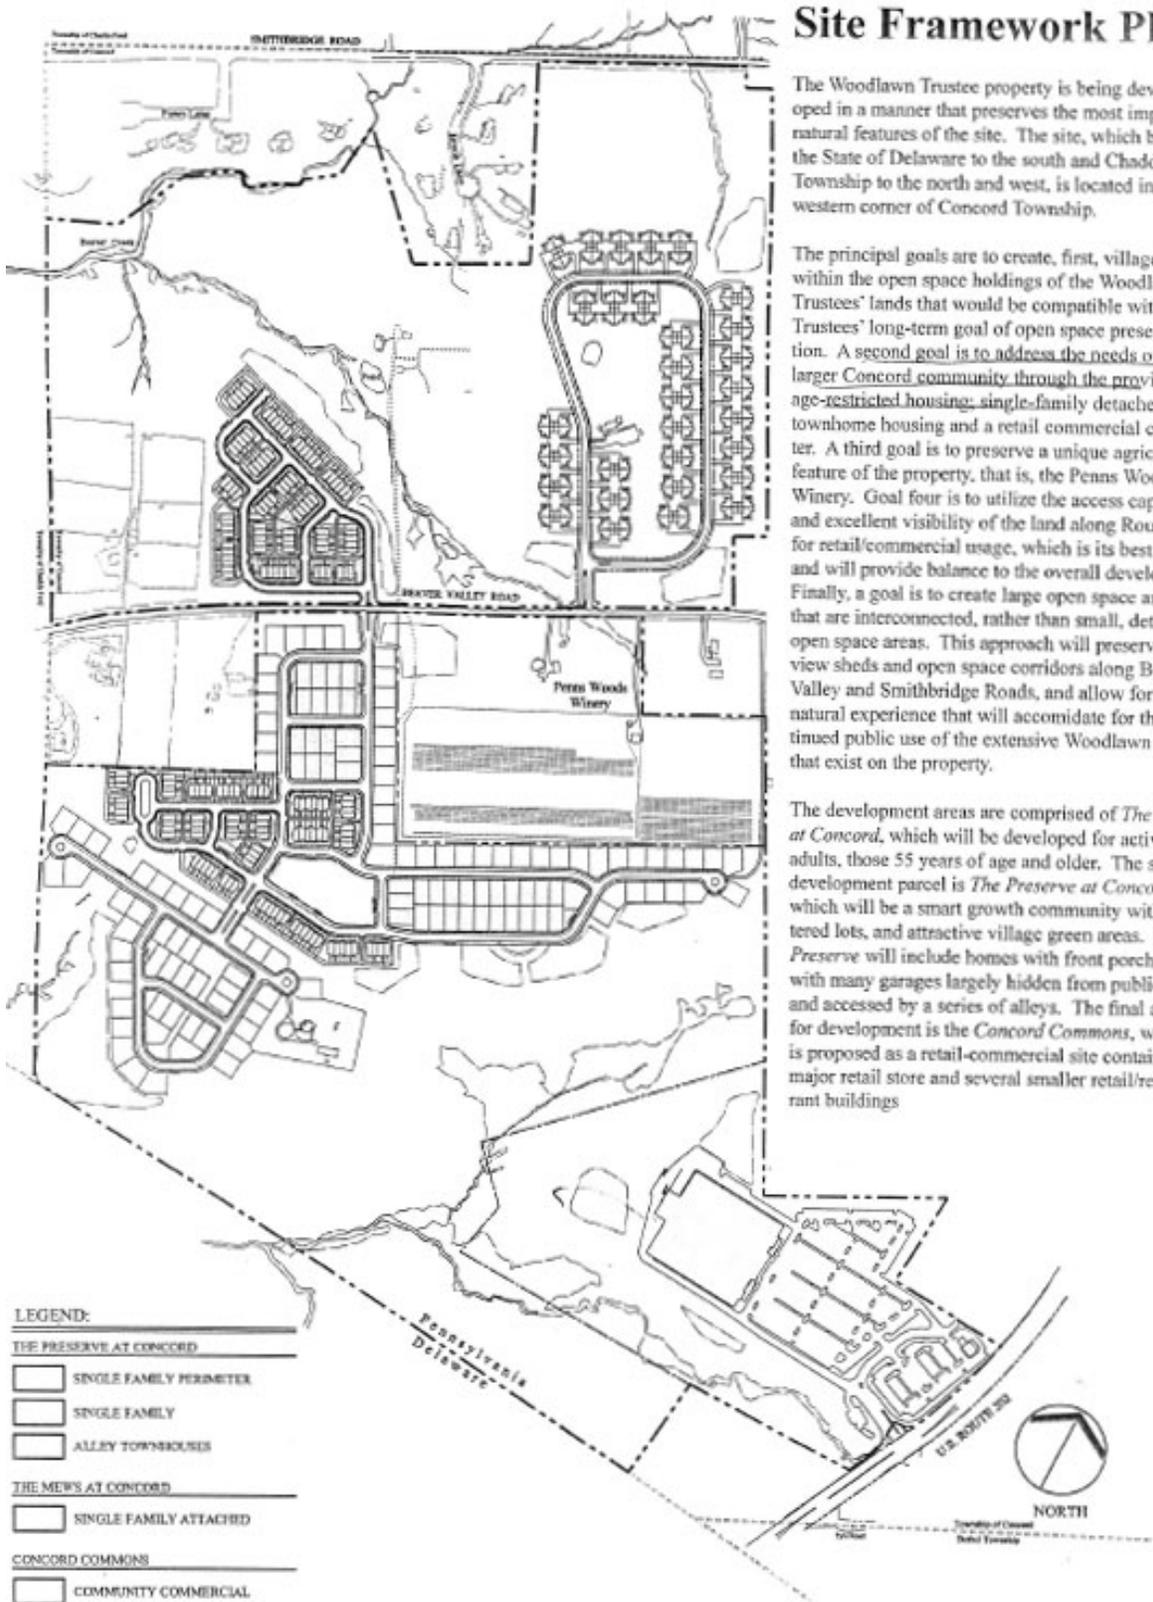
Figure 24. Conceptual plan and text for the subject property offered by developers in 2012. Tributary UNT X is shown, but not all of UNT 00009 or its wetlands are shown.

The principal goals are to create, first, villages within the open space holdings of the Woodlawn Trustees' lands that would be compatible with the Trustees' long-term goal of open space preservation. A second goal is to address the needs of the larger Concord community through the provision of age-restricted housing: single-family detached and townhome housing and a retail commercial center. A third goal is to preserve a unique agricultural feature of the property, that is, the Penns Woods Winery. Goal four is to utilize the access capability and excellent visibility of the land along Route 202 for retail/commercial usage, which is its best use, and will provide balance to the overall development. Finally, a goal is to create large open space areas that are interconnected, rather than small, detached open space areas. This approach will preserve major view sheds and open space corridors along Beaver Valley and Smithbridge Roads, and allow for a more natural experience that will accommodate for the continued public use of the extensive Woodlawn trails that exist on the property.

The development areas are comprised of *The Mews at Concord*, which will be developed for active adults, those 55 years of age and older. The second development parcel is *The Preserve at Concord*, which will be a smart growth community with clustered lots, and attractive village green areas. *The Preserve* will include homes with front porches, and with many garages largely hidden from public view and accessed by a series of alleys. The final area for development is the *Concord Commons*, which is proposed as a retail-commercial site containing a major retail store and several smaller retail/restaurant buildings.

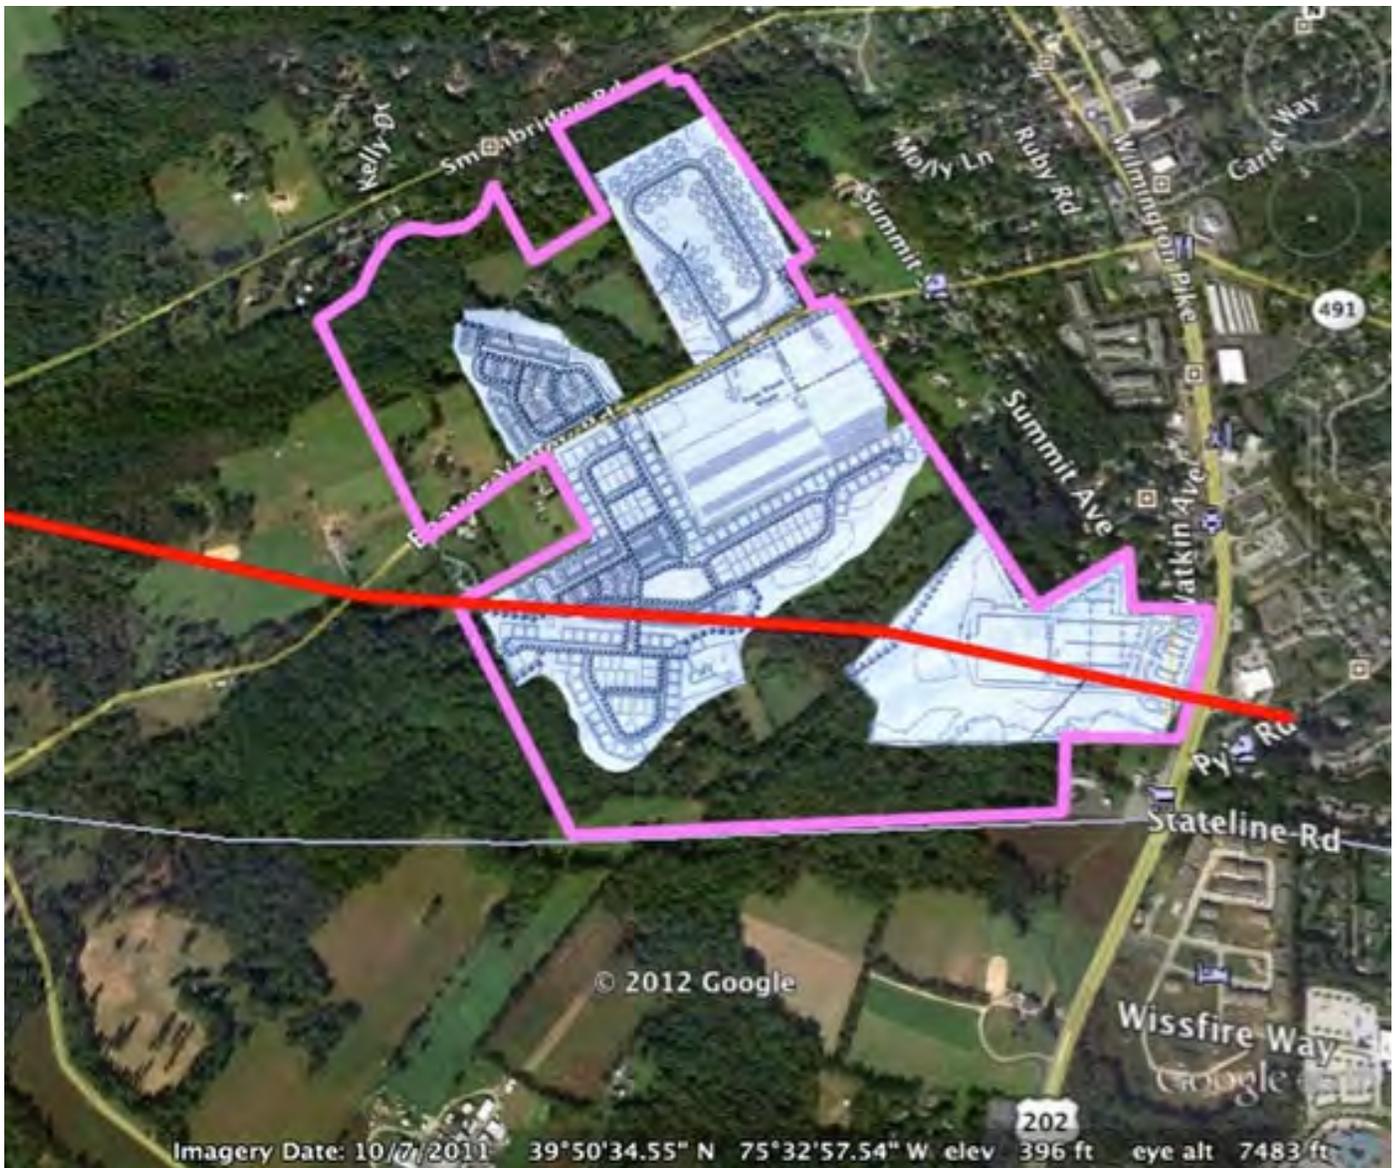
Figure 25. Developers' conceptual plan displayed against a 2011 Google aerial photograph. Existing pipeline right-of-way is highlighted in red.

Safe development adjacent to existing petroleum pipelines is a responsibility of local government. The Township should carefully consider the size and maximum authorized operating pressure of the onsite hazardous liquids pipeline and follow current minimum setback recommendations to reduce the likelihood of future loss of life and property from pipeline rupture and explosion. The Municipal Research and Services Center has developed an entire website that covers these "planning near pipelines" issues. It can be found at:
