CHAPTER 105 WATER OBSTRUCTIONS AND ENCROACHMENT GENERAL PERMIT REGISTRATION

Project Name: Adelphia Gateway Project	Location: Perkiomen Creek Gate, Upland DP2 Montgomery County, PA
--	--

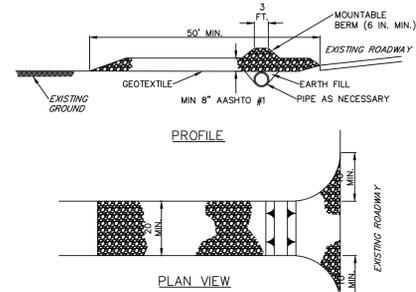
NOTES:
 REMOVE TOPSOIL PRIOR TO INSTALLATION OF ROCK CONSTRUCTION ENTRANCE. EXTEND ROCK OVER FULL WIDTH OF ENTRANCE.
 RUNOFF SHALL BE DIVERTED FROM ROADWAY TO A SUITABLE SEDIMENT REMOVAL BMP PRIOR TO ENTERING ROCK CONSTRUCTION ENTRANCE.
 MOUNTABLE BERM SHALL BE INSTALLED WHEREVER OPTIONAL CULVERT PIPE IS USED AND PROPER PIPE COVER AS SPECIFIED BY MANUFACTURER IS NOT OTHERWISE PROVIDED. PIPE SHALL BE SIZED APPROPRIATELY FOR SIZE OF DITCH BEING CROSSED.
 MAINTENANCE: ROCK CONSTRUCTION ENTRANCE THICKNESS SHALL BE CONSTANTLY MAINTAINED TO THE SPECIFIED DIMENSIONS BY ADDING ROCK. A STOCKPILE OF ROCK MATERIAL SHALL BE MAINTAINED ON SITE FOR THIS PURPOSE. ALL SEDIMENT DEPOSITED ON PAVED ROADWAYS SHALL BE REMOVED AND RETURNED TO THE CONSTRUCTION SITE IMMEDIATELY. IF EXCESSIVE AMOUNTS OF SEDIMENT ARE BEING DEPOSITED ON ROADWAY, EXTEND LENGTH OF ROCK CONSTRUCTION ENTRANCE BY 50 FOOT INCREMENTS UNTIL CONDITION IS ALLEVIATED OR INSTALL WASH RACK. WASHING THE ROADWAY OR SWEEPING THE DEPOSITS INTO ROADWAY DITCHES, SEWERS, CULVERTS, OR OTHER DRAINAGE COURSES IS NOT ACCEPTABLE.

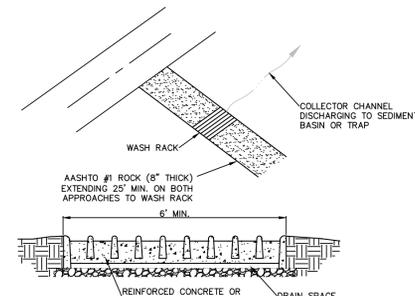
ROCK CONSTRUCTION ACCESS WITH WASH RACK

NOTES:
 WASH RACK SHALL BE 20 FEET (MIN.) WIDE OR TOTAL WIDTH OF ACCESS.
 WASH RACK SHALL BE DESIGNED AND CONSTRUCTED TO ACCOMMODATE ANTICIPATED CONSTRUCTION VEHICULAR TRAFFIC.
 A WATER SUPPLY SHALL BE MADE AVAILABLE TO WASH THE WHEELS OF ALL VEHICLES EXITING THE SITE.
 MAINTENANCE: ROCK CONSTRUCTION ENTRANCE THICKNESS SHALL BE CONSTANTLY MAINTAINED TO THE SPECIFIED DIMENSIONS BY ADDING ROCK. A STOCKPILE OF ROCK MATERIAL SHALL BE MAINTAINED ON SITE FOR THIS PURPOSE. DRAIN SPACE UNDER WASH RACK SHALL BE KEPT OPEN AT ALL TIMES. DAMAGE TO THE WASH RACK SHALL BE REPAIRED PRIOR TO FURTHER USE OF THE RACK. ALL SEDIMENT DEPOSITED ON ROADWAYS SHALL BE REMOVED AND RETURNED TO THE CONSTRUCTION SITE IMMEDIATELY. WASHING THE ROADWAY OR SWEEPING THE DEPOSITS INTO ROADWAY DITCHES, SEWERS, CULVERTS, OR OTHER DRAINAGE COURSES IS NOT ACCEPTABLE.

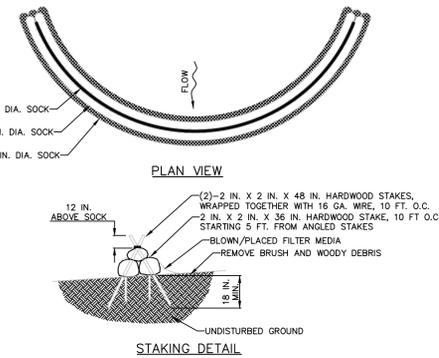
DESIGN NOTES:
 1. COMPOST SOCK SEDIMENT TRAP SHALL BE SIZED TO PROVIDE 2000 CUBIC FEET OF STORAGE CAPACITY FOR EACH ACRE TRIBUTARY TO THE TRAP.
 2. MINIMUM BASE WIDTH IS EQUAL TO THE HEIGHT.

3. SEDIMENT ACCUMULATION SHALL NOT EXCEED 1/3 THE TOTAL HEIGHT OF THE TRAP.
 4. SOCKS SHALL BE OF LARGER DIAMETER AT THE BASE OF THE TRAP AND DECREASE IN DIAMETER FOR SUCCESSIVE LAYERS AS SHOWN ON THE PLAN VIEW.

COMPOST SOCK SEDIMENT TRAPS SHALL BE INSPECTED WEEKLY AND AFTER EACH RUNOFF EVENT. SEDIMENT SHALL BE REMOVED WHEN IT REACHES 1/3 THE HEIGHT OF THE SOCKS.
 PHOTODEGRADABLE AND BIODEGRADABLE SOCKS SHALL NOT BE USED FOR MORE THAN 1 YEAR.

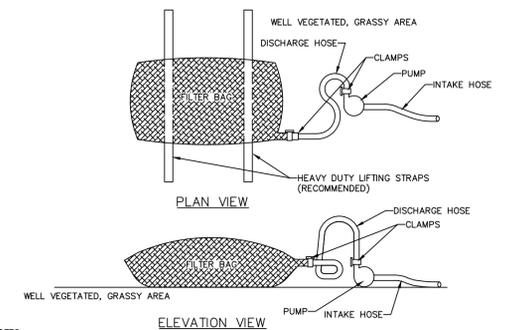
NOTES:
 LOW VOLUME FILTER BAGS SHALL BE MADE FROM NON-WOVEN GEOTEXTILE MATERIAL SEWN WITH HIGH STRENGTH, DOUBLE STITCHED "J" TYPE SEAMS. THEY SHALL BE CAPABLE OF TRAPPING PARTICLES LARGER THAN 150 MICRONS. HIGH VOLUME FILTER BAGS SHALL BE MADE FROM WOVEN GEOTEXTILES THAT MEET THE FOLLOWING STANDARDS:

PROPERTY	TEST METHOD	MINIMUM STANDARD
AVG. WIDE WIDTH STRENGTH	ASTM D-4884	60 LB/IN
GRAB TENSILE	ASTM D-4632	205 LB
PUNCTURE	ASTM D-4833	110 LB
MULLEN BURST	ASTM D-3786	350 PSI
UV RESISTANCE	ASTM D-4355	70%
AOS % RETAINED	ASTM D-4751	80 SIEVE

A SUITABLE MEANS OF ACCESSING THE BAG WITH MACHINERY REQUIRED FOR DISPOSAL PURPOSES SHALL BE PROVIDED. FILTER BAGS SHALL BE REPLACED WHEN THEY BECOME 1/2 FULL OF SEDIMENT. SPARE BAGS SHALL BE KEPT AVAILABLE FOR REPLACEMENT OF THOSE THAT HAVE FAILED OR ARE FILLED. BAGS SHALL BE PLACED ON STRAPS TO FACILITATE REMOVAL UNLESS BAGS COME WITH LIFTING STRAPS ALREADY ATTACHED.
 BAGS SHALL BE LOCATED IN WELL-VEGETATED (GRASSY) AREA, AND DISCHARGE ONTO STABLE, EROSION RESISTANT AREAS. WHERE THIS IS NOT POSSIBLE, A GEOTEXTILE UNDERLAYMENT AND FLOW PATH SHALL BE PROVIDED. BAGS MAY BE PLACED ON FILTER STONE TO INCREASE DISCHARGE CAPACITY. BAGS SHALL NOT BE PLACED ON SLOPES GREATER THAN 5% FOR SLOPES EXCEEDING 5% CLEAN ROCK OR OTHER NON-ERODIBLE AND NON-POLLUTING MATERIAL. BAGS SHALL BE PLACED UNDER THE BAG TO REDUCE SLOPE STEEPNESS.
 NO DOWNSLOPE SEDIMENT BARRIER IS REQUIRED FOR MOST INSTALLATIONS. COMPOST BERM OR COMPOST FILTER SOCK SHALL BE INSTALLED BELOW BAGS LOCATED IN HO OR EV WATERSHEDS, WITHIN 50 FEET OF ANY RECEIVING SURFACE WATER OR WHERE GRASSY AREA IS NOT AVAILABLE.

THE PUMP DISCHARGE HOSE SHALL BE INSERTED INTO THE BAGS IN THE MANNER SPECIFIED BY THE MANUFACTURER AND SECURELY CLAMPED. A PIECE OF PVC PIPE IS RECOMMENDED FOR THIS PURPOSE.
 THE PUMPING RATE SHALL BE NO GREATER THAN 750 GPM OR 1/2 THE MAXIMUM SPECIFIED BY THE MANUFACTURER, WHICHEVER IS LESS. PUMP INTAKES SHALL BE FLOATING AND SCREENED.
 FILTER BAGS SHALL BE INSPECTED DAILY. IF ANY PROBLEM IS DETECTED, PUMPING SHALL CEASE IMMEDIATELY AND NOT RESUME UNTIL THE PROBLEM IS CORRECTED.

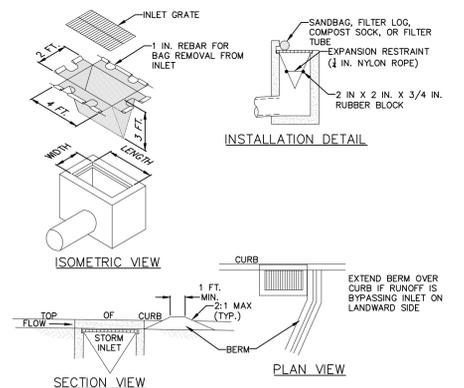
NOTES:
 MAXIMUM DRAINAGE AREA = 1/2 ACRE.
 INLET PROTECTION SHALL NOT BE REQUIRED FOR INLET TRIBUTARY TO SEDIMENT BASIN OR TRAP. BERMS SHALL BE REQUIRED FOR ALL INSTALLATIONS.
 ROLLED EARTHEN BERM SHALL BE MAINTAINED UNTIL ROADWAY IS STONED. ROAD SUBBASE BERM SHALL BE MAINTAINED UNTIL ROADWAY IS PAVED. SIX INCH MINIMUM HEIGHT ASPHALT BERM SHALL BE MAINTAINED UNTIL ROADWAY SURFACE RECEIVES FINAL COAT.
 AT A MINIMUM, THE FABRIC SHALL HAVE A MINIMUM GRAB TENSILE STRENGTH OF 120 LBS, A MINIMUM BURST STRENGTH OF 200 PSI, AND A MINIMUM TRAPEZOIDAL TEAR STRENGTH OF 50 LBS. FILTER BAGS SHALL BE CAPABLE OF TRAPPING ALL PARTICLES NOT PASSING A NO. 40 SIEVE.
 INLET FILTER BAGS SHALL BE INSPECTED ON A WEEKLY BASIS AND AFTER EACH RUNOFF EVENT. BAGS SHALL BE EMPTIED OR RINSED OR REPLACED WHEN HALF FULL OR WHEN FLOW CAPACITY HAS BEEN REDUCED SO AS TO CAUSE FLOODING OR BYPASSING OF THE INLET. DAMAGED OR CLOGGED BAGS SHALL BE REPLACED. A SUPPLY SHALL BE MAINTAINED ON SITE FOR REPLACEMENT OF BAGS. ALL NEEDED REPAIRS SHALL BE INITIATED IMMEDIATELY AFTER THE INSPECTION. DISPOSE OF ACCUMULATED SEDIMENT AS WELL AS ALL USED BAGS ACCORDING TO THE PLAN NOTES.

DO NOT USE ON MAJOR PAVED ROADWAYS WHERE PONDING MAY CAUSE TRAFFIC HAZARDS.

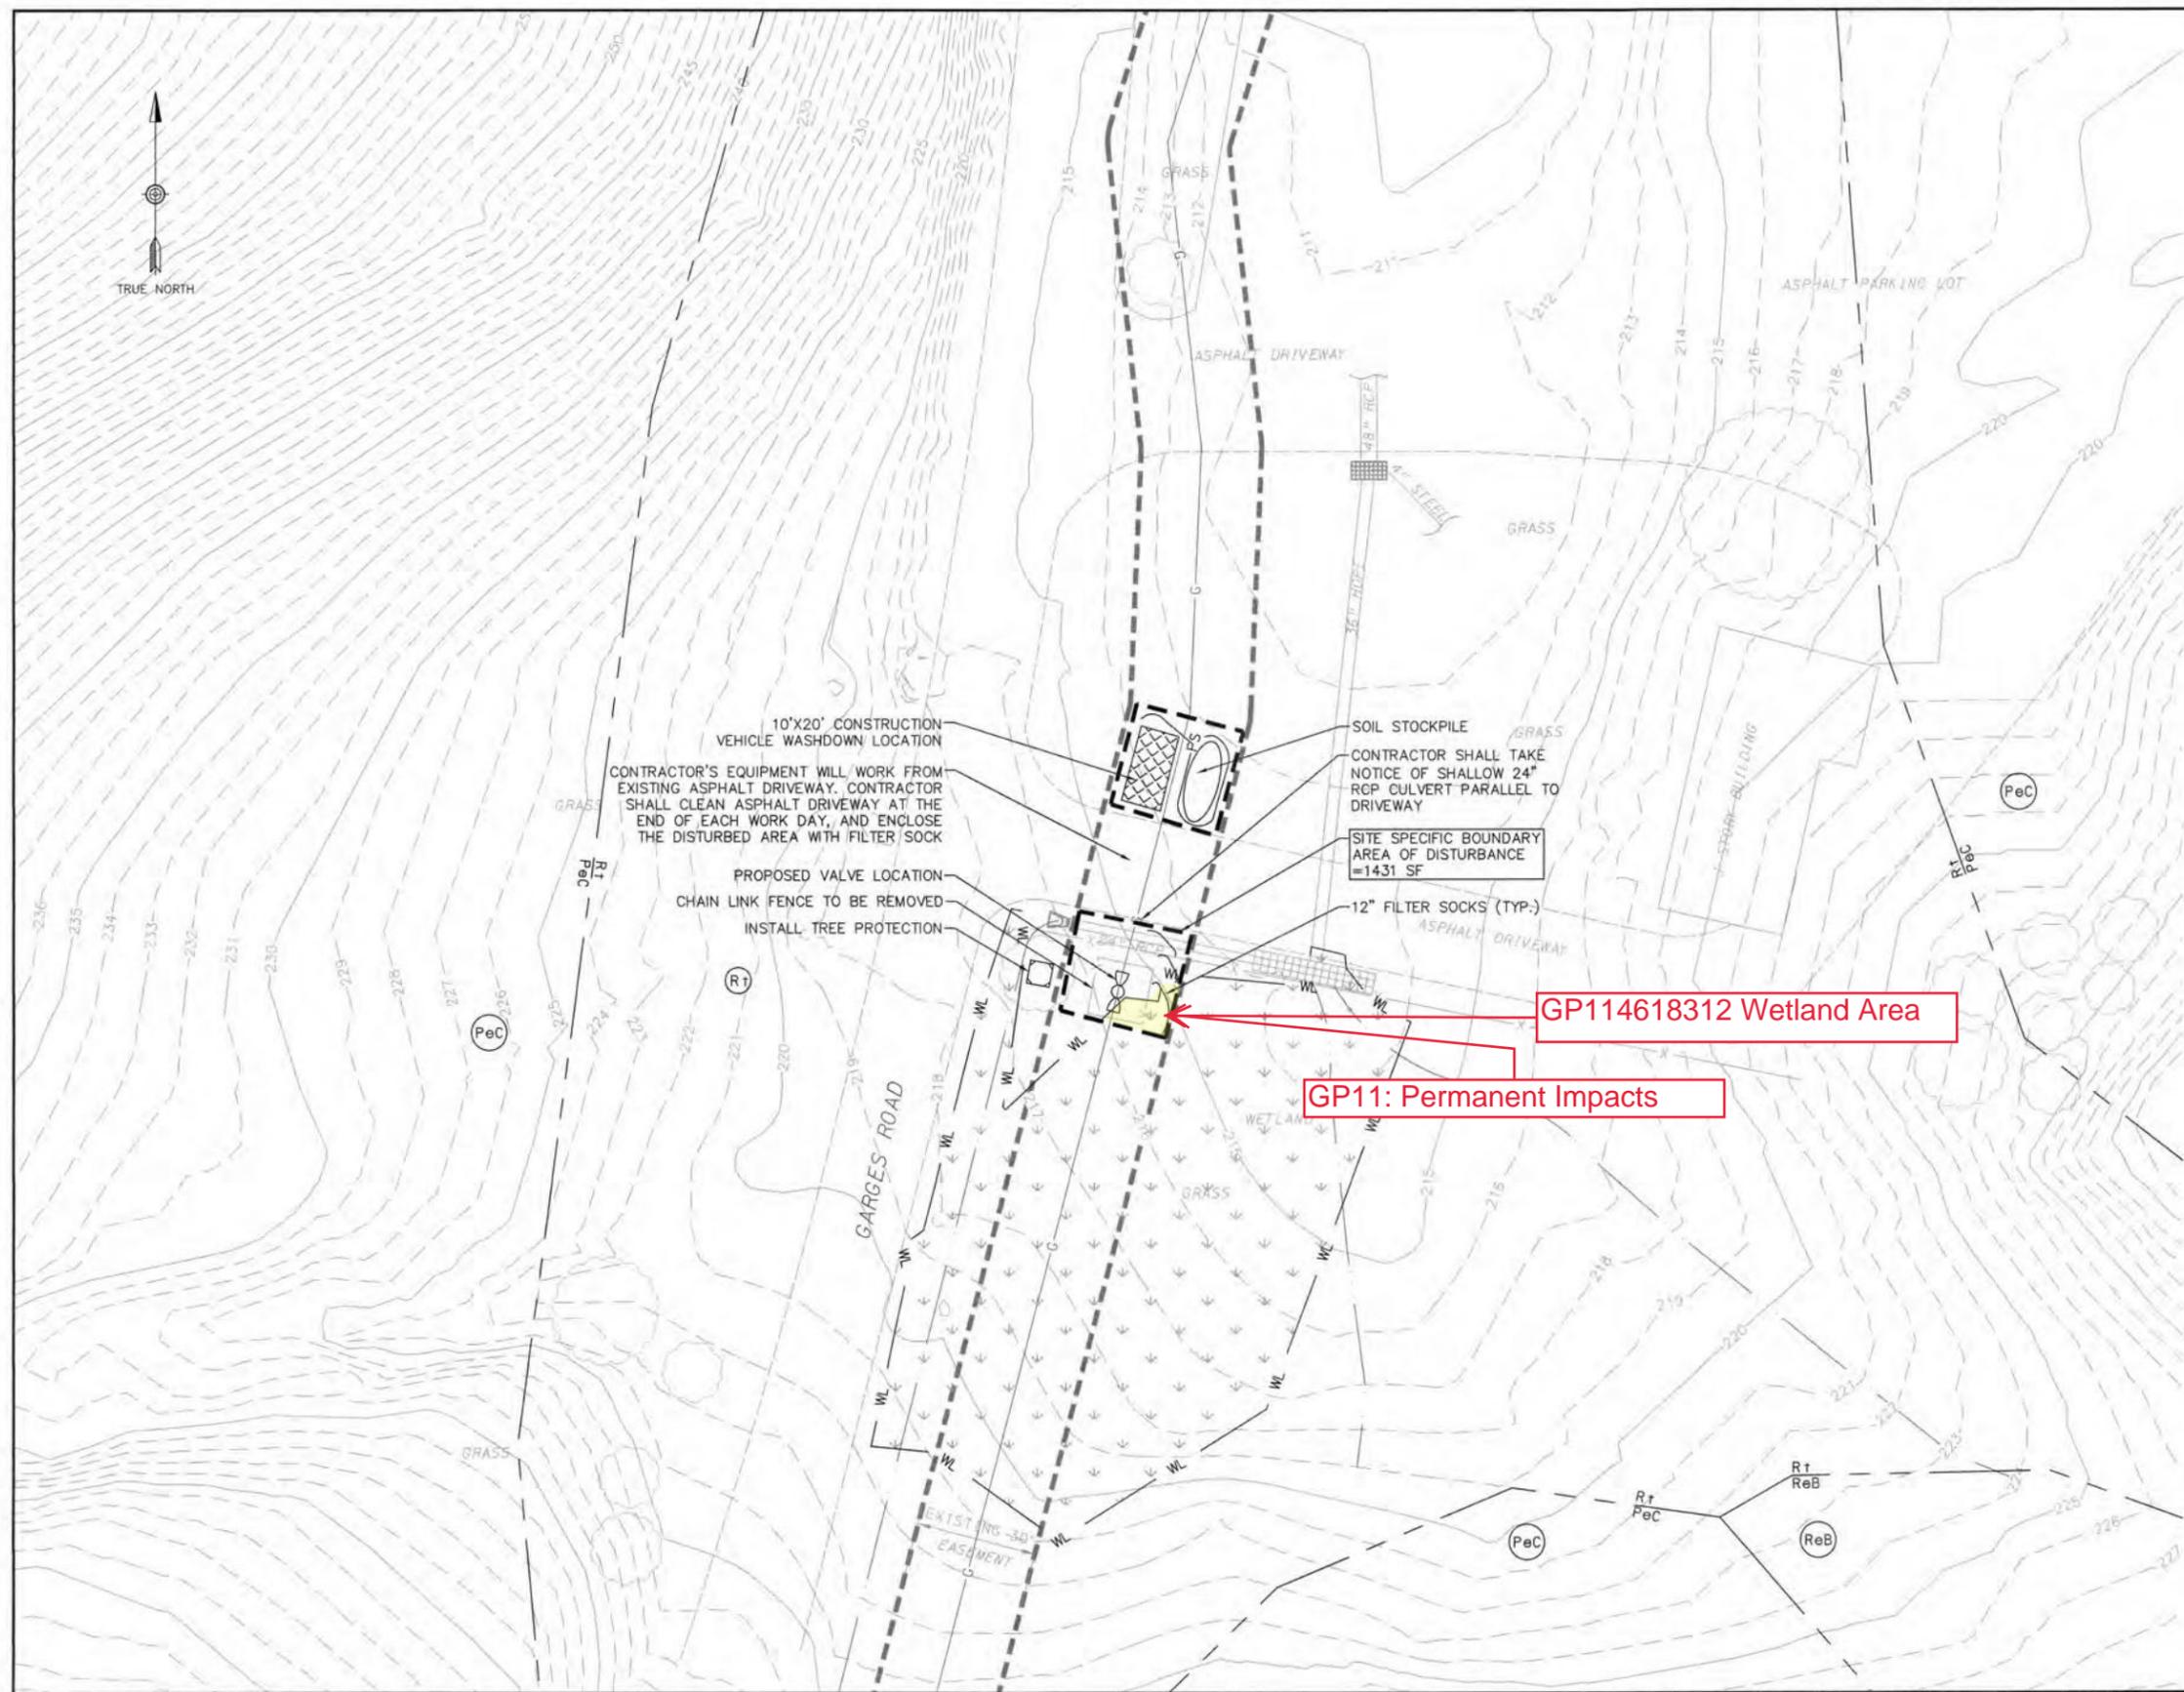
10'X20' CONSTRUCTION VEHICLE WASHDOWN LOCATION
 CONTRACTOR'S EQUIPMENT WILL WORK FROM EXISTING ASPHALT DRIVEWAY. CONTRACTOR SHALL CLEAN ASPHALT DRIVEWAY AT THE END OF EACH WORK DAY, AND ENCLOSE THE DISTURBED AREA WITH FILTER SOCK

SOIL STOCKPILE
 CONTRACTOR SHALL TAKE NOTICE OF SHALLOW 24" RCP CULVERT PARALLEL TO DRIVEWAY
