If Interim report, Subject to Change as Additional Information Becomes Available
If Interim Report, this Report is cumulative, containing information from previous reports in addition to new information and may change
SPLP PENNSYLVANIA PIPELINE PROJECT
HORIZONTAL DIRECTIONAL DRILLING – INADVERTENT RETURN REPORT FORM

REPORT DATE:	Current as of 12/1/2020	HDD ALIGNMENT #	PA-CH-100.0000-RD				
PROJECT SITE:	PPP 6 - S3-0290 - Milford Rd./Little Conestoga Rd		HDD COMPANY:	Michels Directional Crossing			
DATE AND TIME WHEN IR WAS INITIALLY DISCOVERED			DATE:	8/10/2020	TIME:	1530	
LOCATION: STREET	427-423 Green Valley Rd, Downingtown, PA 19335		MUNICIPALITY:	Upper Uwchlan	COUNTY:	Chester	
LATITUDE:	40.0794	LONGITUDE:	-75.7104	FROM STATION:	14824+00	TO STATION	14824+00
STREAM NAME:	S-H10 (UNT to Marsh Creek), S-H11 (UNT to Marsh Creek)		POND / LAKE NAME:	Pond H3 (Marsh Creek Reservoir)	WETLAND NAME:	WL-H17 (PEM, PFO)	
DEP PERMIT Nos. (102 AND 105)	E&S Permit # ESG0100015001, Water Obstruction Permit E15-862						
CORPS PERMIT NO.	PASPGP-5 (issued April 12, 2017)						
IR TRACKING ID:	PPP6_PA-CH-0100.0000-RD_MilfordRd_IRInterim_16_120220						
IS AUGUST 8, 2017 ORDER APPLICABLE?	YES	LISTED

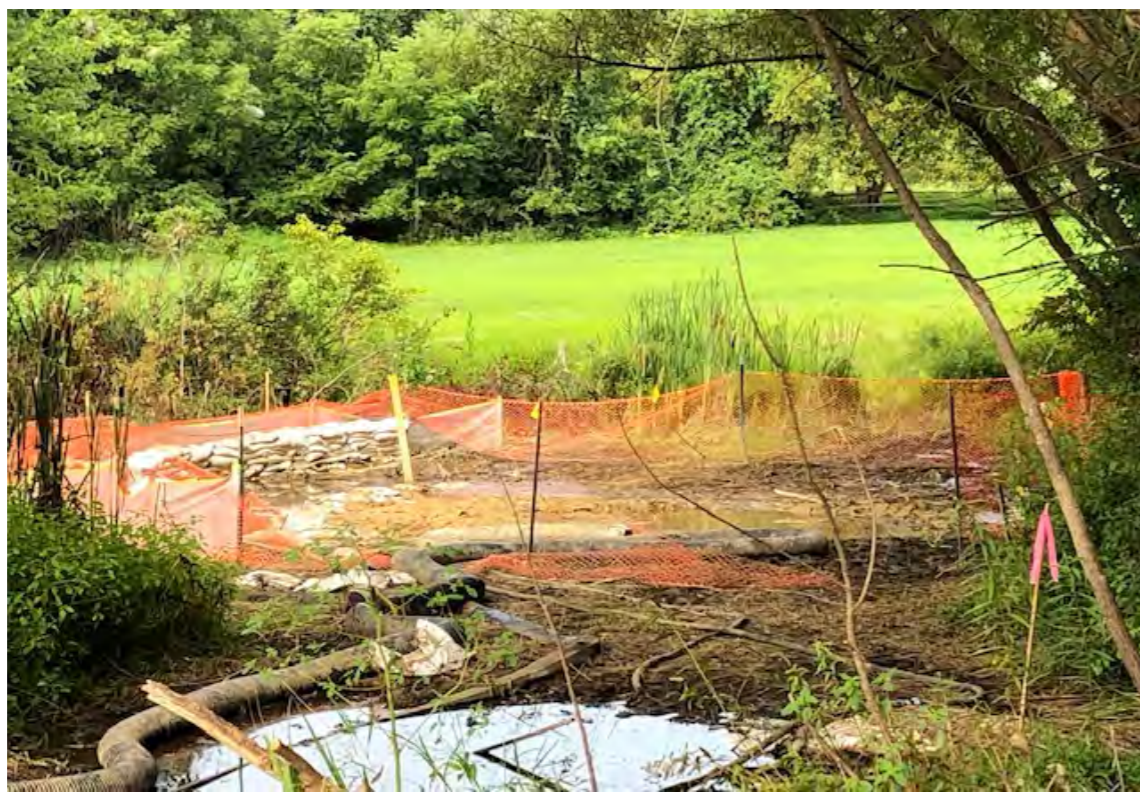
8/22/2020

View of IR release location within WL-H17.

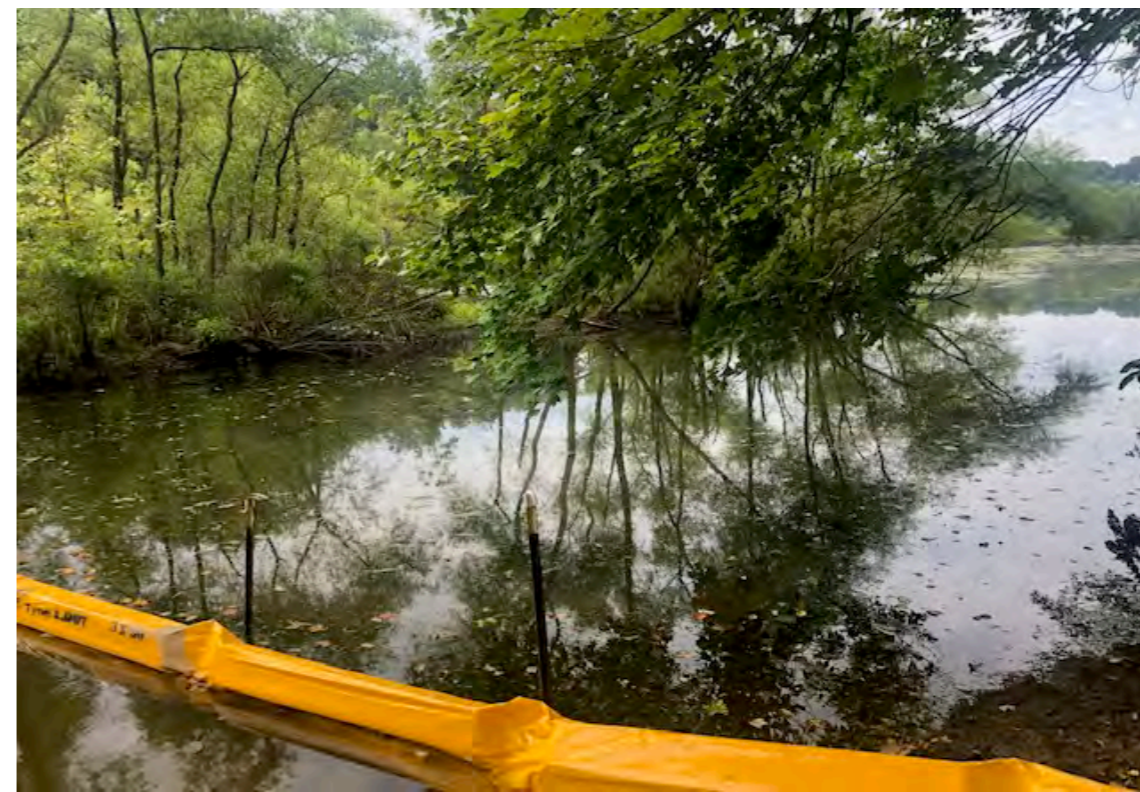
8/22/2020

View of turbidity curtain at the confluence of stream S-H10 (UNT to Marsh Creek) and pond H3 (Marsh Creek Reservoir).

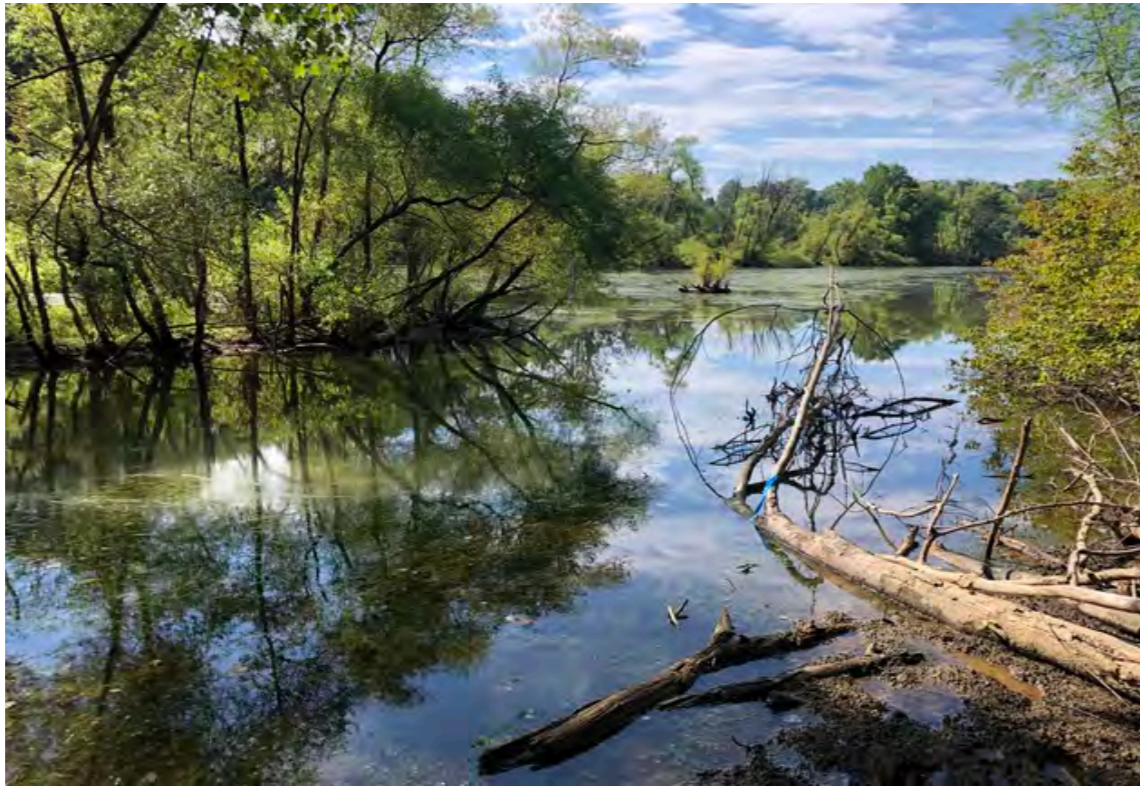
8/24/2020

View of pond H3 (Marsh Creek Reservoir).

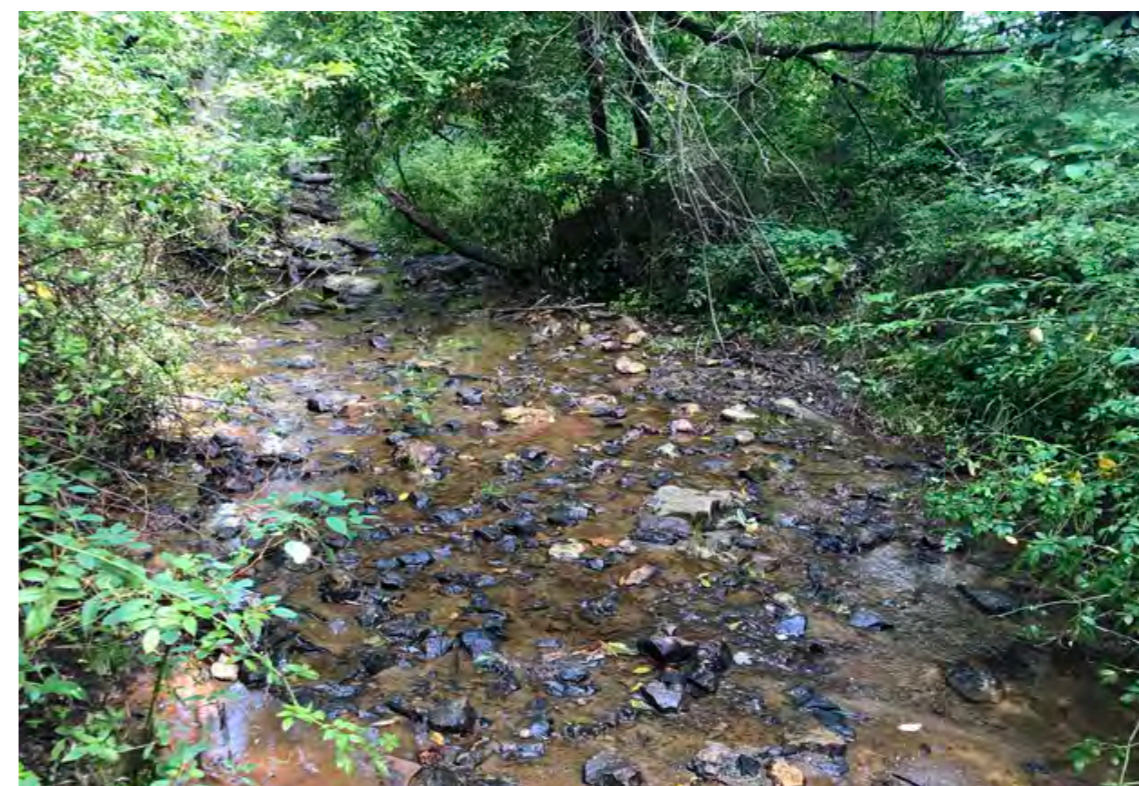
8/24/2020

View of stream S-H10 (UNT to Marsh Creek)

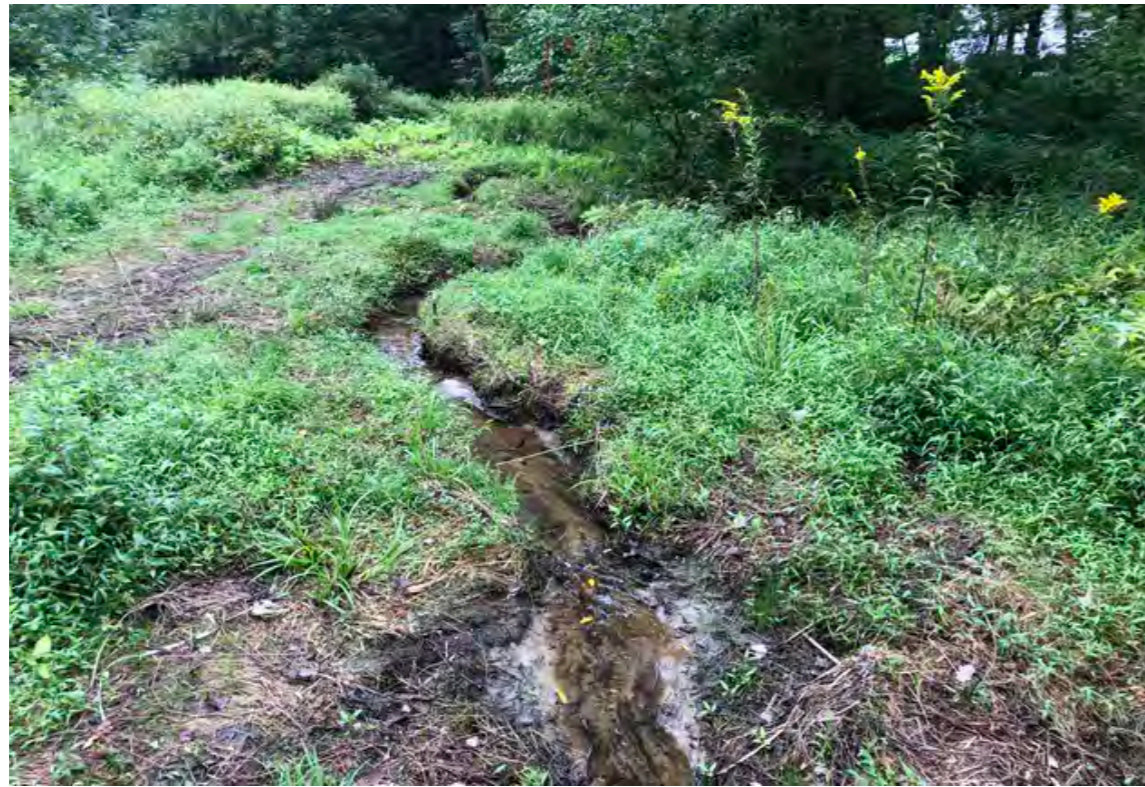
8/31/2020

View of stream S-H10 (UNT to Marsh Creek)

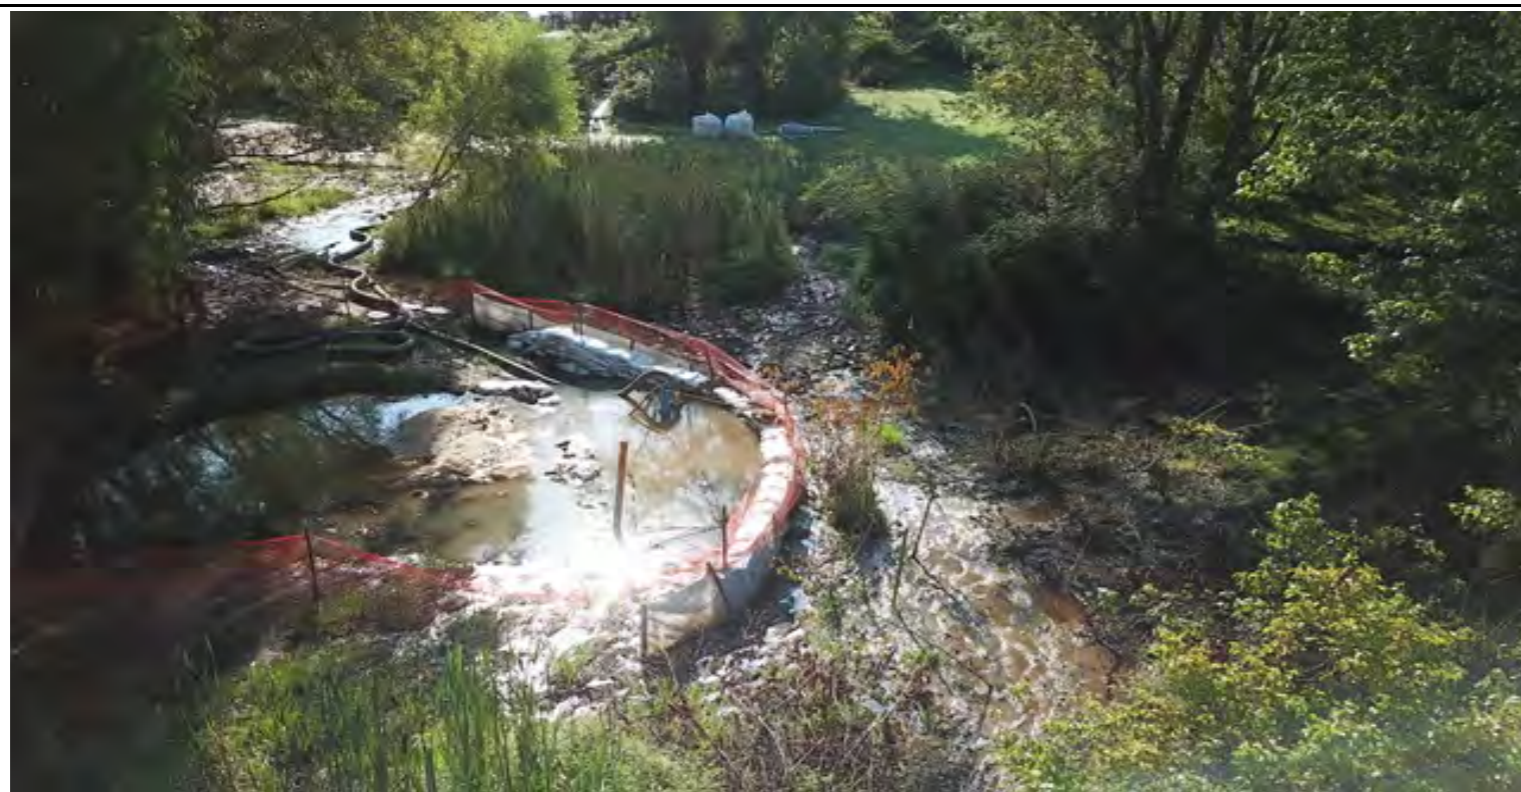
9/4/2020

View of IR release location and containment within WL-H17.

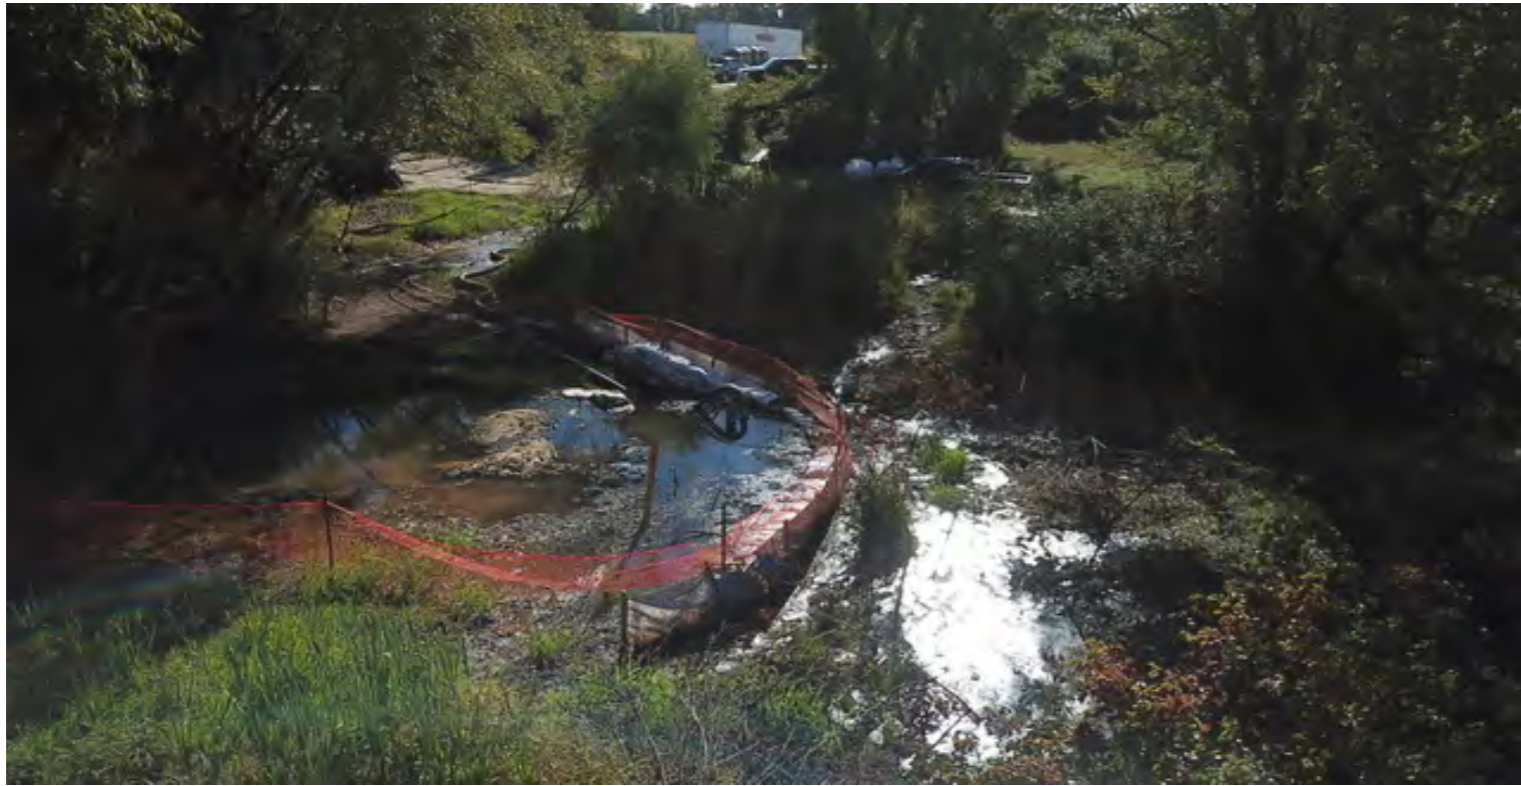
9/21/2020

View of IR release location and containment within WL-H17.

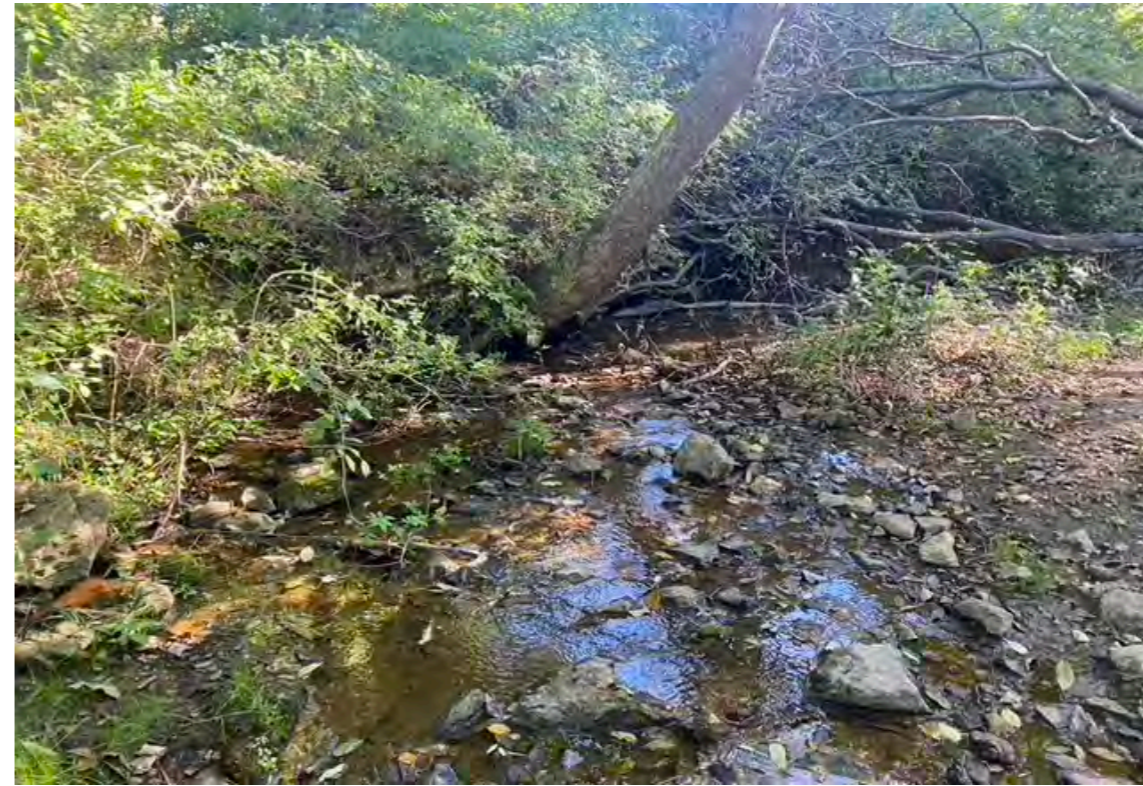
9/21/2020

View of stream S-H10 (UNT to Marsh Creek)

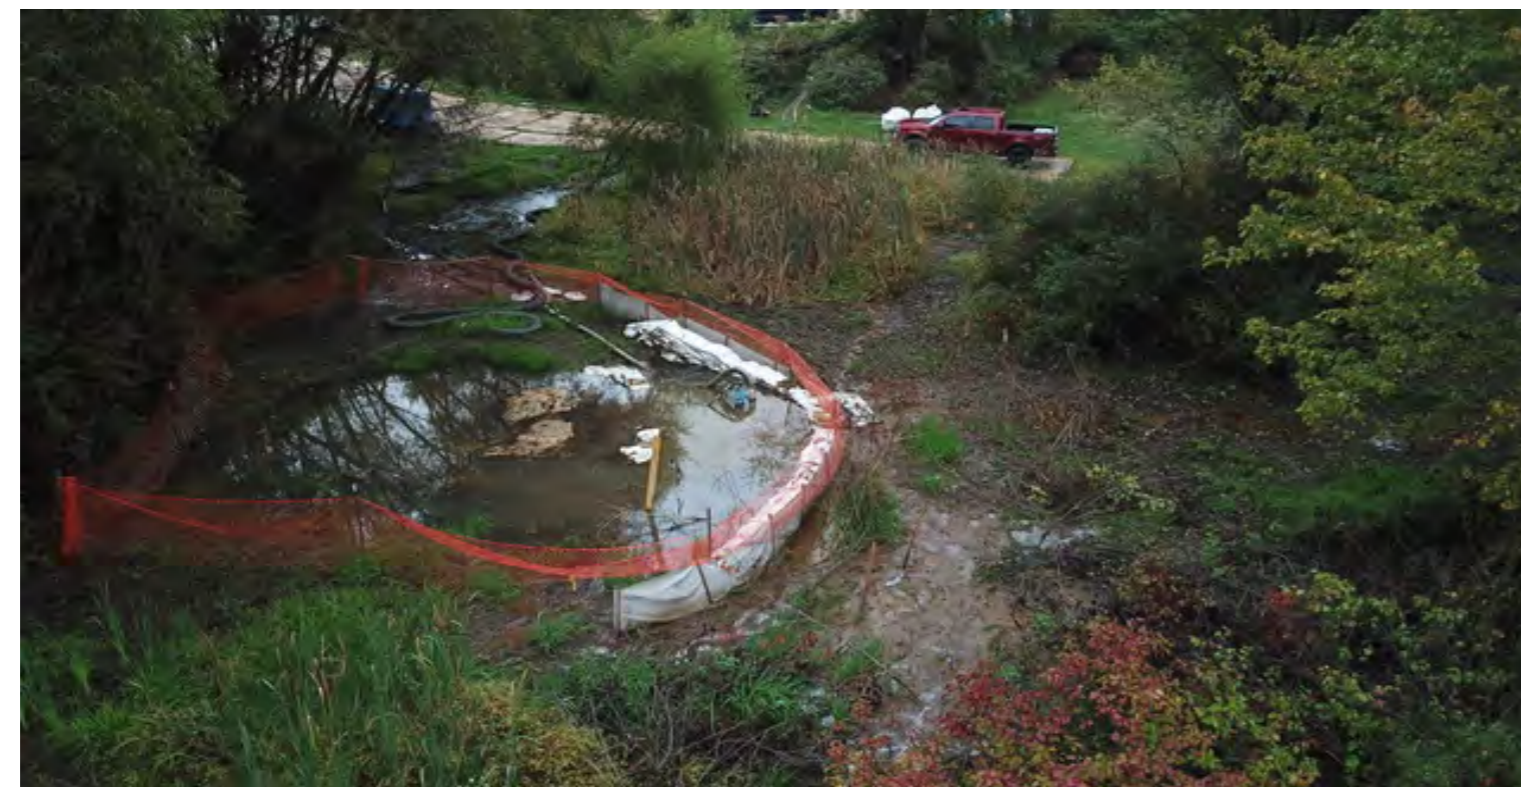
9/28/2020

View of IR release location and containment within WL-H17.

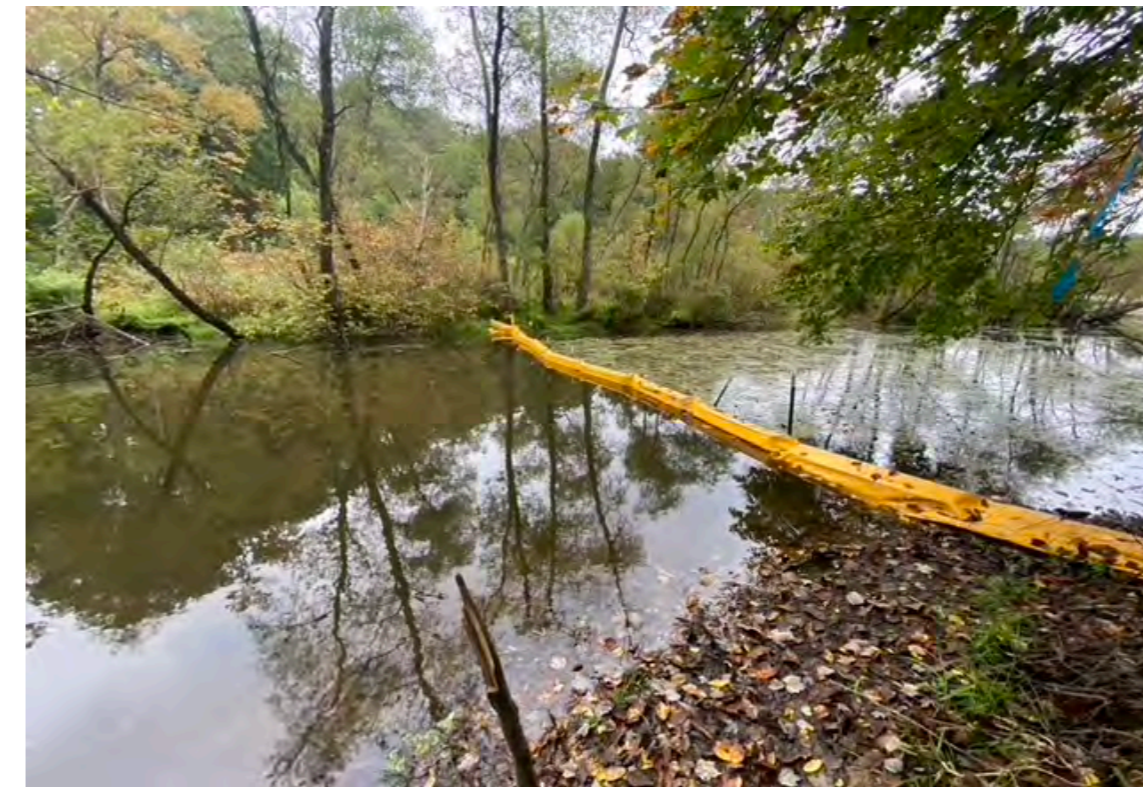
9/28/2020

View of turbidity curtain at the confluence of stream S-H10 (UNT to Marsh Creek) and pond H3 (Marsh Creek Reservoir).

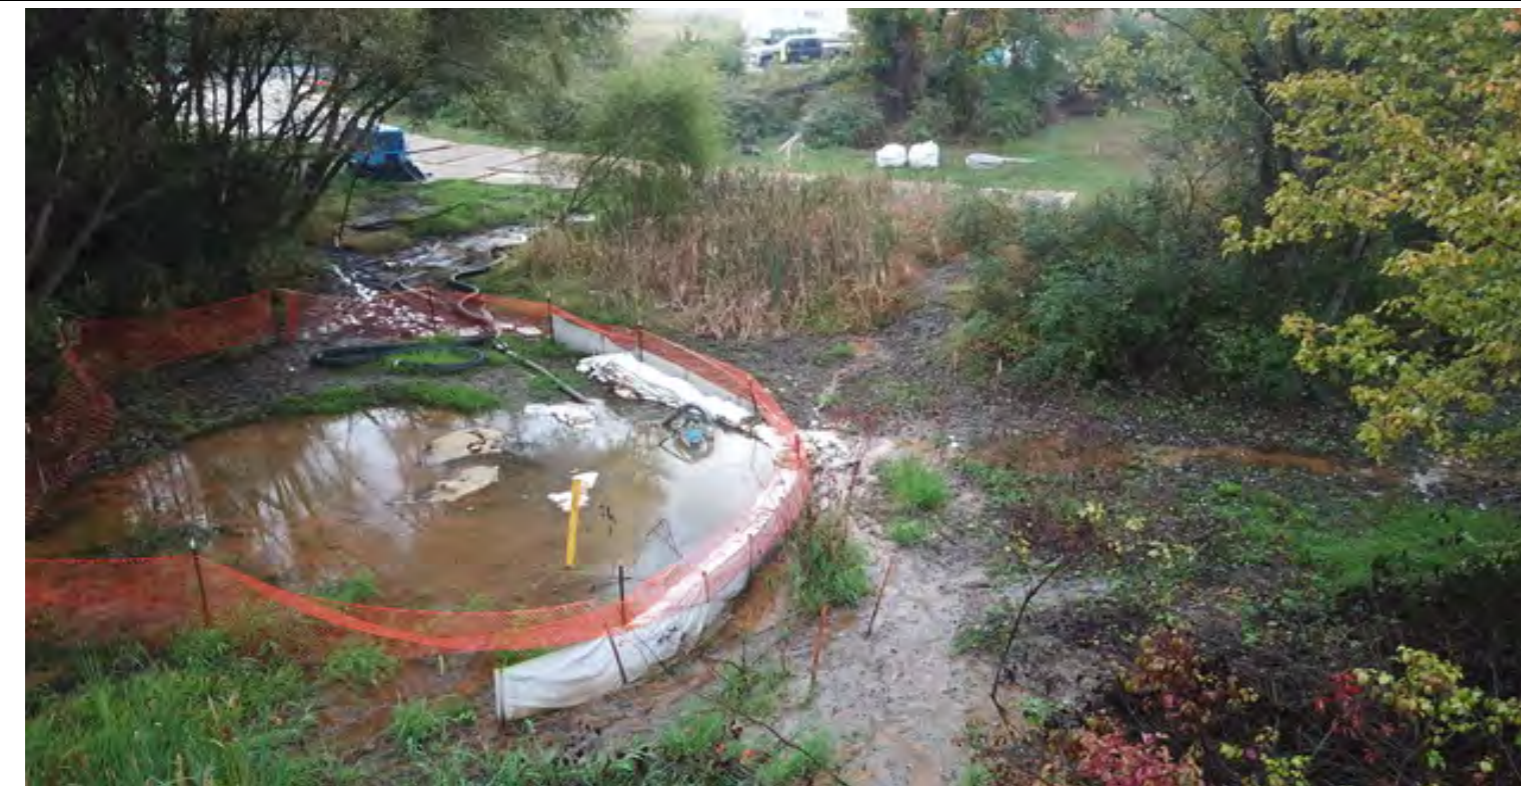
10/5/2020

View of IR release location and containment within WL-H17.

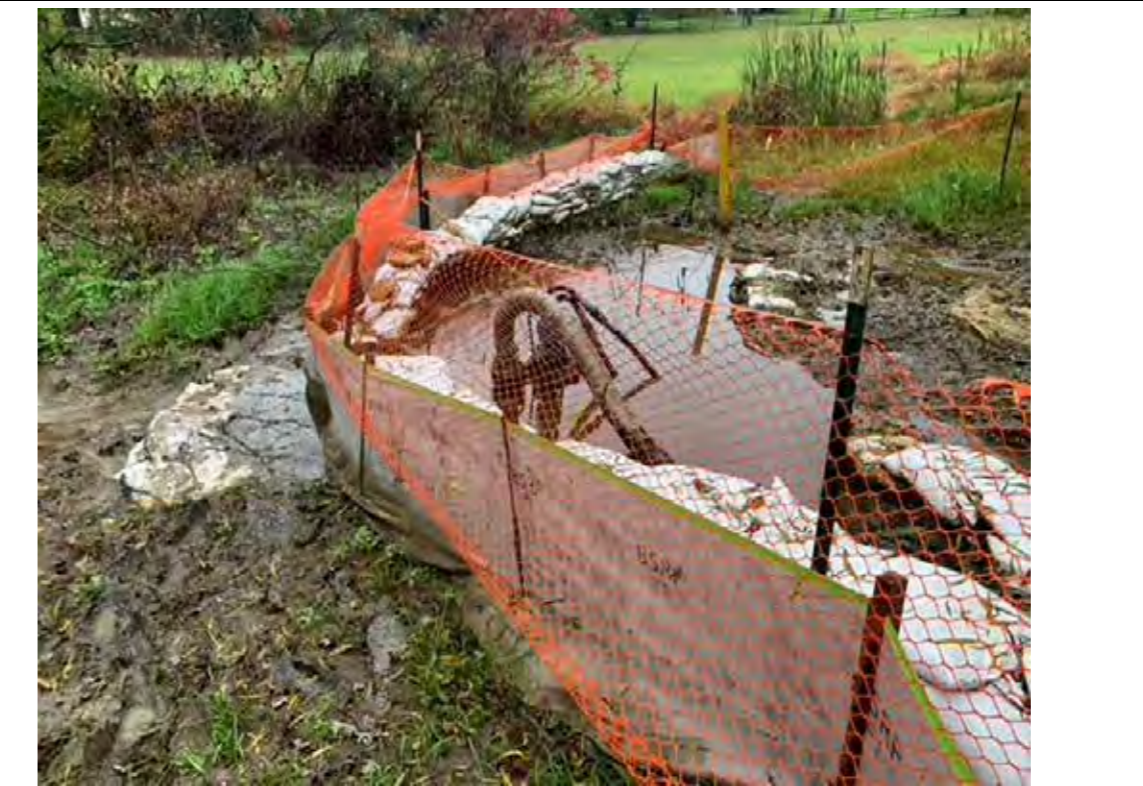
10/12/2020

View of IR release location and containment within WL-H17.

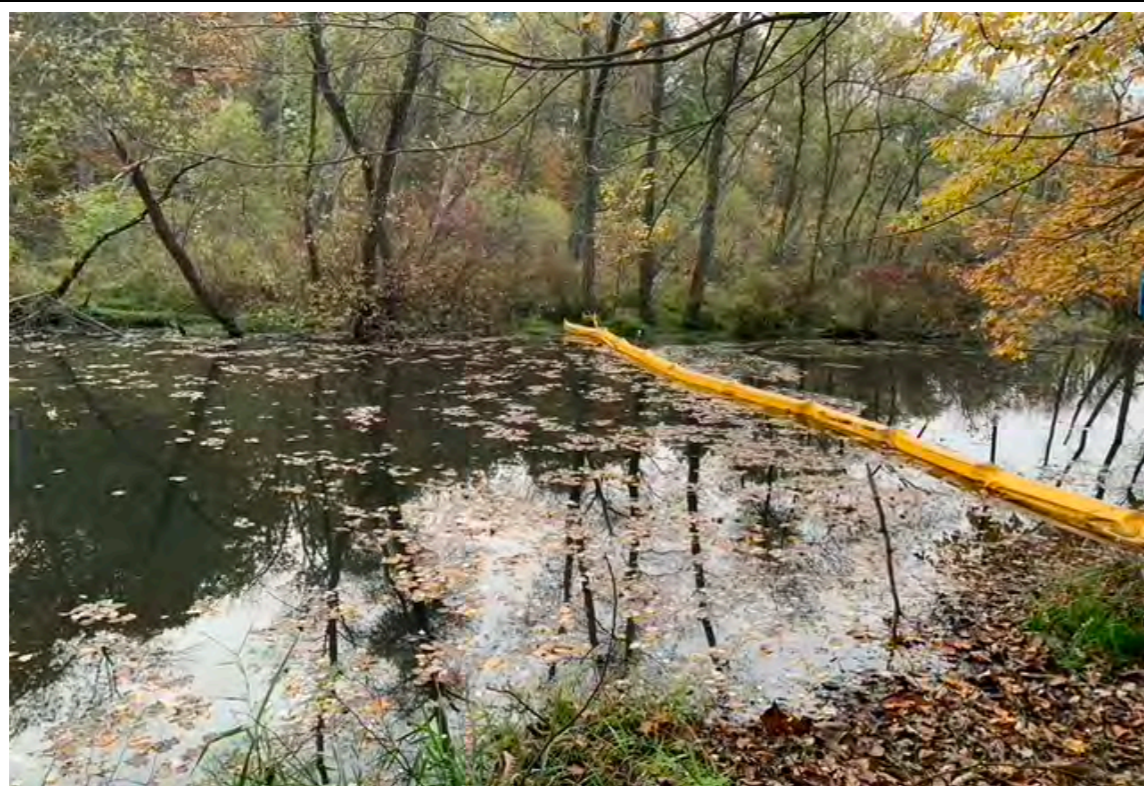
10/19/2020

View of turbidity curtain at the confluence of stream S-H10 (UNT to Marsh Creek) and pond H3 (Marsh Creek Reservoir).

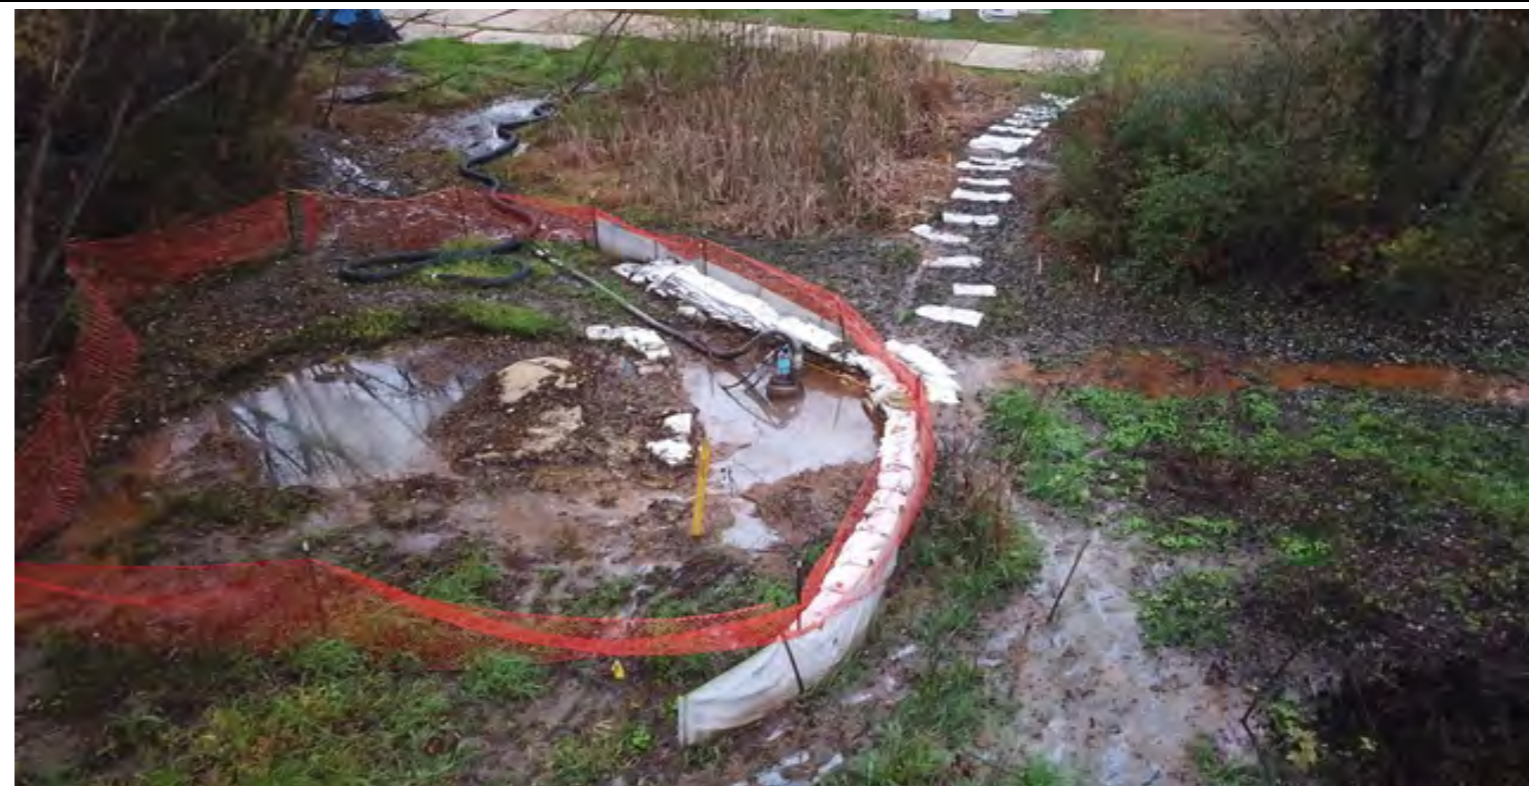
10/26/2020

View of IR release location and containment within WL-H17.

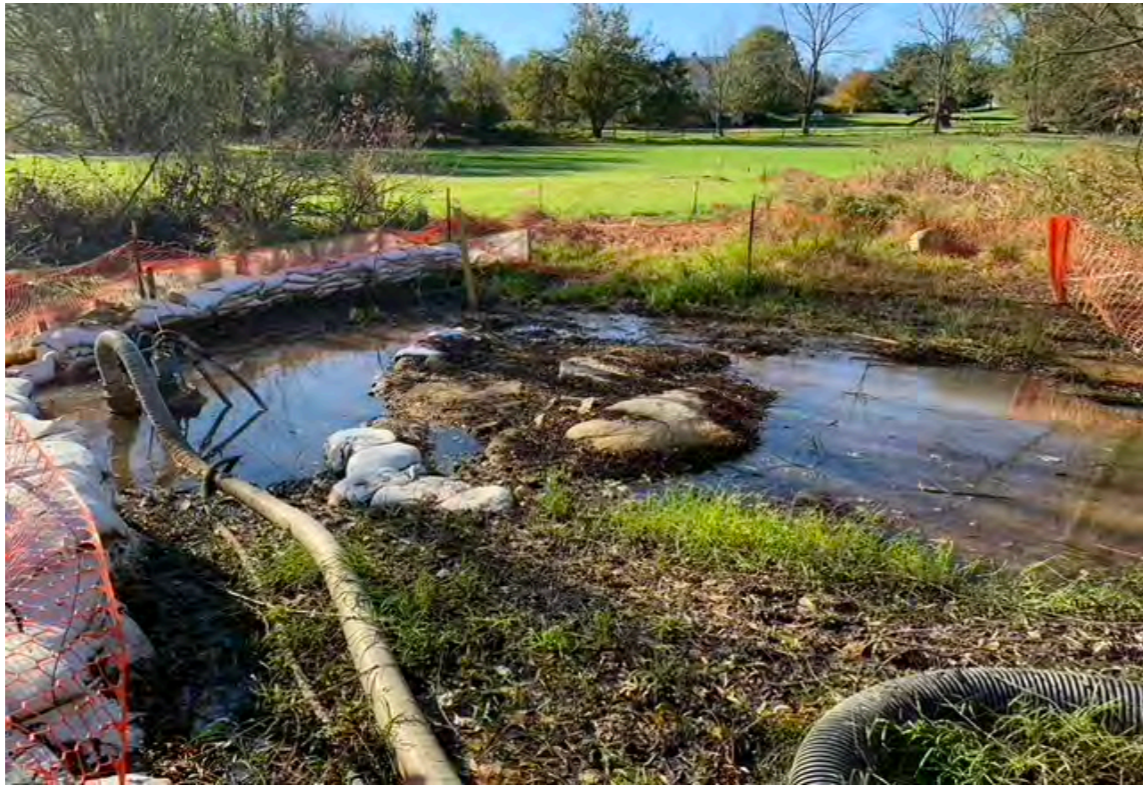
11/2/2020

View of IR release location and containment within WL-H17.

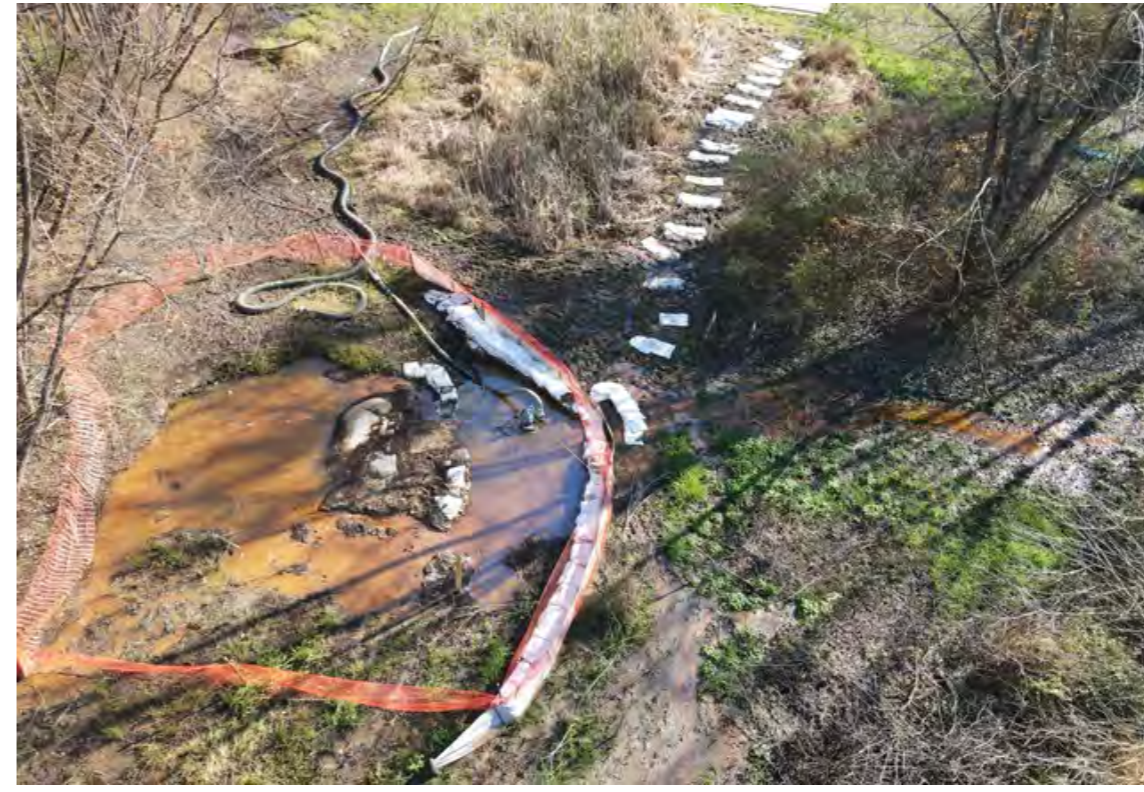
11/9/2020

View of IR release location and containment within WL-H17.

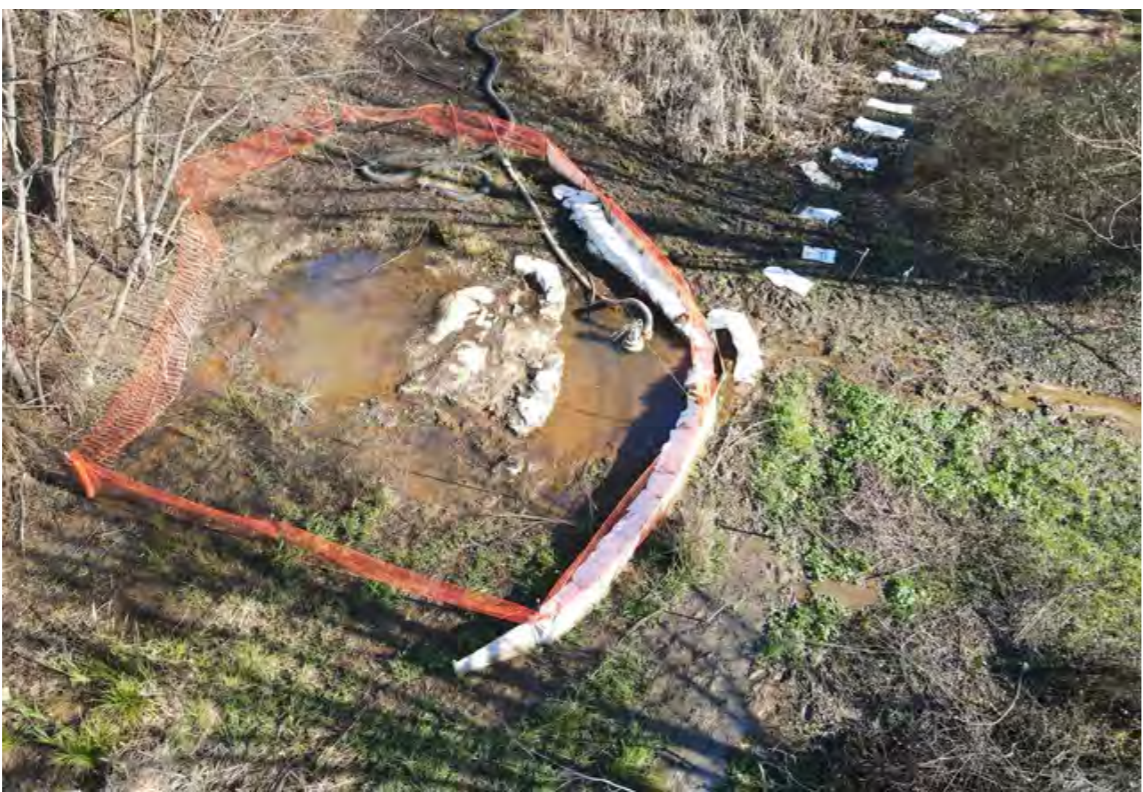
11/16/2020

View of IR release location and containment within WL-H17.

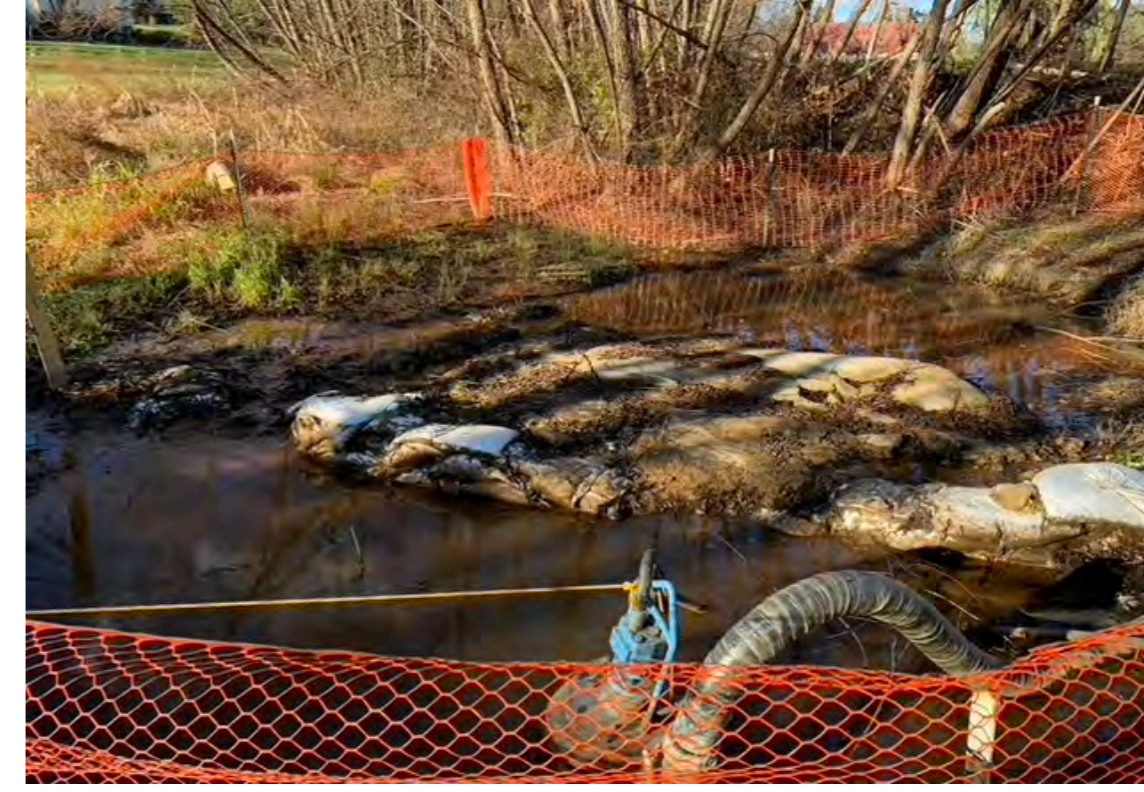
11/23/2020

View of IR release location and containment within WL-H17.

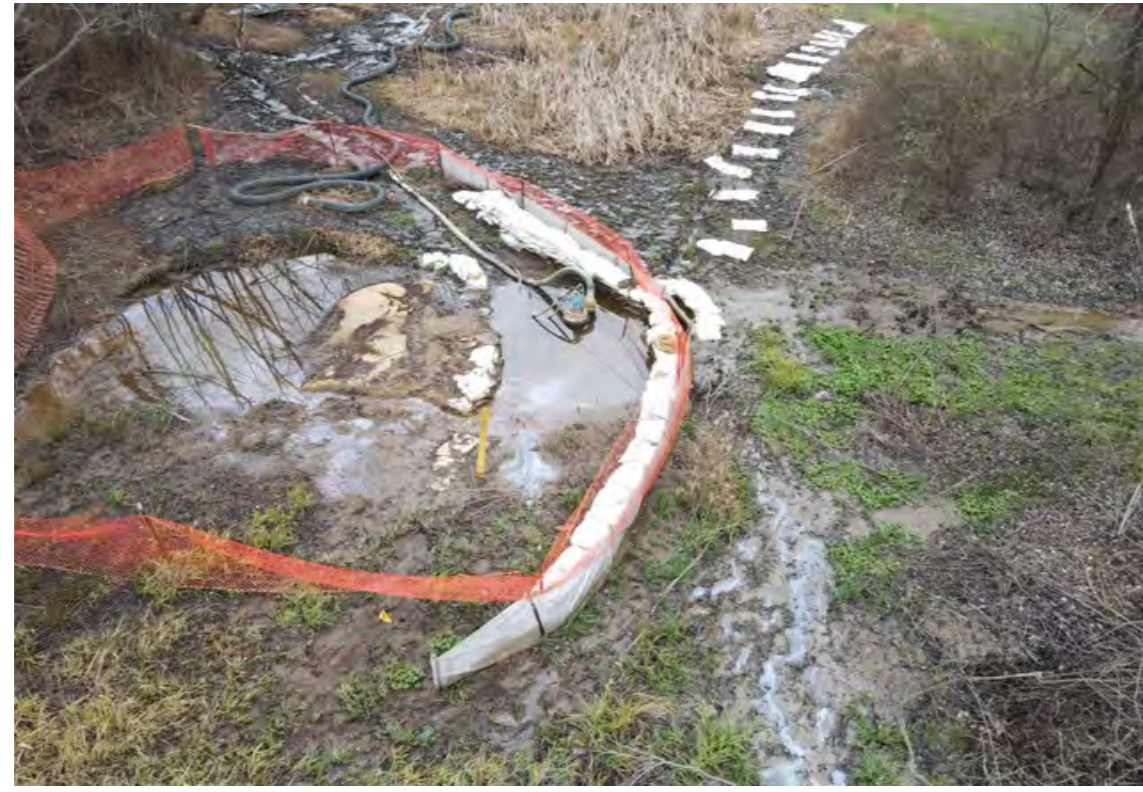
12/1/2020

View of IR release location and containment within WL-H17.
