If Interim report, Subject to Change as Additional Information Becomes Available
If Interim Report, this Report is cumulative, containing information from previous reports in addition to new information and may change
SPLP PENNSYLVANIA PIPELINE PROJECT
HORIZONTAL DIRECTIONAL DRILLING – INADVERTENT RETURN REPORT FORM

REPORT DATE:	Current as of 9/28/2020	HDD ALIGNMENT #	PA-CH-100.0000-RD			
PROJECT SITE:	PPP 6 - S3-0290 - Milford Rd./Little Conestoga Rd	HDD COMPANY:	Michels Directional Crossing			
DATE AND TIME WHEN IR WAS INITIALLY DISCOVERED		DATE:	8/10/2020	TIME:	1530	
LOCATION: STREET	427-423 Green Valley Rd, Downingtown, PA 19335	MUNICIPALITY:	Upper Uwchlan	COUNTY:	Chester	
LATITUDE:	40.0794	LONGITUDE:	-75.7104	FROM STATION:	14824+00	
STREAM NAME:	S-H10 (UNT to Marsh Creek), S-H11 (UNT to Marsh Creek)	POND / LAKE NAME:	Pond H3 (Marsh Creek Reservoir)	WETLAND NAME:	WL-H17 (PEM, PFO)	
DEP PERMIT Nos. (102 AND 105)	E&S Permit # ESG0100015001, Water Obstruction Permit E15-862					
CORPS PERMIT NO.	PASPGP-5 (issued April 12, 2017)					
IR TRACKING ID:	PPP6_PA-CH-0100.0000-RD_MilfordRd_IRInterim_07_092920					
IS AUGUST 8, 2017 ORDER APPLICABLE?	YES	LISTED IN WHICH EXHIBIT?	3	DESCRIP

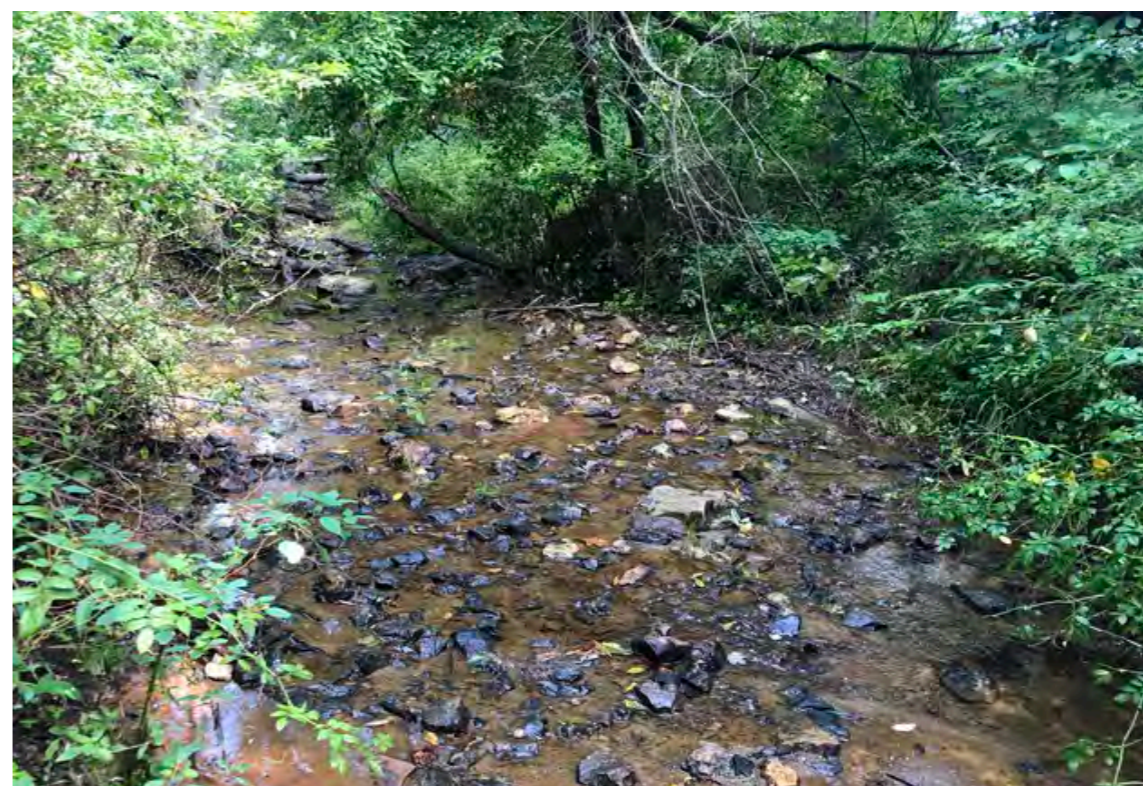
8/24/2020

View of stream S-H10 (UNT to Marsh Creek)

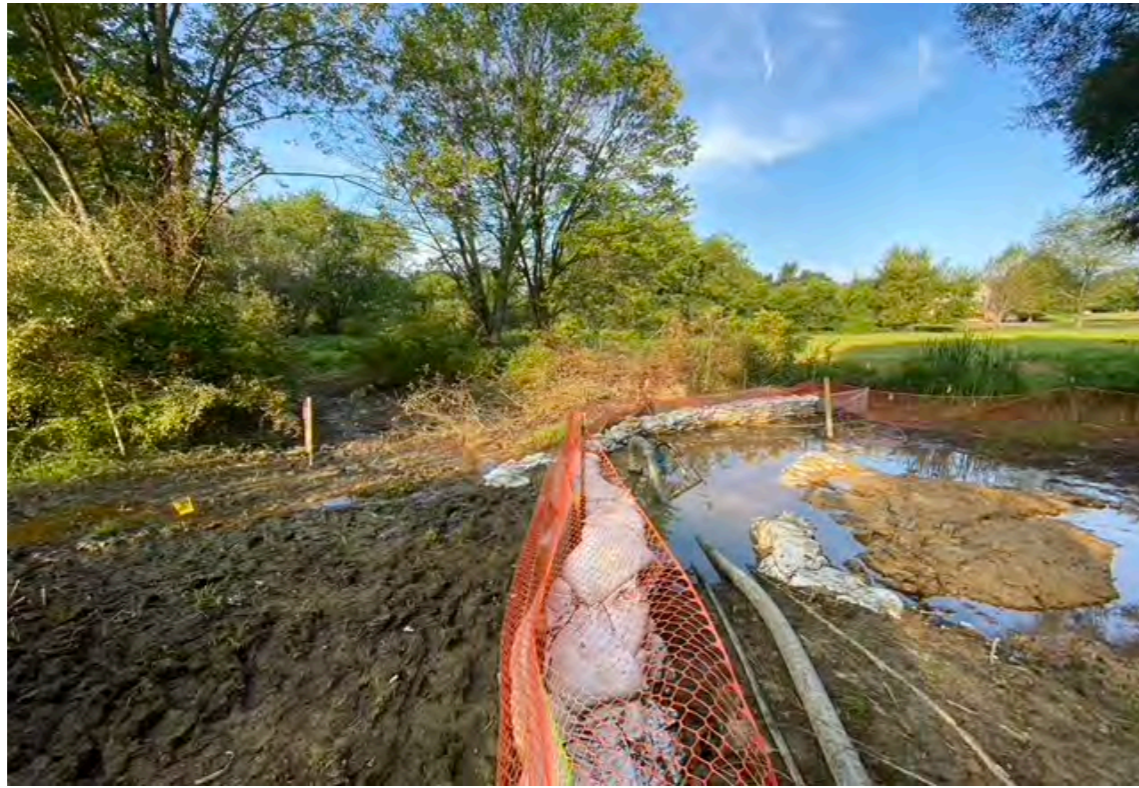
8/28/2020

View of IR release location and containment within WL-H17.

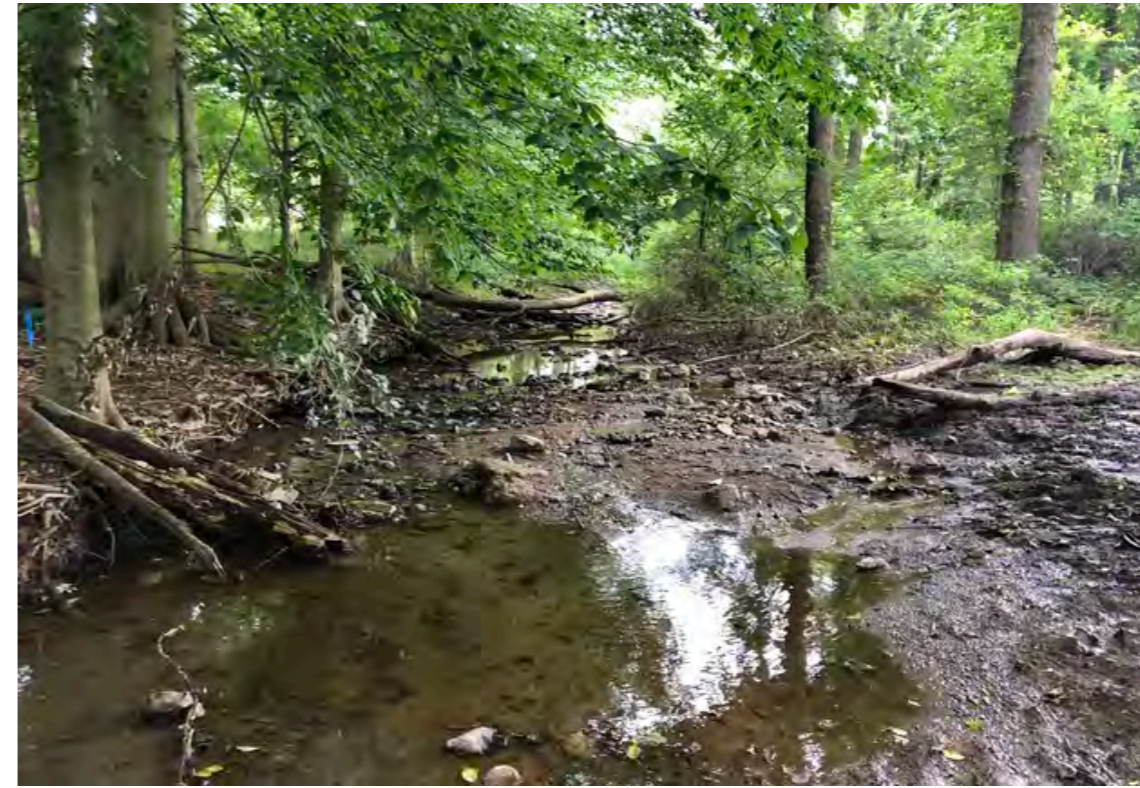
8/31/2020

View of stream S-H10 (UNT to Marsh Creek)

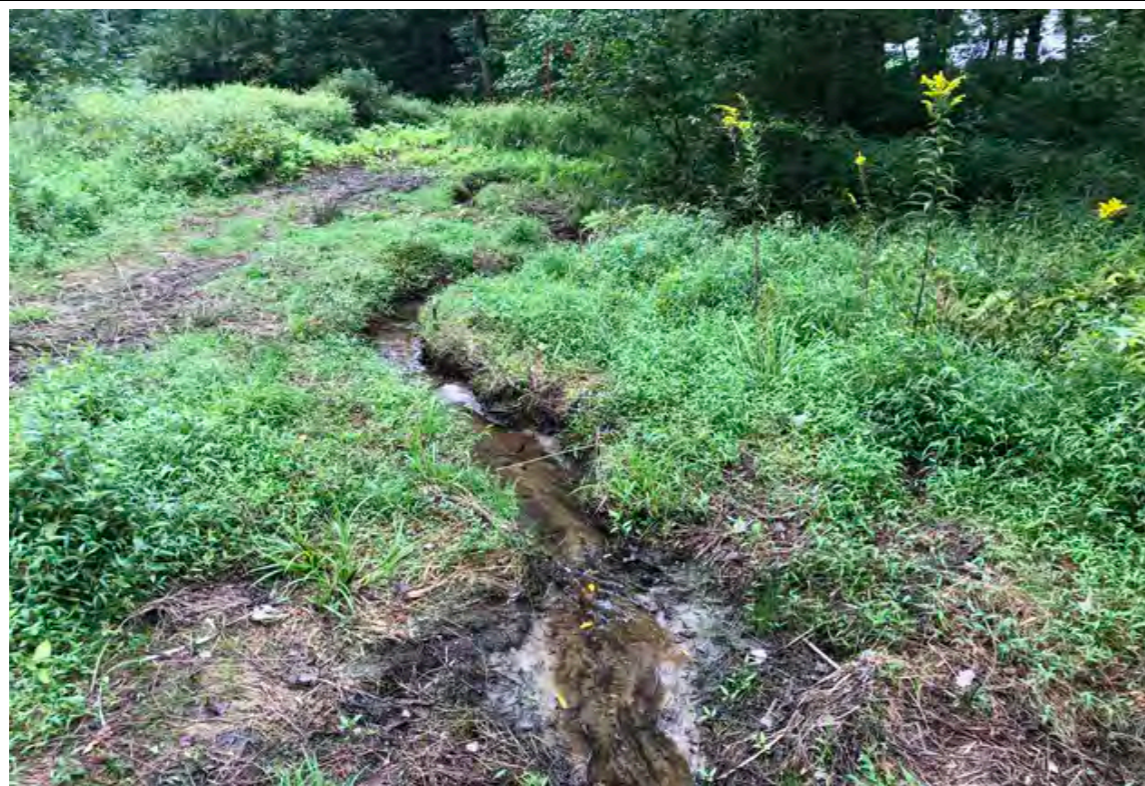
8/31/2020

View of stream S-H10 (UNT to Marsh Creek)

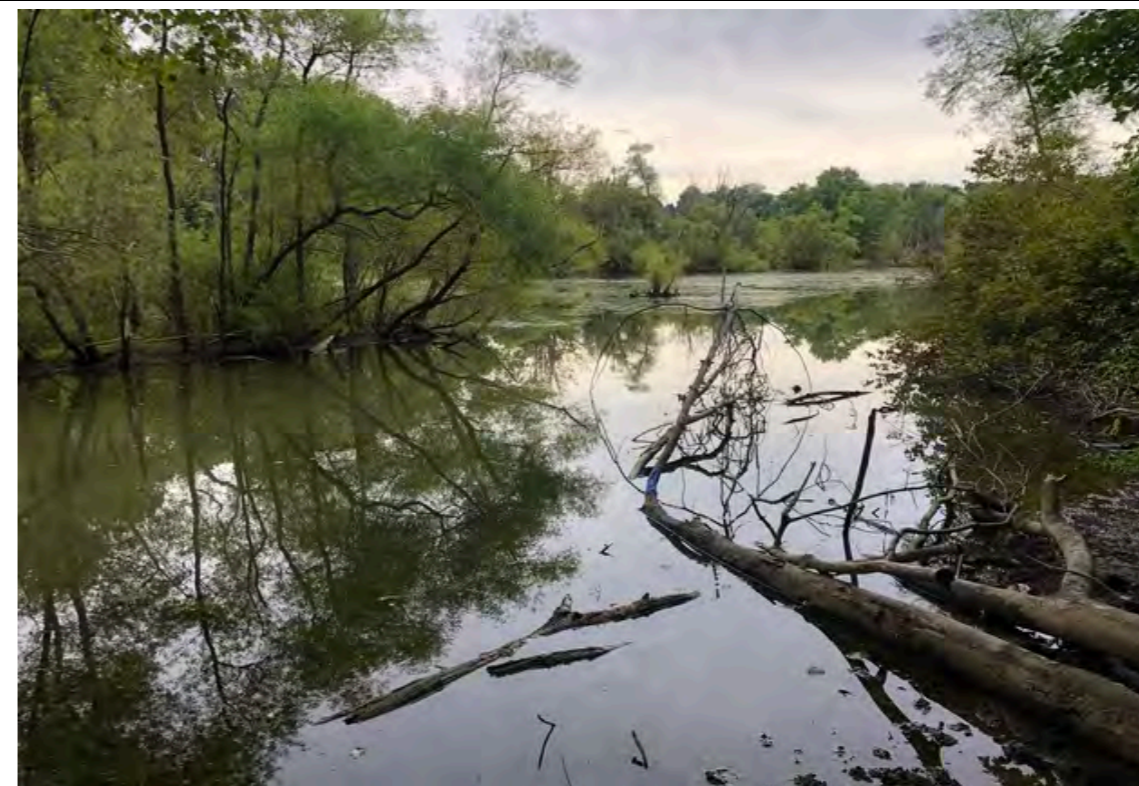
8/31/2020

View of pond H3 (Marsh Creek Reservoir).

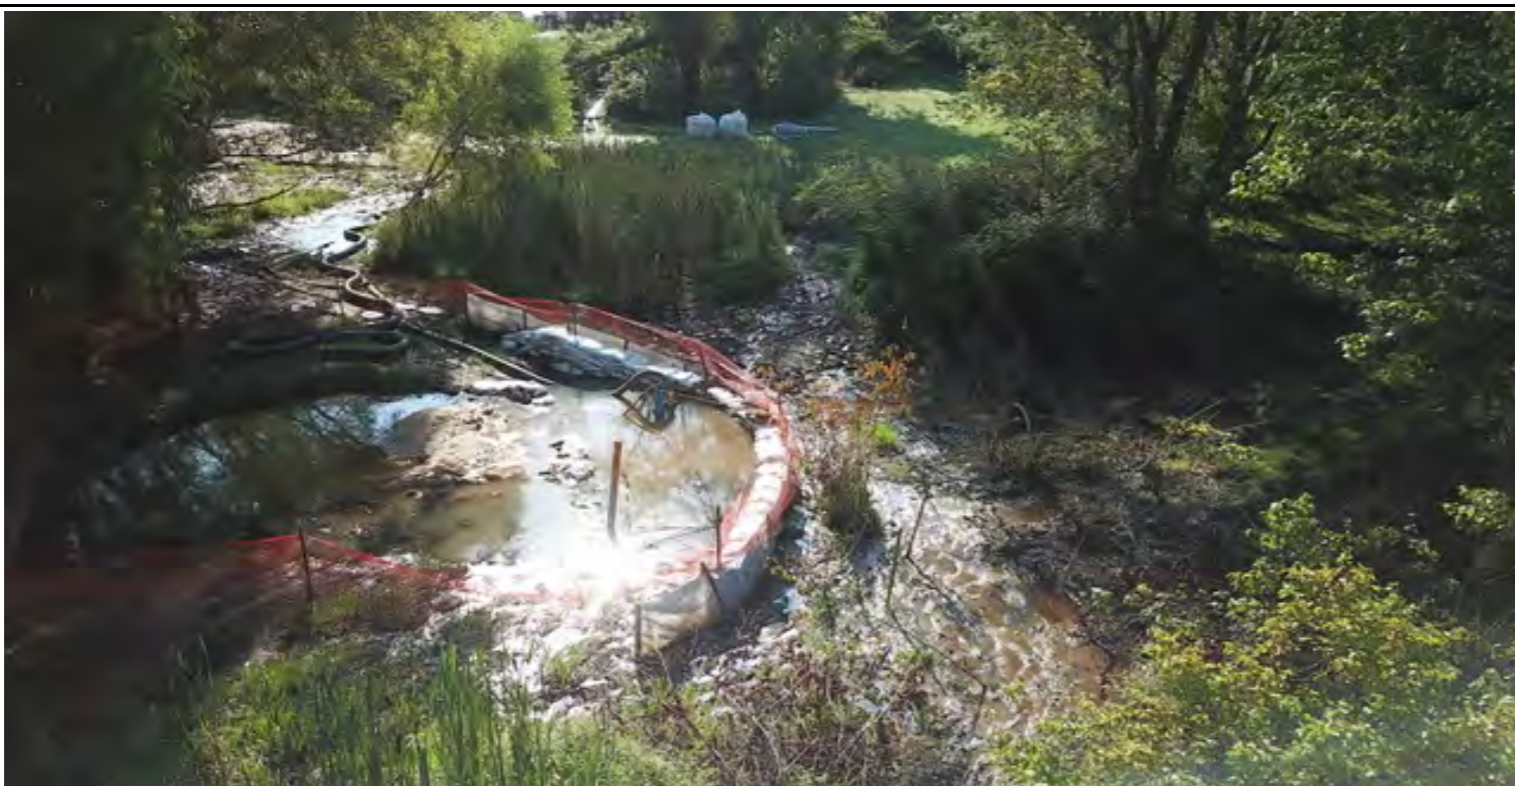
9/4/2020

View of IR release location and containment within WL-H17.

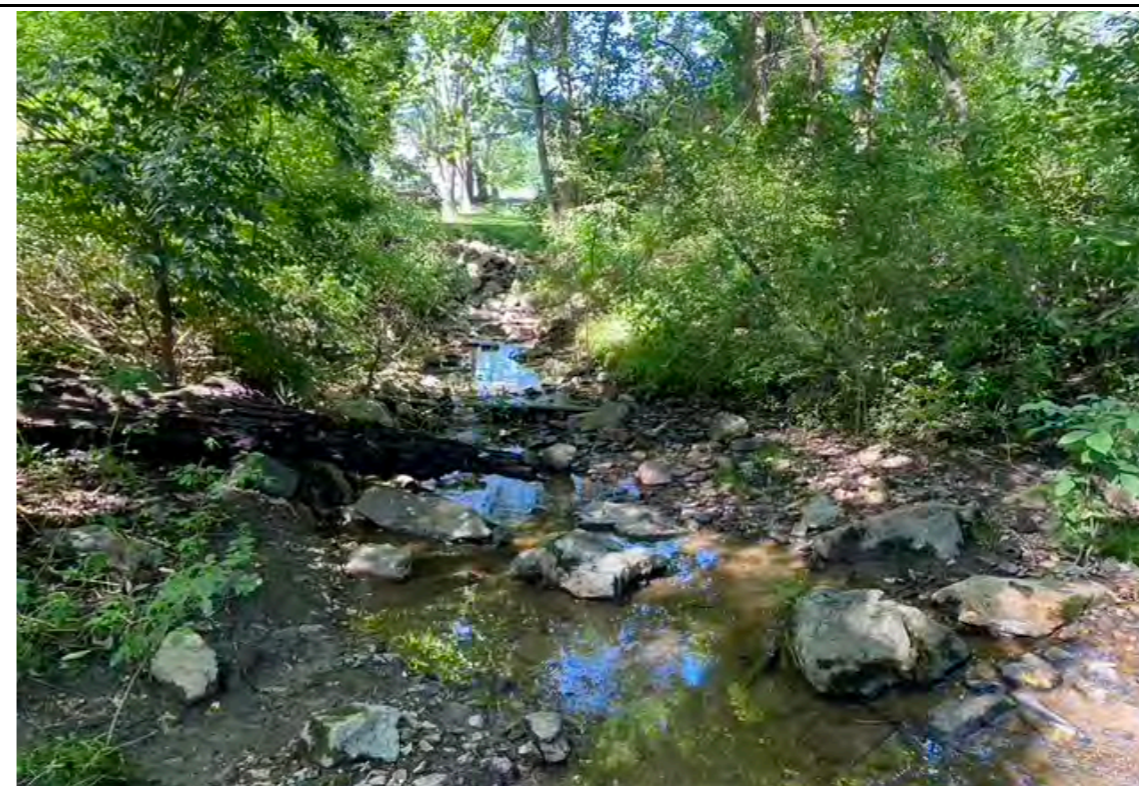
9/5/2020

View of stream S-H10 (UNT to Marsh Creek)

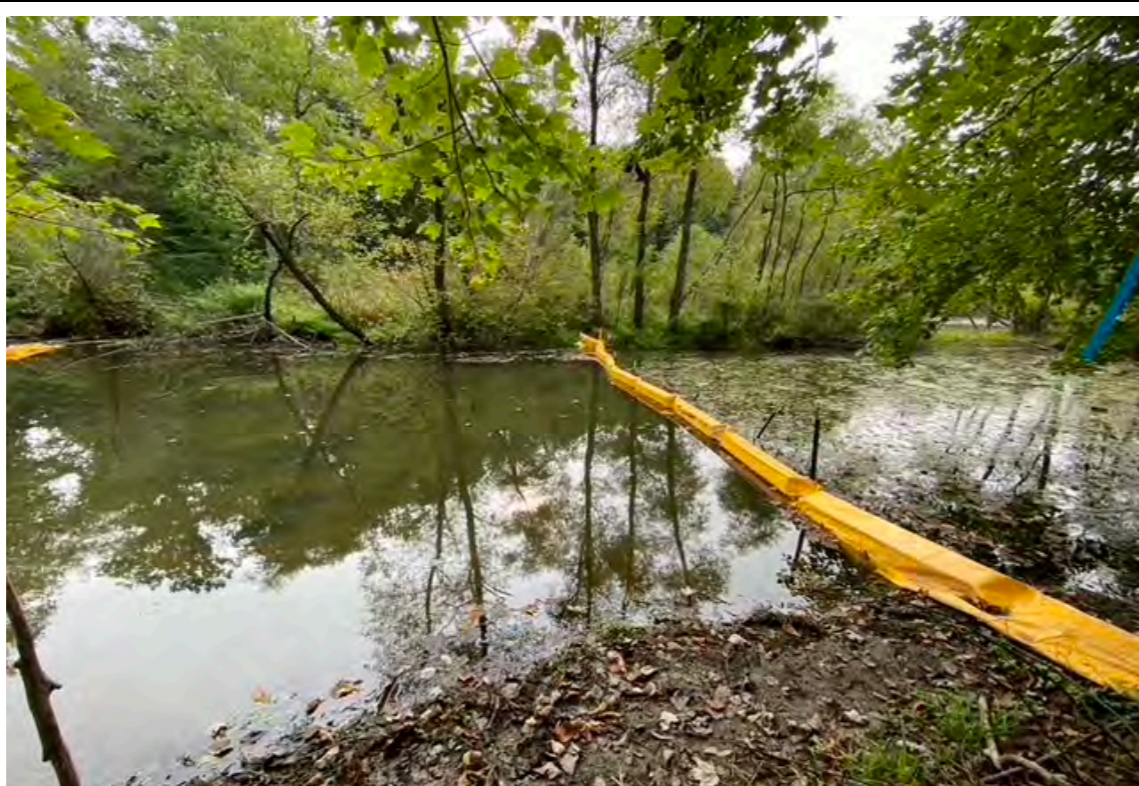
9/14/2020

View of turbidity curtain at the confluence of stream S-H10 (UNT to Marsh Creek) and pond H3 (Marsh Creek Reservoir).

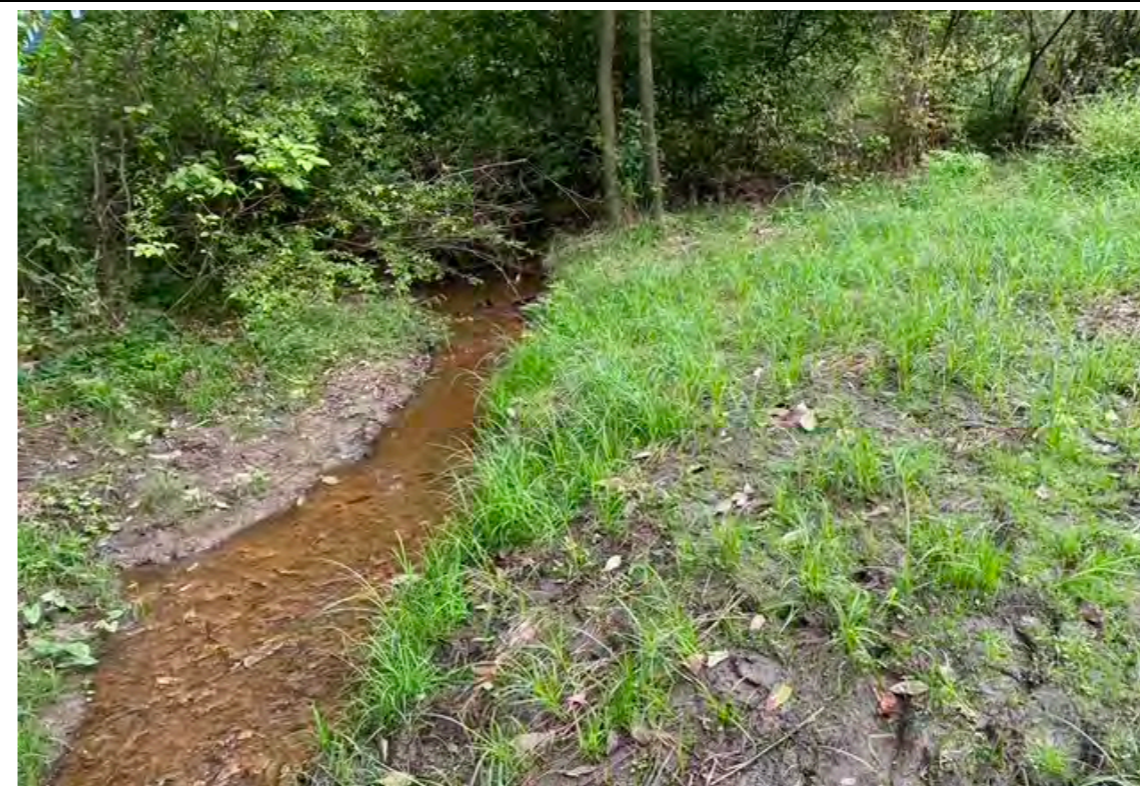
9/14/2020

View of stream S-H10 (UNT to Marsh Creek)

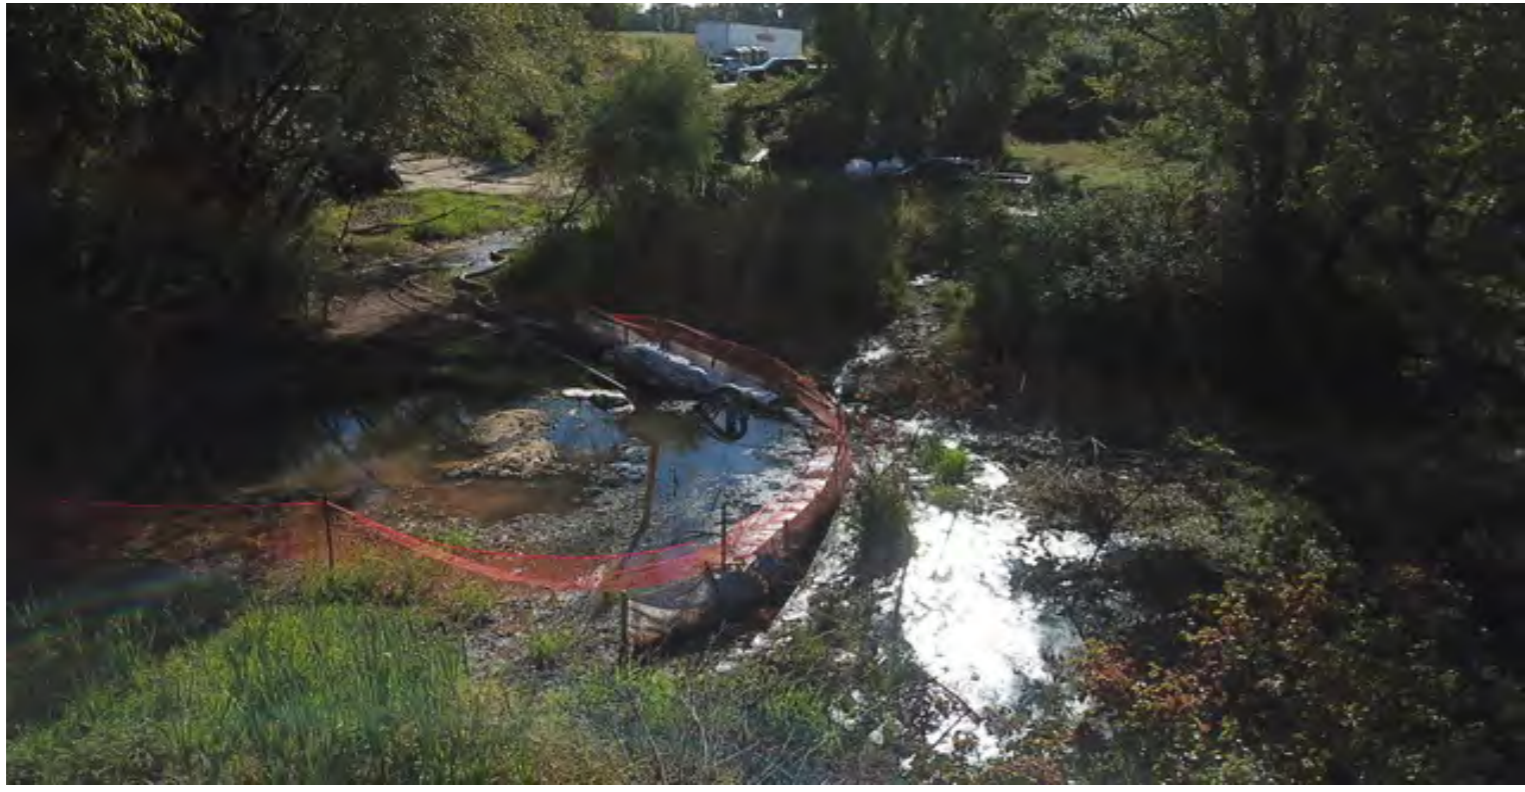
9/21/2020

View of IR release location and containment within WL-H17.

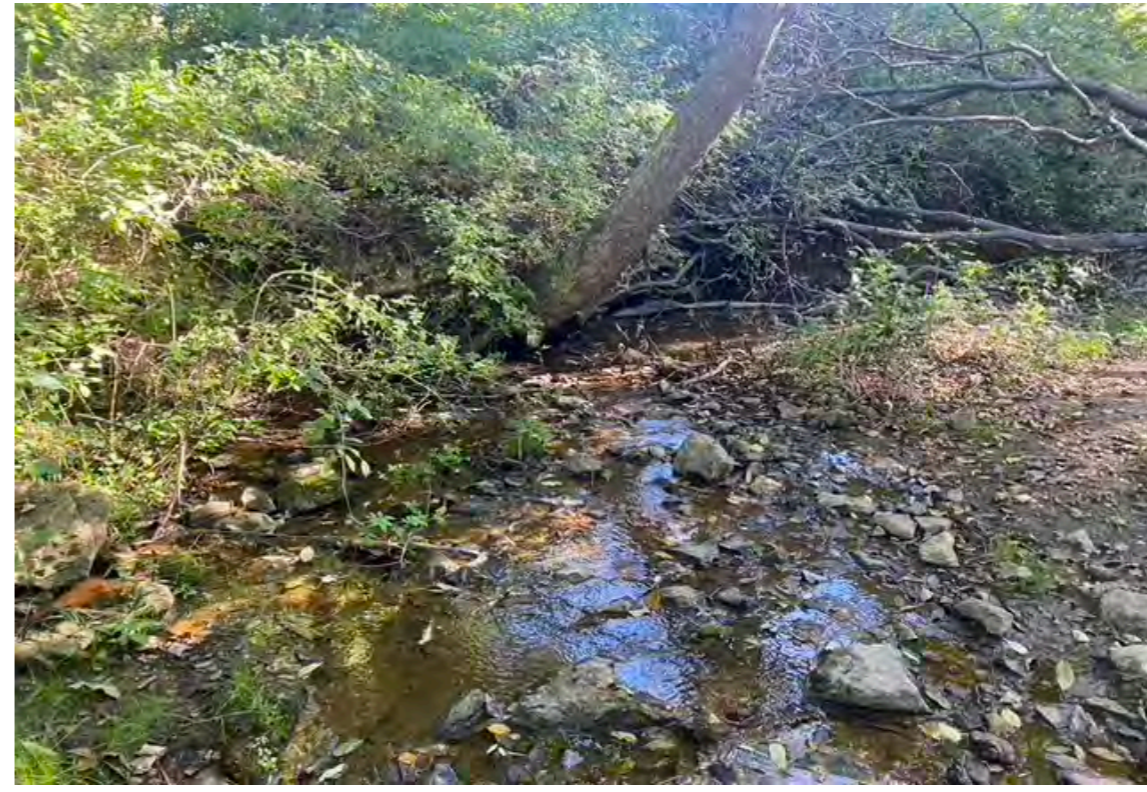
9/21/2020

View of stream S-H10 (UNT to Marsh Creek)

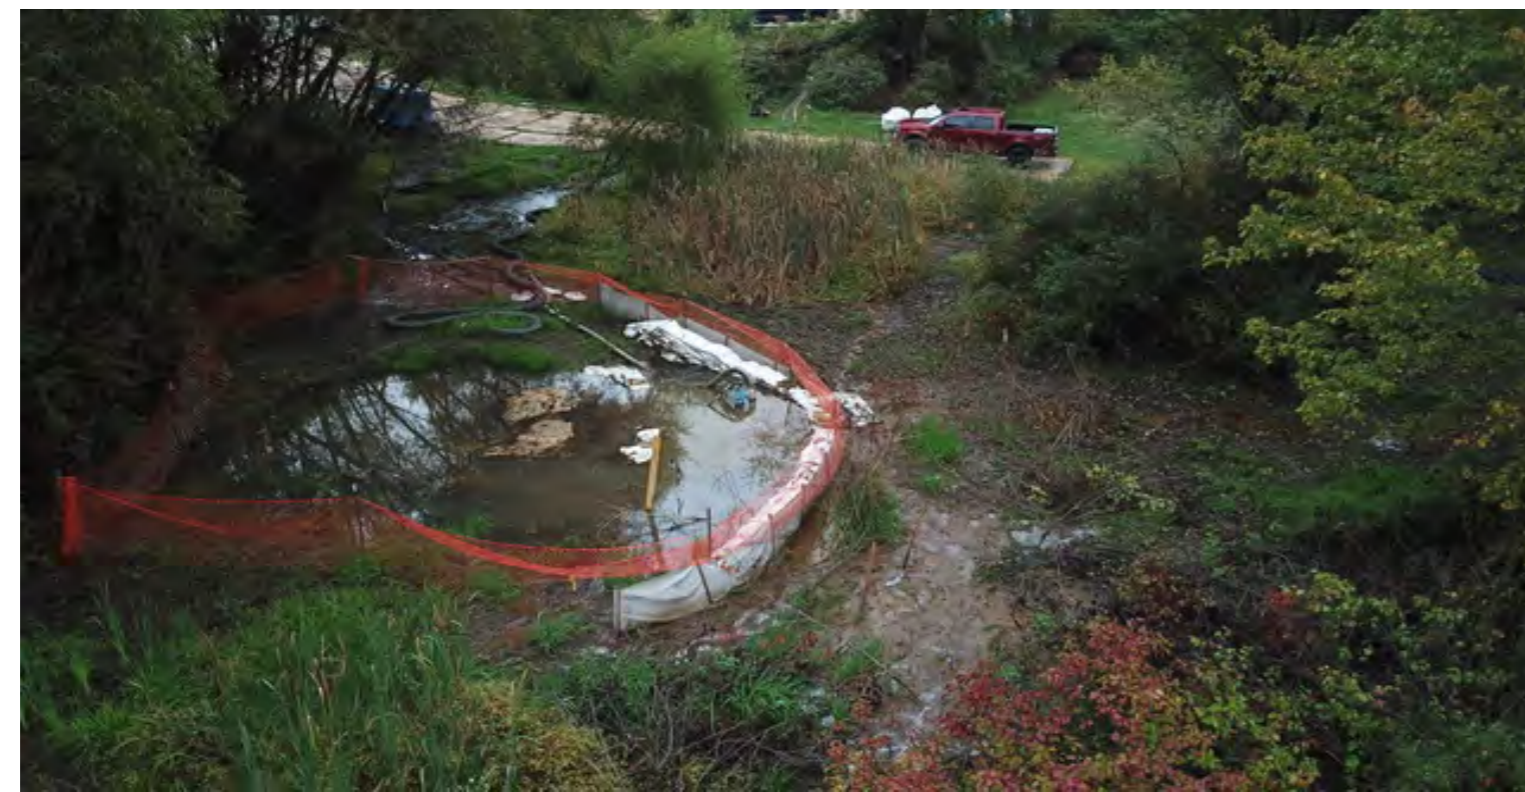
9/28/2020

View of IR release location and containment within WL-H17.

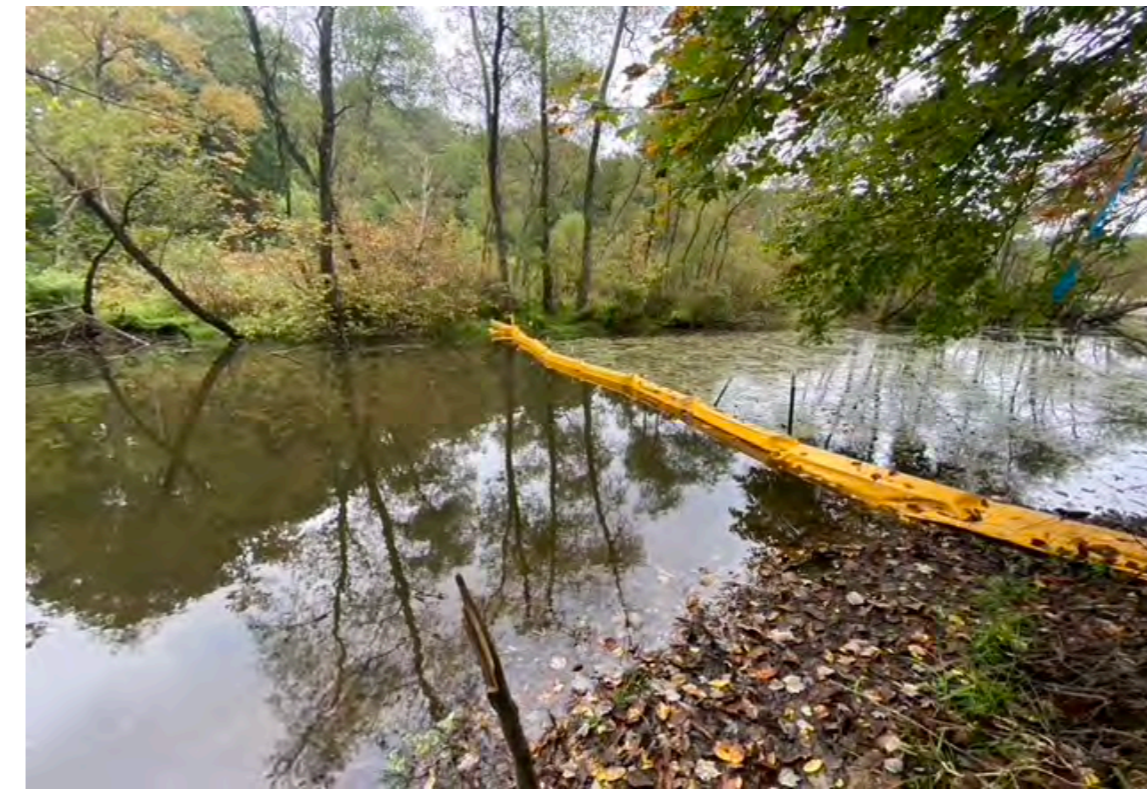
9/28/2020

View of turbidity curtain at the confluence of stream S-H10 (UNT to Marsh Creek) and pond H3 (Marsh Creek Reservoir).
