NARRATIVE REPORT FORM

Facility Name: _____ Primary Facility ID: TBD

Inspection Date: 2/7/2025		Inspection Time: 14:10		Lat/Long: 40.275811, -74.861588	
Program:		<input type="checkbox"/> Storage Tanks	<input type="checkbox"/> HSCA	<input checked="" type="checkbox"/> LRP	
Owner Name: _____			Inspection ID: TBD		Site ID: TBD
Facility Location (911) Address: _____, Washington Crossing, PA 18977				Municipality: Upper Makefield Township	
				County: Bucks	
Responsible Official Name: Dustin Lipik, P.G. Title: Licensed Professional Geologist			Responsible Official Address: Southeast Regional Office, 2 East Main Street, Norristown, PA 19401		
Responsible Official Telephone: 484-250-5795 Email Address: dlipik@pa.gov			Interviewee #1 Name: _____ Affiliation: _____		
Interviewee #2 Name: Ben Weldon Affiliation: Upper Makefield Twp Supervisor Contact Info: 215-518-2549 / bweldon@uppermakefield.org			Interviewee #3 Name: _____ Affiliation: _____

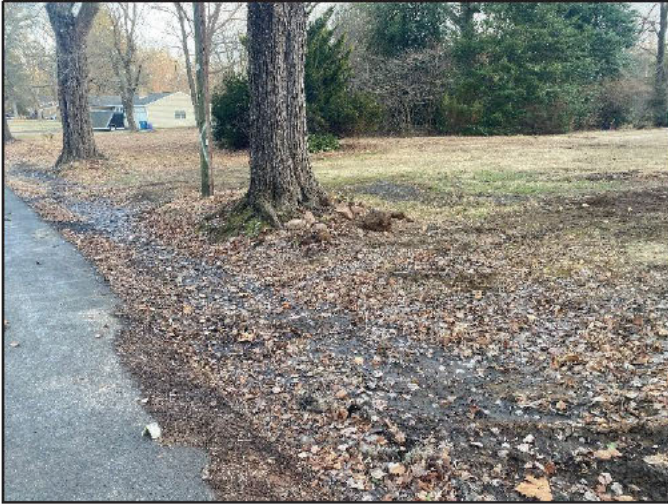
Photo #4

DL noticed the strong odor described by _____ upon approaching the drainage swale. The drainage swales both in the vicinity of _____ and along both the northern and southern sides of _____ are earthen and vegetated with grasses. DL noticed that a large influx of fines and sediments, mostly gray in color, had been deposited in the drainage swale along the southern side of _____, starting at the drilling area at _____ and extending eastward along the drainage ditch before stopping ~25 ft west of the storm drain. These gray fines and sediments were not present on the land surface surrounding the wellhead. DL observed that the soils and leaves present in the areas covered by these gray fines and sediments had very strong olfactory evidence of impacts, while soils outside of the area of deposition did not (see Photos #4 and #5).

Drainage swale in front of [REDACTED], looking east along [REDACTED].
 Gray fines and sediments observed in ditch contained strong odors.
 2/7/2025 @ 16:42

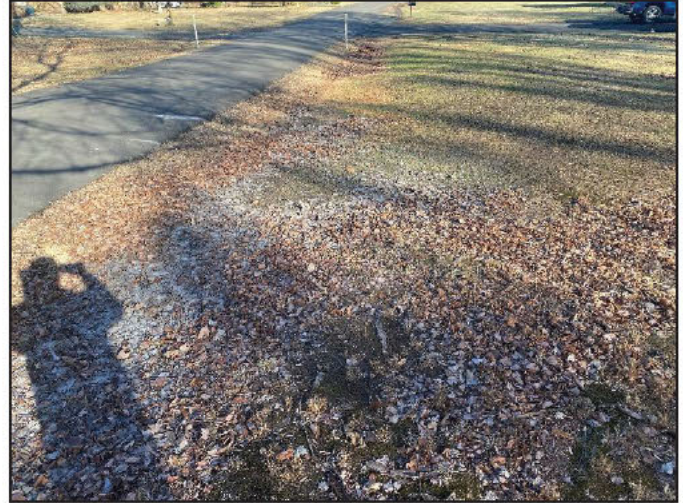
Photo #5

Easternmost extent of gray fines and sediments emplaced in drainage ditch. Photo taken looking east along [REDACTED] with the driveway for [REDACTED] in top right.
 Storm water inlet located near white reflector in center top of photo.
 2/7/2025 @ 14:44.
