PROJECT SITE: NEW HOPE CRUSHED STONE
 SNP #7974SM3
 SOLEBURY TOWNSHIP, BUCKS COUNTY
 PENNSYLVANIA

RECLAMATION UPDATE
 NEW HOPE CRUSHED STONE QUARRY
 NEW HOPE CRUSHED STONE AND LIME CO.

DRAWN BY: JTV
DATE: 8/4/16
PROJECT NO.: 070102.015
DRAWING NUMBER: E-001

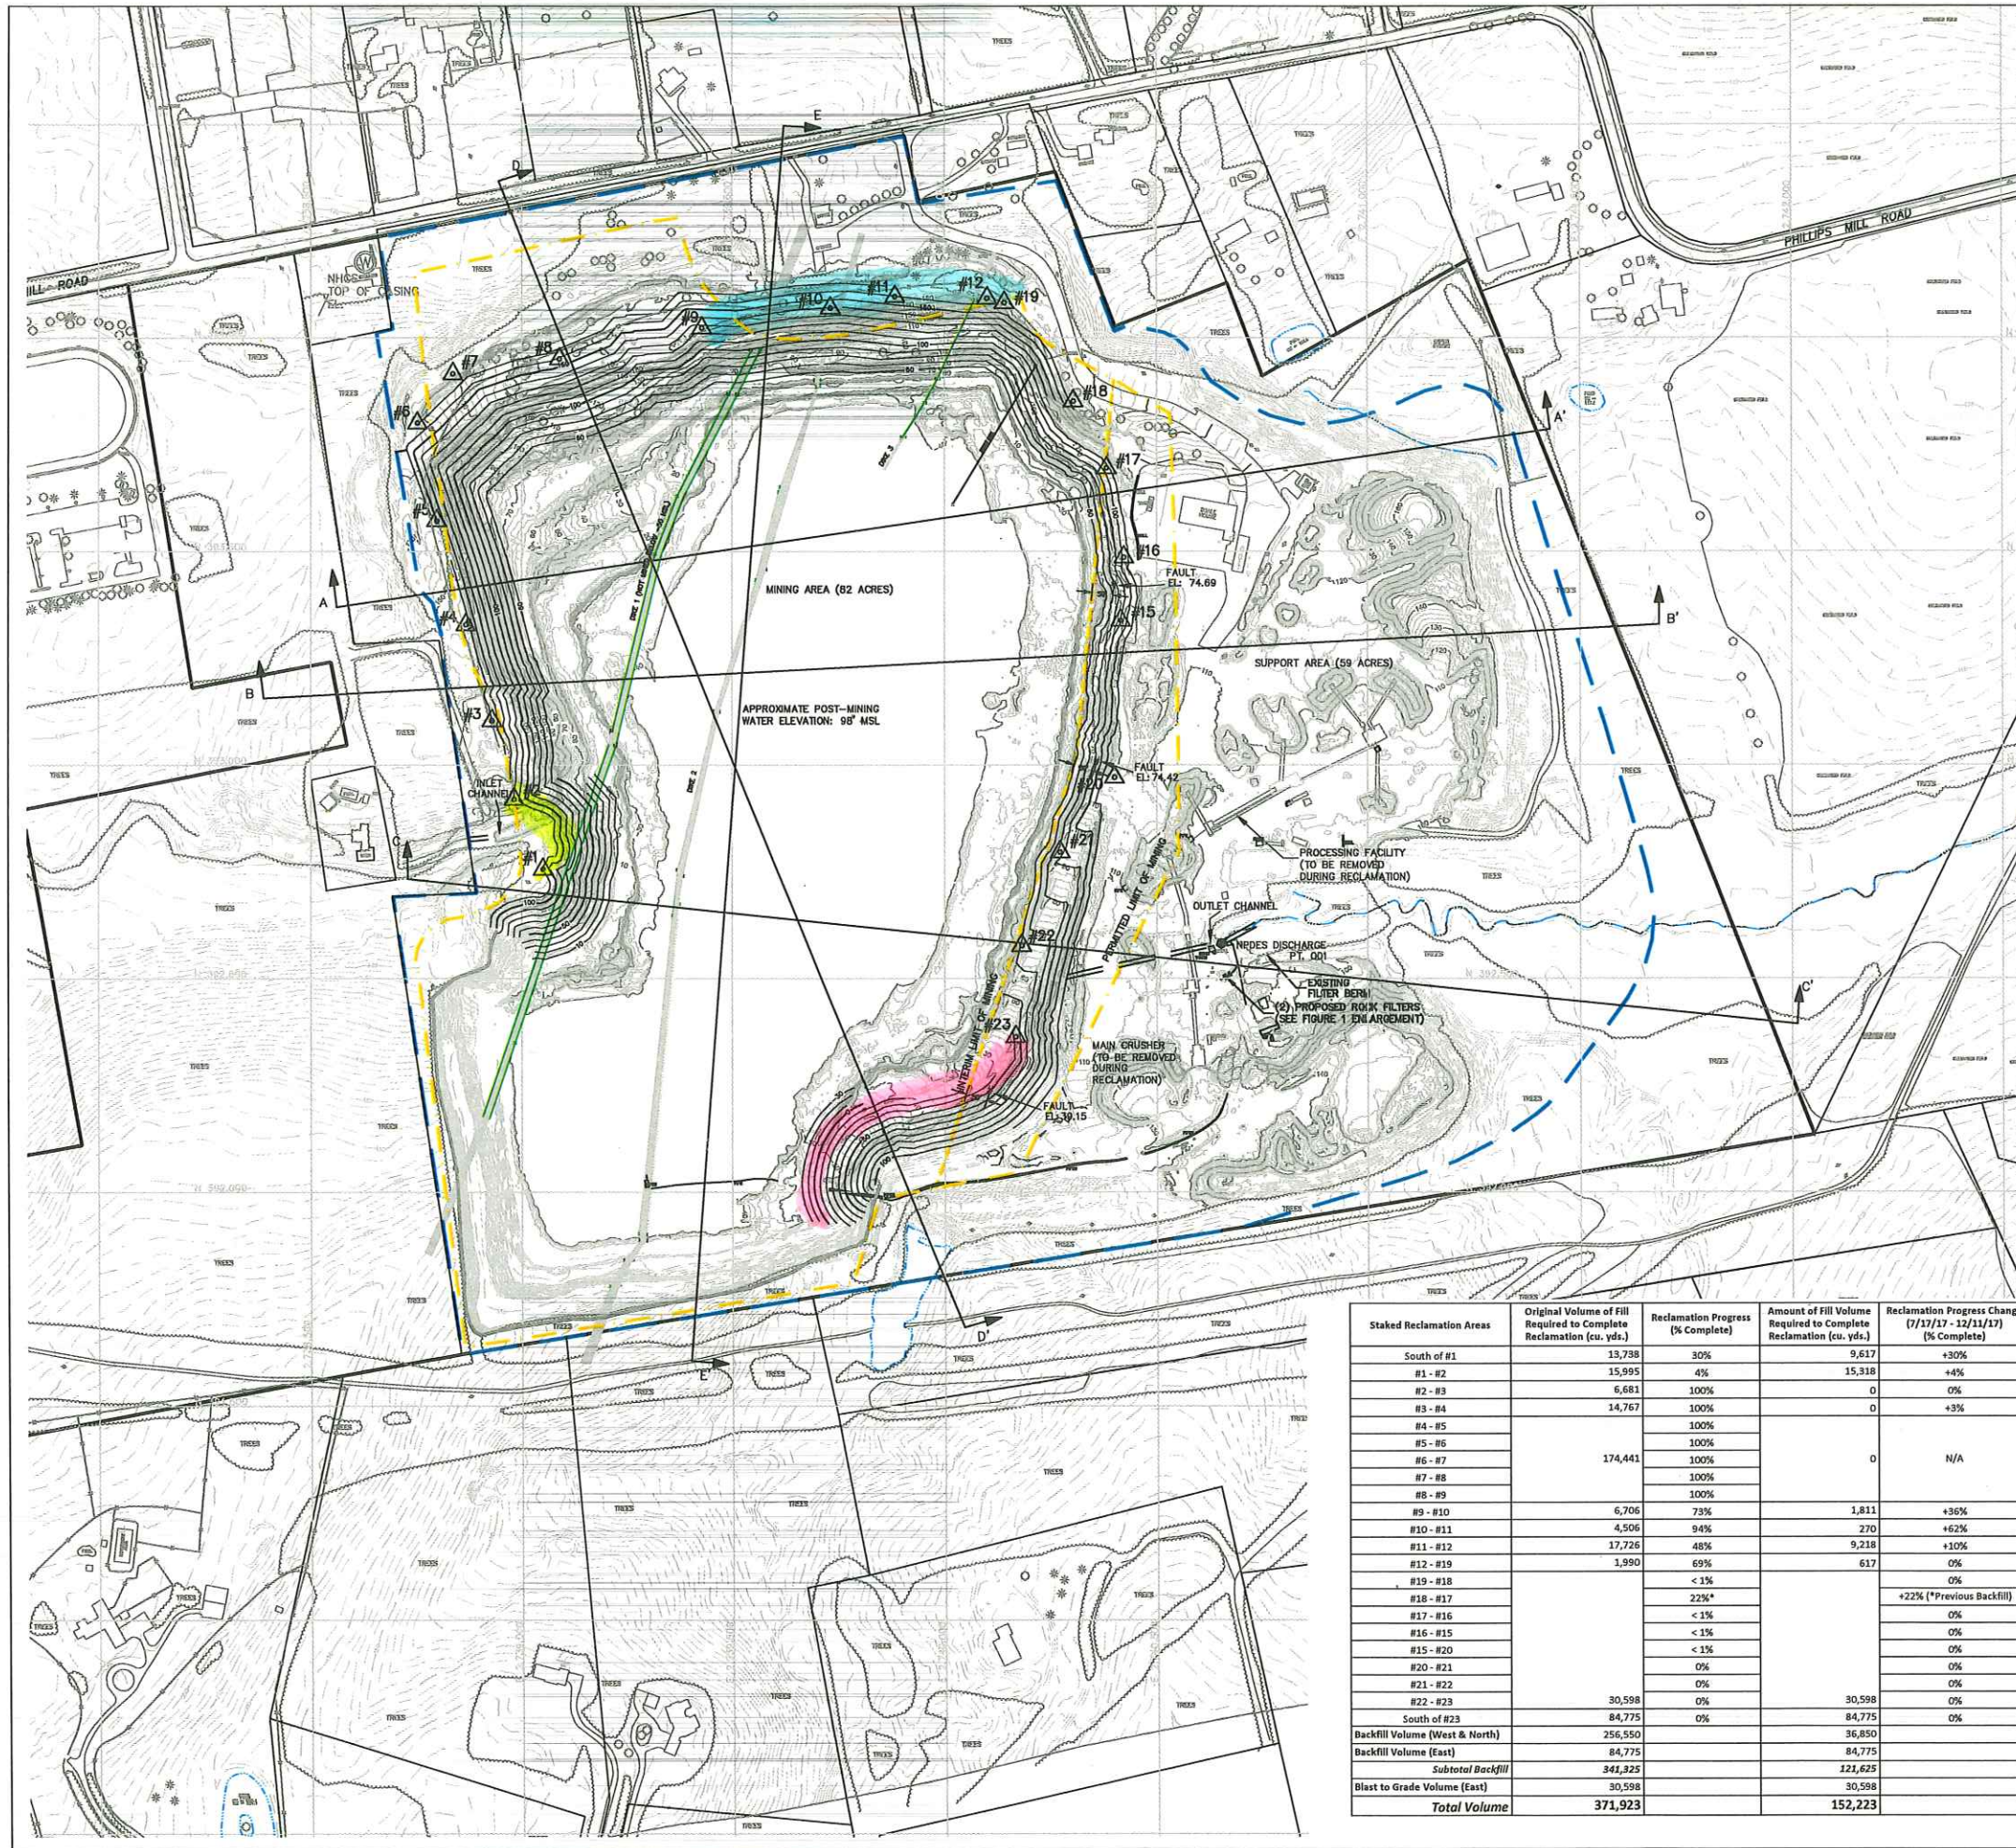
NOTES:
 1. MAPPING COMPILED BY NOR EAST MAPPING, INC. BY PHOTOGRAMMETRIC METHODS FROM AERIAL PHOTOGRAPHY ON JANUARY 03, 2016. THE ACTIVE QUARRY AREA HAS BEEN UPDATED BY CREWS SURVEYING, LLC FROM AERIAL PHOTOGRAPHY ON DECEMBER 11, 2017.
 2. SITE GRID IS BASED ON LOCAL COORDINATE SYSTEM.
