New Hope Crushed Stone

Monthly Update

July 2017

STATUS AS OF:	August 4, 2017
PROJECT	New Hope Crushed Stone (NHCS) Quarry Reclamation and Stream Restoration
START DATE	Reclamation: January 29, 2016 Stream Restoration: January 29, 2016
ANTICIPATED COMPLETION DATE	Reclamation: March 2019 Stream Restoration: March 2019
CURRENT STATUS	Quarry Reclamation On Schedule Stream Restoration On Schedule

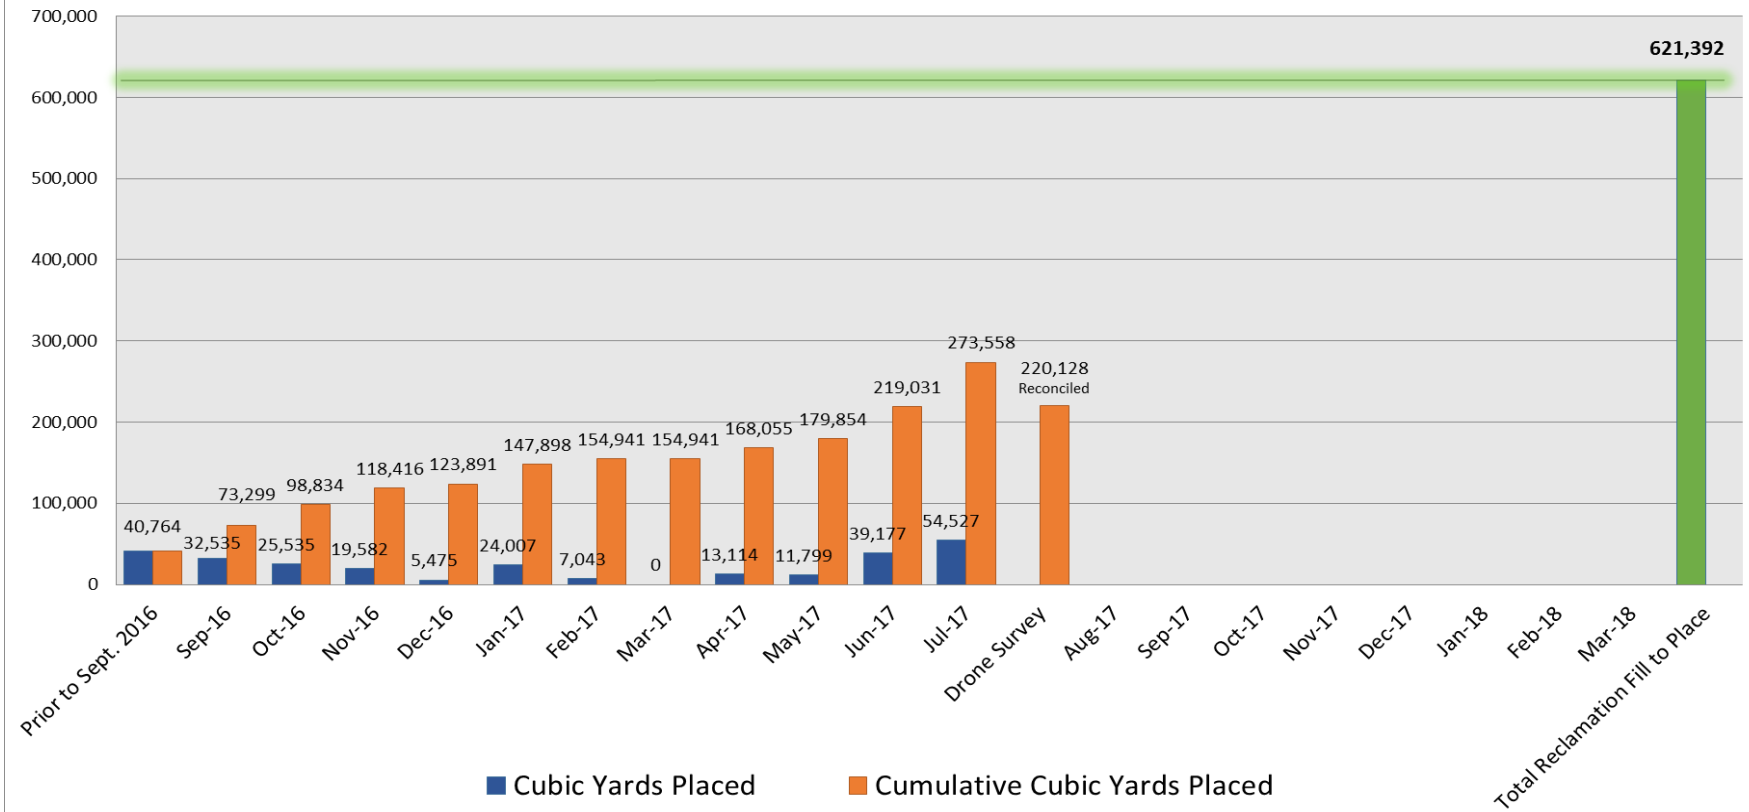
Reclamation Fill Tracking

Reclamation Fill Progress

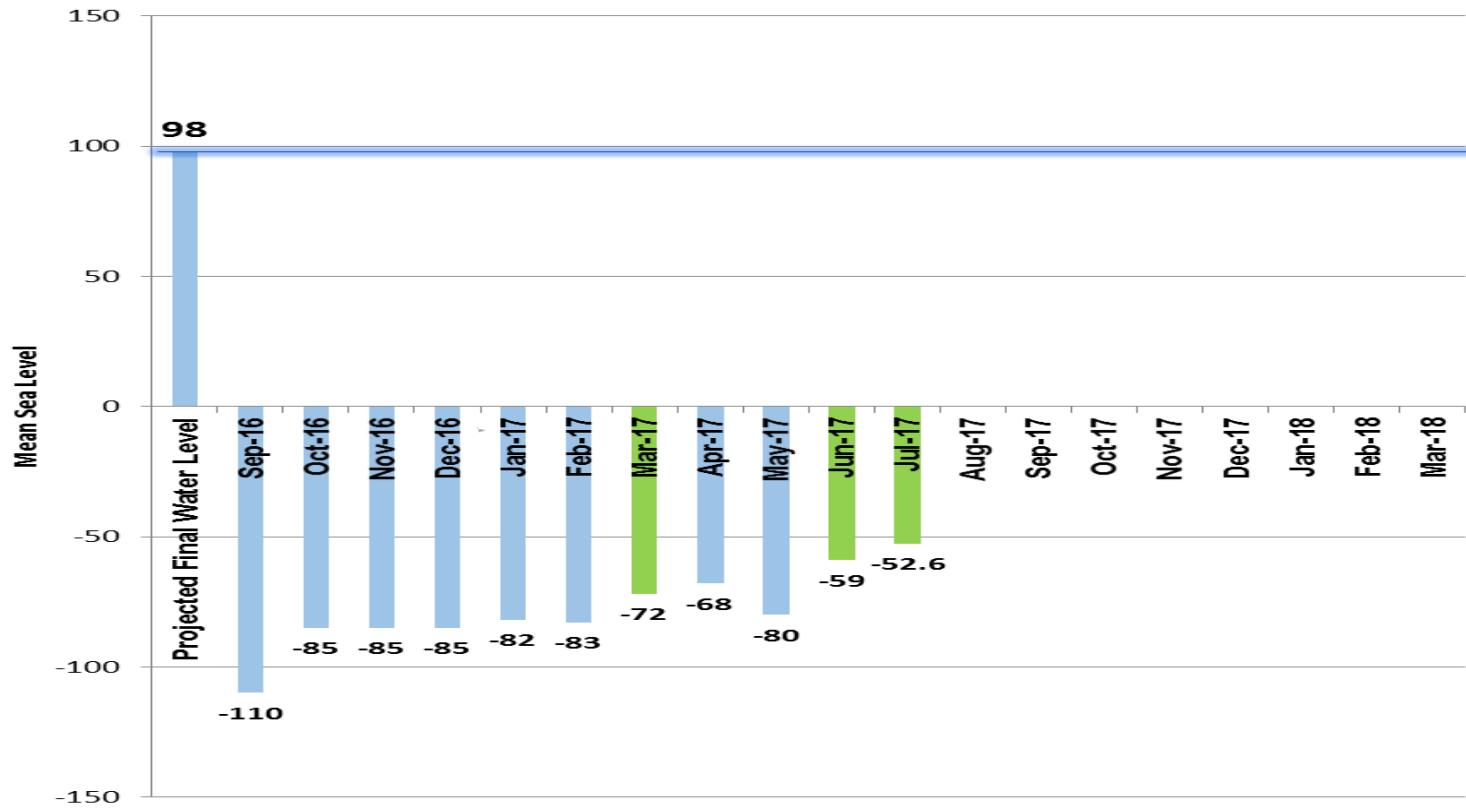
Water Level Status

- 500,000 GPD maximum pumping continues.
 - Stream work occurred on one day.
 - The 2nd quarter status report from NHCS by EarthRes reports the water level at -52.6 Mean Sea Level. The bottom two lifts (-85 and -120 MSL) are under water.

Blue bar = Estimated

Green bar = NHCS quarterly report by their consultant, EarthRes

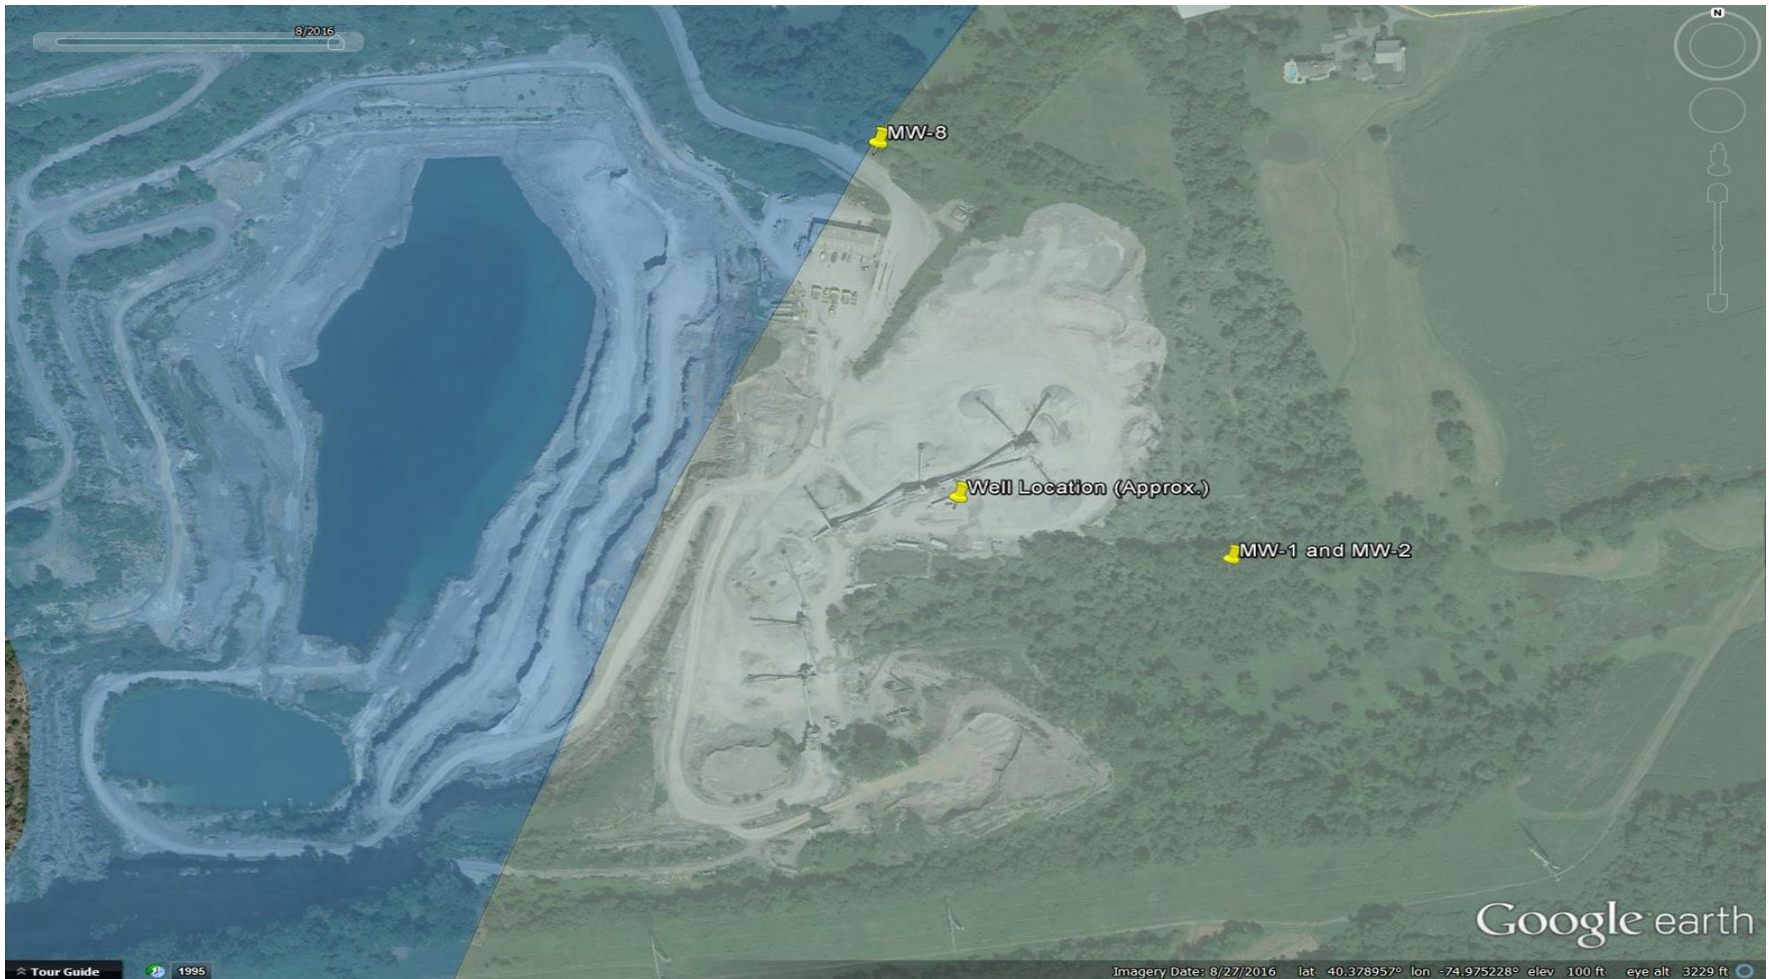
NHCS Monitoring Well Locations

Monitoring well locations are noted by MW1 and MW2 to the right and MW8 at the top center. The fourth in the center is for the plants water use.

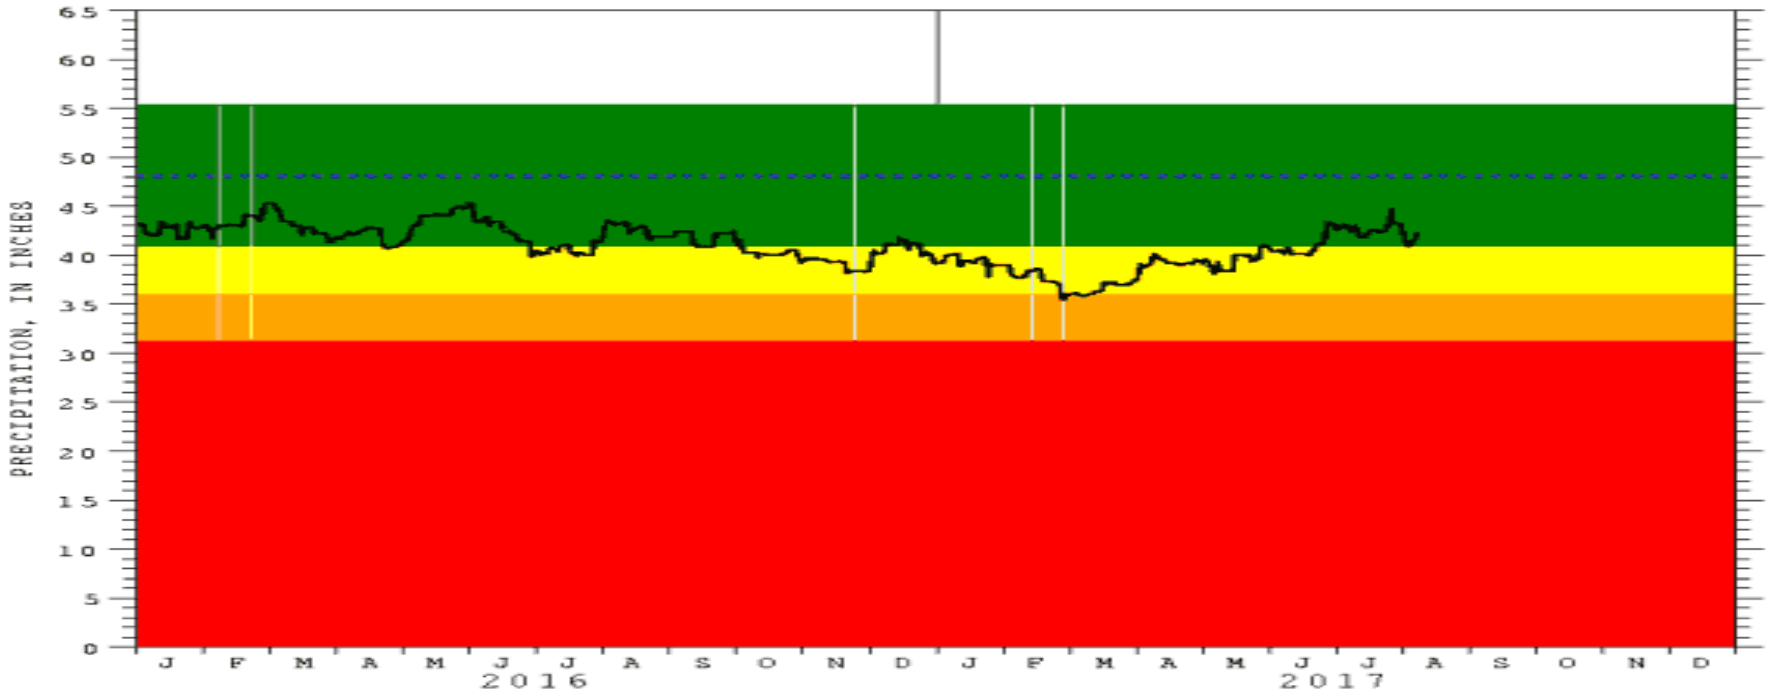
Bucks County Precipitation: 2016-2017

BUCKS COUNTY PRECIPITATION
 USGS PLOT OF NATIONAL WEATHER SERVICE DATA
 MOVING 365-DAY TOTAL PRECIPITATION
 DATE OF PLOT=08/06/17

COLORED BANDS REPRESENT DROUGHT INDICATOR CRITERIA USED BY THE PENNSYLVANIA DEPARTMENT OF ENVIRONMENTAL PROTECTION FOR DROUGHT MONITORING

SOLID LINE = CURRENT MOVING 365-DAY TOTAL, IN INCHES
 DASHED LINE = MOVING AVERAGE 365-DAY TOTAL FOR 1981-2010, MARFC 2013

GREEN (TOP) BAND = 15 PERCENT ABOVE TO 15 PERCENT BELOW AVERAGE (NORMAL)
 ORANGE BAND = 10 PERCENT ABOVE TO 10 PERCENT BELOW AVERAGE (WATCH)
 YELLOW BAND = 5 PERCENT ABOVE TO 5 PERCENT BELOW AVERAGE (WARNING)
 RED (BOTTOM) BAND = GREATER THAN 5 PERCENT BELOW AVERAGE (EMERGENCY)

The overall status for Bucks County has changed to the normal level (as of June 25, 2017).

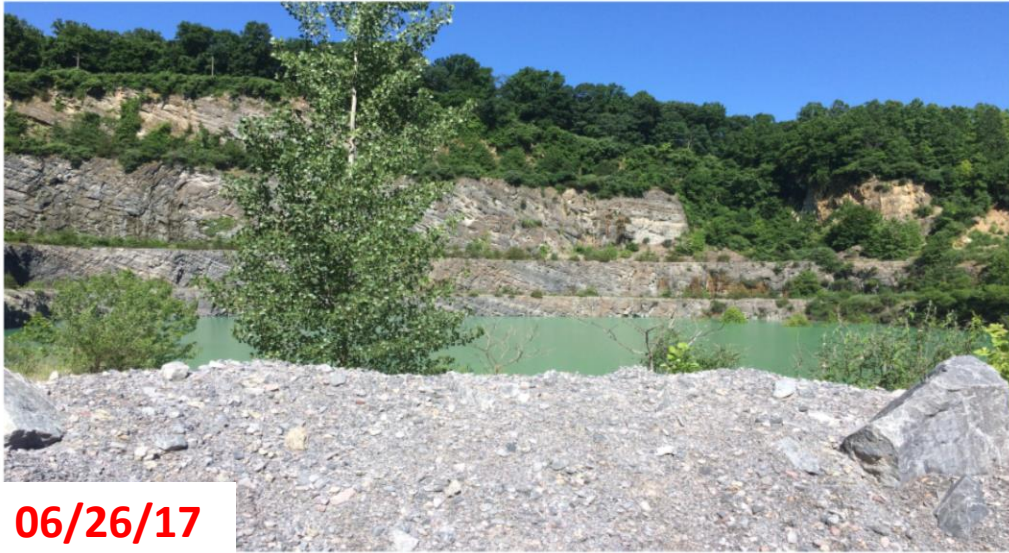
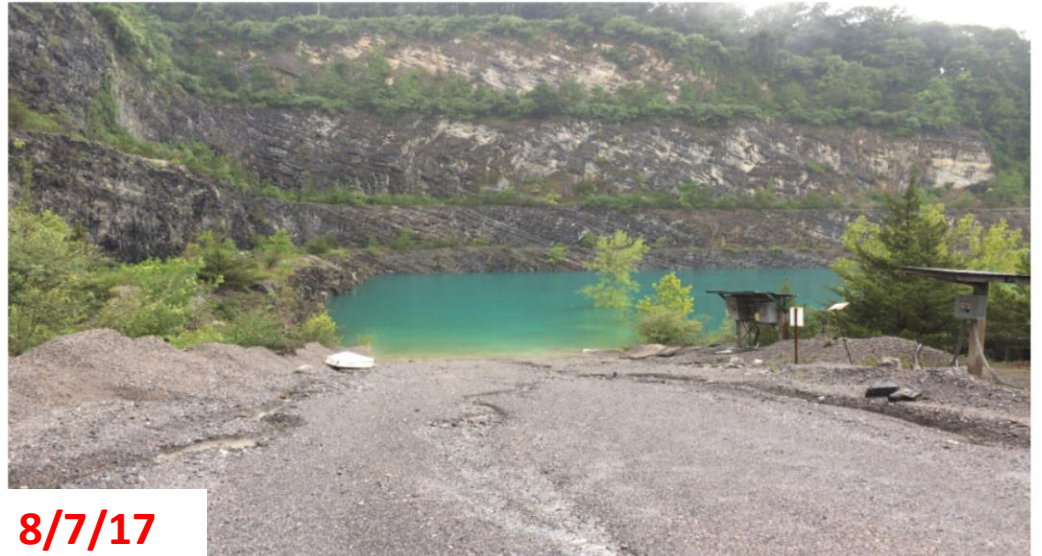
Sump Area

Slight rise in water level.

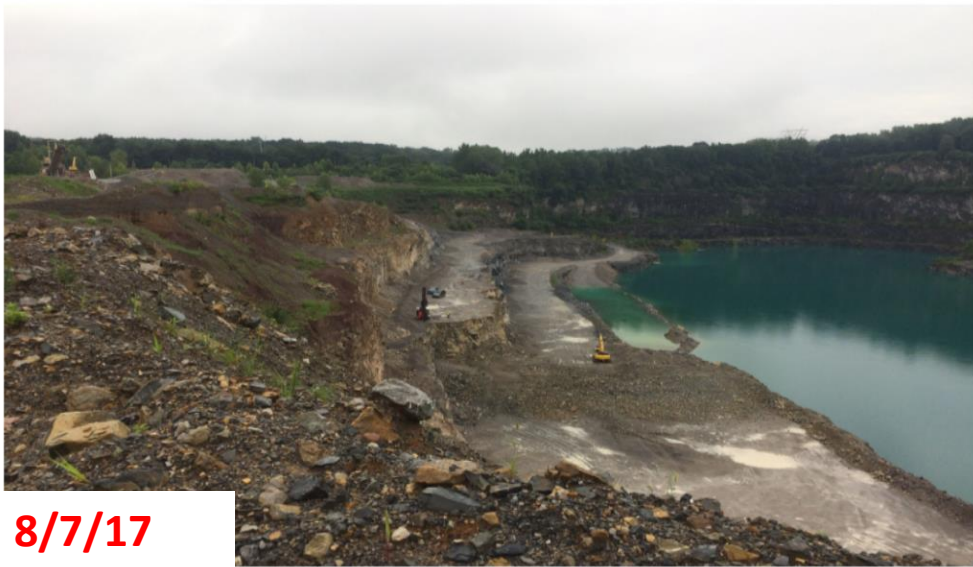
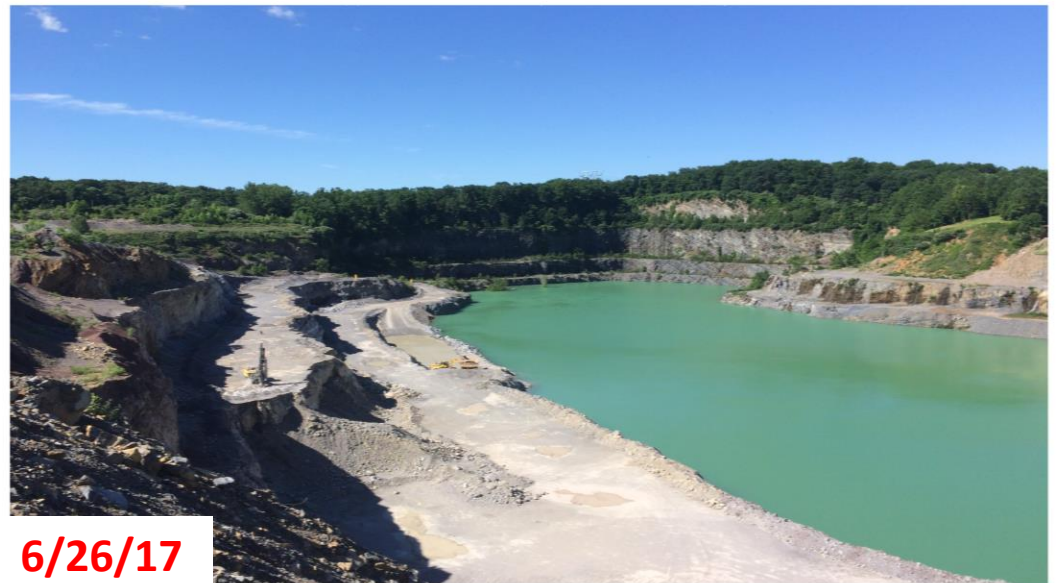
Ramp, Looking South

Rise in the water level can be seen as well as reclamation impact over the past month.
