New Hope Crushed Stone

Monthly Update

February 2018

February 2018 Project Status

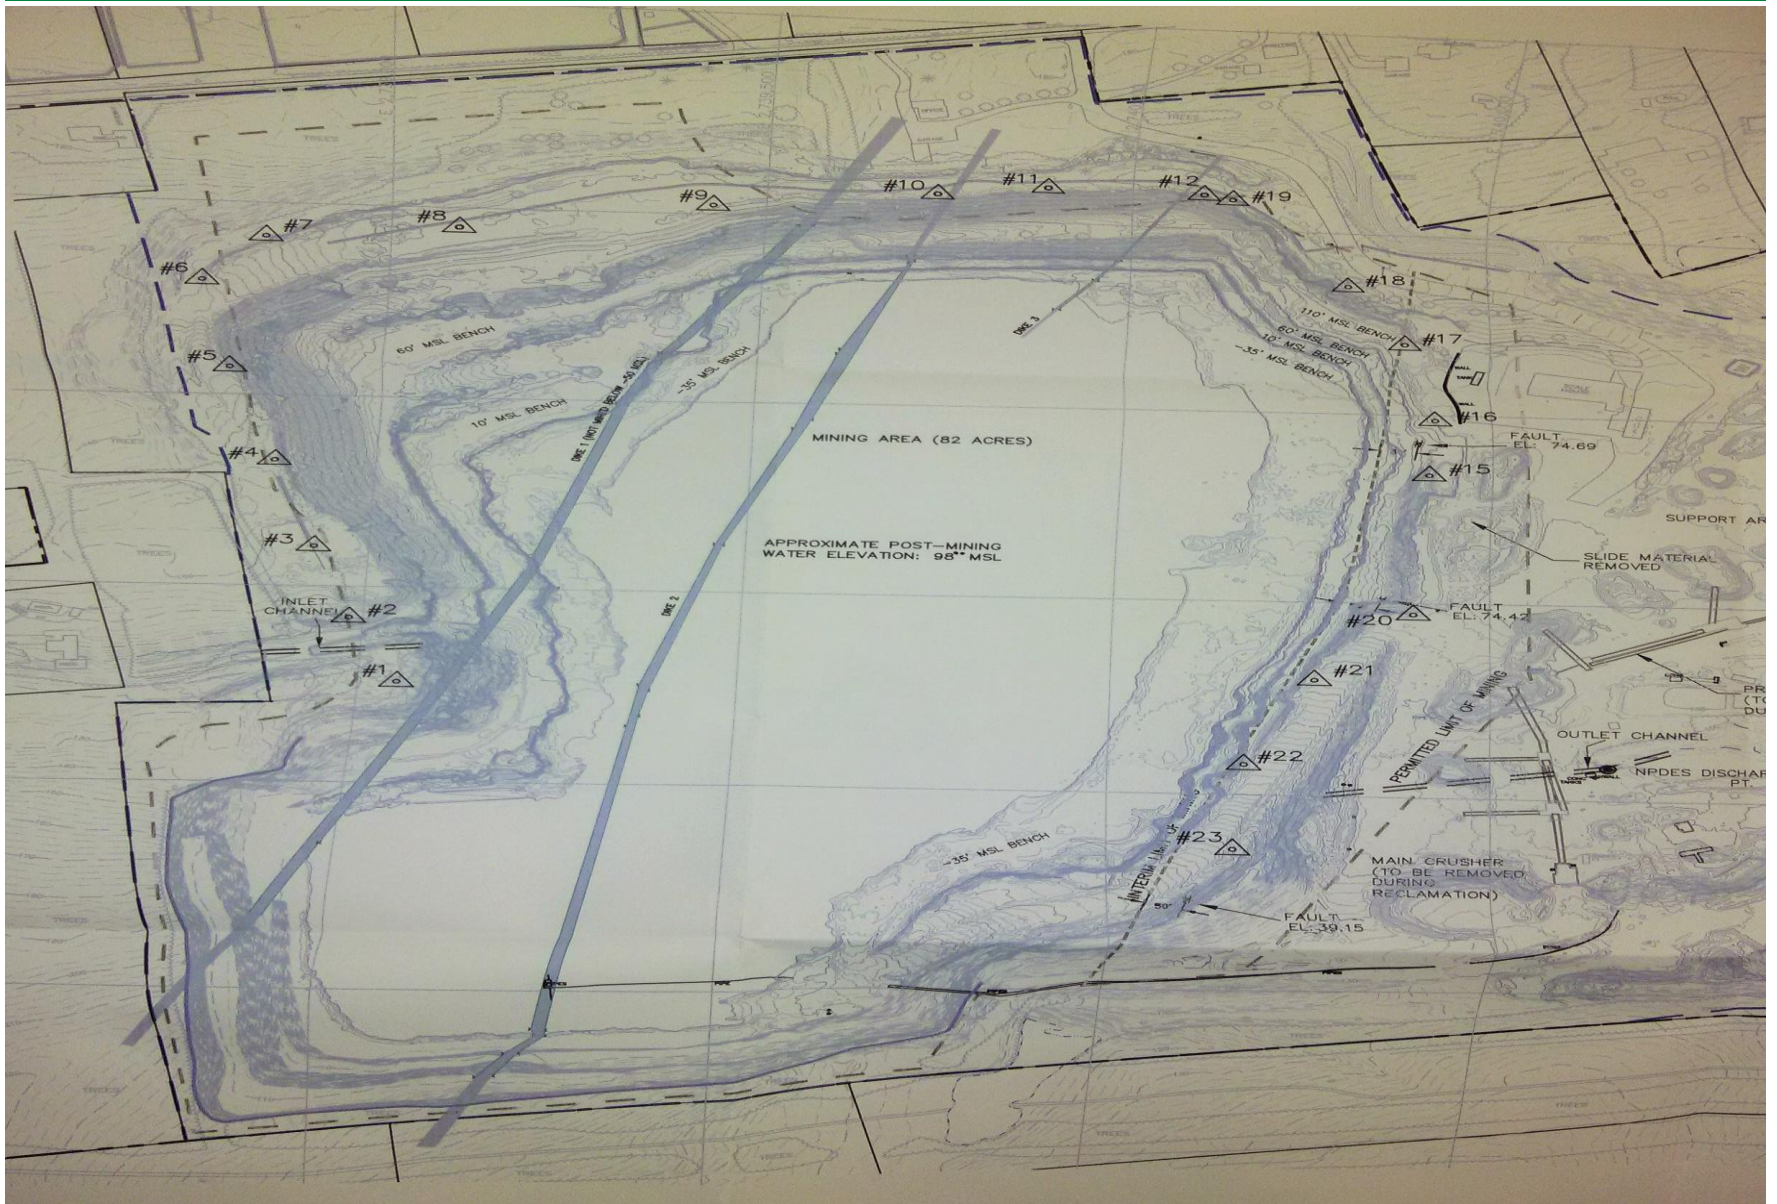
Reclamation Progress Location Map

NOTE: See next page for map referencing the staked areas. Green areas show completed sections which may require some final grading and work to bring them to the 35 degree standard based on a final assessment.

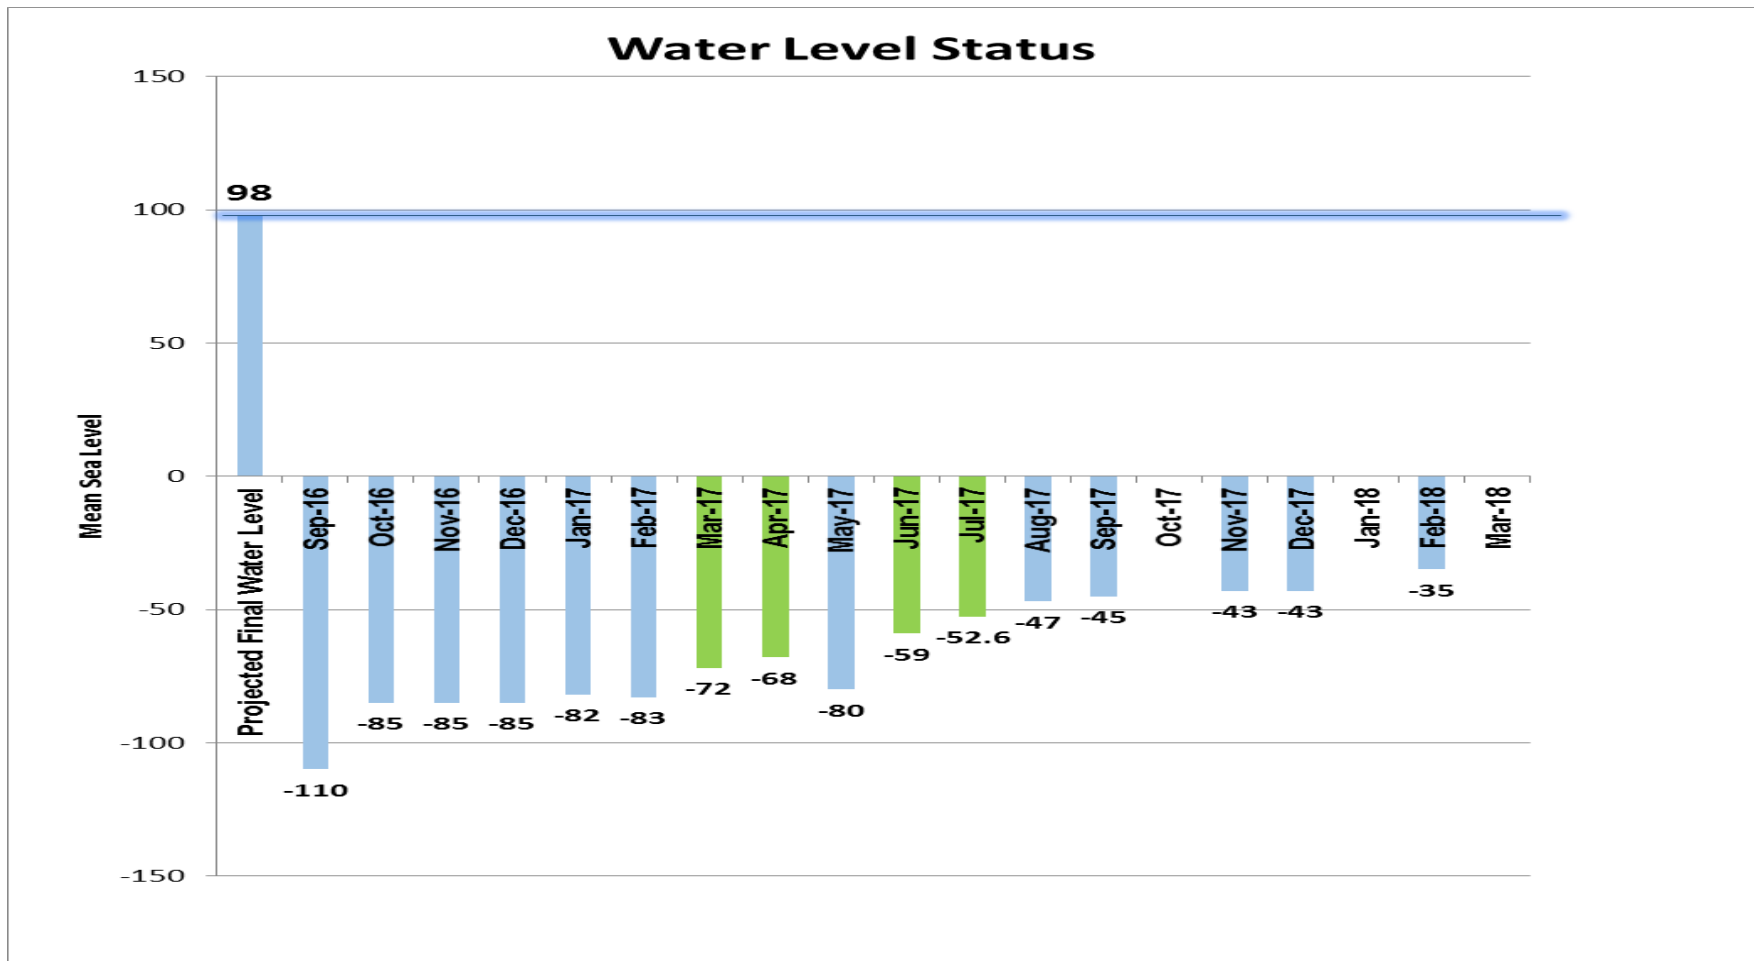
Water Level Tracking

Blue bar = Estimated

Green bar = NHCS consultant, EarthRes, PE stamped reports

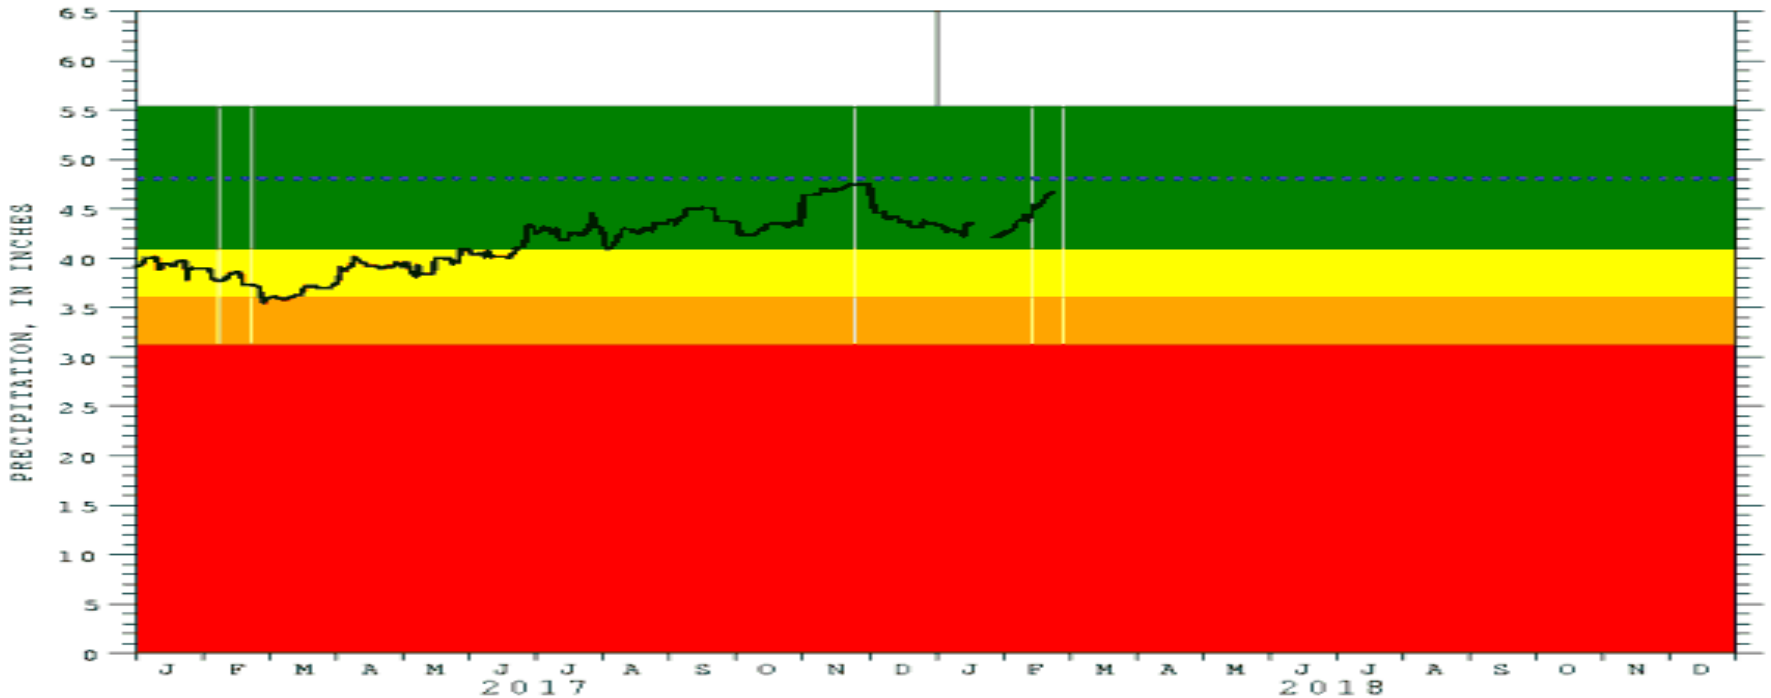
Bucks County Precipitation: 2017-2018

BUCKS COUNTY PRECIPITATION
 USGS PLOT OF NATIONAL WEATHER SERVICE DATA
 MOVING 365-DAY TOTAL PRECIPITATION
 DATE OF PLOT=02/21/18

COLORED BANDS REPRESENT DROUGHT INDICATOR CRITERIA USED BY THE PENNSYLVANIA DEPARTMENT OF ENVIRONMENTAL PROTECTION FOR DROUGHT MONITORING

SOLID LINE = CURRENT MOVING 365-DAY TOTAL, IN INCHES
 DASHED LINE = MOVING AVERAGE 365-DAY TOTAL FOR 1981-2010, MARFC 2013

GREEN (TOP) BAND = 15 PERCENT ABOVE TO 15 PERCENT BELOW AVERAGE (NORMAL)
 YELLOW BAND = 15 TO 25 PERCENT BELOW AVERAGE (WATCH)
 ORANGE BAND = 25 TO 35 PERCENT BELOW AVERAGE (WARNING)
 RED (BOTTOM) BAND = GREATER THAN 35 PERCENT BELOW AVERAGE (EMERGENCY)

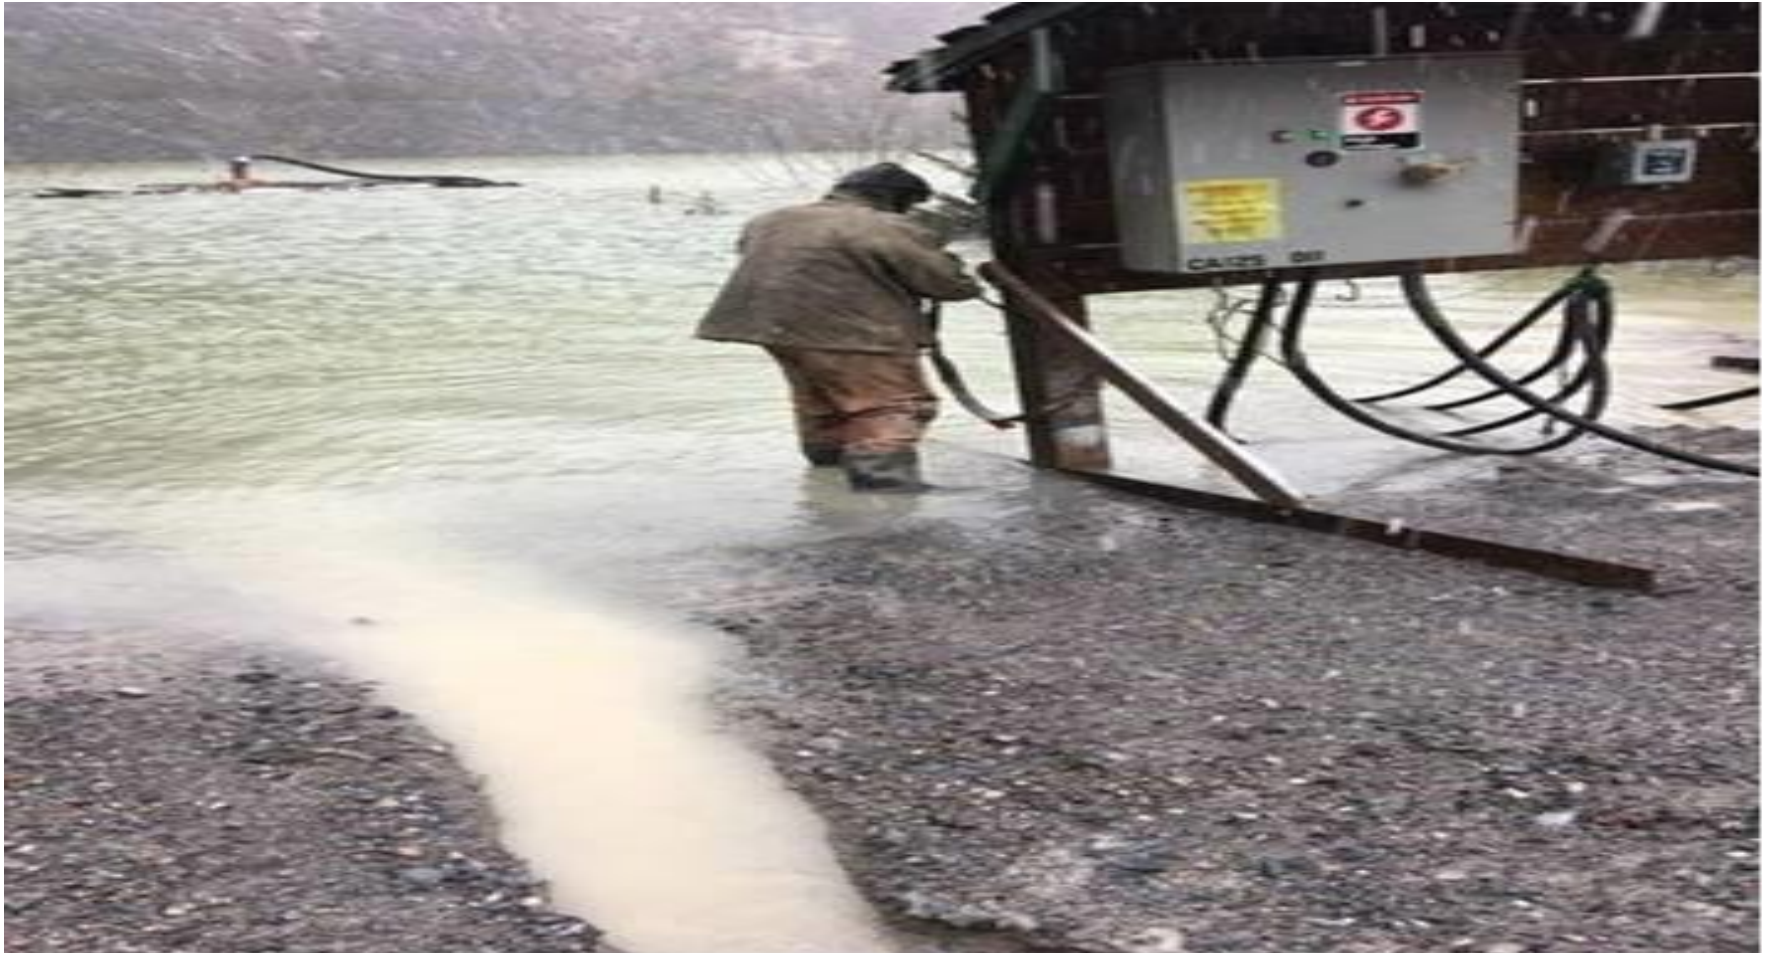
Emergency Water Level: March 2, 2018

- Temporary increase in pumping approved by DEP.
 - On March 2, NHCS requested to temporarily increase pumping in accord with the January 29, 2016, letter to prevent inundation of the electrical panel (picture on slide 12).

- DEP granted the request the same day.
 - The temporary rate is up to 2 million gallons a day (from 500,000 gallons per day).
 - NCHS is required to provide to DEP a cost estimate of moving the panel, a timeline for its movement, and documentation that includes photos of quarry lake water levels and/or pumping data that the increased pumping at the quarry is congruent with the temporary emergency authorization (last point, reported daily during pumping).

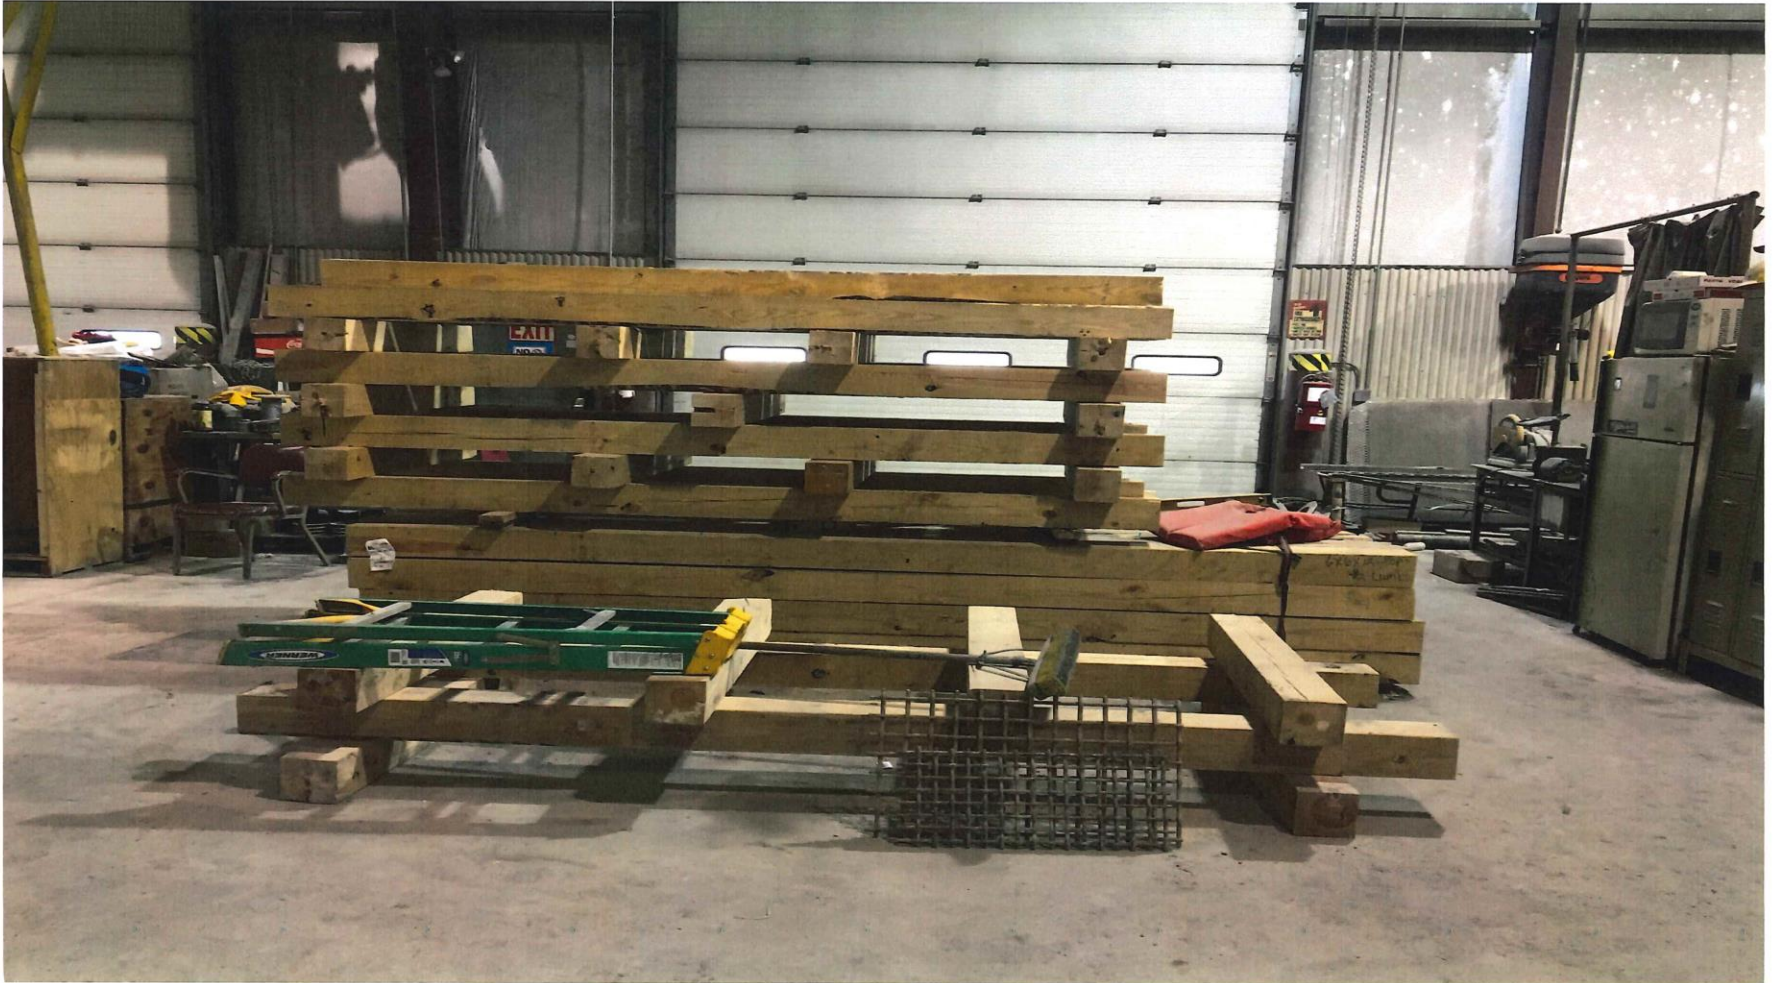
Crib Building

Note: Cribs are being used towards the stream inlet to stabilize the banks. They allow for vegetation to grow which will become the bank structure as the wood decays.
