New Hope Crushed Stone

Status Update

June 2018 Project Status

STATUS AS OF:	Varies: End of 2017 to June 2018	
PROJECT	New Hope Crushed Stone (NHCS) Quarry Reclamation and Stream Restoration	
START DATE	Reclamation: January 29, 2016 Stream Restoration: January 29, 2016	
ANTICIPATED COMPLETION DATE	Reclamation: March 2019 Stream Restoration: March 2019	
CURRENT STATUS	Quarry Reclamation	On Schedule
	Stream Restoration	On Schedule

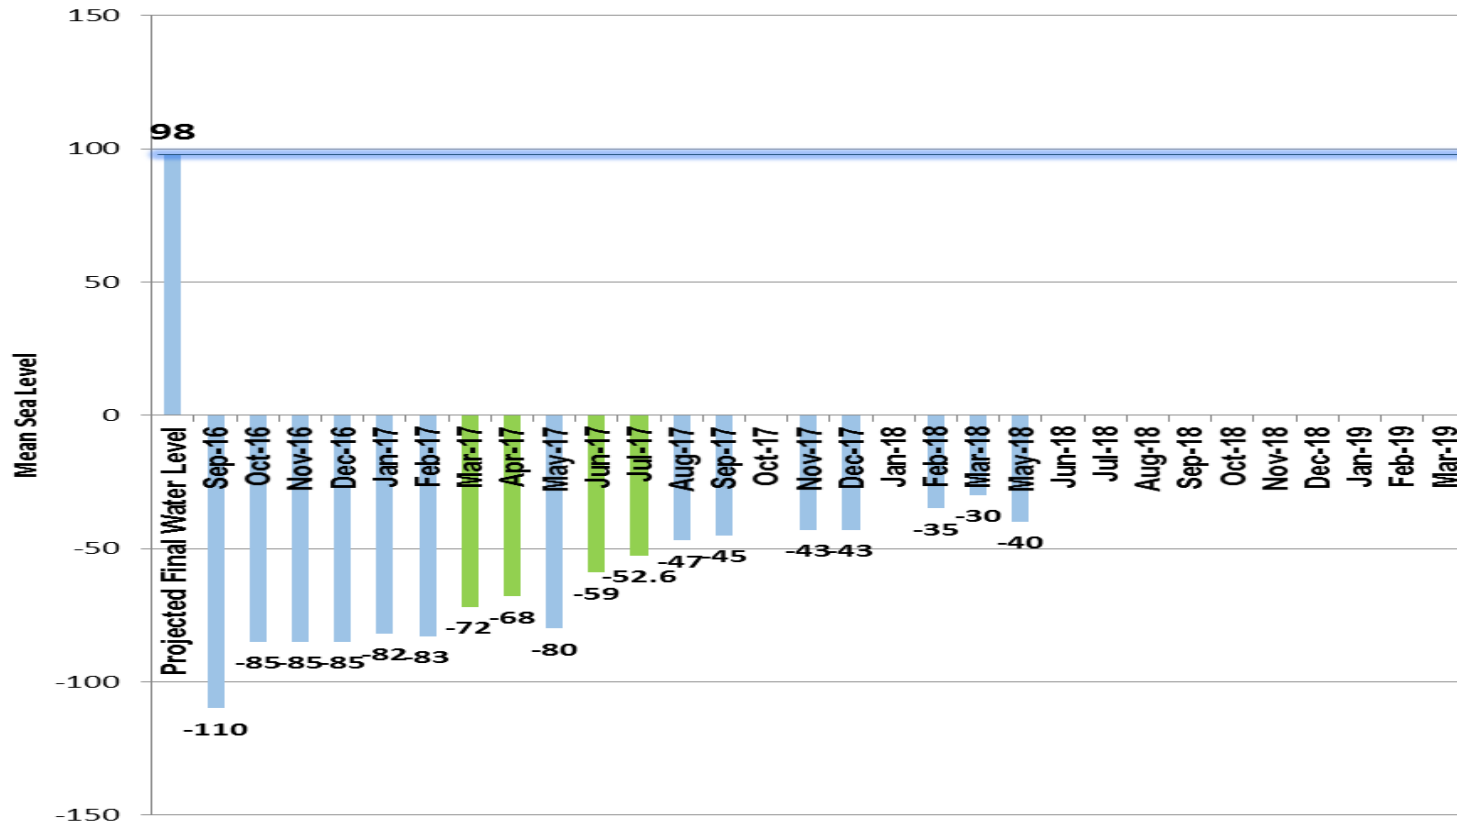
Water Level Status

Blue bar = Estimated Green bar = NHCS consultant, EarthRes, PE stamped reports
 Note: Emergency increased pumping allowed in March 2018 to provide a minimum safety bench level of -35 until the transformers are moved. Can not go lower than -40.

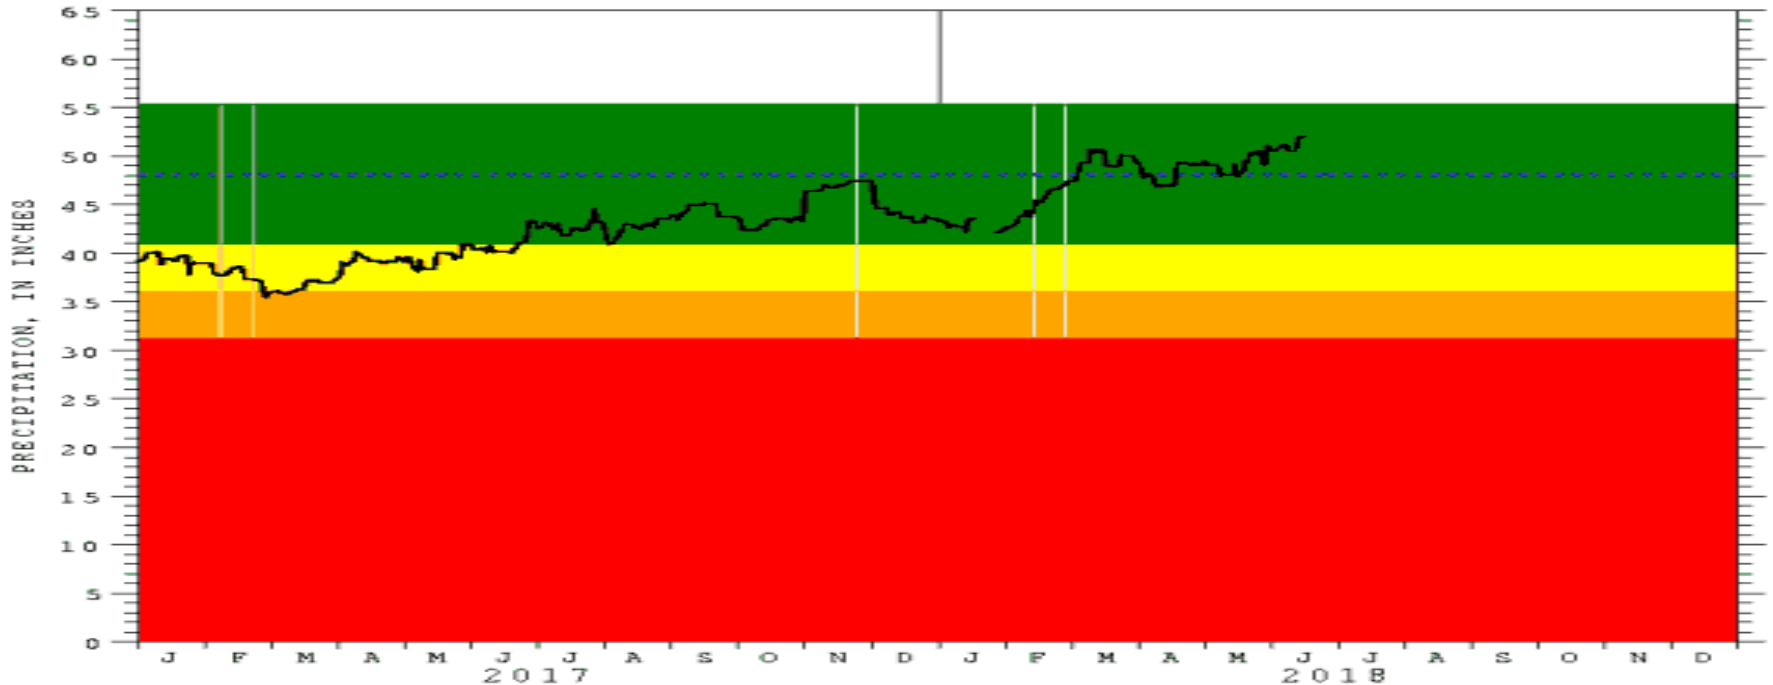
Bucks County Precipitation: 2017-2018

BUCKS COUNTY PRECIPITATION
 USGS PLOT OF NATIONAL WEATHER SERVICE DATA
 MOVING 365-DAY TOTAL PRECIPITATION
 DATE OF PLOT=06/14/18

COLORED BANDS REPRESENT DROUGHT INDICATOR CRITERIA USED BY THE PENNSYLVANIA DEPARTMENT OF ENVIRONMENTAL PROTECTION FOR DROUGHT MONITORING

SOLID LINE = CURRENT MOVING 365-DAY TOTAL, IN INCHES
 DASHED LINE = MOVING AVERAGE 365-DAY TOTAL FOR 1981-2010, MARFC 2013

GREEN (TOP) BAND = 15 PERCENT ABOVE TO 15 PERCENT BELOW AVERAGE (NORMAL)
 YELLOW BAND = 15 TO 25 PERCENT BELOW AVERAGE (WATCH)
 ORANGE BAND = 25 TO 35 PERCENT BELOW AVERAGE (WARNING)
 RED (BOTTOM) BAND = GREATER THAN 35 PERCENT BELOW AVERAGE (EMERGENCY)

- Reclamation and Stream Restoration Progress
 - Stream work
 - Due to the wet spring (see precipitation graph) there has not been much recent work on the stream.

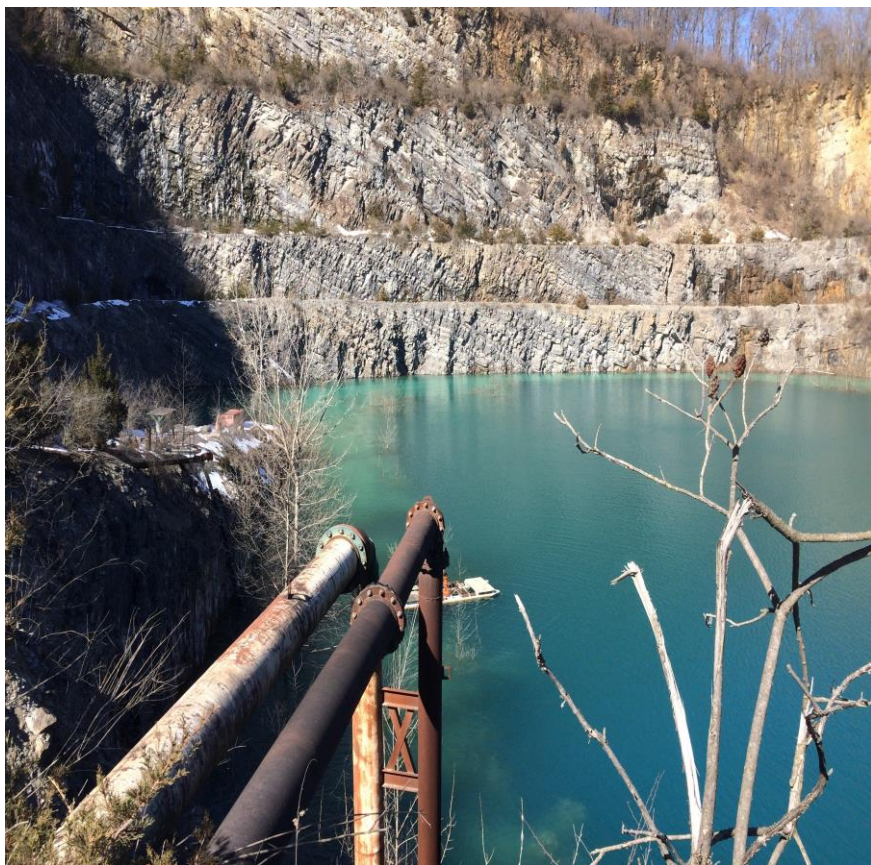
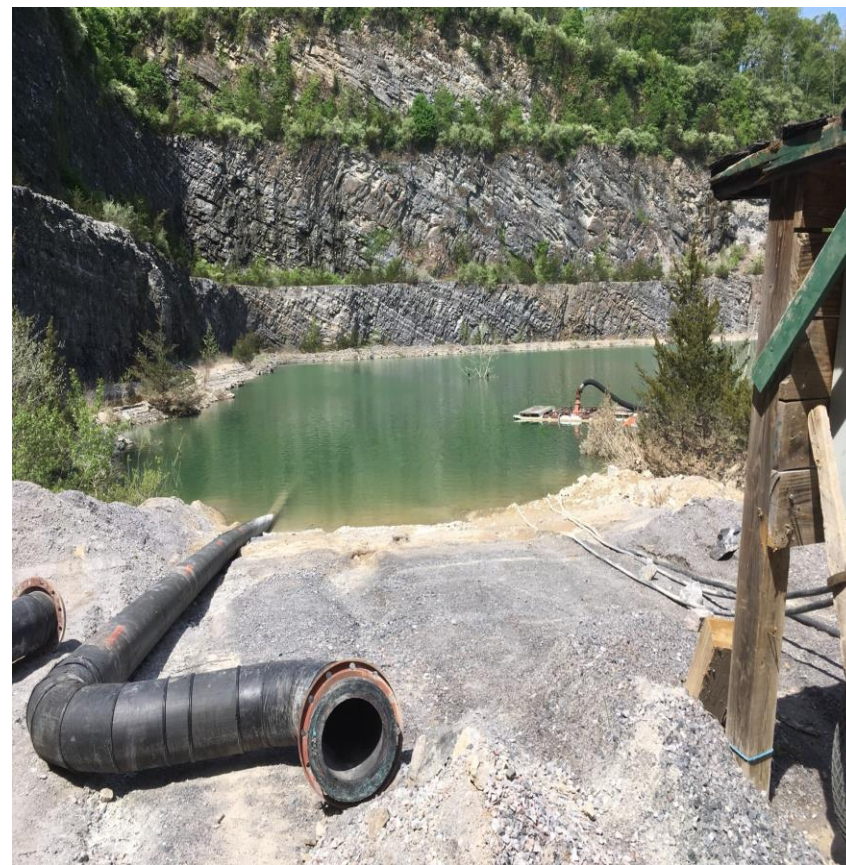
Sump Area, South End

Note: Sump area pictures from 2016 were taken from the opposite side which was cover by water in early 2017.
