# Supplemental Aquatic Resources Report

## Mariner East Project – Houston to Delmont Mainline

**Supplemental Aquatic Resources Report  
Mariner East 1, Houston to Delmont Project  
Washington County, Pennsylvania**

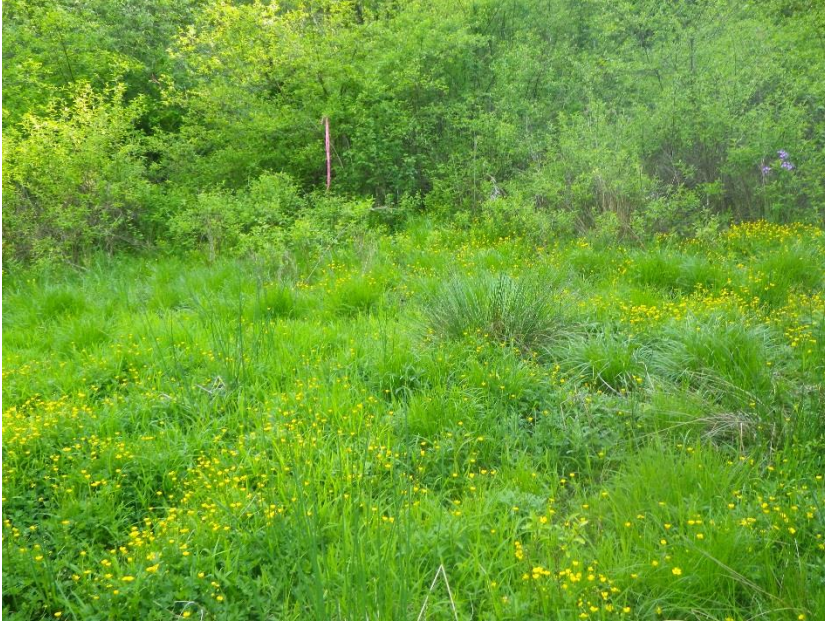
**Photographer:** N. Grosse  
**Date:** 5/19/2014  
**Photo No.:** 1  
**Direction:** S

**Comments:** Wetland W201 vegetation.

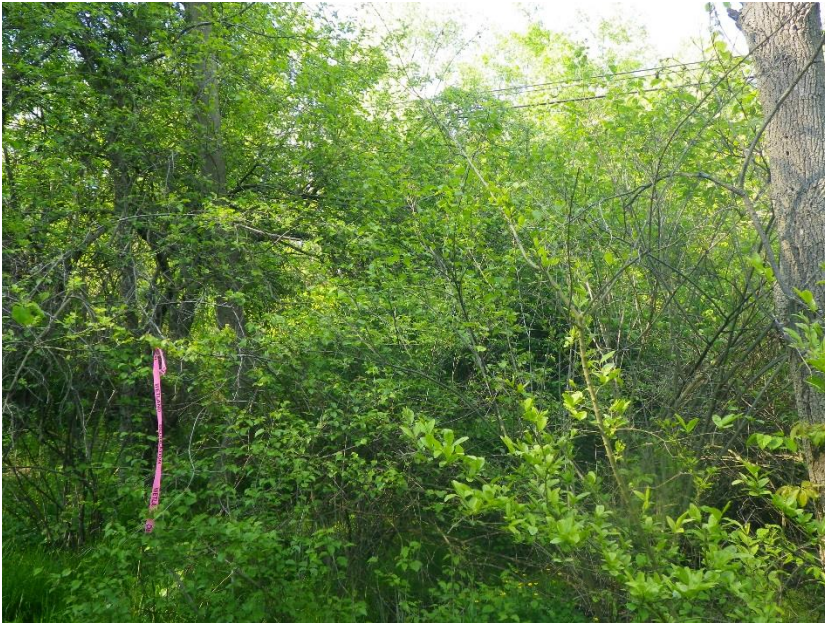
**Photographer:** N. Grosse  
**Date:** 5/19/2014  
**Photo No.:** 2  
**Direction:** N

**Comments:** Upland vegetation adjacent to wetland W201.

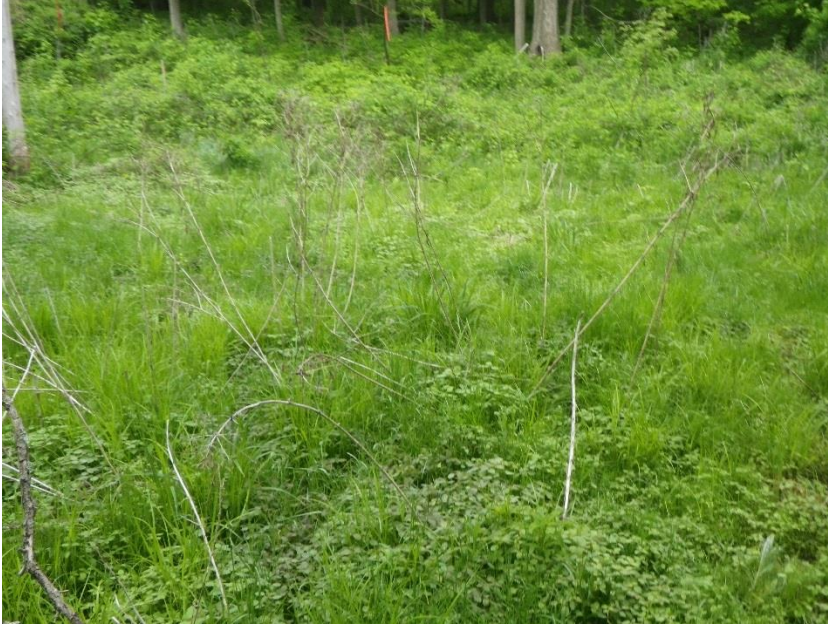
**Photographer:** N. Grosse  
**Date:** 5/21/2014  
**Photo No.:** 3  
**Direction:** S

**Comments:** Wetland W204 vegetation.

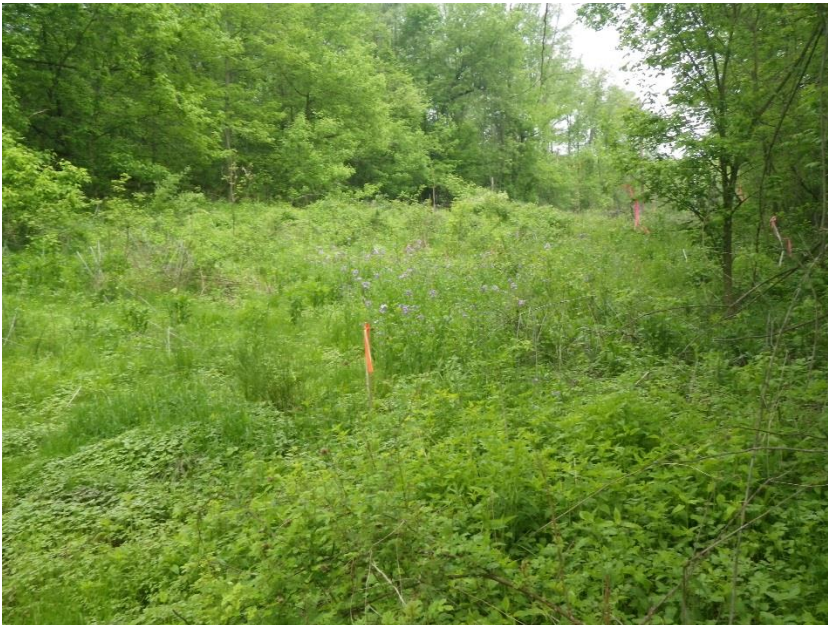
**Photographer:** N. Grosse  
**Date:** 5/21/2014  
**Photo No.:** 4  
**Direction:** SW

**Comments:** Upland vegetation adjacent to wetland W204.

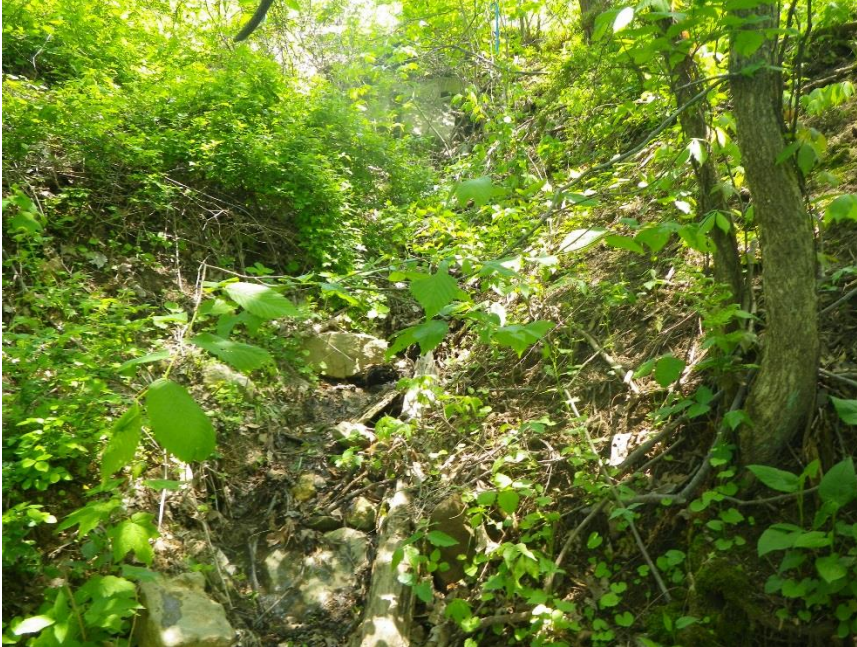
**Photographer:** N. Grosse  
**Date:** 5/19/2014  
**Photo No.:** 7  
**Direction:** E

**Comments:** Stream S260  
upstream

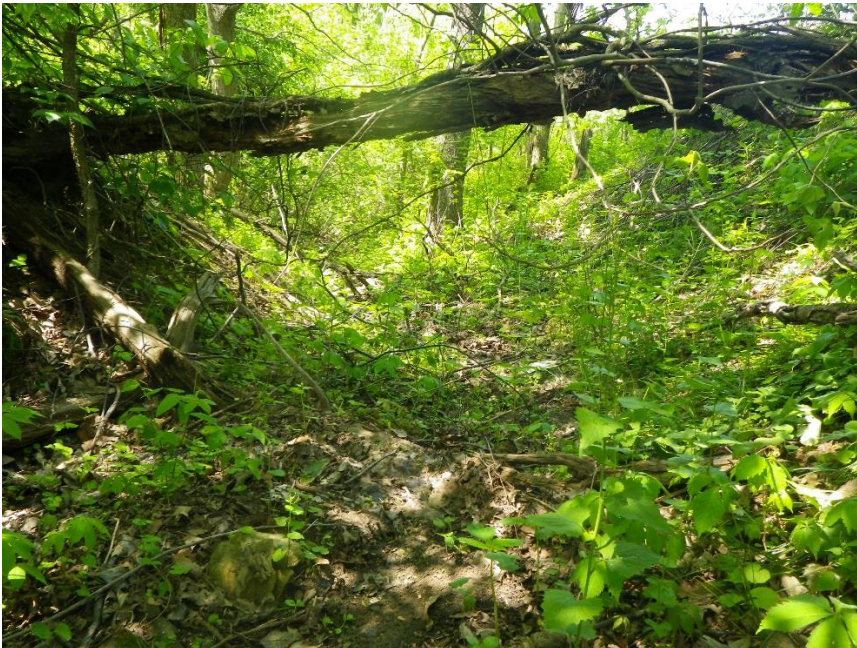
**Photographer:** N. Grosse  
**Date:** 5/19/2014  
**Photo No.:** 8  
**Direction:** W

**Comments:** Stream S260  
downstream

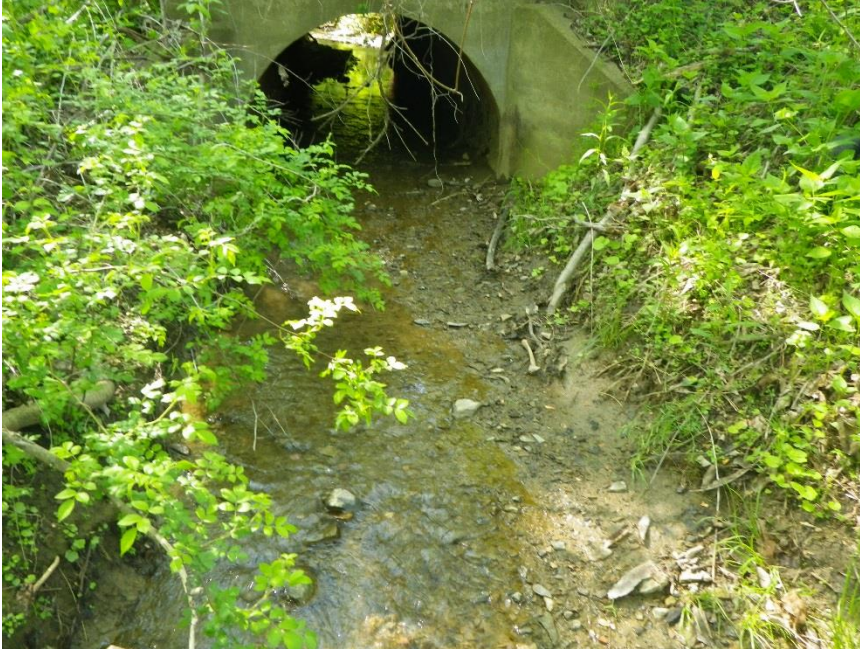
**Photographer:** N. Grosse  
**Date:** 5/19/2014  
**Photo No.:** 9  
**Direction:** W

**Comments:** Stream S269  
upstream.

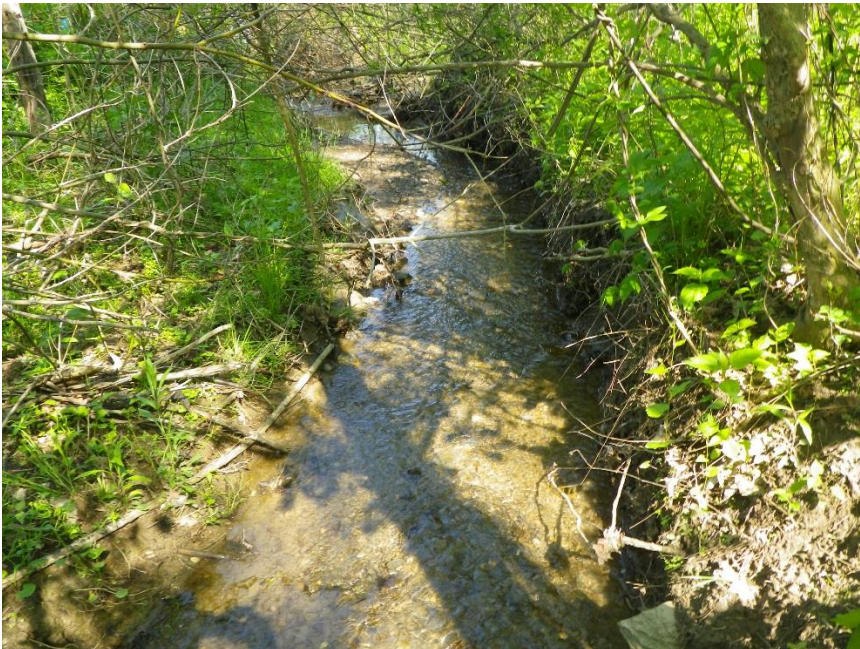
**Photographer:** N. Grosse  
**Date:** 5/19/2014  
**Photo No.:** 10  
**Direction:** E

**Comments:** Stream S269  
downstream.

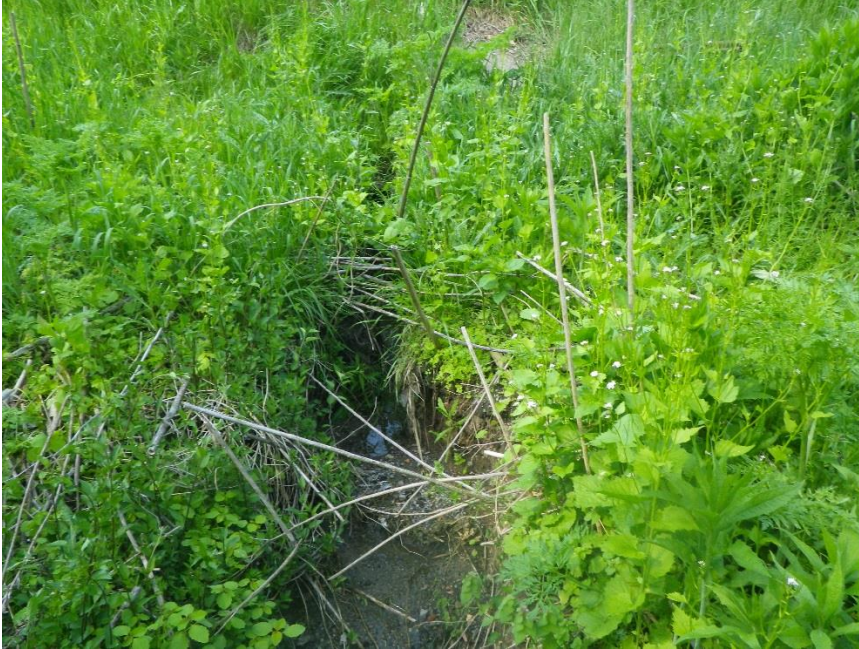
**Photographer:** N. Grosse  
**Date:** 5/19/2014  
**Photo No.:** 11  
**Direction:** N

**Comments:** Stream S270  
upstream.

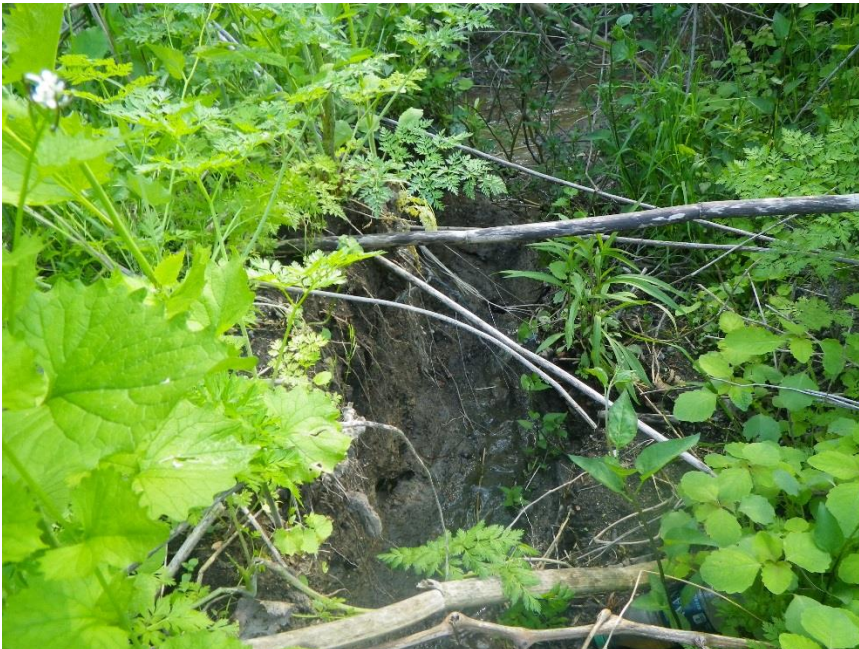
**Photographer:** N. Grosse  
**Date:** 5/19/2014  
**Photo No.:** 12  
**Direction:** S

**Comments:** Stream S270  
downstream.

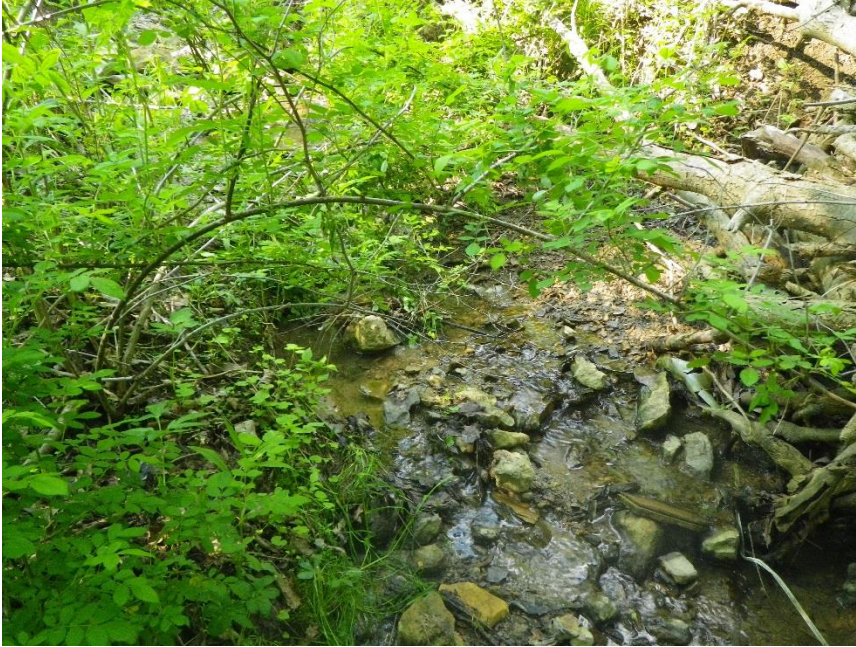
**Photographer:** N. Grosse  
**Date:** 5/19/2014  
**Photo No.:** 13  
**Direction:** N

**Comments:** Stream S271  
upstream.

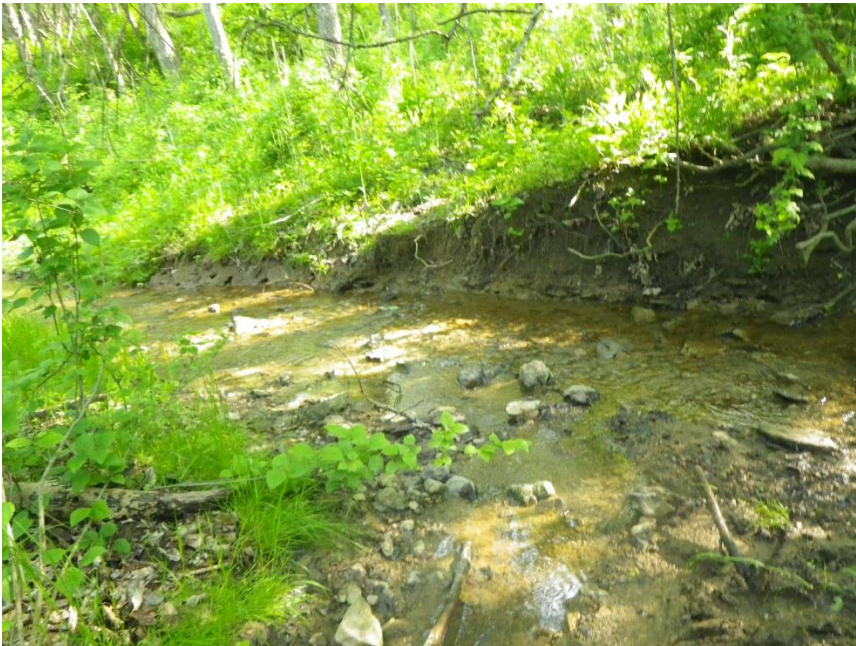
**Photographer:** N. Grosse  
**Date:** 5/19/2014  
**Photo No.:** 14  
**Direction:** S

**Comments:** Stream S271  
downstream.

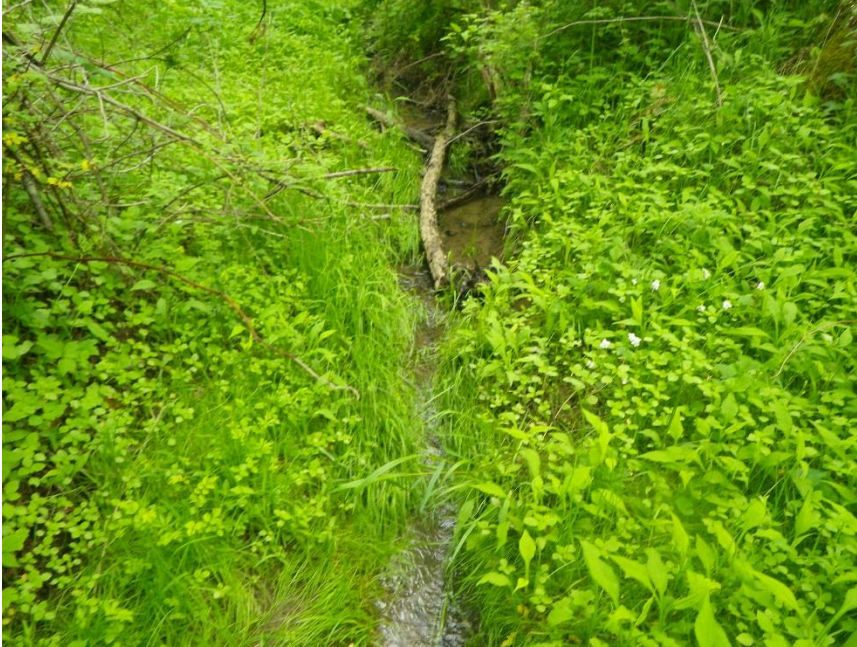
**Photographer:** N. Grosse  
**Date:** 5/20/2014  
**Photo No.:** 15  
**Direction:** NE

**Comments:** Stream S279  
upstream.

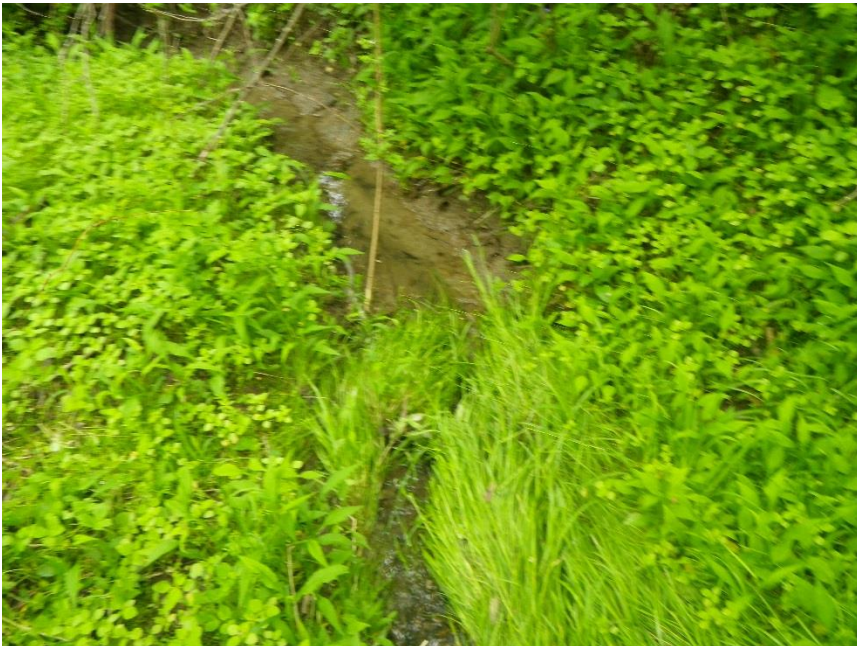
**Photographer:** N. Grosse  
**Date:** 5/20/2014  
**Photo No.:** 16  
**Direction:** SW

**Comments:** Stream S279  
downstream.

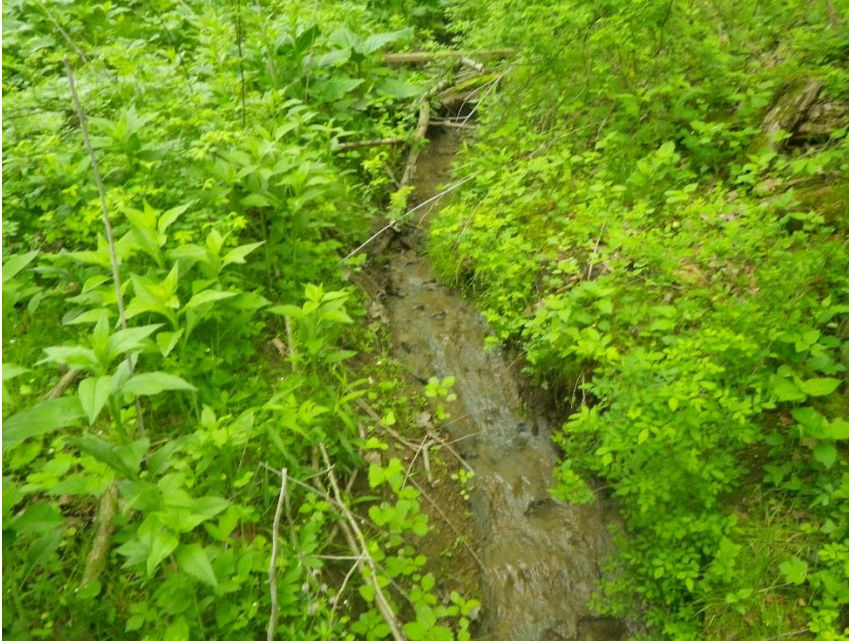
**Photographer:** N. Grosse  
**Date:** 5/20/2014  
**Photo No.:** 17  
**Direction:** E

**Comments:** Stream S280  
upstream.

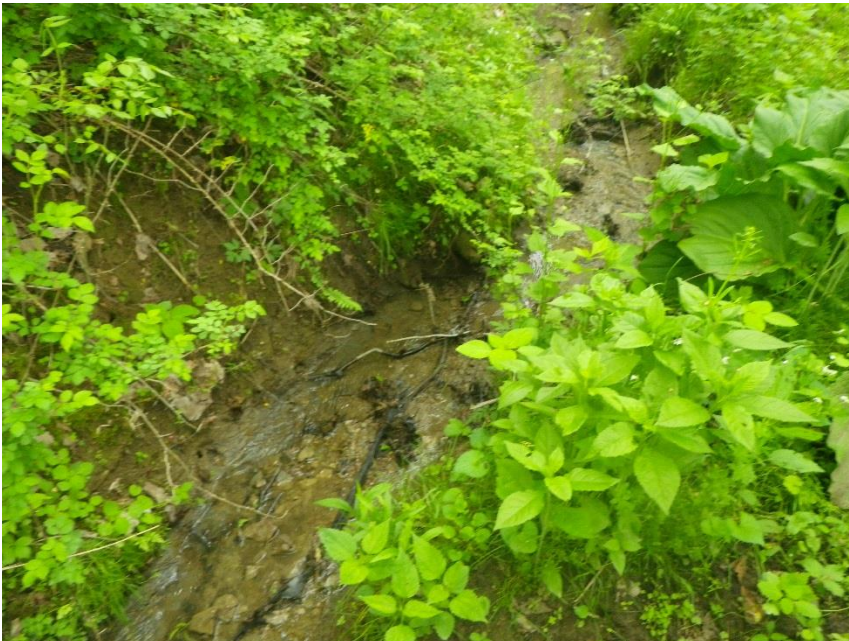
**Photographer:** N. Grosse  
**Date:** 5/20/2014  
**Photo No.:** 18  
**Direction:** W

**Comments:** Stream S280  
downstream.

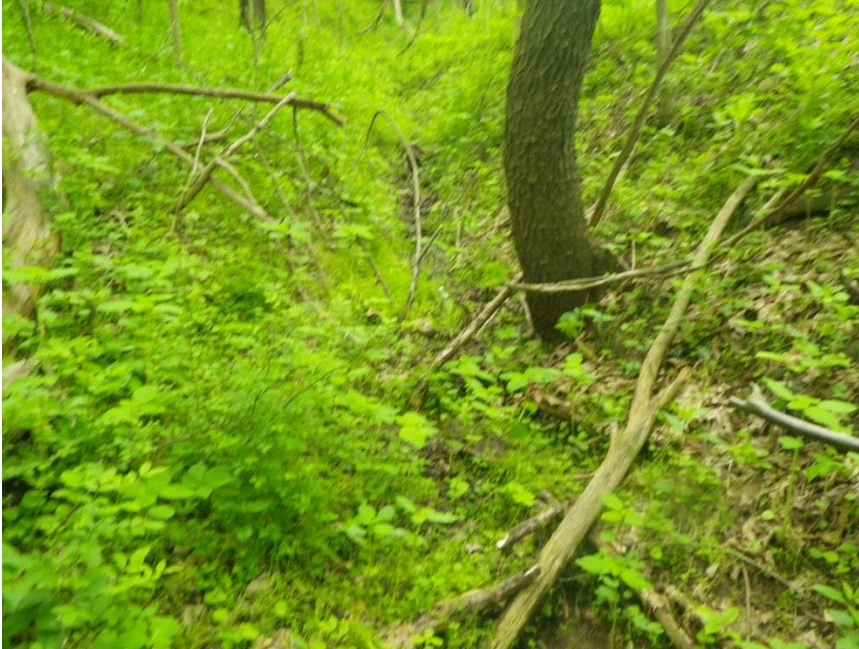
**Photographer:** N. Grosse  
**Date:** 5/20/2014  
**Photo No.:** 19  
**Direction:** E

**Comments:** Stream S281  
upstream.

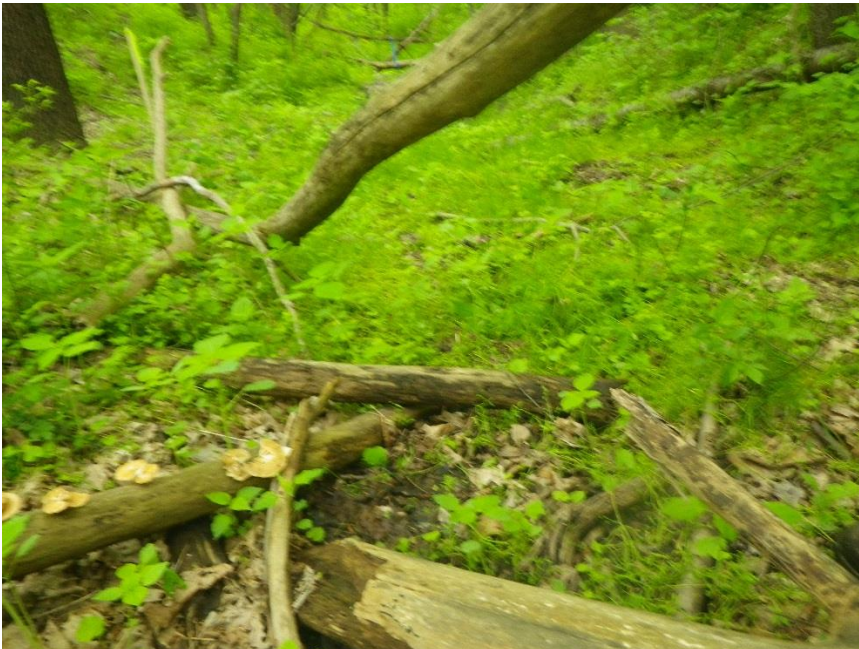
**Photographer:** N. Grosse  
**Date:** 5/20/2014  
**Photo No.:** 20  
**Direction:** W

**Comments:** Stream S281  
downstream.
