**Re: Mussel Habitat Assessment Report
Falcon Ethane Pipeline Project
Shell Pipeline Company, LP
Beaver, Allegheny, and Washington Counties, Pennsylvania USFWS Project # 2015-1047**

SHELL PIPELINE COMPANY, LP FALCON ETHANE PIPELINE PROJECT

Freshwater Mussel (Unionid) Habitat Assessment

RE: Freshwater Mussel Habitat Assessment
Shell Pipeline Company, LP
Falcon Ethane Pipeline Project
Multiple Streams
Allegheny, Beaver, and Washington Counties, Pennsylvania

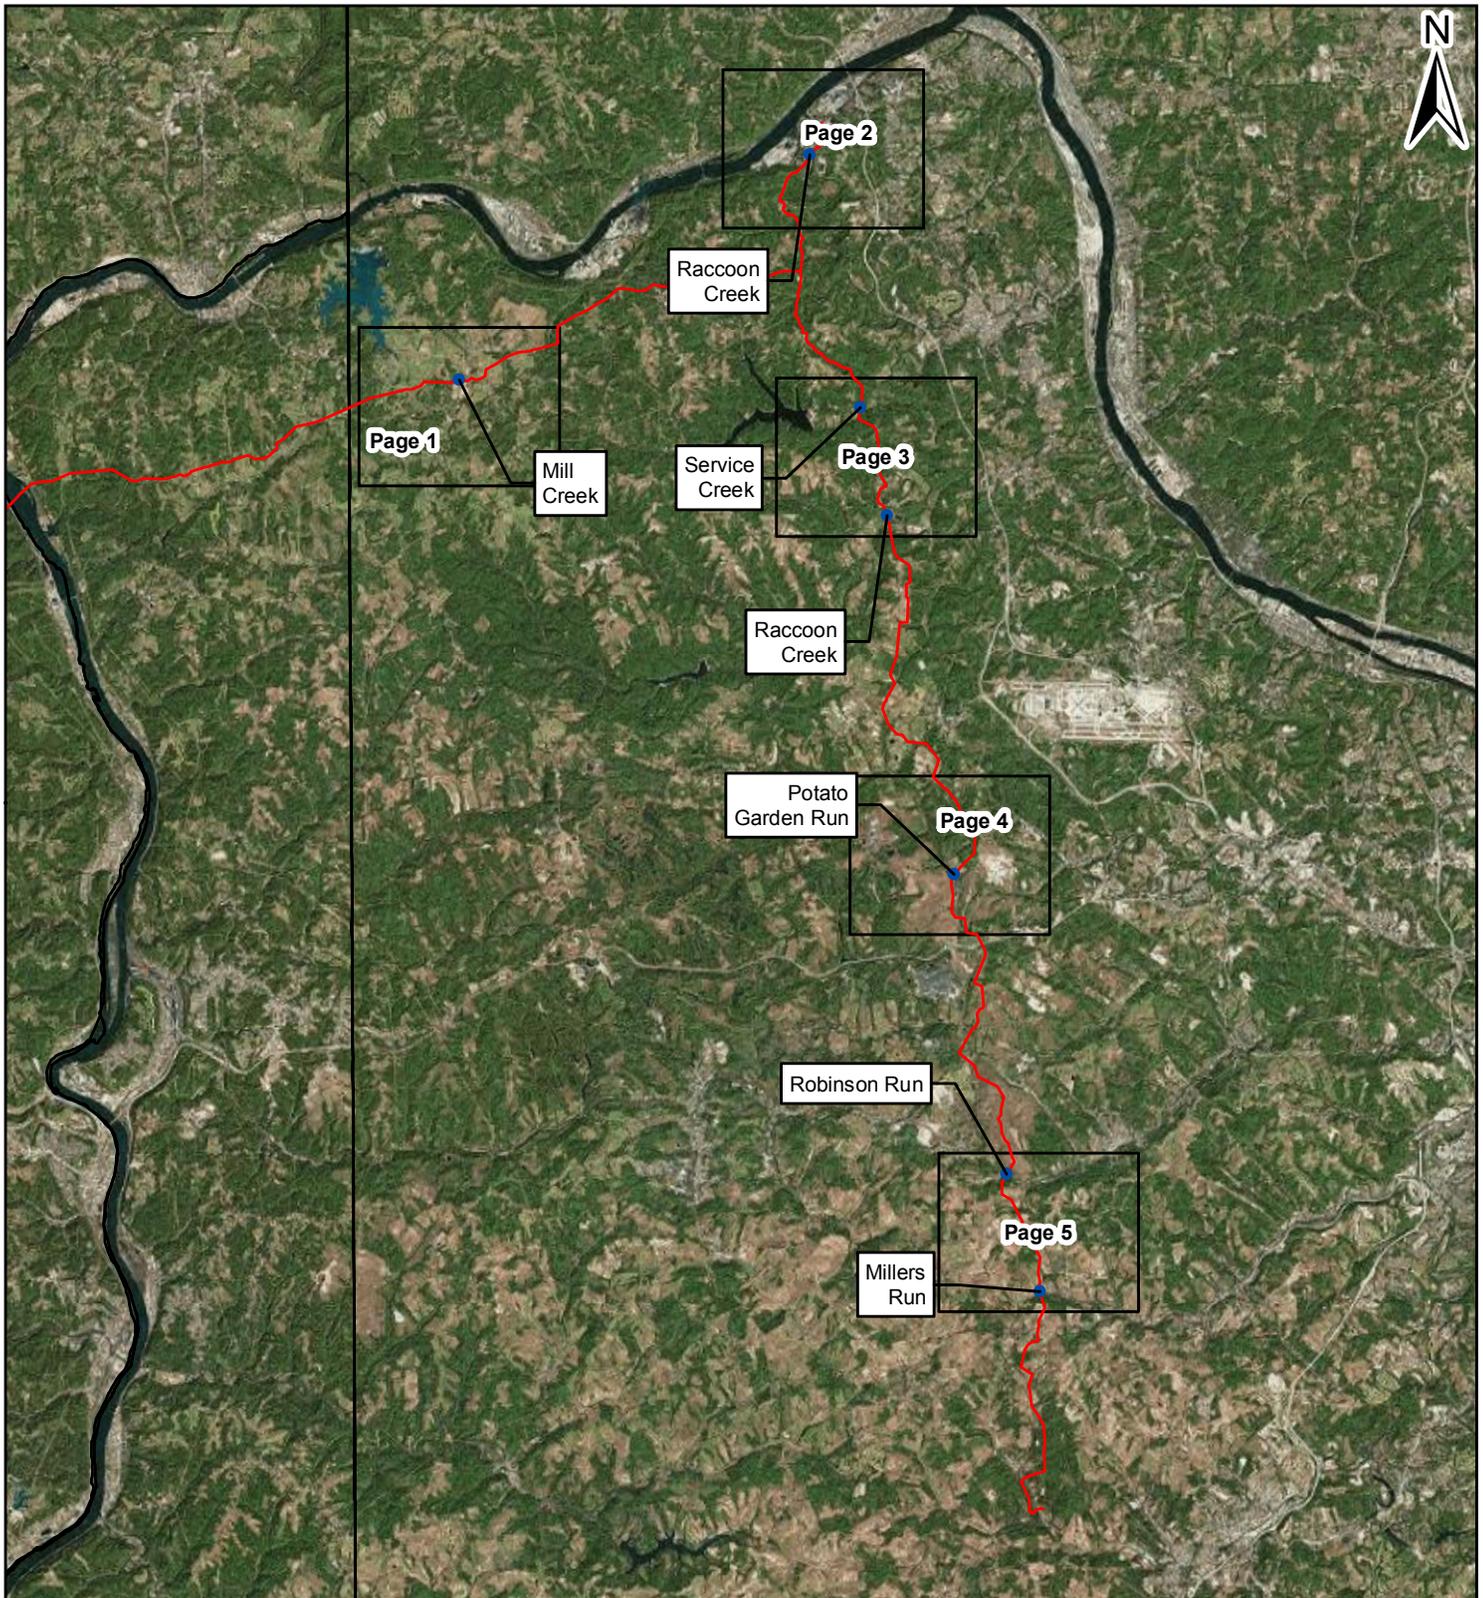
FIGURE 1

**MUSSEL STREAM OVERVIEW
PENNSYLVANIA**

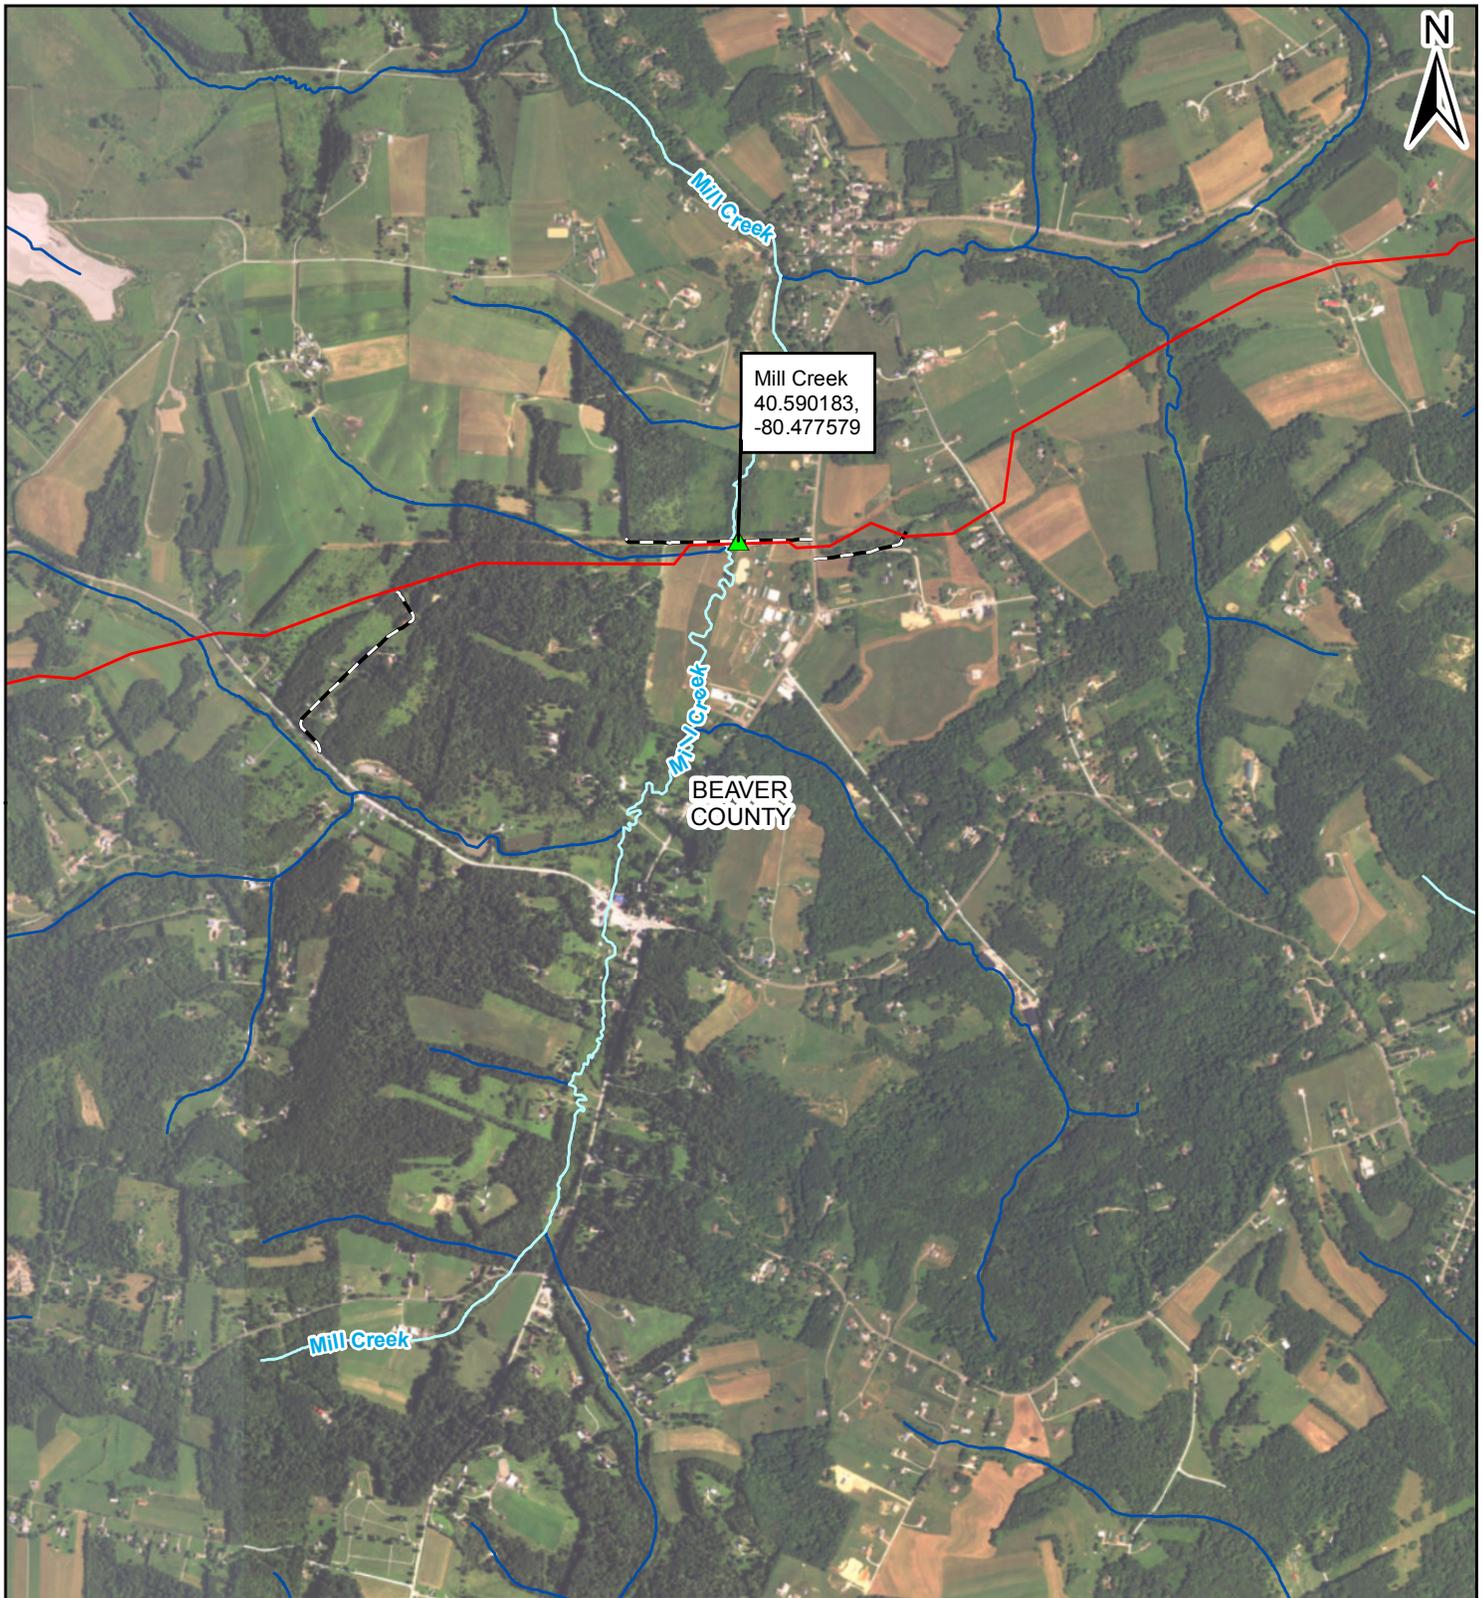
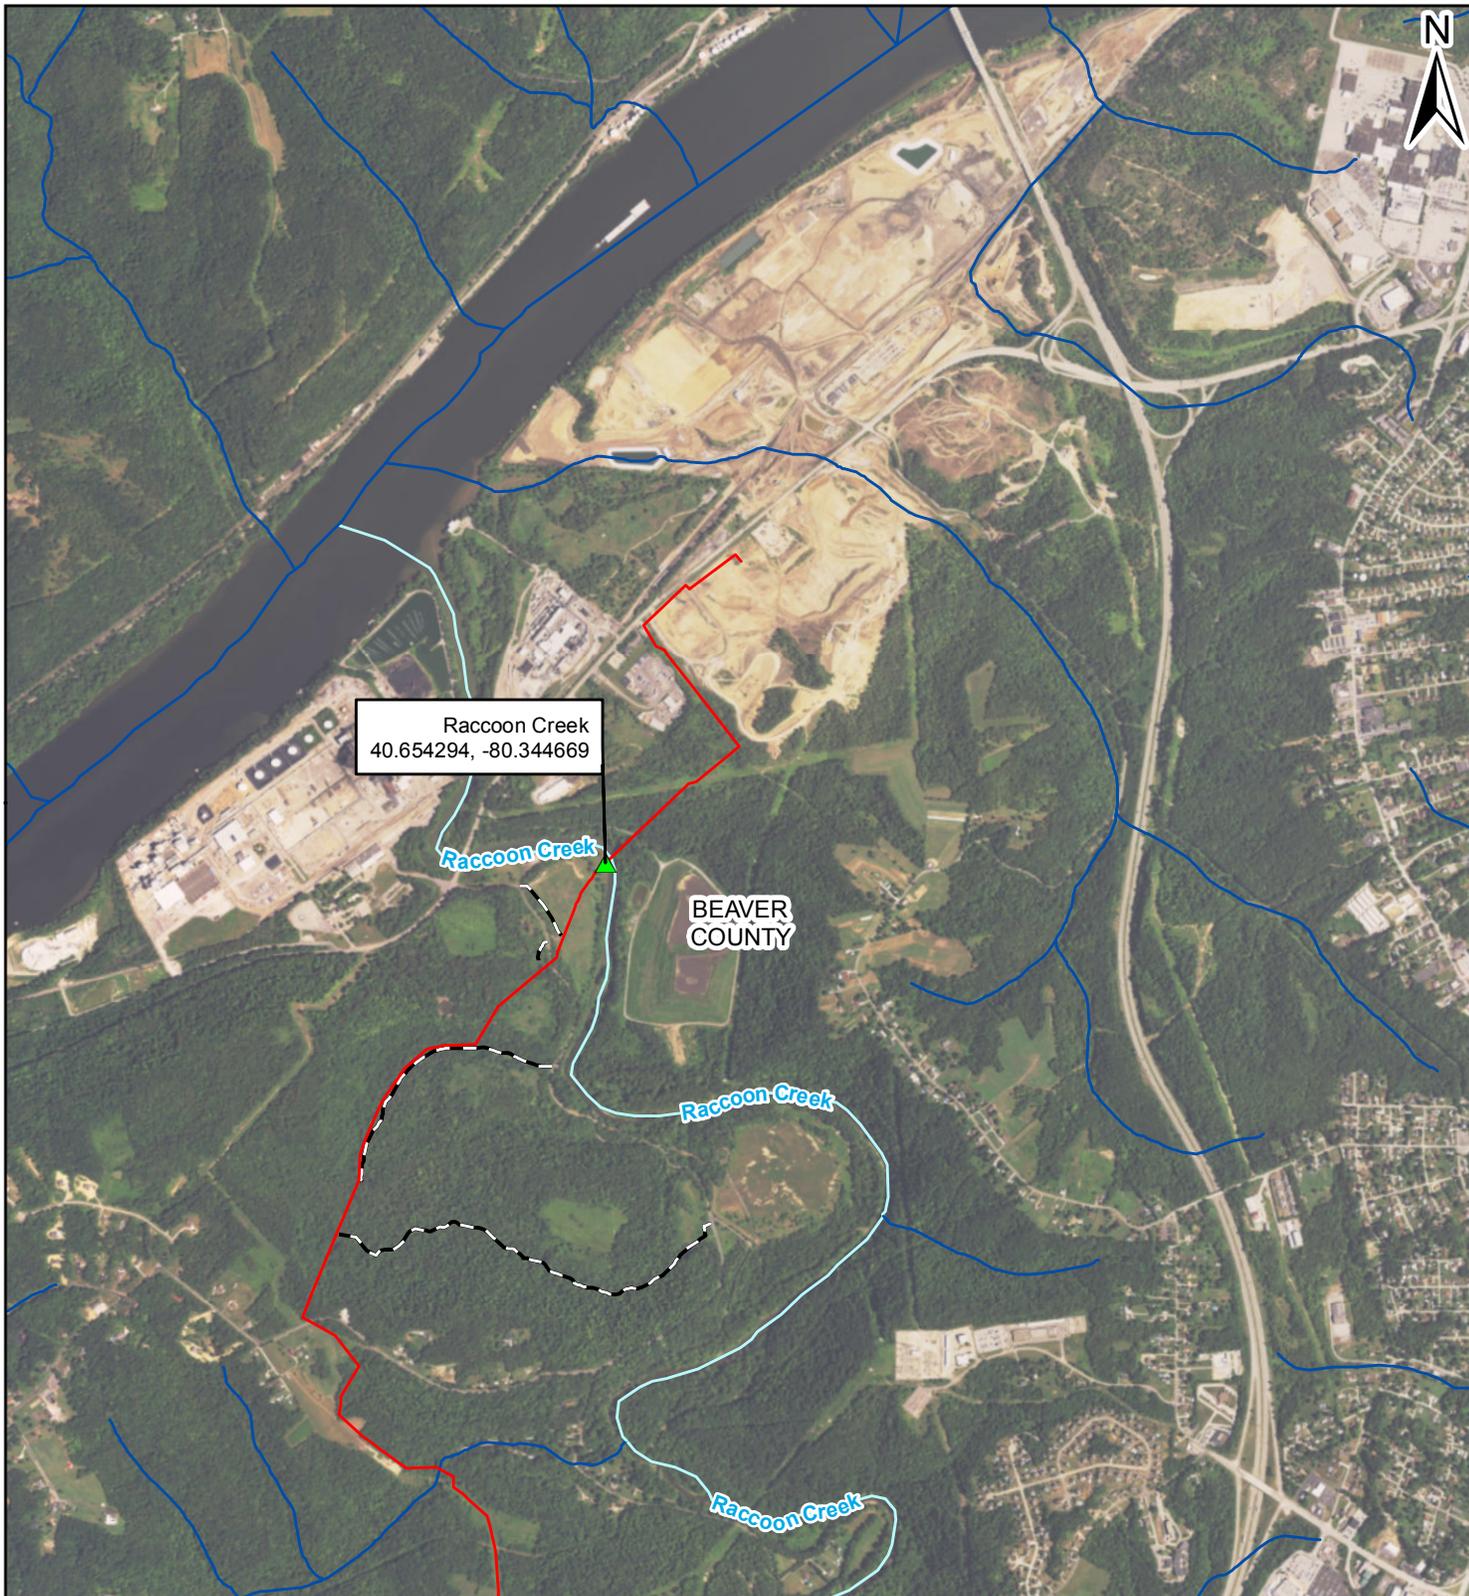
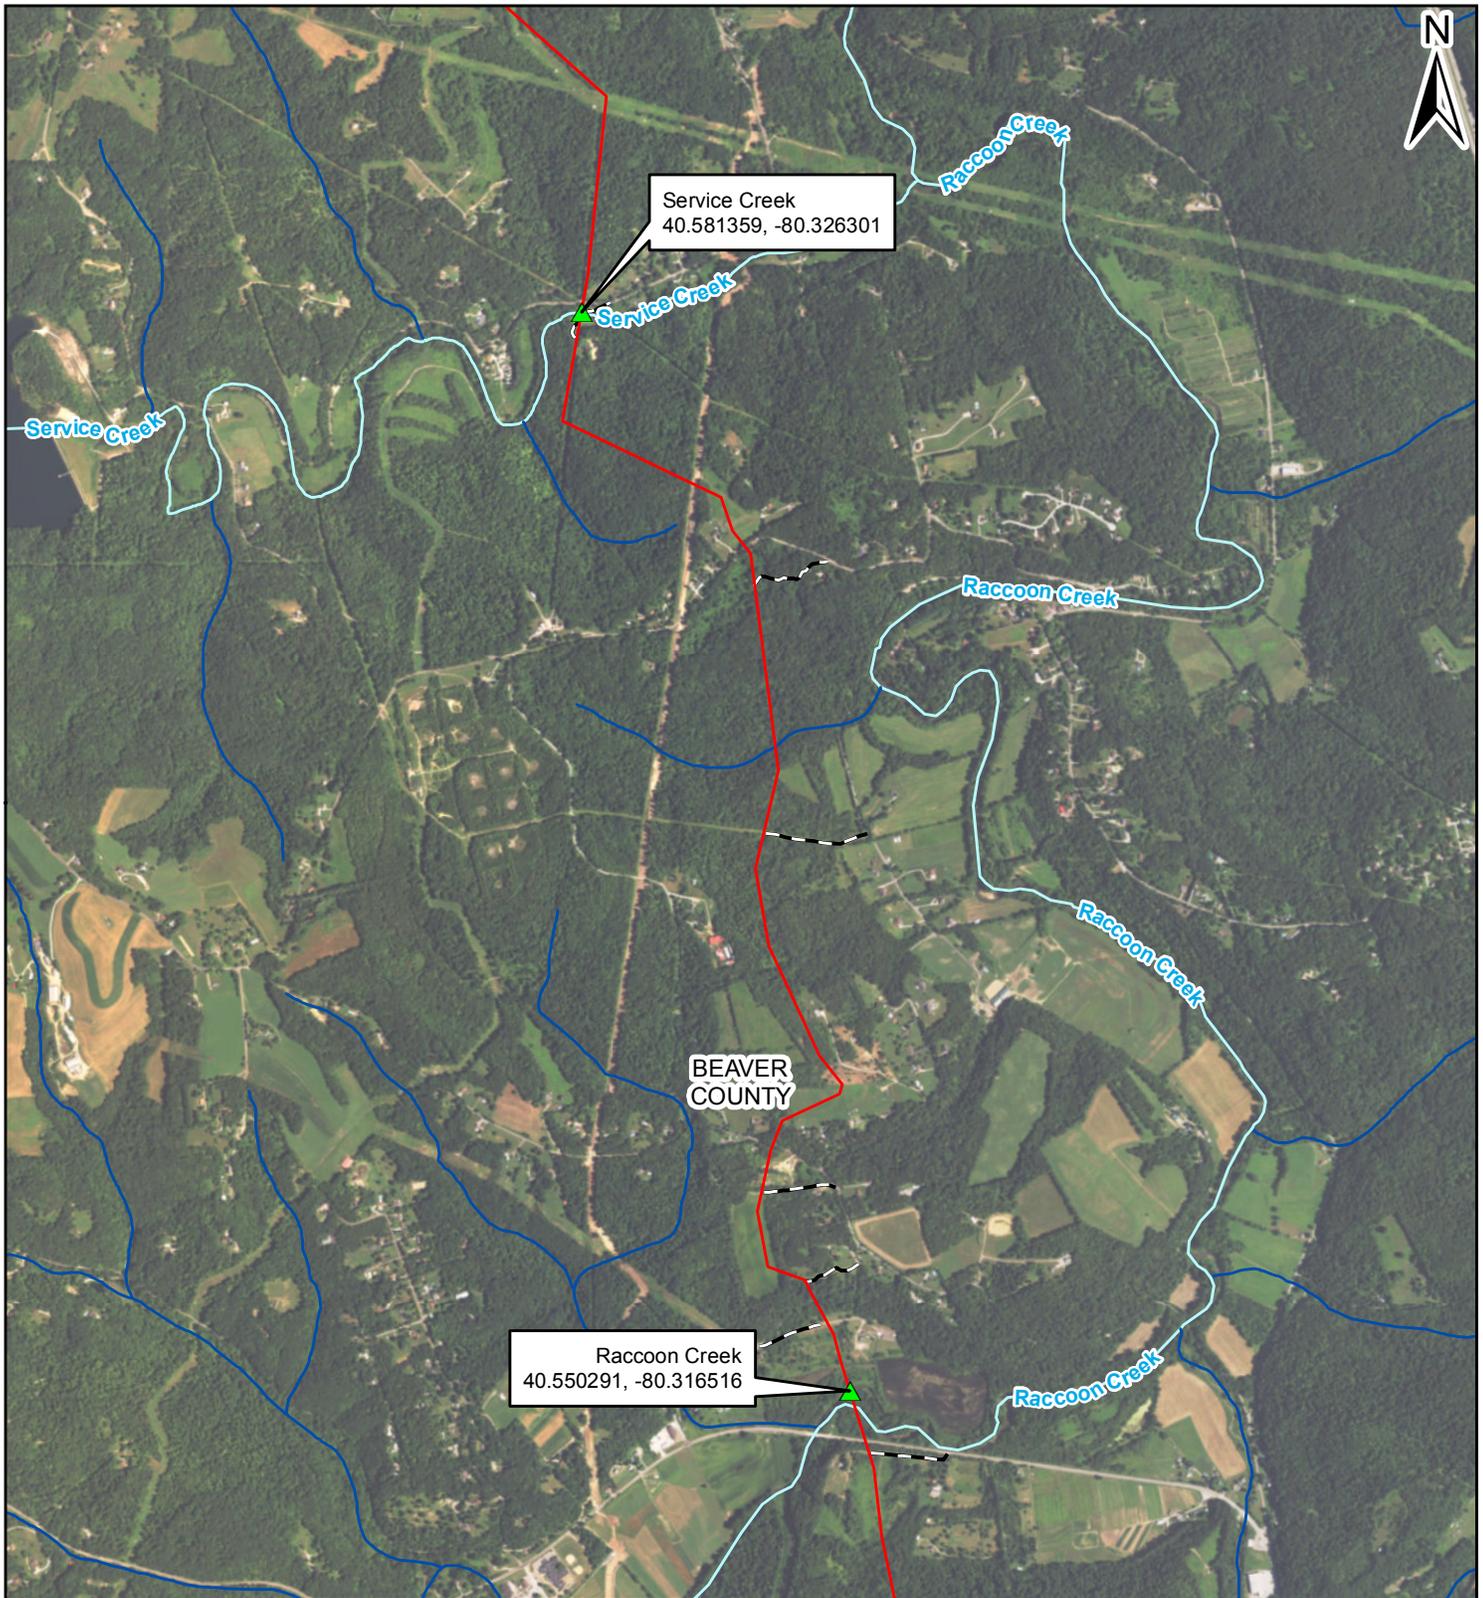
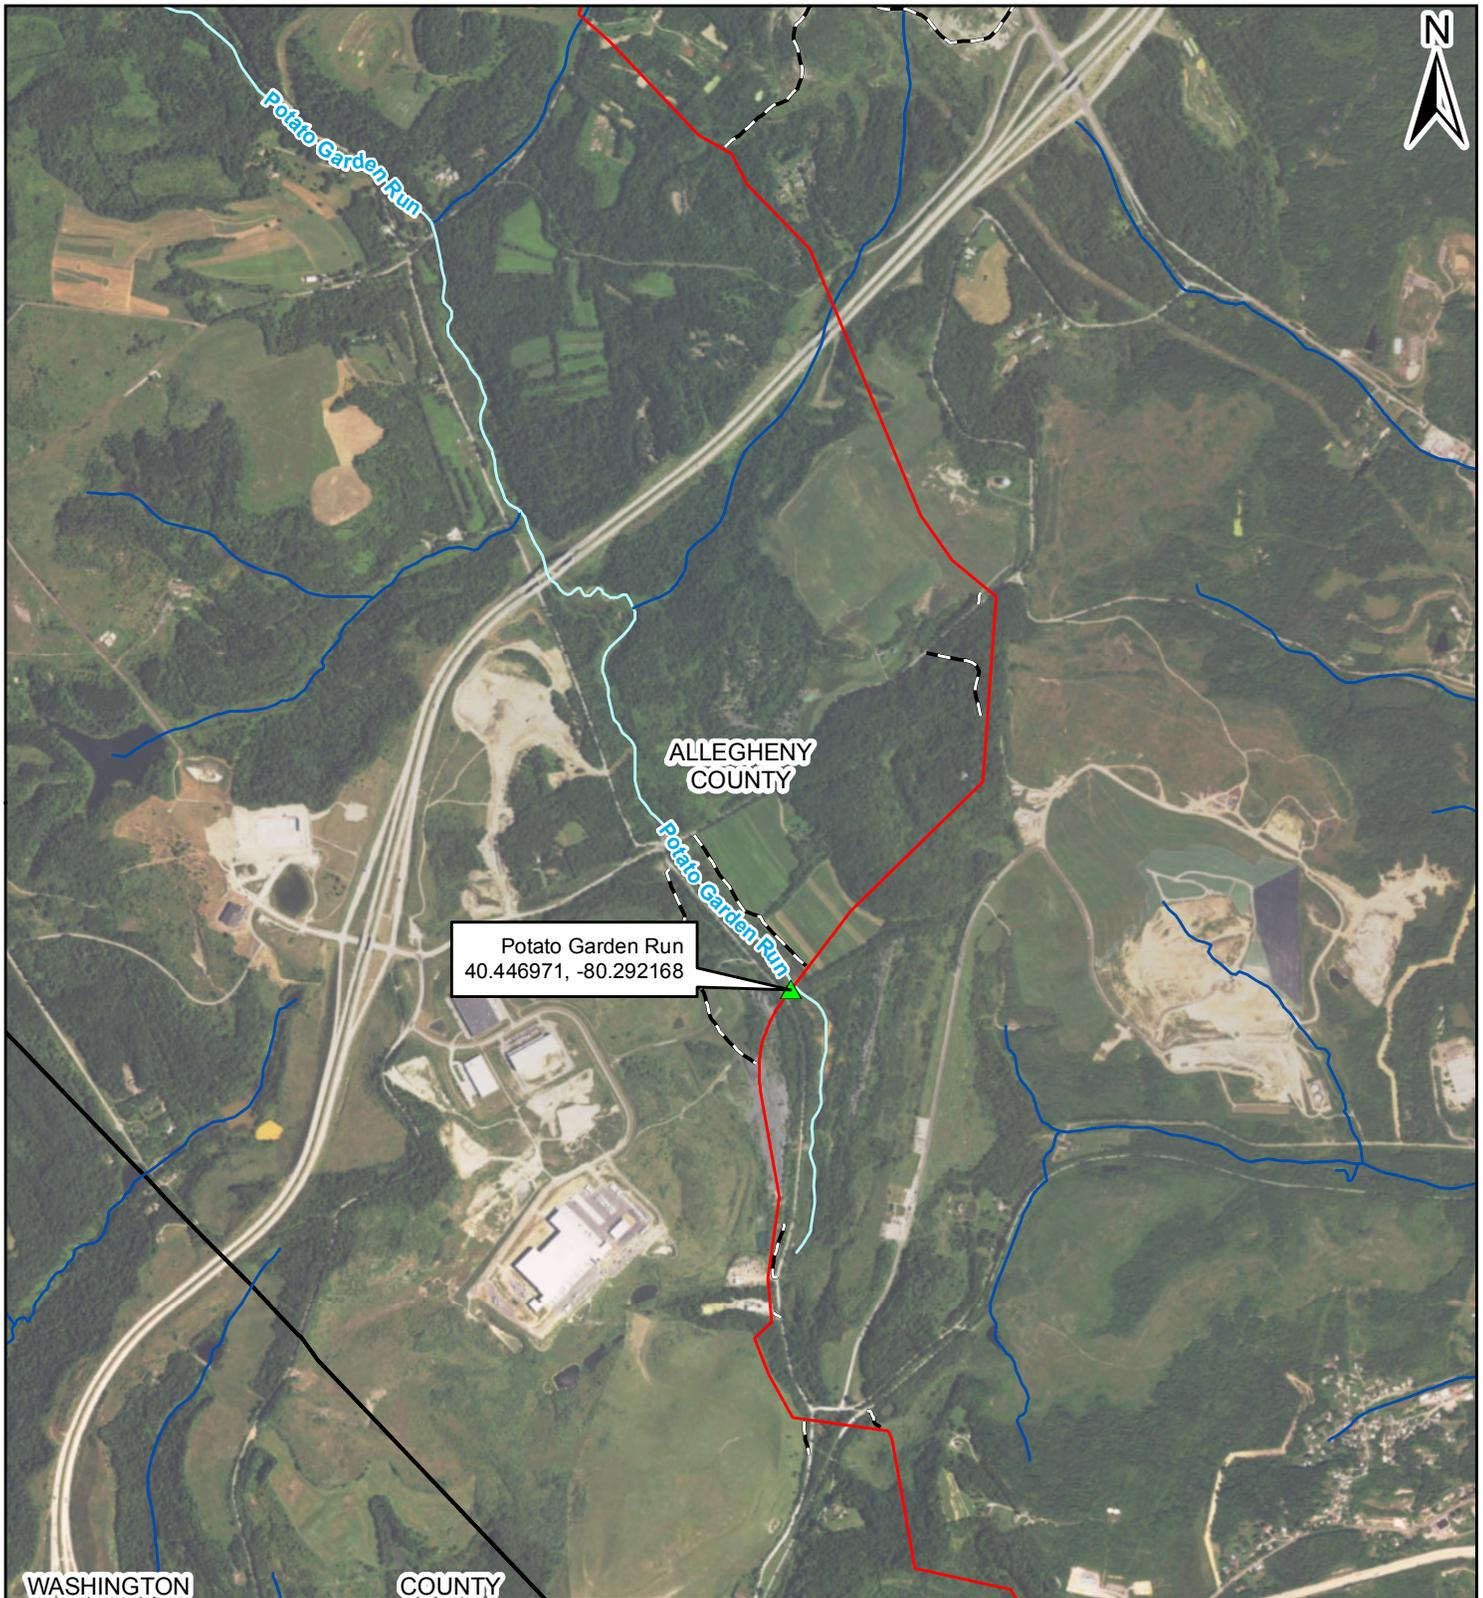
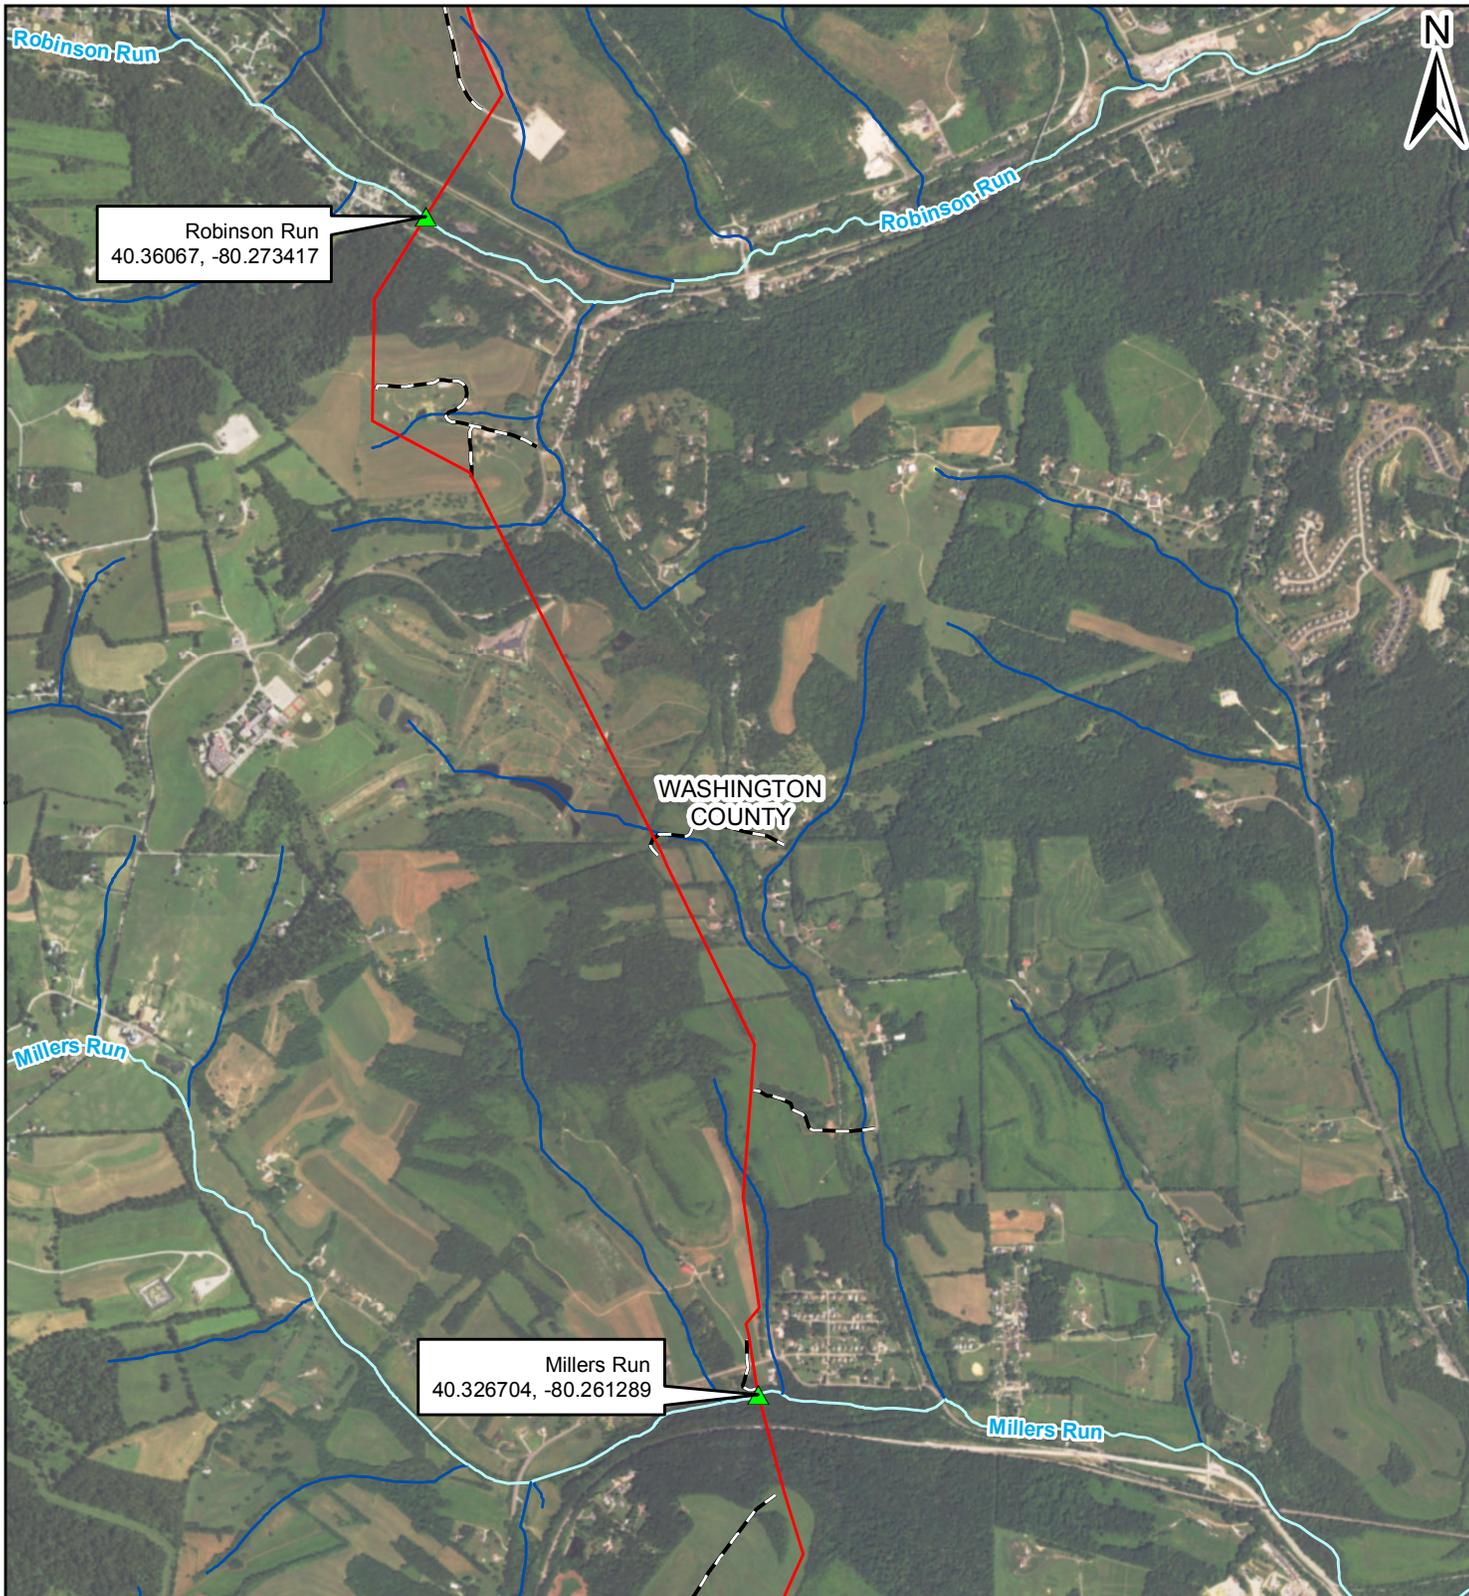
FIGURE 2

Prior to field efforts, a desktop review of the proposed pipeline route as of April 28, 2016 was conducted to identify each perennial stream and its drainage area (DA) at the proposed pipeline crossing location. Habitat assessments were performed for a total of seven crossing locations in Pennsylvania in the following streams: Mill Creek, Service Creek, Raccoon Creek (2 sites), Potato Garden Run, Robinson Run, and Millers Run. Each crossing location evaluated as part of this habitat assessment is depicted on Figure 1 – Mussel Stream Overview. The pipeline crossing locations of these six streams are presented in Figure 2 – Mussel Stream Crossings.

**MUSSEL STREAM CROSSINGS
PENNSYLVANIA**

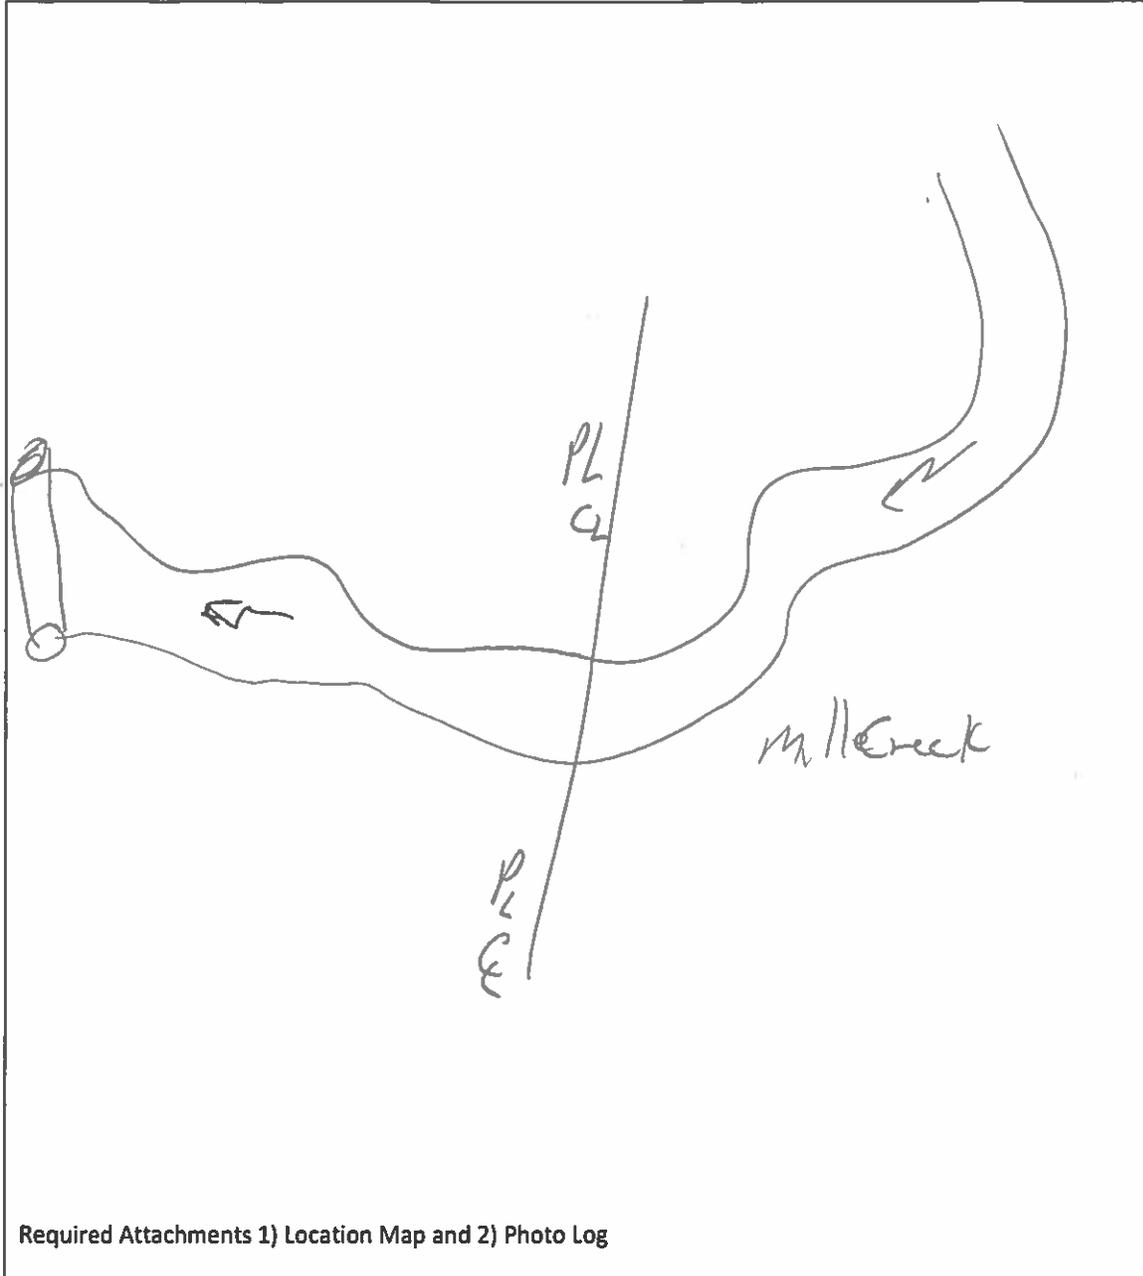
Mill Creek
5/23/14

None - Resurvey under better visibility and habitat and sphaeriidae observed

Sphaeridia
Abundant

No live mussels or shells observed

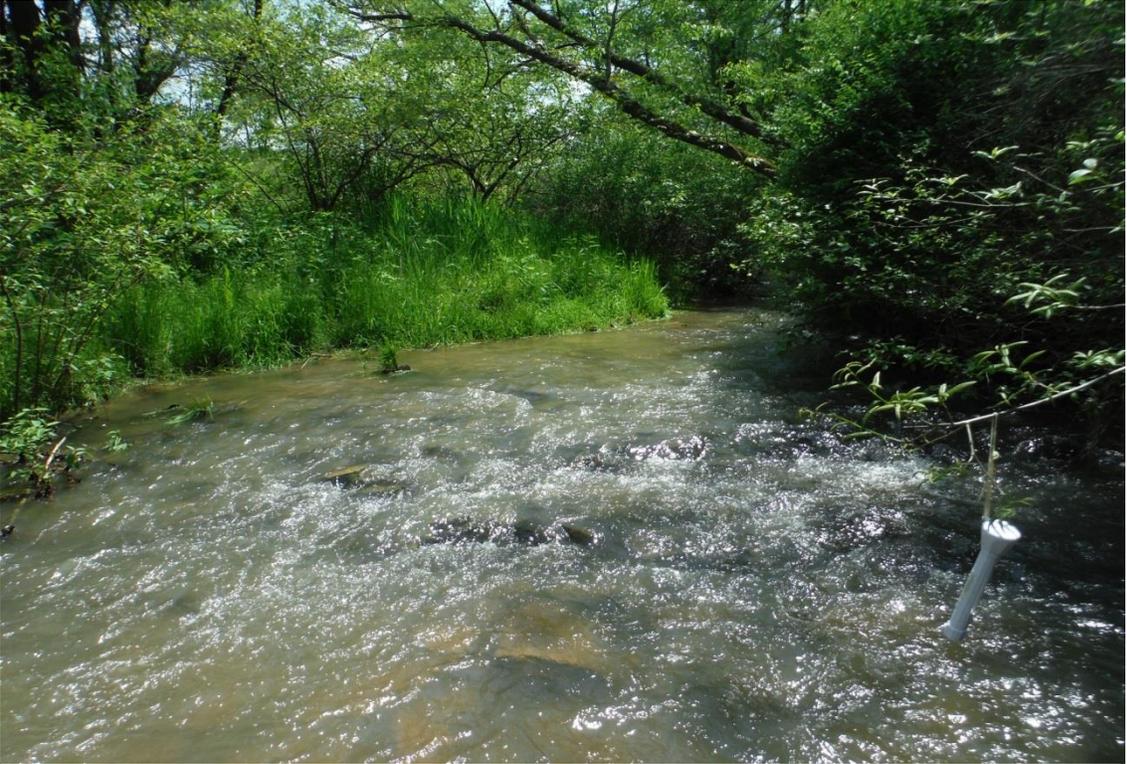
Client Name: Shell Pipeline Company, LP Falcon Ethane Pipeline Project		Site Location: Mill Creek and Service Creek, Beaver County, PA	Project No. 60487539
Photo No. 1	Date: 5/24/16

Direction Photo Taken: East			
Description: Mill Creek facing upstream at the proposed approximate pipeline crossing location

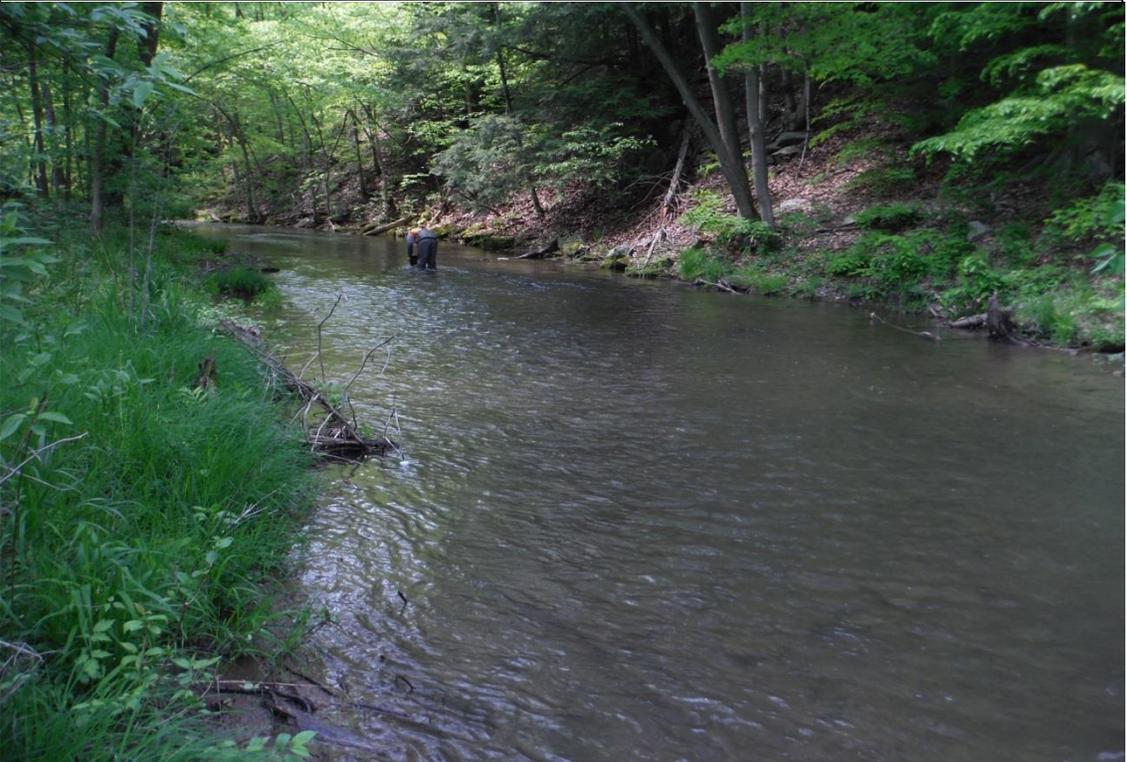
Photo No. 2	Date: 5/24/16

Direction Photo Taken: South			
Description: Service Creek facing upstream

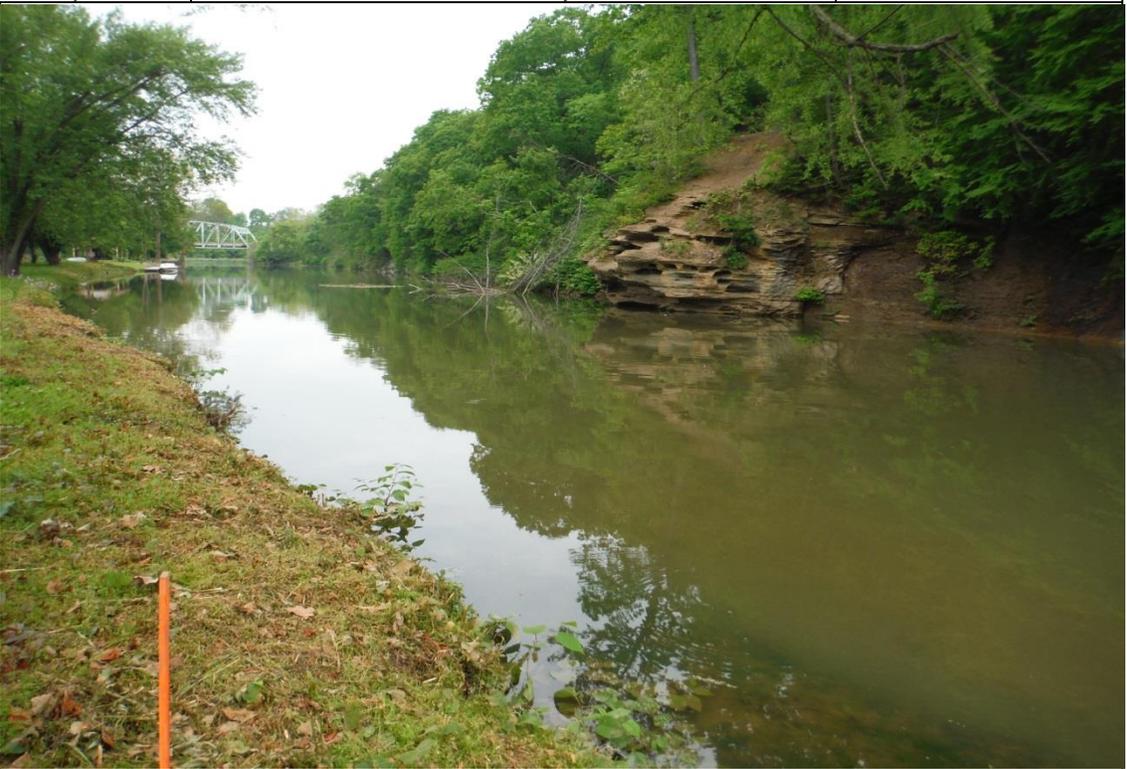
Client Name: Shell Pipeline Company, LP Falcon Ethane Pipeline Project		Site Location: Raccoon Creek, Beaver County, PA	Project No. 60487539
Photo No. 3	Date: 5/26/16

Direction Photo Taken: South			
Description: Raccoon Creek facing upstream at the proposed approximate downstream pipeline crossing location

Results from the habitat reconnaissance indicate the presence of bivalves at Raccoon Creek due to the proximity to the Ohio River and live detections at the upstream crossing location. Both locations are currently proposed for Horizontal Directional Drill crossing and no impacts are anticipated as a result of these crossings. No evidence of unionids was observed at Mill Creek, Service Creek, Potato Garden Run, Robinson Run, or Millers Run. Should direct surface impacts to the stream channel be necessary at the Raccoon Creek proposed pipeline crossing locations additional survey and coordination may be required.

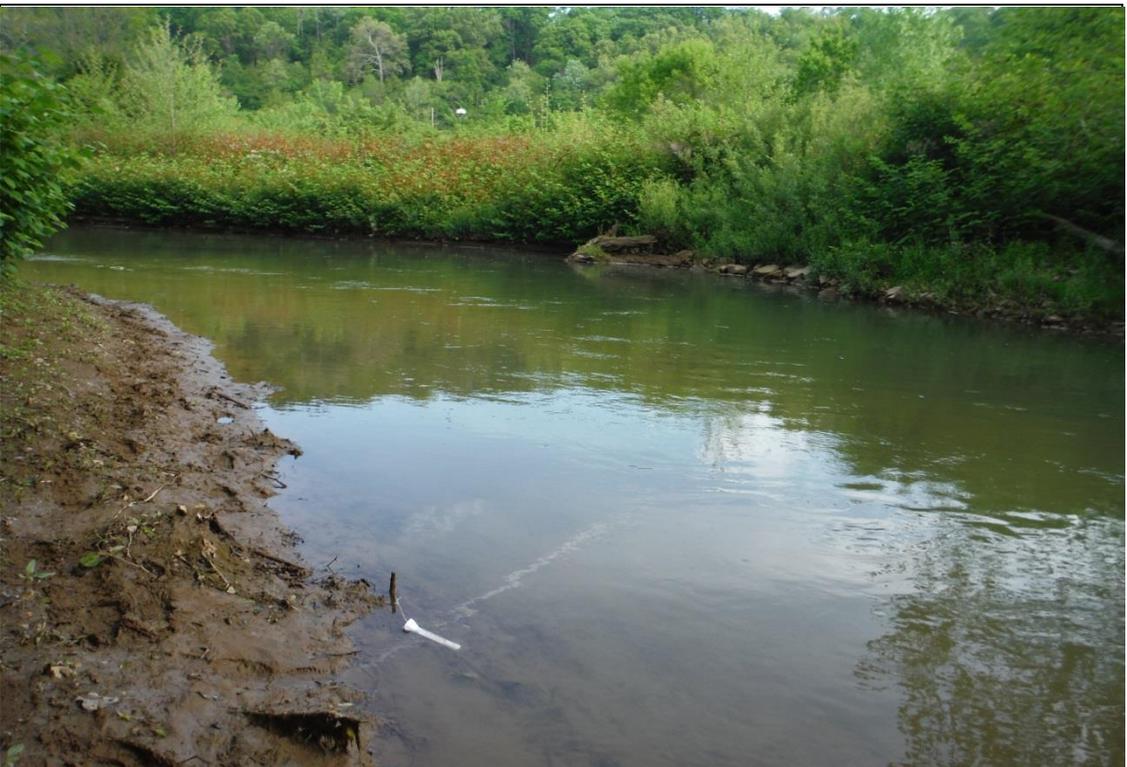
Photo No. 4	Date: 5/26/16

Direction Photo Taken: North			
Description: Raccoon Creek facing upstream at the proposed approximate pipeline crossing location

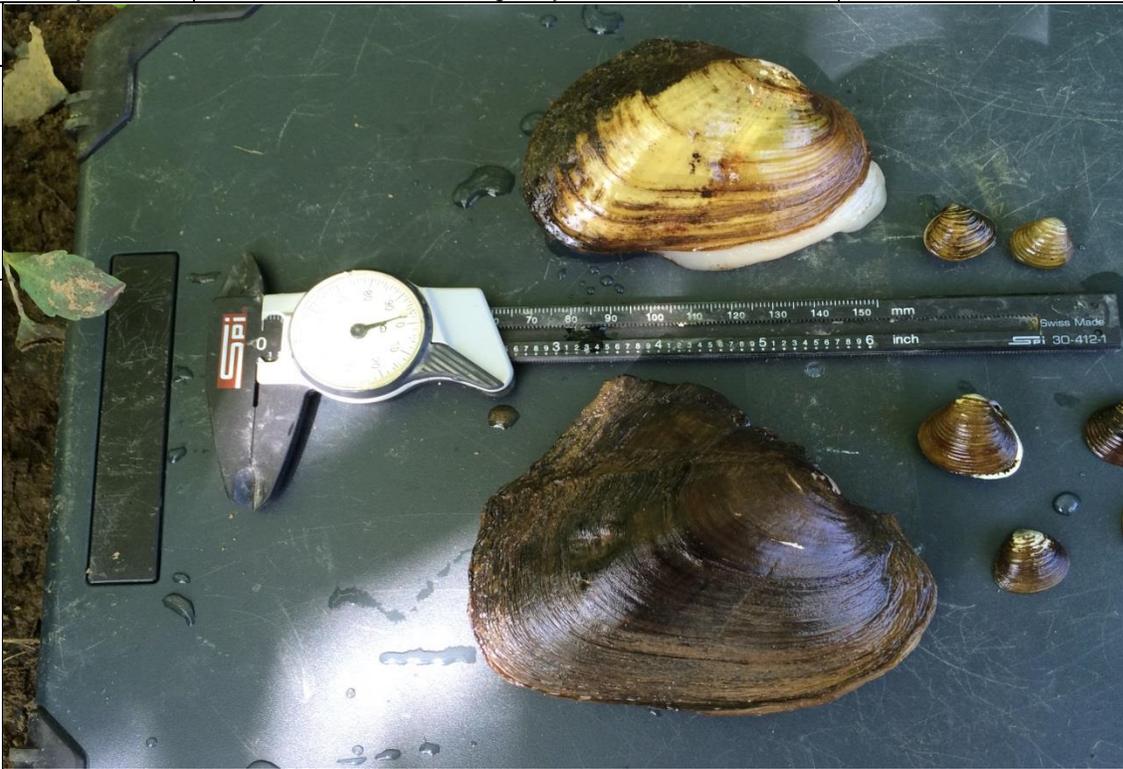
Live *Leptodea fragilis* and *Potamilus alatus* observed in the vicinity the proposed approximate upstream pipeline crossing location on Raccoon Creek.

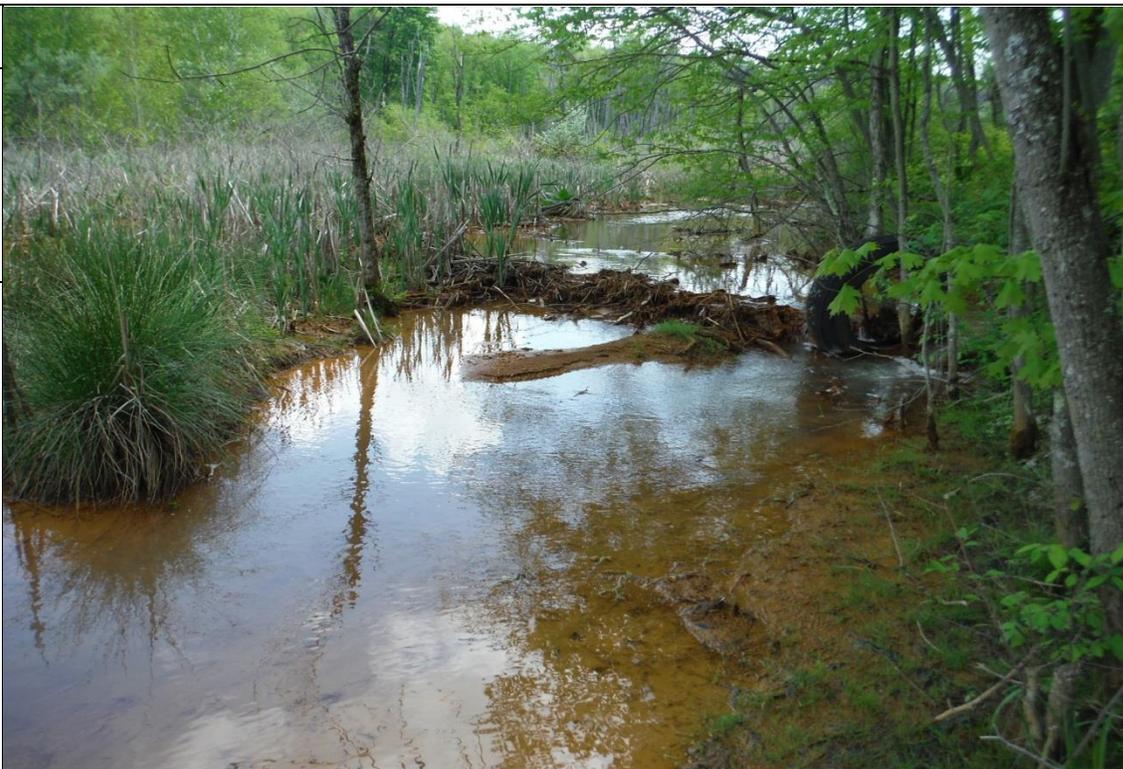
Photo No. 6	Date: 5/23/16
Direction Photo Taken: East

Potato Garden Run facing upstream and acid mine drainage effects

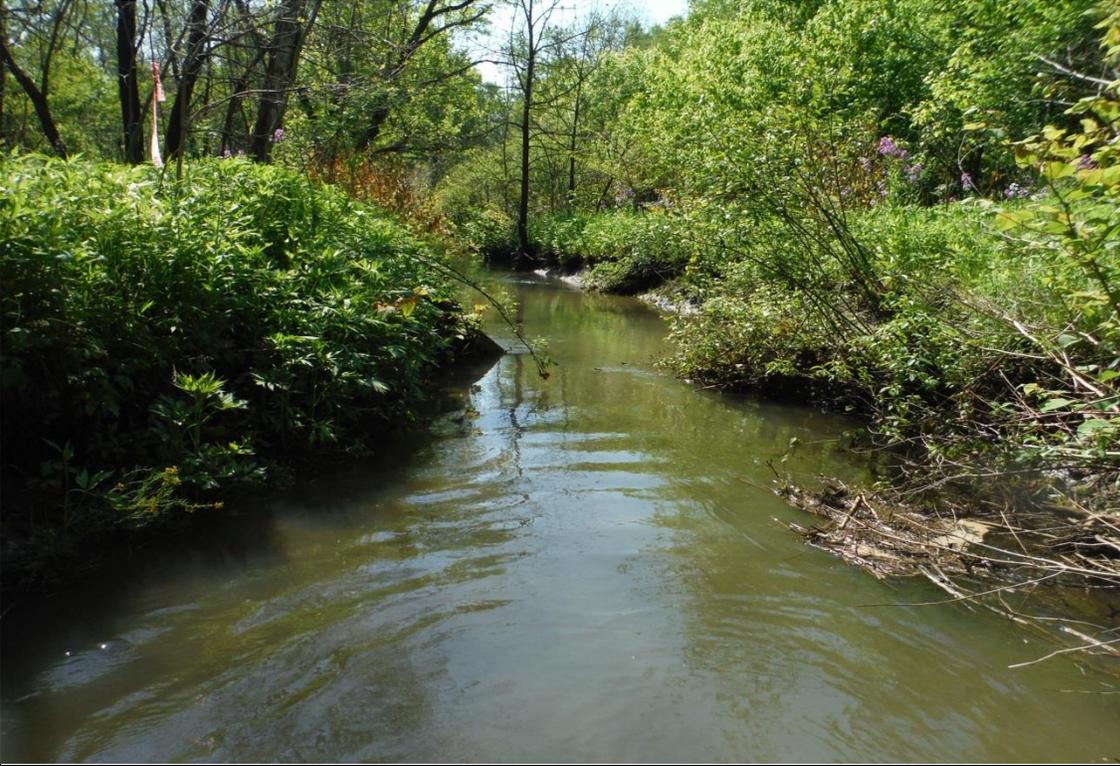
Client Name: Shell Pipeline Company, LP Falcon Ethane Pipeline Project		Site Location: Robinson Run and Millers Run, Washington County, PA	Project No. 60487539
Photo No. 7	Date: 5/23/16

Direction Photo Taken: North			
Description: Robinson Run facing upstream
