**Re: Mussel Habitat Assessment Report
Falcon Ethane Pipeline Project
Shell Pipeline Company, LP
Beaver, Allegheny, and Washington Counties, Pennsylvania USFWS Project # 2015-1047**

SHELL PIPELINE COMPANY, LP FALCON ETHANE PIPELINE PROJECT

Freshwater Mussel (Unionid) Habitat Assessment

RE: Freshwater Mussel Habitat Assessment
Shell Pipeline Company, LP
Falcon Ethane Pipeline Project
Multiple Streams
Allegheny, Beaver, and Washington Counties, Pennsylvania

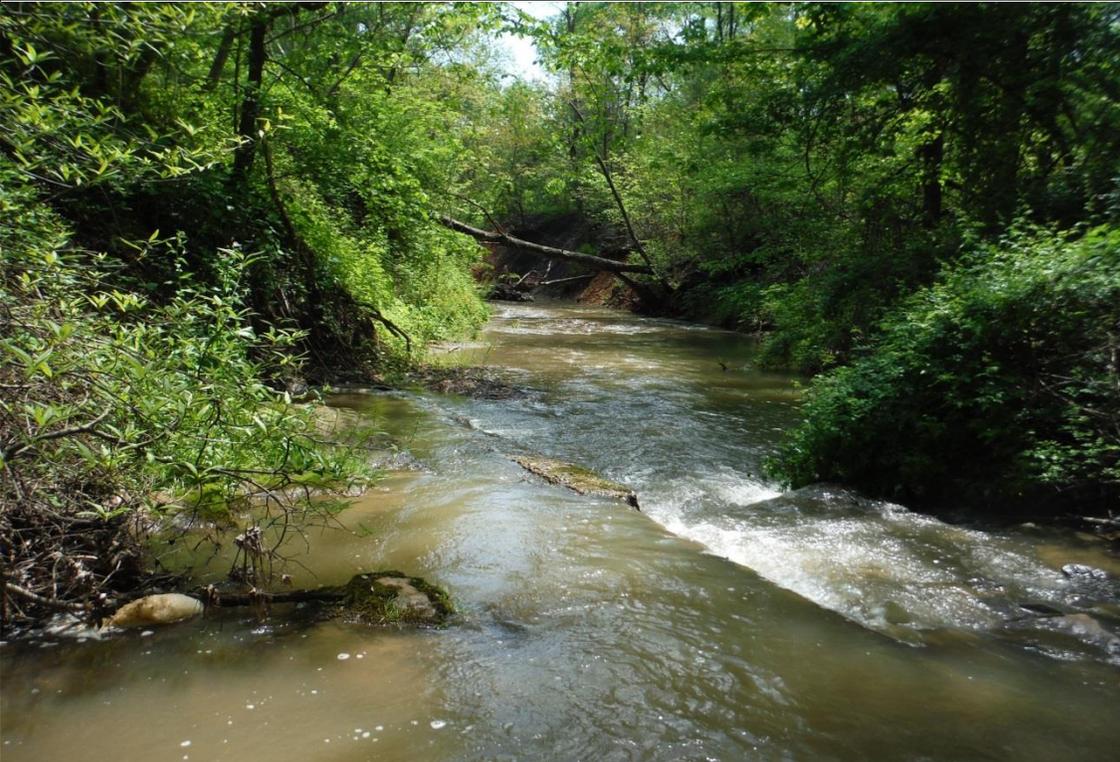
Photo No. 8	Date: 5/23/16

Direction Photo Taken: East			
Description: Millers Run facing downstream
