ENHANCED TECHNICAL ASSISTANCE EVALUATION

Jackson Center Borough Wastewater Treatment Plant

Jackson Center Borough, Mercer County

NPDES #PA0103331

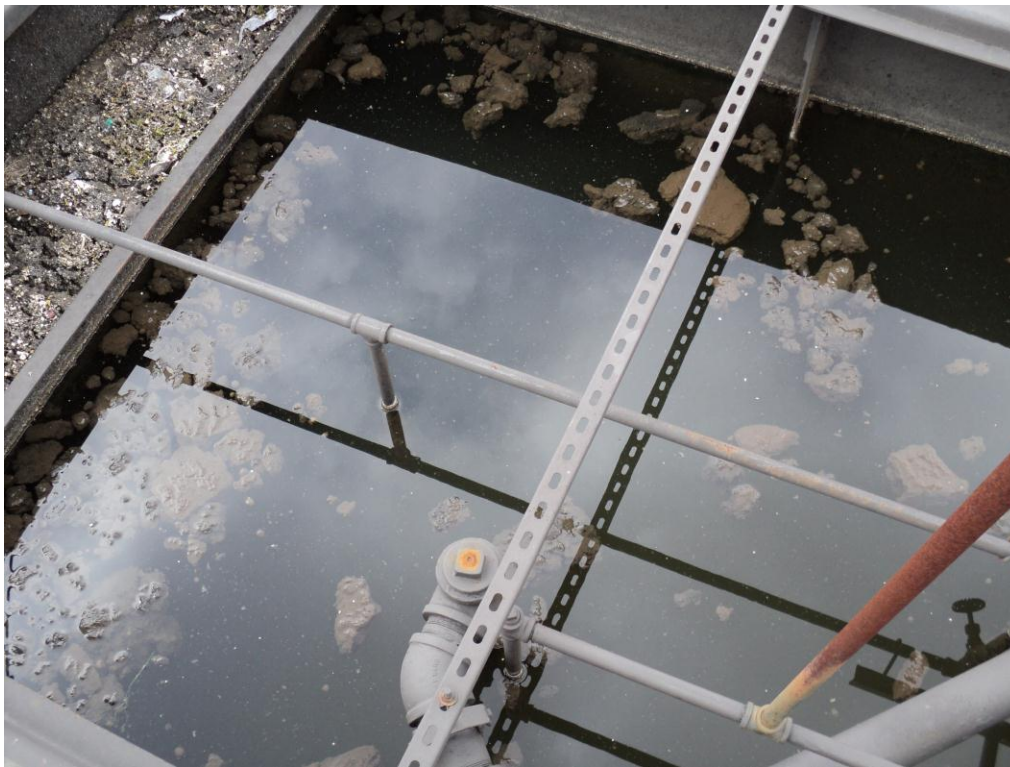
2. The sludge wasting frequency from the domestic sewage train should be increased to prevent denitrification and rising chunks of solids. This should significantly aide in reducing the volume of solids discharged to the chlorine contact tank and the receiving stream Generally, the sewage sludge is "wasted" from the sewage clarifier to the aeration tank of the industrial plant as seed sludge on a weekly basis. As shown in Figure 1 above, it appears that weekly wasting of sludge is not adequate. This frequency would not be typical at a traditional wastewater plant and appears to not be very effective here either. More frequent wasting should reduce denitrification in the clarifier which appears to be causing the excess sludge rising to the surface. Excess nitrate trapped in the sludge converts to nitrogen gas while sitting in the clarifier with no oxygen and rises with the sludge to the surface. This will lead to excess solids discharged in the effluent. On several occasions the clarifier was covered with sludge which is attributed to the infrequent wasting. See Figure 1 below.

Figure 1: Photo of clarifier for the domestic sewage plant.

8. One of the skimmers nearest the influent end of the sewage clarifier appears to be out of operation as evidenced by missing piping for the airlift portion of a skimmer. A skimmer in this location would assist in removing the floating solids as pictured above. Increasing or adjusting the return activated sludge rates may also help to reduce this situation.

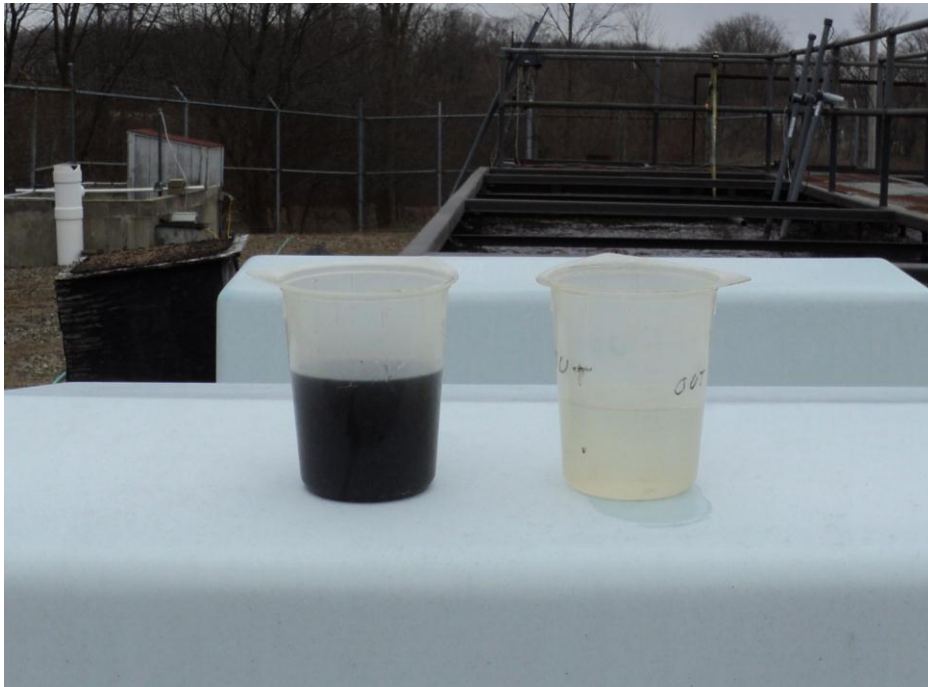
The domestic sewage train had an appearance typical of a wastewater plant, while the industrial treatment plant train had a dark colored influent which carried through to the effluent as seen in the Figure 2.

Figure 2: Industrial waste treatment plant effluent on the left and sewage treatment plant effluent on the right.

More frequent feeding of healthy biomass to the industrial side of the plant should provide that train with more active and healthy biomass in turn improving the industrial waste (IW) train performance. Several microscopic evaluations of the IW train mixed liquor revealed nearly no active protozoa.

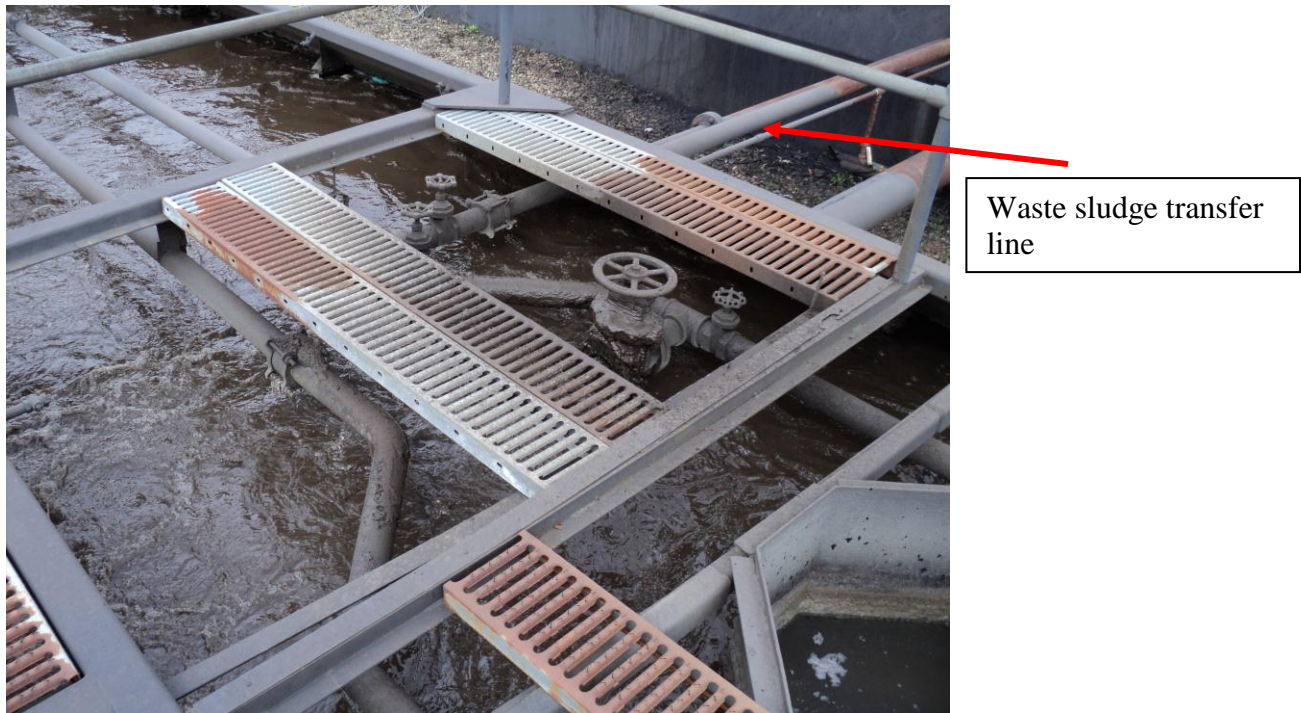
There are several areas in the wastewater plants with leaking air lines, broken or cracked waste lines, and grating that is thoroughly rusted; the safety of the grating is questionable at best.

Figure 4: The waste sludge transfer line to move domestic waste sludge to the industrial side aeration tank.

3. There are many air leaks and pipe leaks throughout the facility that should be repaired.
4. Much of the grating is rusted and its safety/stability is questionable.

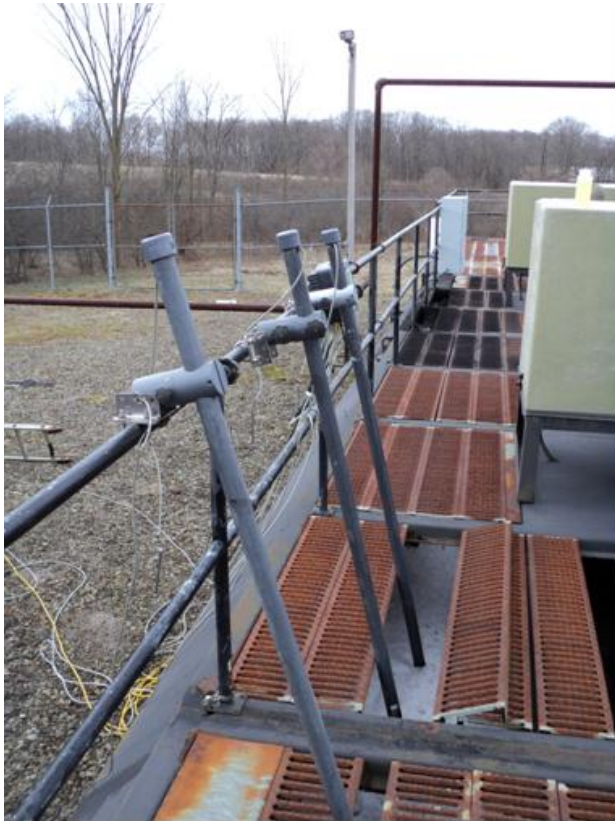
Figure B.1: Photo showing example of online monitoring equipment installed on the industrial train. Much of the grating throughout the facility is heavily rusted similar to that shown in the picture.
