**WASTEWATER TREATMENT EVALUATION**  
**CAMPBELLTOWN EAST STP**  
SOUTH LONDONDERRY TOWNSHIP, LEBANON COUNTY, PA  
NPDES #PA0087700

AUGUST-SEPTEMBER 2015

## **Executive Summary**

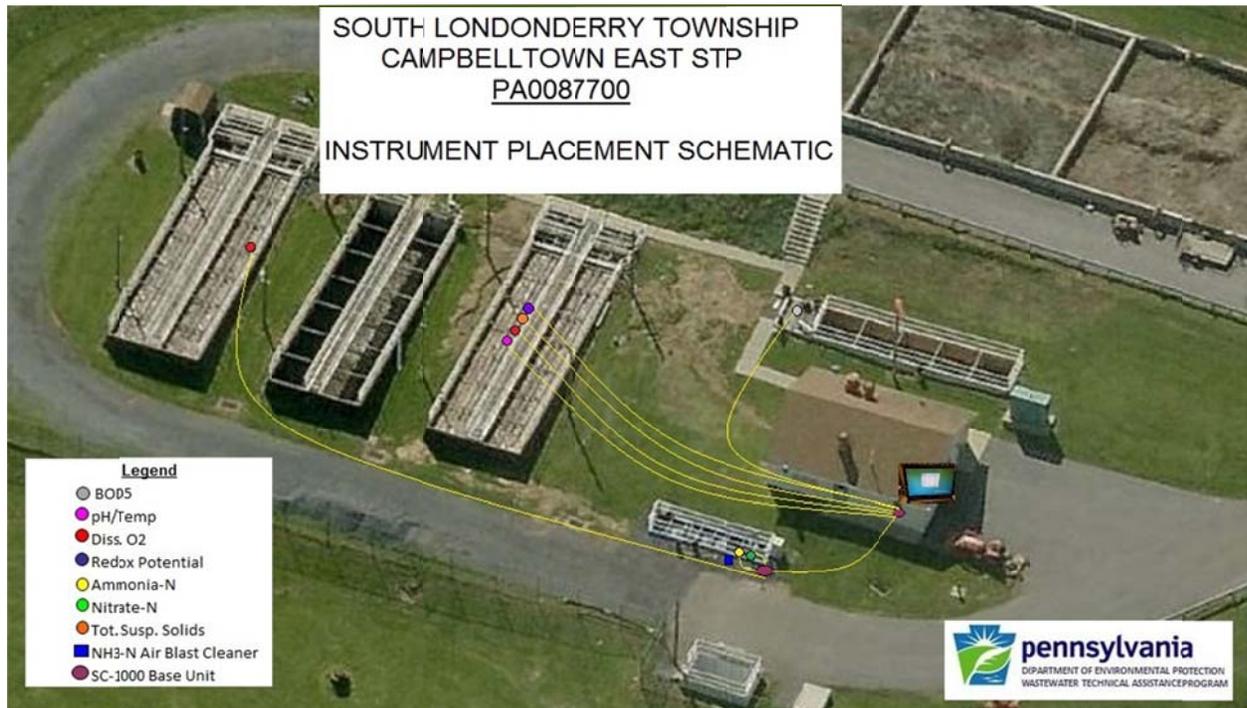
## ATTACHMENT 2: EQUIPMENT PLACEMENT SCHEMATIC

This illustration shows the probe placement for the evaluation. Train 1 had probes for:

- pH / Temperature
- Dissolved Oxygen
- Oxidation / Reduction Potential
- Total Suspended Solids

Train 2 had a DO probe; the Influent Splitter Box had a BOD/UVAS probe; and the discharge end of the Chlorine Contact Tank (baffled for ultrasonic flowmeter) had probes for:

- Ammonium-nitrogen
- Nitrate-nitrogen

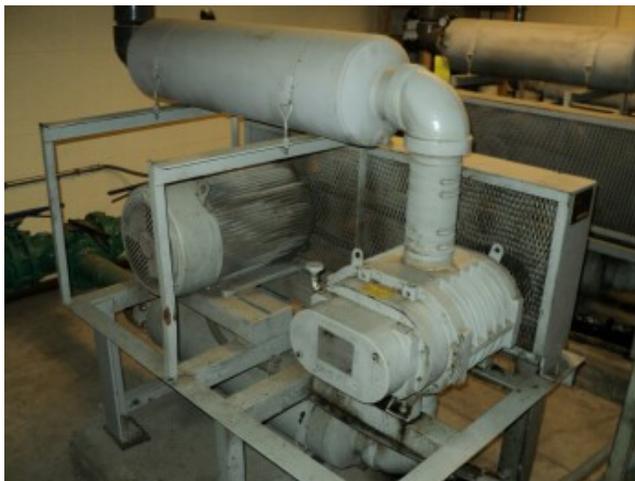
A preliminary record of the existing motors was made using a Fluke Power Logger that was connected to one of two blower motors for a period of thirty days. The purpose was to set a baseline against which future improvements could be compared. The figure at right shows the general power consumption for the blower motor as 12.8 kW with a power factor of 0.789, which is typical.

Power			
2015-07-30, 13:28			
L123	12.8 <sub>tot</sub>	16.2 <sub>tot</sub>	0.789 <sub>tot</sub>
	kW	kVA	PF
L1	4.2	5.4	0.787
L2	4.3	5.4	0.788
L3	4.3	5.4	0.793

An evaluation of the existing blower motor showed that it consumed approximately 130 kW/day for continuous aeration on a 24/7/265 basis. The facility has four positive displacement (PD) blowers dating from original construction. The blowers are considered “hard start” and have significant initial amp draw when starting. This precluded DEP from attempting intermittent aeration for BNR. However, at other facilities, DEP has found that a general thirty percent (30%) reduction of electrical consumption is achieved when the aeration system is run intermittently to achieve denitrification. A simple calculation of reduced power consumption by this blower motor shows that at use 70% of the day, the 60 hp motor would consume:

- 91.3 kW/day for 16 hr., 48 min. per day for intermittent aeration, 38.7 kW/day reduction over continuous operation.
- If electrical cost is seven cents per kilowatt-hour, there would be a \$2.71 per day savings that equates to \$988.79 savings per year, one blower operating.

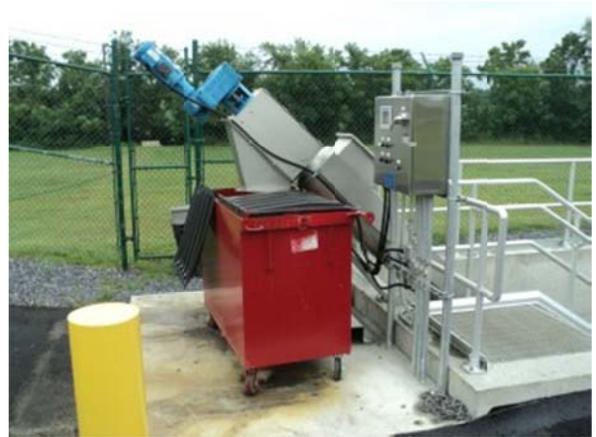
New Fine-screening Facility

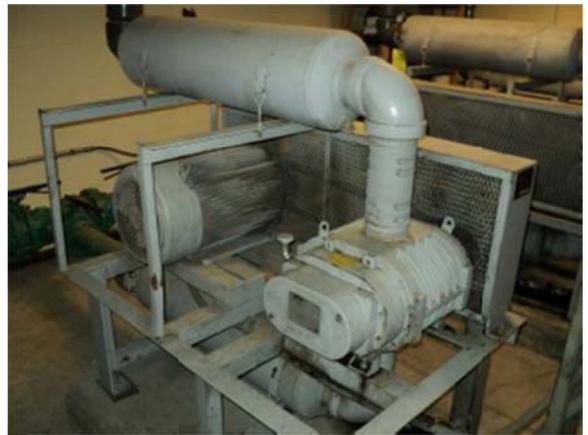
PD Blower with 60 h.p. Motor

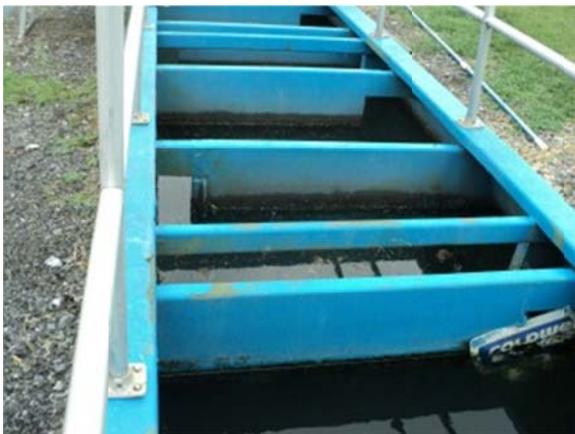
Chlorine Contact Tank w/ solids baffle
