A Successful HSCA Funded Cleanup:

Yuhas Dump Site

Pocono Township, Monroe County, PA

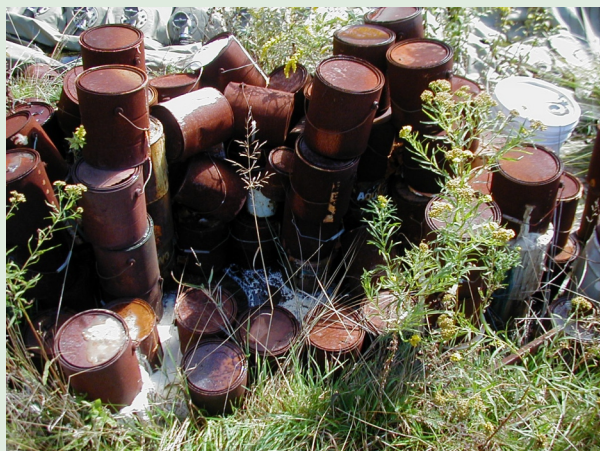
Containerized waste before cleanup

For Phase I, completed in October 2008, DEP conducted a Prompt Interim Response to characterize, transport and properly dispose of the abandoned containerized wastes and hazardous substances located on the former Yuhas property. The hazardous and non-hazardous waste materials identified at the Yuhas Dump Site, were consolidated, containerized, characterized and properly disposed of at permitted facilities. The accumulated waste included fifty-five (55) drums using overpacks; eighteen (18) cubic yard boxes; one (1) 30-gallon overpack; five (5) 5-gallon buckets and a 20-cubic yard non-hazardous waste roll-off box. Three (3) separate, visually impacted areas of the ground surface were identified, excavated, containerized, characterized, and properly disposed of at a permitted facility. Confirmatory soil sampling was conducted in the remediated areas and the sample results met the residential SHSs. Therefore, no additional soil remediation was recommended or required.

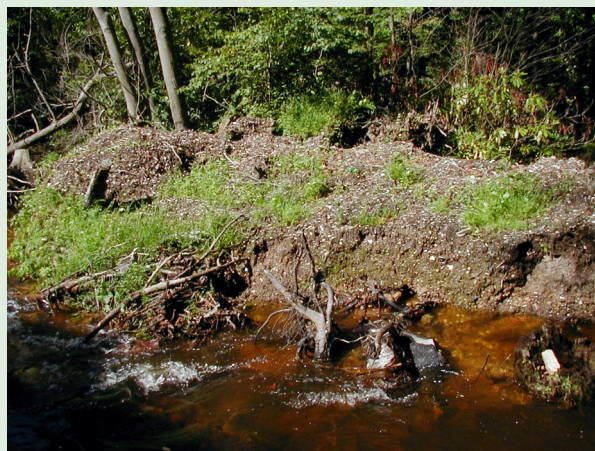
Dry Sawmill Run before cleanup

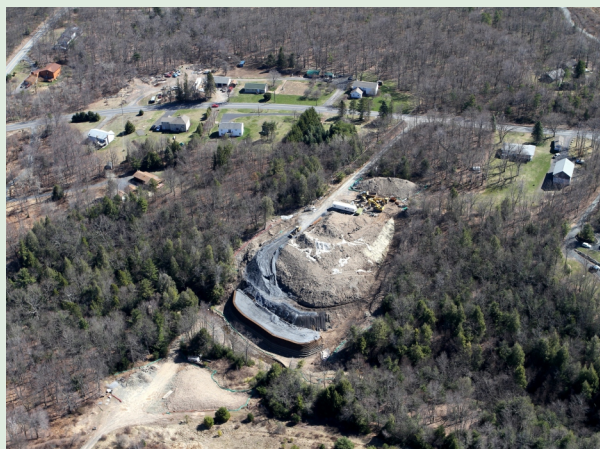
Remaining waste pile stabilization

For Phase II, completed between 2009 and 2016, DEP conducted an Interim Response action on the unpermitted disposal of C&D waste containing hazardous substances and/or contaminants that posed an ongoing threat to public health, safety and the environment. The action included demolition of the house, relocation of a portion of the Dry Sawmill Run away from the toe of the C&D waste pile, stabilization of the waste pile with the construction of a mechanically stabilized earth wall and the grading, covering and vegetation of the waste pile material with permanent post construction storm water controls. The completed action prevents ongoing sloughing of the waste pile and associated hazardous substances into Dry Saw Mill Run. The action protects Dry Saw Mill Run from further degradation caused by the ongoing deposition of waste materials into the stream. The site is now fully vegetated, stable and satisfies the Army Corp of Engineers stream permits. DEP will continue site inspections and periodic operation & maintenance (O&M) activities. DEP will require that institutional controls be implemented to protect the remedy.

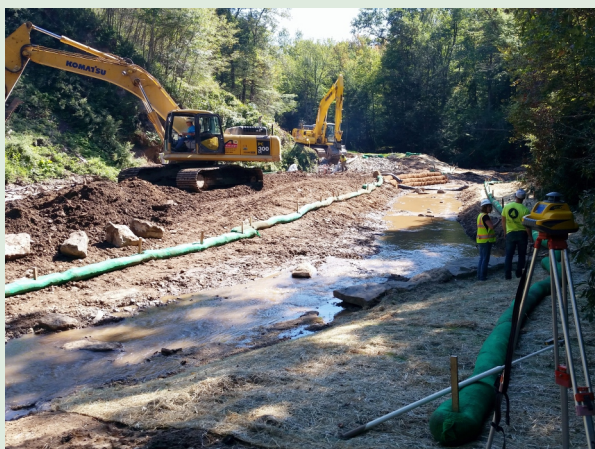
Dry Sawmill Run cleanup

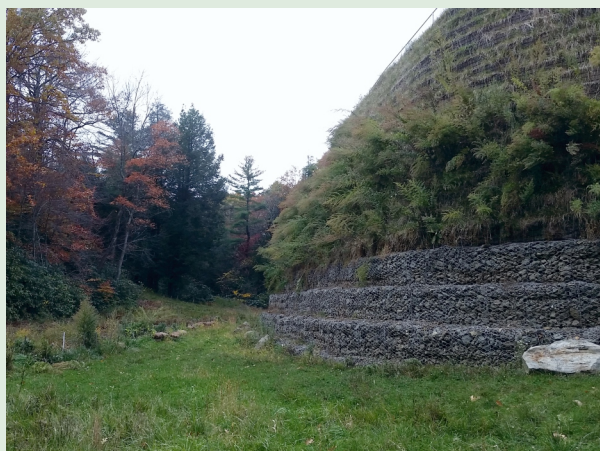
After cleanup and stabilization of the remaining waste pile

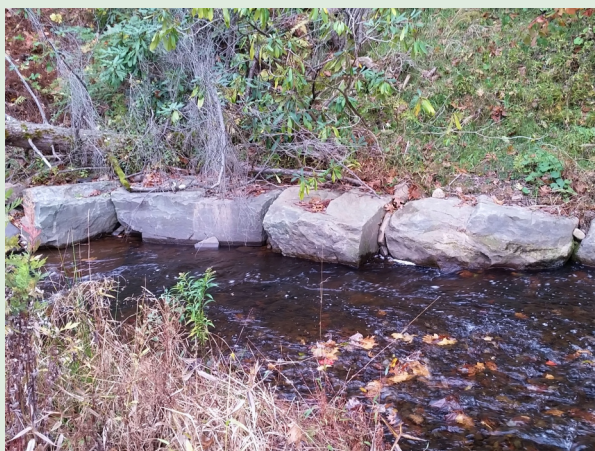
Dry Sawmill Run after relocation
