EASTMONT SWIM CLUB  
Abandoned Mine Reclamation Project  
Contract No. OSM 02(0835)102.1

**EASTMONT SWIM CLUB  
ABANDONED MINE RECLAMATION PROJECT  
CONTRACT NO. OSM 02(0835)102.1**

**FACT SHEET**

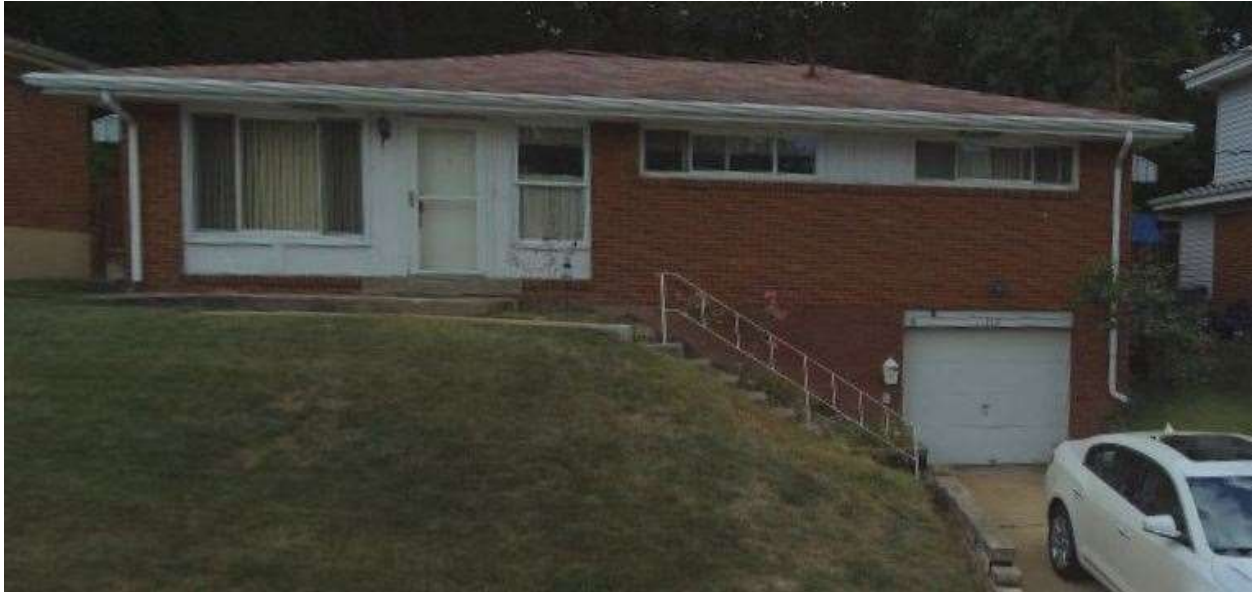
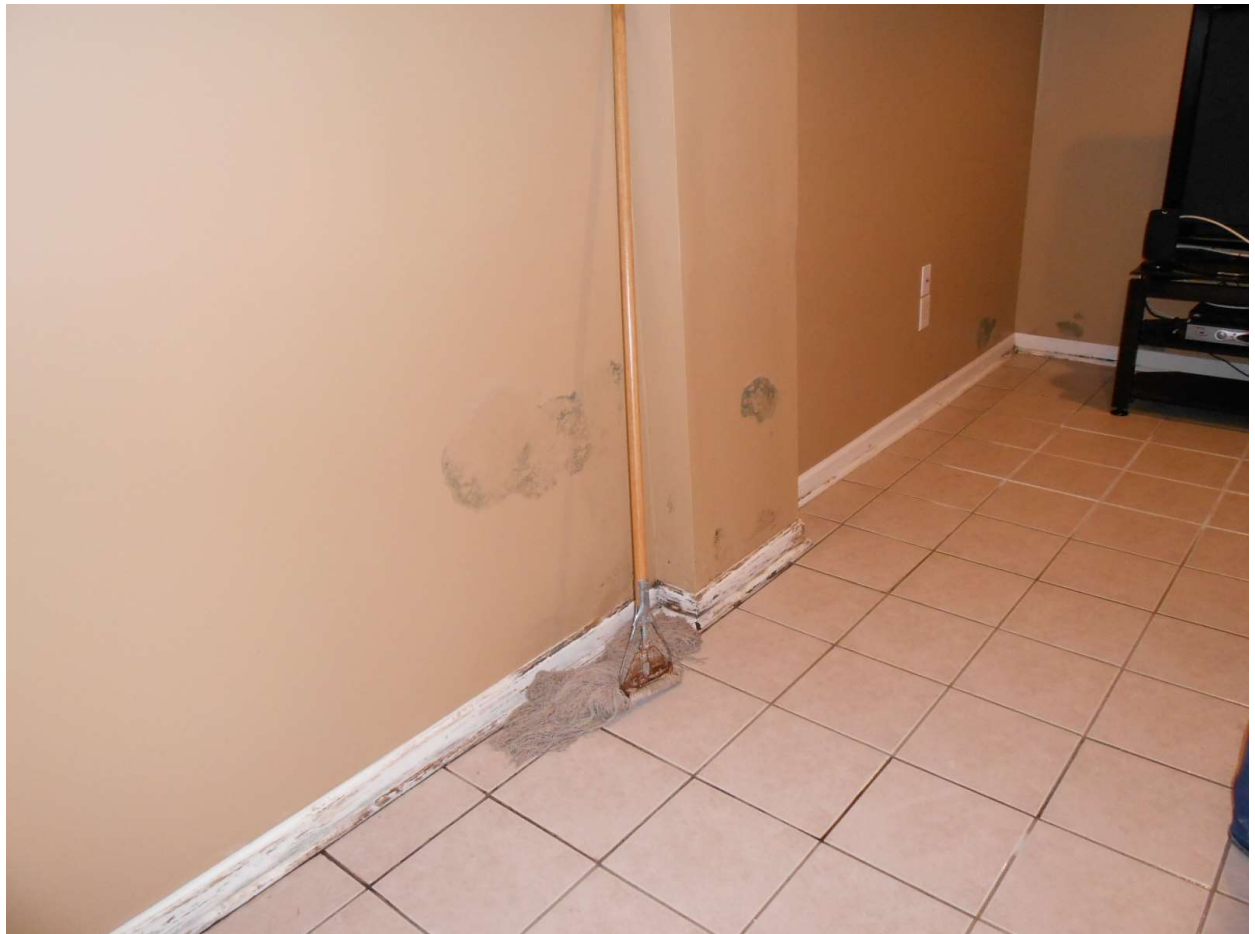
Pre-Construction

**Description:** A dangerous slide condition, adjacent to the basement of the Davis residence, was eliminated. An unstable abandoned mine land (AML) related land mass subgrade adjacent to the home was overly saturated by abandoned mine drainage (AMD) and was impacting the stability of the home's footer and foundation walls. A basement wall/foundation drain system was installed to direct the AMD away from the home and towards an existing storm water system along Gilmore Avenue. A drainage system reduced the public health and safety threat to the Davis residence. Over 60 residential structures are located within 500 feet of the project site, while the Davis residence is located directly adjacent to the dangerous slide. This dangerous AML feature met the Office of Surface Mining
