NEWPORT NORTH PROJECT
OSM 40(2152)101.1

Newport Township
Luzerne County, Pennsylvania

INTRODUCTION

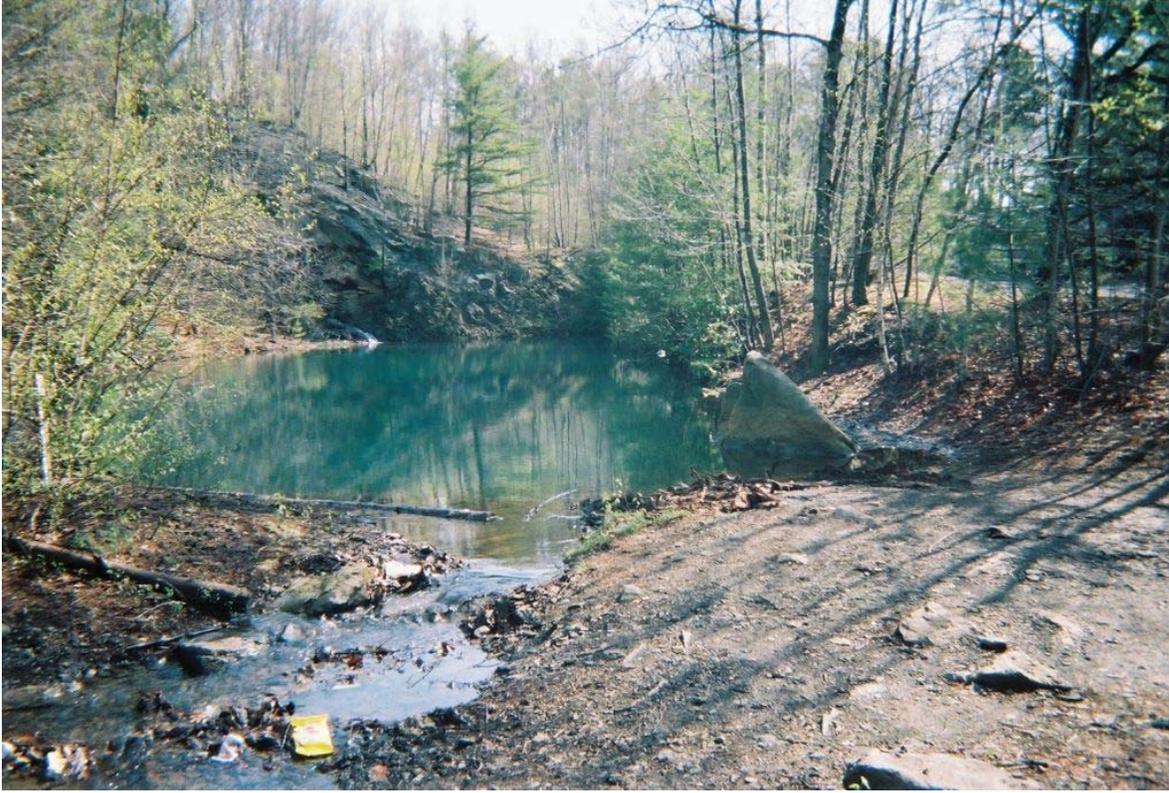
Figure 2: Water-filled pit that was the location of six fatalities.

Just north of this pit was the location of a much smaller pit that measured only about a half-acre in area. This smaller pit was located just off a heavily traveled dirt road that meandered through the woods. The pit had a mine-water discharge at one end that kept it water filled year round. A highwall surrounded the entire pit, except for an area near the outlet of the pond where the terrain was level with a dirt road. These two noted abandoned mine features account for only a fraction of the dangers left from mining that exist in an 1,500 acre area northwest of Nanticoke.

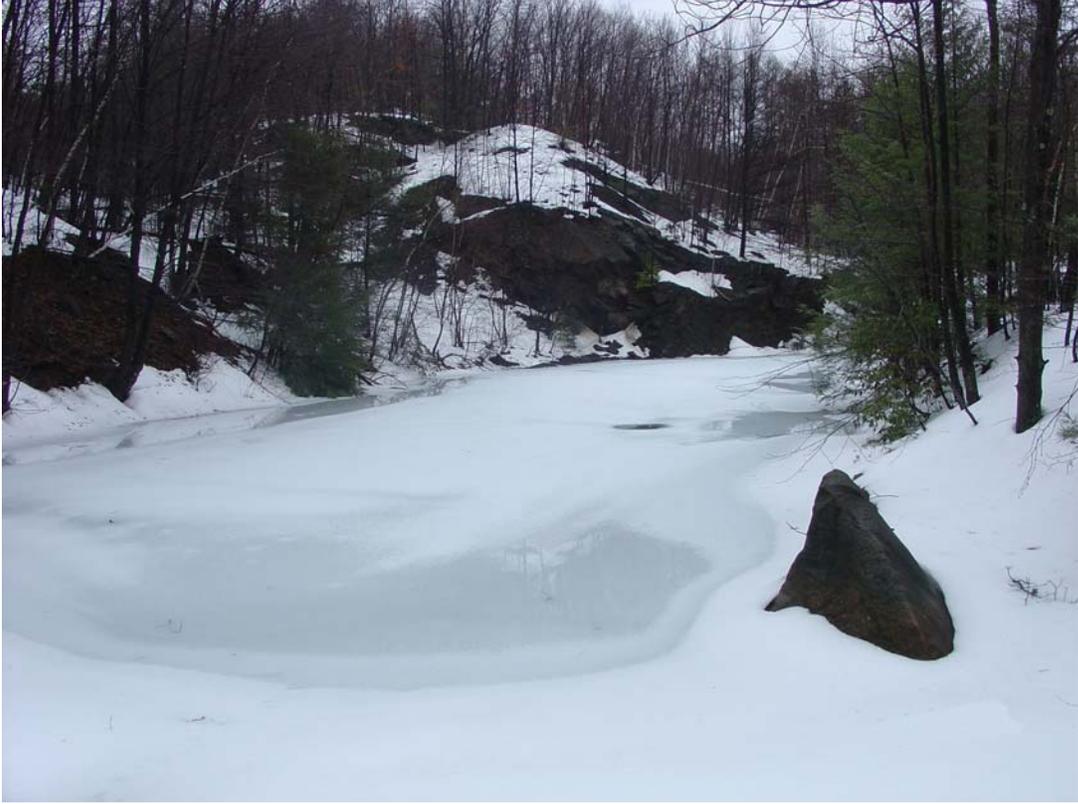
Figure 5: The water-filled pit frozen and snow covered.

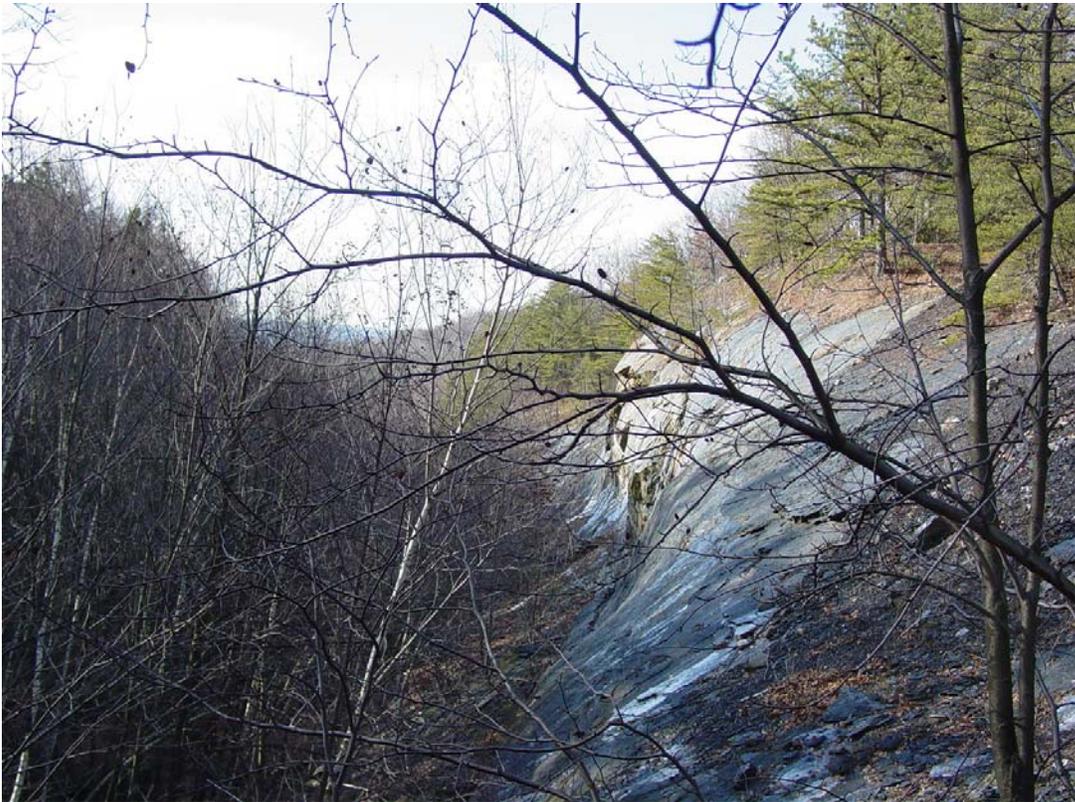
Figure 6: Near-vertical highwall of a stripping pit at the Newport North site.

In the anthracite region, the geology of most coal seams does not lie flat, but rather folds either downward or upward. Because of these folds, the stripping of the coal seams in the anthracite region resulted in huge long pits with steep, sometimes vertical, sidewalls. The pattern of pits and spoil piles are commonplace within the anthracite region. This includes the area where the Newport North project lies. Upon the demise of the region's coal-mining industry, a myriad of hazardous abandoned mine features remained, leaving the local landscape highly degraded. Through SMCRA, a system was developed to prioritize the abandoned mine features according to, among other criteria, the risk they pose to public health and welfare.

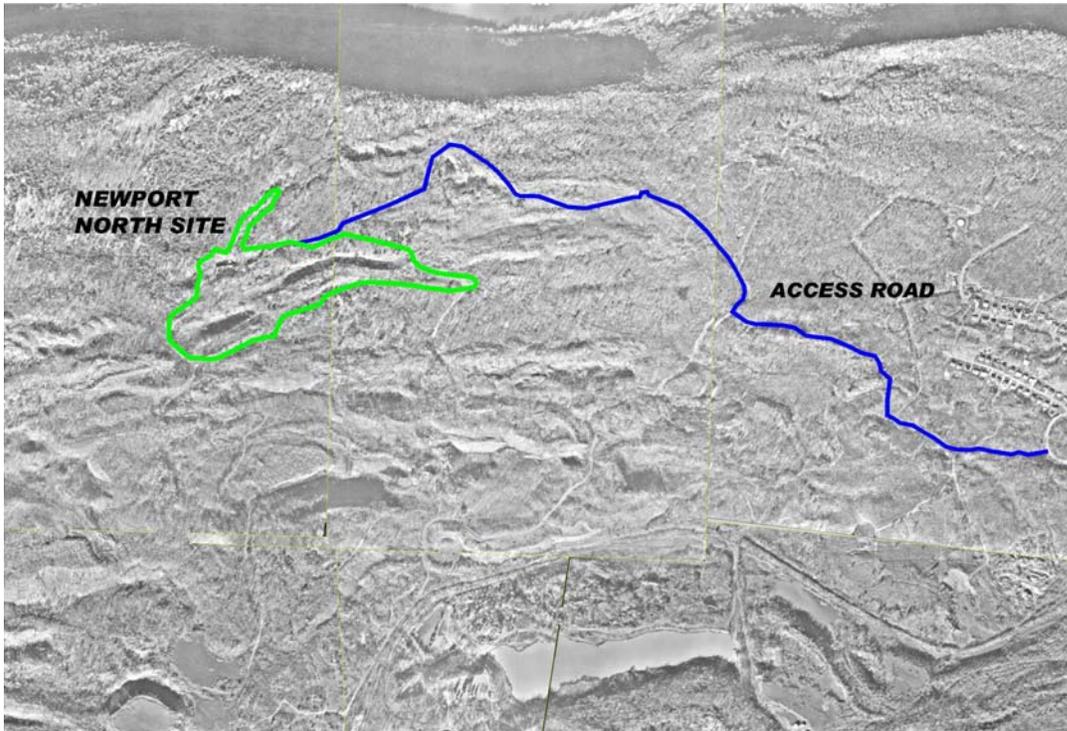
Figure 7: Aerial imagery showing the length of access road, remoteness of site, and the numerous features in the PA 2152 problem area.

The contractor's first task was to widen and upgrade the one and three-quarter (1 ³/₄) miles long access road. The narrow and rough dirt road needed improvement to handle the construction traffic. The contractor greatly improved the access road to minimize the amount of maintenance necessary during the project. Once the installation of the erosion and sedimentation controls and clearing and grubbing were complete, the contractor began the grading. The contractor used a Caterpillar D-11 as its primary earthmover, along with excavators and trucks. The plan called for more than 1,000 tons of rock for the drainage ditches, which would equate to over 50 truckload deliveries. The prospect of having fully loaded tri-axle trucks negotiating a dirt road under difficult winter weather conditions convinced the contractor to separate rock during the grading process and then stockpile it for use in the ditches. Prior to the backfilling of the water-filled pit, the contract required treatment of the mine discharge fed water followed by dewatering via pumping. Treatment of the discharge was needed in order to prevent the low pH water from polluting a nearby-unnamed stream. The contractor executed all the required grading, drainage work, and reforested vegetation at the site with a combination of grass, legumes and tree seeds. Completion of the project occurred on August 21, 2009 at a final cost of \$672,590.91 and successfully accomplished the goals without any major problems. No longer do potentially dangerous features exist in this 36-acre section of former strip-mined land.

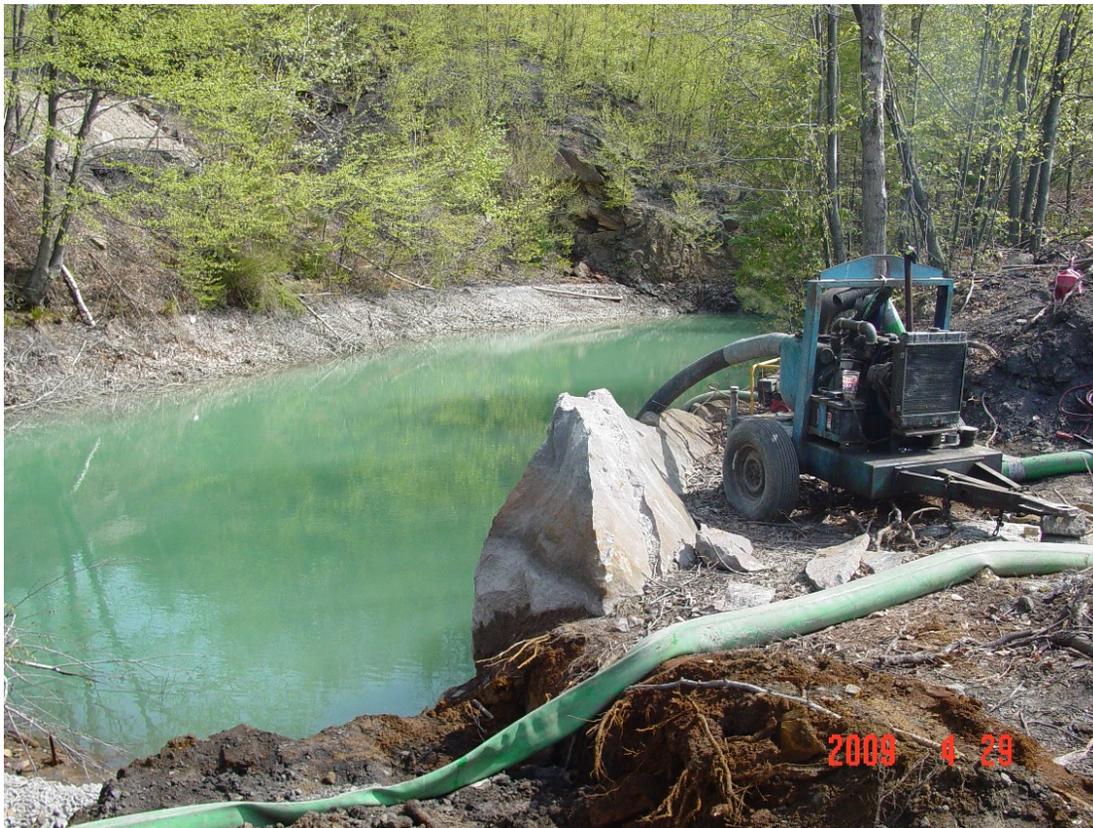
Figure 8: The pumping of the water-filled pit.

problems associated with larger projects, which could delay the design process. The project site's property owner was very receptive to the reclamation plans. The remote location of the project dictated the need for a very long access road through rough terrain. The adjacent property owner and a utility owner granted permission for the project's access to pass through their lands. The Department obtained the environmental clearances needed to assure the project would not affect endangered species or their habitats. The project's design entailed eliminating more than 3,000 feet of highwall during the backfilling of a number of strip pits (AML Features 1 and 16); including the waterbody that was the scene of the two accidents. The material to fill the pits originated from a large on-site spoil pile (AML Feature 17). The design called for grading approximately 370,000 cubic yards of on-site material with slopes less than a three-to-one ratio (3:1) to resemble the pre-mining condition. In addition, the proposed project included installing more than 1,800 feet of rock-lined ditch to control storm runoff and a mine discharge that fed the water-filled pit.

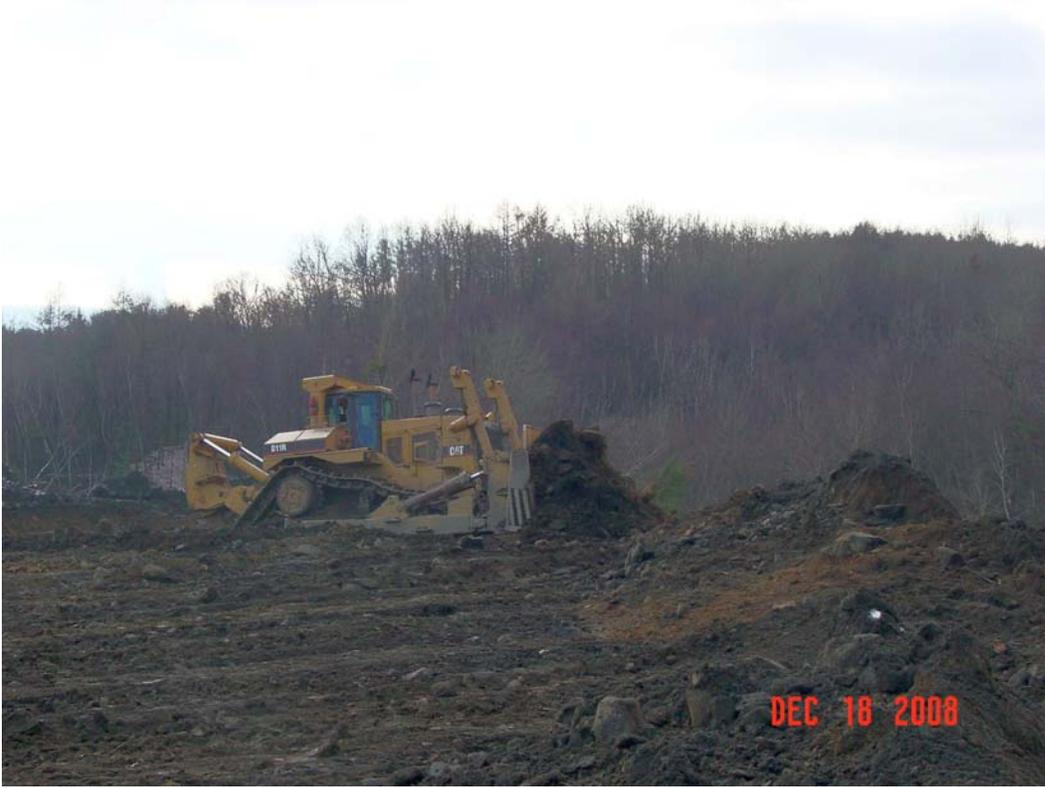
Figure 9: Contractor grading site with a Cat-D11 dozer.

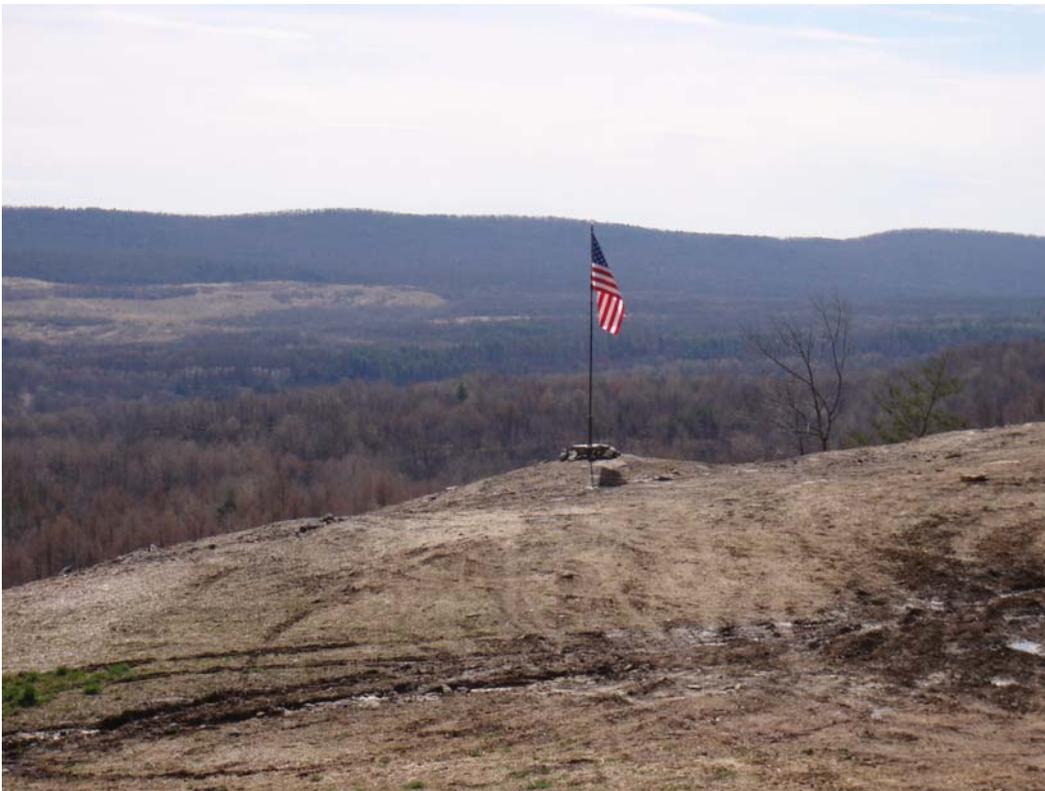
Figure 10: Shortly after reclamation, the trespassers erected a flagpole.

Even though reclaimed, people still frequent this remote area with off-road trucks and all-terrain vehicles. DEP has worked with the property owners in an attempt to block access points but the trespassers either remove the blockages or create new entrances. Trespassing to these remote locations has become part of the culture to a small group. The drivers of the four-wheel drive trucks have turned one section of the project into a mud bog pit for their entertainment. At a high point on the project that overlooks Nanticoke and much of the region, those who frequent the area erected a large flagpole with solar lights as a sign of their defiant claim to this area.

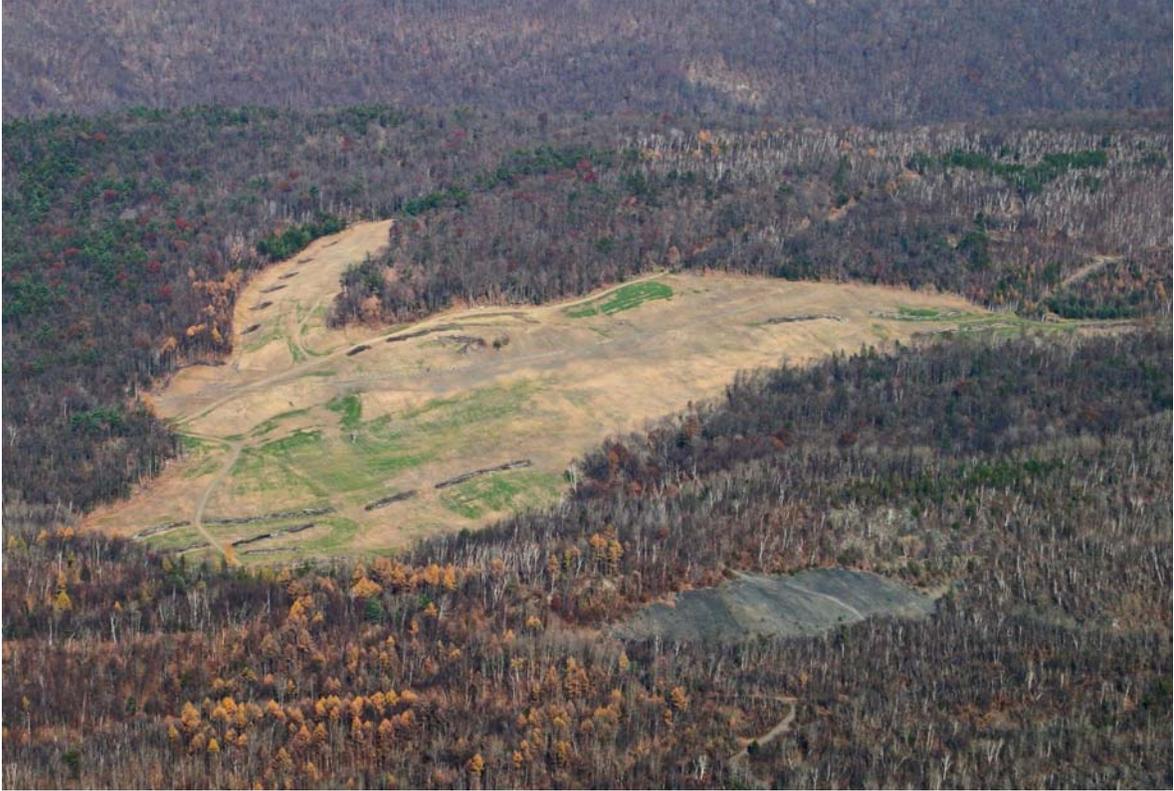
Figure 11: An aerial view of the Newport North project shortly after completion.

The reclaimed Newport North site now mirrors the pre-mining landscape. The project's vegetation has grown nicely, preventing erosion issues and supporting wildlife. Birds and small mammals now inhabit the sporadically placed wildlife habitats. The project has already blended with the surrounding environment. The individuals that abide by the landowner's requirements can now safely hike or hunt on this land.

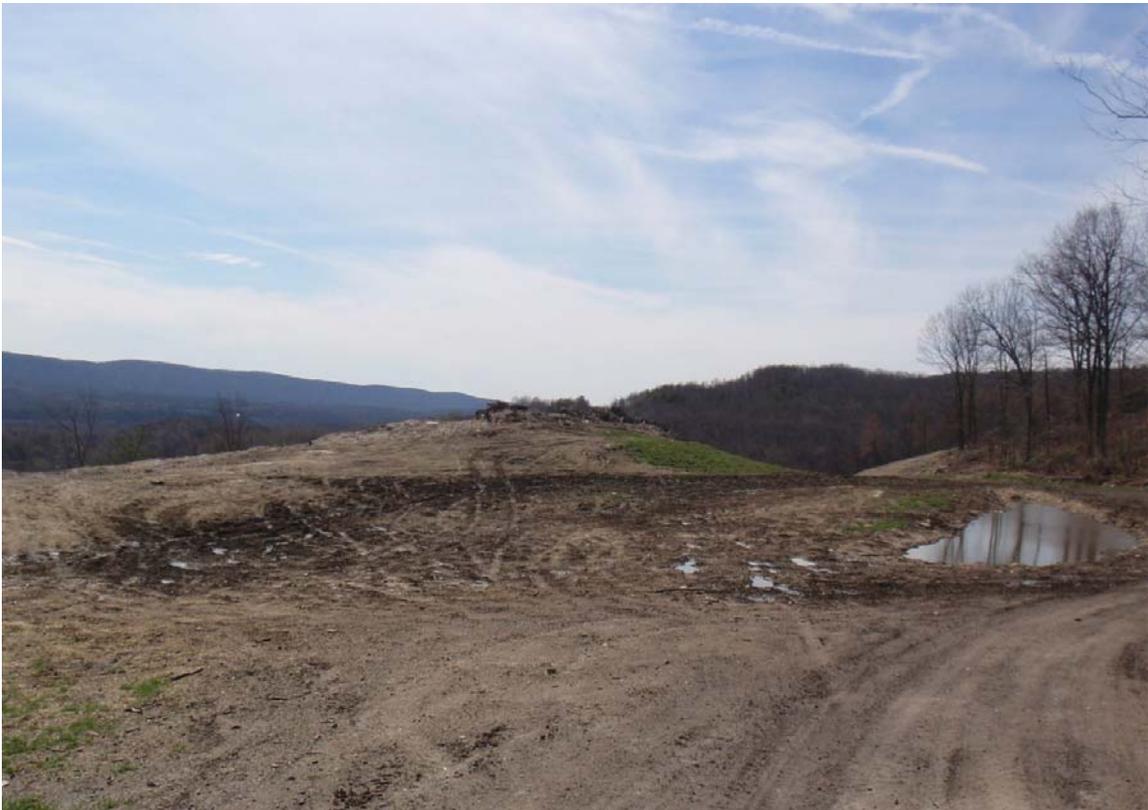
Figure 12: The mud bogging area trespassers created.
