Anthracite Outdoor Adventure Area Bear Valley

2022 OSMRE Award Nomination

Anthracite Outdoor Adventure Area - Bear Valley 2018 Abandoned Mine Land Economic Revitalization (AMLER) Project

Problem Area 3233 (PA 3233)
Coal and Zerbe Townships, Northumberland County

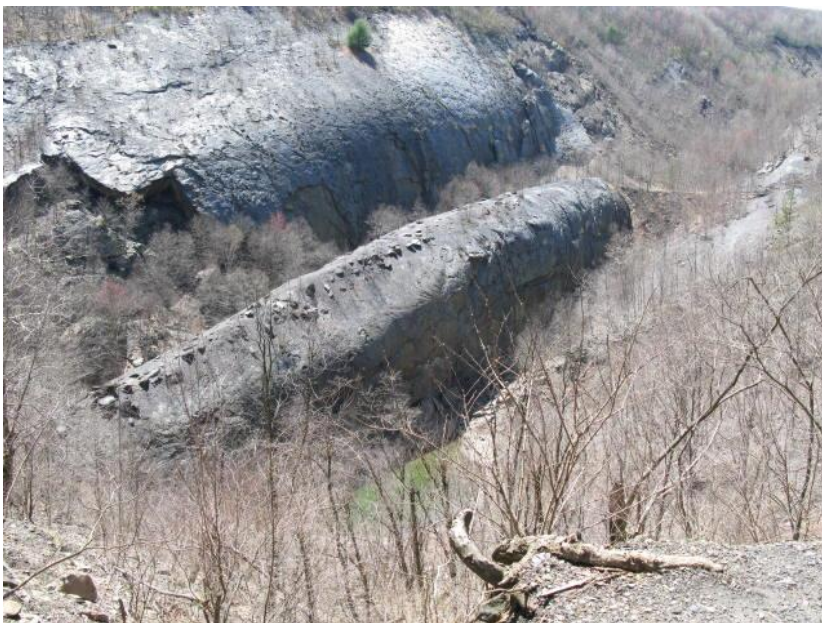
Figure 3 – The Whaleback

A unique geological feature called the “Whaleback” was discovered during underground mining operations and then later daylighted during the strip-mining operations (along the same strip cut within the AOAA – Bear Valley project). The Whaleback is an anticline of the Pennsylvania Llewellyn Formation, which was beneath the Mammoth coal seam. It is known to be one of the best exposures of folded rock in the country and consequently, it is a popular destination for college geology class field trips (See Figure 3). More information about the Whaleback can be found here [PDFProvider.ashx \(pa.gov\)](https://www.pa.gov/documents/energy-environment/geology/geology-education/whaleback-geology-field-trip/).

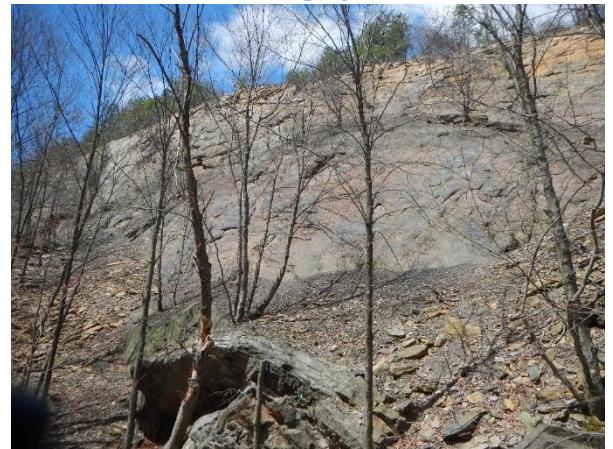
Figure 4 – DH at the southern portion of the site

As mentioned in the *Project Summary*, there were a total of six (6) P2 AML features that were reclaimed, including 4,000 feet of Dangerous Highwall (DH) along the southern portion of the site with an average height of 100 feet (See Figure 4), 1,000 feet of DH along the northern portion of the site with an average height of 80 feet, a 1.3-acre Hazardous Water Body (HWB) located within the southern DH, an eight (8) feet by 15 feet Vertical Opening (VO) (depth unknown), one smaller VO measuring three (3) feet by four (4) feet (shallow depth, non-bat habitat) and one Hazardous Equipment/Facilities (HEF). The HEF measured approximately 45 feet by 60 feet with an average height of 15 feet. The locations of the AML features are shown in the Project Area Map (Figure 5). More details regarding the AML features are in section titled “*Elimination of Significant Health and Safety Problems*”.

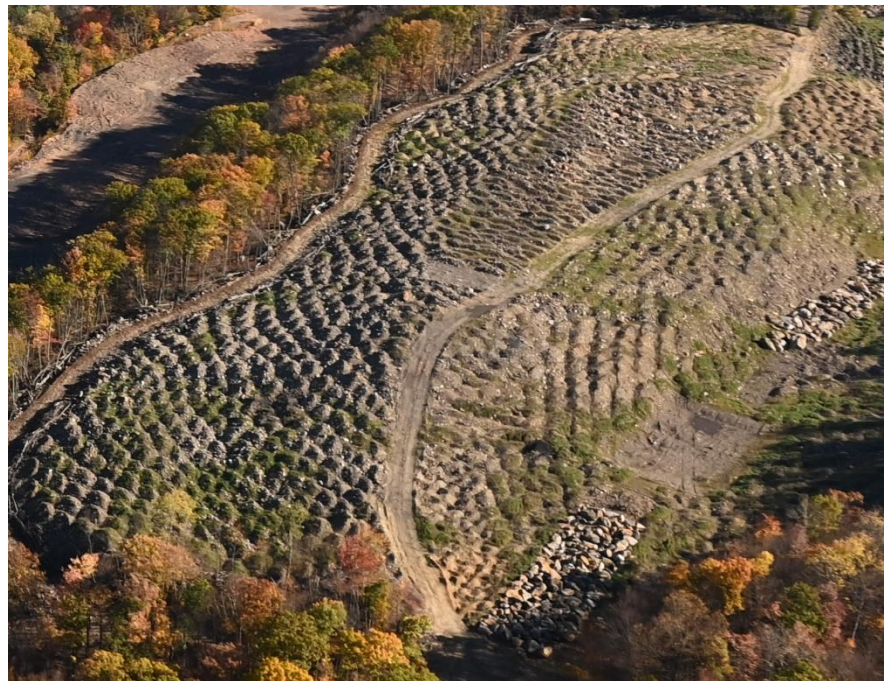
Figure 6 – Hummocky Piles from the Air

Also utilized on this project was the Forestry Reclamation Approach (FRA) for planting tree seedlings. The FRA is a method for reclaiming coal-mined land to forest under the federal Surface Mining Control and Reclamation Act of 1977. The FRA is based on knowledge gained from both scientific research and experience and it can achieve cost-effective regulatory compliance for mine operators while creating productive forests that generate value for their owners and provide watershed protection, wildlife habitat and other environmental services. This method has also been used on AML sites where it has successfully established trees as the piles create loose soils for root/tree growth while also helping to capture moisture and prevent erosion. State mining agencies and the Department of the Interior's (DOI) Office of Surface Mining Reclamation and Enforcement (OSMRE) consider the FRA to be an appropriate and desirable method for reclaiming coal-mined land to support forested land uses. Pennsylvania, California, Kentucky, Maryland, Ohio, Tennessee, and West Virginia have codified the FRA in their official policy or a memorandum of understanding to signal their acceptance of the FRA as a means of reforesting mined sites. (The Forestry Reclamation Approach: Guide to Successful Reforestation of Mined Lands, US Department of Agriculture, Forest Service. Adams, M. [2017]).

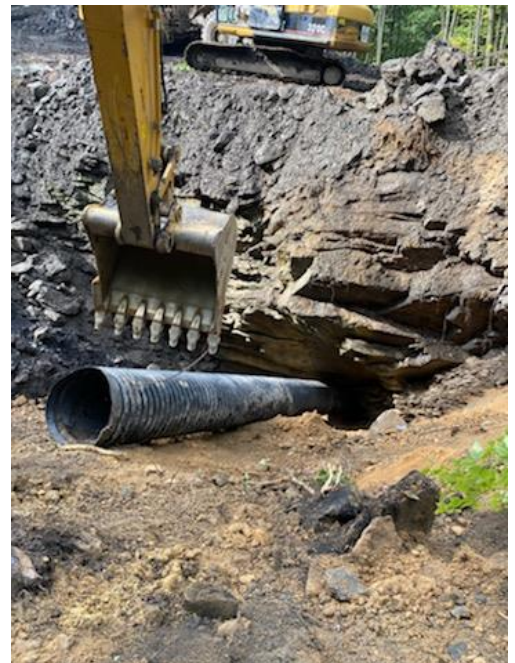
Figure 7 – Bat Gate During Installation

The contractor also had many other issues to address, including but not limited to the demolition of an old abandoned mine structure, the placement and seeding of the FRA hummocky piles in very steep, rocky areas which required benching for installation, and the installation of a bat gate into a crop fall on a particularly steep, remote area of the project. The bat gate work required many pieces of equipment including two (2) excavators, operating in tandem, to line up and install the pipe. The contractor and Department of Environmental Protection (Department) personnel had to be very sharp, staying a safe distance away from the mine opening while lowering the pipe safely into place, anchoring it into the opening, and then carefully backfilling and securing it so continued ingress and egress is still possible by the bats but also preventing any human access.

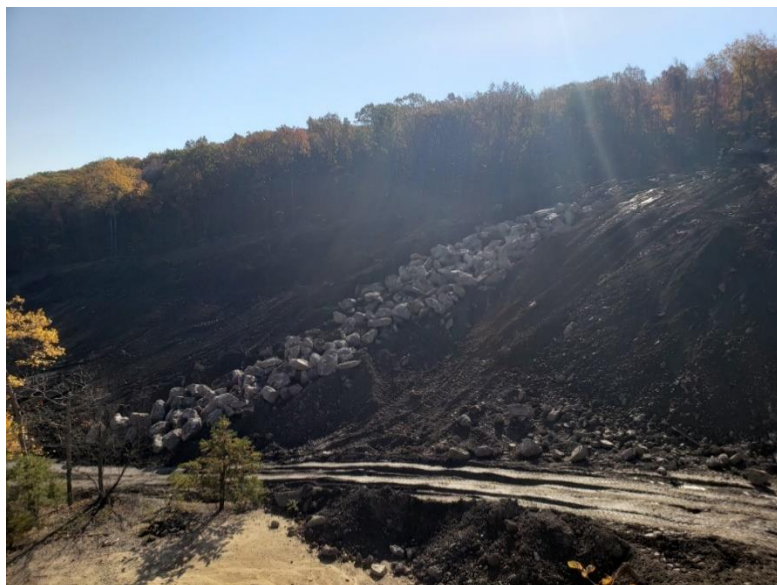
Figure 8 – An Extreme Rock Trail Climb on a Steep Slope near the Western End of the Project During Construction

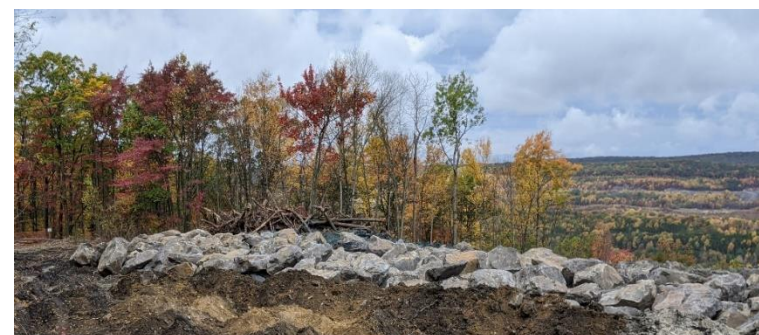
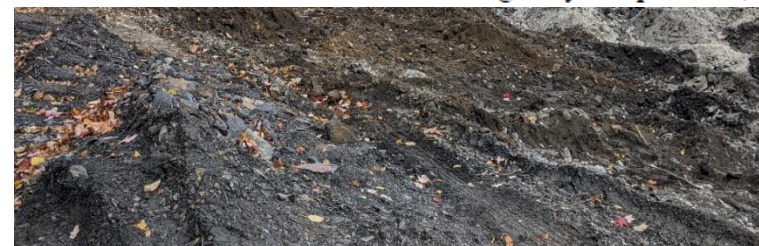
These extreme trails are to be as gnarly as possible.

Figure 9 – Extreme Rock Crawling Trail with Actual Contract Language from Project Designer, Steve Fisanick, to Describe its Construction

Again, the most obvious difficulty with this project was the fact it was the first of its type completed. There was no template, no specification or detailed drawing previously used with success, therefore making it a one-of-a-kind design. The project designer, Steve Fisanick, worked closely with AOAA representatives to effectively manage their expectations and then blended classic reclamation techniques used in the past with newly developed techniques to create the extreme rock crawling trails and ATV trails in a manner acceptable to the lessee. Once completed, it was bundled in a way that would also make sense to the contractor for building according to the designer's intentions. While this was done, as good as anyone could have reasonably expected, there remained much to discuss and decide in the field. Several meetings were conducted by Department Representative, Rodney Webb, and the Department's Inspection staff consisting of Kent Pheasant, Tom Dizio, and Ed Frey, to determine the specific details. The most important meeting occurred in October 2020, when it was brought to the Department's attention that the way the extreme rock trail was depicted on the project drawings and plans would not be safe for the AOAA's future riders. At this meeting, all parties agreed on an acceptable change in the design of the project and work was able to continue without any issue or delay.

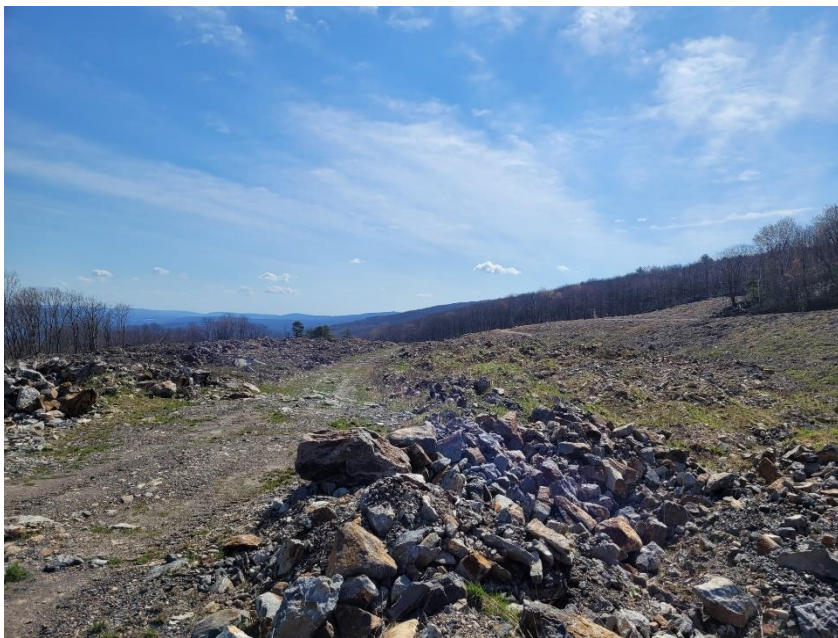
Figure 10 – Hummocky Piles in Rocky Areas

The approximately 88-acre AML site was very rocky with long, steep sidewalls. Although the project work reclaimed the dangerous highwalls, some steep graded areas were constructed due to both the extreme rock crawling trail design and to accommodate the adventure park. Thus, several techniques, including the FRA-hummocky piles and hauling/grading equipment, described above in the section titled 'Innovative Use of Technology', were required to help control drainage. The hummocky piles were created over a large portion of the site regardless of the varied types of soil found throughout the project. Some areas had decent material easily graded into 4-foot mounds and placed in an interlocking pattern. However, other portions were placed in areas with almost no soil, and final grade required adjustment for bedrock. In those areas, more cohesive material was hauled in and placed using an end-dump method. This was much more

difficult and time consuming, but in the end, it proved to be well worth the effort. The rocky areas typically expected to produce more stormwater run-off performed very similarly to the other areas with regard to absorbing run-off as there were no significant issues of drainage or sediment creating an off-site issue. A large portion of the storm drainage water is

absorbed and held in the valleys of the hummocky piles, where you have vegetative growth. Most of what remained follows the path of the main extreme rock trail and was met temporarily with multiple rows of 32-inch compost filter sock and earthen berms to keep any sediment from exiting the project site. However, during the several years of project work it was obvious that a permanent structure should be installed to continue to filter the sediment after the work was completed. Hence, a significant large rock apron was constructed using some of the smaller boulders and rocks not used for the extreme rock trails. Since its construction, it has performed very well. There is no reason to believe it will not continue to benefit the park if it is maintained and sediment is removed intermittently.

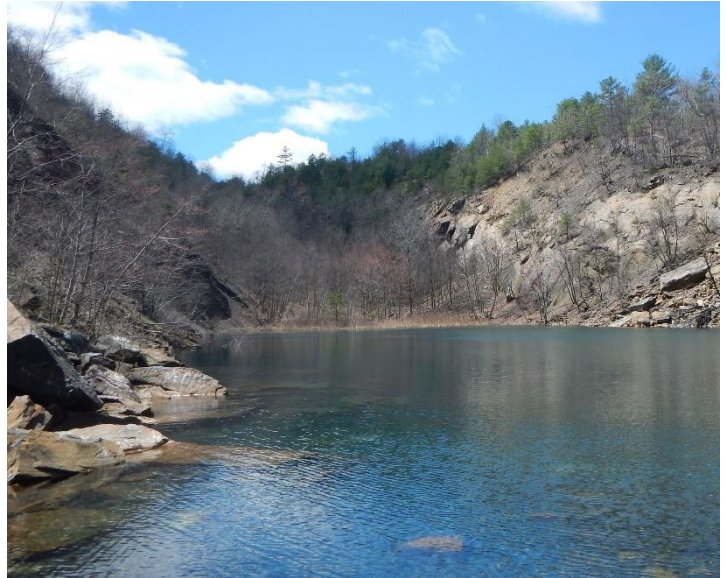
Figure 11 – Hazardous Water Body

The project site was heavily visited. Residents used the hazardous water body (HWB) as a recreational swimming area. The adjacent rock cliff (in the southern portion of the project site) was used to jump into the HWB, which created a very dangerous situation (See Figure 11). In addition, the project site is located within the existing AOAA's Western Reserve ATV trail system. Many of the ATV trails in this area were dangerous due to being close to the six (6) identified P2 AML features. The project reclaimed all six (6) features, thus eliminating the significant health and safety hazards. The HWB and both DHs (5,000 feet) were backfilled with over 2.4 million CY of on-site material, utilizing the FRA method as previously discussed. The HEF was demolished. A bat-friendly gate consisting of a 36-inch high-density polyethylene pipe and angle iron was installed in the larger VO, while the smaller VO (non-bat habitat) was backfilled.

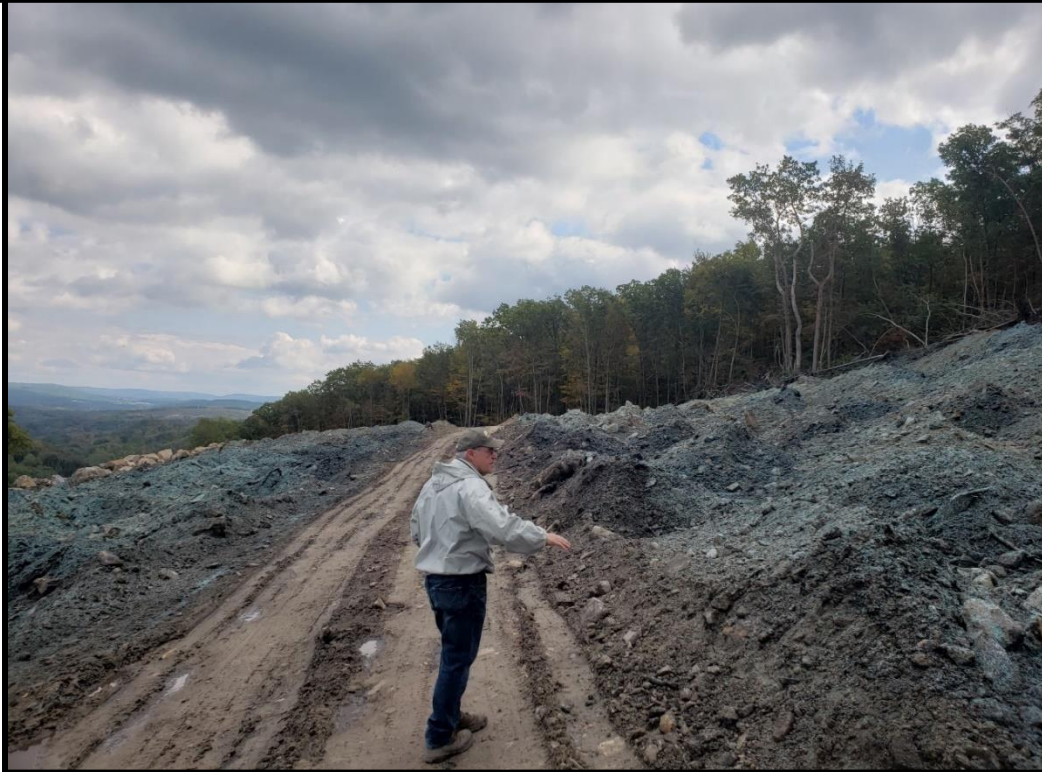
FOREST REVEGETATION APPROACH - HUMMOCKY PILES, WITH PROJECT INSPECTOR KENT PHEASANT

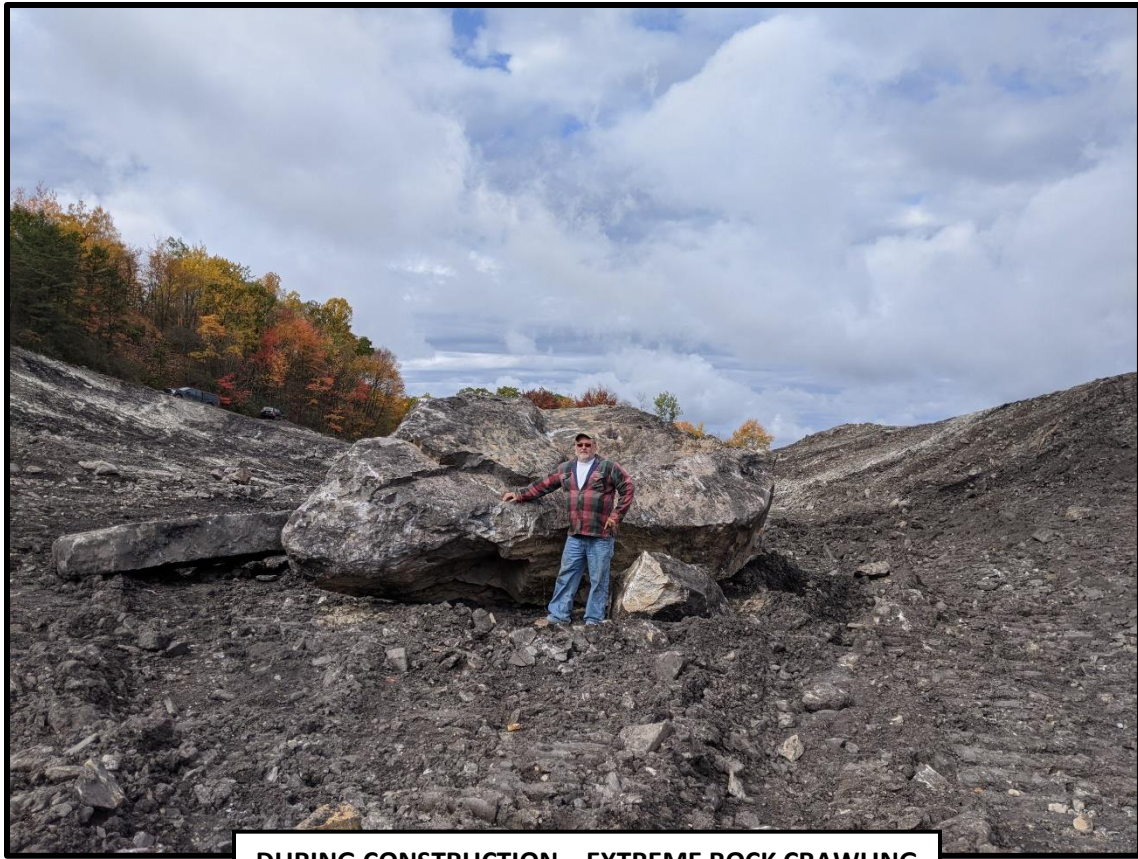
1ST PIECE OF COMPLETED EXTREME ROCK CRAWLING TRAIL

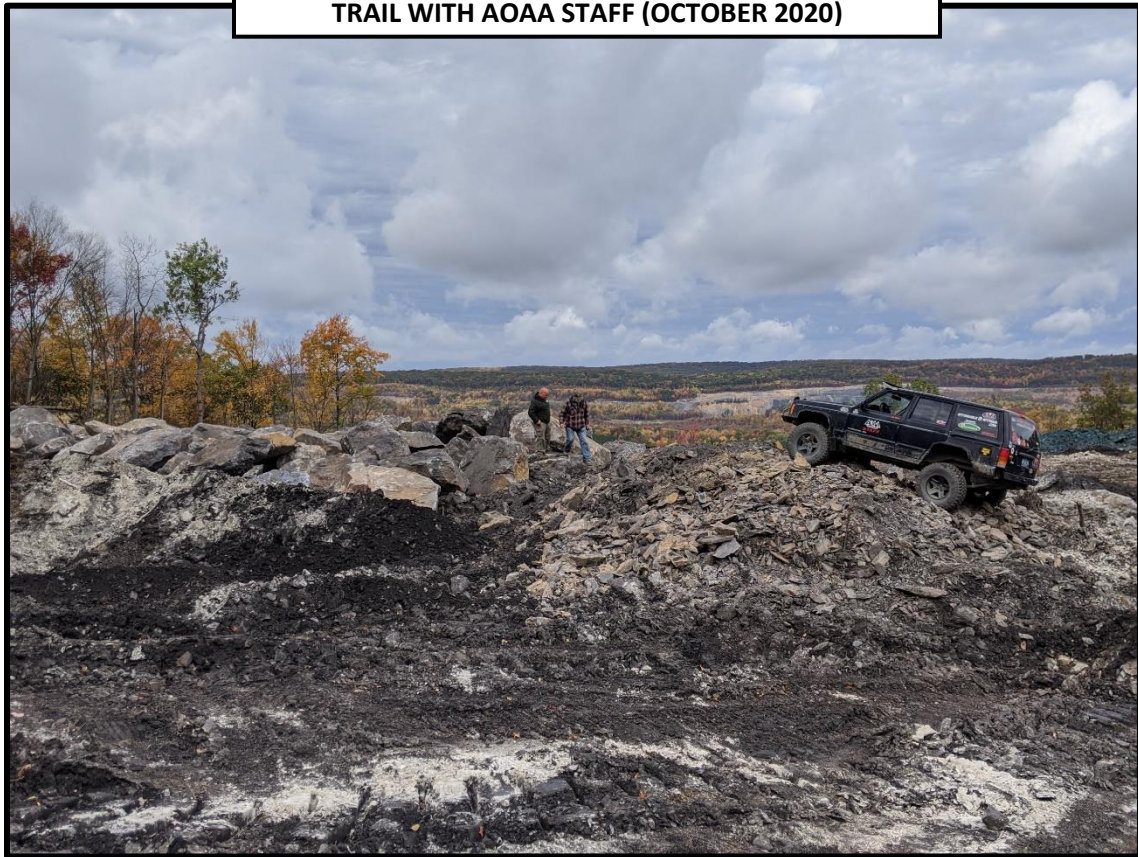
**DURING CONSTRUCTION – EXTREME ROCK CRAWLING
TRAIL WITH AOAA STAFF (OCTOBER 2020)**

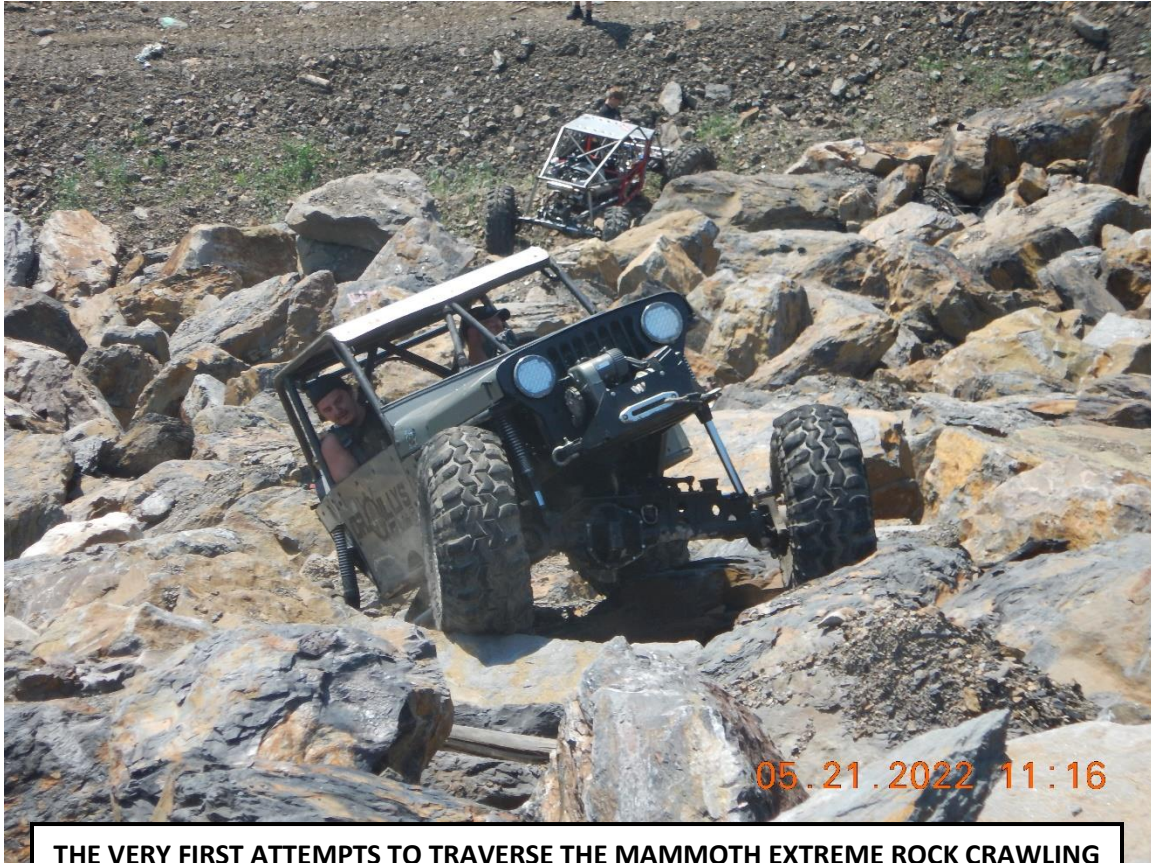
THE VERY FIRST ATTEMPTS TO TRAVERSE THE MAMMOTH EXTREME ROCK CRAWLING TRAIL – NONE OF THE 7 SELECTED TESTERS FINISHED THE WHOLE COURSE AND IT TOOK 3 HOURS TO TRAVEL 1,100 OF THE 6,600 FEET OF TRAIL

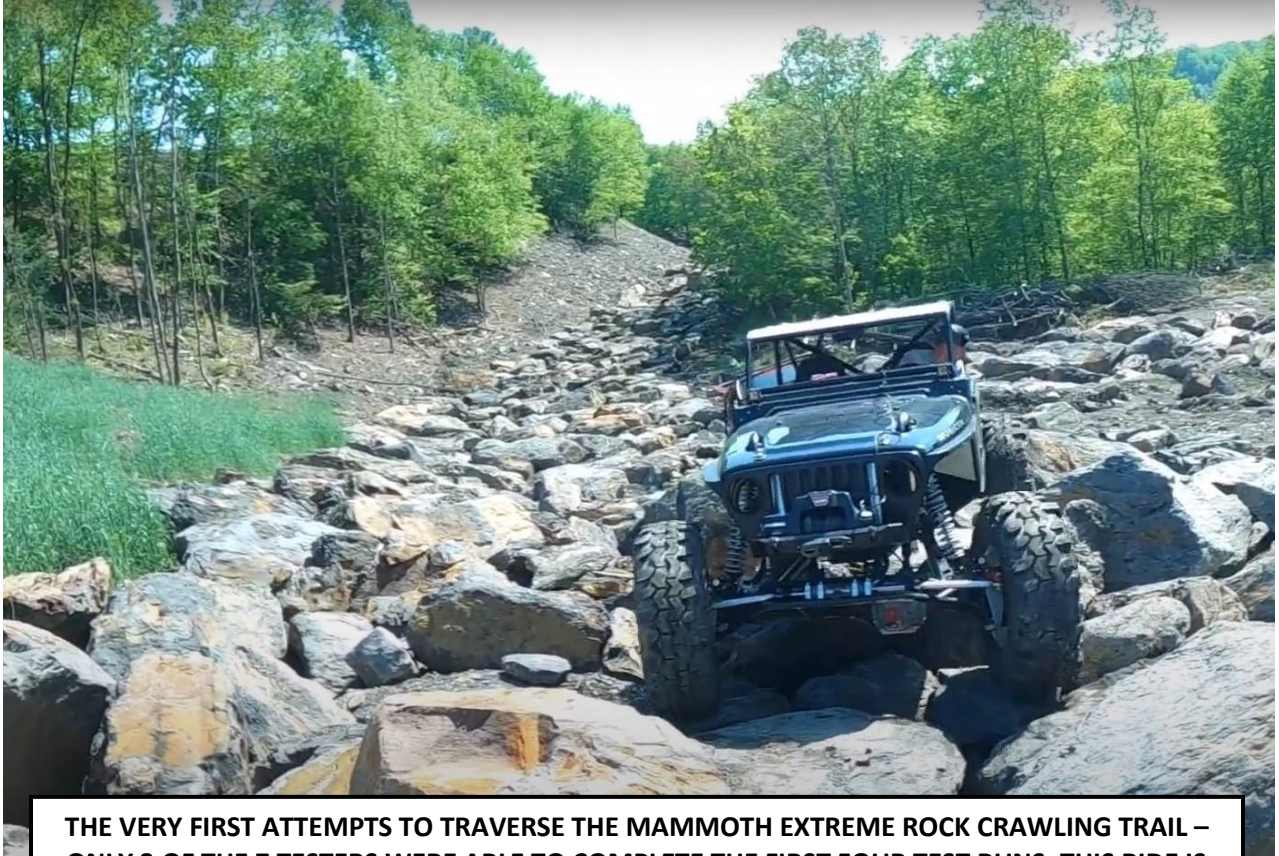
THE VERY FIRST ATTEMPTS TO TRAVERSE THE MAMMOTH EXTREME ROCK CRAWLING TRAIL – ONLY 3 OF THE 7 TESTERS WERE ABLE TO COMPLETE THE FIRST FOUR TEST RUNS. THIS RIDE IS “NOT FOR THE FAINT OF HEART” ACCORDING TO TORQ-MASTERS INDUSTRIES, WHO TOURED THE SITE IN MAY 2022
