PITT-02-19-016

February 1, 2019

**Re: Sunoco Pipeline L.P. – Pennsylvania Pipeline Project (Mariner East II)  
Chapter 105 Permit No. E07-459 – Major Modification  
Modification Request for Reroute and Installation Method Change at Piney Creek HDD  
Woodbury Township, Blair County, PA**

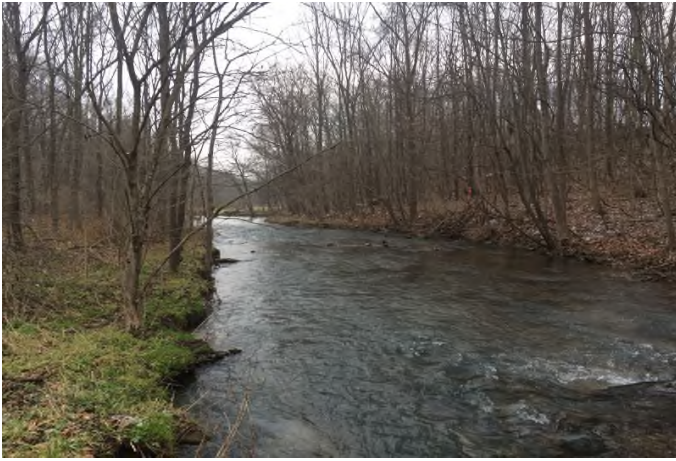
**Notes: 12/31/2018 -- Stream S-M30 (Piney Creek)**  
Facing upstream of proposed crossing location

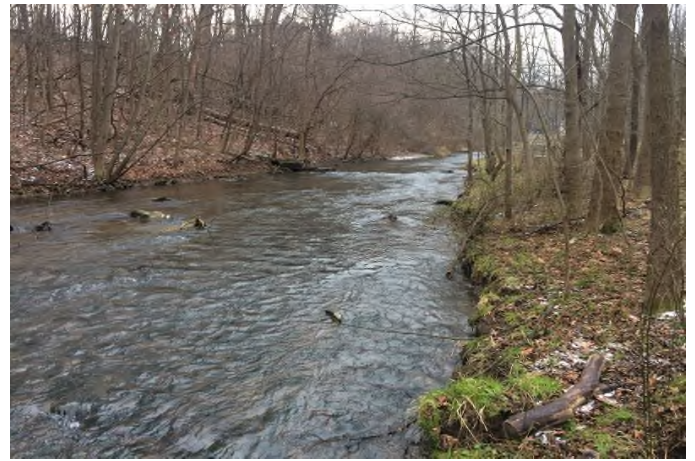
**Notes: 12/31/2018 -- Stream S-M30 (Piney Creek)**  
Facing downstream of proposed crossing location

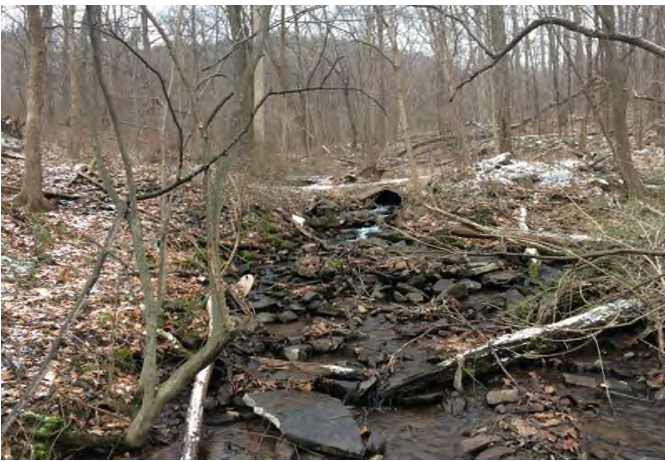
**Notes: 12/31/2018 -- Stream S-M33**  
Facing upstream of proposed crossing location

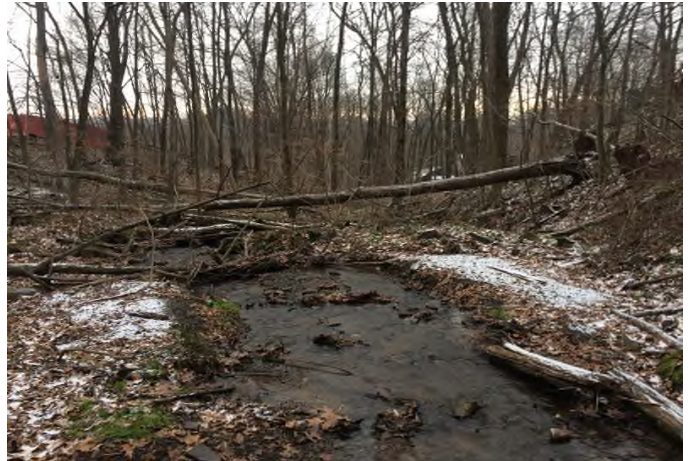
**Notes: 12/31/2018 -- Stream S-M33**  
Facing downstream of proposed crossing location

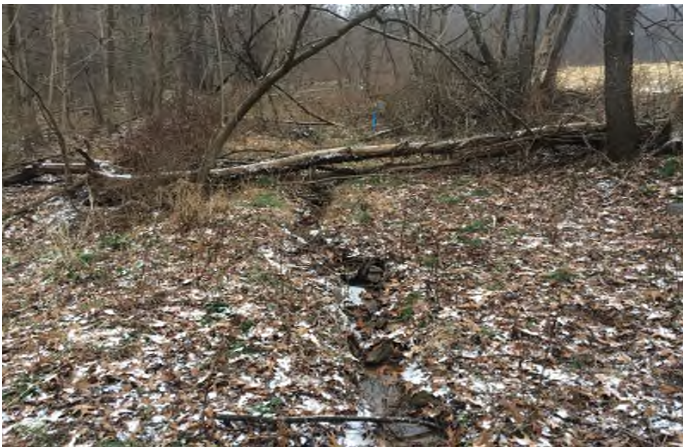
**Notes: 12/31/2018 -- Stream S8r**  
Facing upstream of proposed crossing location

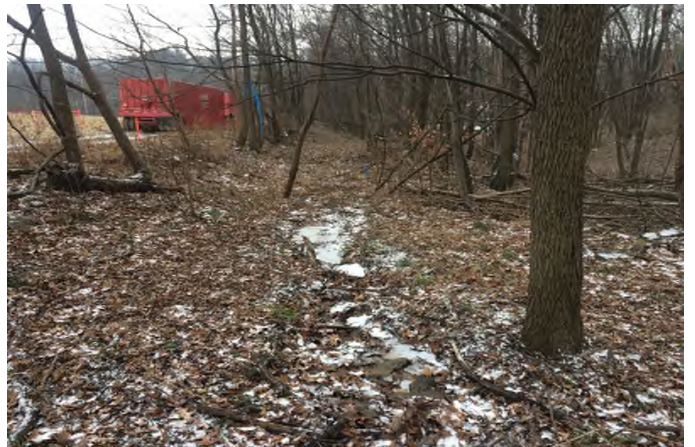
**Notes: 12/31/2018 -- Stream S8r**  
Facing downstream of proposed crossing location

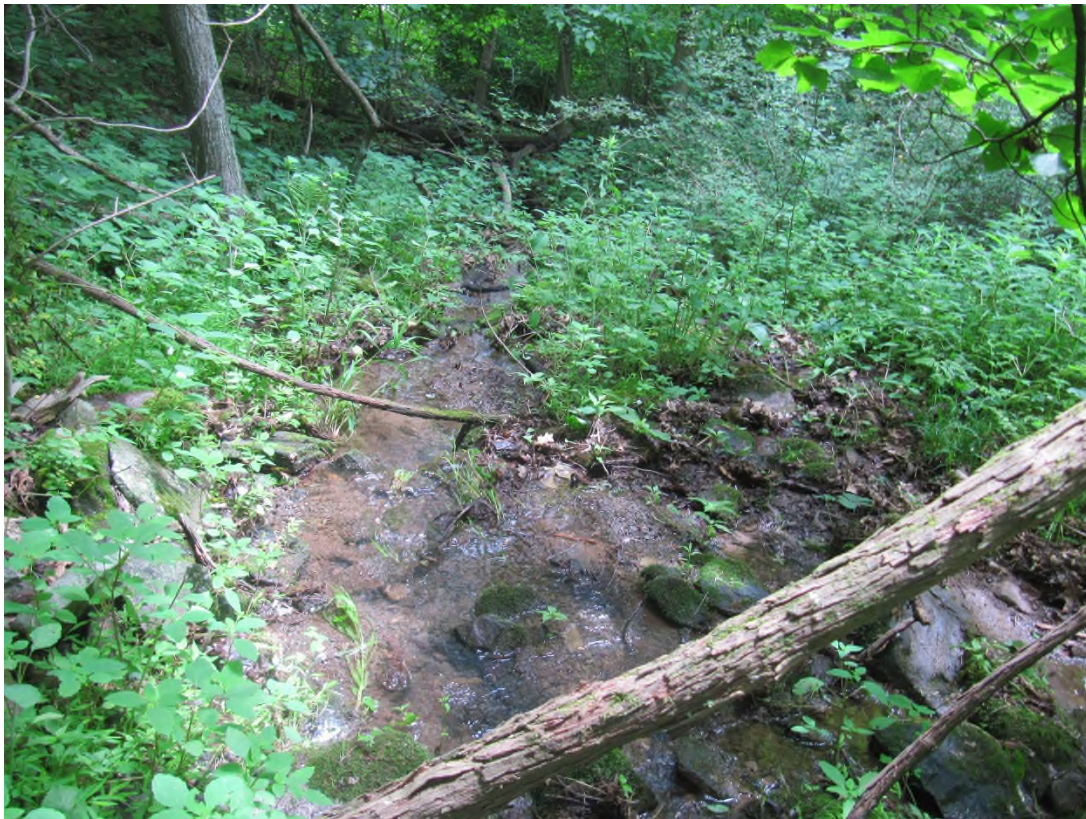
**Photograph Number:** 166    **Feature Name:** S-M34    **Date:** 06/28/2014  
**Direction:** E, Downstream    **Flow Regime:** Perennial    **Remarks:** N/A

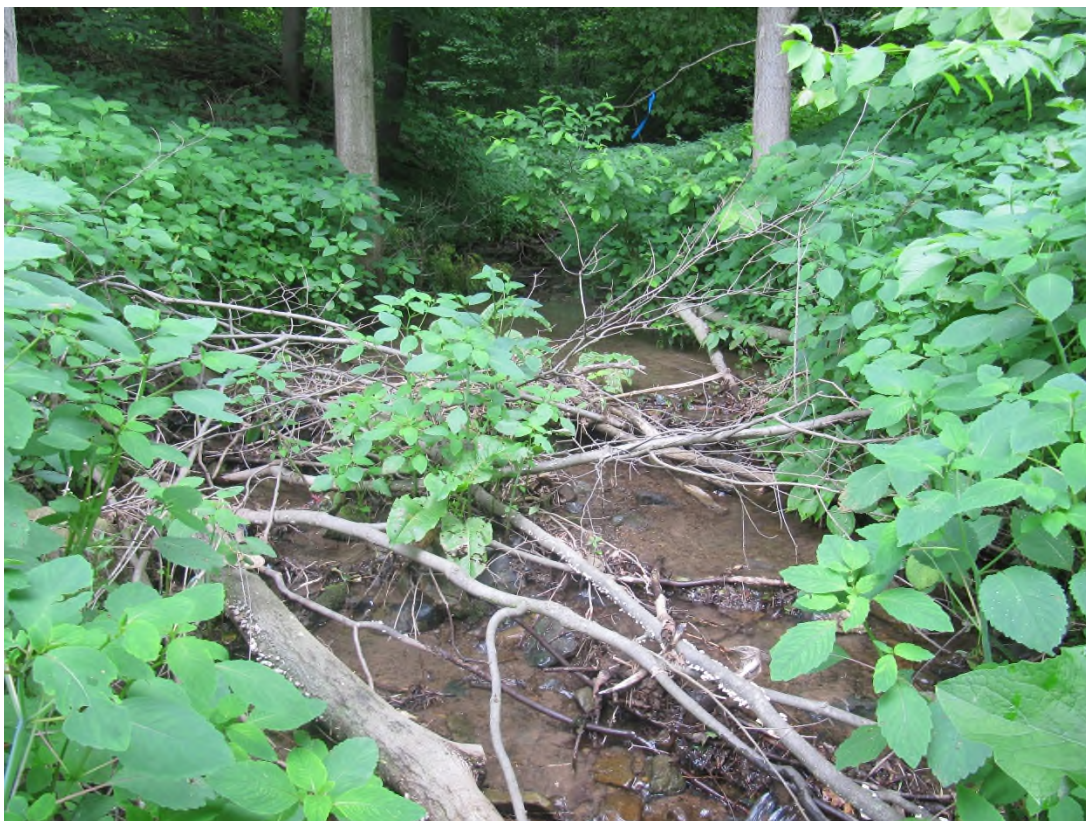
**Photograph Number:** 167    **Feature Name:** S-M33    **Date:** 06/28/2014  
**Direction:** NW, Upstream    **Flow Regime:** Perennial    **Remarks:** N/A

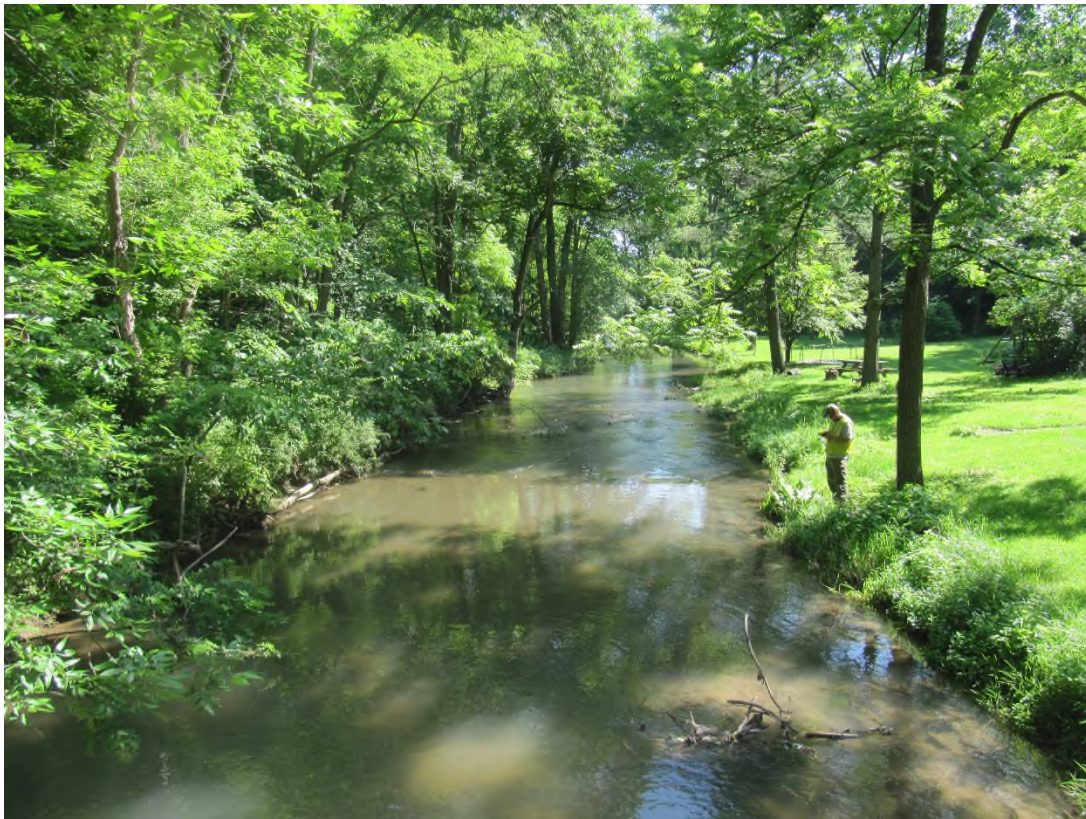
**Photograph Number:** 168    **Feature Name:** S-M30    **Date:** 06/27/2014  
**Direction:** NE, Downstream    **Flow Regime:** Perennial    **Remarks:** Piney Creek

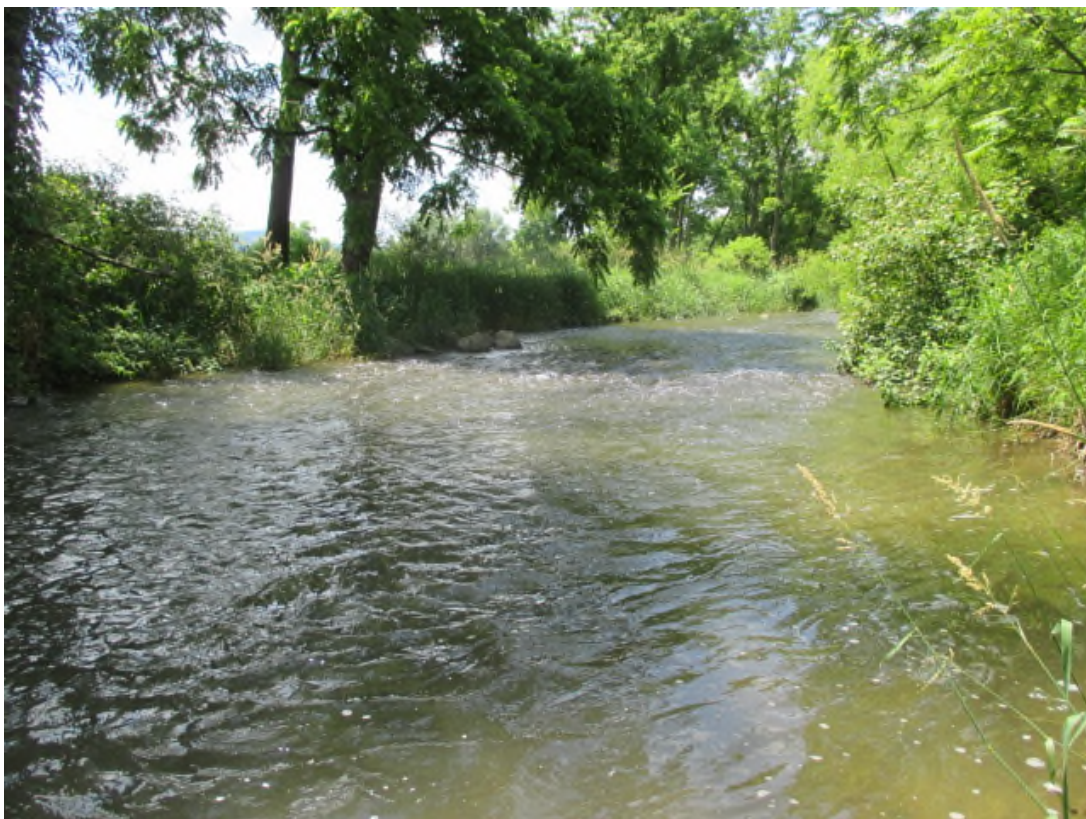
**Photograph Number:** 169    **Feature Name:** S-L58    **Date:** 06/27/2014  
**Direction:** SW, Upstream    **Flow Regime:** Perennial    **Remarks:** Clover Creek

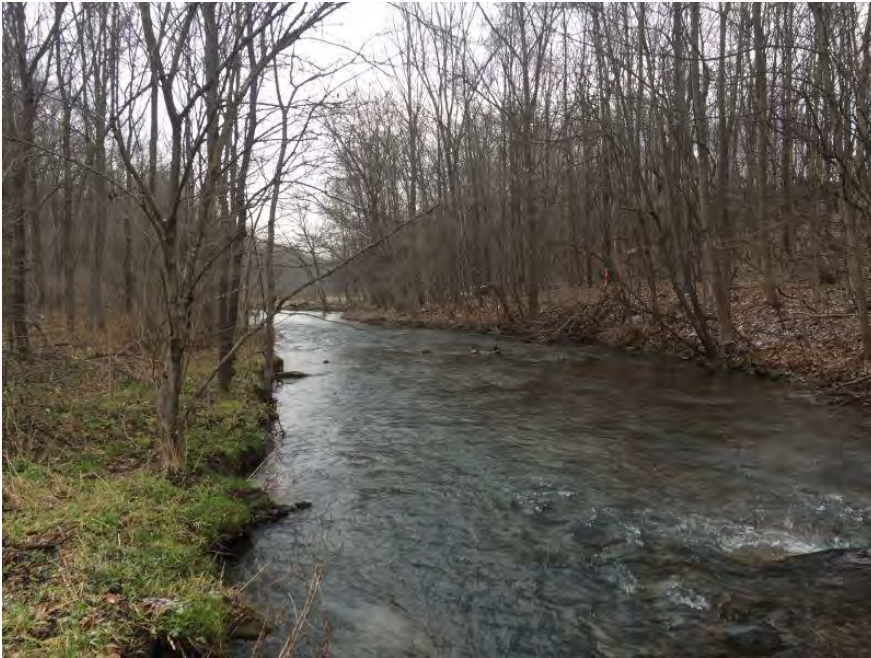
**Photographer:** K. Berend  
**Date:** 12/13/2018  
**Photo No.:** 1  
**Direction:** North  
**Comments:** Stream S-M30  
(Piney Creek) crossing location,  
downstream

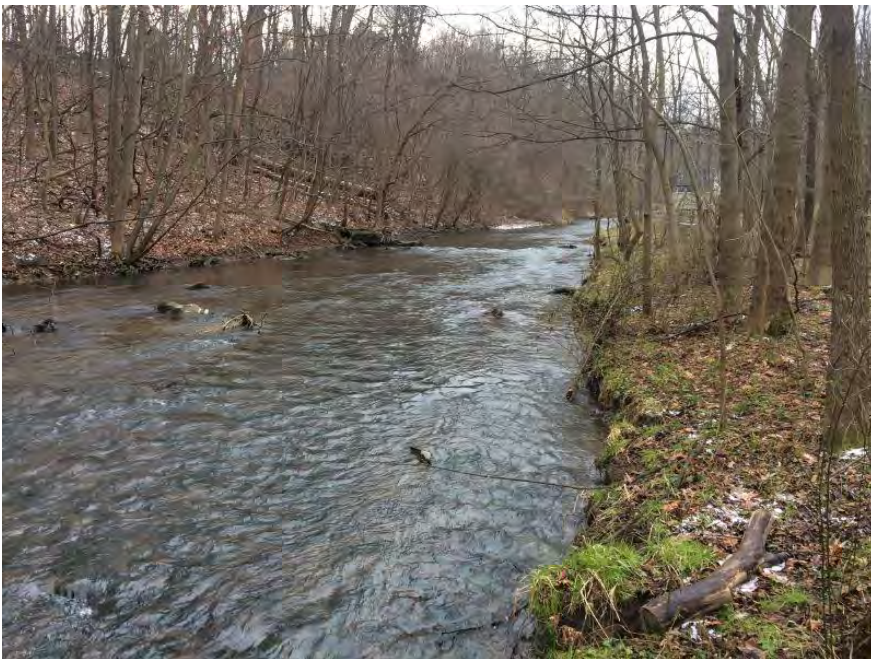
**Photographer:** K. Berend  
**Date:** 12/13/2018  
**Photo No.:** 2  
**Direction:** South  
**Comments:** Stream S-M30  
(Piney Creek) crossing location,  
upstream

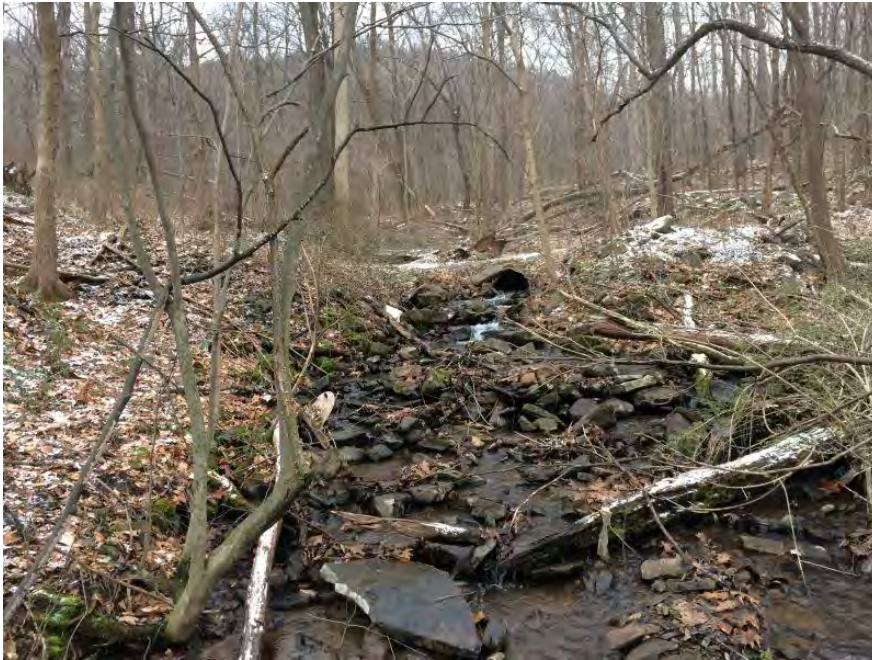
**Photographer:** K. Berend  
**Date:** 12/13/2018  
**Photo No.:** 3  
**Direction:** Northwest  
**Comments:** Stream S-M33 crossing location, upstream

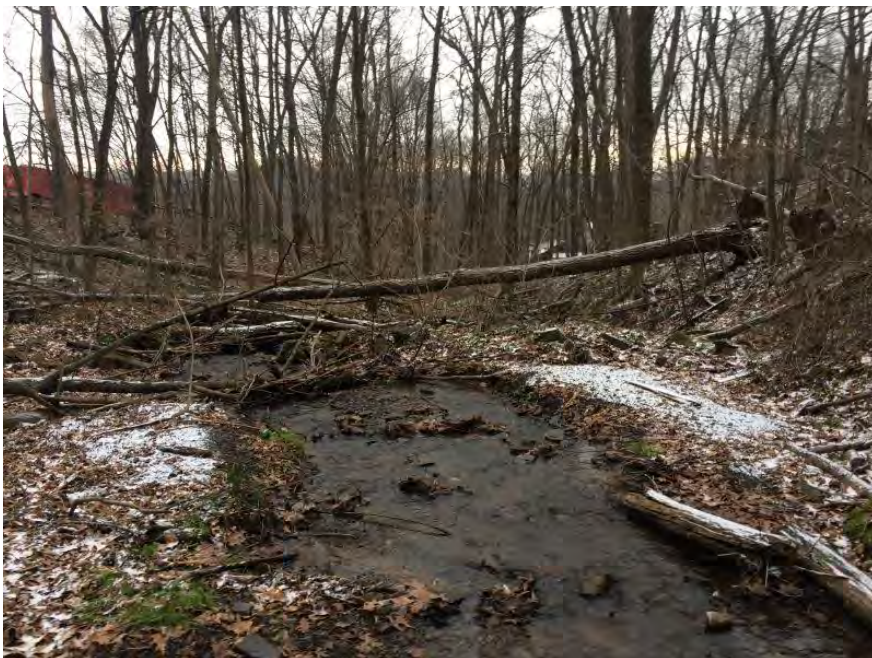
**Photographer:** K. Berend  
**Date:** 12/13/2018  
**Photo No.:** 4  
**Direction:** Southeast  
**Comments:** Stream S-M33 crossing location, downstream

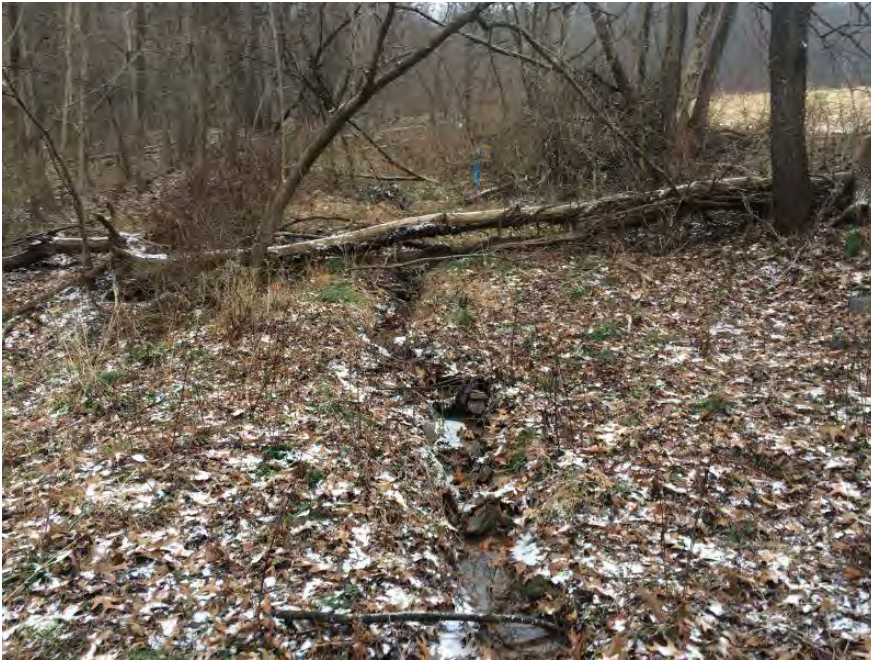
**Comments:** Stream S8r  
crossing location, upstream

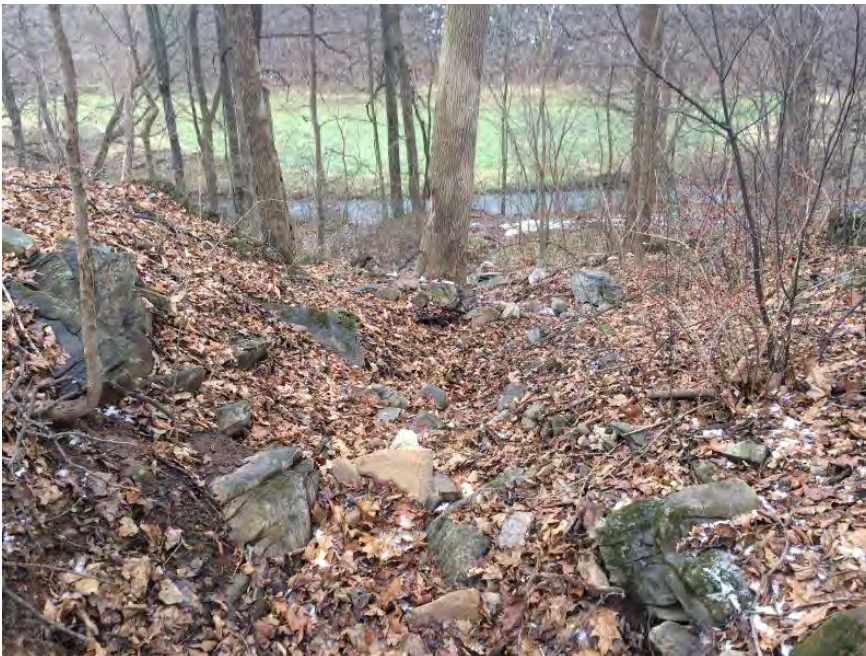
**Photographer:** K. Berend  
**Date:** 12/13/2018  
**Photo No.:** 8  
**Direction:** East  
**Comments:** Stream S9r from hilltop, downstream

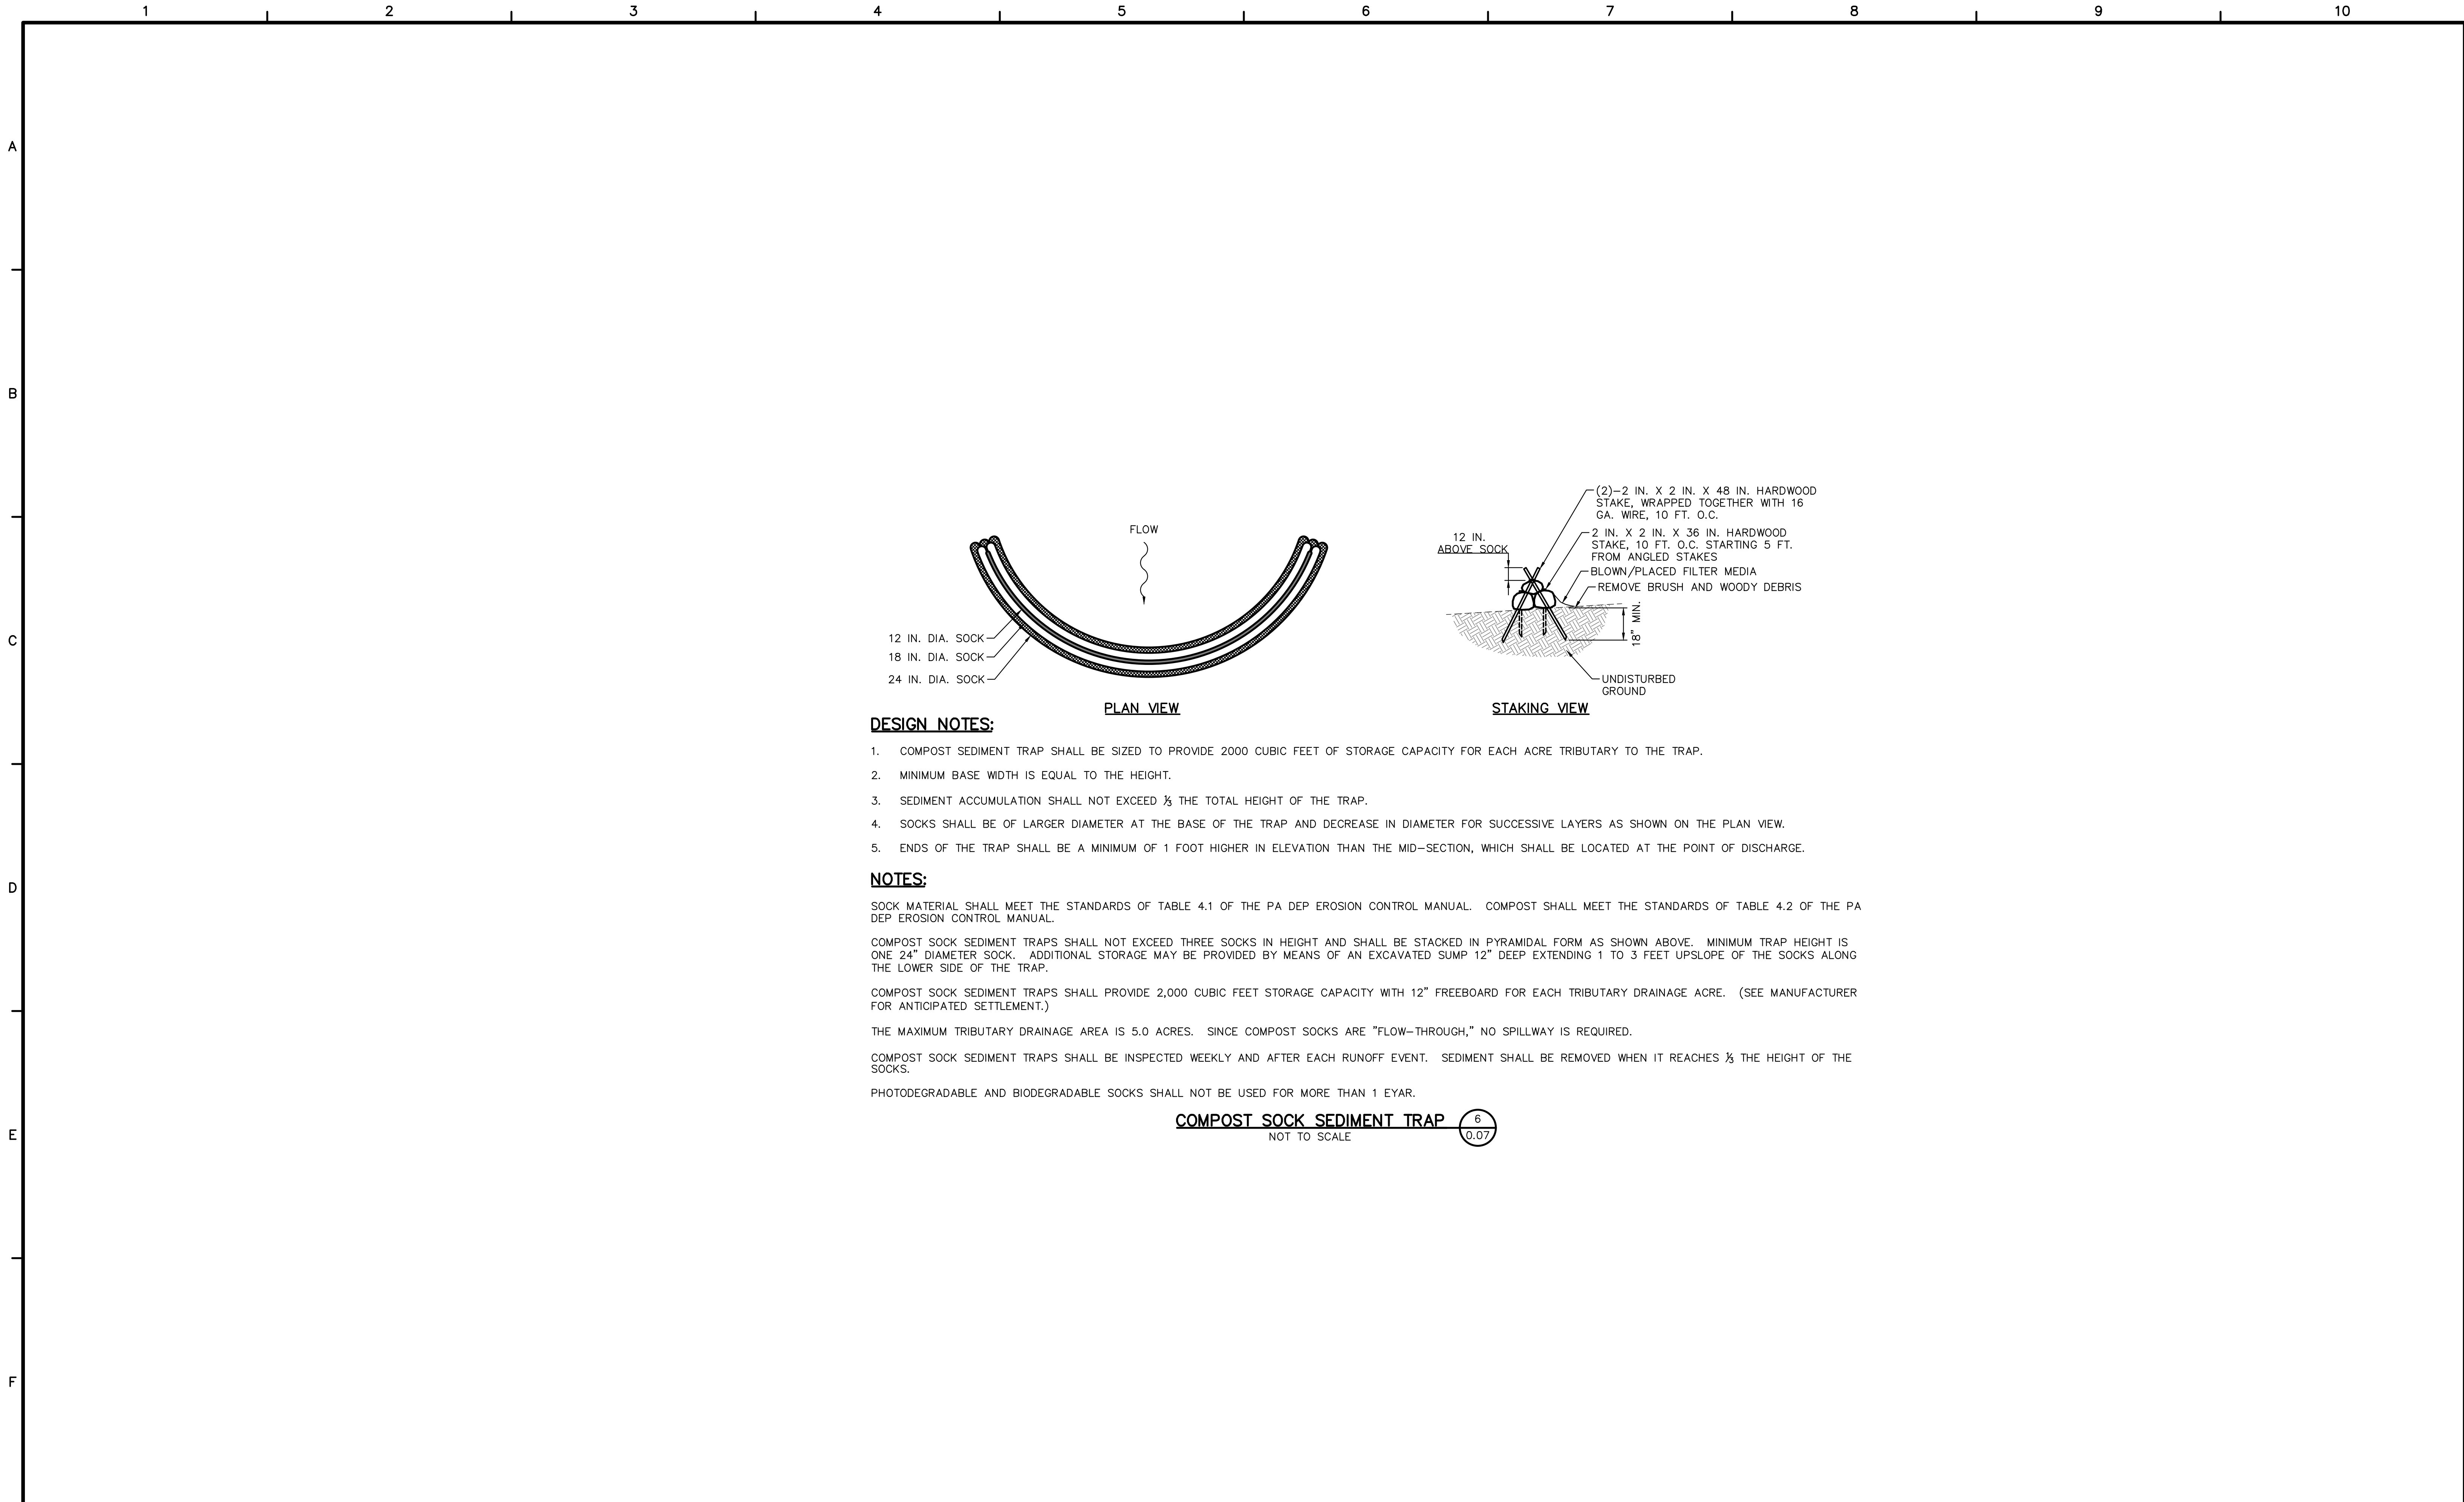
**COMPOST SOCK SEDIMENT TRAP** 6/0.07  
NOT TO SCALE

**DESIGN NOTES:**

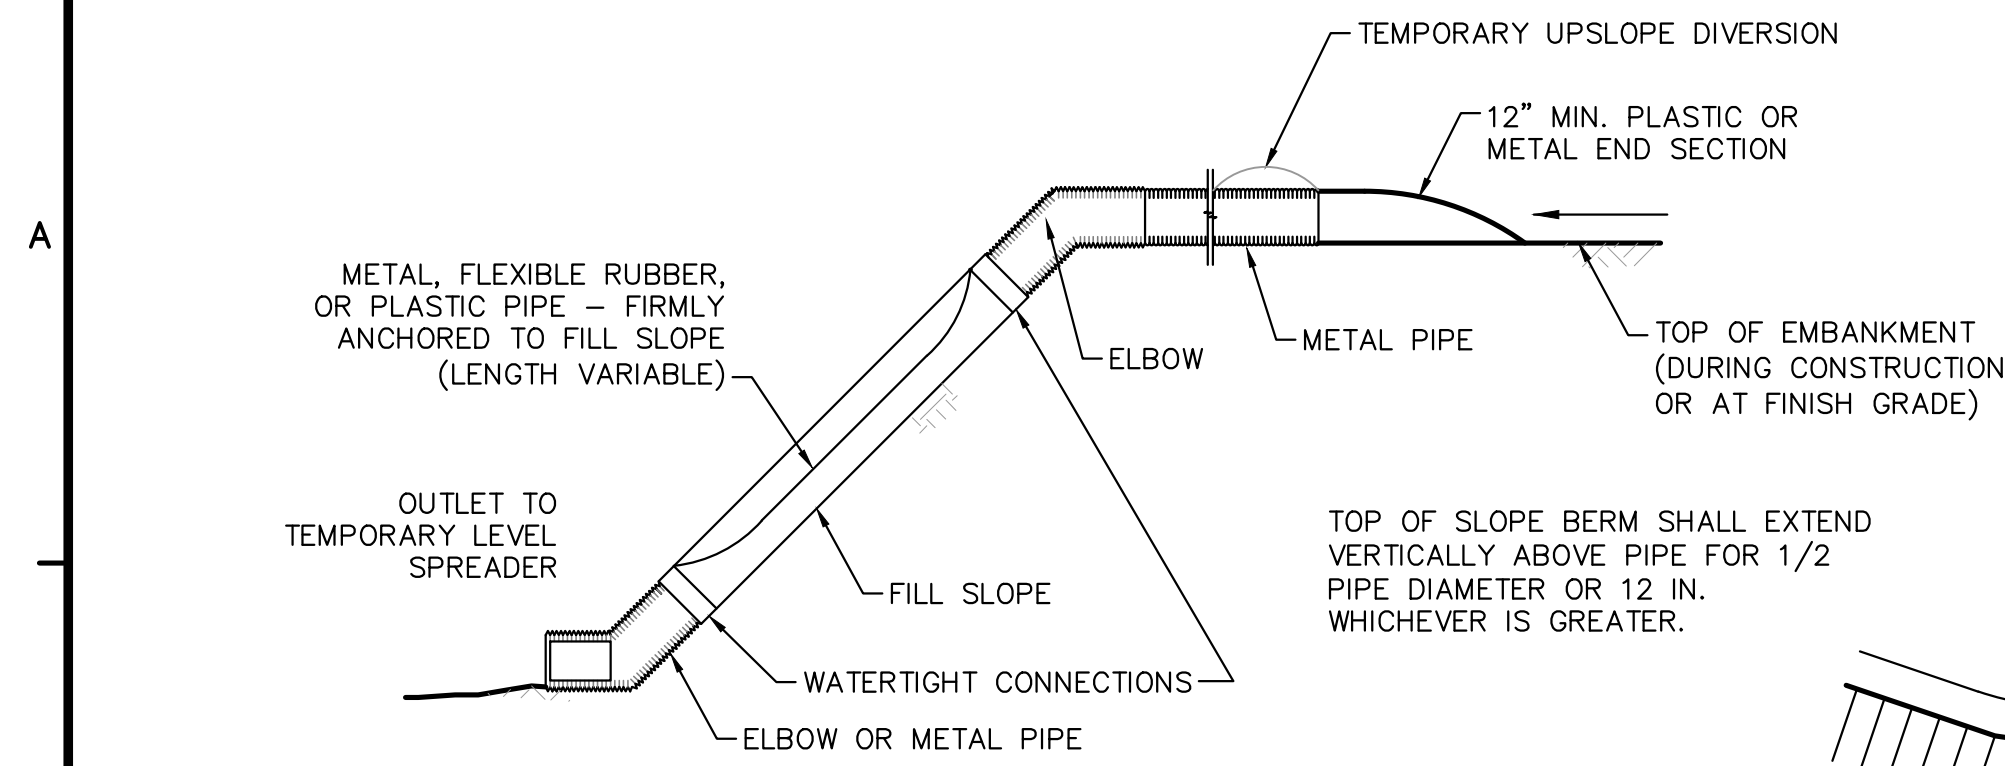
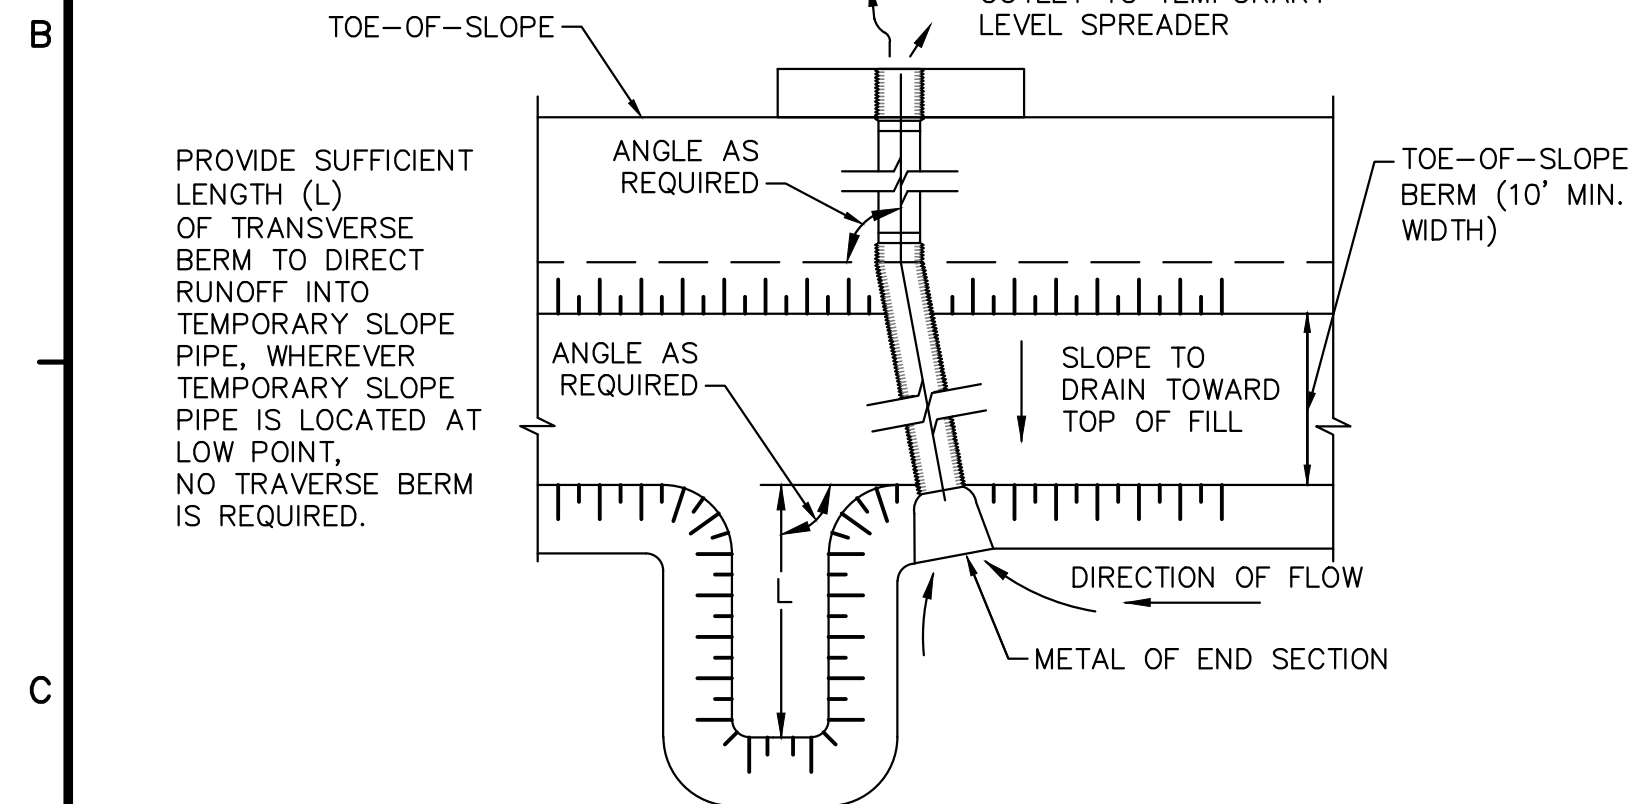
MINIMUM DIMENSIONS FOR TEMPORARY SLOPE PIPES		
DRAINAGE AREA (ACRES)	MINIMUM PIPE DIAMETER (IN.)	MINIMUM BERM HEIGHT (IN.)
<2	12	24
2-4	15	27
4-5	18	30

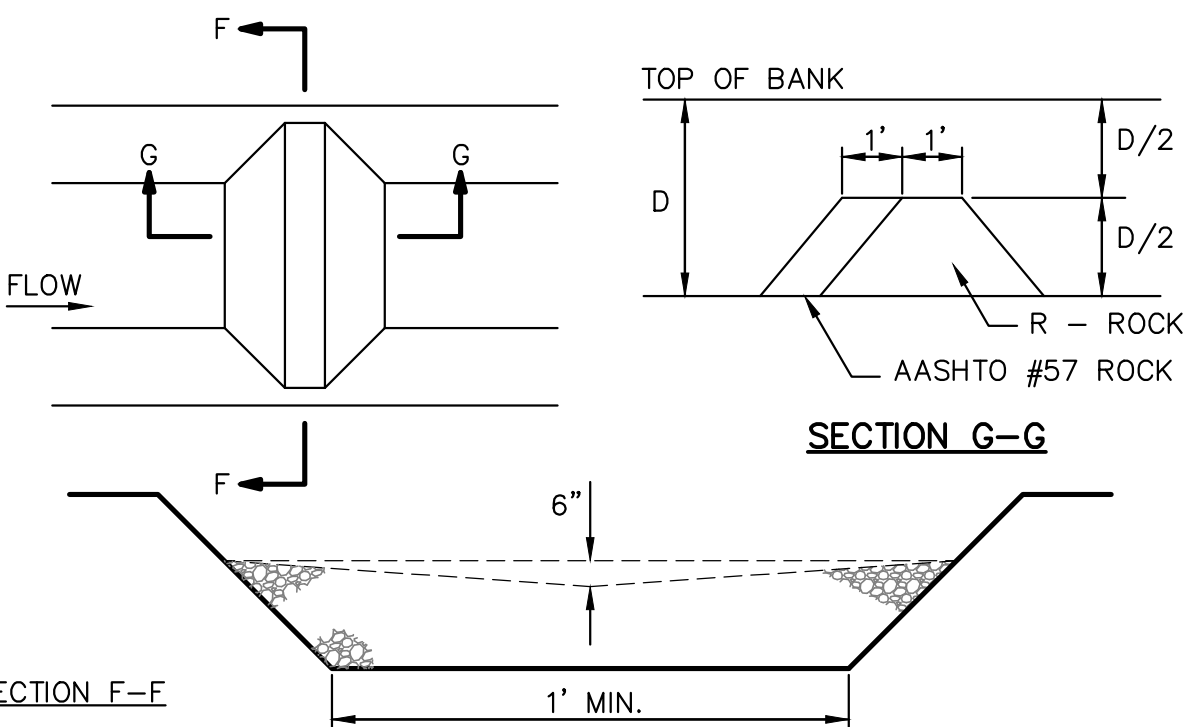
FOR 3' ≤ D USE R-4  
FOR 2' ≤ D < 3' USE R-3  
FOR 1' ≤ D < 2' USE R-2

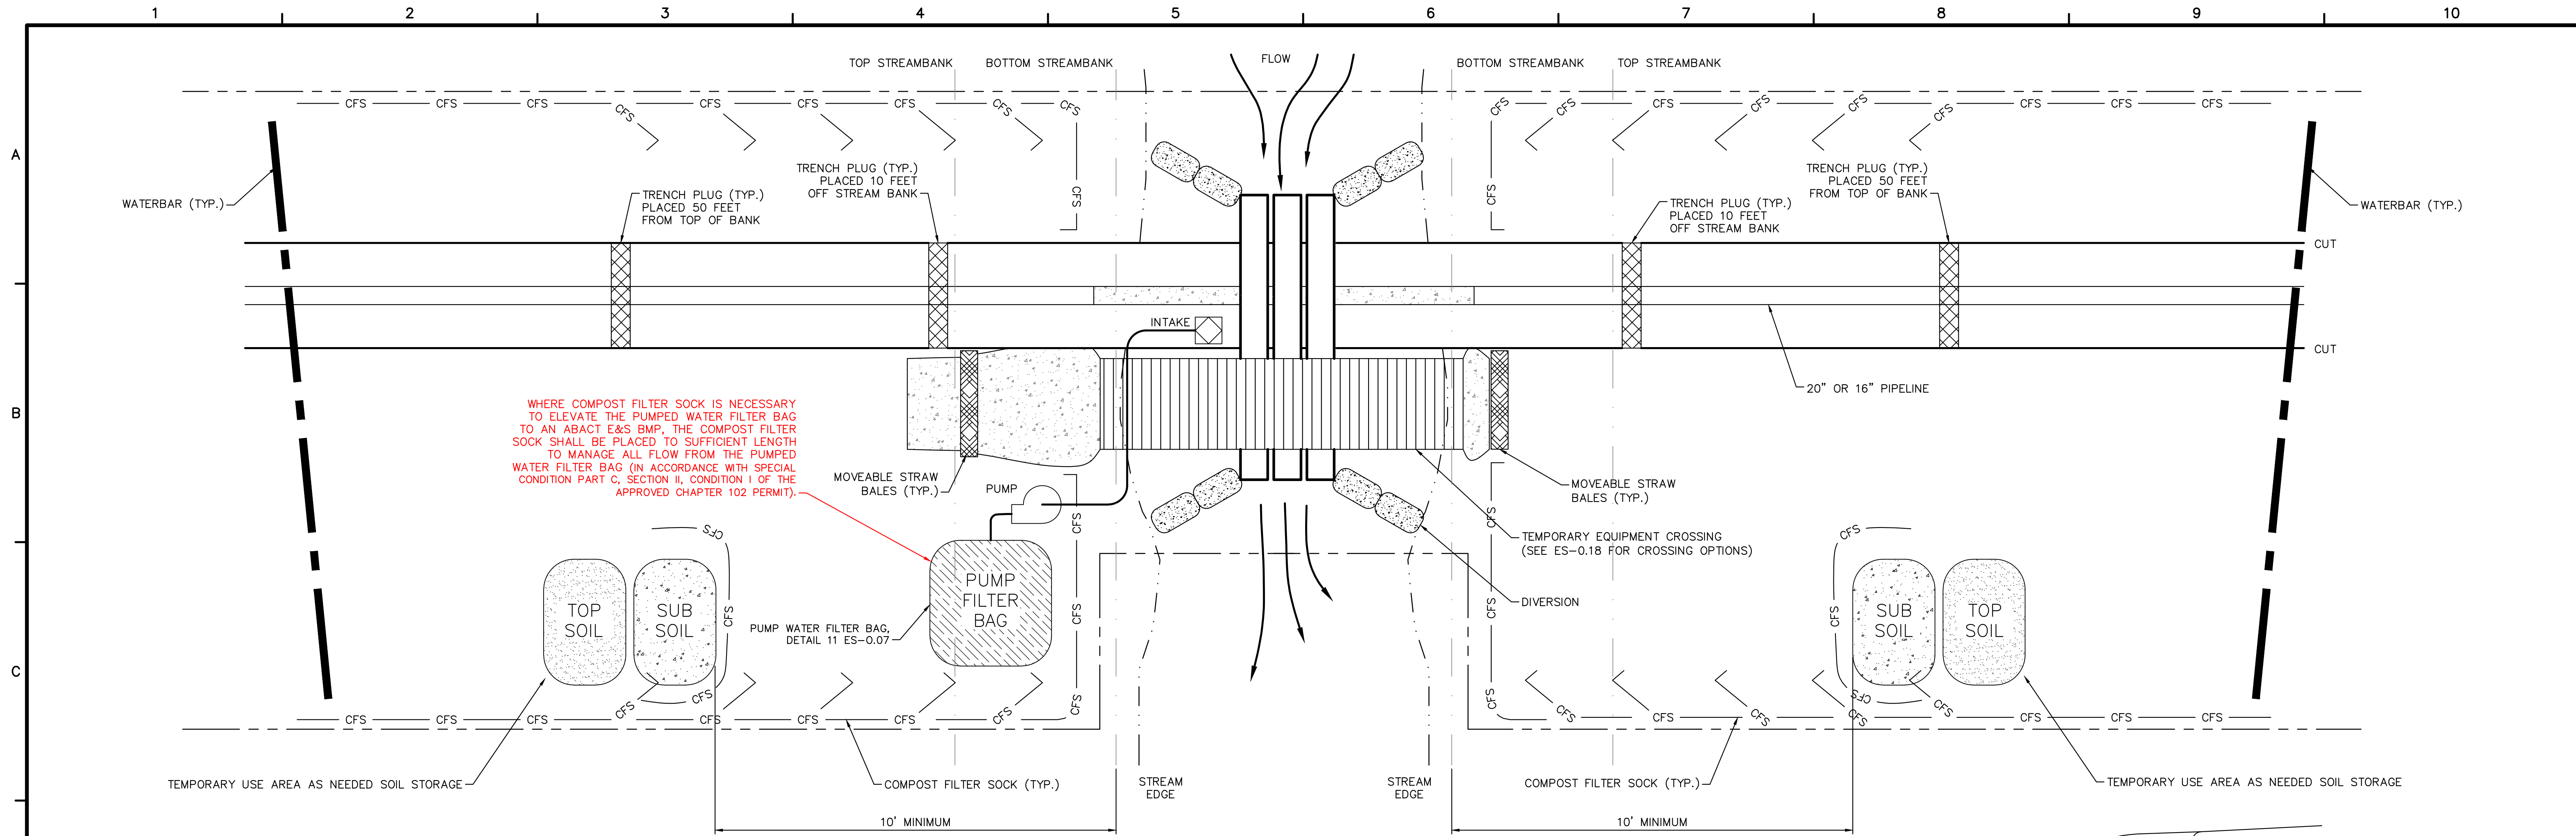
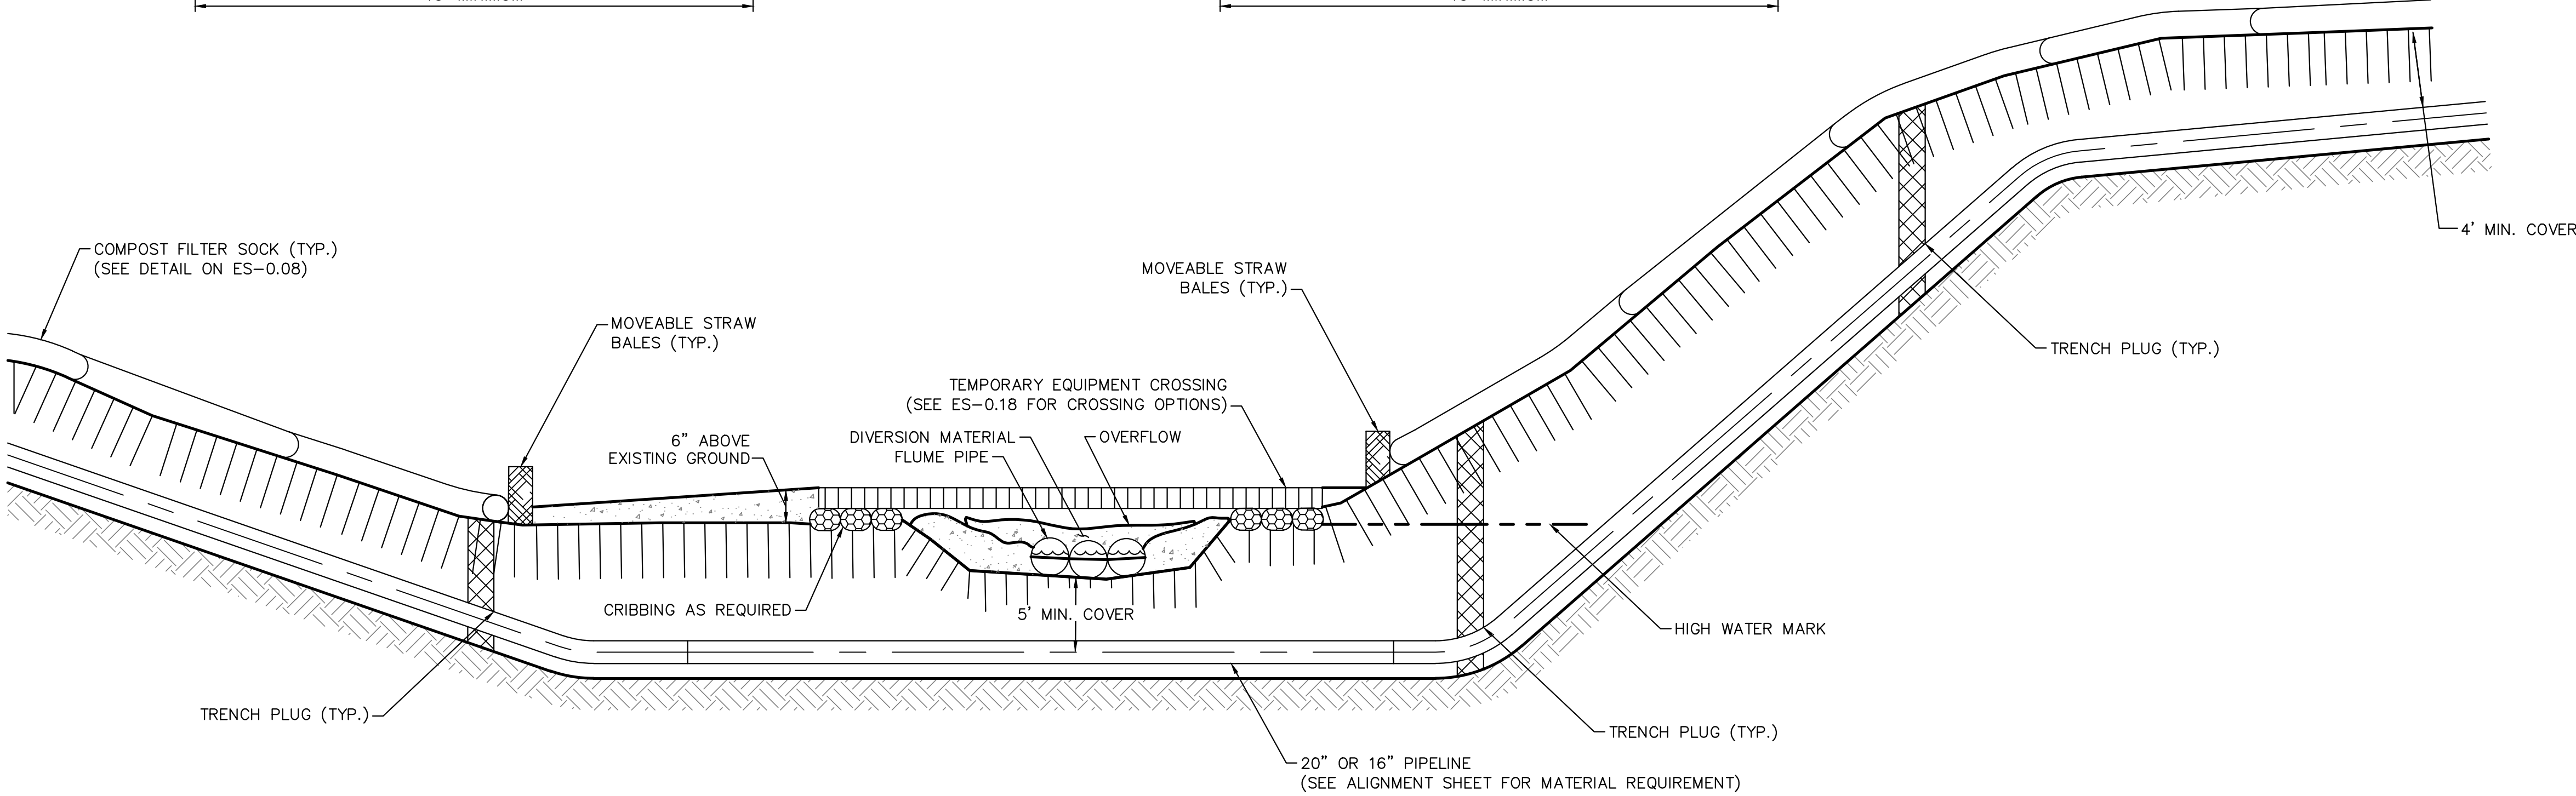
**TYPICAL PIPELINE INSTALLATION STREAM CROSSING -  
DRY FLUME DETAIL**  
NOT TO SCALE

- NOTES:**
1. SEE PLAN SHEETS FOR FLOODWAY AND FLOODPLAIN LOCATIONS AND FOR REFERENCE TO SITE-SPECIFIC STREAM CORRING DRAWINGS.
  2. THE FLUME SHOULD BE OF SUFFICIENT SIZE TO CONVEY NORMAL STREAM FLOW OVER THE OPEN TRENCH (MINIMUM SIZE OF 12 INCHES);
