PITT-02-19-016

February 1, 2019

**Re: Sunoco Pipeline L.P. – Pennsylvania Pipeline Project (Mariner East II)  
Chapter 105 Permit No. E07-459 – Major Modification  
Modification Request for Reroute and Installation Method Change at Piney Creek HDD  
Woodbury Township, Blair County, PA**

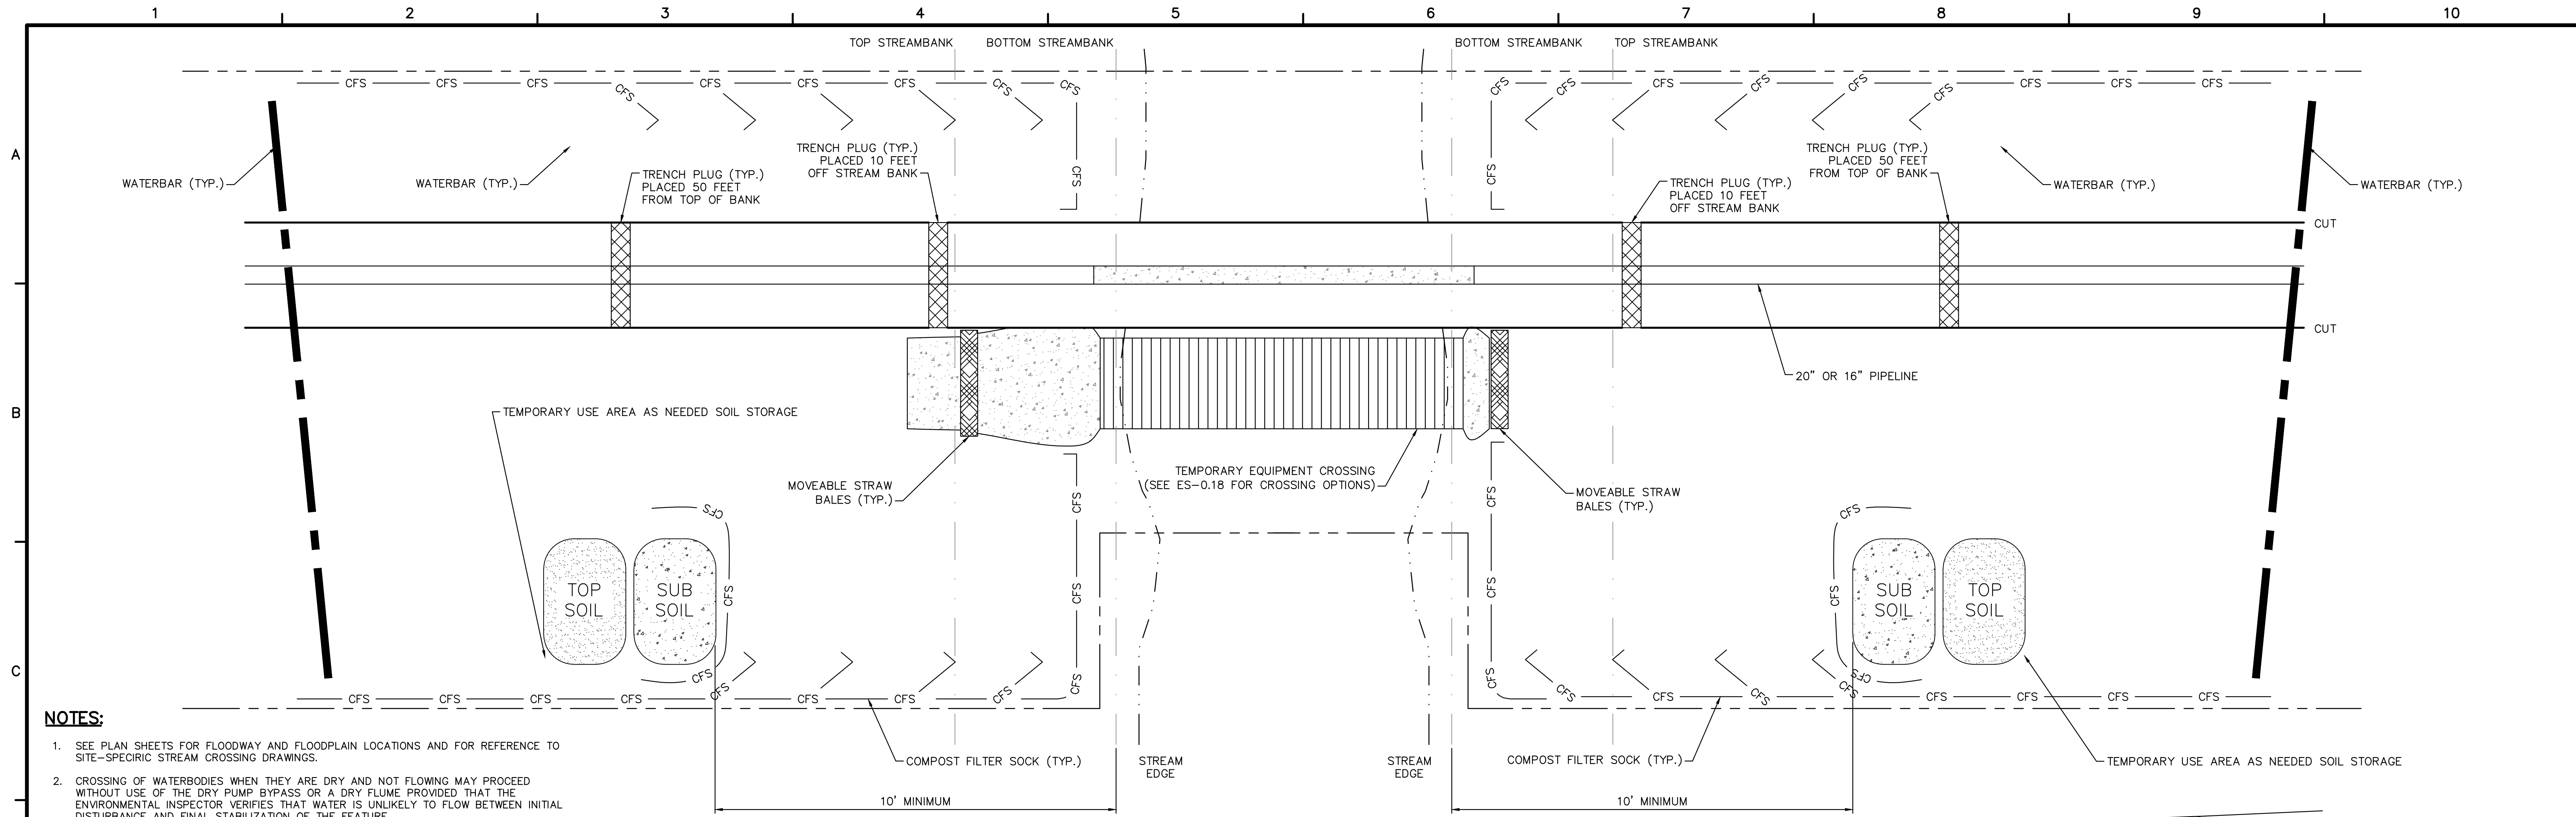
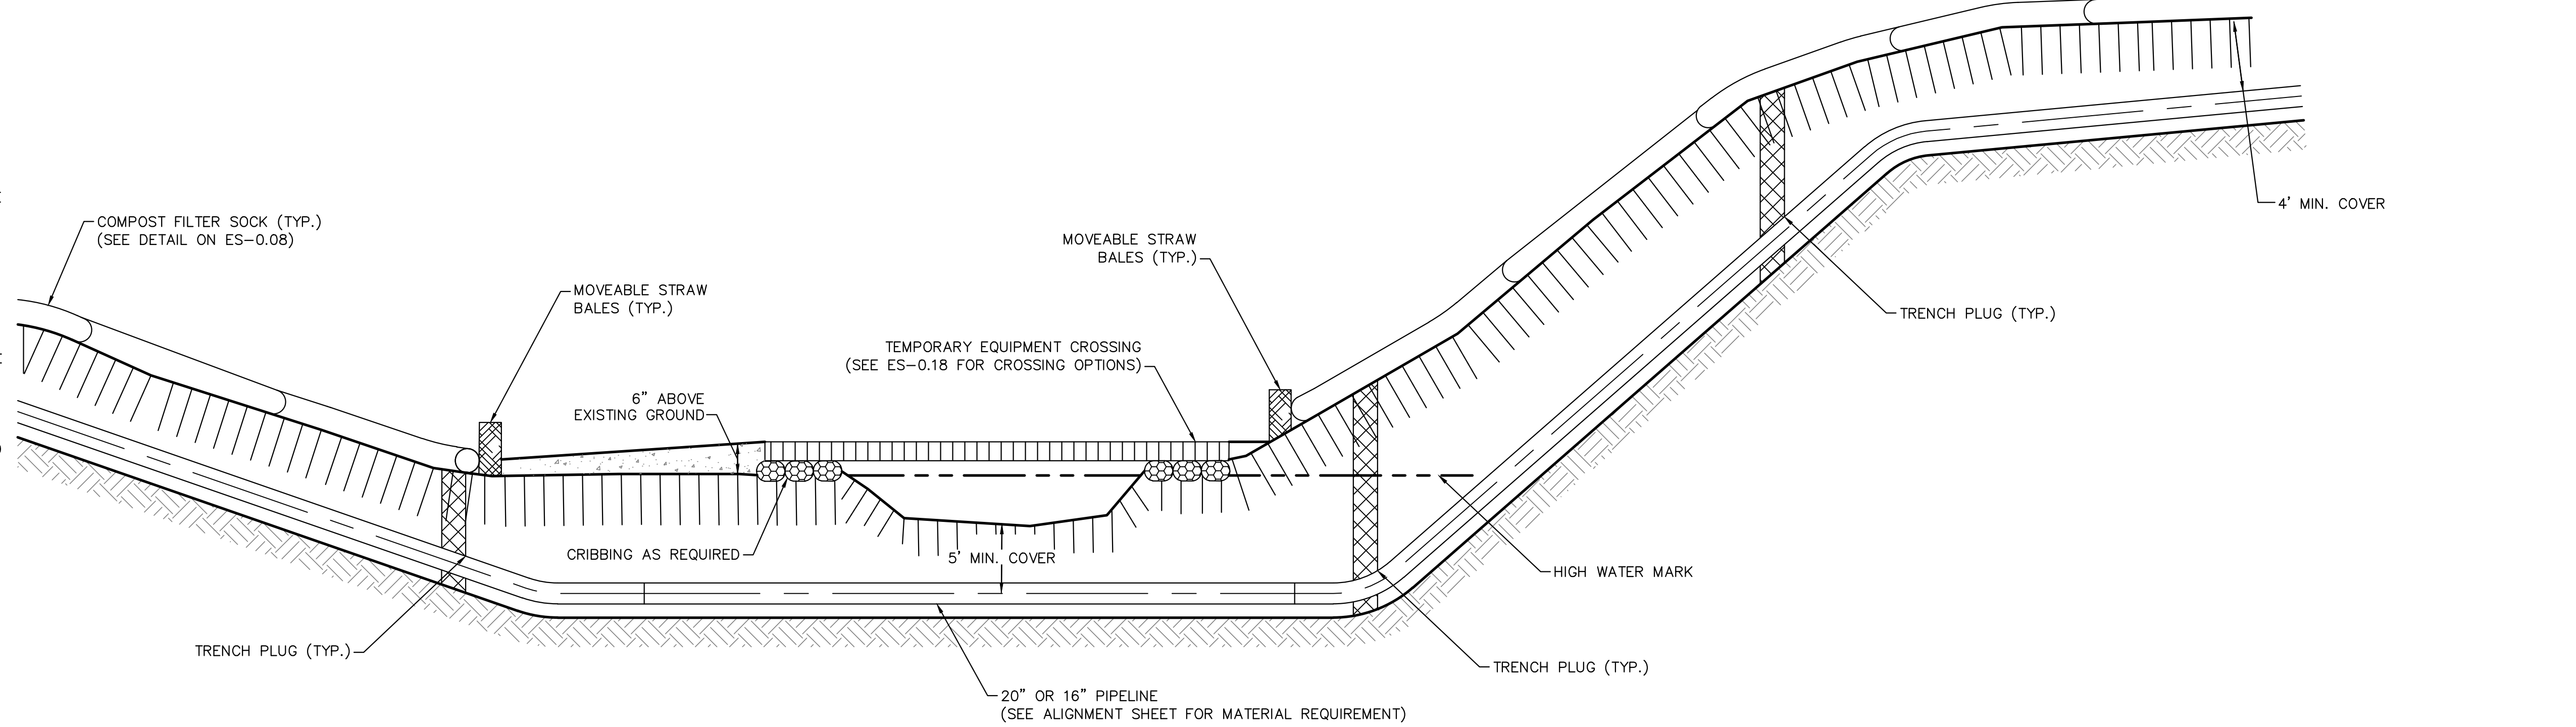
**TYPICAL PIPELINE INSTALLATION STREAM CROSSING –  
DRY OPEN CUT DETAIL**  
NOT TO SCALE

- NOTES:**
- SEE PLAN SHEETS FOR FLOODWAY AND FLOODPLAIN LOCATIONS AND FOR REFERENCE TO SITE-SPECIFIC STREAM CROSSING DRAWINGS.
  - CROSSING OF WATERBODIES WHEN THEY ARE DRY AND NOT FLOWING MAY PROCEED WITHOUT USE OF THE DRY PUMP BYPASS OR A DRY FLUME PROVIDED THAT THE ENVIRONMENTAL INSPECTOR VERIFIES THAT WATER IS UNLIKELY TO FLOW BETWEEN INITIAL DISTURBANCE AND FINAL STABILIZATION OF THE FEATURE.

All the streams will be crossed via the open cut method with the appropriate dam and pump bypass installed to convey stream flow across the workspace and outlet downstream within the permitted limit-of-disturbance, such that work will be conducted in a dry stream channel. After the stream bypasses are in place, the trench will be excavated, and the 16-inch pipe will be installed via the open trench method through the dry streambeds in accordance with all permit conditions and requirements. In order to efficiently complete all construction activities and minimize resource impacts, SPLP is proposing a 50-foot-wide limit of disturbance (LOD) across the two perennial streams (Piney Creek, S-M30 and UNT to Piney Creek, S-M33). Timber mats and bridges will be placed within the travel lane where the streams are crossed to avoid soil compaction, allow for trench excavation, stream substrate segregation, and stockpiling of excavated materials in adjacent upland areas. Once the pipe and appropriate trench plugs are installed, the trench will be backfilled, and restored to pre-existing conditions. All work will be conducted in accordance with permit conditions/requirements as well as the revised/updated Erosion & Sediment and Restoration plan (refer to *Attachment D* of this permit modification). The reroute will not result in any loss of wetland area or water quality/quantity, and the localized stream impacts are considered minor and temporary.

The 0.57-mile reroute would involve conventional open trench excavation through three (3) streams including two that were crossed by the original route, and no wetlands (refer to *Attachments C and E* for additional information about these water resources): wetland M26 (PEM), an Exceptional Value (EV) wetland, crossed by the original route will be avoided. All work will be conducted in accordance with permit conditions/requirements as well as the E&S and restoration plans (refer to Appendix D of this permit modification). The crossing will not result in any loss of wetland area or water quality/quantity and the localized impacts are considered minor and temporary.
