Appendix D: Permittee Responsible Mitigation Plan

# Permittee-Responsible Mitigation Plan for the Tioga Pathway Project

# **Camp Brook PRM Site**

Elkland Borough, Tioga County, Pennsylvania National Fuel Gas Supply Corporation

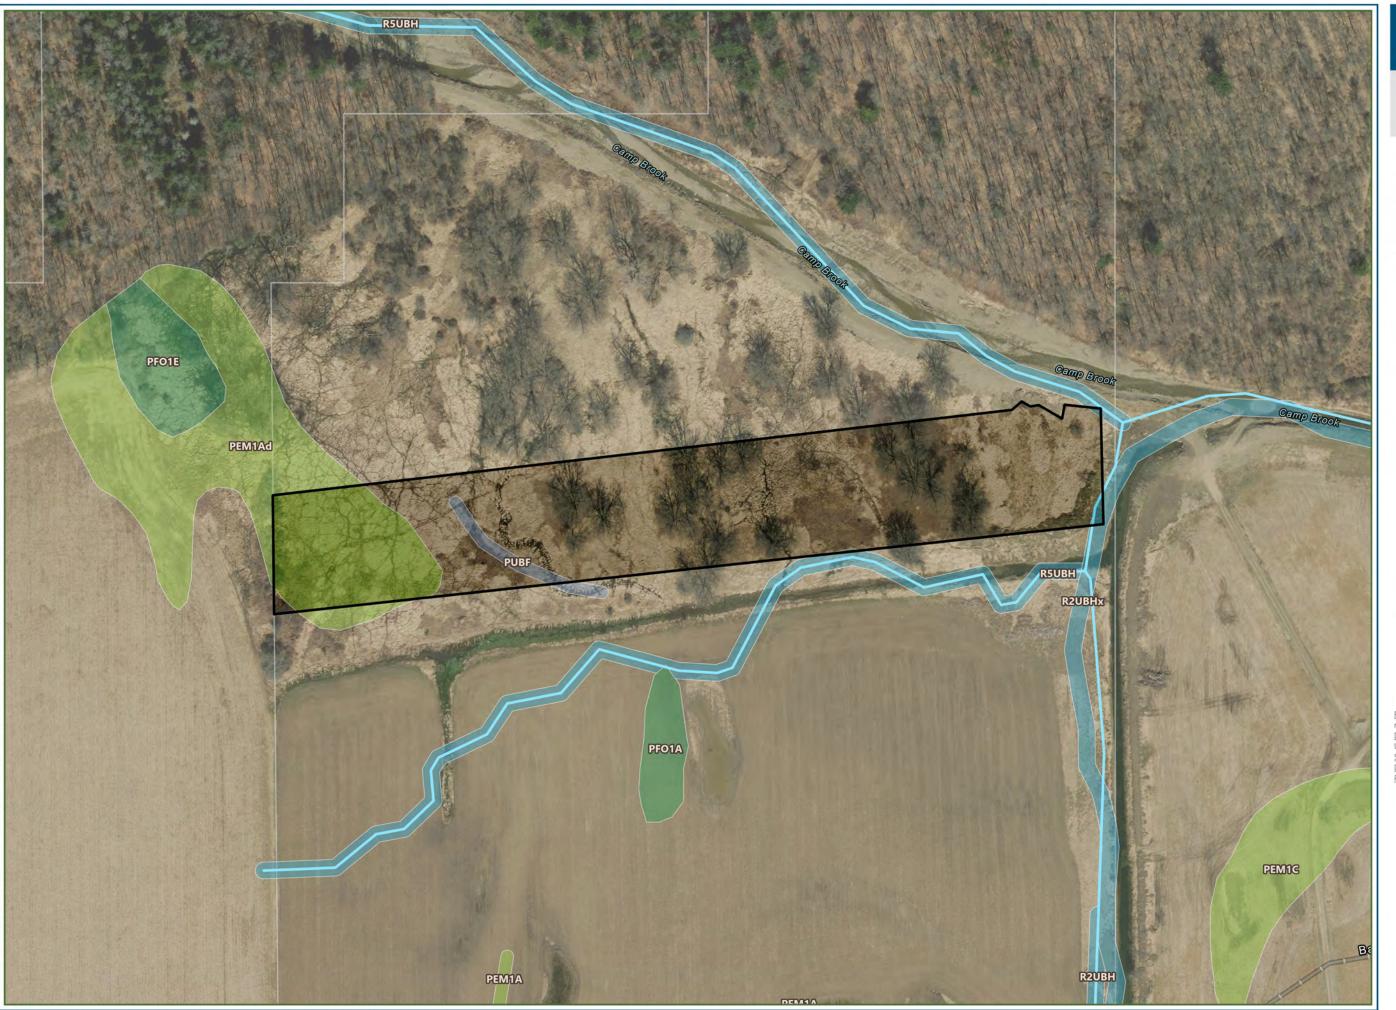
# Figure 3A Existing Conditions

Figure 3A: Existing Conditions Map (Appendix A) shows the delineated resources within PRM Site of the CBRS. Additionally, Figure 8: Topographic Map highlights the topographic contours and elevations at the PRM Site used to aid in the delineation. The CBRS, which has a contributing drainage of approximately 0.49 square miles, drains to a direct tributary to Camp Brook. A drainage area and FEMA floodway map is provided in Appendix A: Figures, as Figure 9: FEMA Map.

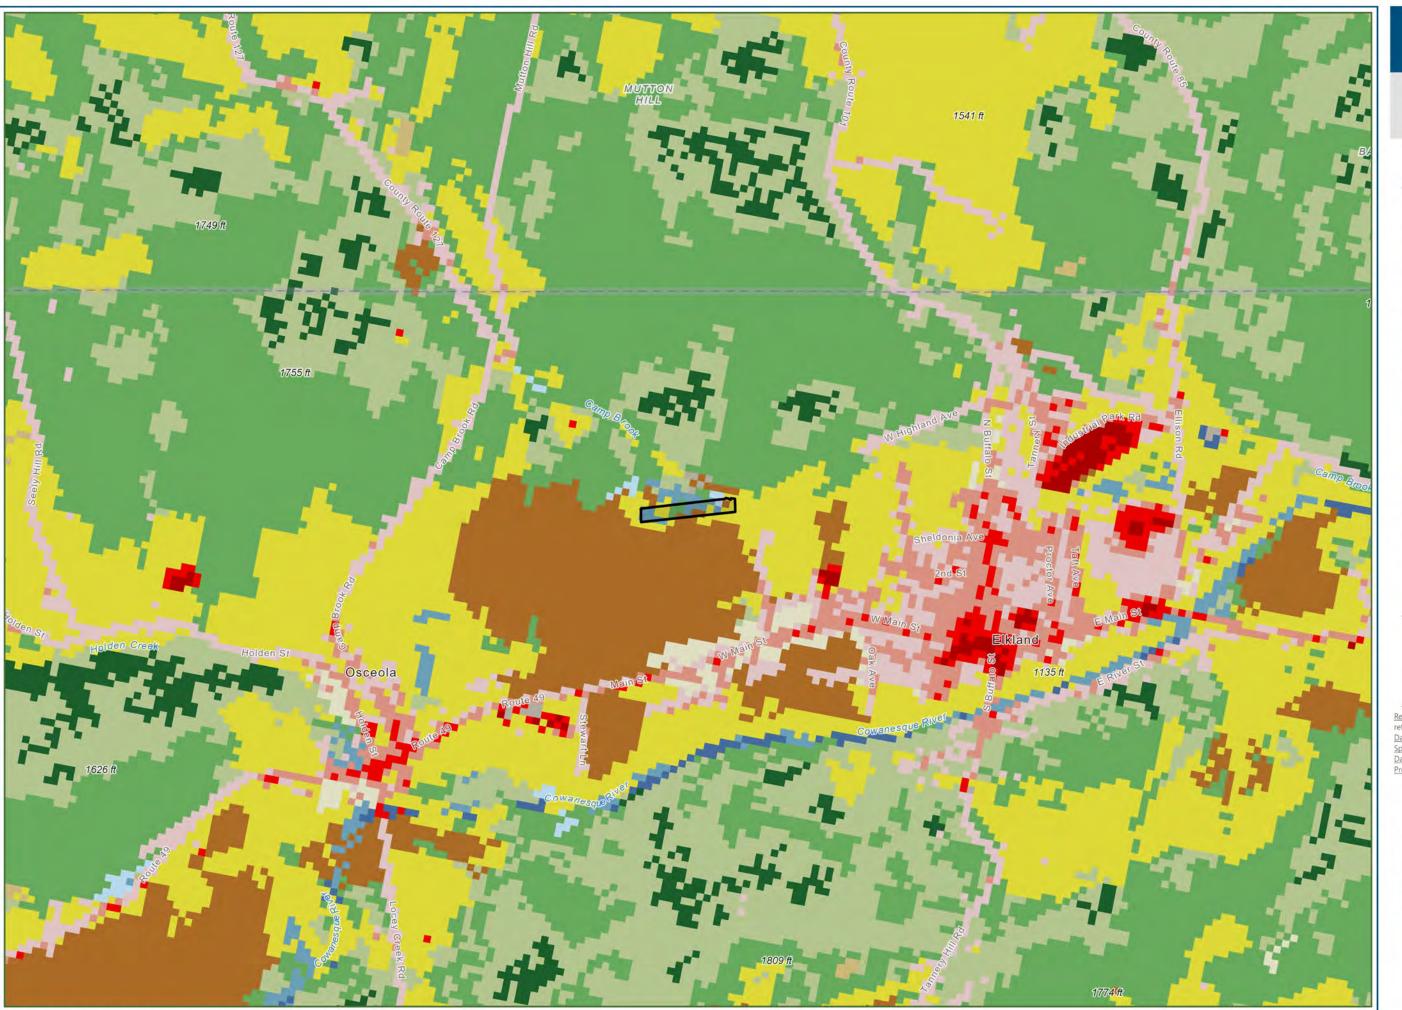
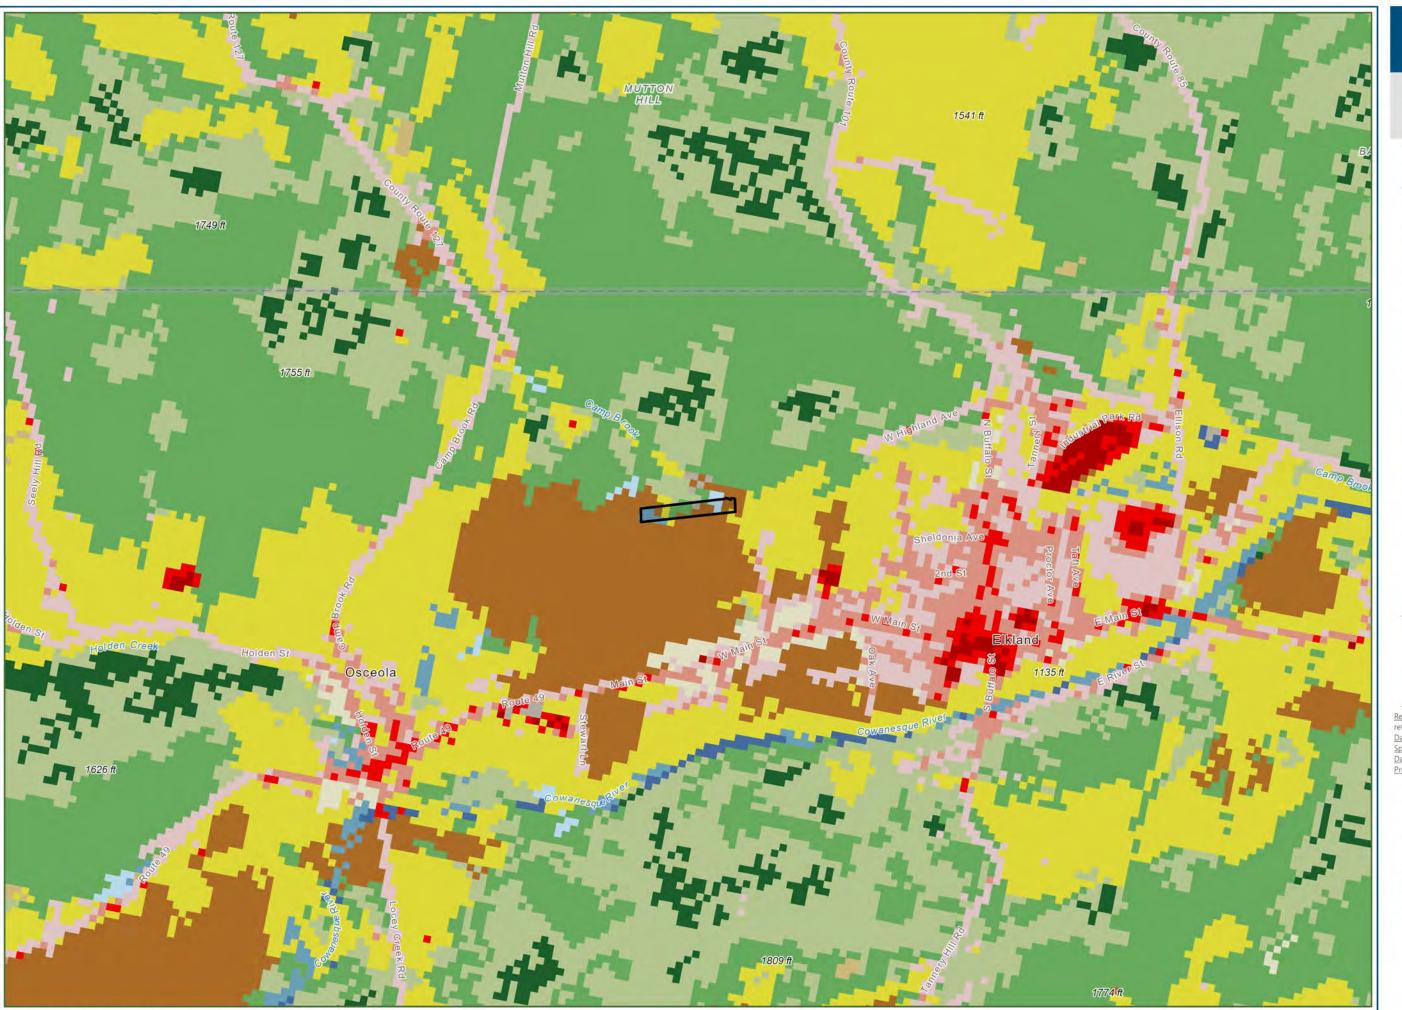
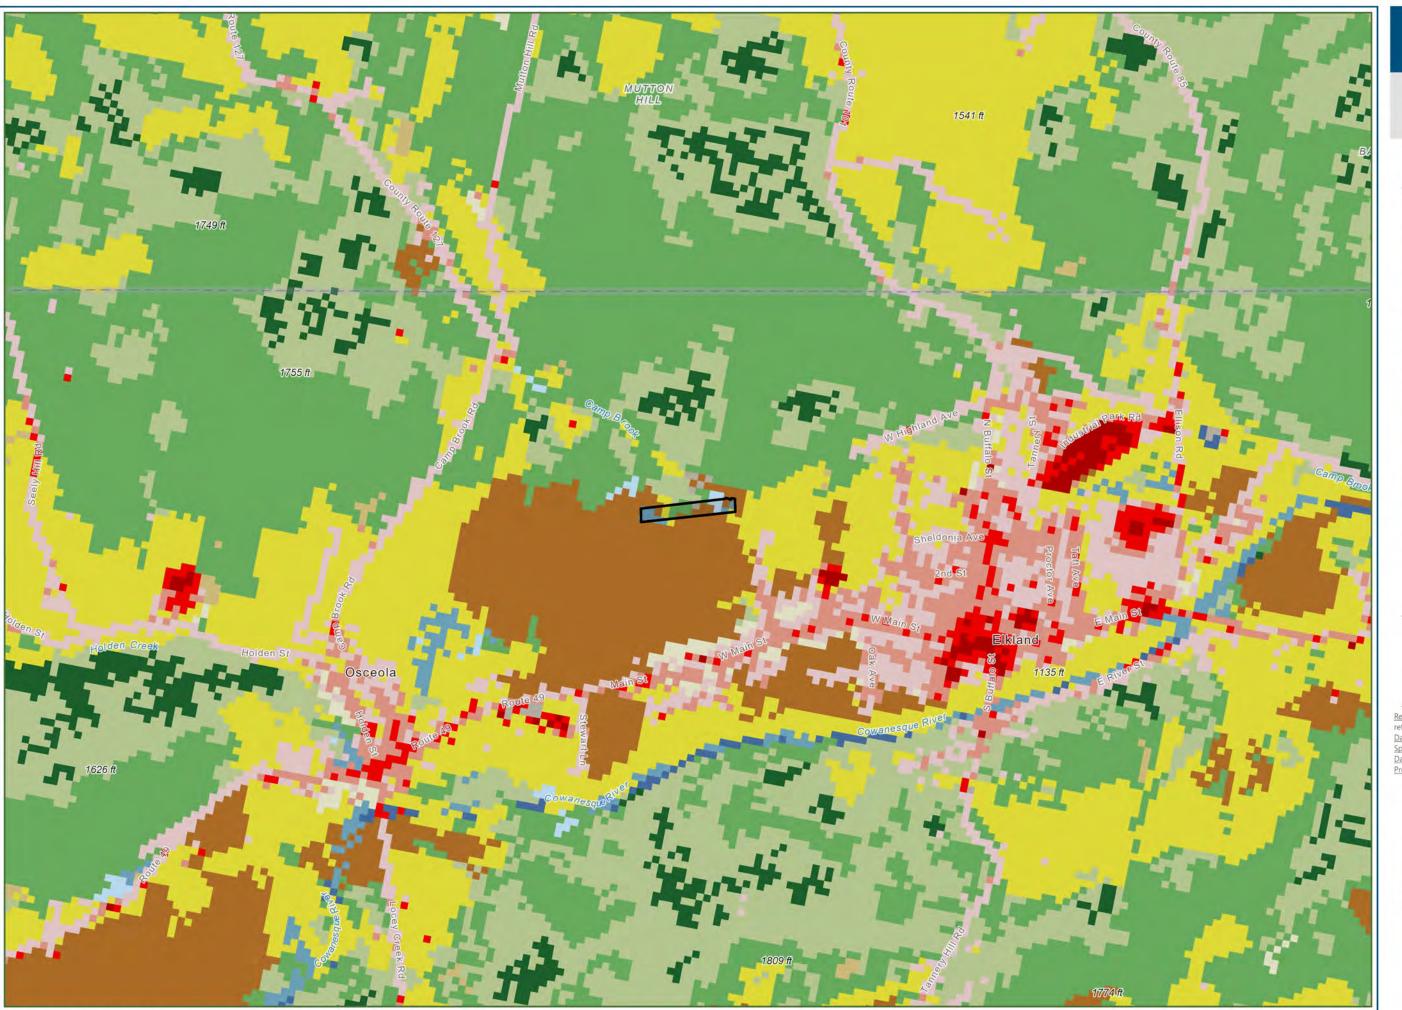
The on-site existing conditions of the PRM Site make it a very attractive mitigation site for restoration opportunities like those described above. Tributaries within the proposed PRM Site are first order in nature, are primarily characteristic of headwaters and exhibit degradation due to agricultural activities. The Camp Brook watershed is rural and heavily influenced by agricultural practices which has resulted in ongoing water quality degradation. Land cover within the PRM Site is primarily agricultural (pasture/hay and cultivated crops) (Appendix A, Figure 5 Series: National Land Cover Series).

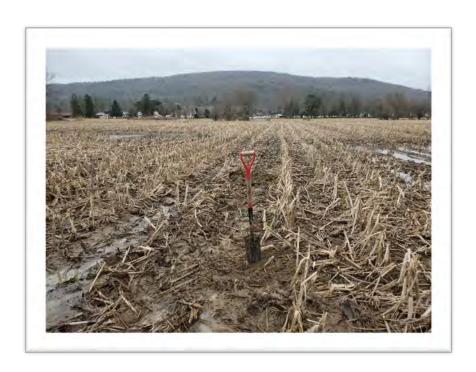
Photo 1: Representative Disturbed PEM Overview, Wetland W1-PEM, Sampling Point DPK025, Facing South, Hydrology and Disturbance of Vegetation/Soil from Crop Planting

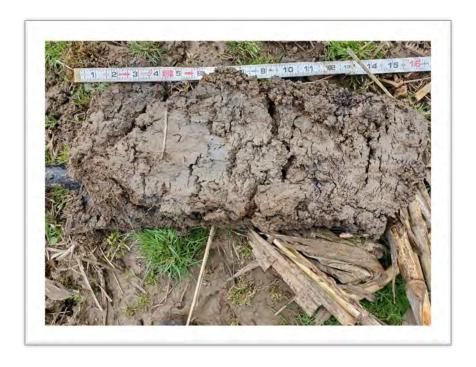
Photo 2: Soil Core, Wetland W1-PEM, Sampling Point DPK015 Showing Hydric F3
Depleted Matrix Indicator

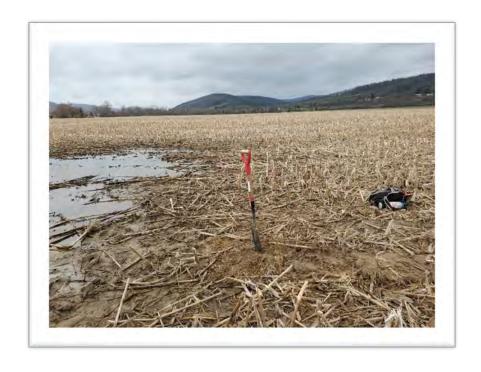
Photo 6: Representative of Wetland Lacking Hydrophytic Vegetation Due to Severe Disturbance, W1-PEM, DPK022, Note Surface Water

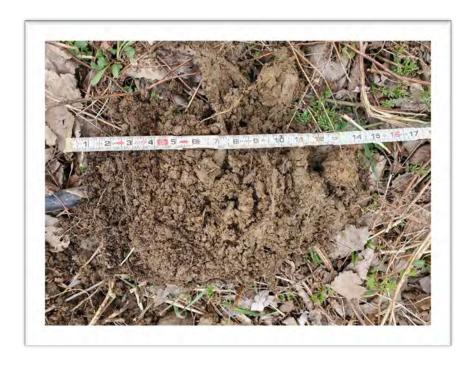
Photo 8: Soil Core of Wetland W1-PFO, Sampling Point DPK008, Showing F3
Depleted Matrix Hydric Soil Indicator

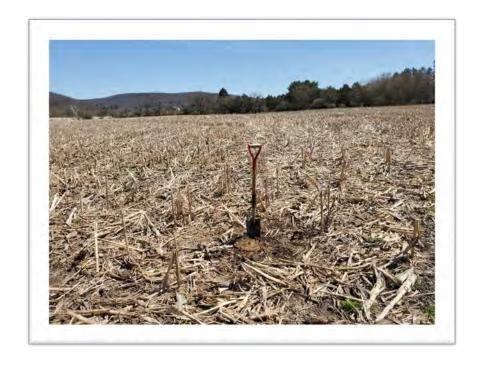
Photo 14: Representative PEM Overview, Wetland 6-PEM, Sampling Point DPK036, Facing East, Note Severe Disturbance and Lacking Hydrophytic Vegetation

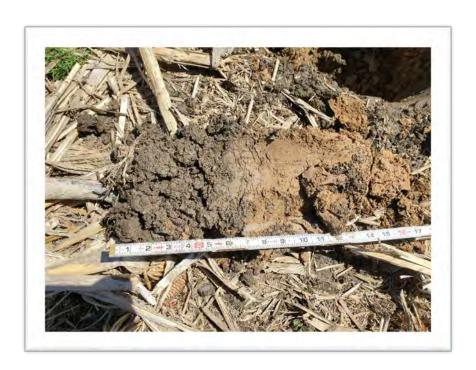
Photo 15: Soil Core of Wetland W6-PEM, Sampling Point DPK036 Showing F3
Depleted Matrix Hydric Soil Indicator With Oxidized Rhizospheres On Living Roots

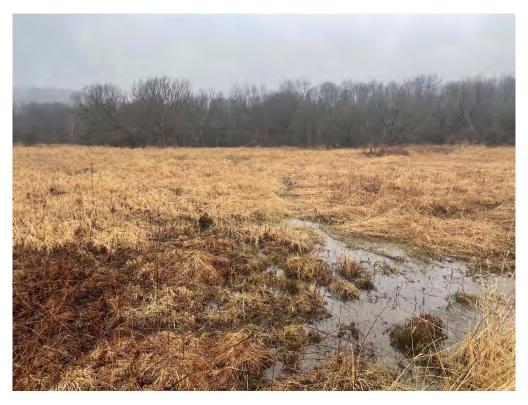
Photograph 1: Overview of existing PEM wetland dominated by *Phalaris arundinacea* (reed canary grass) within the proposed PRM site.

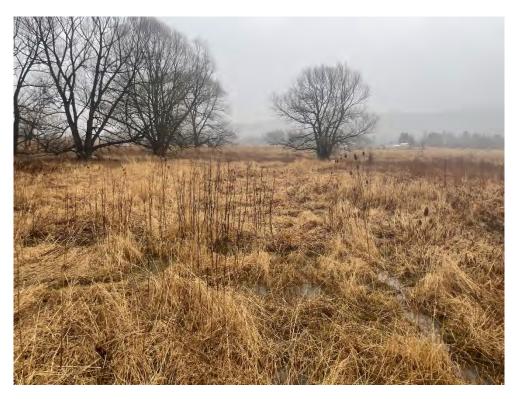
Photograph 3: Invasive dominated PEM wetlands within the proposed PRM site.

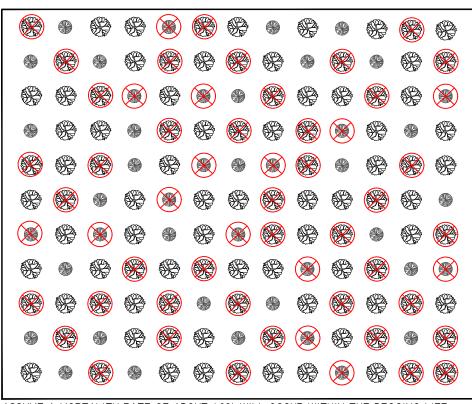
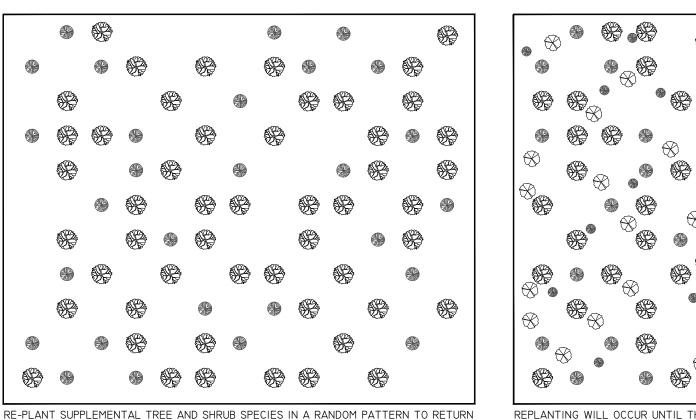
MATRIX PLANTING PLAN DETA	١L
---------------------------	----

ASSUME A MORTALITY RATE OF ABOUT 40% WILL OCCUR WITHIN THE BEGGING LIFE CYCLE OF THE SITE, CAUSING THE GRID PATTERN TO DISSIPATE. ACTUAL MORTALITY TO BE VERIFIED DURING MONITORING.

REPLANTING WILL OCCUR UNTIL THE SITE RETURNS TO THE REQUIRED DENSITIES PER ACRE AND THE SITE HAS BEEN CLOSED OUT
