Permittee-Responsible Mitigation Plan for the Tioga Pathway Project

Camp Brook PRM Site

Elkland Borough, Tioga County, Pennsylvania
National Fuel Gas Supply Corporation

**February 2025
REVISED June 2025**

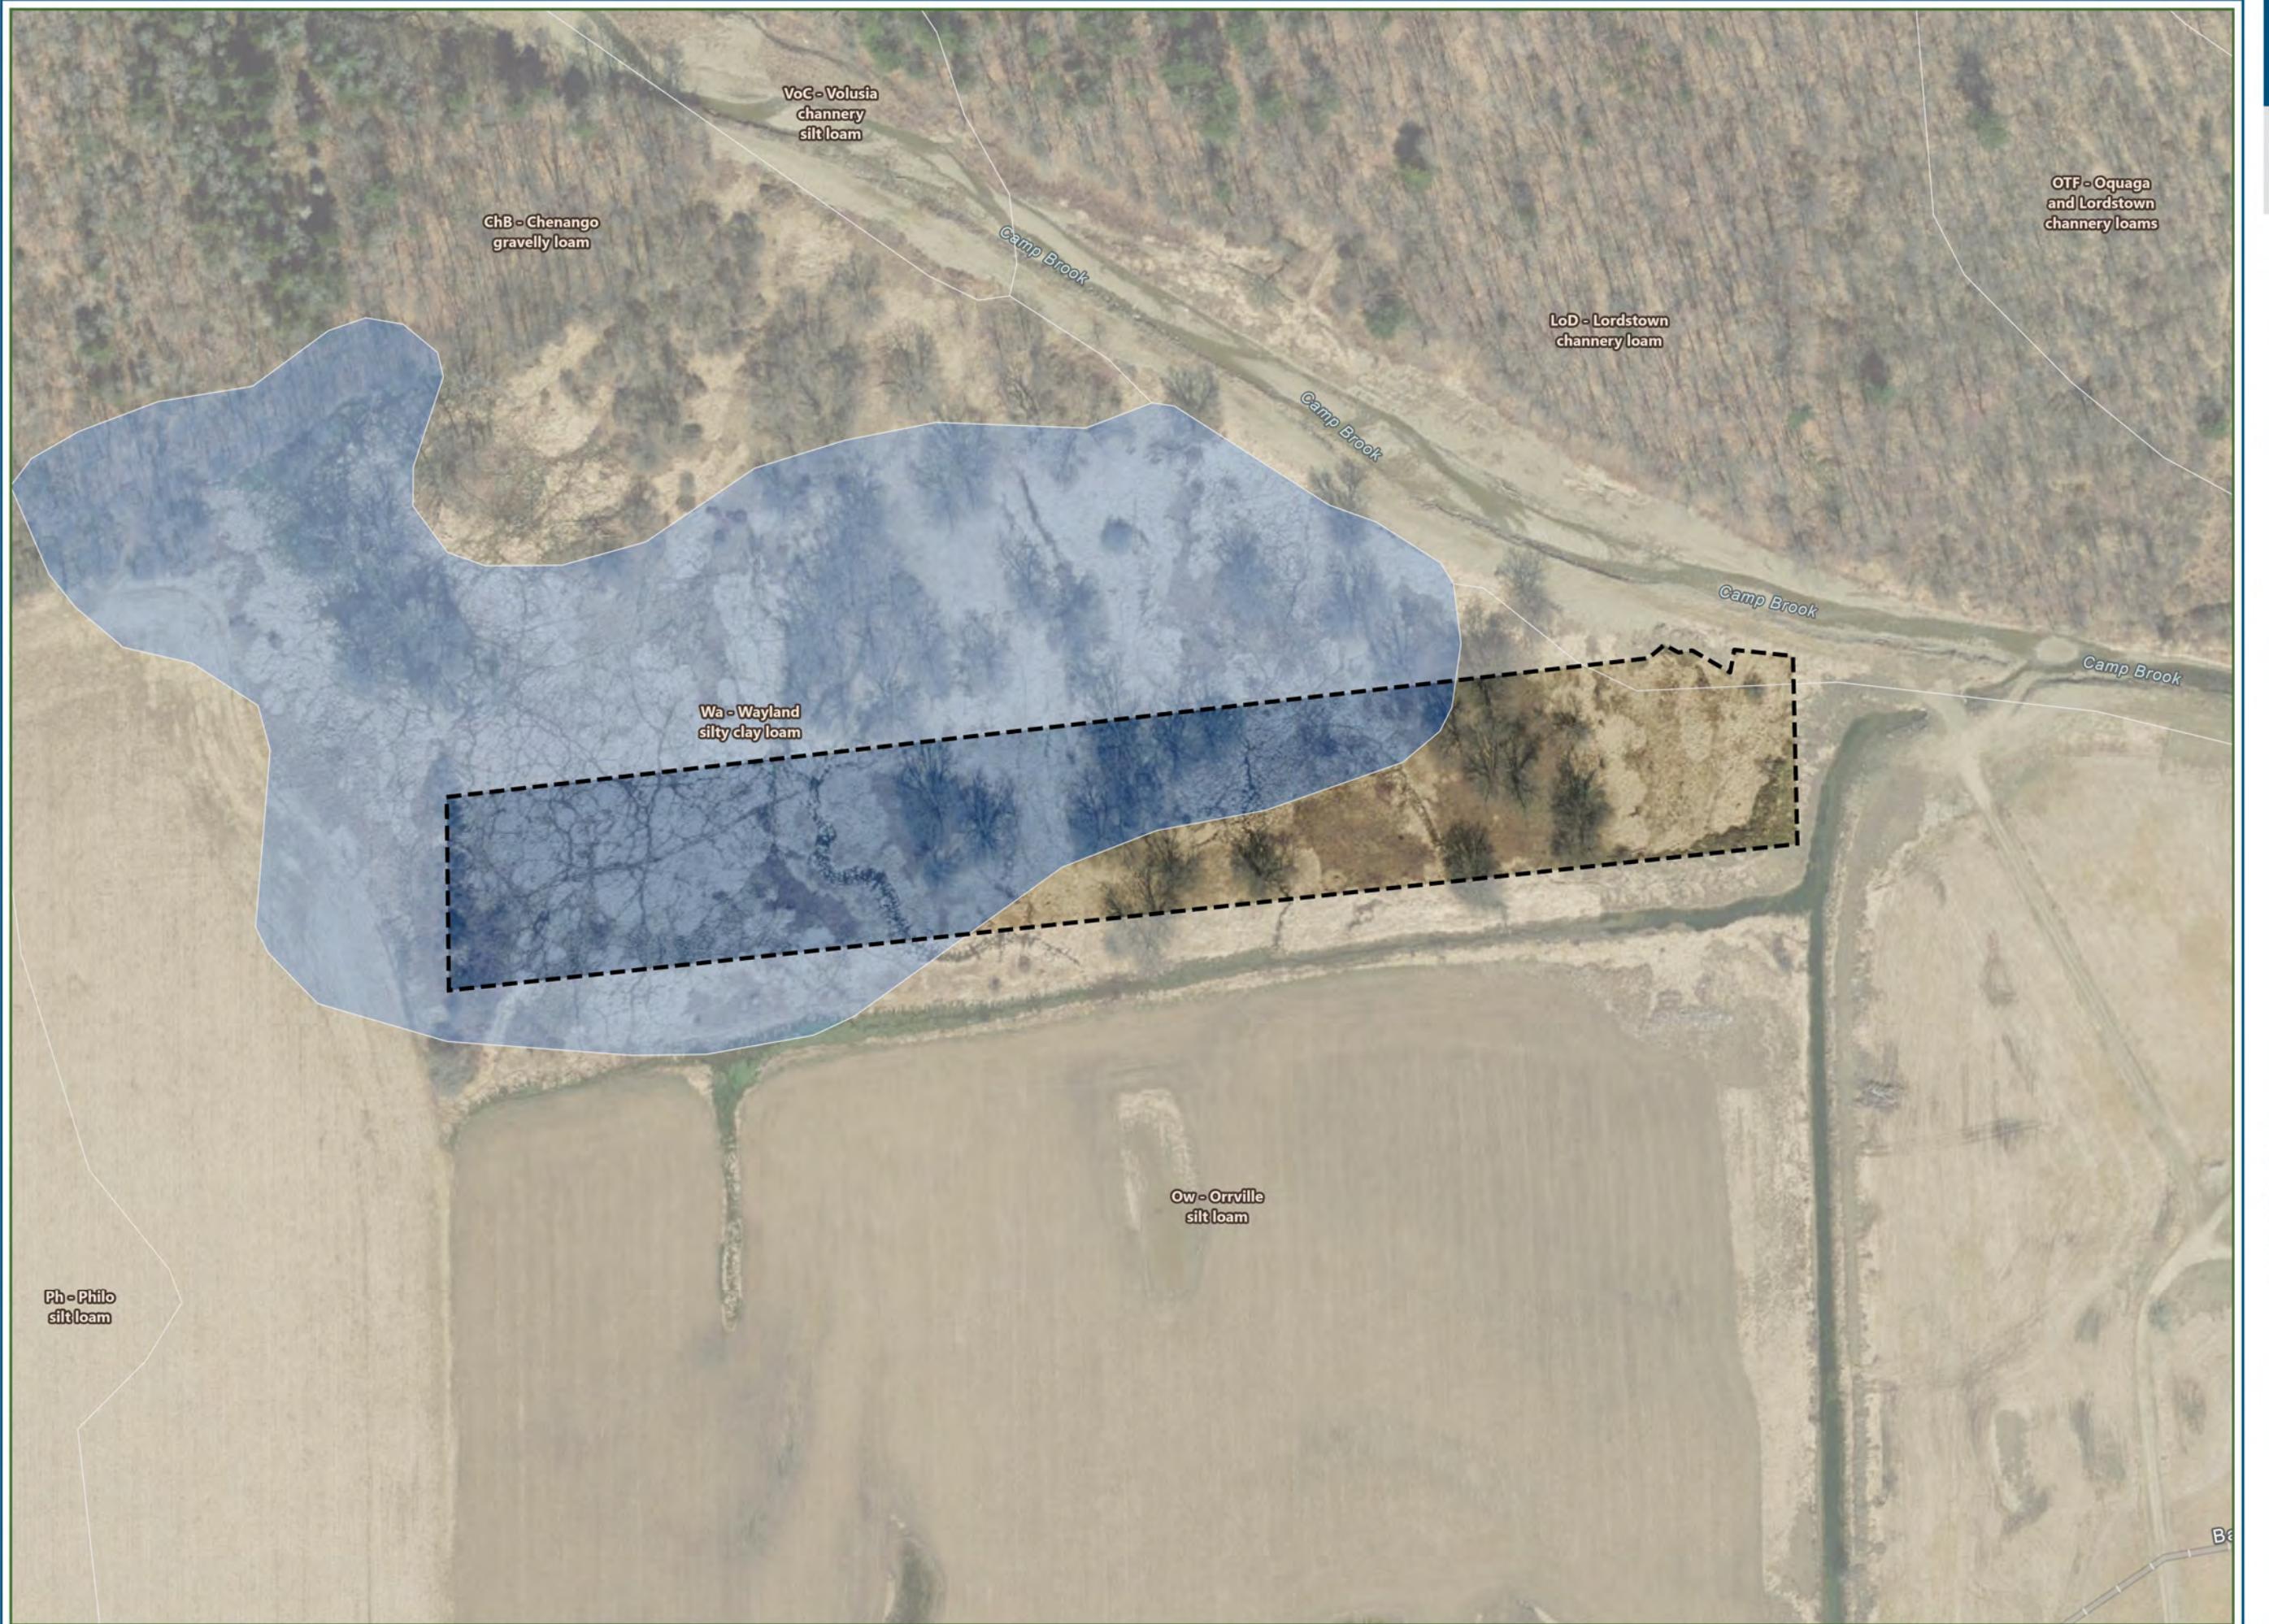
Figure 8
Topography

Contours (10ft)

Contours (2ft)

Figure 3A: Existing Conditions Map (Appendix A) shows the delineated resources within PRM Site of the CBRS. Additionally, Figure 8: Topographic Map highlights the topographic contours and elevations at the PRM Site used to aid in the delineation. The CBRS, which has a contributing drainage of approximately 0.49 square miles, drains to a direct tributary to Camp Brook. A drainage area and FEMA floodway map is provided in Appendix A: Figures, as Figure 9: FEMA Map.

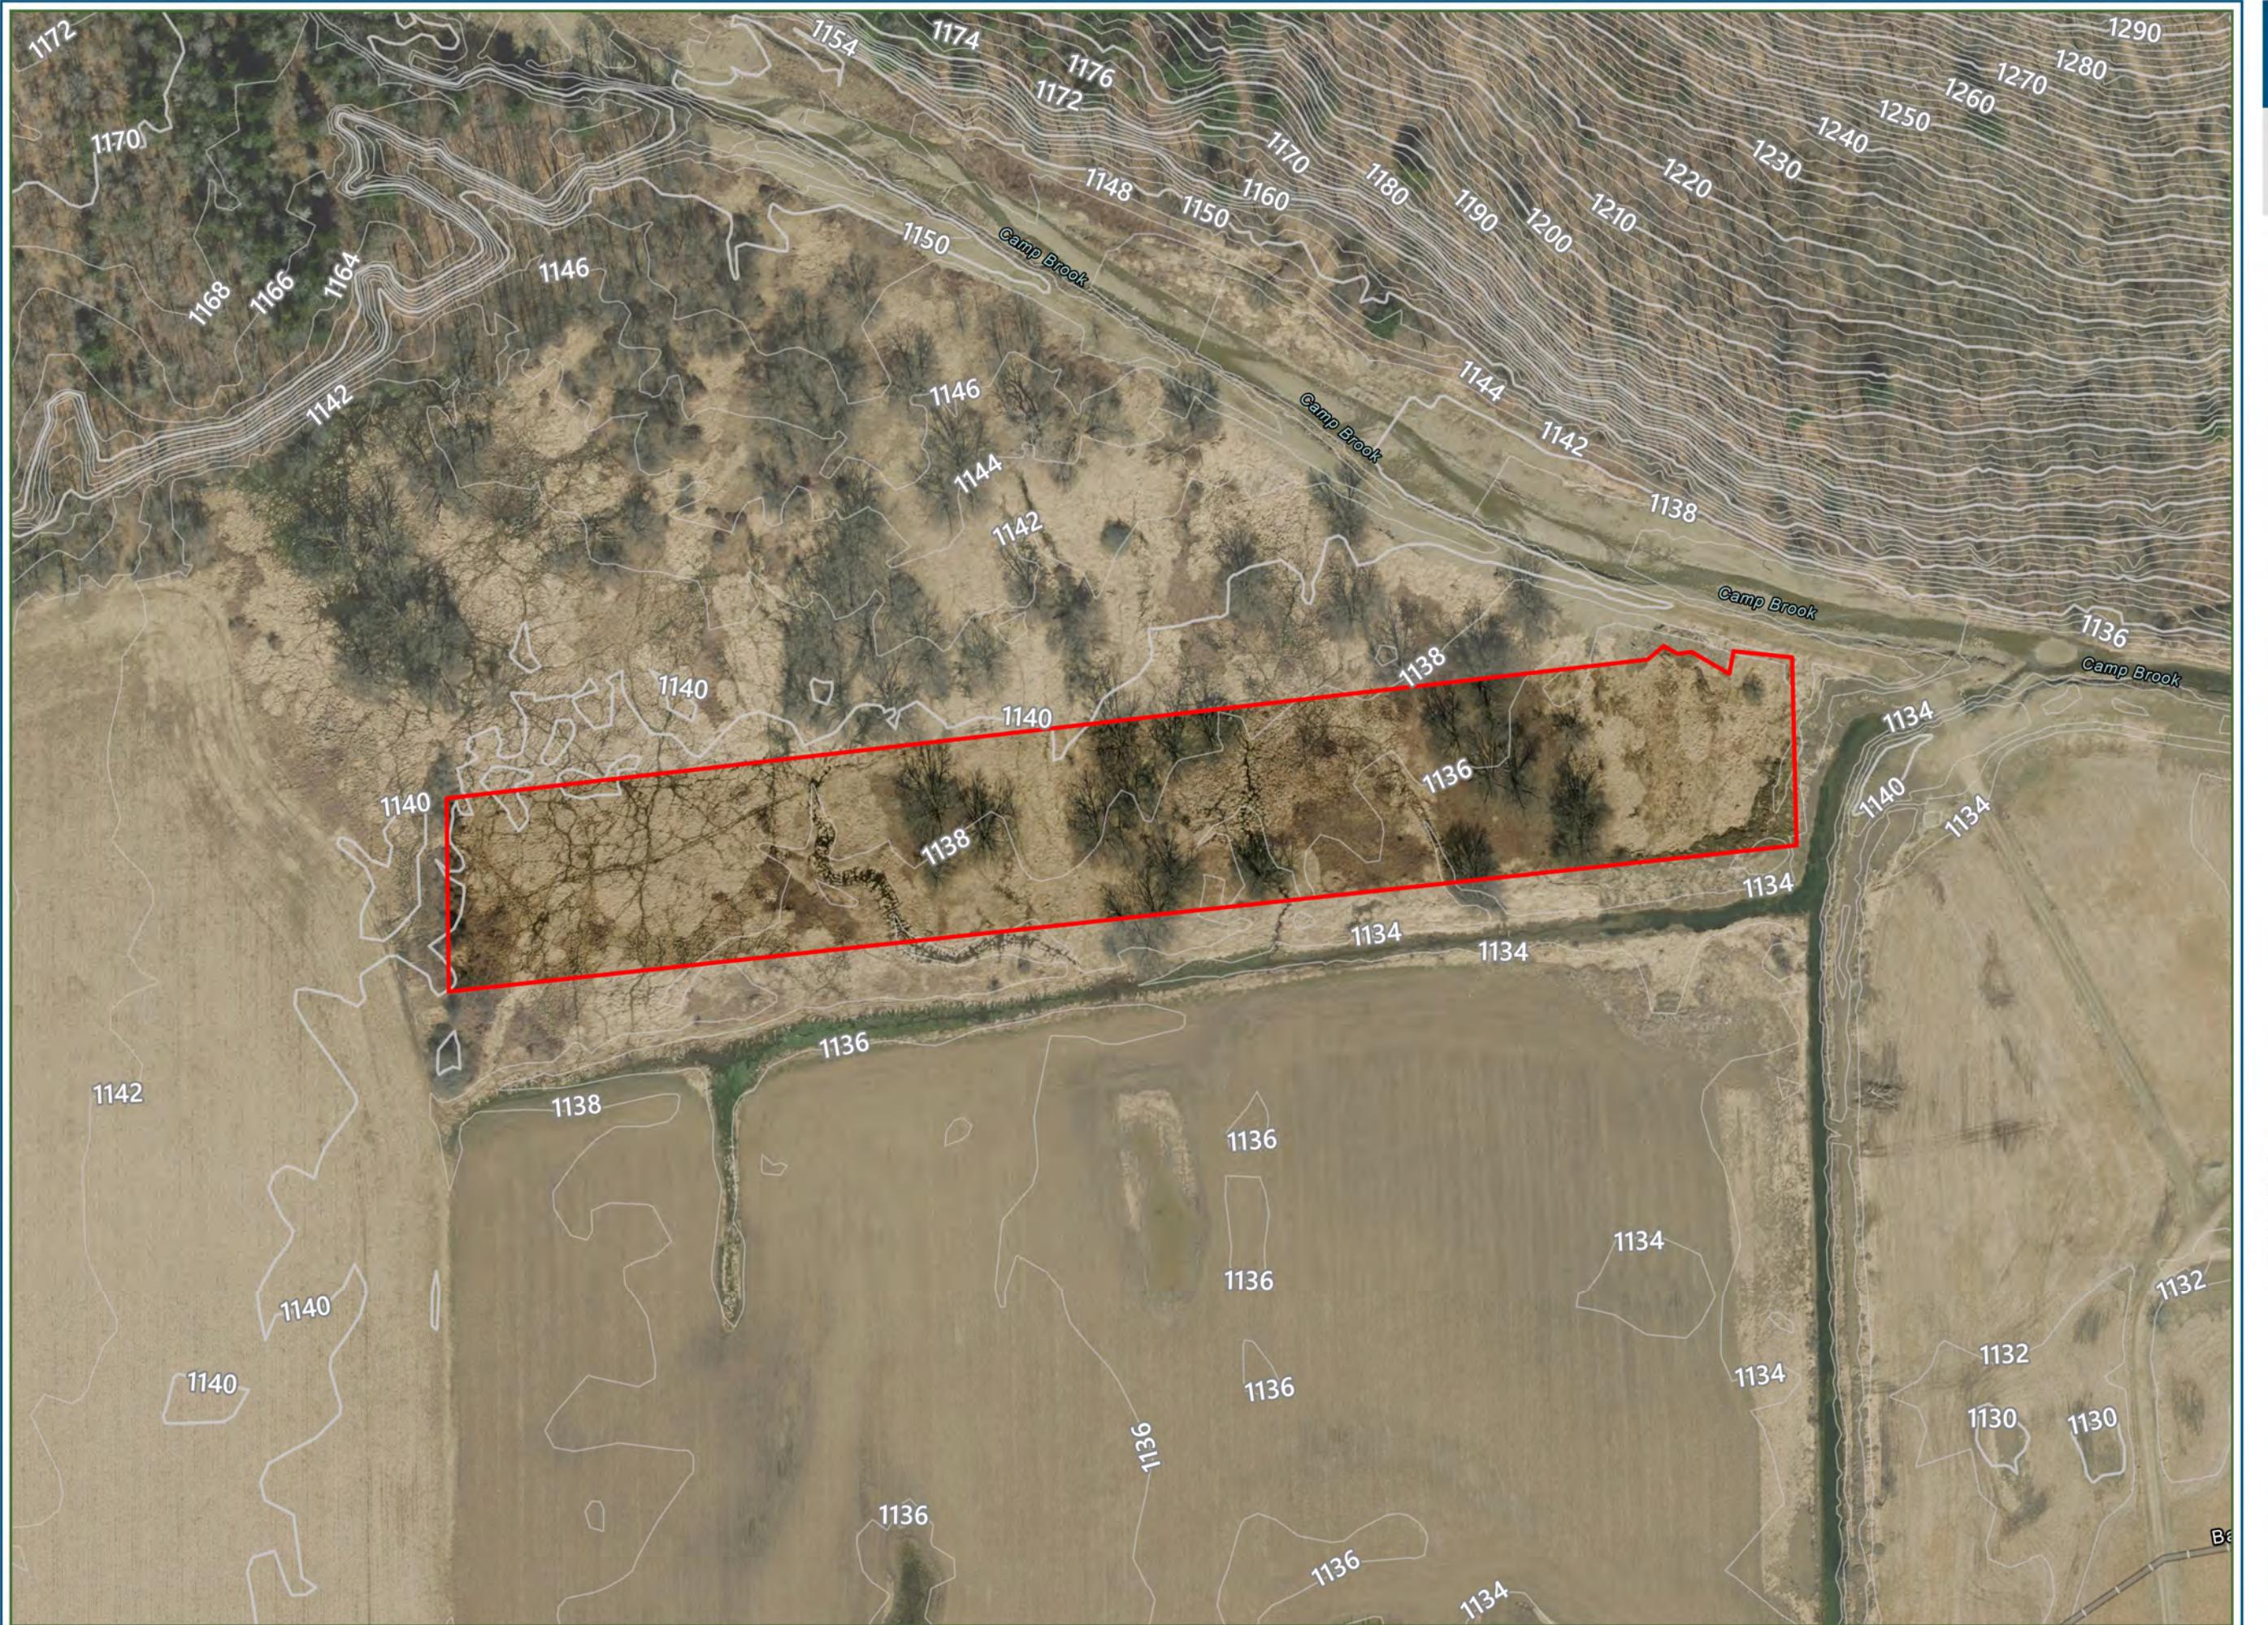
Figure 9
FEMA Flood Hazards

1% Annual Chance Flood Hazard

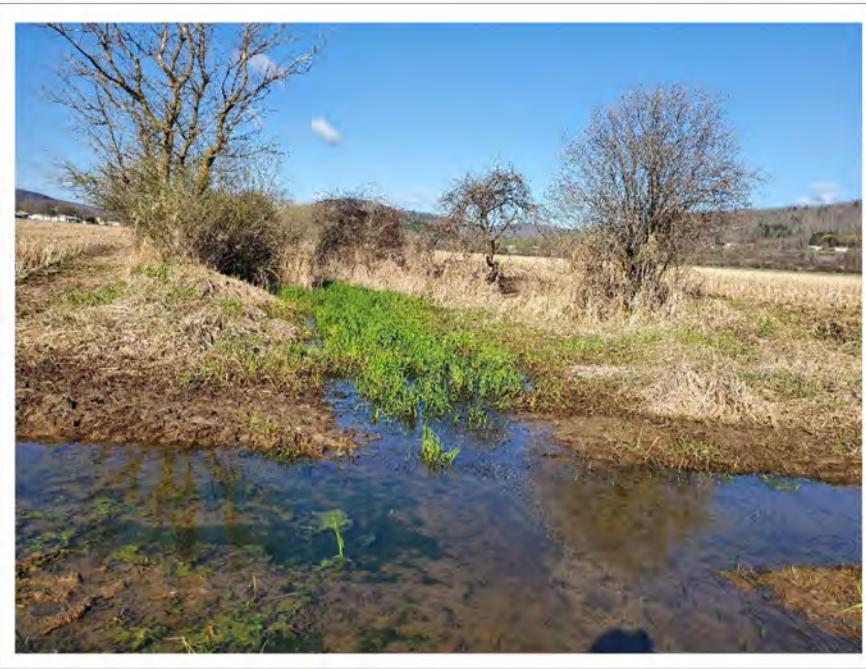
Photo 3: Stream S1, Perennial, Facing Upstream Through Emergent Wetland 1 Complex, Large Presence of Invasive Reed Canary Grass

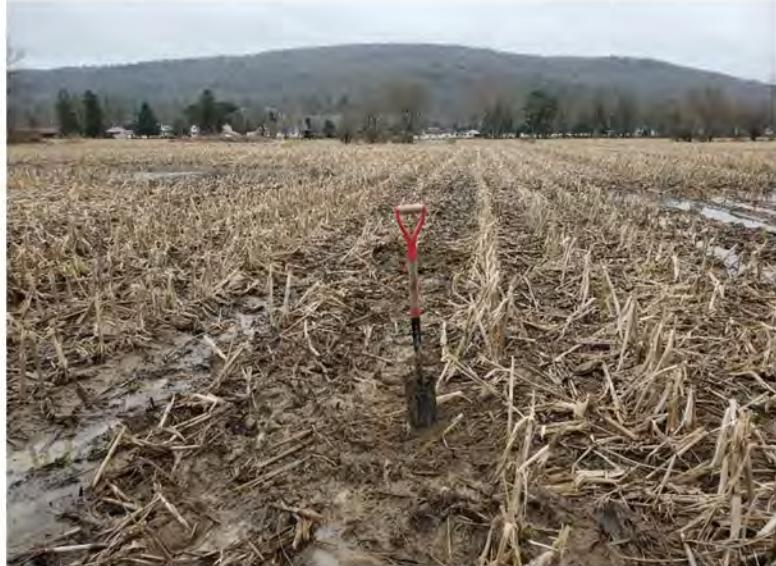
Photo 1: Representative Disturbed PEM Overview, Wetland W1-PEM, Sampling Point DPK025, Facing South, Hydrology and Disturbance of Vegetation/Soil from Crop Planting

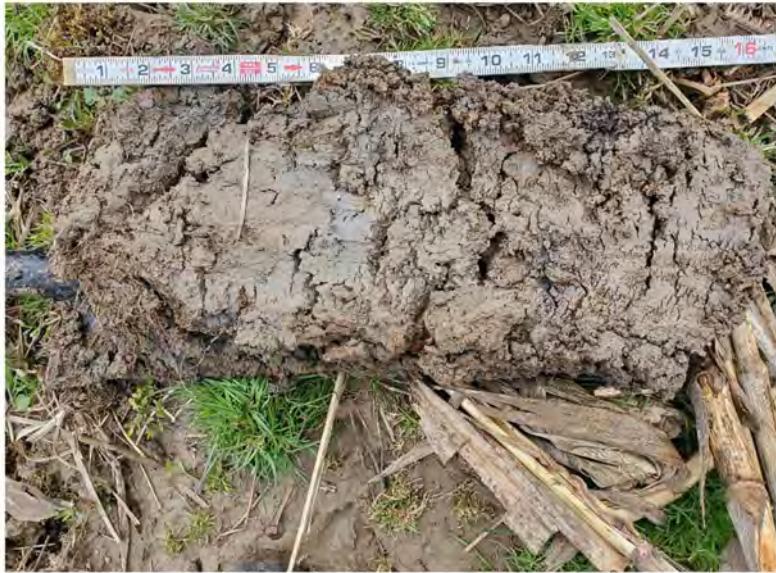
Photo 2: Soil Core, Wetland W1-PEM, Sampling Point DPK015 Showing Hydric F3 Depleted Matrix Indicator

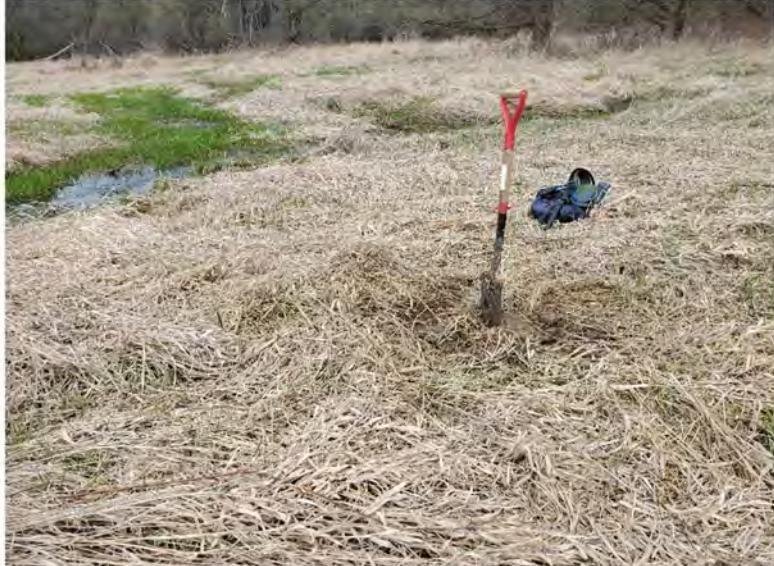
Photo 3: Representative Open Field PEM Overview, Wetland W1-PEM, Sampling Point DPK012, Facing North, Hydrophytic Reed Canary Grass Monoculture

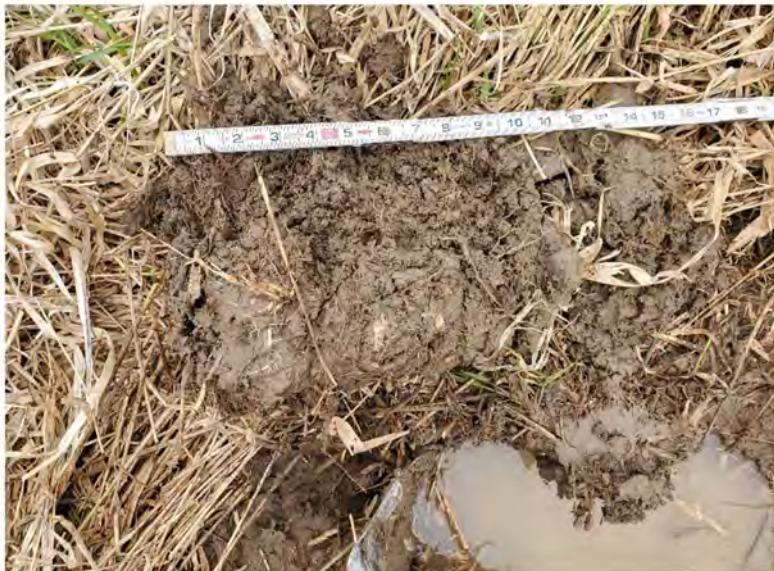
Photo 4: High Water Table Hydrology of Wetland W1-PEM, Sampling Point DPK010

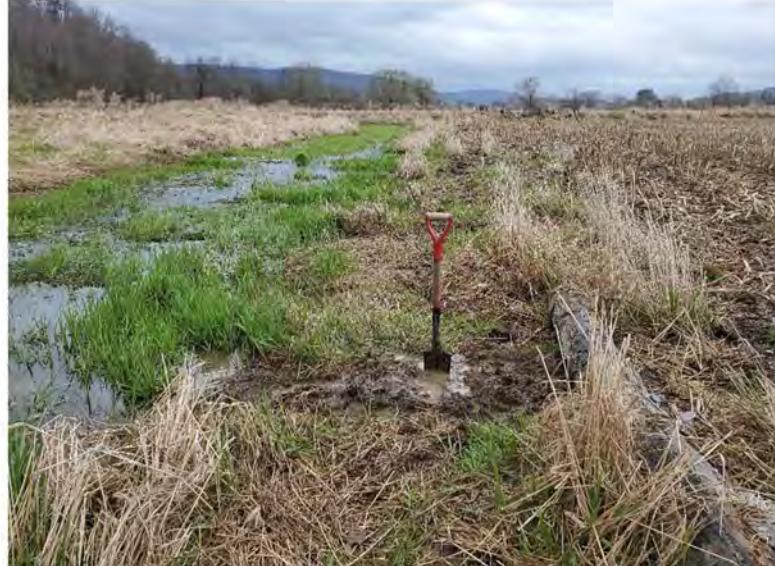
Photo 5: Drainage Patterns Hydrology of Wetland W1-PEM, DP031, Facing East

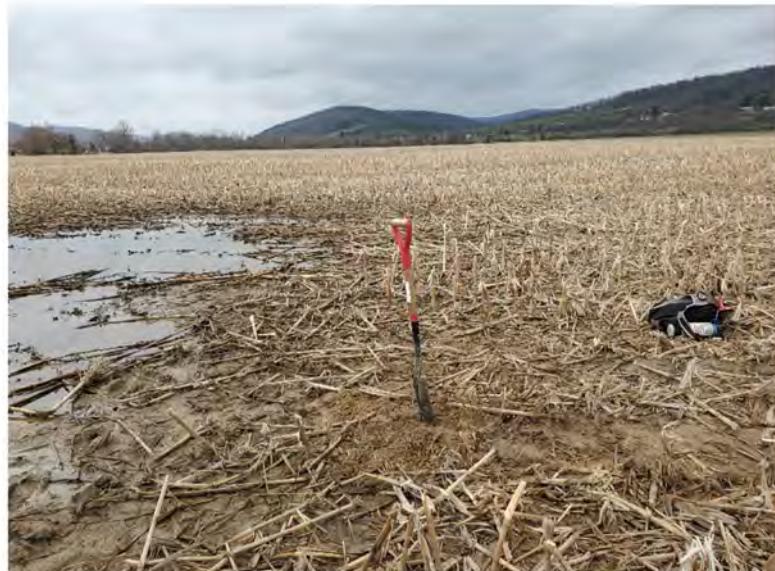
Photo 6: Representative of Wetland Lacking Hydrophytic Vegetation Due to Severe Disturbance, W1-PEM, DPK022, Note Surface Water

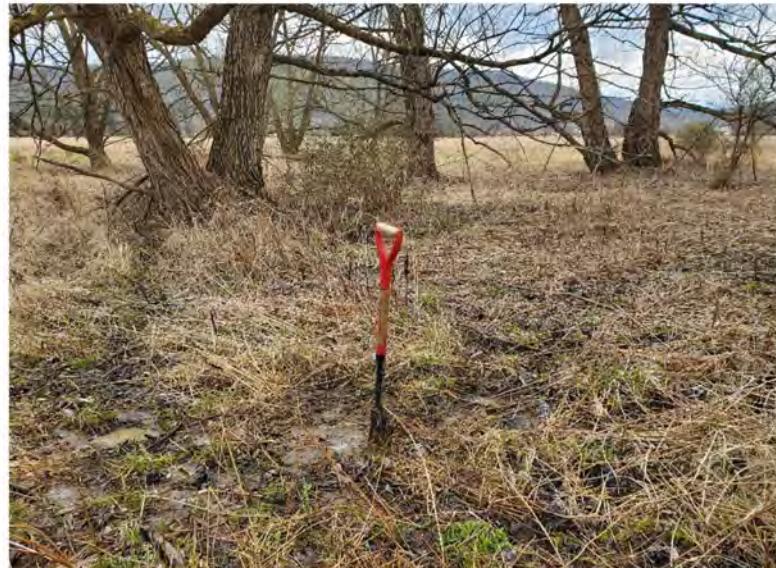
Photo 7: Representative PFO Overview, Wetland W1-PFO, Sampling Point DPK011, Facing South, Note Water-Stained Leaves

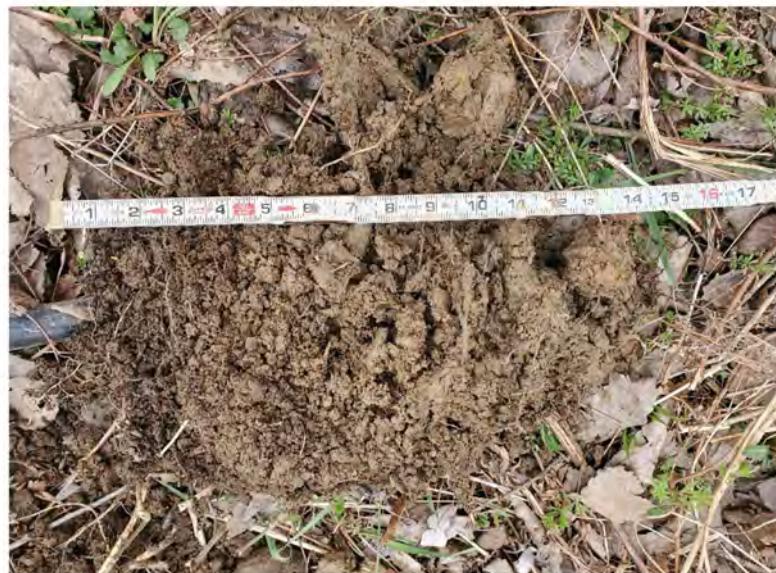
Photo 8: Soil Core of Wetland W1-PFO, Sampling Point DPK008, Showing F3 Depleted Matrix Hydric Soil Indicator

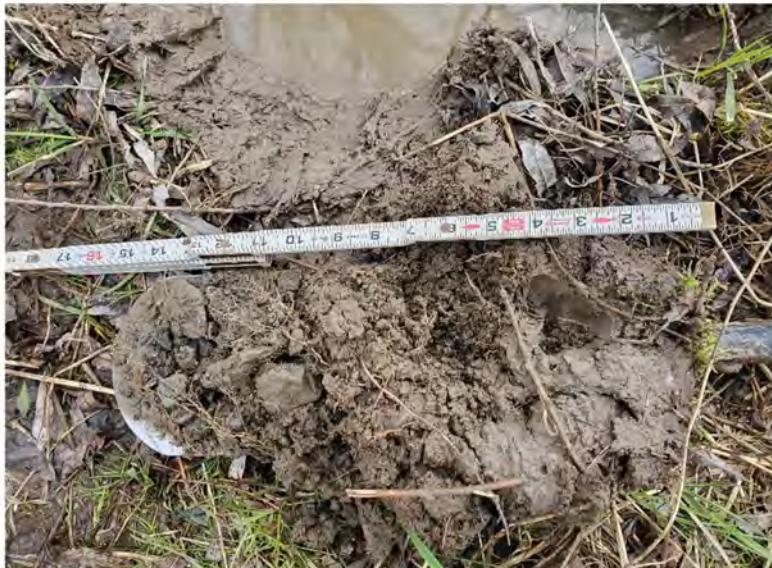
Photo 9: High Water Table Hydrology of Wetland WK001-PFO, Sampling Point DPK011

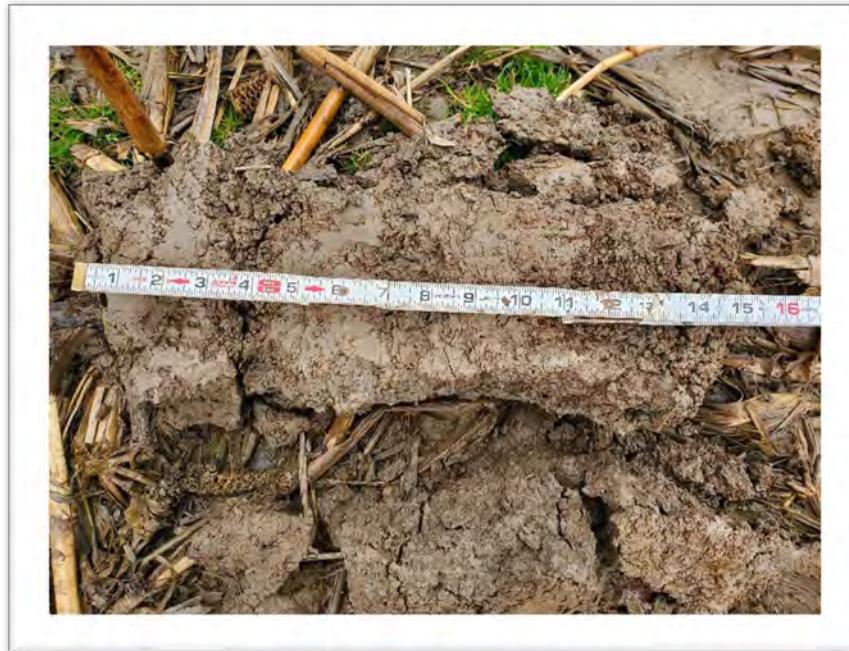
Photo 11: Soil Core of Wetland W2-PEM, Sampling Point DPK017 Showing F3 Depleted Matrix Hydric Soil Indicator

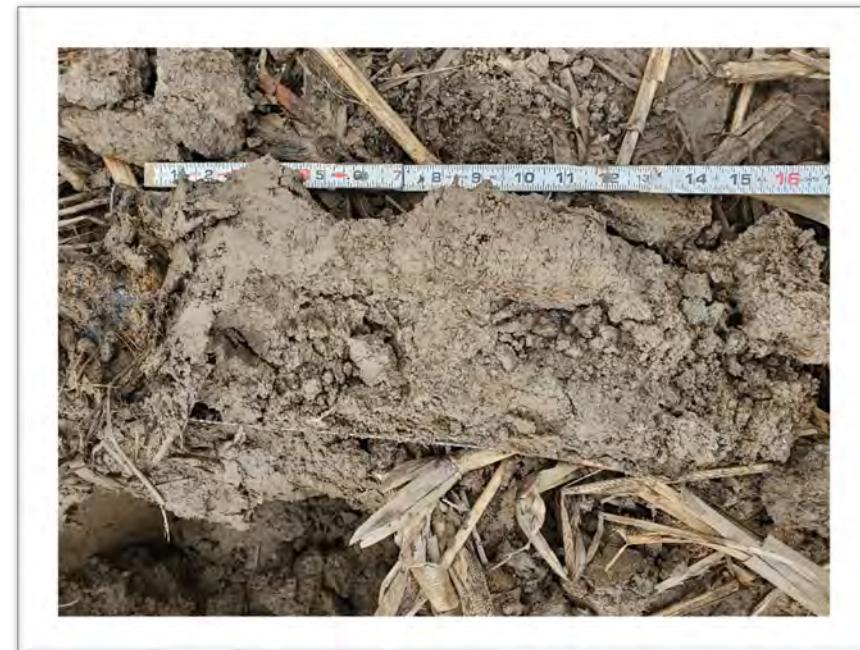
Photo 13: Soil Core of Wetland W4-PEM, Sampling Point DPK020 Showing F3 Depleted Matrix Hydric Soil Indicator

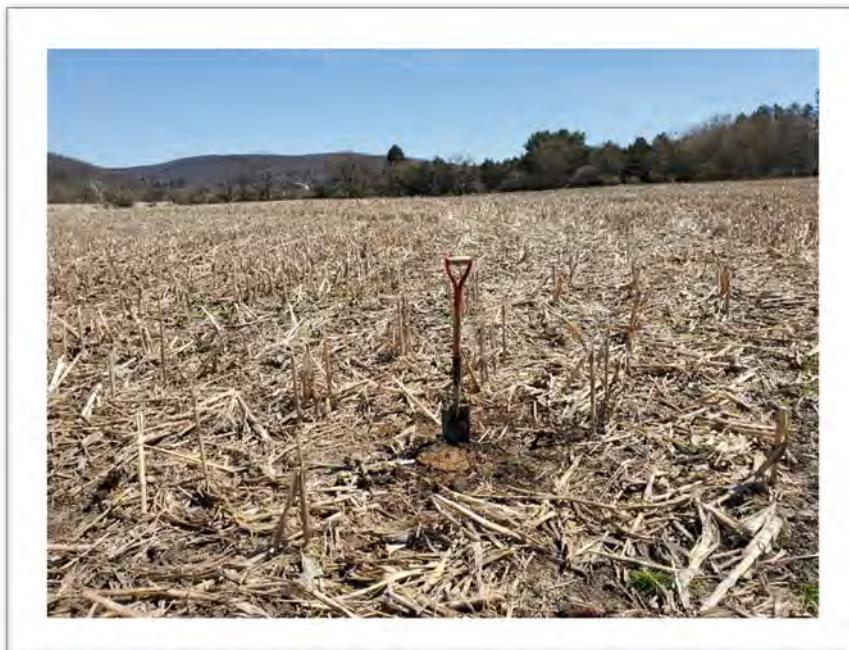
Photo 14: Representative PEM Overview, Wetland 6-PEM, Sampling Point DPK036, Facing East, Note Severe Disturbance and Lacking Hydrophytic Vegetation

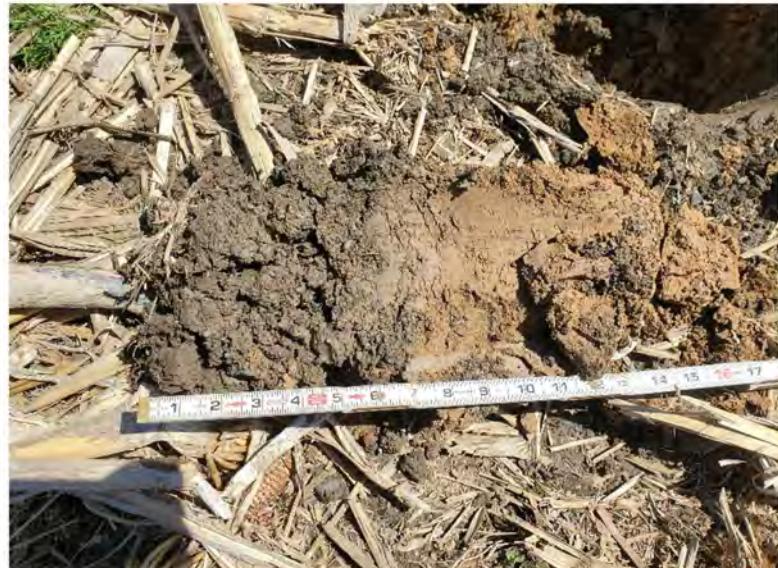
Photo 15: Soil Core of Wetland W6-PEM, Sampling Point DPK036 Showing F3 Depleted Matrix Hydric Soil Indicator With Oxidized Rhizospheres On Living Roots

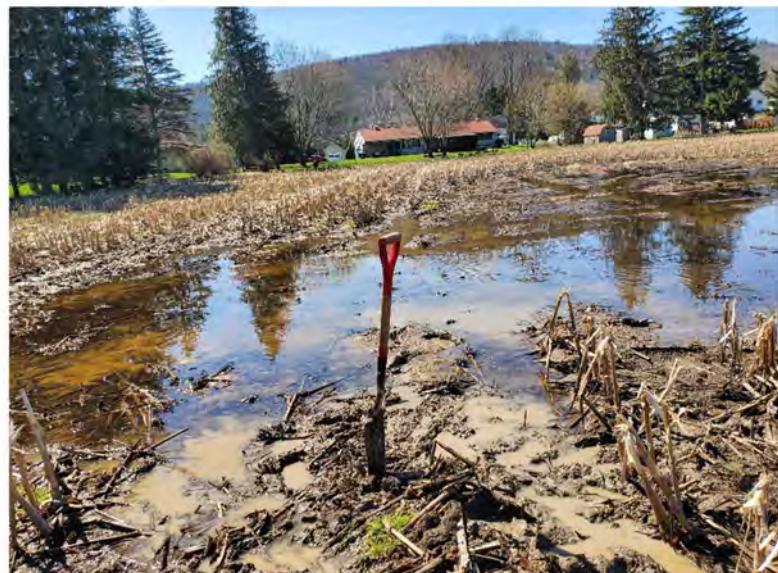
Photo 16: : Representative PEM Overview, Wetland 9-PEM, Sampling Point DPK033, Facing South, Note Surface Water and Severe Disturbance

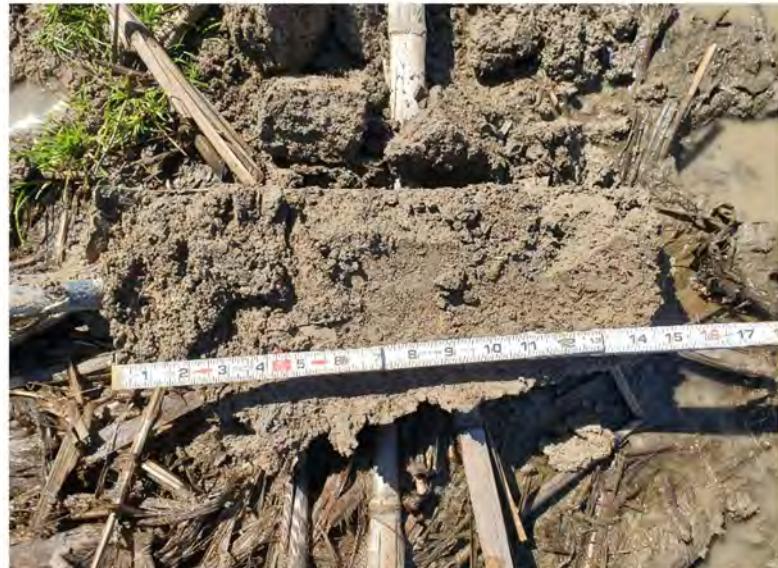
Photo 17: Soil Core of Wetland W9-PEM, Sampling Point DPK033 Showing F3 Depleted Matrix Hydric Soil Indicator

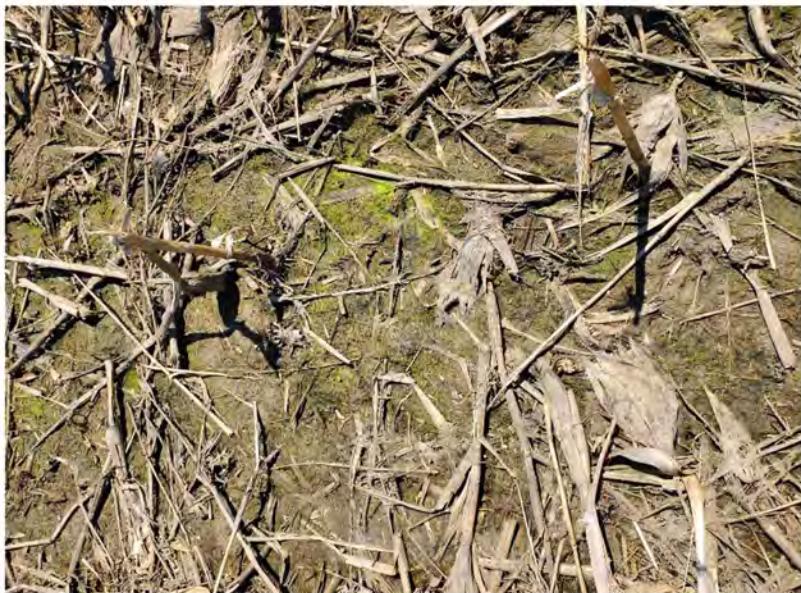
Photo 18: Algal Mat or Crust Hydrology of Wetland W9-PEM, DPK033

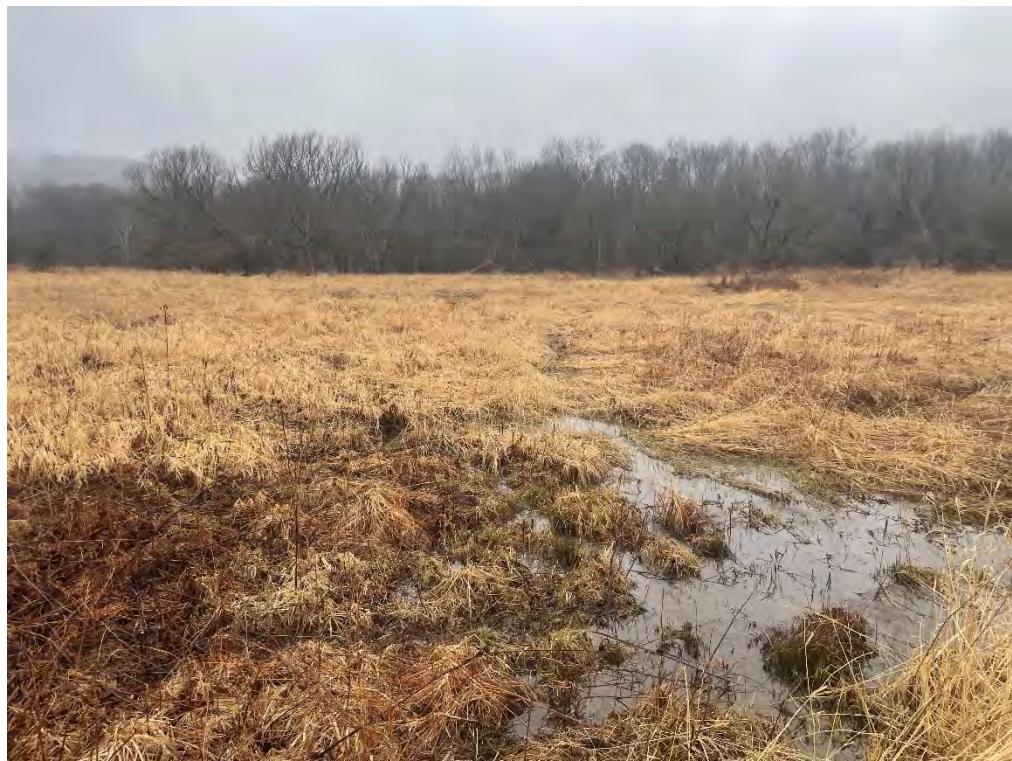
Photograph 1: Overview of existing PEM wetland dominated by *Phalaris arundinacea* (reed canary grass) within the proposed PRM site.

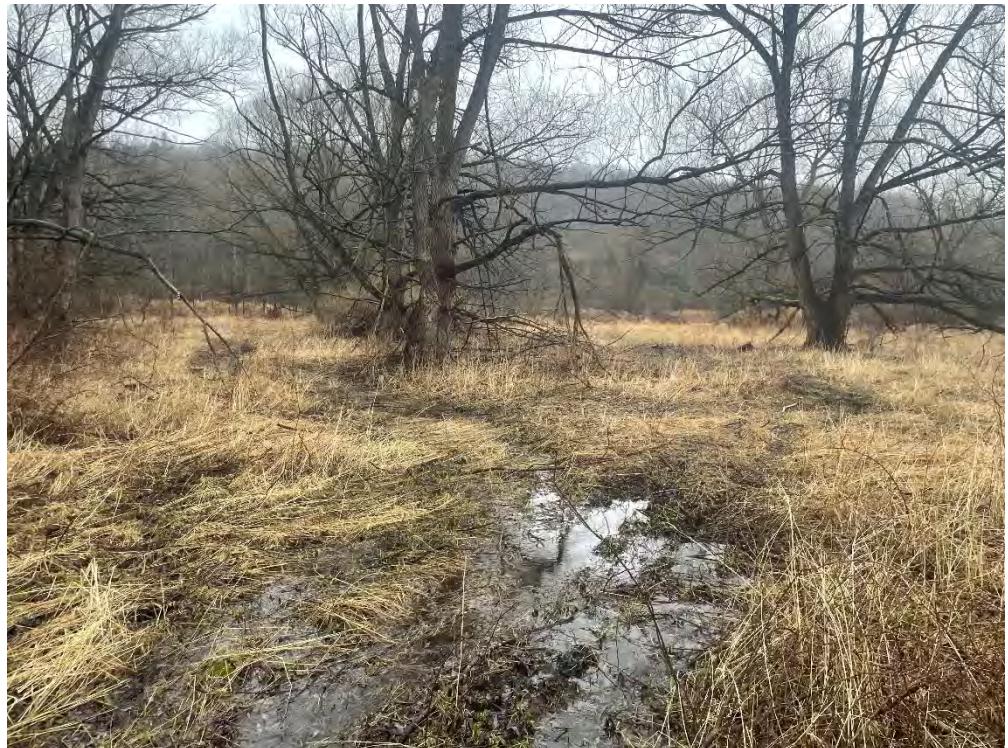
Photograph 2: Additional view of existing PEM wetlands at the boundary with PFO components within the proposed PRM site.

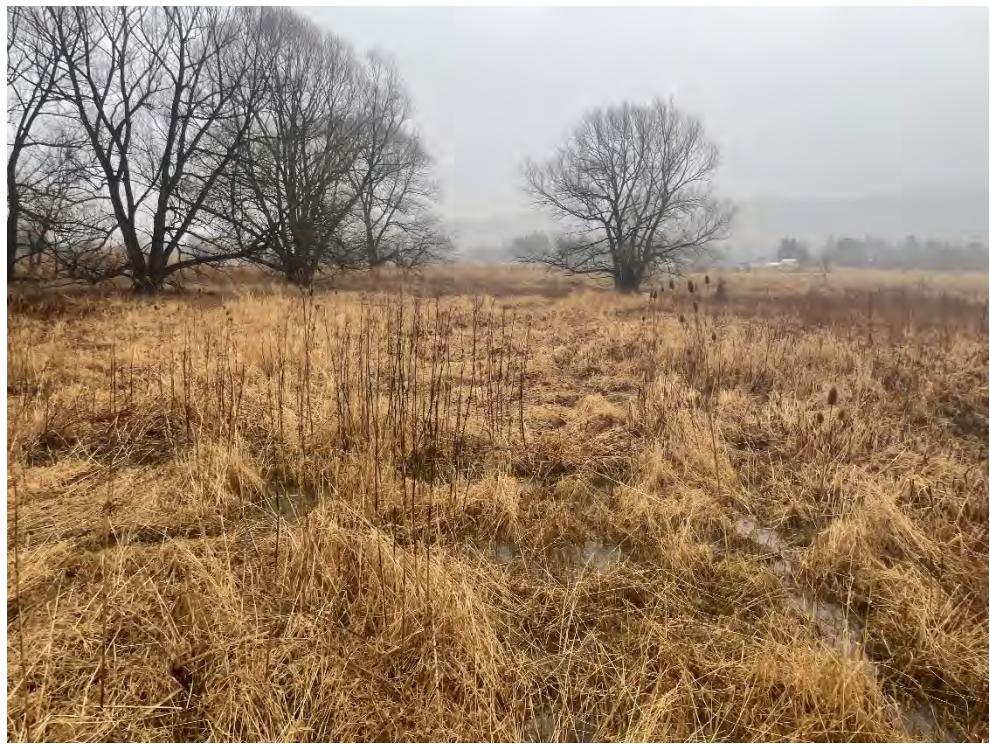
Photograph 3: Invasive dominated PEM wetlands within the proposed PRM site.
