Stream Morphology and Water Quality Based Restoration Plan for the Paradise Creek Watershed

Phase I Technical Report for the Paradise Creek Watershed Assessment

Prepared by Robert Limbeck, Watershed Scientist
Delaware River Basin Commission, West Trenton, NJ
For the Brodhead Watershed Association, Henryville, PA

February 2005

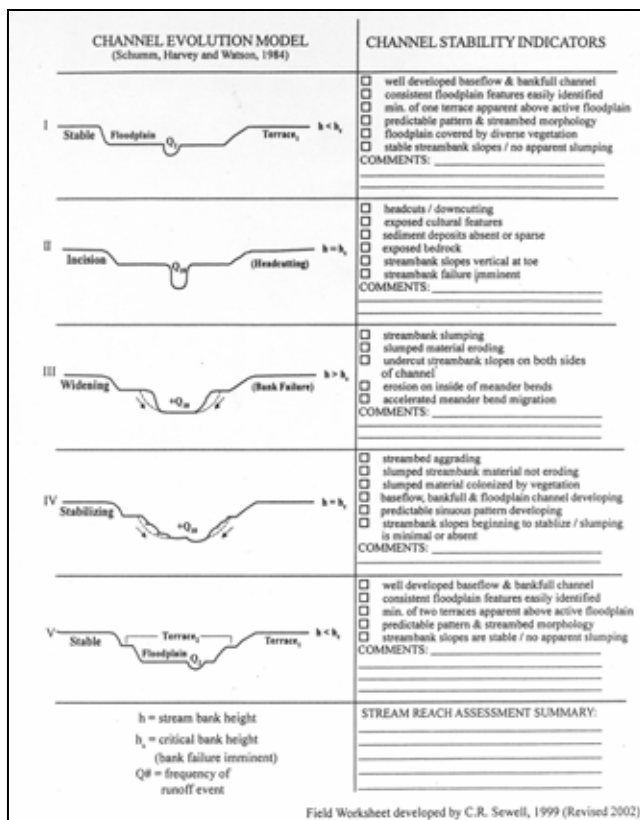
Figure 3. Channel Evolution Model (Schumm, Harvey and Watson 1984; field observation checklist adapted by Randy Sewell, VHB, Inc., Williamsburg, VA)

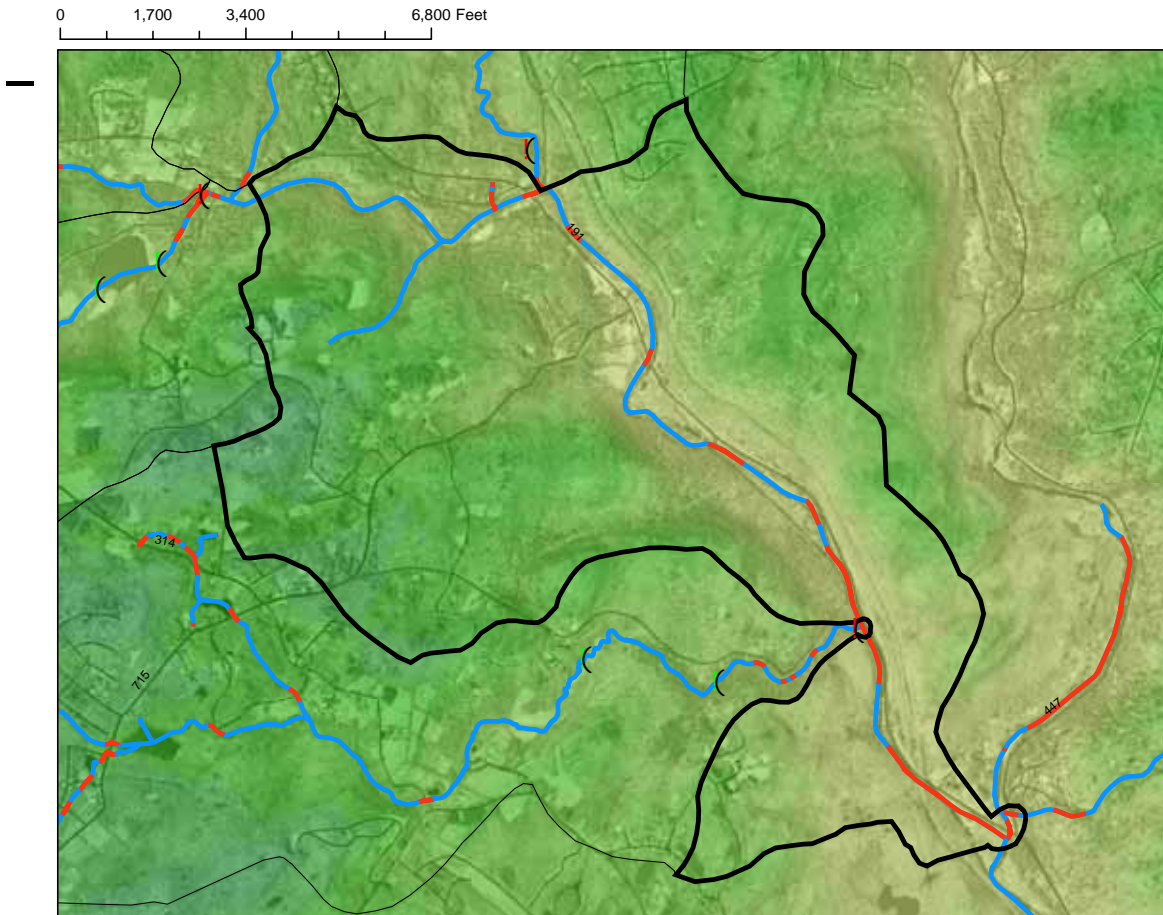
Figure 4 – Potential restoration sites in the Lower Paradise sub-watershed. Sites were identified by means of topographic map examination; stream proximity within 150 feet of roads, bridges and culverts; aerial photo examination and field verification.

1. Paradise Creek along Route 191 (4 segments): extensive channelization. Improve habitat within incised channel.

Install habitat improvement structures.

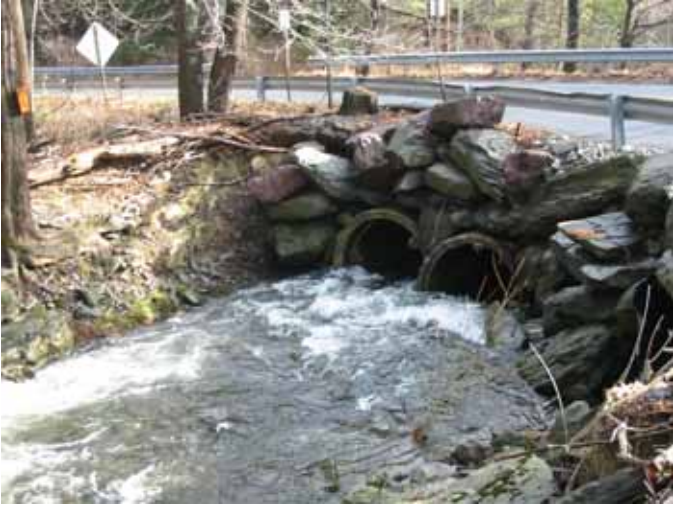
Figure 7 - Cranberry Creek at Browns Hill Road: culvert is undersized, threatens road. Culvert should be replaced and sized sufficiently to provide additional cross sectional area and improve fish passage.

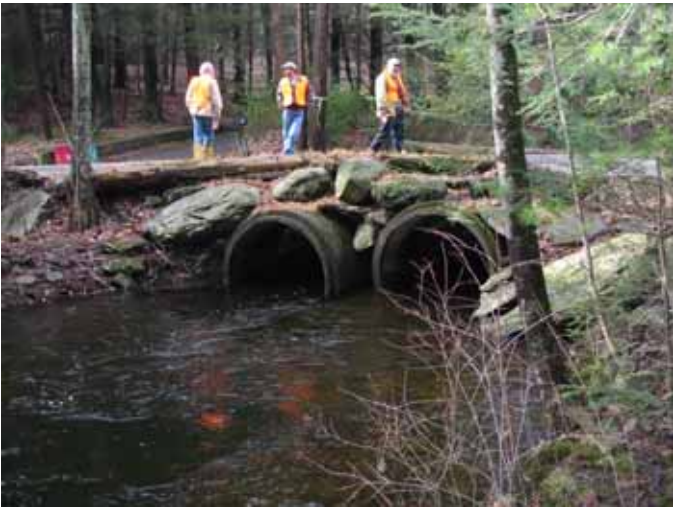
Figure 8 - Cranberry Creek at Cranberry Creek Road crossing. Culvert undersized, road frequently floods. Stream receives a large amount of road runoff. Non-point source pollution management recommended here.

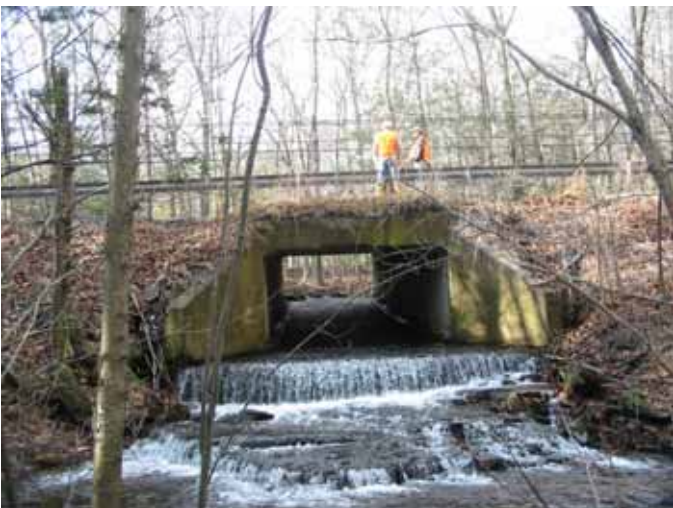
Figure 9 - Cranberry Creek at Route 191 crossing. This location receives a large quantity of road runoff, which should be managed to reduce introduction of pollutants to stream.

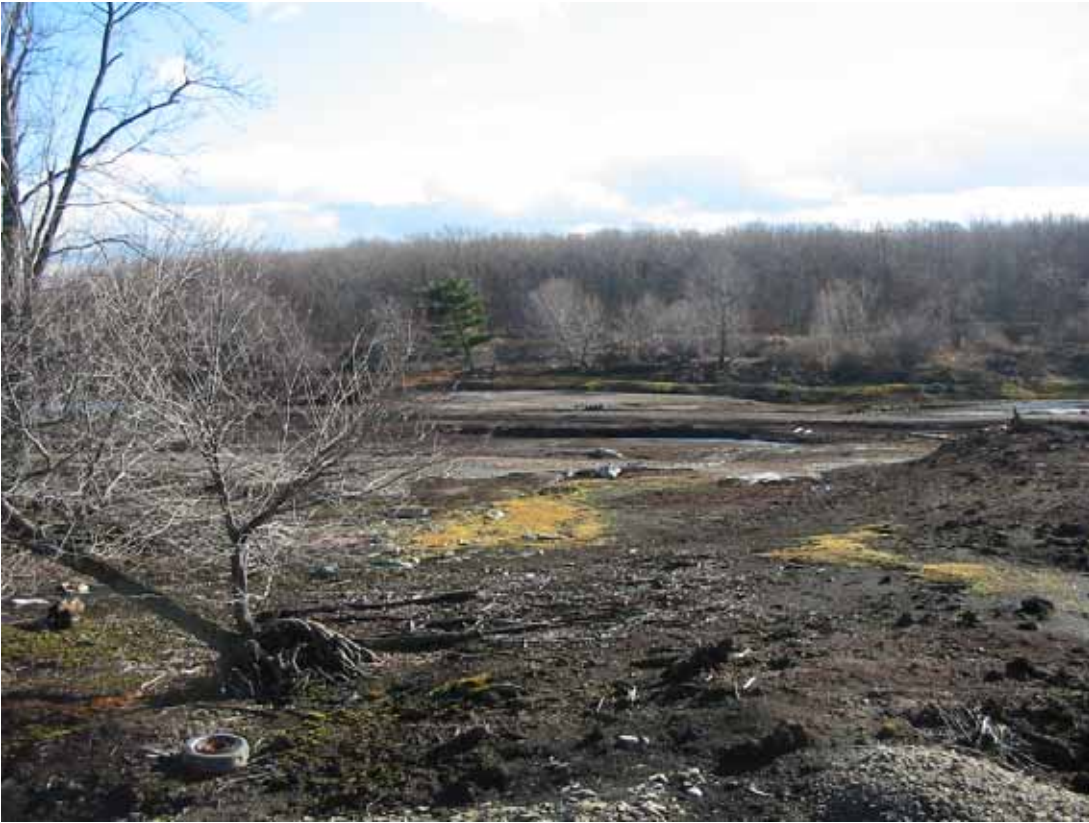
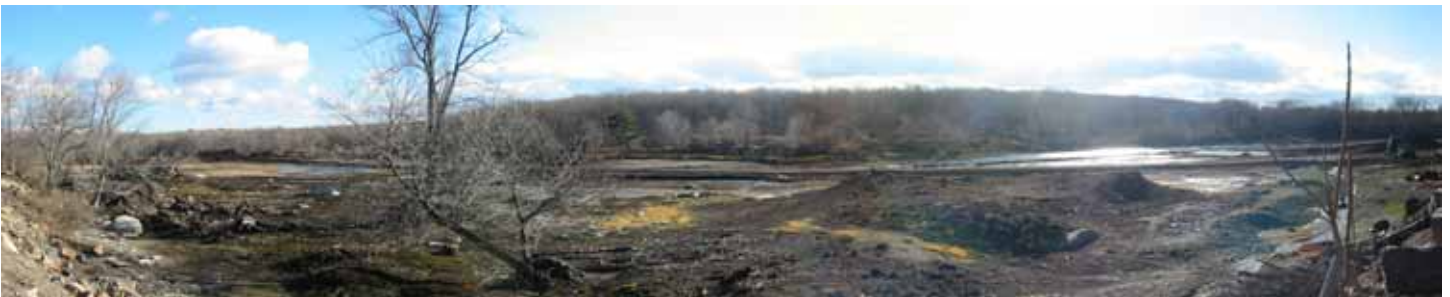
Figure 10 (left) and Figure 11 (below): headwaters of Cranberry Creek watershed at active peat mining operation. Upon conclusion of peat mining operations, this site will require extensive restoration. Little is presently done to manage water quality impacts at this site.

- See 8534 Aerial Photo. Extensive disturbance of stream channel, mitigation necessary once mining operation is completed.

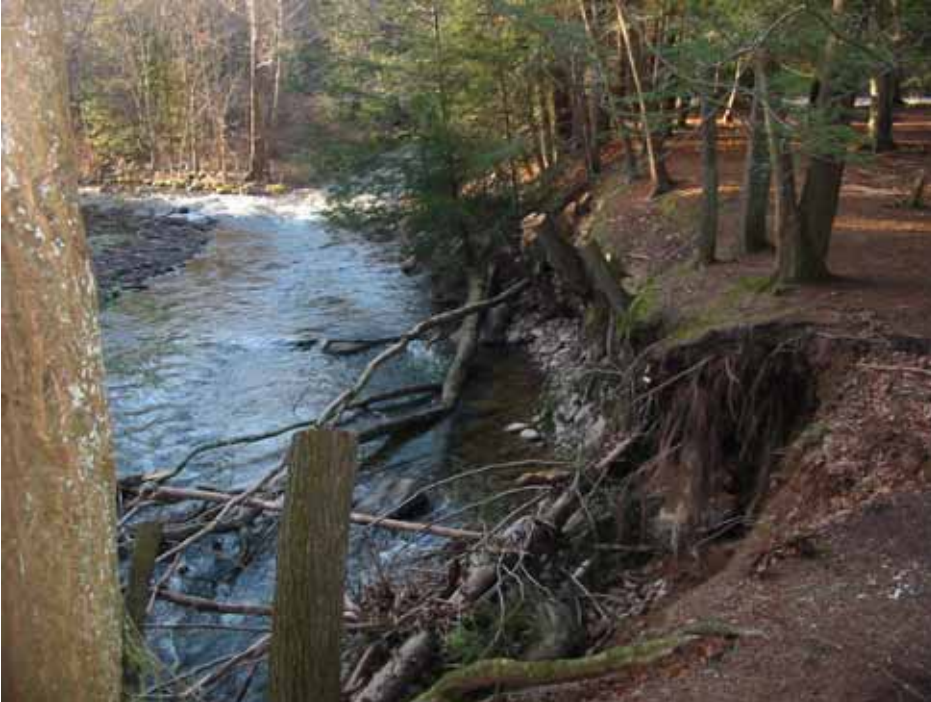
Figure 13: Lower Swiftwater Project 1: Left bank erosion at confluence of Forest Hills Run and Swiftwater Creek. Landowner has received emergency stabilization funding, but post-stabilization habitat improvements and perhaps upstream channel realignment would improve instream conditions. This site was previously channelized, creating a 90-degree confluence of the streams and producing these erosion effects.

Landowner received disaster recovery funds for bank stabilization. Habitat improvements needed. Large restoration project – up to 2 miles of stream affected by backwater flooding & erosion. Stabilization and habitat improvement recommended (large project). Examine storm water runoff management at site, potential future projects with Aventis (small project). Manage highway runoff (small project).

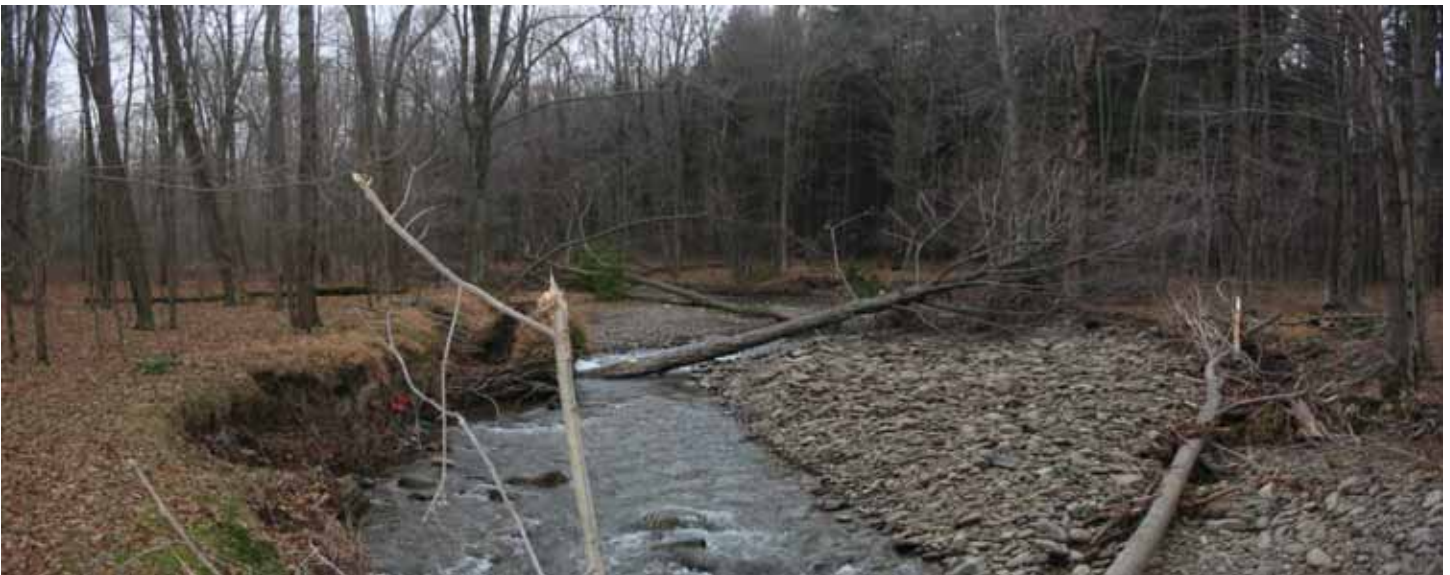
Figure 14 - Lower Swiftwater Project #2: Swiftwater Creek upstream of Route 314 crossing – up to 2 miles of severe erosion.

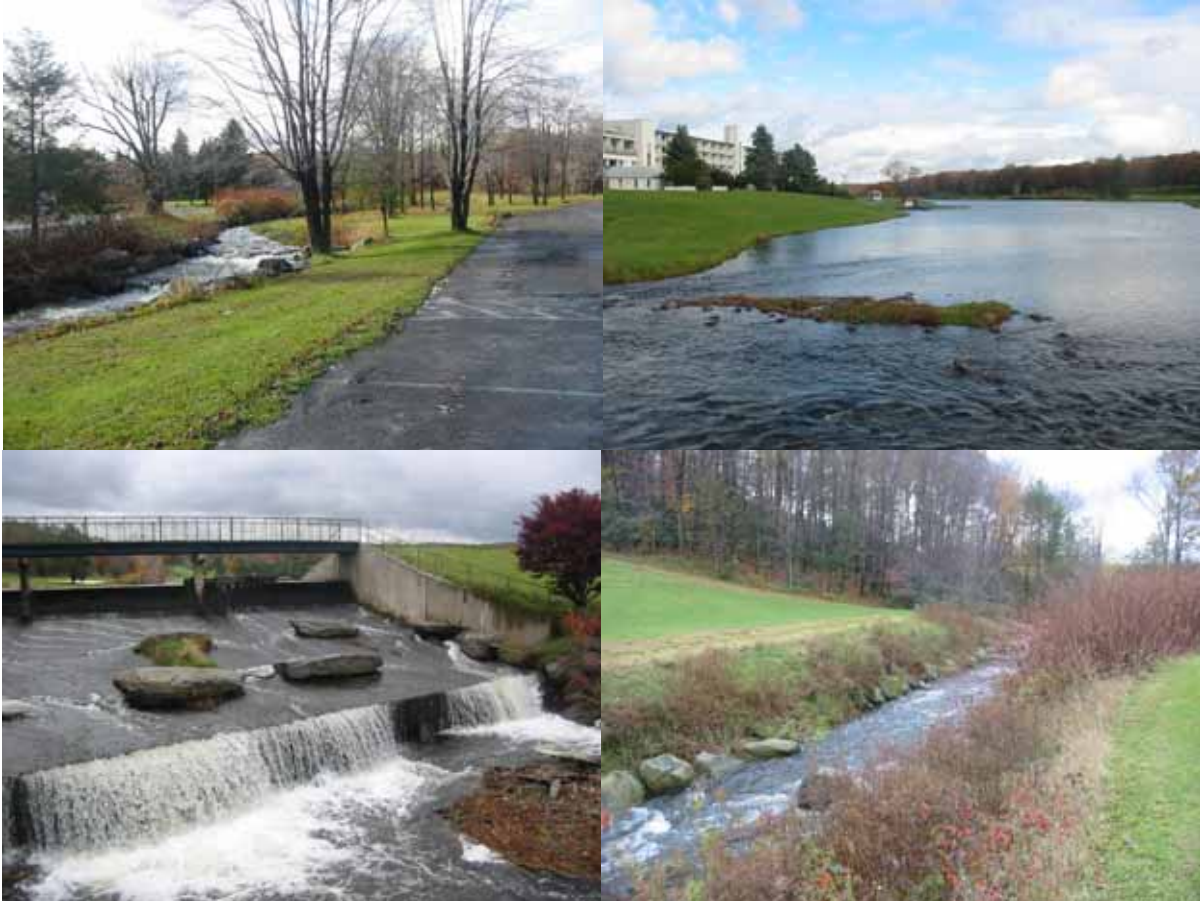
Figure 17 – Forest Hills Run Projects 2,3,4,5: Mount Airy Lodge site, where improvements can be made to the riparian buffer, storm water management for water quality, stream channelization repair, invasive species removal, and Canada Goose management.

Photo 1 – Parking lot upstream of Woodland Road by Forest Hills Run

Photo 2 – Forest Hills Run enters Lake, see sediment deposit, extensive lawn and no buffer.

Photo 3 – Dam and Spillway of Lake, fish passage blocked.

Photo 4 – Downstream of Lake at golf course fairway – channelized, invasive species, poor buffer.

- Manage runoff quality; establish riparian areas.
- Establish riparian zone; reduce water quality effects of turfgrass & fertilizers; reduce Canada Goose impacts; prepare storm water plan for site.

Establish riparian zone as environmentally sensitive area on golf course; remove invasive plants; reconstruct meanders if necessary (detailed survey to determine erosive energy of stream, create restoration plan).

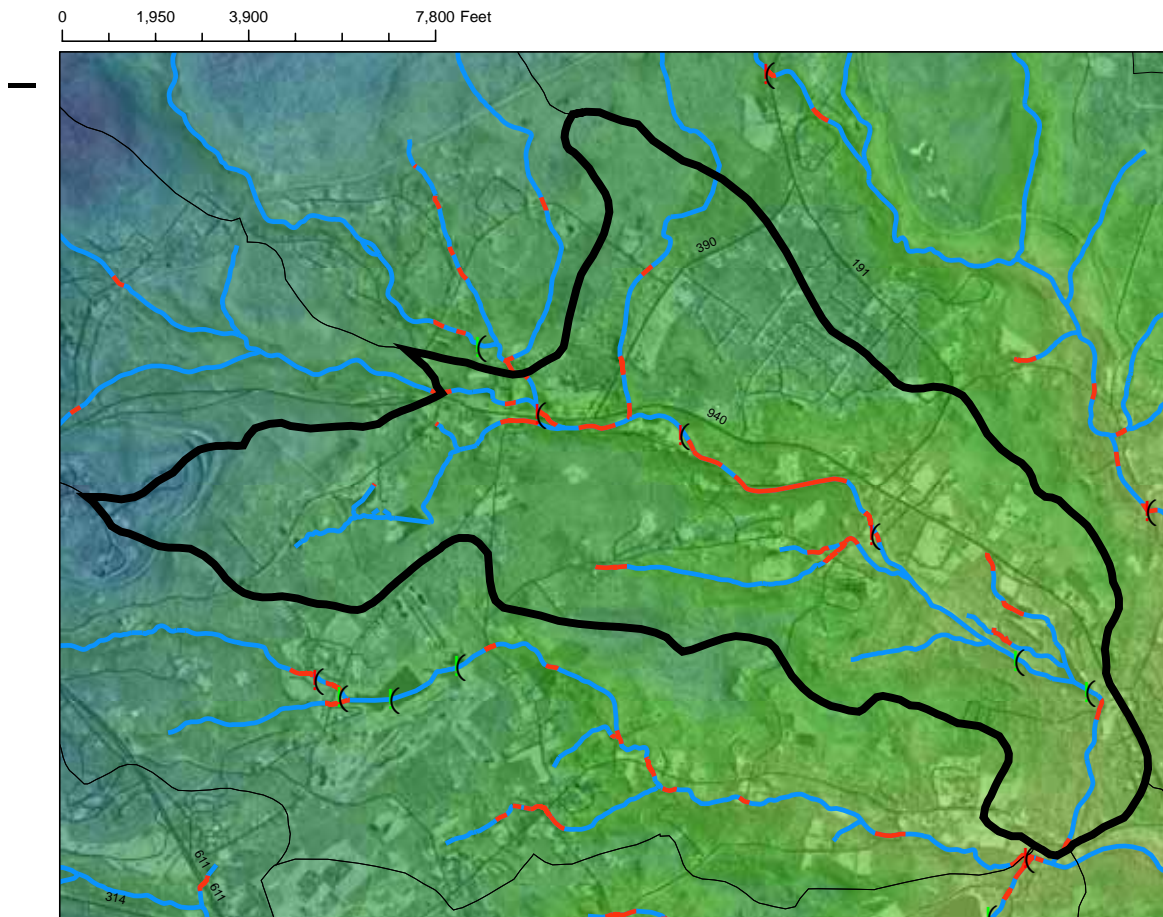
Figure 18 – Potential restoration sites in the Upper Paradise Creek sub-watershed. Sites were identified by means of topographic map examination; stream proximity within 150 feet of roads, bridges and culverts; aerial photo examination and field verification.

1. Paradise Creek upstream to downstream of Red Rock Rd crossing – channel migration, incision, widening.
2. Paradise Creek in vicinity of abandoned Pocono Gardens Resort – runoff, channelized, breached dam, road crossings.

3. Paradise Creek at Route 940 – road effects, runoff.

4. Paradise Creek at Crawford Lake dam – dam effects.
5. Paradise Creek upstream of and entering Lake Crawford – channelization, sediment bar, wandering channel into lake.

Large project - protect private property and stabilize up to 1 mile of stream.

Long channelized reach produces high energy downstream. Improve habitat, reduce energy, restore channel upstream of breached dam, create stormwater management plan, install BMPs.

Address road runoff and runoff effects of stable.

Install fish passage structure. Implement lake management recommendations.

Install sediment capture forebay, maintain regularly. Possible large restoration project to ½ mile upstream of lake.

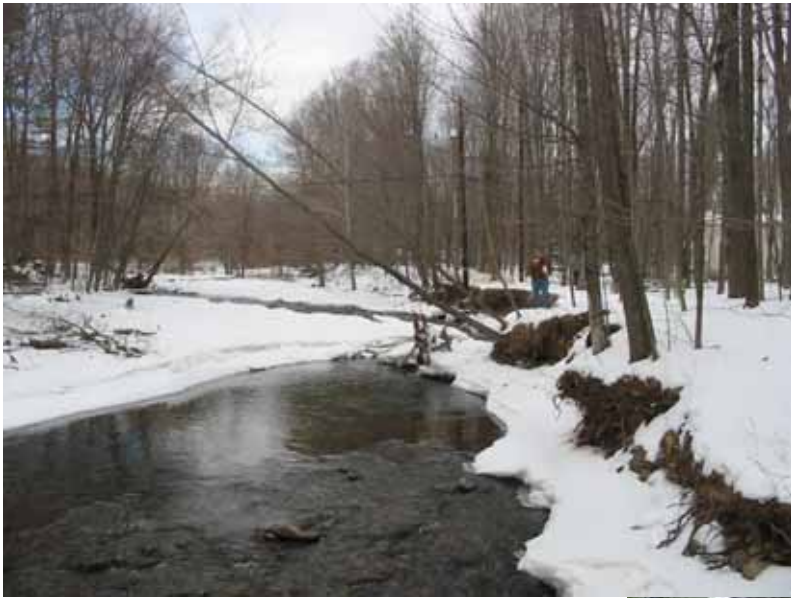
Figure 19 – Upper Paradise Project 1: Paradise Creek from the vicinity of Red Rock Road to Lake Crawford. Previously channelized, this reach is now widening, forming meanders, and threatening private property. Note the telephone pole in background, once about 15 feet from the stream, is now about to be undermined. A more detailed assessment and restoration is recommended from Red Rock Road to Lake Crawford.

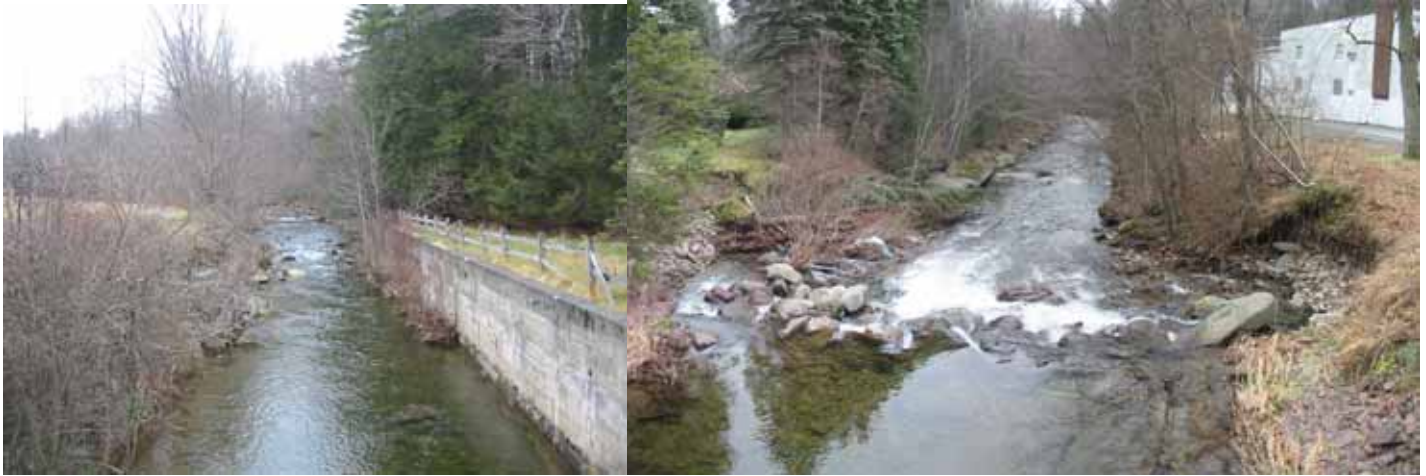
Figure 20 – Upper Paradise Project 2: Pocono Gardens Resort Site – upstream view of channelized section (above) and downstream view past breached dam (right).

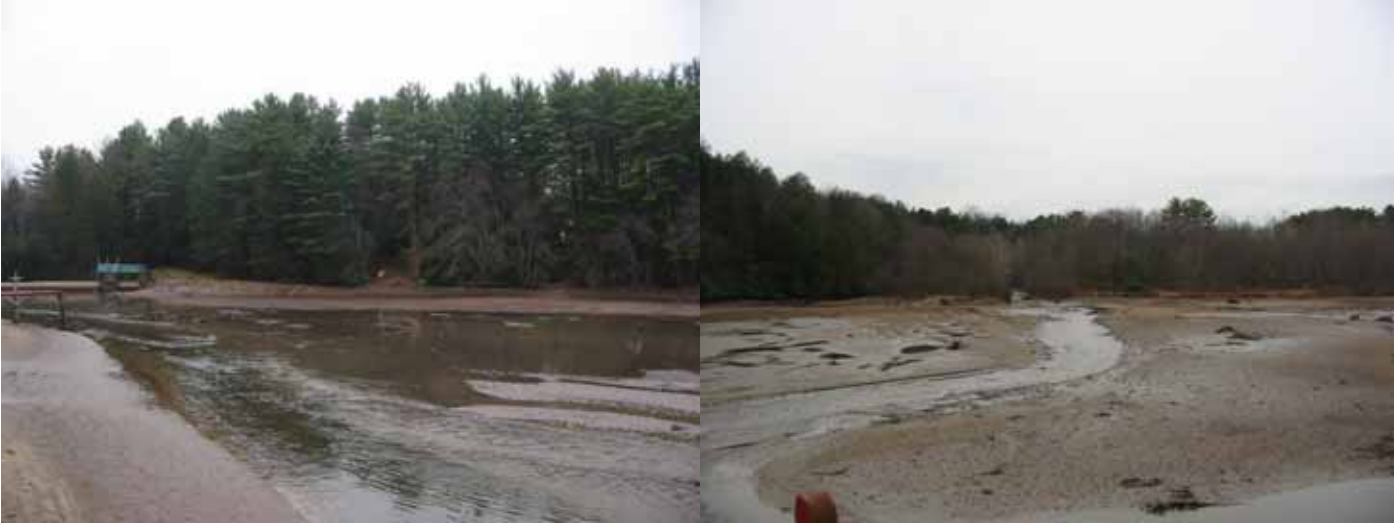
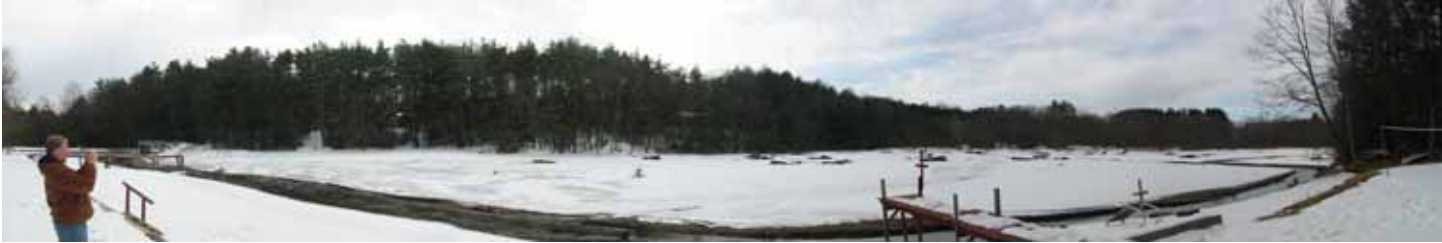
Figure 21 - Crawford Lake dredging, December 2004: Once the lake is dredged, a sediment forebay could be created for future sediment capture and maintenance, and approximately ½ mile of upstream stabilization of Paradise Creek. Installation of a fish passage structure and additional habitat improvements are recommended. Left – Downstream view toward dam. Right – Upstream view of Paradise Creek entering Lake Crawford. Below – panoramic view of dredging project taken February 2005.

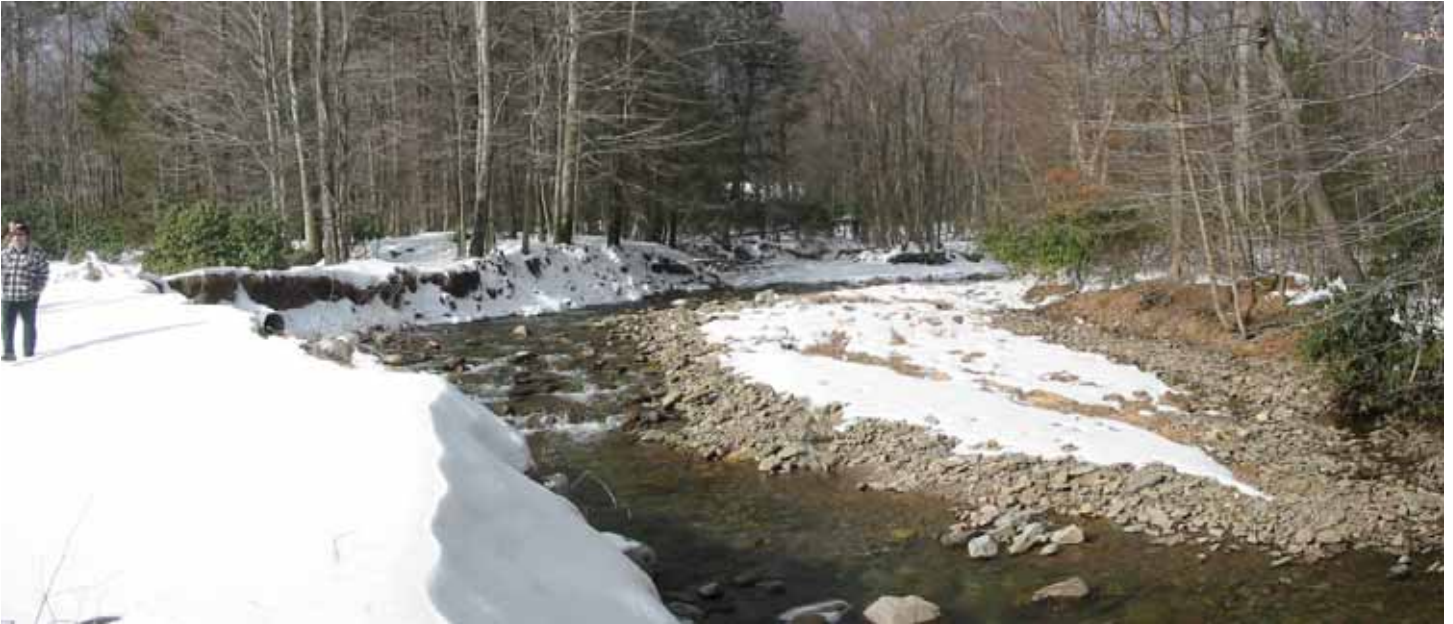
Figure 23 - Devils Hole Creek at upstream end of Caesar's Paradise Stream Resort. The stream has widened, eroding the stream bank and creating a large bar. The erosion threatens part of the resort property. Emergency stabilization is necessary at this location. Between this location and the dam downstream (see photos below), it is believed that the stream was channelized at some time past. This part of the stream is located in the transition area between high-gradient mountainous terrain and the low-gradient, wide valley of the Paradise Creek.

Major restoration and stabilization project.
Recommend dam removal at lower end of reach.

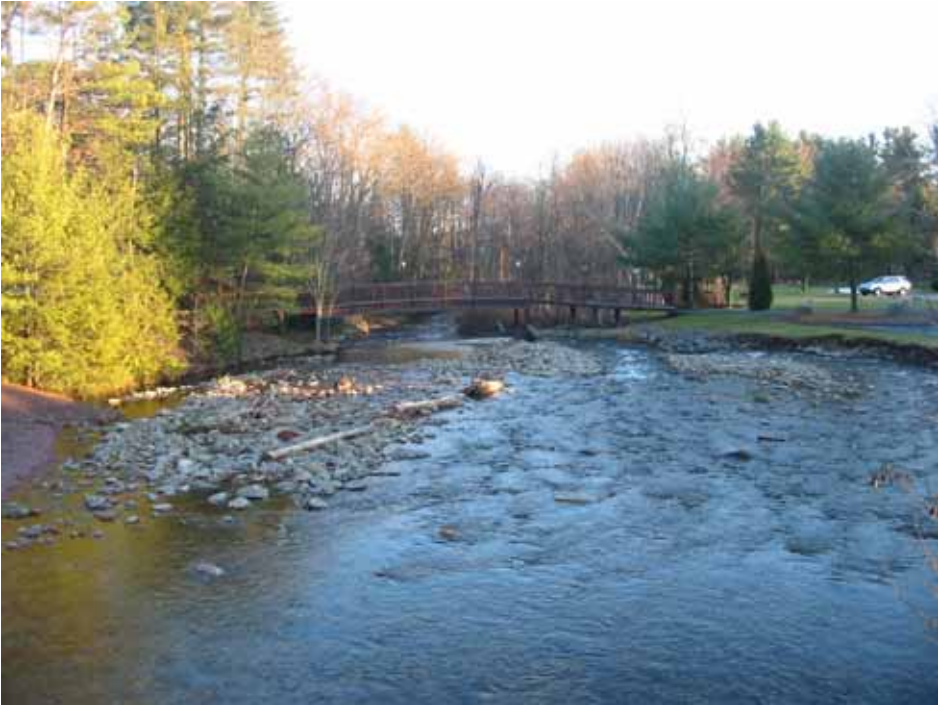
Figure 24 - Downstream view of sediment-filled small impoundment on Devils Hole Creek. The dam is just upstream of the footbridge in the background, and is located about 100 yards upstream of the confluence of Devils Hole Creek and Paradise Creek. Bank erosion to the right threatens a driveway and building. Dam removal is recommended at this location. Unless such impoundments are maintained frequently, installation of dams in high-energy stream environments is discouraged.
