# **Engineering Review Summary For Chapter 105 Applications**

## **Phase IV Pipeline**

**Cummings & McHenry Townships, Lycoming County**

September 2023

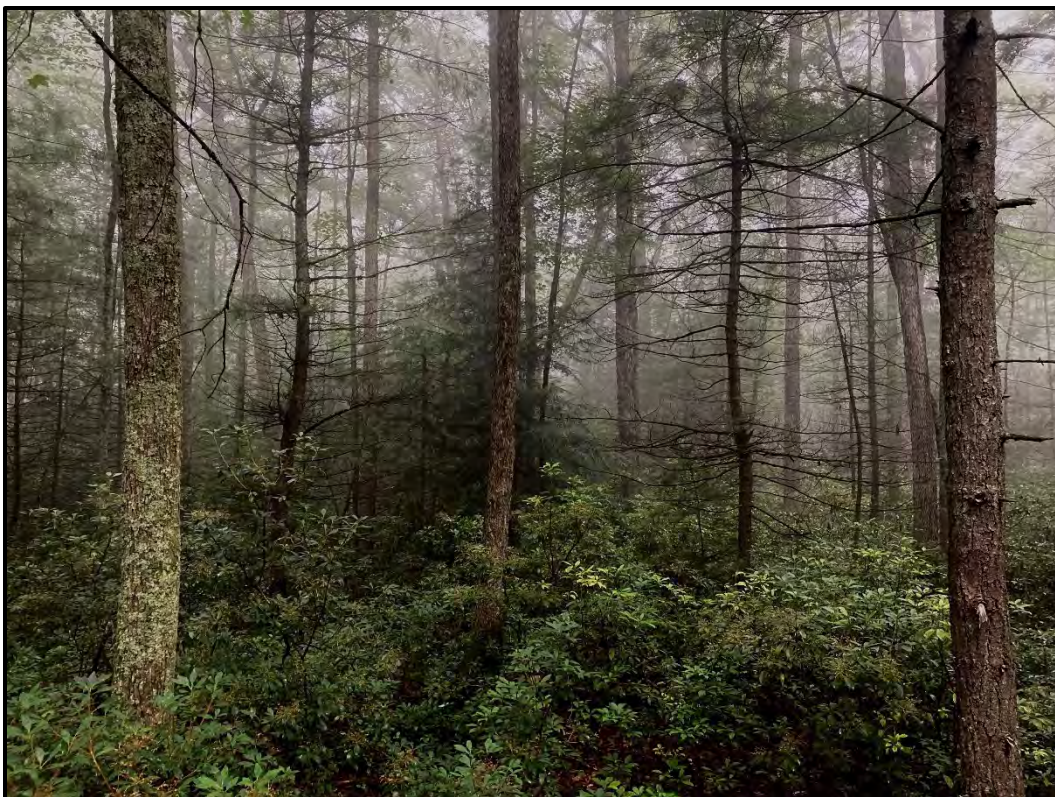
**Photo 1. Conditions in Northern Part of APE.**

Figures 1 and 2 show the project area on the Cammal USGS 7.5-minute quadrangle and a recent aerial photo respectively. Photos 1-2 show field conditions. Most of the APE is on soils mapped Clymer very stony loam 8 to 25 percent slopes (CnD) and Cookport channery loam very stony 8 to 25 percent slopes (CxB) (USDA n.d.). Elevations in the APE range from approximately 1465 feet above mean sea level to 1600 feet, increasing generally from north to south.
