CHAPTER 102 INSPECTION REPORT

PA Department of Environmental Protection

Permit No.: PAD510225

Project/Site Name:	<u>Alliance 51st Street, Philadelphia</u>	Permit Issuance Date:	<u>9/5/2023</u>
Site Address:	<u>1656 S. 51st St.</u>	Permit Expiration Date:	<u>9/4/2028</u>
Site City, State, ZIP:	<u>Philadelphia, PA 19143</u>	Permit Type:	<u>NPDES IP</u>
RP/Permittee Name:	<u>Eric Carlson</u>	Site Municipality(ies):	<u>Philadelphia</u>
RP/Permittee Address:	<u>40 Morris Ave., Suite 230</u>	Site County(ies):	<u>Philadelphia</u>
RP/Permittee City, State, ZIP:	<u>Bryn Mawr, PA 19010</u>	Earth Disturbance:	<u>11.54</u> acres
RP/Permittee Email:	<u>ecarlson@alliancehp.com</u>	Site Latitude:	<u>39.935278</u>
Surface Water(s):	<u>Schuylkill River</u>	Site Longitude:	<u>- 75.209236</u>
Special Protection?	<input type="checkbox"/> Yes <input checked="" type="checkbox"/> No	Complaint Inspection?	<input checked="" type="checkbox"/> Yes <input type="checkbox"/> No
Construction Stage:	<u>Inactive</u>	Activity:	<u>Construction ≥ 1 ac.</u>

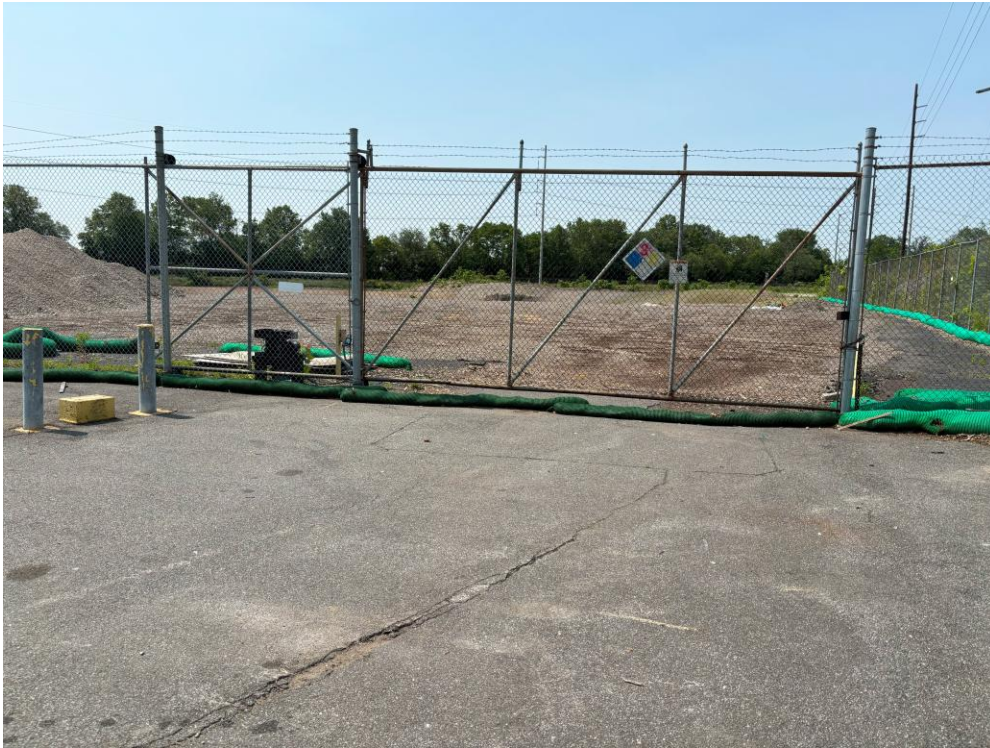
I noted that the filter sock along both 51st St. gates to the site were in proper position and in good operating condition. Mulching levels at the upslope portion of the site appeared relatively uniform. Very little permanent stabilization was observed in the upslope portion of the site.

Upslope gate filter sock and upslope section of site.

1. In accordance with DEP's Erosion and Sediment Pollution Control Program Manual, Technical Guidance No. 363-2134-008 (March 2012), Page 65, inspect filter socks weekly and after each runoff event. In addition, DEP requests that damaged socks be repaired according to manufacturer's specifications or replaced within 24 hours of inspection.
2. Maintaining filtersock areas, to prevent any overtopping condition, is recommended.
3. It is recommended to investigate the addition of a storage BMP (i.e., a sediment basin) in the downslope portion of the site.
4. Since the growing season is under way as of the time of this inspection, DEP recommends considering strategies for further site stabilization at this time.
5. Replacement of the filter socks in front of the inlets draining to the Schuylkill River (along the wall of the Bartram's Garden trail), is recommended.

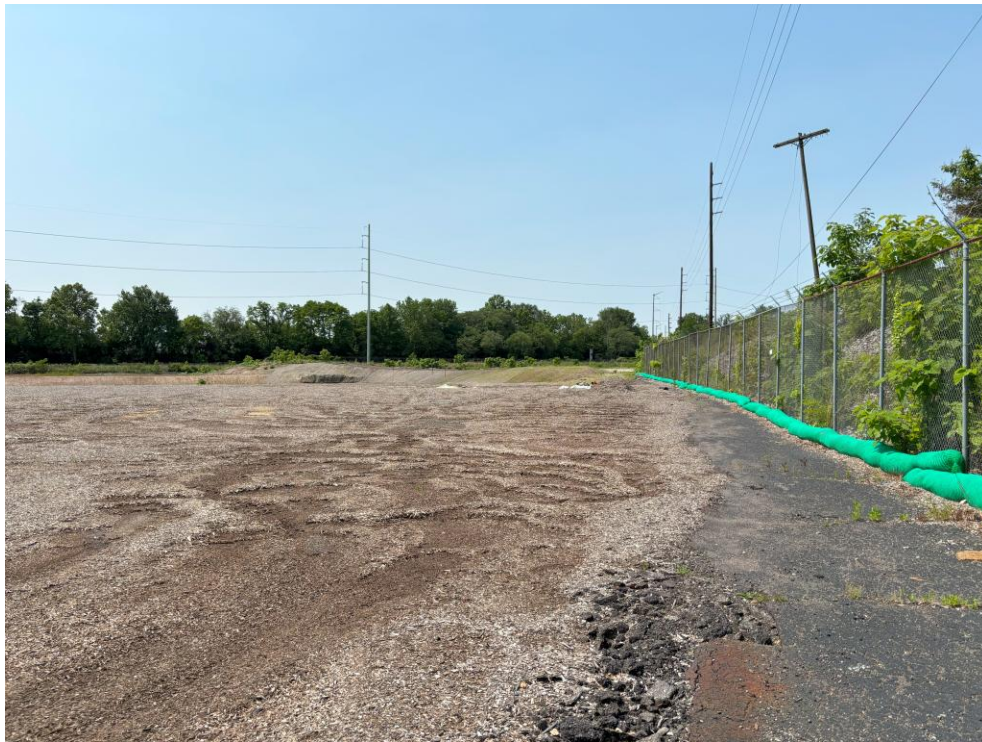
Upslope portion of site.

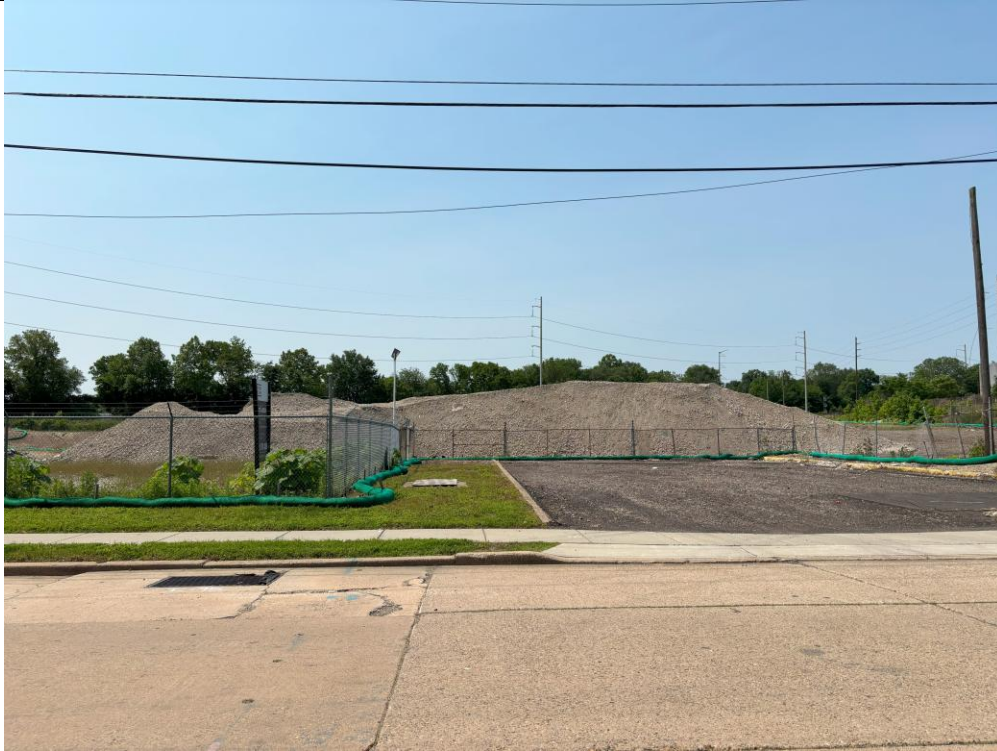
The stone stockpile near the 51st St. midslope site boundary appeared unchanged from the previous inspection. The "For Lease" signage remains in place. Some permanent stabilization was observed in the midslope portion of the site, but not approaching a 70% uniform stabilized condition.

Midslope gate and stone stockpile.

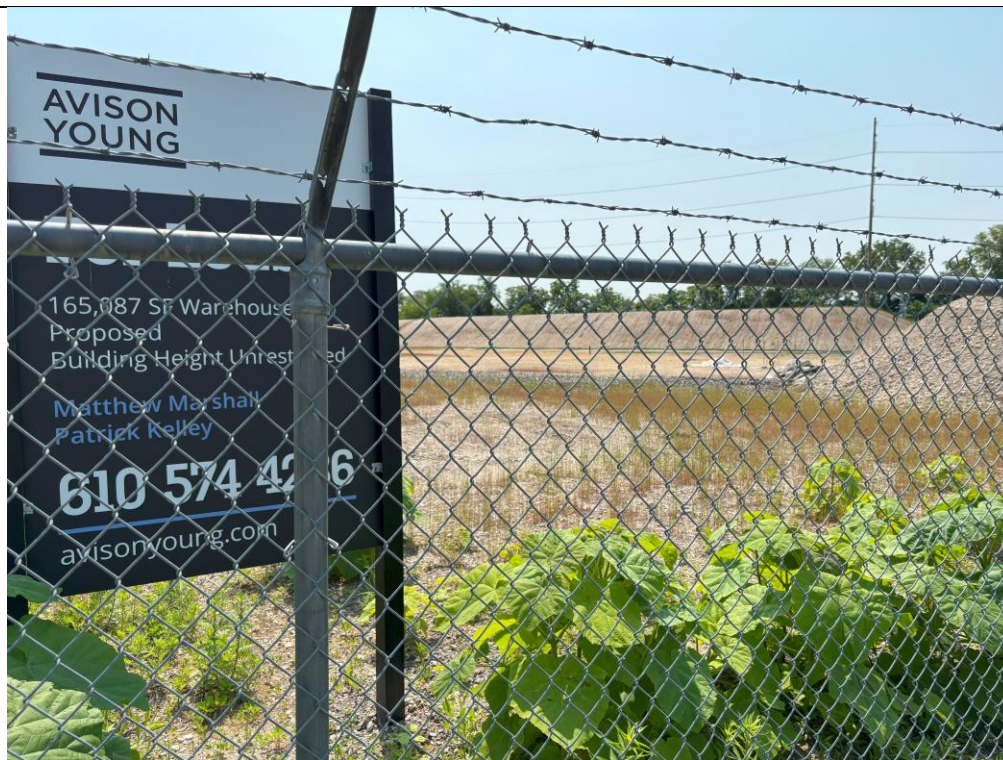
"For Lease" sign and midslope portion of site.

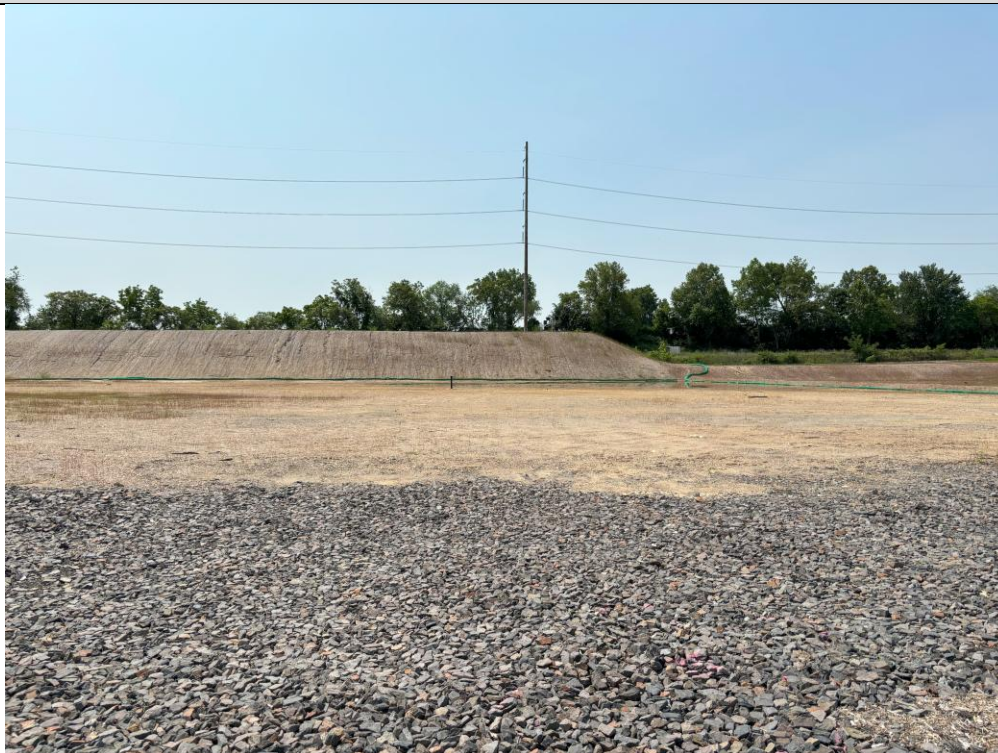
The rolled up portion of erosion control matting noted in the previous inspection, was repaired by the time of this inspection. Two vertical strips of permanent stabilization were noted on the large fill dirt stockpile (see accompanying photograph). All other erosion control matting that was visible, appeared to be in proper operational condition. I noted other areas of permanent stabilization on the back side of the large fill dirt stockpile (adjacent to the railroad tracks).

Midslope section of site with large fill dirt stockpile in background.

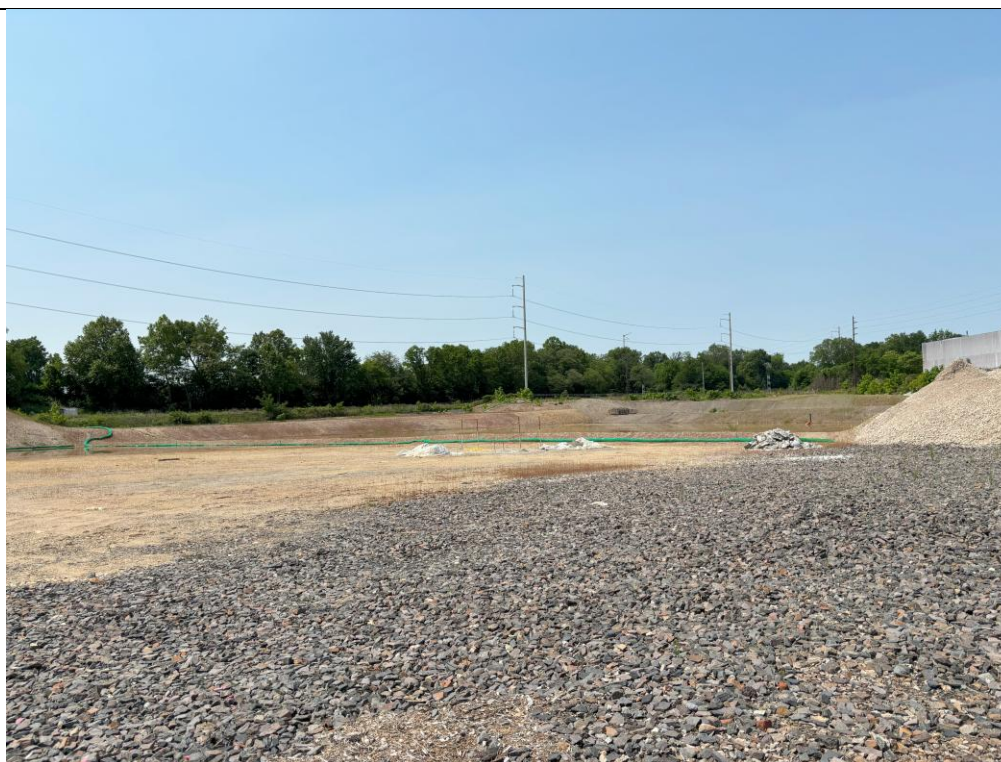
Midslope and upslope section of site with testing areas at center.

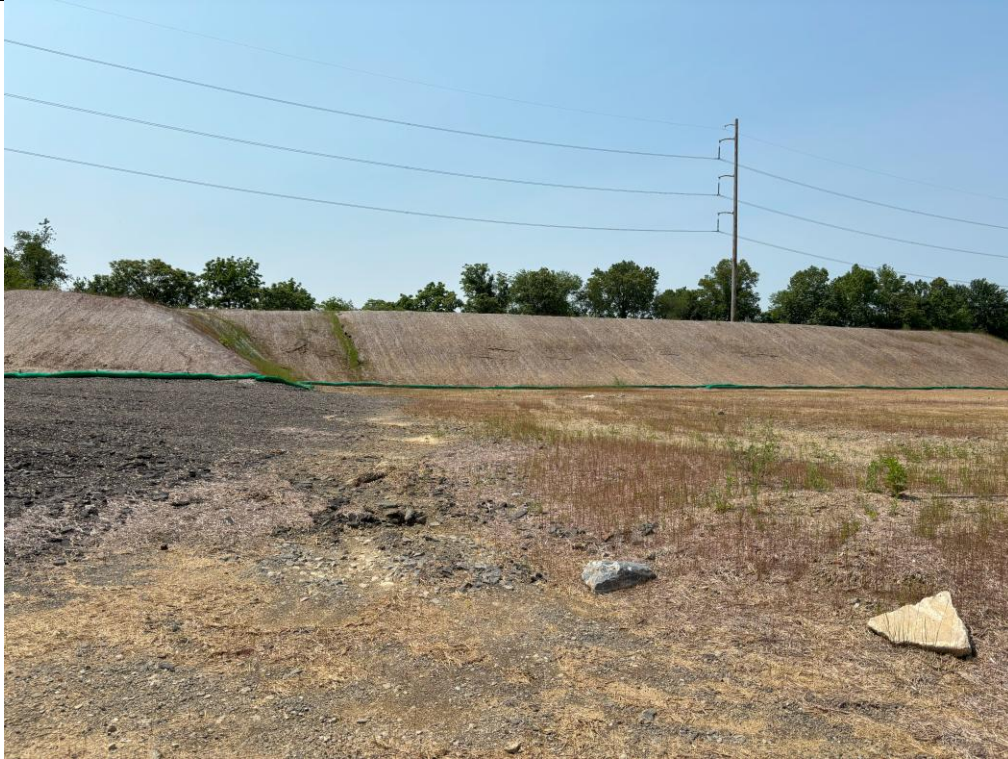
Midslope section of site and large fill dirt stockpile.

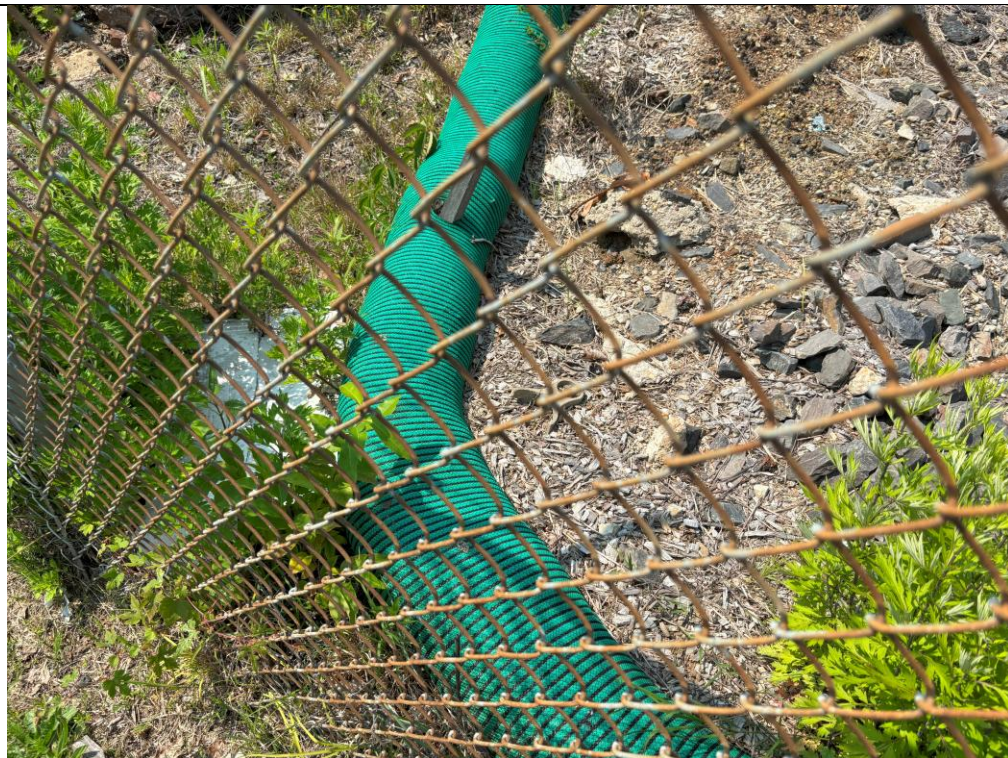
I observed a short stretch of filtersock along the downslope boundary of the site were nearing an overtopping condition by collected mulch from upslope areas.

Close-up of downslope filter sock nearing an overtopping condition.

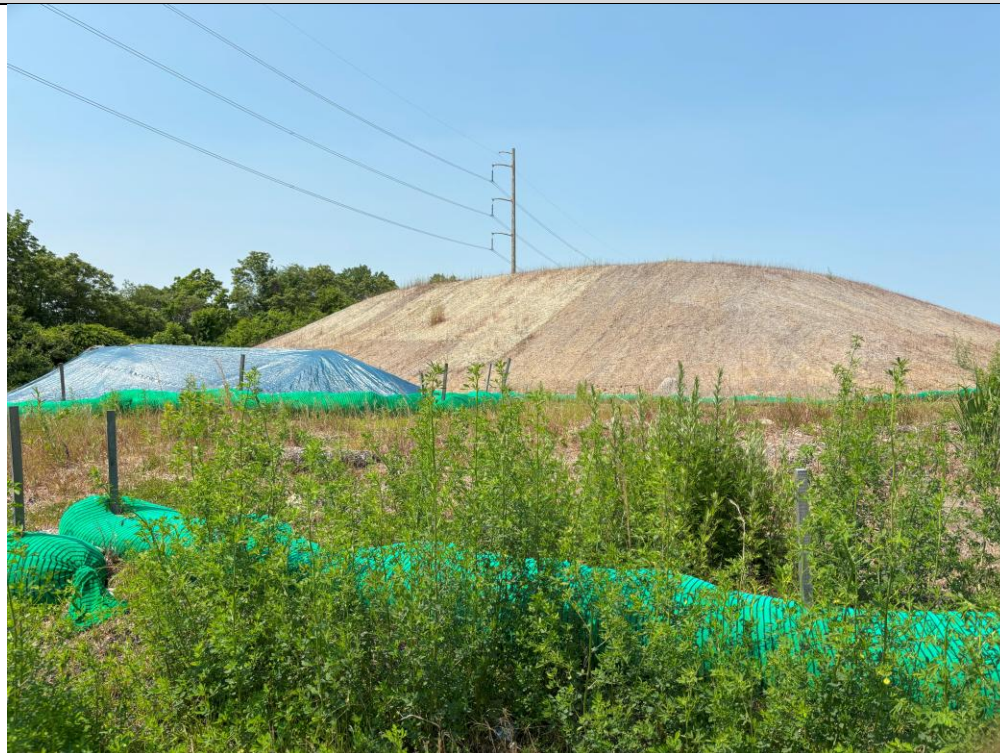
The tarp covering the small pile of contaminated soil downslope of the large fill dirt stockpile was intact and fully covered the soil.

Contaminated fill dirt stockpile at left center, covered by tarp; downslope portion of large fill dirt stockpile in background.

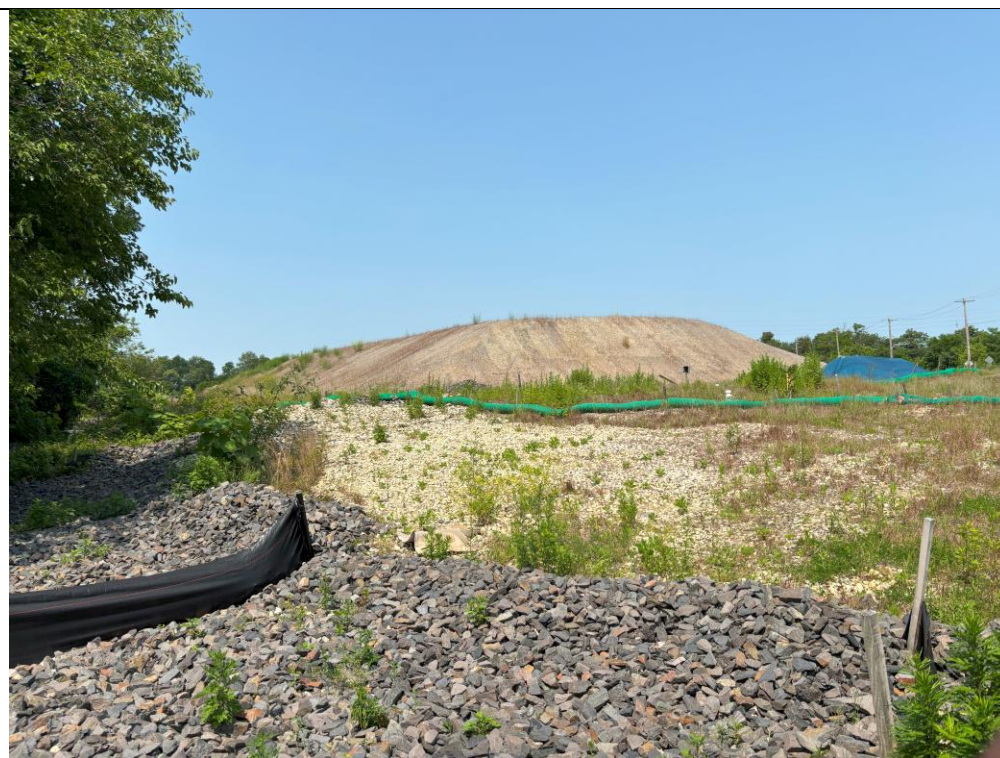
Rear portion of large fill dirt stockpile (facing railroad tracks); stone-covered swale with silt sock.

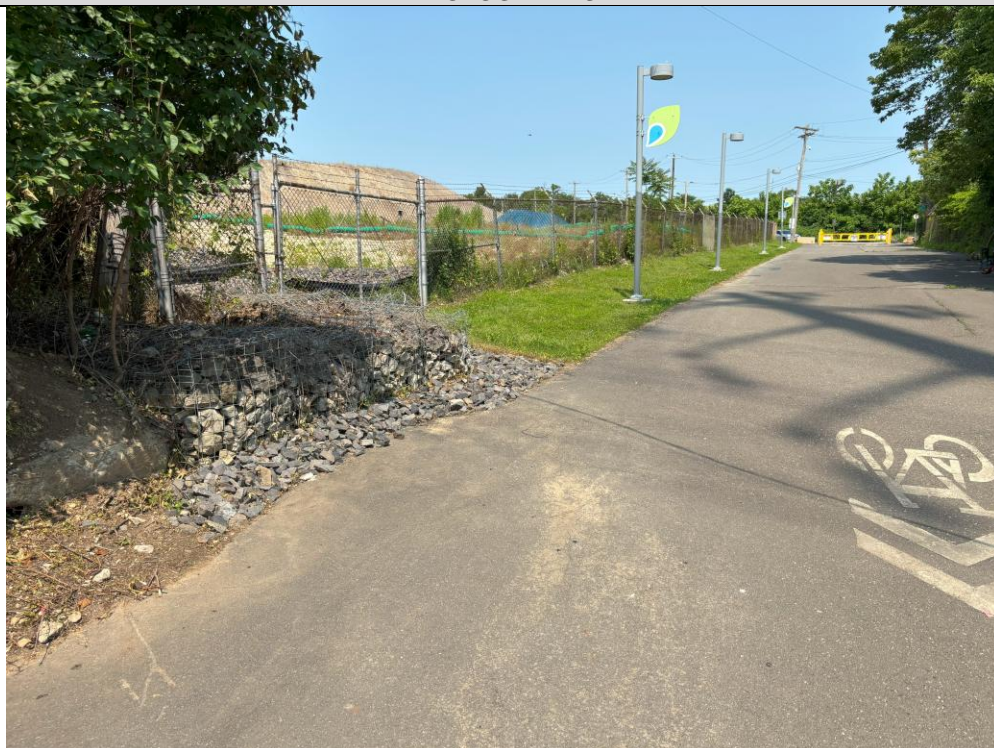
I noted some new sediment deposits at low points of the adjacent section of the Bartram's Garden trail (under the railroad bridge). Given that I did not note evidence of a sediment trail leading from the site to these deposits, and am not noting any Chapter 102 violations in this inspection report, and a deposit was upgradient from where any sediment leaving the site would have gone, it is possible that the new sediment deposits were left by other sources, such as river flooding during both high tide and a heavy rain event; or from upslope areas not part of the Alliance 51st site.

Bartram's Garden trail with sediment staining.

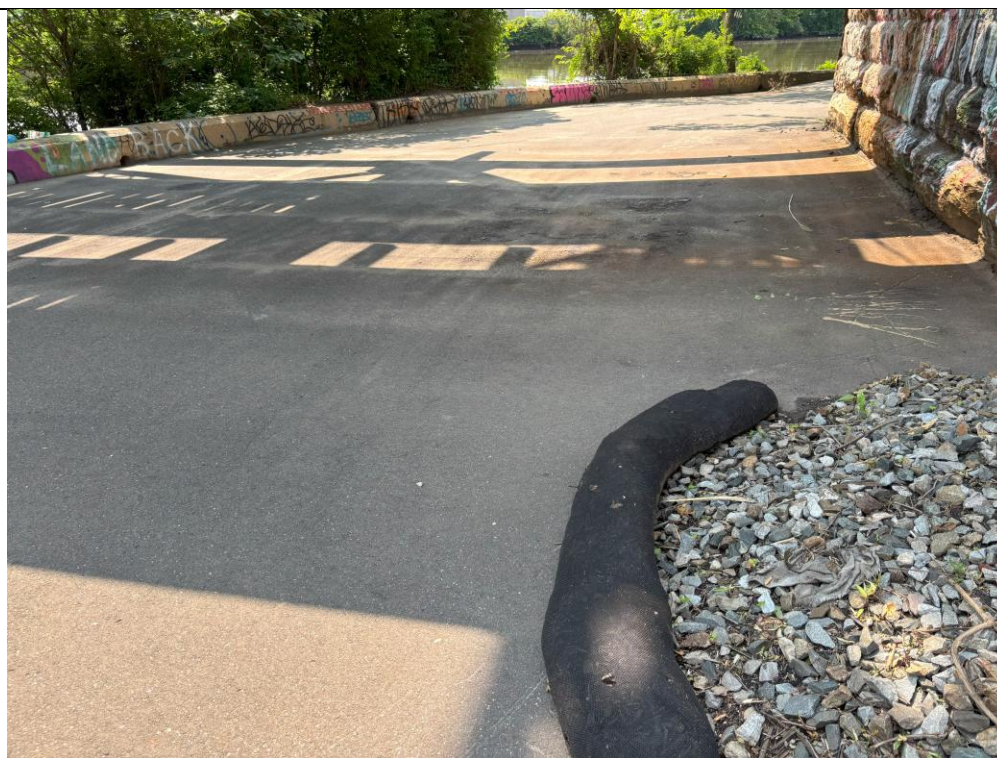
I observed that the inlet protection filter sock along the Bartram's Garden trail was moved to the other side of the trail.

Bartram's Garden trail with river inlet filter sock moved away from inlet.

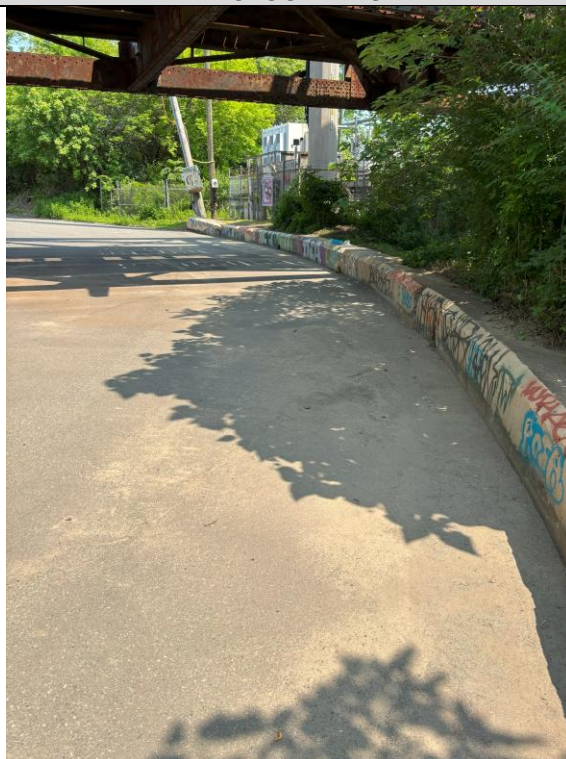
Sediment staining and deposit on Bartram's Garden trail along wall adjacent to Schuylkill River.

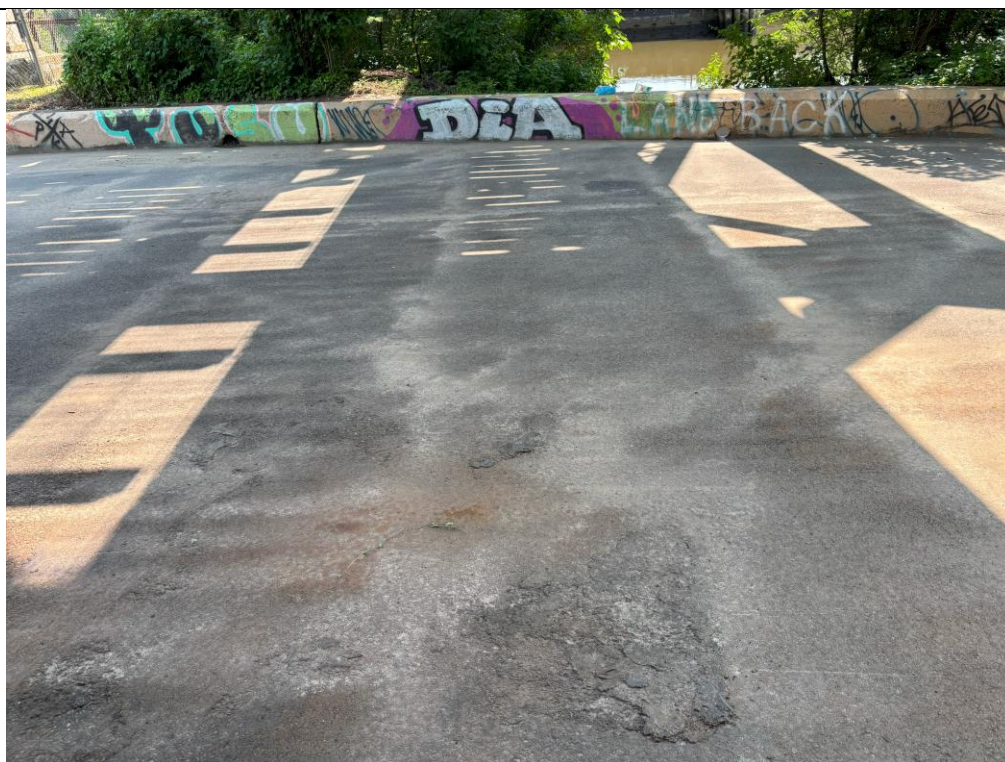
Sediment deposits and staining on Bartram's Garden trail under railroad bridge, looking towards Schuylkill River.

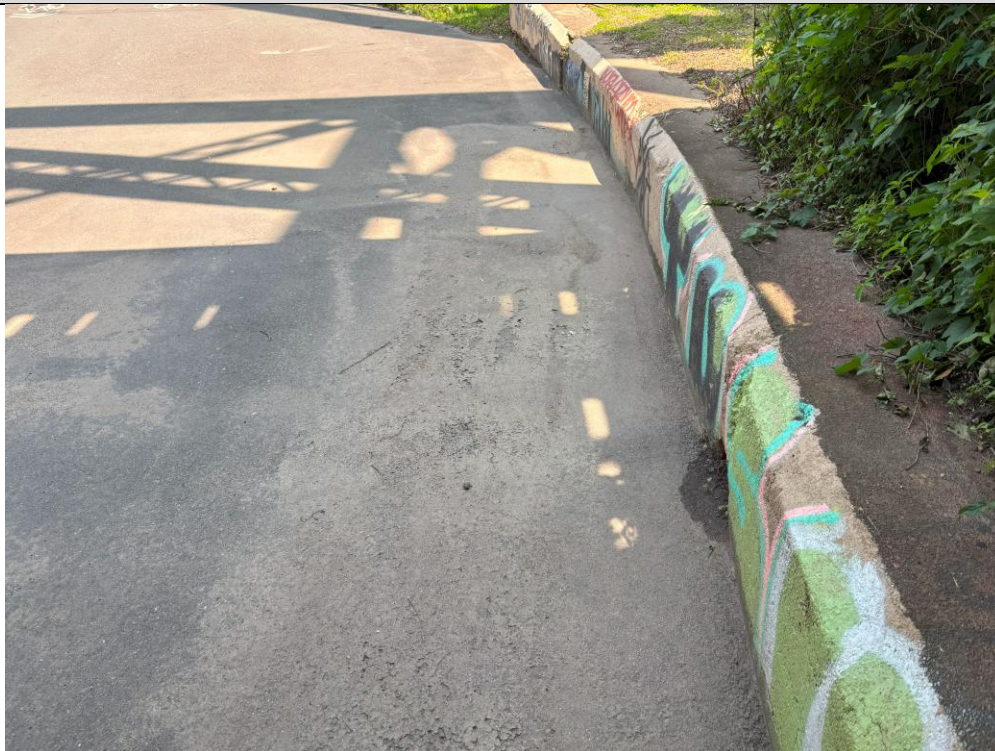
Sediment staining and deposits along Bartram's Garden trail along wall adjacent to Schuylkill River, under railroad bridge.

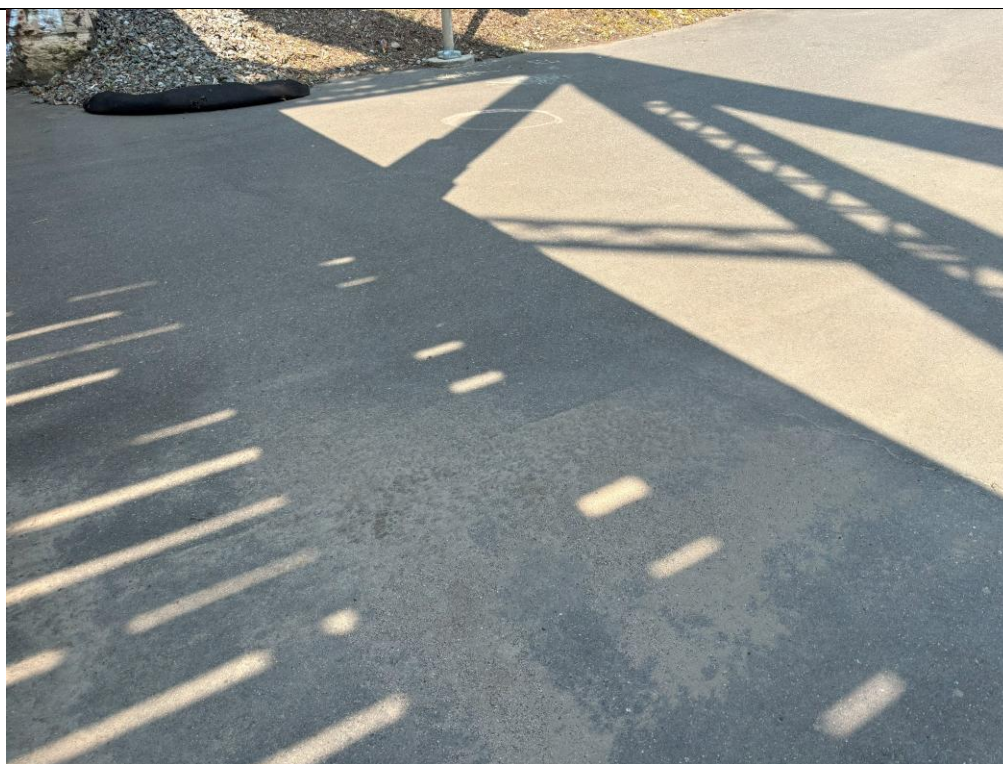
Sediment staining on Bartram's Garden trail, under railroad bridge.
End of photo log.
