CHAPTER 102 INSPECTION REPORT

PA Department of Environmental Protection

Permit No.: PAD510225

Report No.: 11

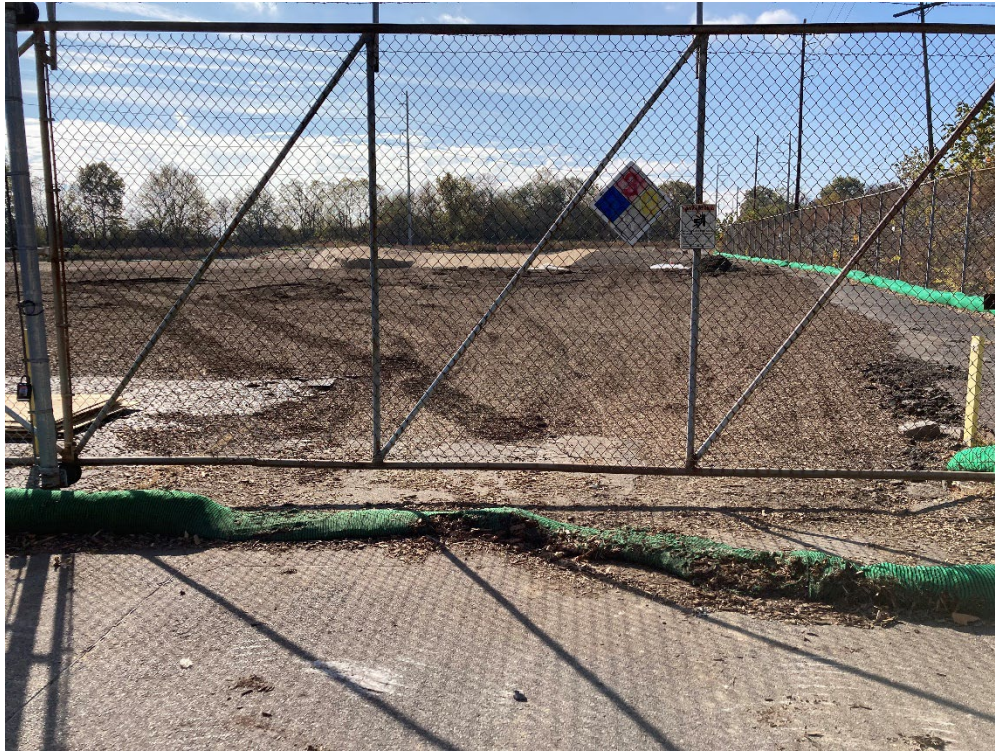
After parking adjacent to the stone stockpile along the 51st St. side of the site, I noted that the filter sock at the most upslope gate has been run over by vehicles and badly damaged. Filter sock at the adjacent downslope gate (along the stone stockpile) had not been replaced in front of the gate.

Upslope gate along 51st St. with run-over and damaged filter sock.

1. Significant erosion gullies remain on the large fill dirt stockpile. To maintain compliance with 25 Pa. Code, Section 102.22(b), addressing and maintaining the temporary stabilization of the large fill dirt stockpile is recommended.
2. In accordance with DEP's Erosion and Sediment Pollution Control Program Manual, Technical Guidance No. 363-2134-008 (March 2012), Page 65, inspect filter socks weekly and after each runoff event. In addition, DEP requests that damaged socks be repaired according to manufacturer's specifications or replaced within 24 hours of inspection.
3. Ensure that filter sock moved to open the gate and allow vehicle entry to the site, is replaced upon vehicle exit and gate closure.
4. Repair and maintain the chain-link security fence as needed.

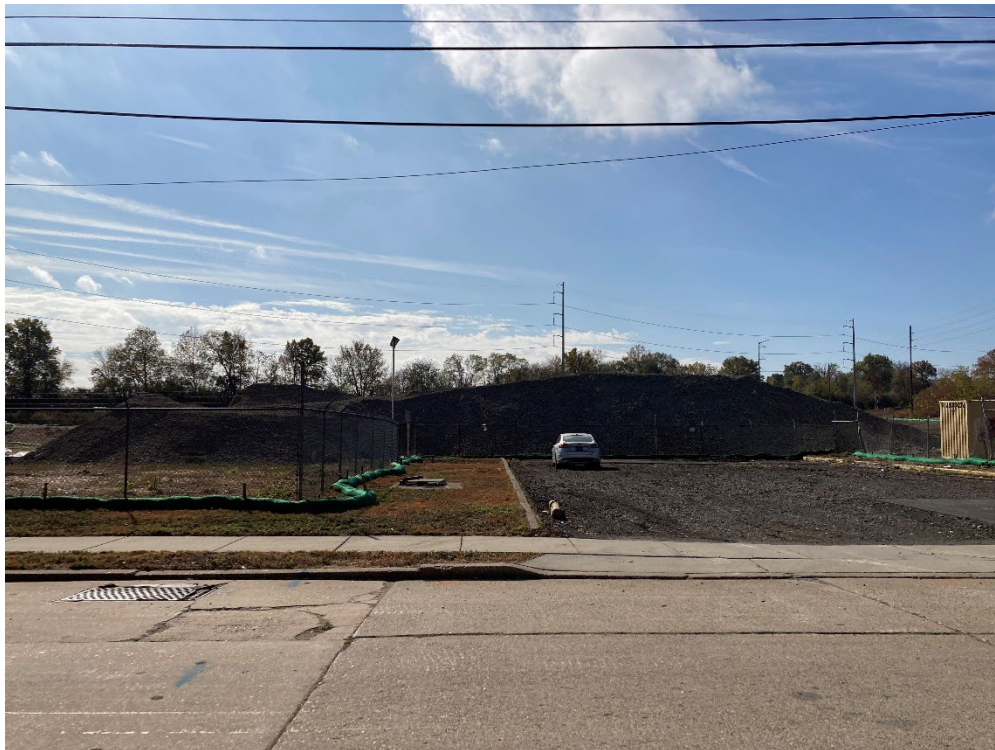
- The stone stockpile appeared unchanged from the previous inspection.
- The vehicle gates at 51st and Botanic Sts. were open during this inspection, but trail closure signage remained on the open gates. The opposite set of gates (to the south, just south of the railroad bridge) remained closed.
- The hole in the chain-link fence next to the area of Bartram's Garden trail sediment staining is more apparent now due to less vegetation being present.
- There was some damage to the chain-link fence along 51st St.

Stone stockpile as photographed from 51st St.

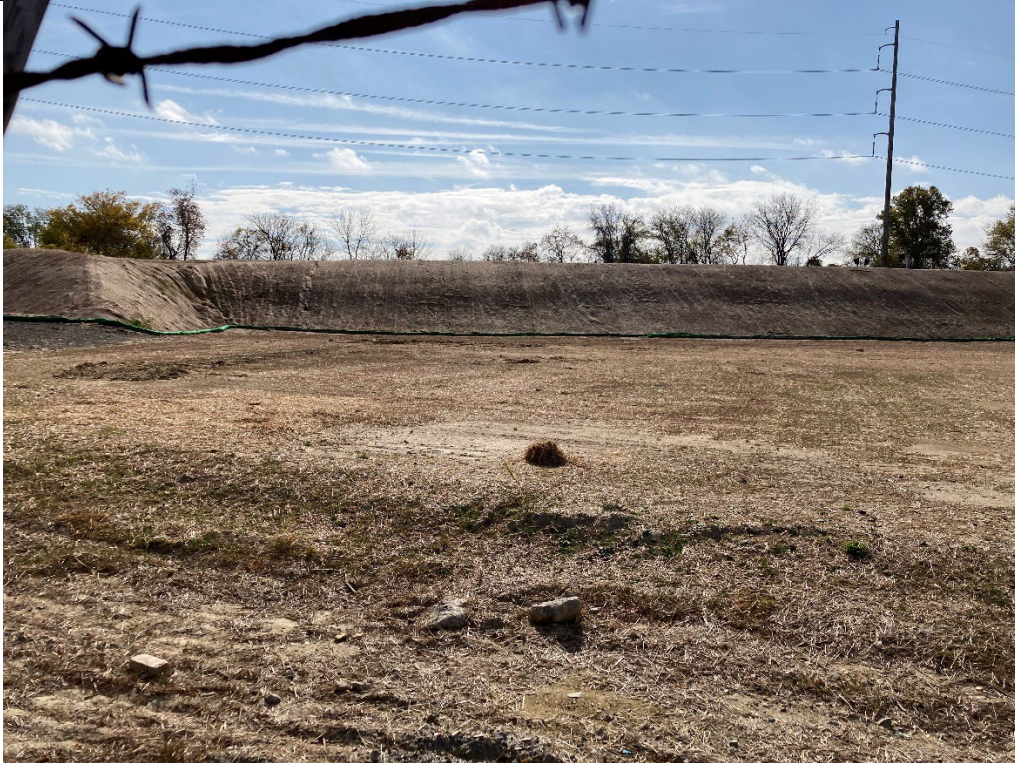
I noted the continued presence of erosion gullies on the large fill dirt stockpile (first described in Report No. 10, 10/22/24). Failure of temporary stabilization to minimize accelerated erosion and sedimentation is a violation of 25 Pa. Code, Section 102.22(b).

Partially or totally due to drought conditions existing at the time of this inspection, any germination that had begun on the large fill dirt stockpile, as noted in past inspection reports, appeared as of today's inspection to be gone.

Large fill dirt stockpile with erosion gullings present towards left.

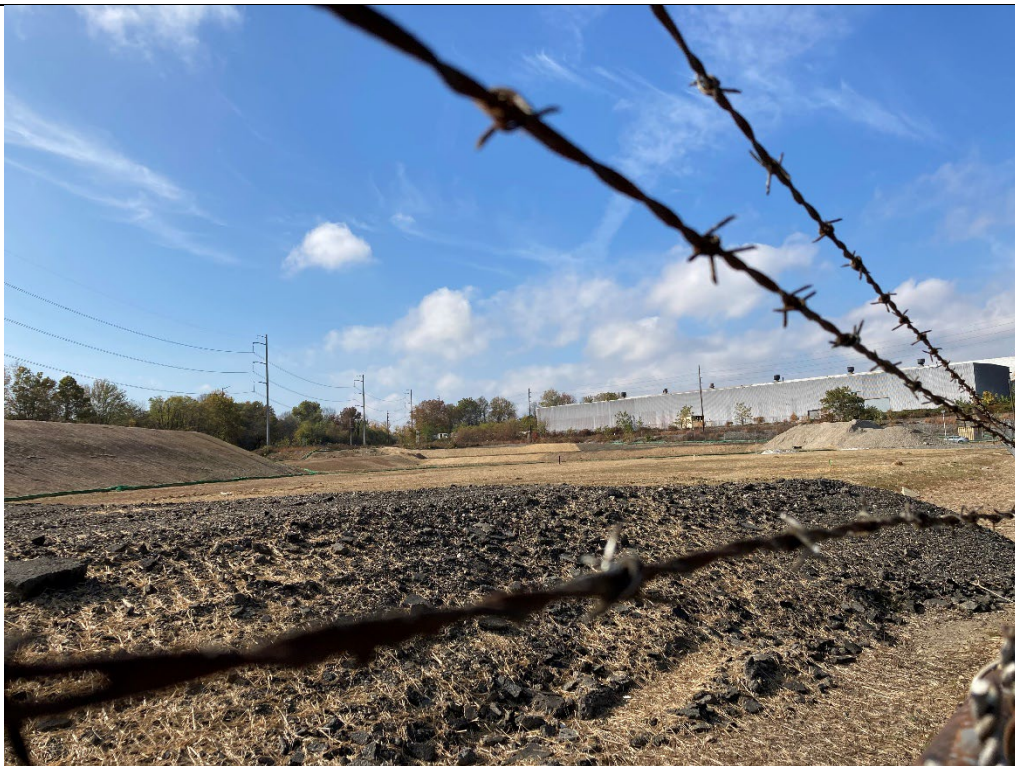
Looking from downslope to upslope across site.

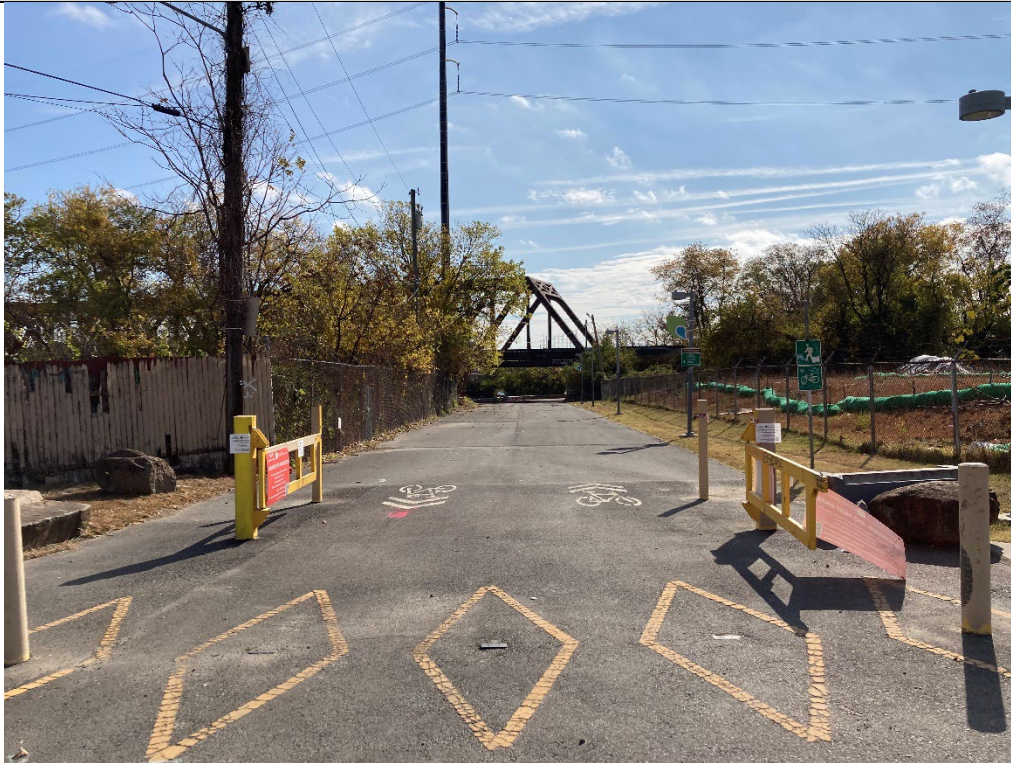
Open gates of Bartram's Garden trail at 51st and Botanic Streets.

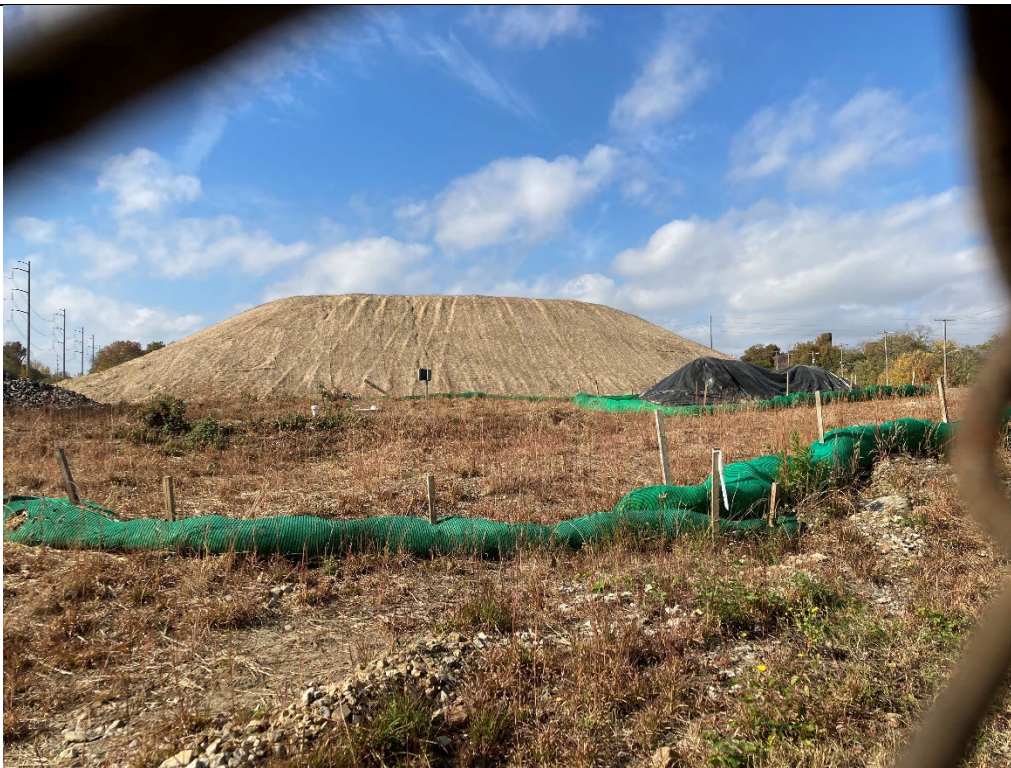
The black tarp covering the small pile of contaminated soil downslope of the large fill dirt stockpile, which was noted as partially removed in the previous inspection report, has been re-placed and was observed to be fully covering this pile again.

Downslope end of large fill dirt stockpile, with erosion gullies present. Small contaminated dirt pile is covered in black tarp at right-center.

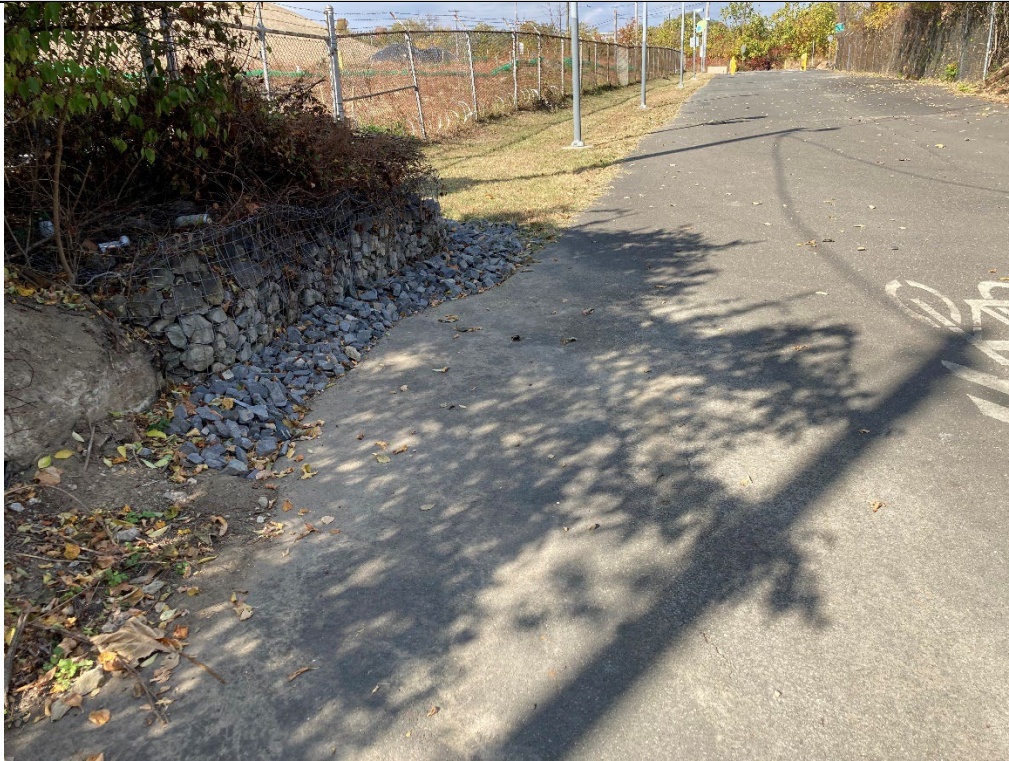
Sediment staining on the Bartram's Garden trail appeared generally unchanged from the previous inspection report.

Sediment staining along Bartram's Garden trail.

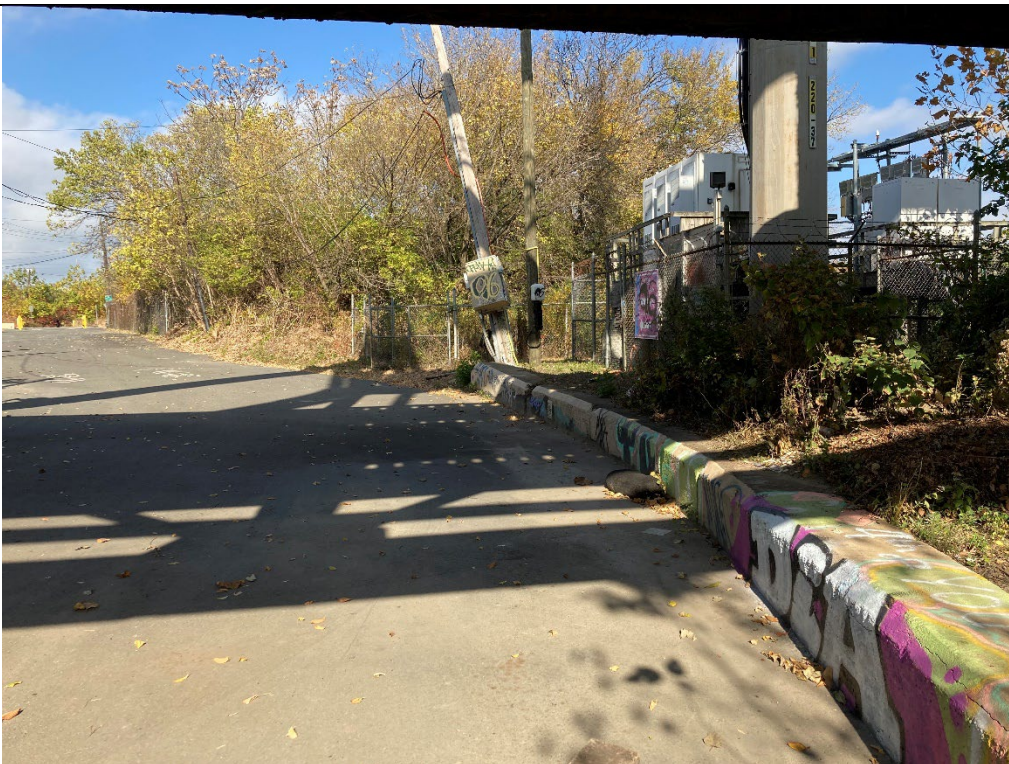
Sediment staining and inlets along Bartram's Garden trail under railroad bridge. Bright spots are sunlight getting through openings in bridge.

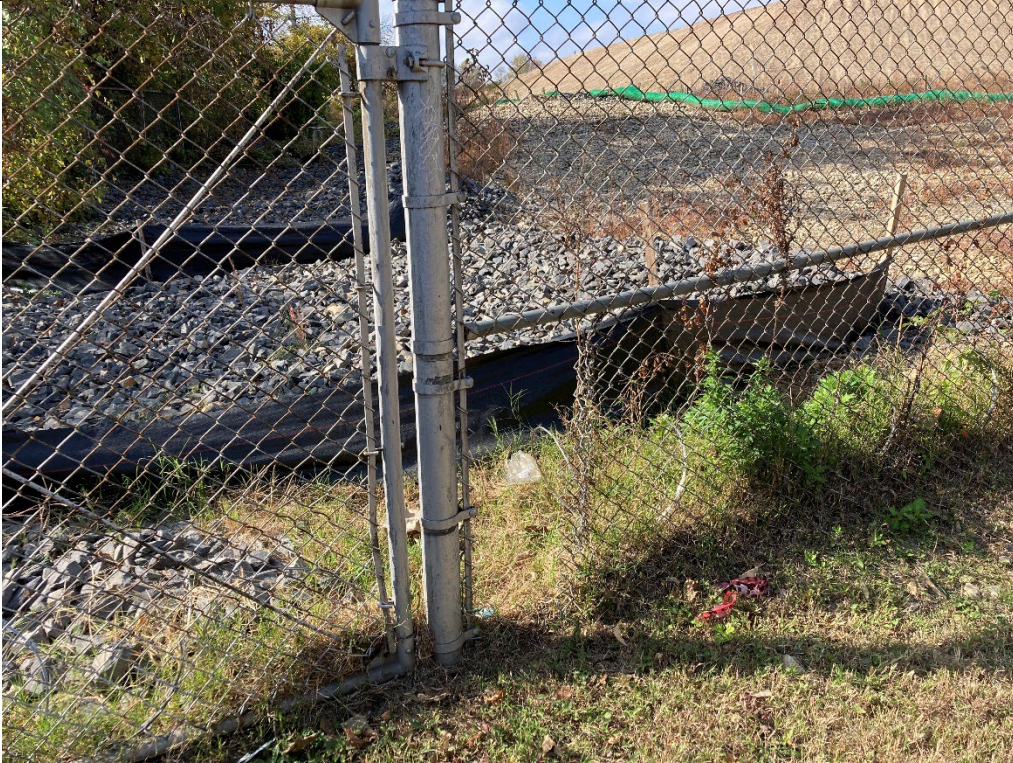
Chain link fence and hole in fence at downslope end of site.

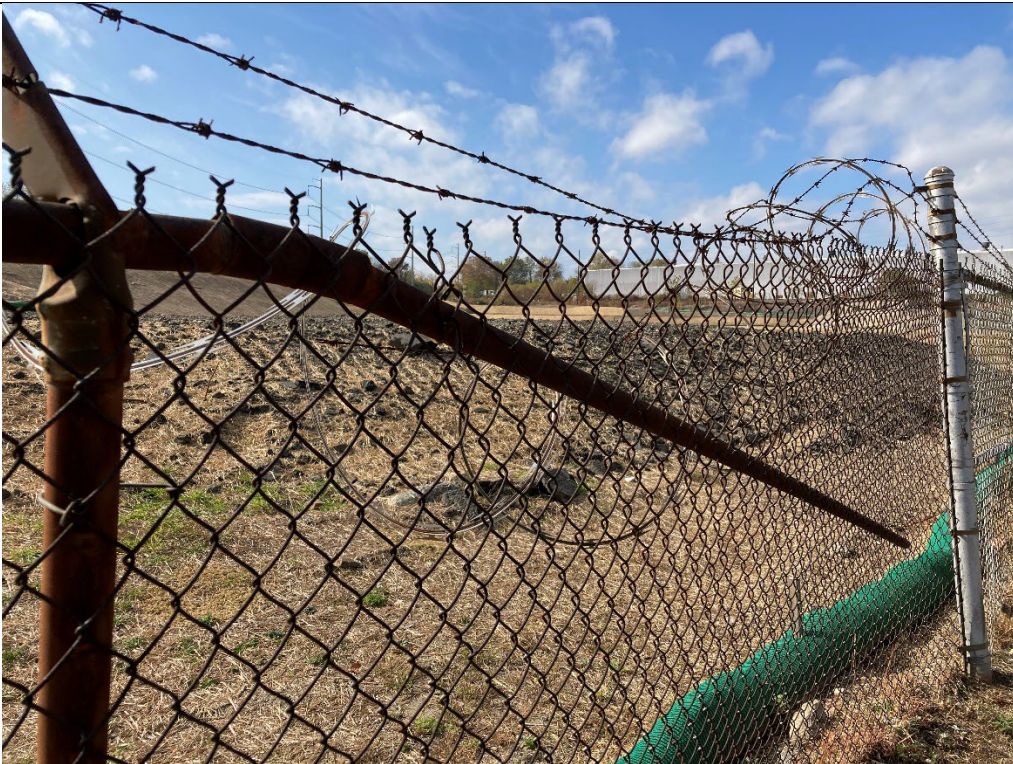
Chain link fence damage along 51st St.
