CHAPTER 102 INSPECTION REPORT

PA Department of Environmental Protection

Permit No.: PAD510225

Report No.: 15

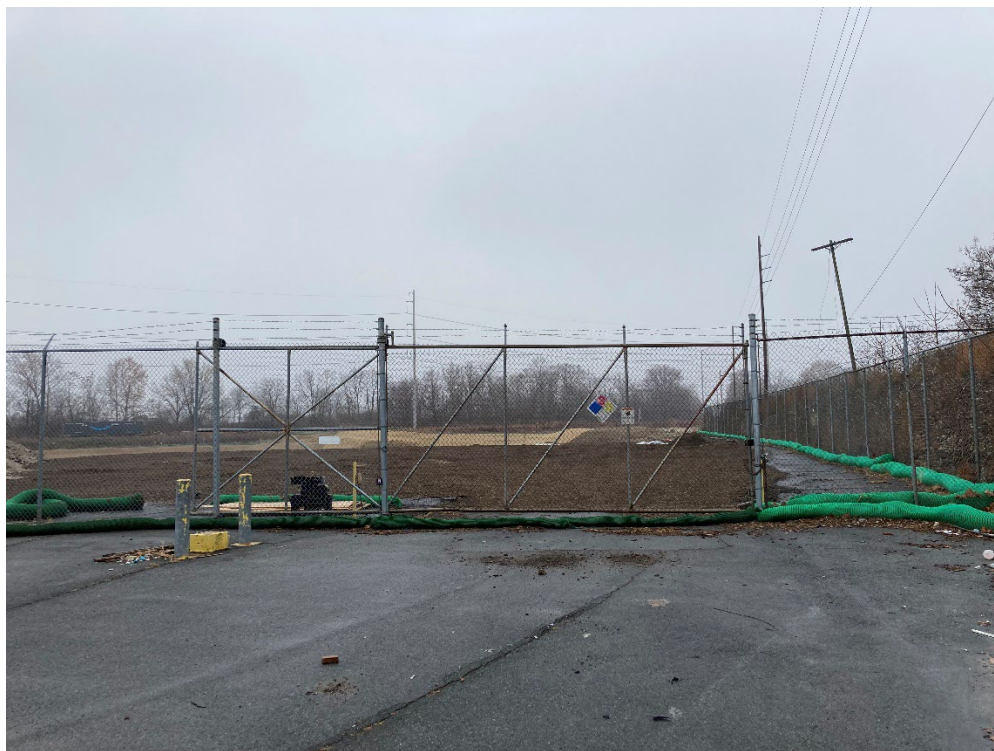
I noted that the filter sock along both 51st St. gates to the site were in proper position and in good operating condition.

Most upslope gate, along 51st St.

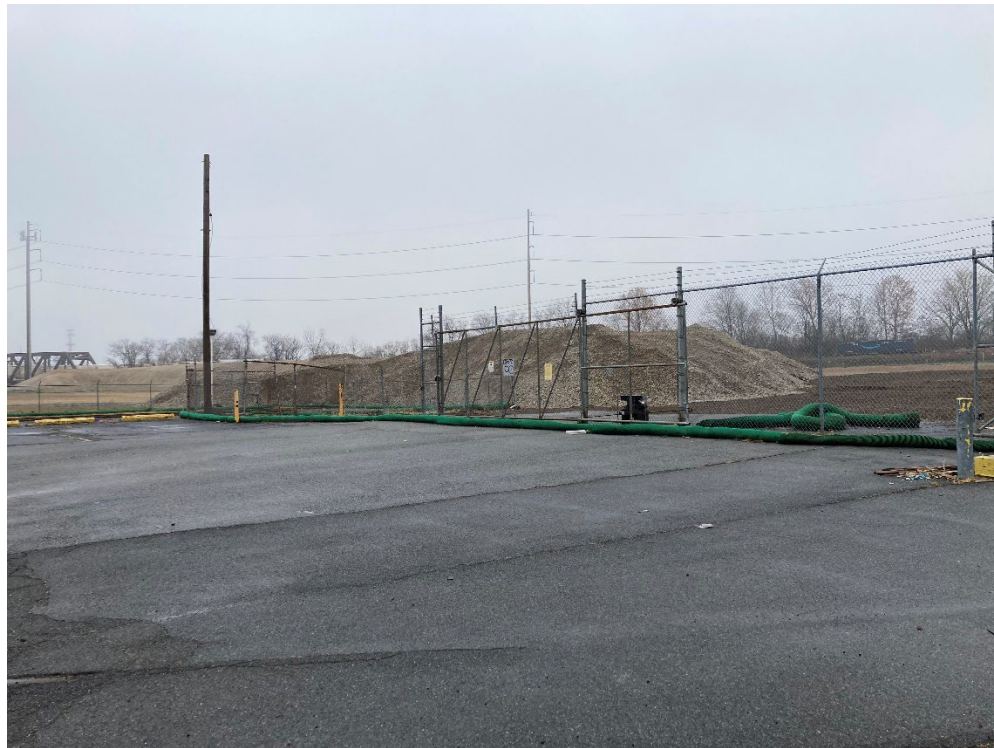
Mulch quantity and depth around the site remained generally uniform. The stone stockpile remained similar in appearance to previous recent inspections.

Filter sock and stone stockpile, taken from parking lot along 51st St.

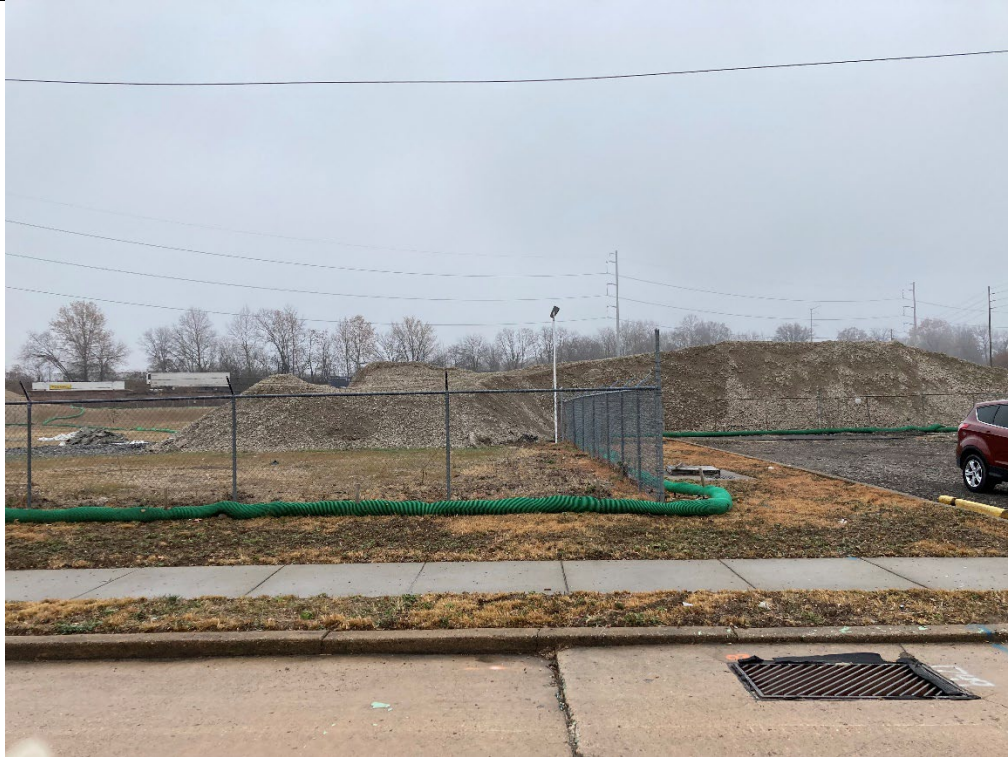
Stone stockpile, as taken from 51st St.

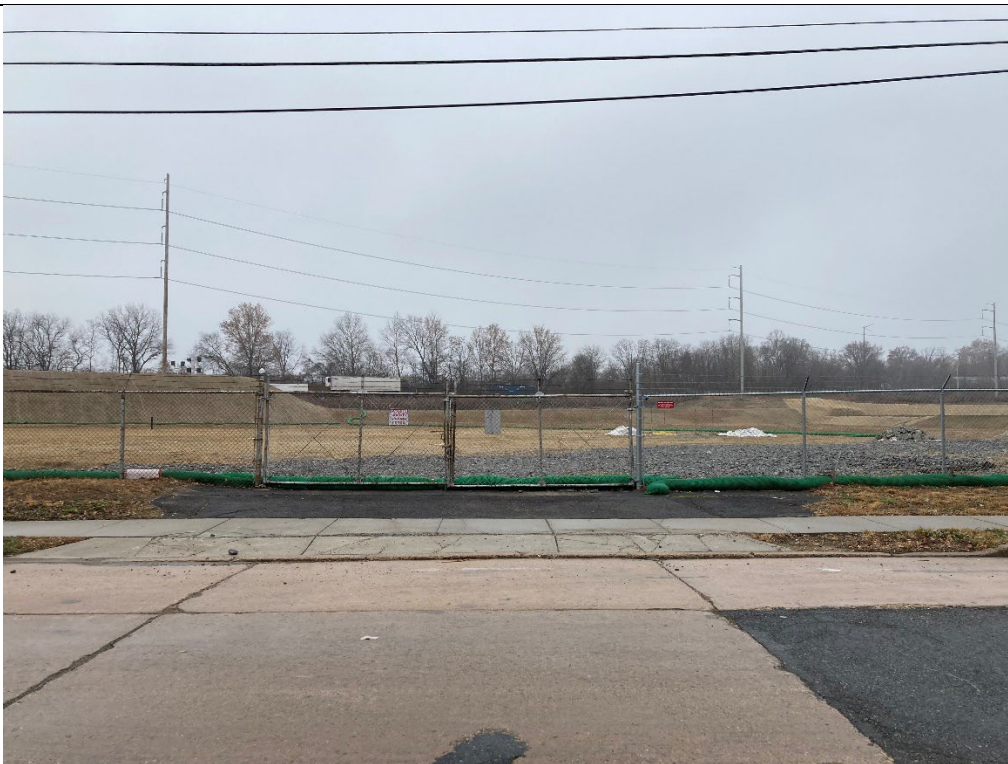
More downslope of the two gates along 51st St.

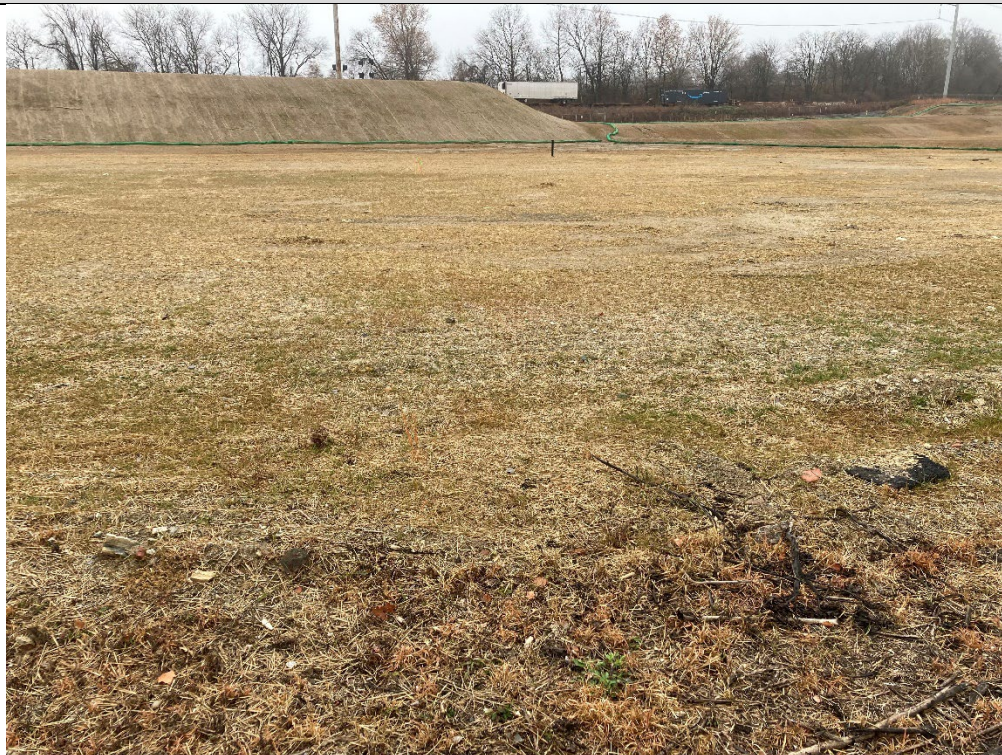
There continued to be some minor grass growth/germination in the downslope flat portion of site.

Midslope section of site with some germination.

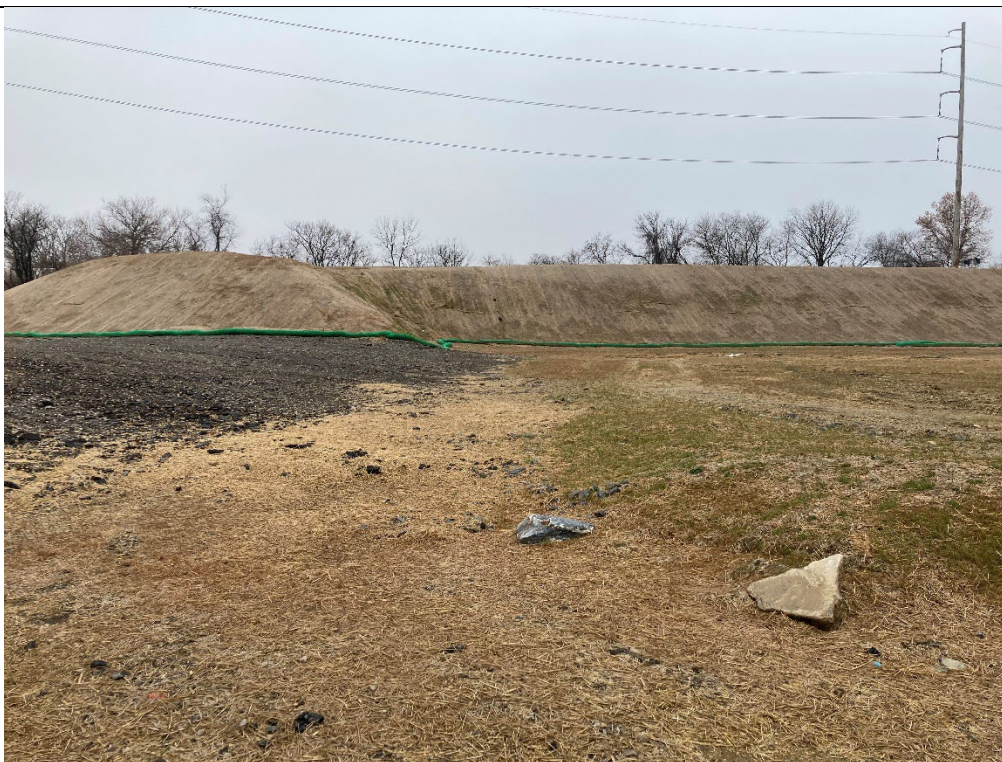
The erosion gullies first noted on the large fill dirt stockpile (first described in Report No. 10, 10/22/24), remained present. Failure of temporary stabilization to minimize accelerated erosion and sedimentation is a violation of 25 Pa. Code, Section 102.22(b). The large fill dirt stockpile remained very similar in appearance with regard to germination level since the prior inspection.

Downslope section of site with some germination. Large fill dirt stockpile in background with erosion gullying present.

1. Significant erosion gullies remain on the large fill dirt stockpile. To maintain compliance with 25 Pa. Code, Section 102.22(b), addressing and maintaining the temporary stabilization of the large fill dirt stockpile is recommended.
2. In accordance with DEP's Erosion and Sediment Pollution Control Program Manual, Technical Guidance No. 363-2134-008 (March 2012), Page 65, inspect filter socks weekly and after each runoff event. In addition, DEP requests that damaged socks be repaired according to manufacturer's specifications or replaced within 24 hours of inspection.
3. Replacing the black tarp over the small contaminated dirt stockpile and further securing it from blowing off from high winds is recommended.
4. Removing collected mulch from the areas of downslope filter sock that are nearly overtopped, is recommended.
5. Repair of the security fence along 51st St. is recommended.

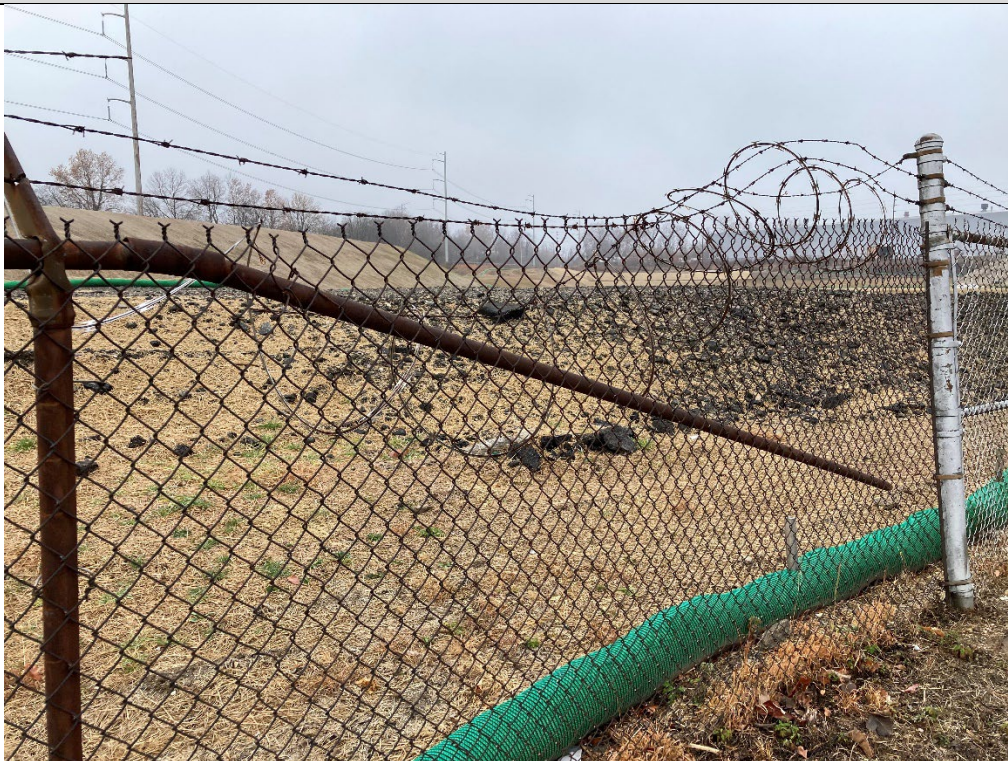
I saw that parts of the security chain-link fence along 51st St. remained damaged.

Security fence damage along 51st St.

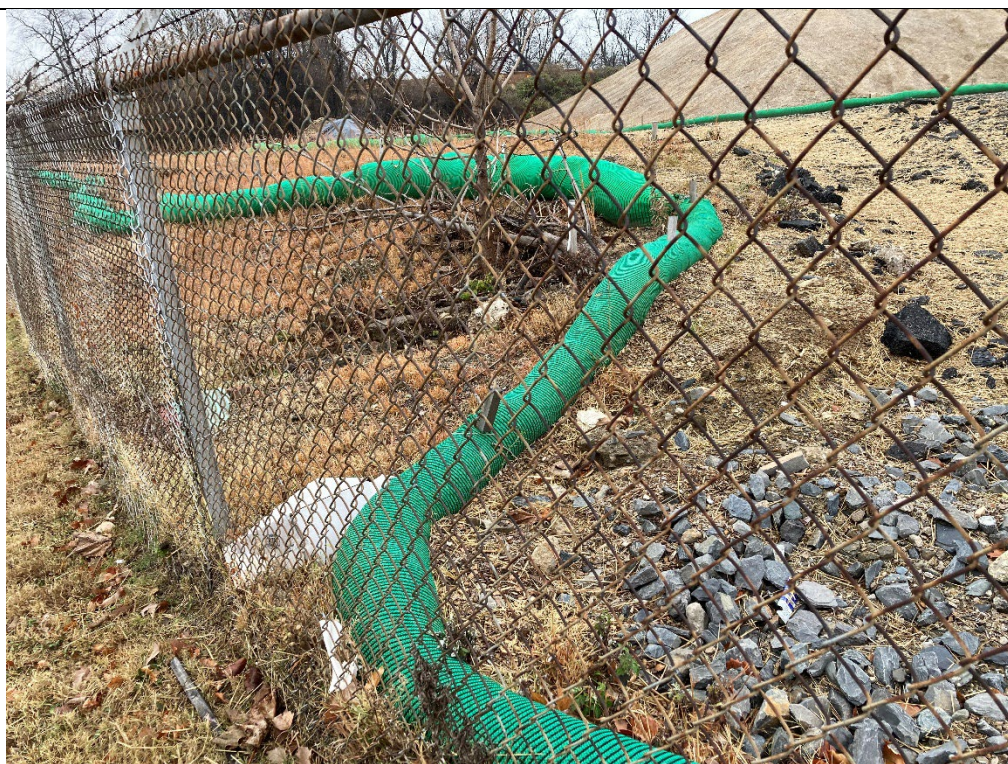
Some short sections of most downslope perimeter filter sock were close to becoming overtopped with mulch.

Filter sock along downslope(eastern) border of site, with some parts of filtersock nearly overtopped.

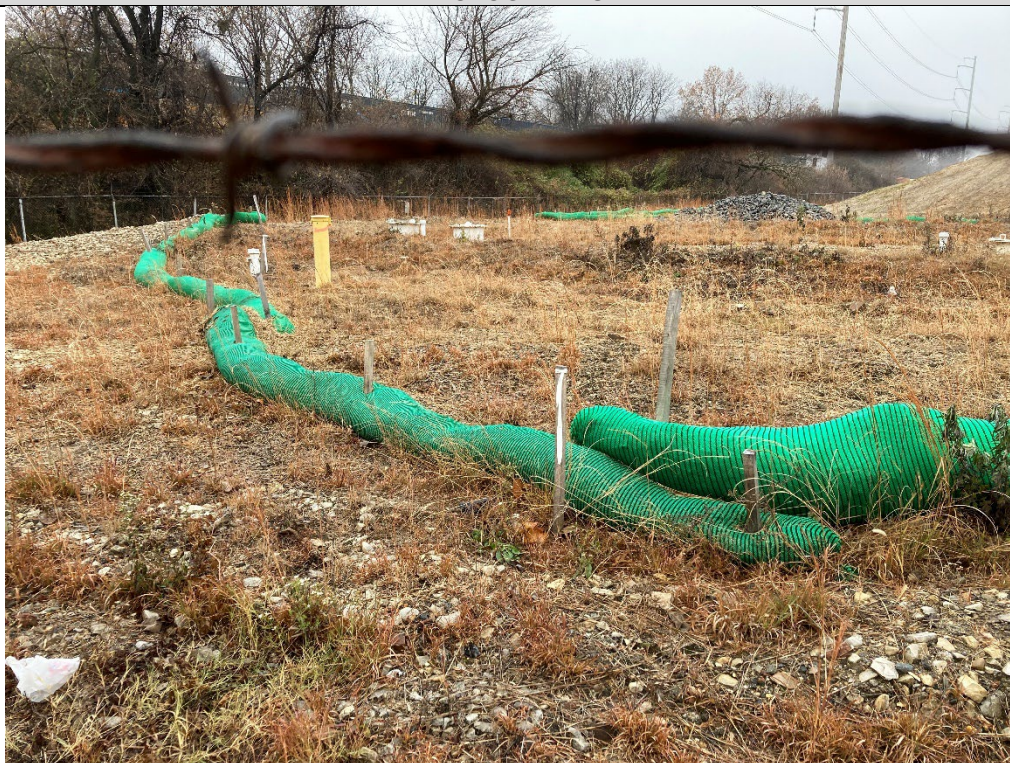
Filter sock along downslope(eastern) border of site, with some parts of filtersock nearly overtopped.

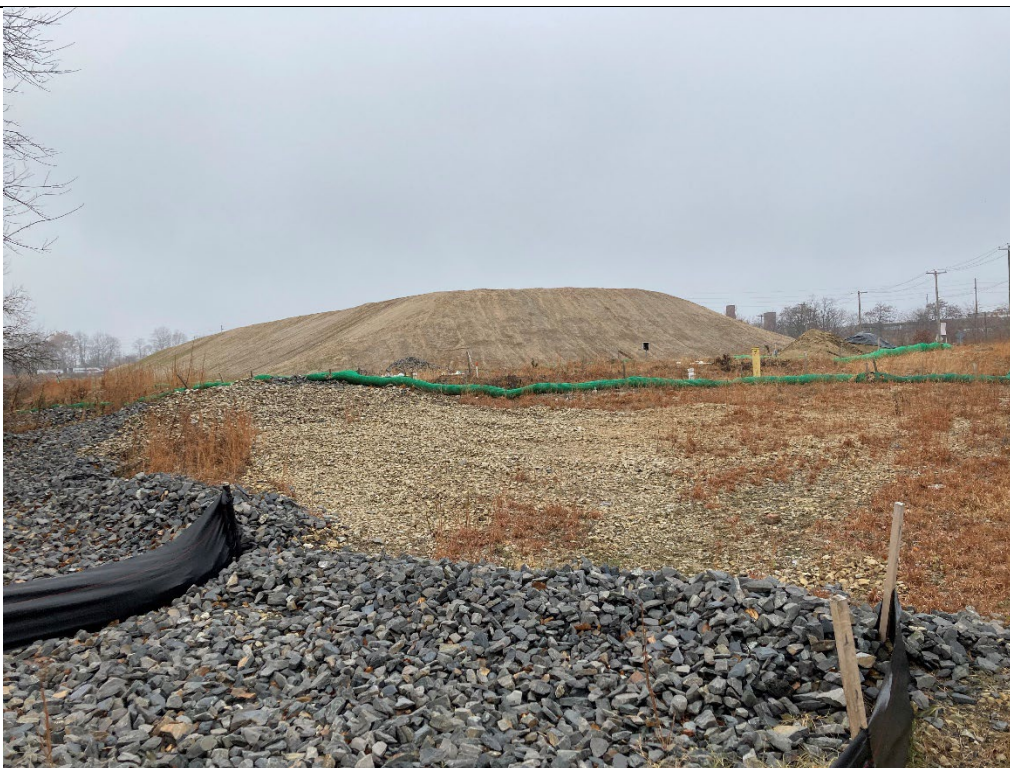
Downslope and southern side of large fill dirt stockpile.

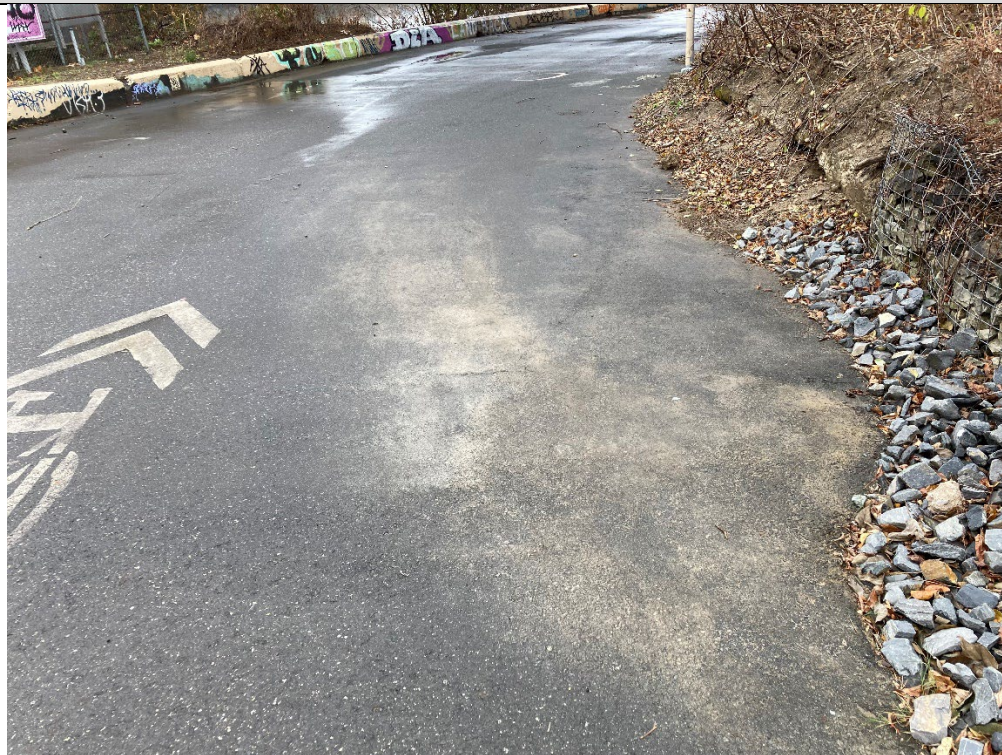
Sediment staining on the Bartram's Garden trail appeared similar overall as in previous inspections.

Sediment staining along Bartram's Garden trail.

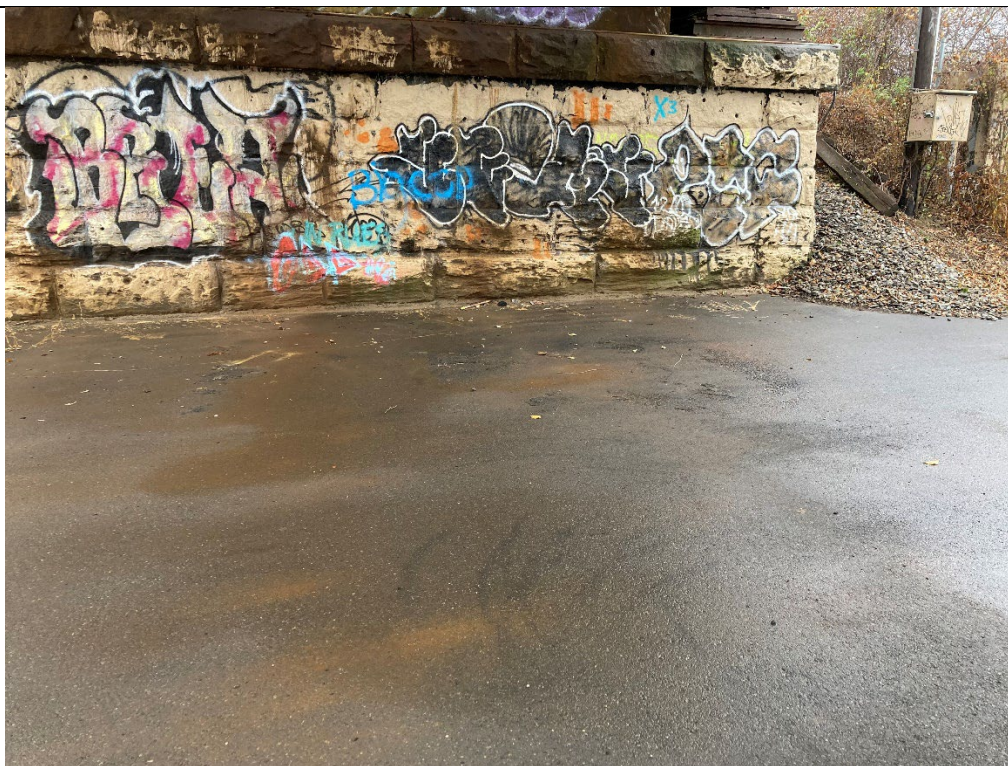
Sediment staining on Bartram's Garden trail under railroad bridge.

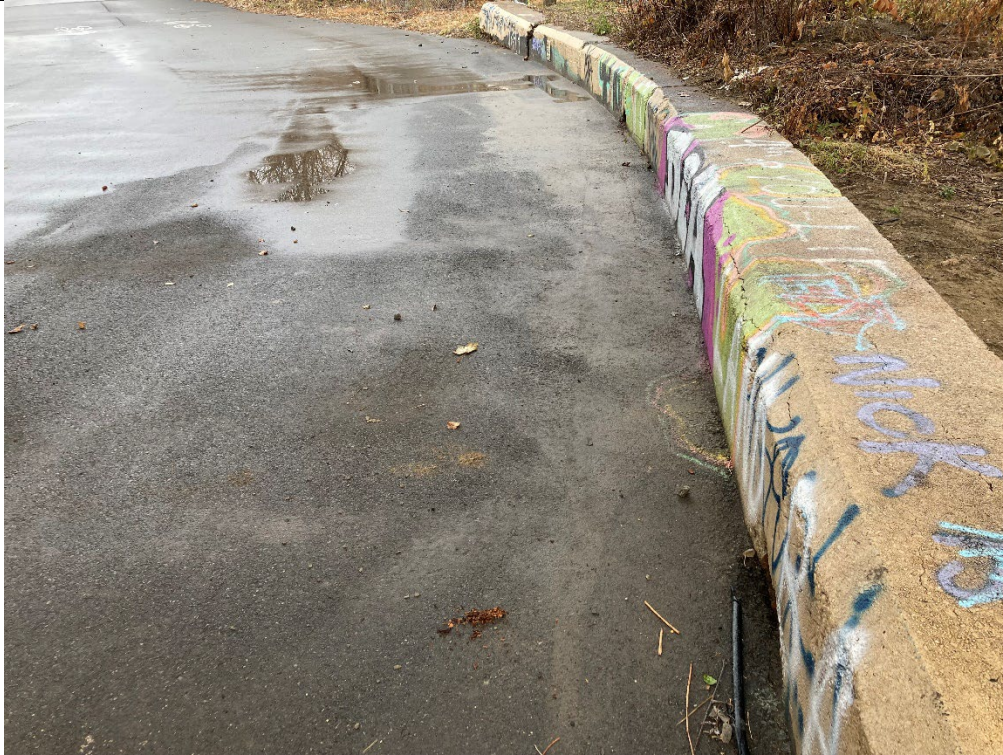
Inlet protection socks along the wall separating the Bartram's Garden trail, as present during previous inspections, were not present during this inspection. One inlet sock was displaced on the other side of the trail, as seen in the attached photo log.

Wall along Bartram's Garden trail adjacent to Schuylkill River without storm drain protection.

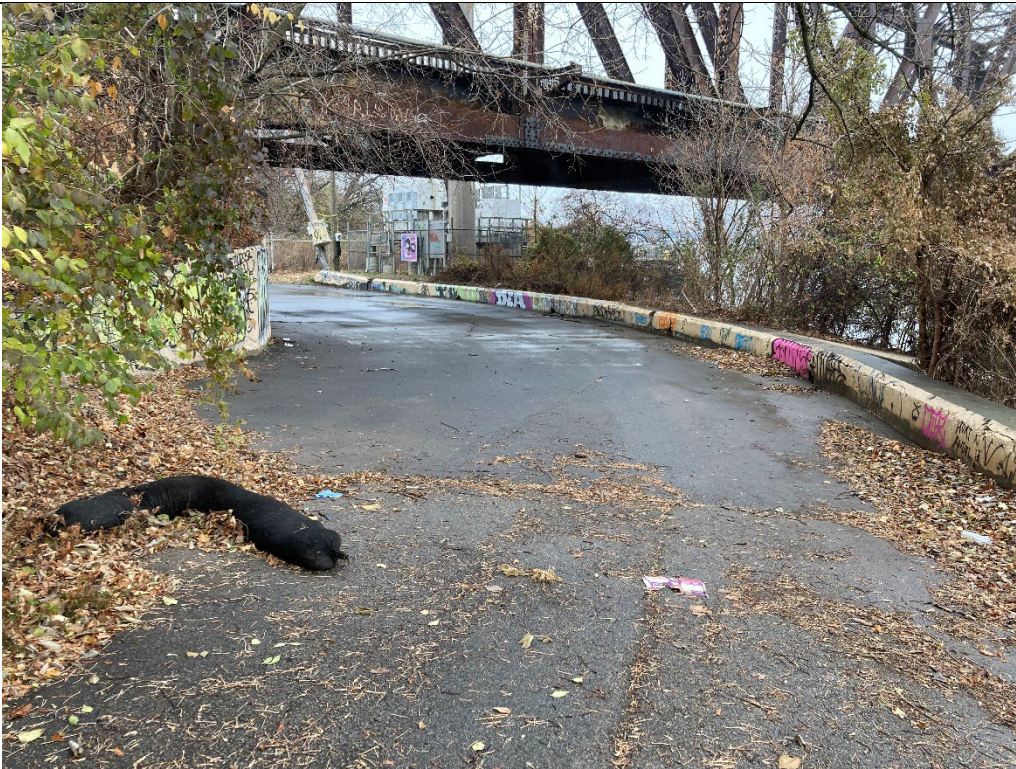
Bartram's Garden trail taken from south side of railroad bridge, with misplaced filter sock in left foreground.

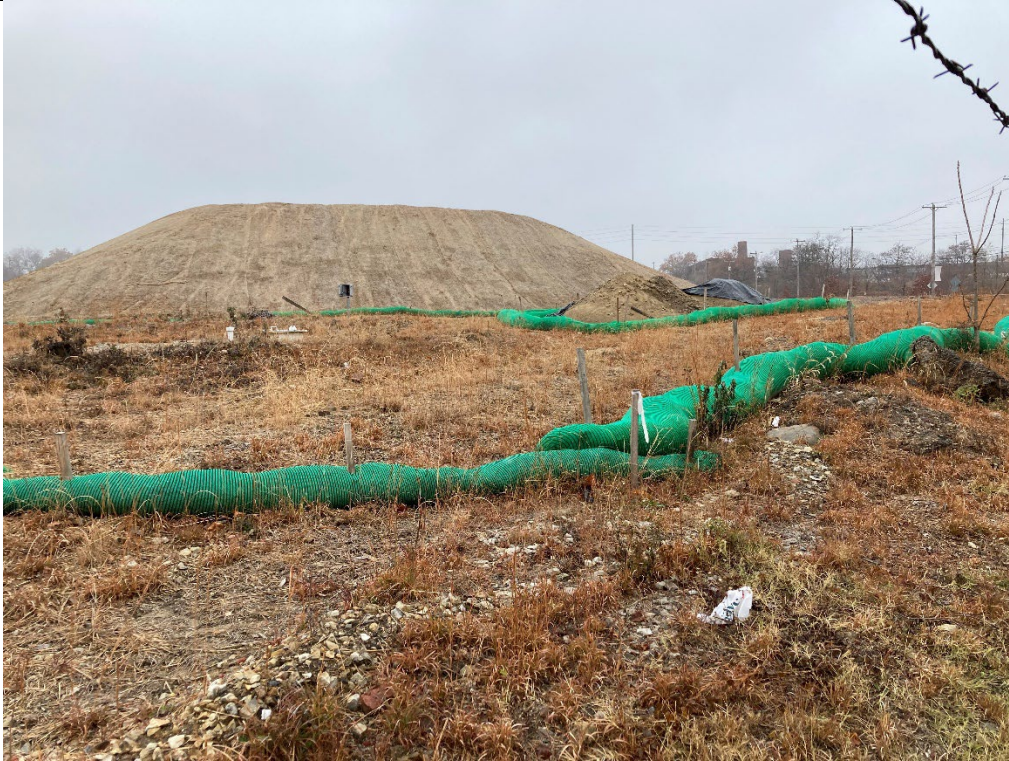
The black tarp covering the small pile of contaminated soil downslope of the large fill dirt stockpile was once again partially blown off the stockpile. Perimeter control (filter sock) around this pile, and the downslope site perimeter, remained intact.

Smaller contaminated dirt stockpile with black tarp partially removed.
End of photo log.
