## CHAPTER 102 INSPECTION REPORT

PA Department of Environmental Protection

Permit No.: PAD510225

Project/Site Name:	<u>Alliance 51<sup>st</sup> Street, Philadelphia</u>	Permit Issuance Date:	<u>9/5/2023</u>
Site Address:	<u>1656 S. 51<sup>st</sup> St.</u>	Permit Expiration Date:	<u>9/4/2028</u>
Site City, State, ZIP:	<u>Philadelphia, PA 19143</u>	Permit Type:	<u>NPDES IP</u>
RP/Permittee Name:	<u>Eric Carlson</u>	Site Municipality(ies):	<u>Philadelphia</u>
RP/Permittee Address:	<u>40 Morris Ave., Suite 230</u>	Site County(ies):	<u>Philadelphia</u>
RP/Permittee City, State, ZIP:	<u>Bryn Mawr, PA 19010</u>	Earth Disturbance:	<u>11.54</u> acres
RP/Permittee Email:	<u>ecarlson@alliancehp.com</u>	Site Latitude:	<u>39.935278</u>
Surface Water(s):	<u>Schuylkill River</u>	Site Longitude:	<u>- 75.209236</u>
Special Protection?	<input type="checkbox"/> Yes <input checked="" type="checkbox"/> No	Complaint Inspection?	<input checked="" type="checkbox"/> Yes <input type="checkbox"/> No
Construction Stage:	<u>Inactive</u>	Activity:	<u>Construction ≥ 1 ac.</u>

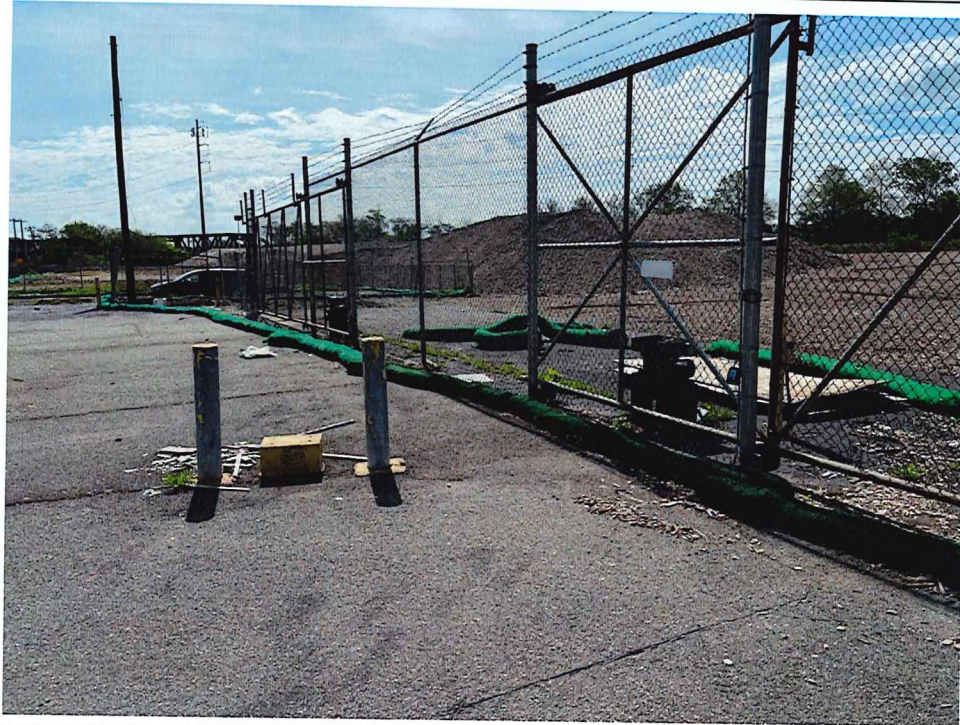
I noted that the filter sock along both 51<sup>st</sup> St. gates to the site were in proper position and in good operating condition. Mulching on the site appeared to remain relatively uniform. I observed some germination in the upslope far end of the site (along the railroad tracks).

Most upslope gate and filter sock.

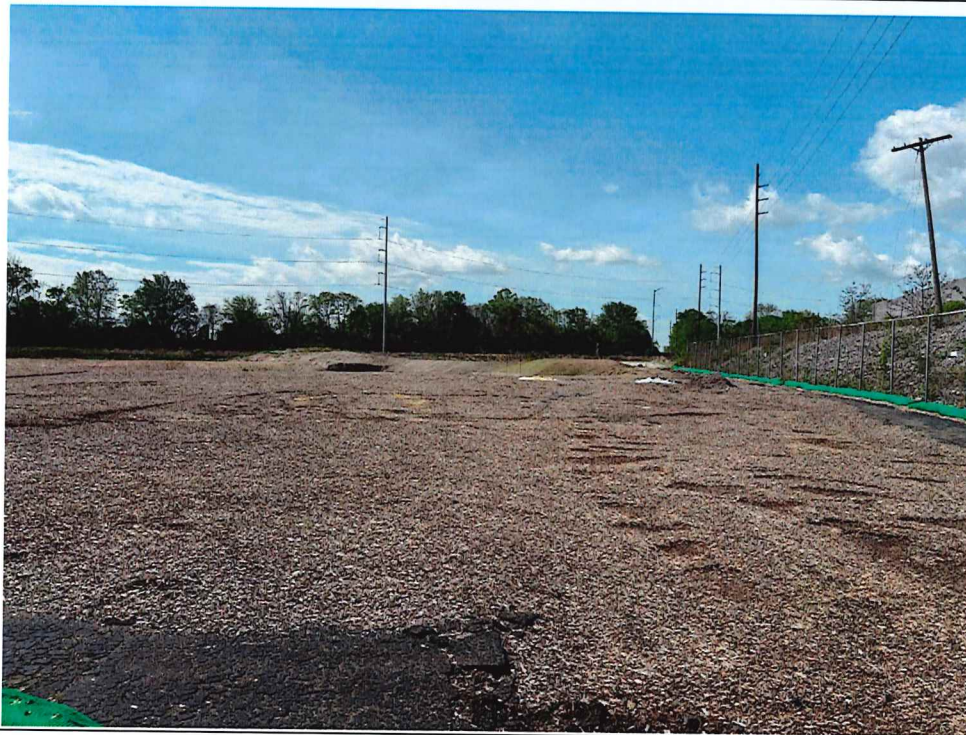
Upslope portion of site with some germination in distance.

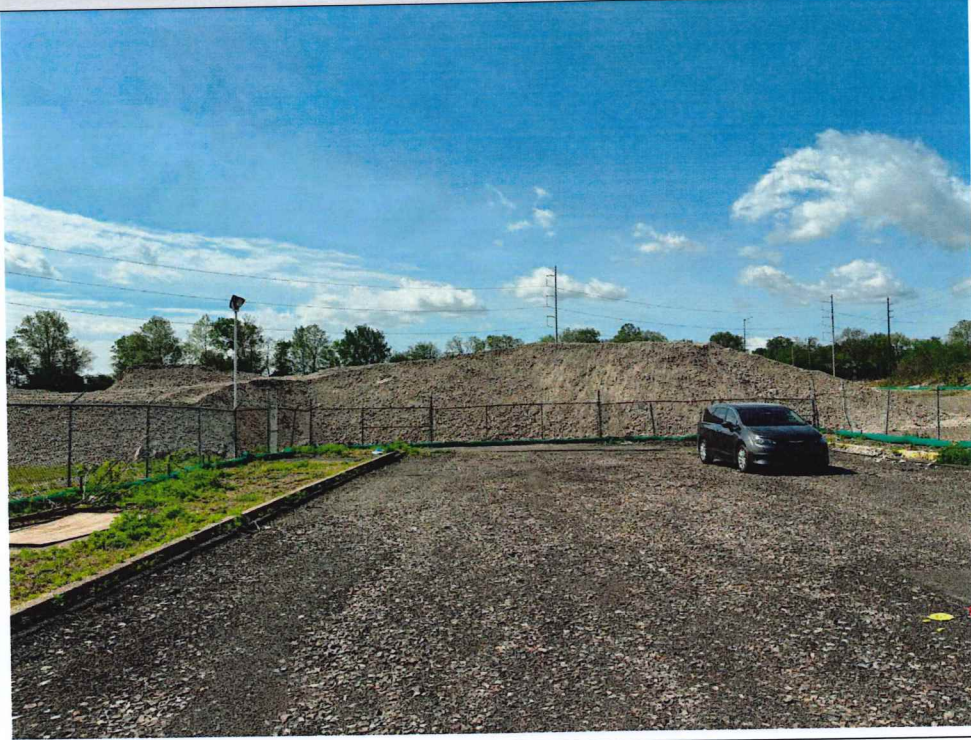
The stone stockpile near the 51<sup>st</sup> St. midslope site boundary appeared unchanged from the previous inspection. The "For Lease" signage remains in place. I noted some sporadic germination in midslope areas of the site.

Stone stockpile and midslope filter sock.

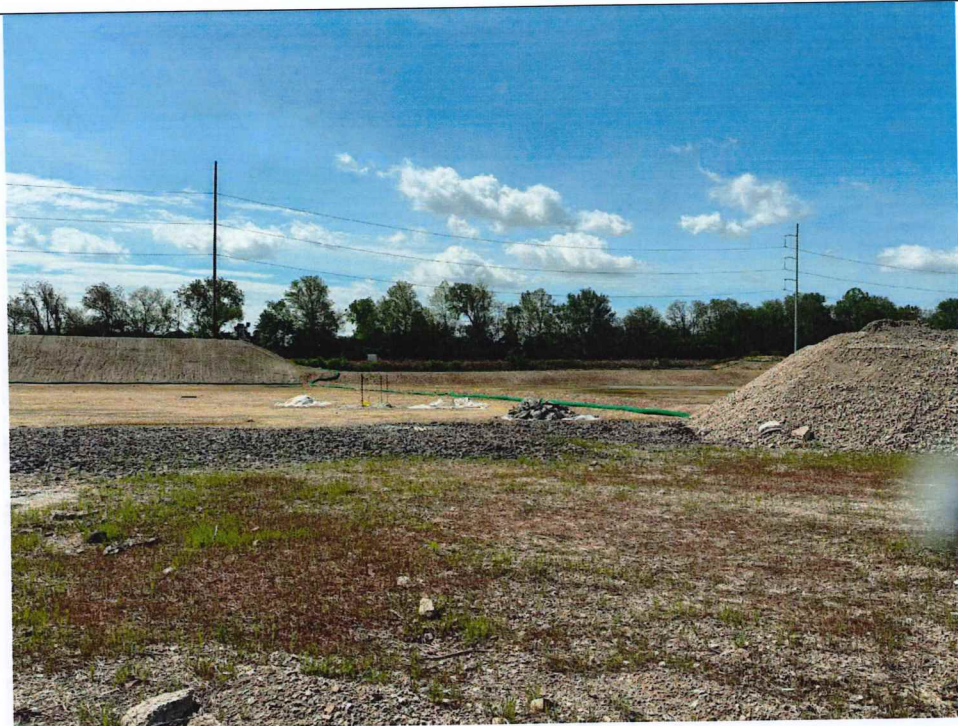
I saw that some work had been done in a midslope portion of the site, as photographed. I observed a new small pile of rock or concrete, plastic wrap, and rebar that may be part of a new ground testing site.

Area of midslope work with rock/concrete pile, plastic sheeting, and rebar present at center.

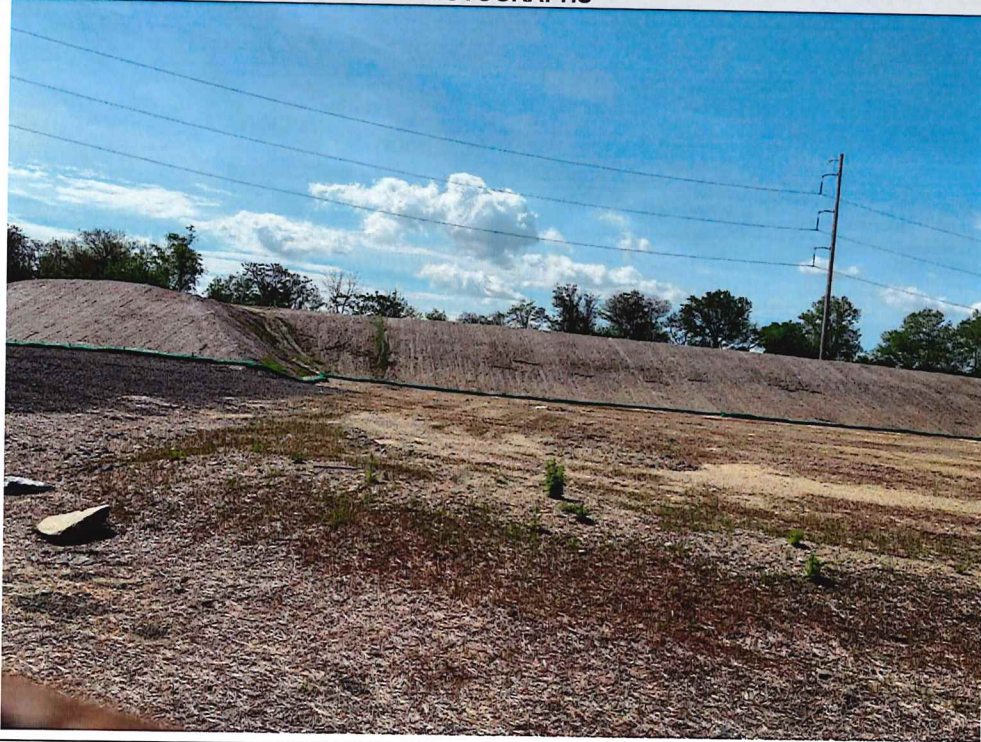
Erosion control matting remained in place at the interior bend of the large fill dirt stockpile, and on the most downslope side. There were some areas of germination on this stockpile, including on the back side (adjacent to the railroad tracks).

Large fill dirt stockpile in distance with some germination present.

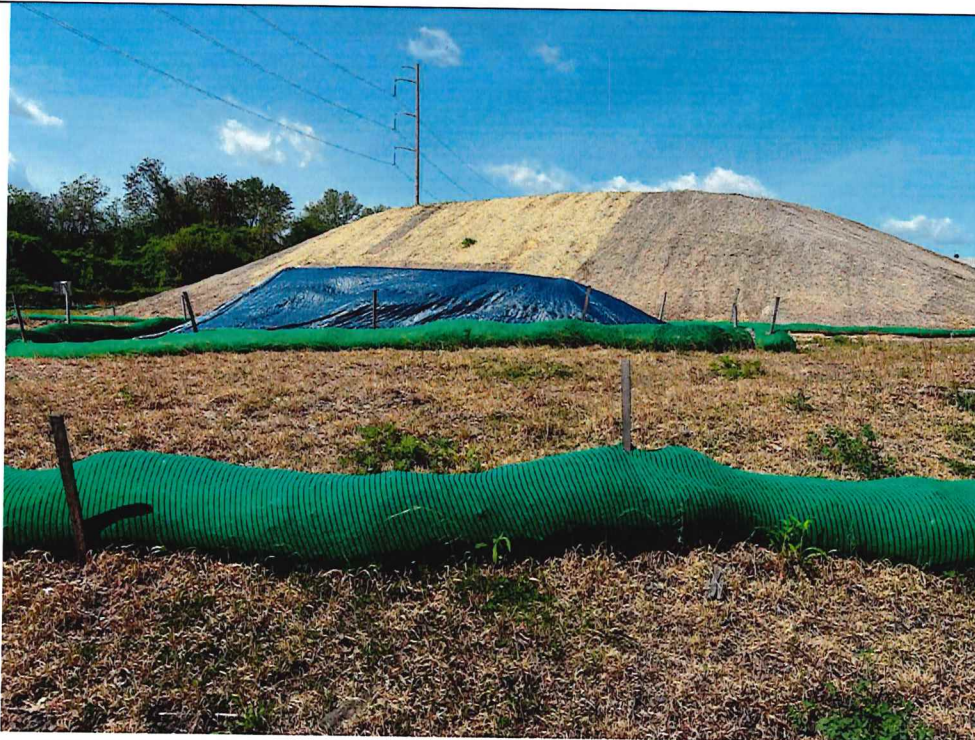
A new tarp covering the small pile of contaminated soil downslope of the large fill dirt stockpile was intact and fully covered the soil.

Downslope filtersock (foreground); contaminated fill dirt stockpile with tarp (at center); downslope end of large fill dirt stockpile with erosion matting (background).

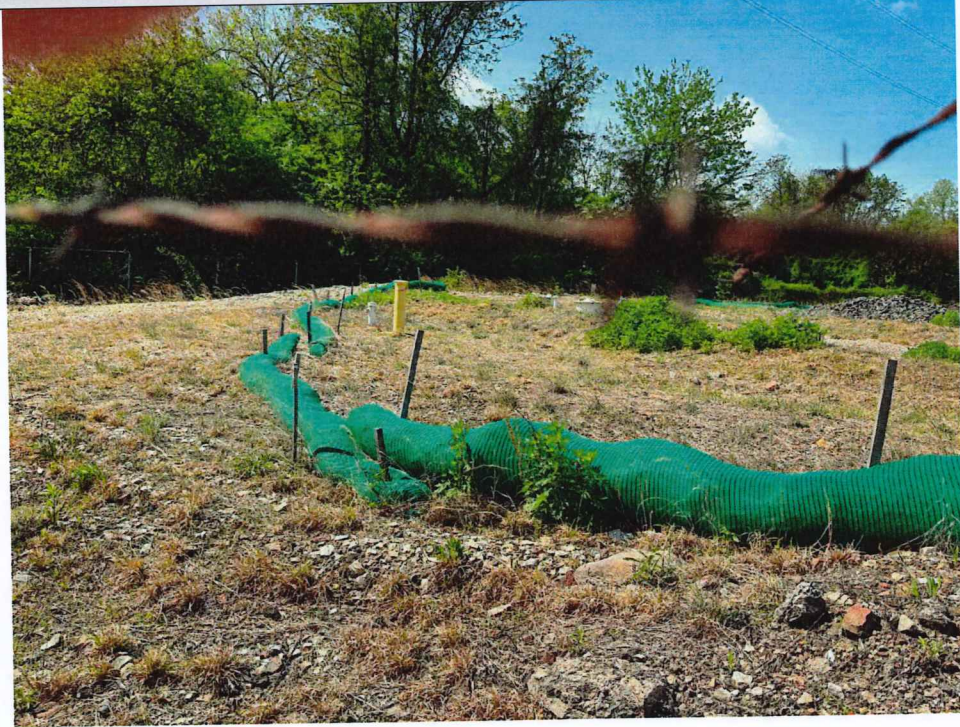
I observed that some short stretches of filtersock along the downslope boundary of the site were nearing an overtopping condition by collected mulch from upslope areas.

Filtersock along downslope boundary of site.

1. In accordance with DEP's Erosion and Sediment Pollution Control Program Manual, Technical Guidance No. 363-2134-008 (March 2012), Page 65, inspect filter socks weekly and after each runoff event. In addition, DEP requests that damaged socks be repaired according to manufacturer's specifications or replaced within 24 hours of inspection.
2. Maintaining filtersock areas, to prevent any overtopping condition, is recommended.
3. It is recommended to investigate the addition of a storage BMP (i.e., a sediment basin) in the downslope portion of the site.
4. Since the growing season is under way as of the time of this inspection, DEP recommends considering strategies for further site stabilization at this time.

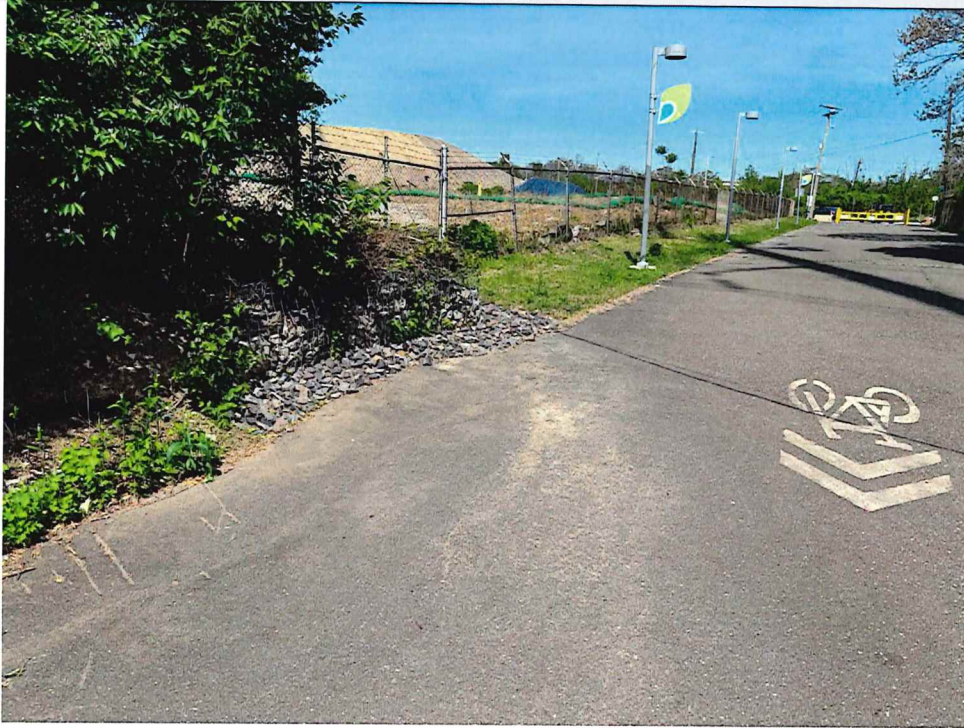
I did not observe any change to the sediment staining on the Bartram's Garden trail downslope of the site.

Sediment staining on Bartram's Garden trail.

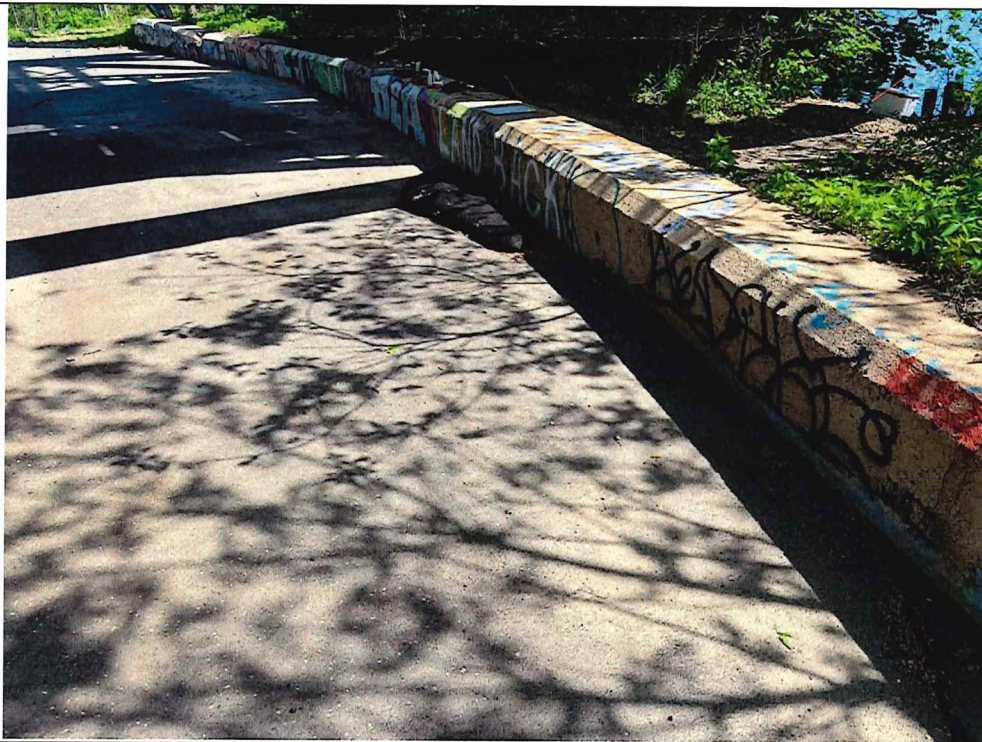
One inlet protection filter sock was in place along the wall of the Bartram's Garden trail.

Bartram's Garden trail staining and inlet protection under railroad bridge.  
End of photo log.
