**BISHOP TUBE SITE**  
**LITTLE VALLEY CREEK SURFACE WATER AND SPRING MONITORING**  
**SAMPLING EVENT REPORT**

**Prepared by**  
**Dustin A. Armstrong**  
**Project Officer**

**August 27, 2003**

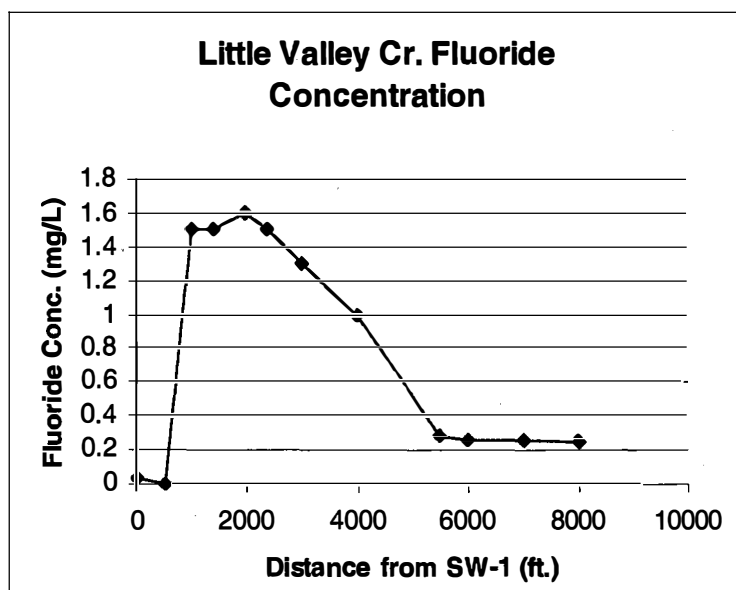
**Chart 1** – May 2003 Little Valley Creek Fluoride Concentration vs. Downstream Distance Between Bishop Tube Site and Worthington Steel Site

*Please note that each data point in the charts presented in this section represents a sample location from the May 2003 sampling event. From left to right across the charts the data points are: SW-1, SW-2, SW-3, SW-4, SW-6, SW-8, SW-9, SW-10, SW-15, SW-16, SW-17 and SW-20.*

*Samples from tributaries and springs are not included in the charts. Distances from SW-1 are approximate, based upon measurements from the USGS topographical map.*

Evaluation of the data presented in Chart 1 indicates that elevated fluoride concentrations in Little Valley Creek are likely the result of the Bishop Tube site. Hydro fluoric and nitric acids were used at the site in the tube manufacturing process. Acid wastes were disposed of in a lagoon located on the northeastern side of the property. The lagoon was closed in the late-1970s, and is allegedly located under a receiving area subsequently added to Plant 8 (lower building).

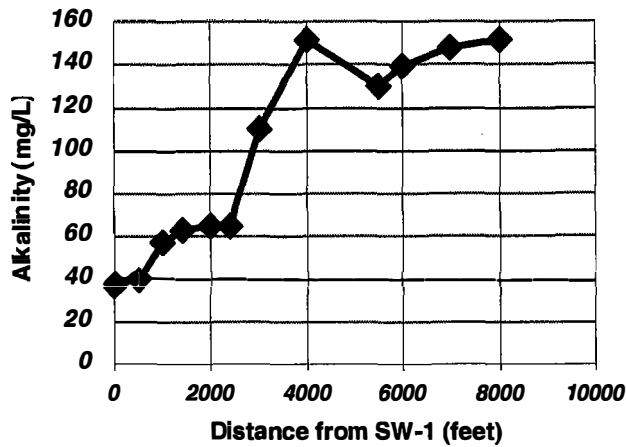
**Chart 2 – May 2003 Little Valley Creek**  
Total Alkalinity Concentration vs. Downstream Distance  
Between Bishop Tube Site and Worthington Steel Site

Chart 2 reveals that alkalinity generally increases downstream of the site. The only downward trend occurs between SW-10 and SW-15. This decrease is likely the result of the contribution of the Morehall tributary in this stream segment. Total alkalinity was reported at 86.3 mg/L in a sample from the Morehall trib just above its confluence with Little Valley Creek. Most notably areas with the maximum alkalinity increases were between SW-2 and SW-3 and between SW-8 and SW-10. Increasing alkalinity in these areas indicates that groundwater may be discharging to Little Valley Creek along the eastern site boundary and between Conestoga and Morehall Roads. Since groundwater in these areas is known to contain elevated concentrations of TCE, it is anticipated that in-stream TCE concentrations would increase in these areas. Chart 3 depicts the alkalinity levels shown in Chart 2 (in mg/L) and TCE concentrations (in ug/L)

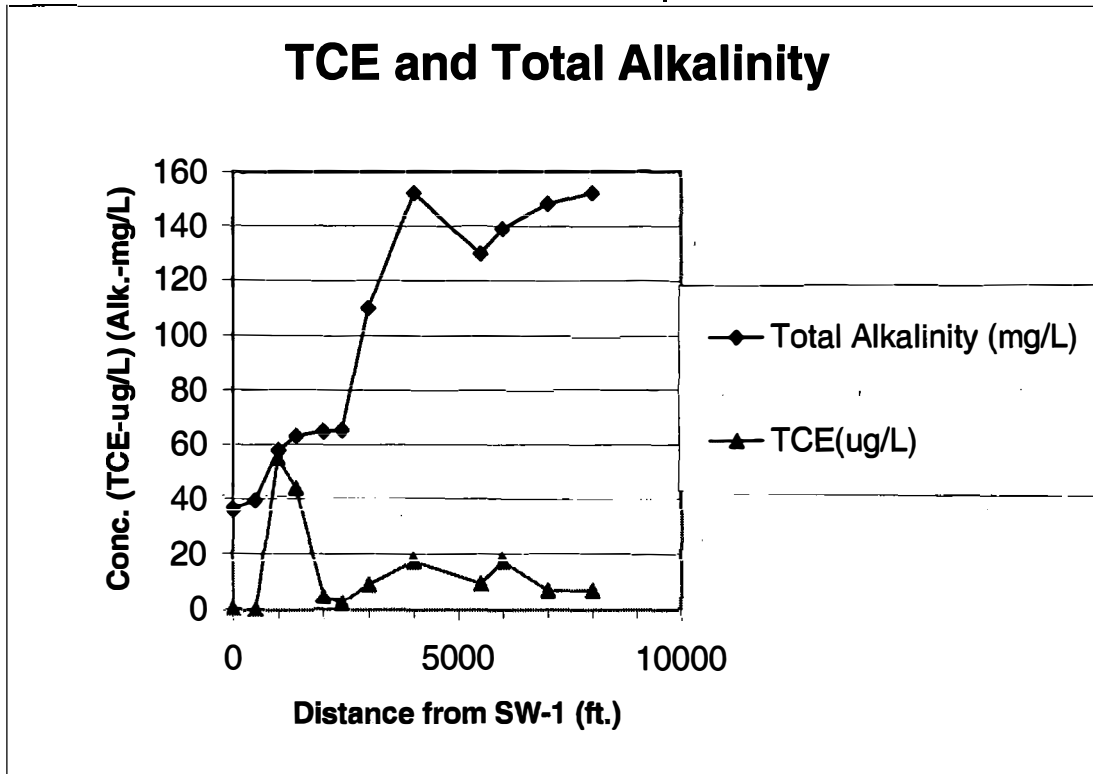
**Chart 3 – May 2003 Little Valley Creek**  
 Total Alk. (mg/L) and TCE (ug/L) Concentrations vs. Downstream Distance  
 Between Bishop Tube Site and Worthington Steel Site

Chart 3 depicts a strong relationship between alkalinity and TCE concentrations in Little Valley Creek. The link seems to be the strongest adjacent to the site (between SW-2 and SW-3). This is not surprising, given that the groundwater in this vicinity is highly contaminated by TCE. Two other areas of increasing TCE levels should also be noted. Between Conestoga Road (SW-8) and above Morehall Road (SW-10) alkalinity rises significantly and TCE concentrations also increase. Similar corresponding increases in alkalinity and TCE levels are apparent between SW-15 and SW-16. Interestingly, water from a large spring (SP-4) enters the creek between these locations. In-stream TCE concentrations due to groundwater discharge would be expected to vary depending on the makeup and source of the discharging water. The geologic complexity of the underlying formation makes it difficult to link contaminants to any one source. This is especially true in the case of a contaminant such as TCE, which is one of the most ubiquitous contaminants found in groundwater.

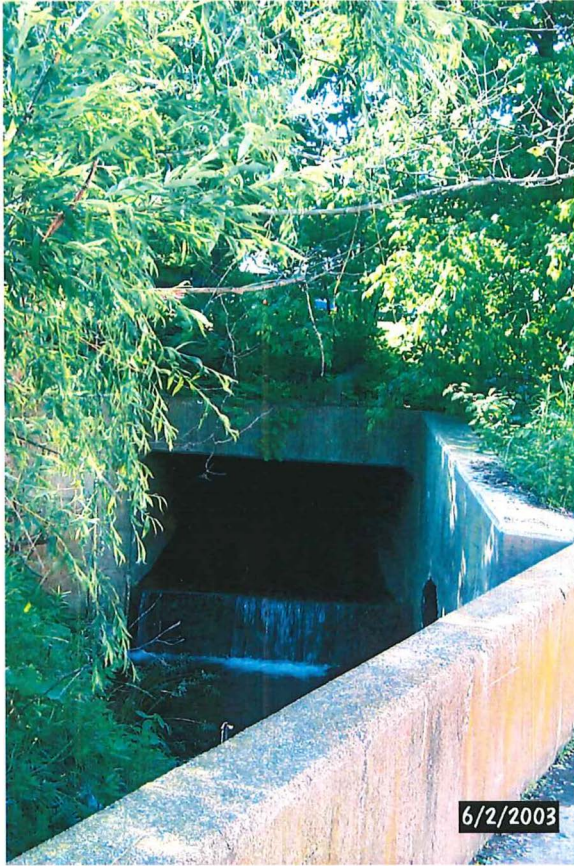
**Photo 1:** Sample Location SW-11  
Morehall Rd. Tributary at Lancaster Ave.

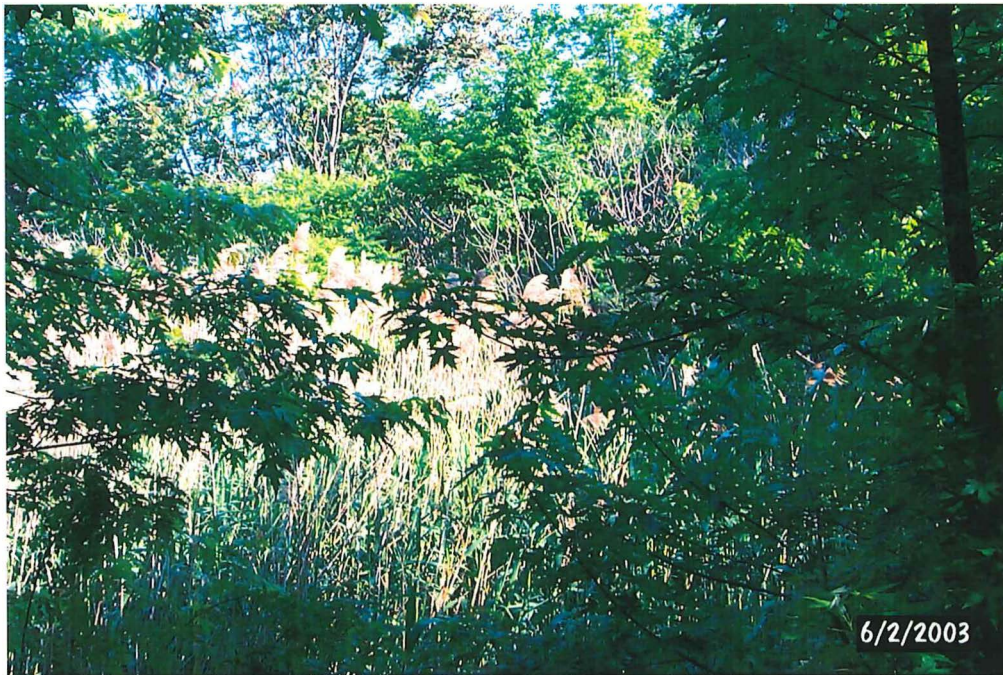
**Photo 2:** Sample location SP-3 near extended stay hotel.

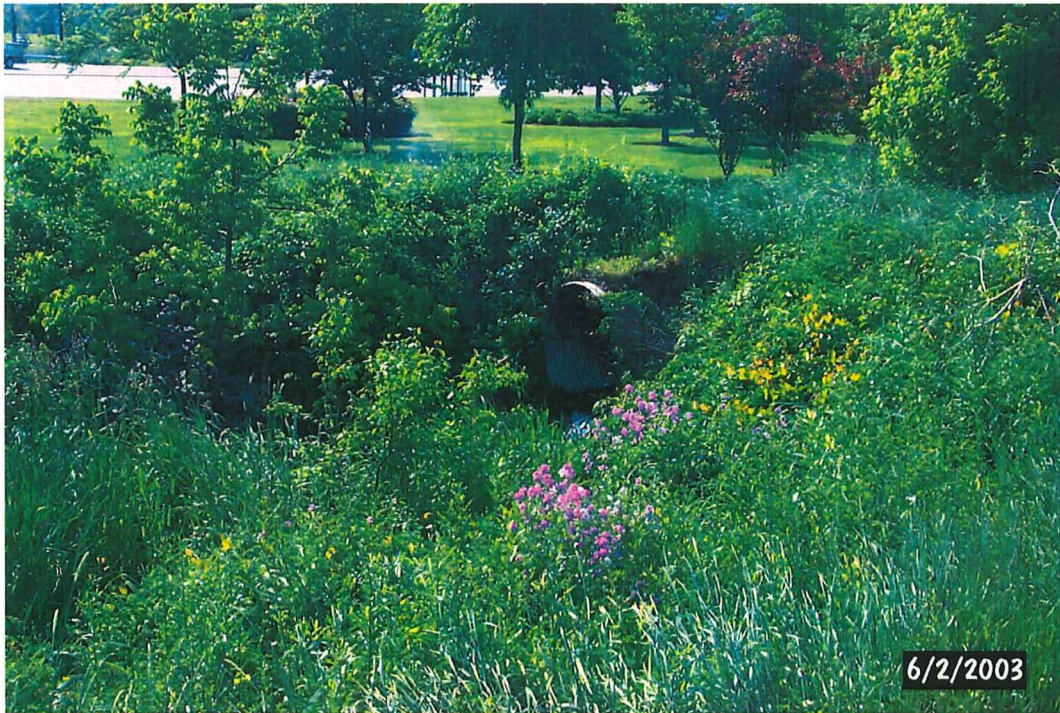
**Photo 3:** Sample location SW-13. Morehall Tributary under power line. Morehall Rd. in background.

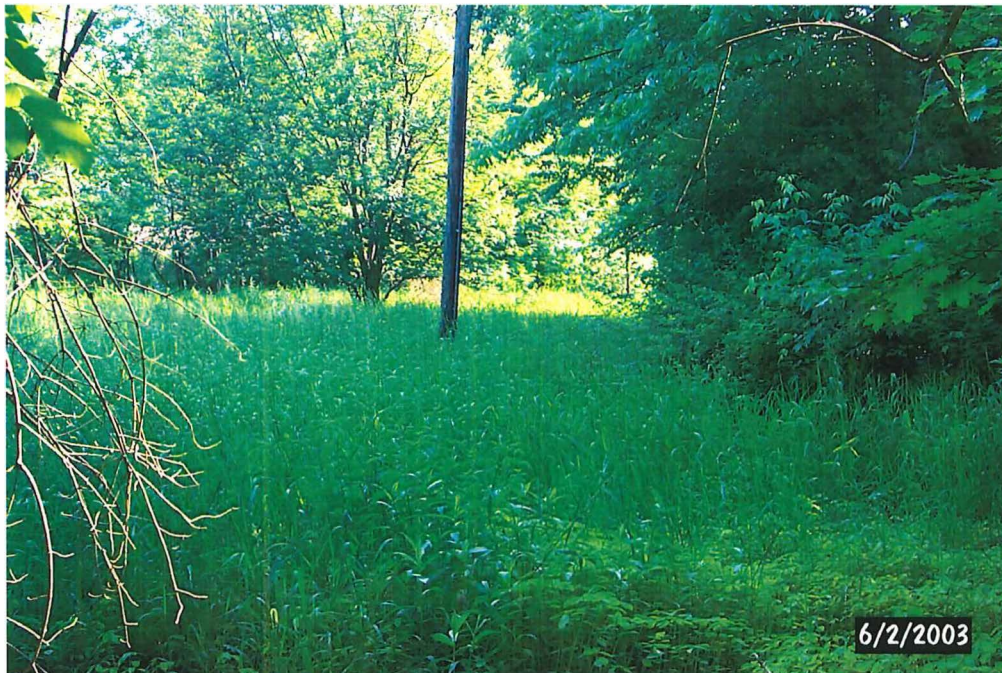
As noted above, TCE was detected in each of the springs sampled during this event. Concentrations ranged from a low of 0.23 ug/L at SE-1 (just upgradient of the source area) to 150 ug/L at SP-4B (wetlands discharge area between Morehall Rd. and the former Worthington Steel property). SP-4 is the most significant spring directly entering Little Valley Creek in the study area. A springhouse marks the origin of SP-4, but a large wetland area is located just to the north of the springhouse and apparently results from a large area of groundwater discharge. Lower concentrations of TCE were detected in samples SP-3 and SE-1. SP-3 was collected from a fragmities wetland area located adjacent to the Summerfield Suites Hotel (20 Morehall Rd.). This spring enters the Morehall tributary of Little Valley Creek just below Lancaster Avenue. SP-3 contained TCE at a concentration of 6.5 ug/L. This sample was the only sample collected in the event found to contain Chloroform and Bromodichloromethane. These VOCs are in a group of compounds called trihalomethanes, which are chlorination byproducts. This spring is located near a swimming pool associated with the hotel. A very low concentration of TCE (0.23 ug/L) was detected in sample SE-1, which was collected on the Bishop Tube property, just upstream from the manufacturing facility. This detection may be the result of chemical diffusion from the drum storage area, the nearest source area at the site.

**Photo 4:** Sample location SP-4B. Spring area in wetland near Norwood Industries facility.
