BISHOP TUBE SITE
SURFACE WATER INVESTIGATION – DATA SUMMARY
UPSTREAM OF LANCASTER AVENUE – SOURCE AREA DISCHARGE

Prepared by Dustin A. Armstrong, Project Officer

April 2005

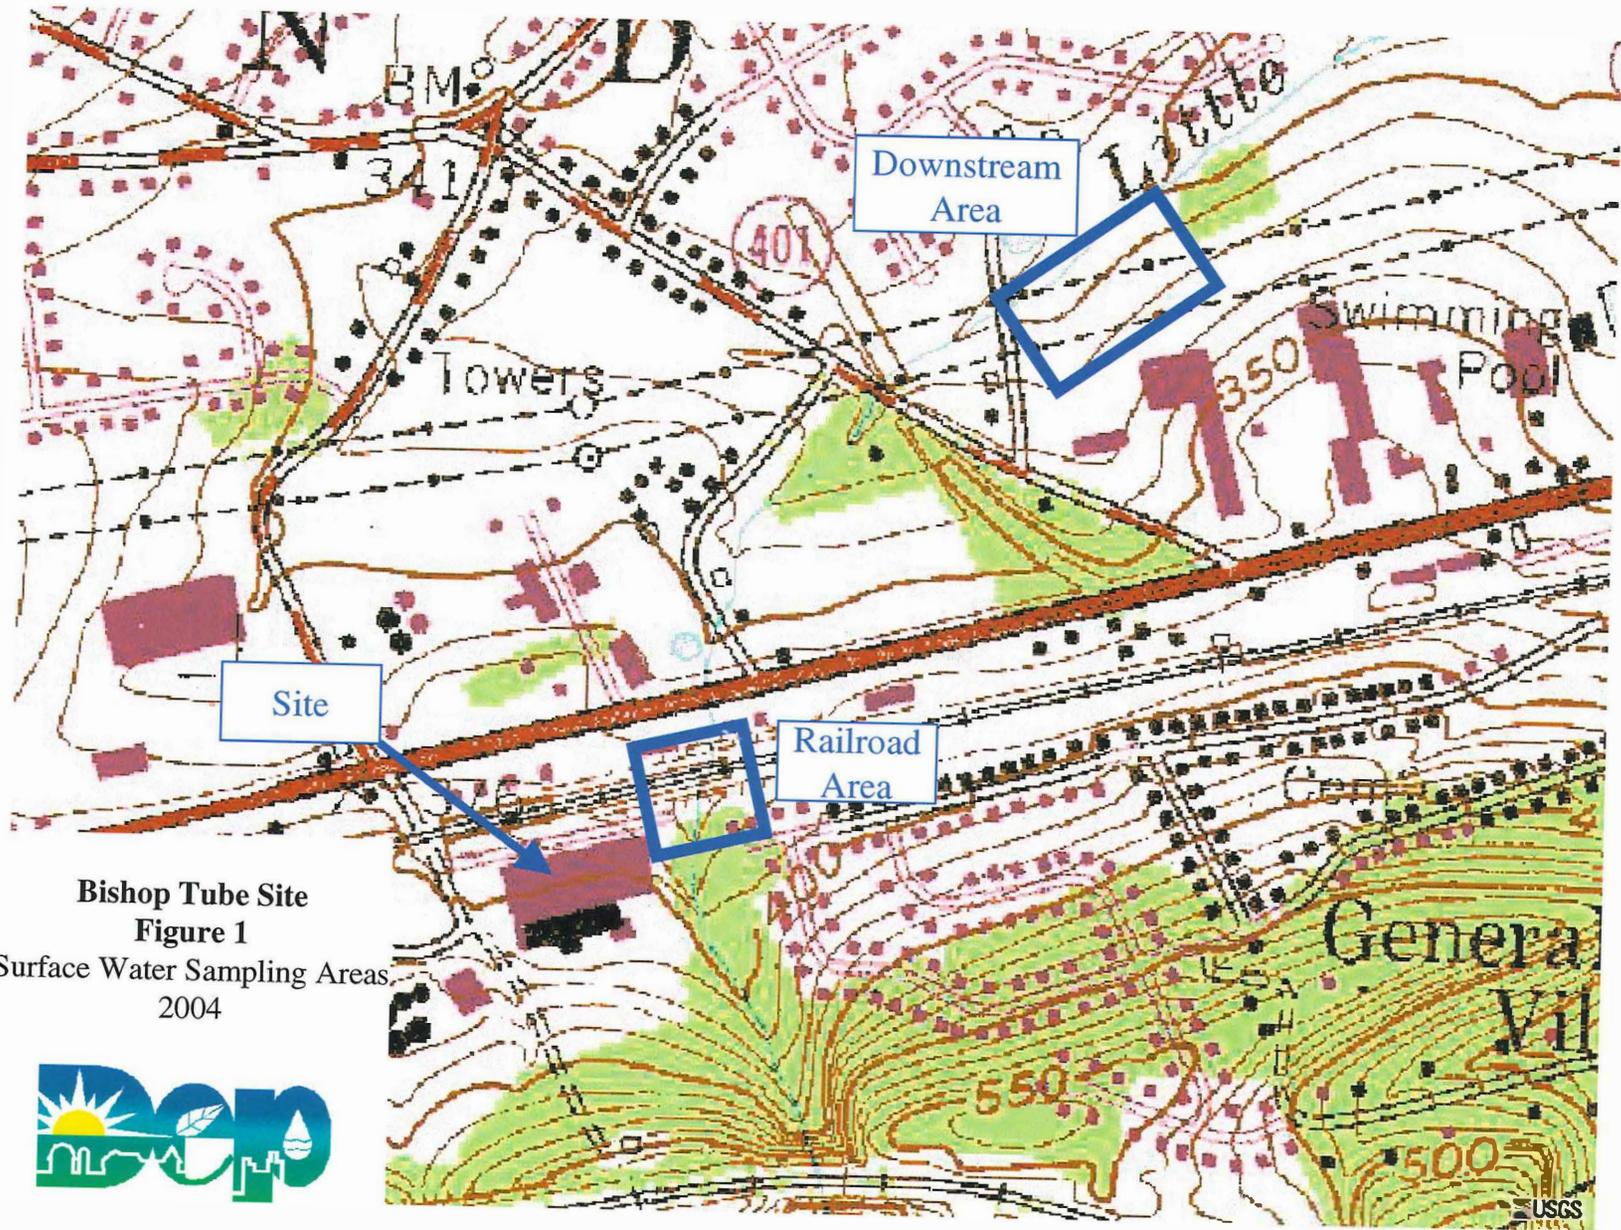
Bishop Tube Site
Figure 1
 Surface Water Sampling Areas
 2004

The Bishop Tube site is located in East Whiteland Township, Chester County, PA. The site is a former stainless steel tube manufacturing facility. A site location map is included as Figure 1. In addition to the site location, this figure shows the areas investigated during our 2004 surface water investigation. The Department and a former site owner (Christiana Metals) have conducted extensive environmental investigations at the site and determined that widespread severe contamination of soil and groundwater has resulted from activities at the site. The Bishop Tube property is now abandoned, and is currently being marketed for redevelopment by the current site owner (Central and Western Chester County Redevelopment Authority). Contaminants of concern include the following volatile organic compounds (VOCs): trichloroethene, tetrachloroethene, 1,1,1-trichloroethane, methylene chloride, and their breakdown products. Chlorinated VOCs were used by Bishop Tube for degreasing redrawn stainless steel tubes. The Department has detected inorganic constituents of concern in groundwater at the site including fluoride, nickel, and chromium.

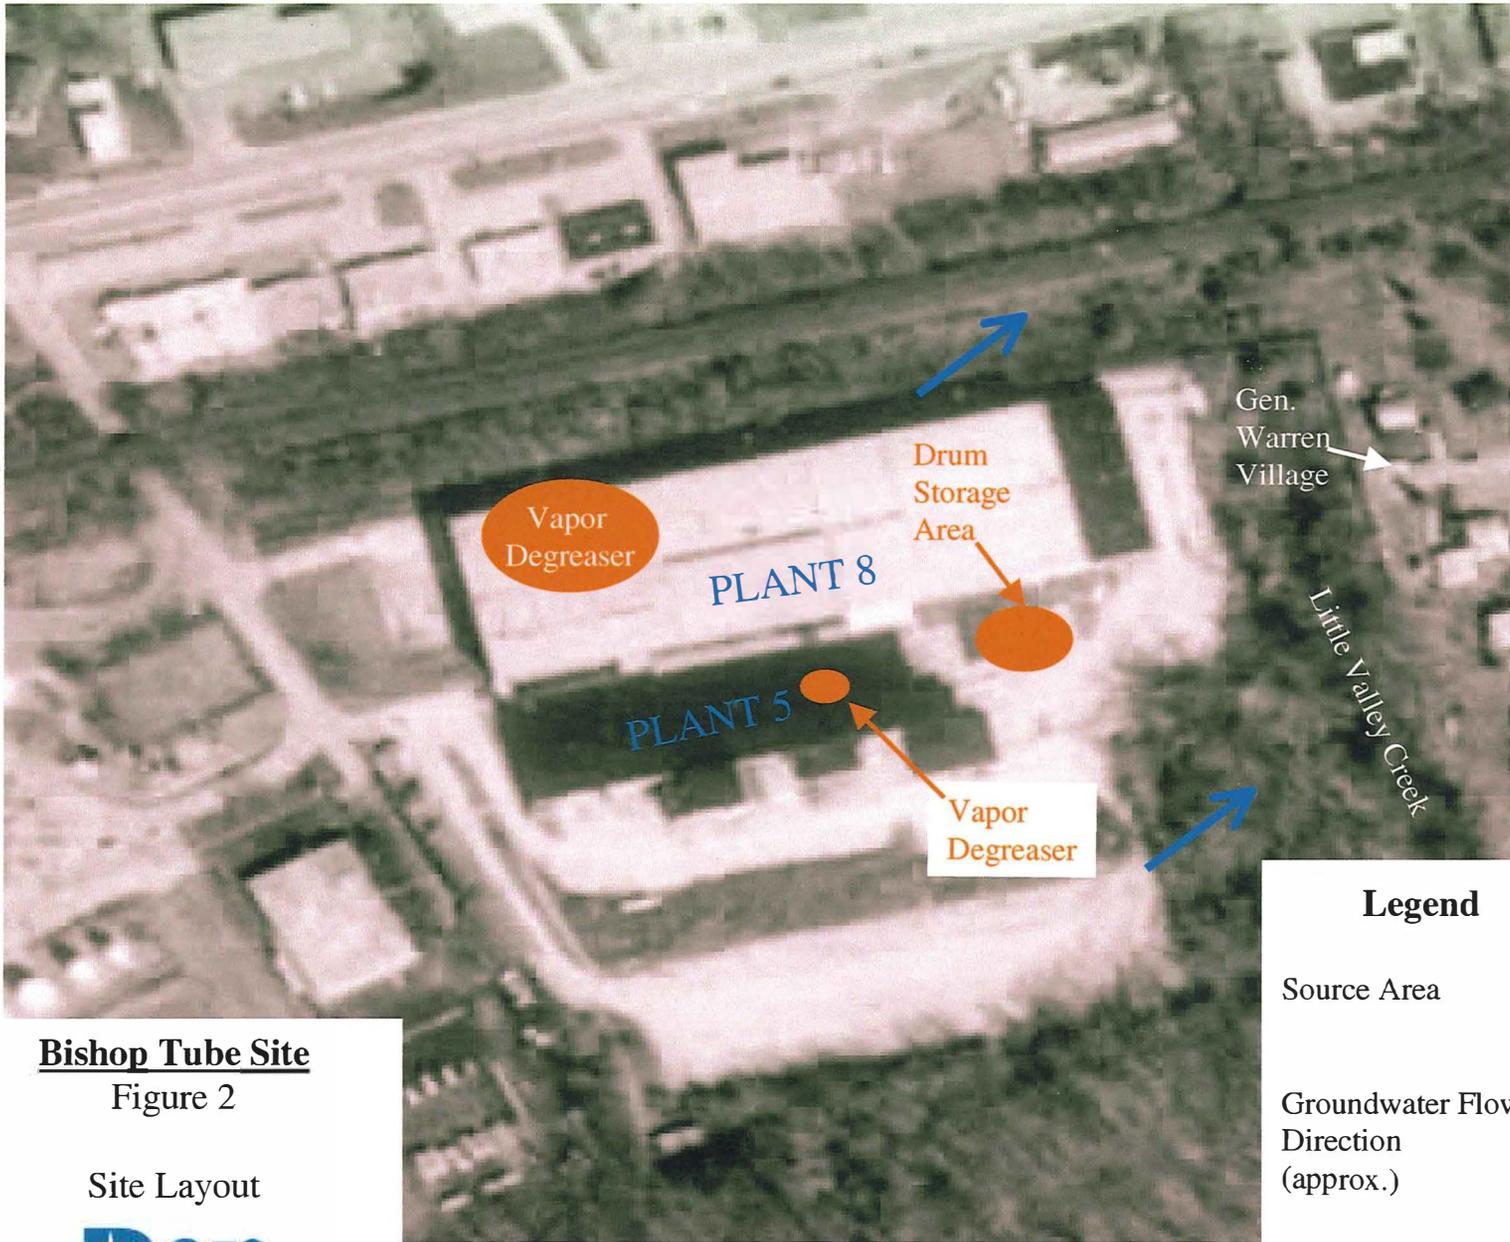
Figure 2

Components of the CSM closely related to the stream discharge include the relatively shallow contamination on the former Bishop Tube property. Three source areas have been identified through soil sampling at the site. Shallow groundwater, which locally occurs under semi-confined conditions in shallow bedrock and unconsolidated material just above bedrock flows toward the stream and carries dissolved contaminants. Residual product may exist as small droplets within the unconsolidated material, particularly in areas of lower permeability. The source areas and generalized groundwater flow direction are shown in Figure 2. Samples of shallow groundwater collected in 2004 from the unconsolidated overburden, across Little Valley Creek reveal that contaminants are flowing under the stream toward the east. This finding has caused the Department to initiate an investigation of potential vapor intrusion impacts to homes in General Warren Village. A wetland area across the stream from the site may also be a discharge area for site-related contaminants.

Site Layout

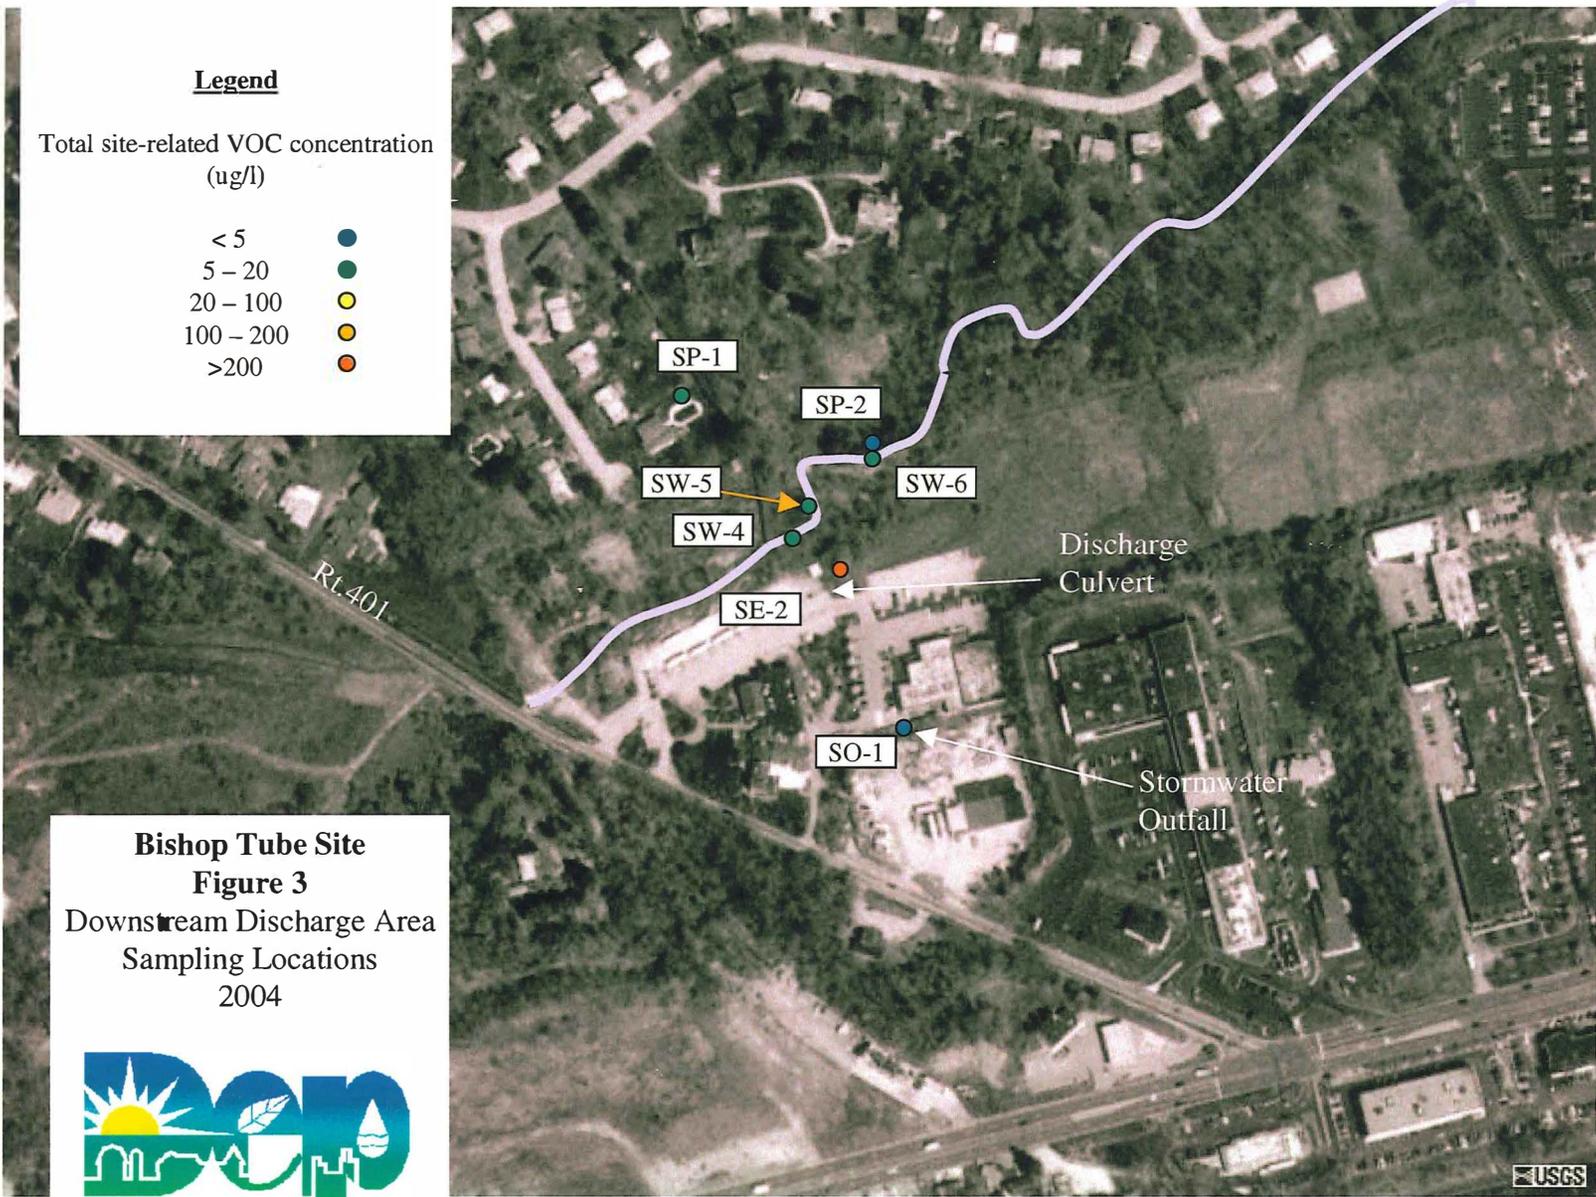
Results of our August sample from the stormwater structure did not provide any additional information to clarify the source of TCE in the June drainage swale sample. No volatile organics were detected in the August sample. The samples collected from the Winding Way spring confirmed that TCE is not entering the stream from this spring. Low concentrations of tetrachloroethene (5.6 ug/L at the source and 1.6 ug/L near its confluence with the Little Valley Creek) were detected. Sample locations for the downstream area are shown on Figure 3.

Total site-related VOC concentration
(ug/l)

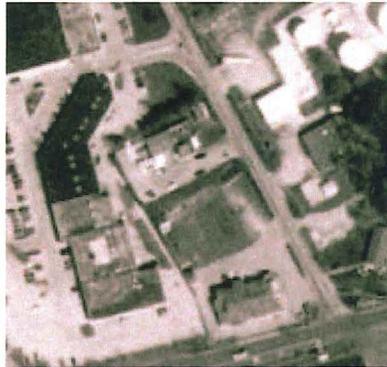
Bishop Tube Site
Figure 4
Railroad Area
Sample Locations
2004

- < 5 ●
- 5 – 20 ●
- 20 – 100 ●
- 100 – 200 ●
- >200 ●

Stream samples were collected from the area adjacent to the former Bishop Tube manufacturing building to better delineate the area of groundwater discharge which is resulting in contamination of the surface water by TCE. Earlier sampling had revealed the presence of TCE downstream and along the Bishop Tube property. The intent of the 2004 sampling was to better define the location(s) of any discharge. Sample locations and concentration information are shown on Figure 4 and results are tabulated in Table 2 a, b, and c (June event) and Table 3 (August event).

As evidenced by the VOC concentration information displayed on Figure 4, discharge of contaminants to the stream appears to be originating at the mouth of the northern drainage swale, where TCE was detected at a concentration of 160 ug/l in our June sample. This conclusion is further bolstered by the analytical results for calcium and alkalinity, which appear to indicate that the swale is discharging groundwater. In both cases these constituents are present at much higher levels than the upstream or downstream surface water. This finding is consistent with the more limited historical sampling results which also indicated that the swale is a source of surface water contamination in Little Valley Creek.

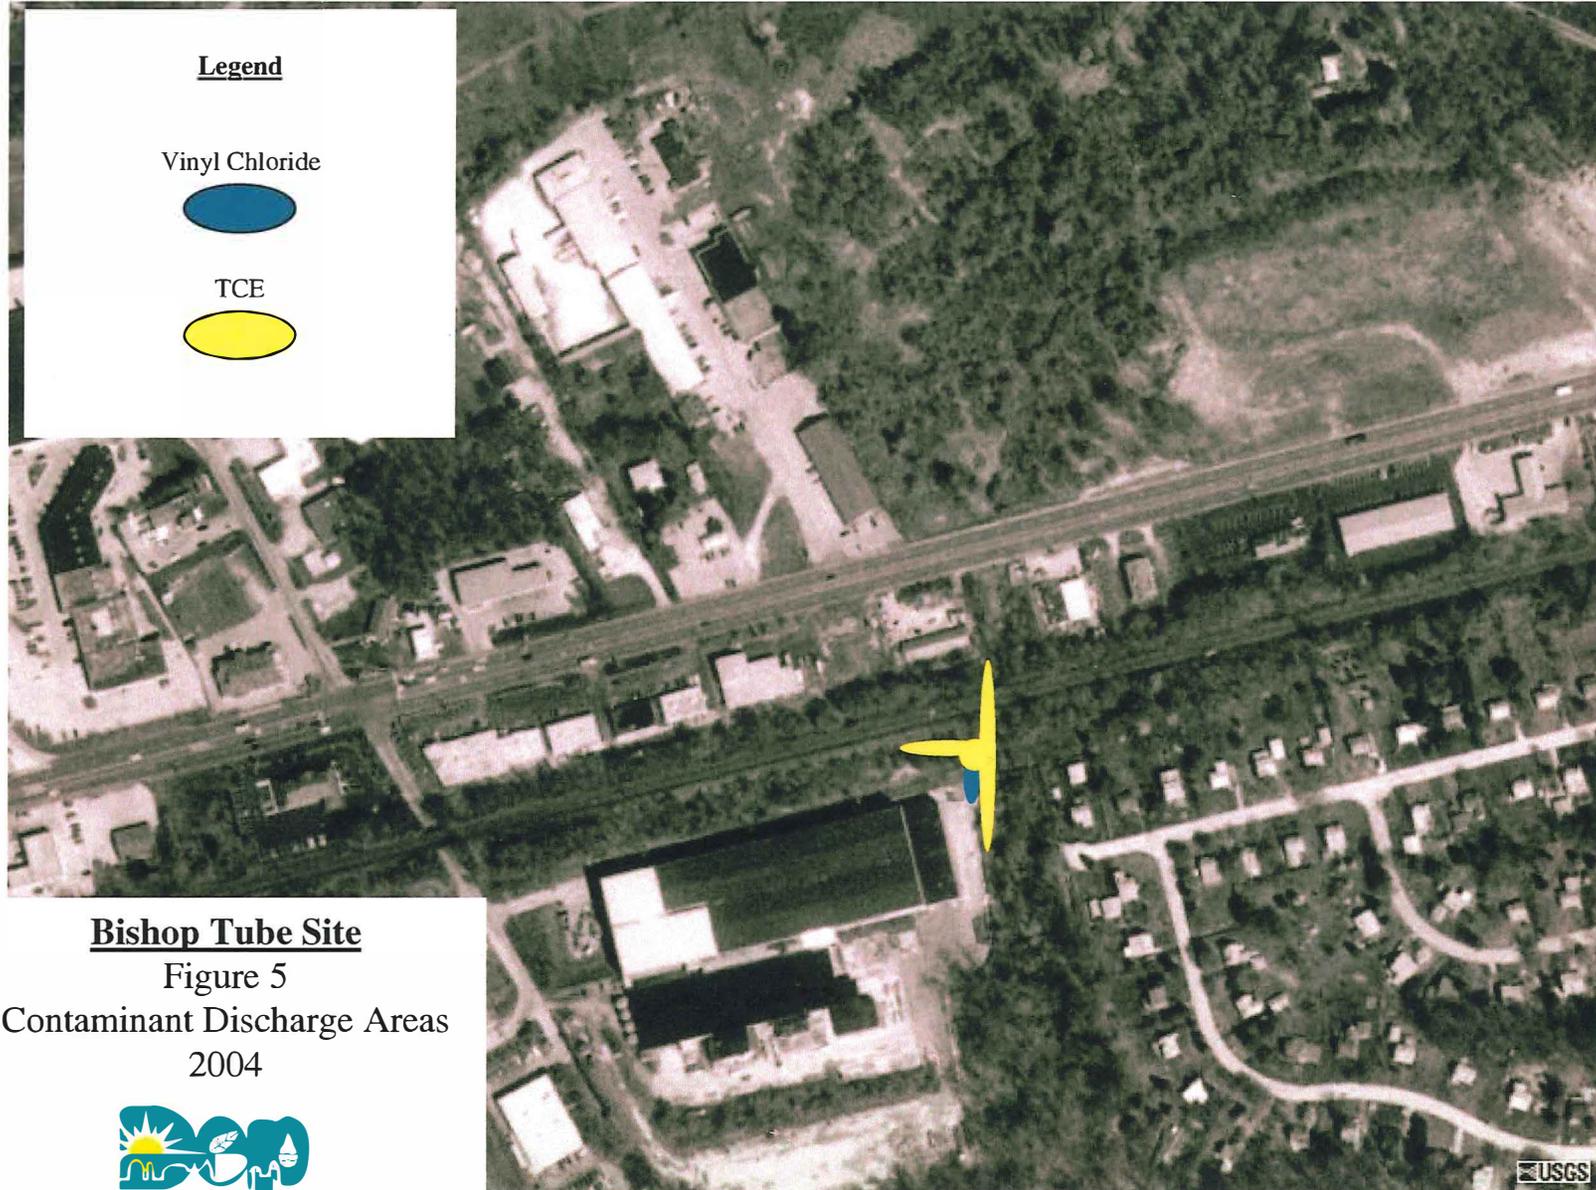
To summarize the findings of our characterization of Little Valley Creek and the northern drainage swale along the Bishop Tube property a map approximating the discharge areas has been prepared, and is attached to this document as Figure 5. This map reflects information collected during our June and August 2004 investigation only.
