# Data Gap Pre-Design Investigation Report Volume 1: Soil

GTAC 8-1-472 – Bishop Tube HSCA Site

1 S. Malin Road, East Whiteland Township, Chester County, Pennsylvania

July 15, 2026

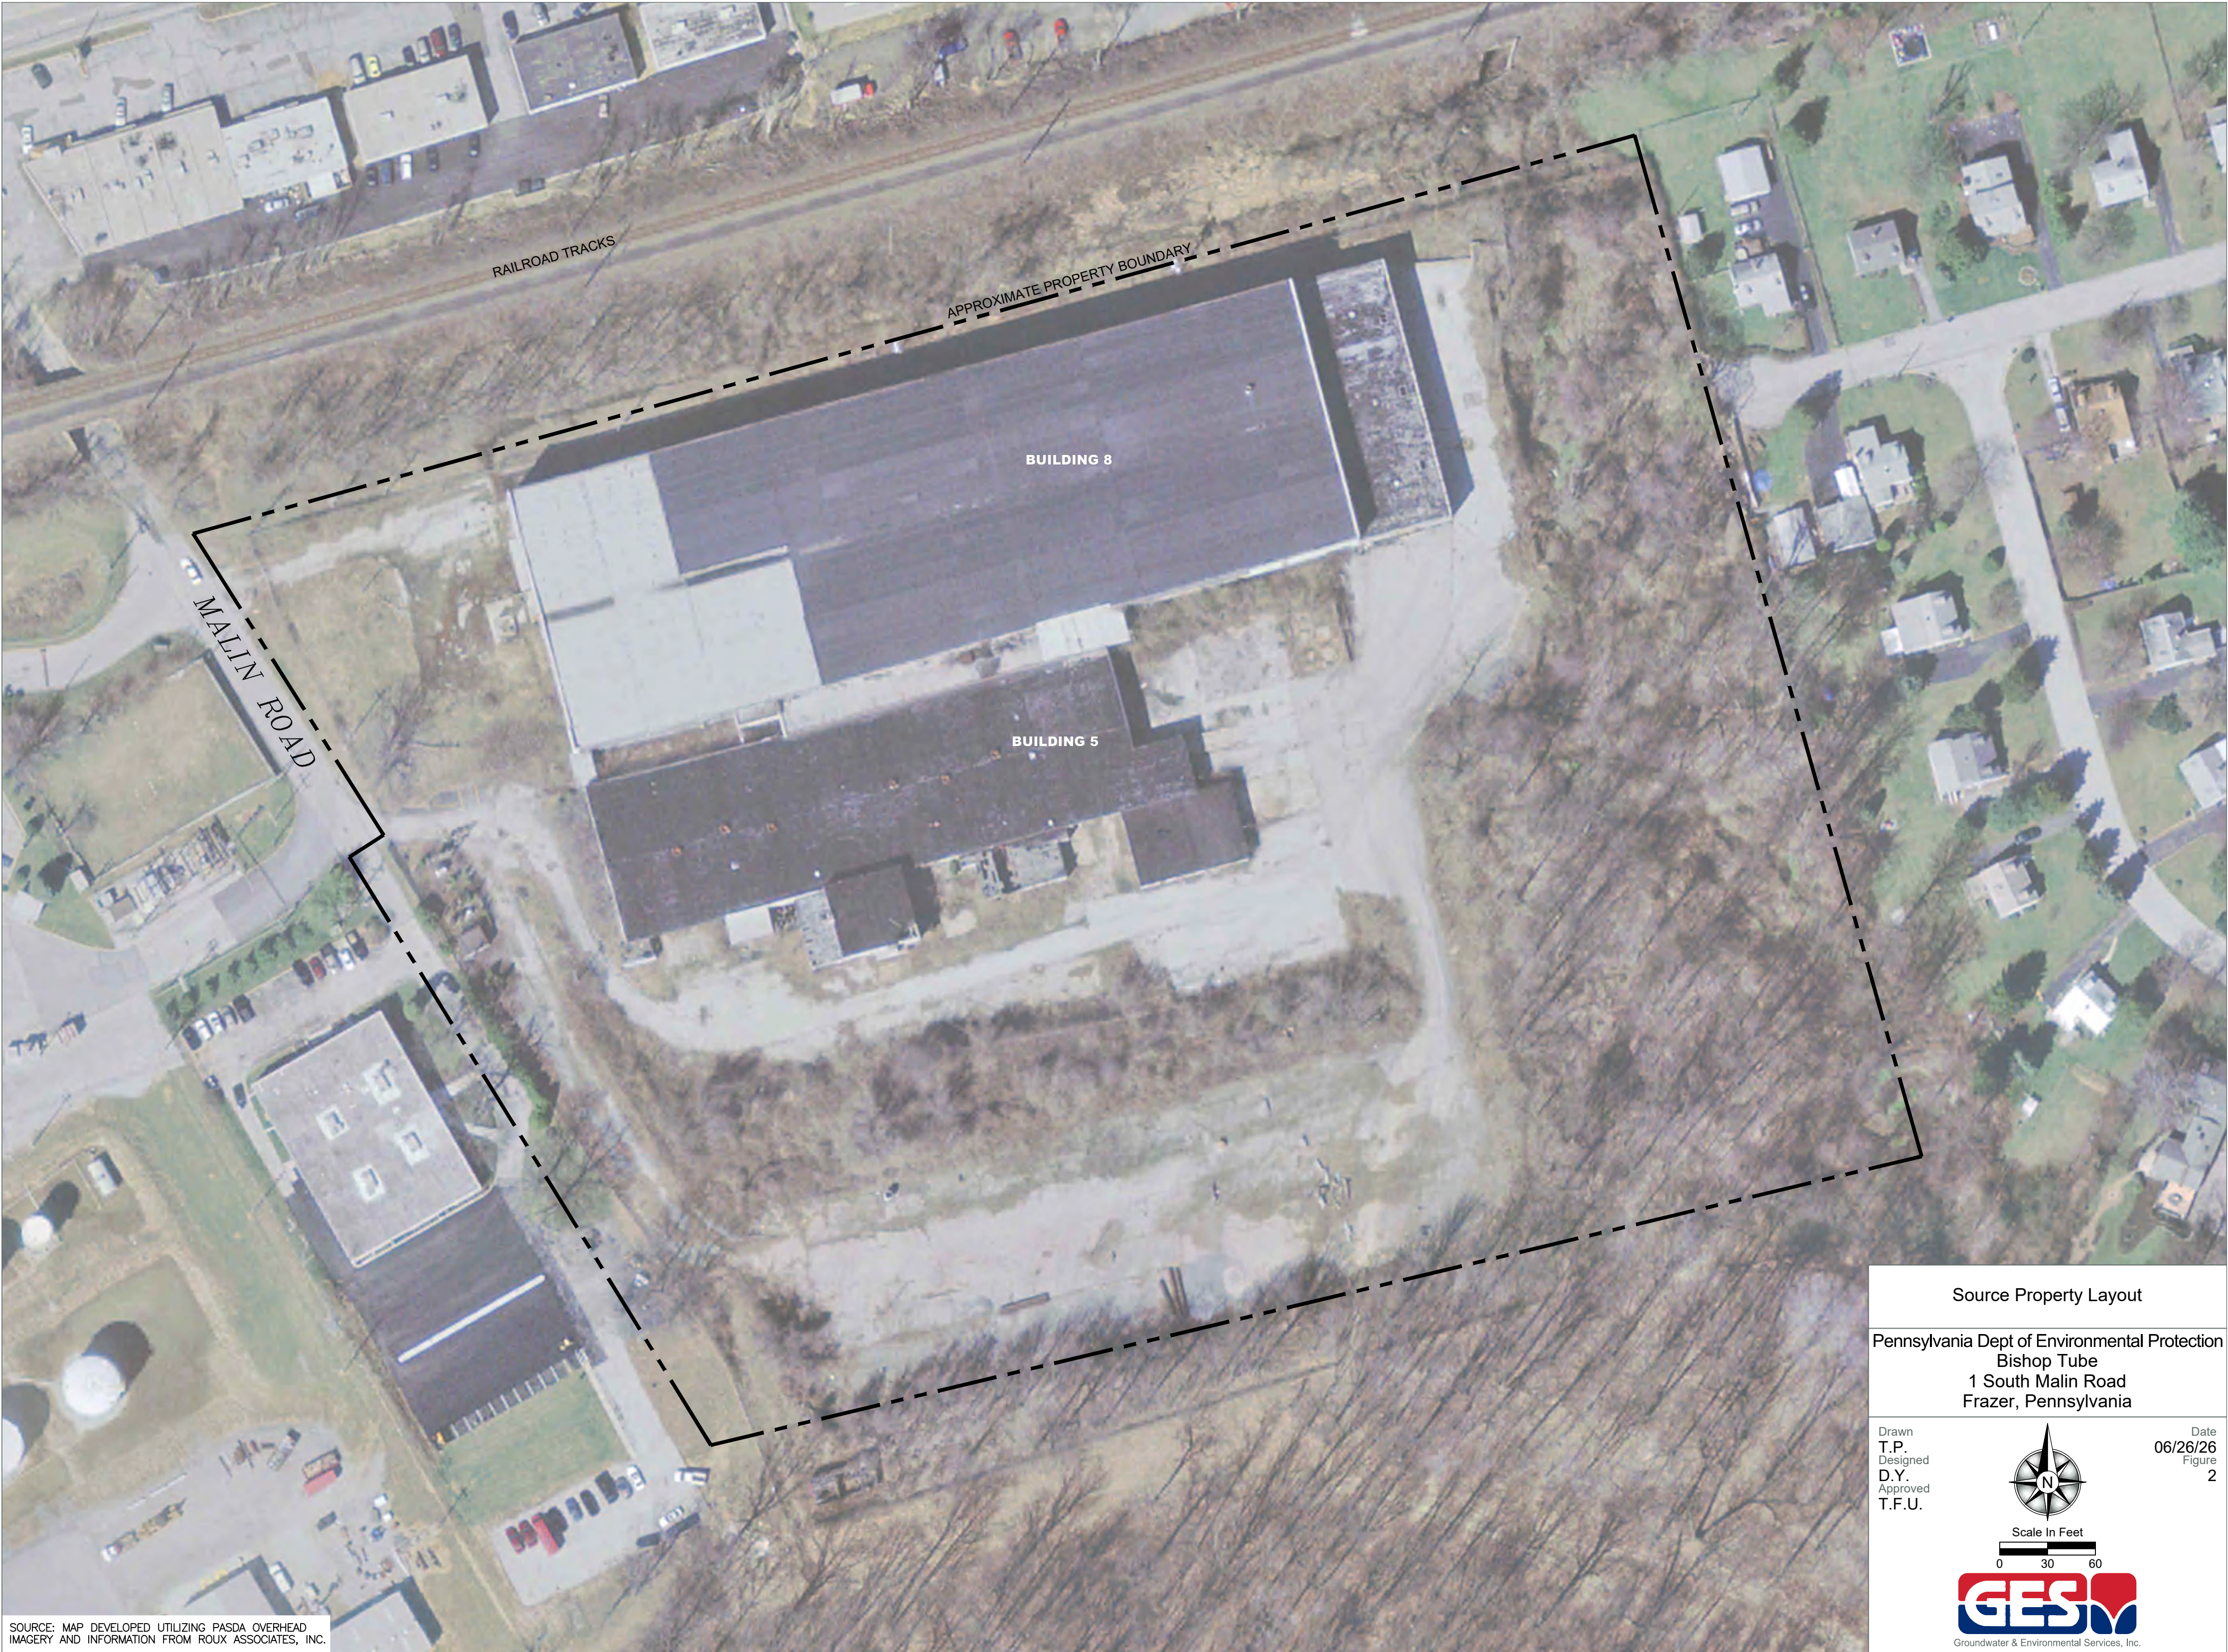
**Figure 2 – Source Property Layout**

The source property is an approximate 13.7-acre former manufacturing facility located at 1 South Malin Road in Malvern, East Whiteland Township, Chester County, Pennsylvania. The approximate geographical coordinates of the center of the property are 40 degrees, 02 minutes, 23 seconds north (latitude) by 75 degrees, 32 minutes, 12 seconds west (longitude). The area defined as the Site includes the area within the source property boundaries and the extent of groundwater contamination beyond the property boundaries. **Figure 1** (Site Location Map) illustrates the location of the Site on the U.S. Geological Survey (USGS) 7.5-Minute Topographic Map for Malvern, Pennsylvania. **Figure 2** (Site Map) is an aerial photograph, which illustrates the layout of the source property.

Current features include two large vacant structures identified as Building 5 and Building 8 that cover approximately 3.7 acres of the source property. The area immediately surrounding the two buildings predominantly consists of concrete and asphalt covered surfaces formerly used for facility driveways, parking and loading areas. The remainder of the Site, primarily in the southern and eastern portions, is forested with mature trees and brush. The source property was historically zoned industrial; however, the sources property was rezoned by East Whiteland Township for residential use in 2014.

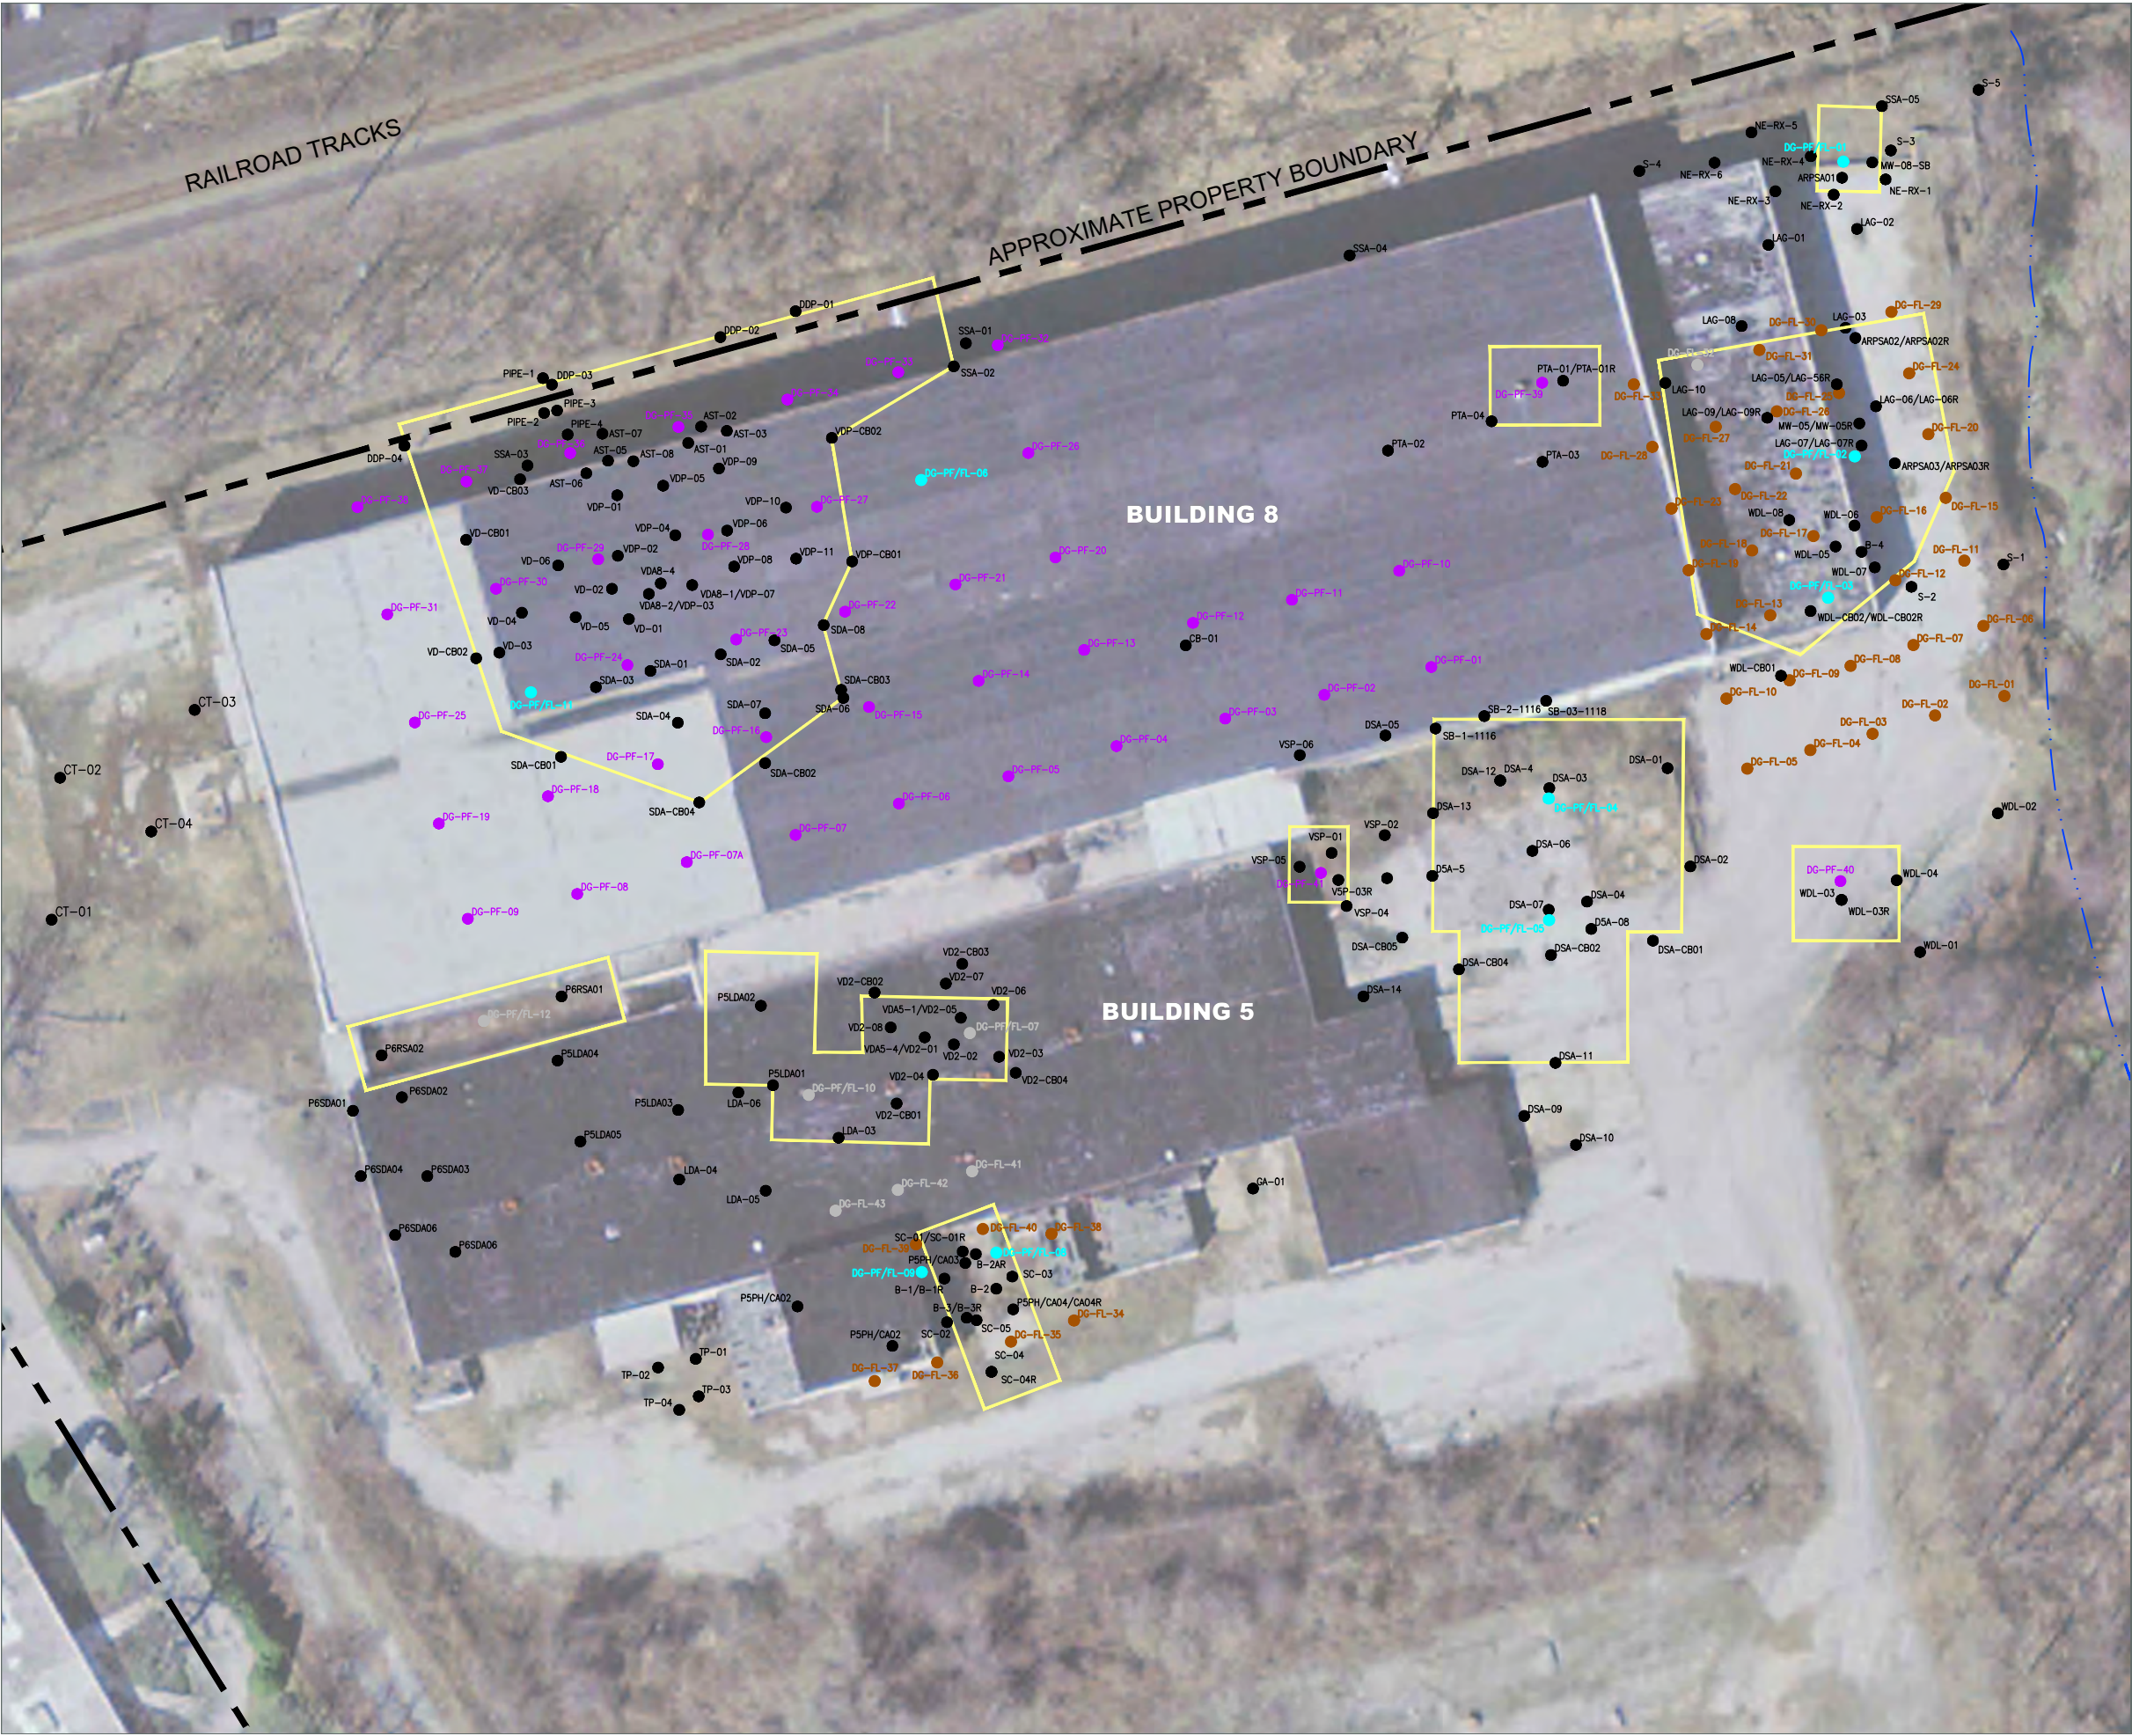
**Figure 4 – Soil Sample Location Map**

From February 3 through March 6, 2026, GES mobilized to the Site to oversee the advancement of 90 soil borings to investigate concentrations of PFAS (42 locations), fluoride (39 locations) or both (9 locations) in the following areas of the Site as shown in **Figure 4**:

- Fluoride near the former cesspool area (9 locations)
- Fluoride near the acid rinsewater handling/spill area at the eastern end of Building 8 (34 locations)
- PFAS in the former pipe drawing and vapor degreasing areas in Building 8 (39 locations)
- PFAS and/or fluoride in AOCs identified in the GES TAM as shown on **Figure 3**, including:
  - GES AOC 1 – Two (2) Fluoride samples
  - GES AOC 2 – One (1) PFAS sample
  - GES AOC 3 – Two (2) PFAS samples

- GES AOC 4 – One (1) PFAS sample / One (1) Fluoride sample
  - GES AOC 7 – Two (2) PFAS samples
  - GES AOC 8 – One (1) PFAS sample
  - GES AOC 9 – Two (2) PFAS samples / Two (2) Fluoride samples
  - GES AOC 10 – One (1) PFAS sample
- Volatile organic compound (VOC) samples were also collected from soil boring locations based on field observations (i.e., elevated PID readings and visual impacts) to provide additional information for the upcoming Pre-Design Investigation (PDI) activities.
  - Note that proposed borings in GES AOC 5 and 6 were eliminated due to safety concerns within Building 5.

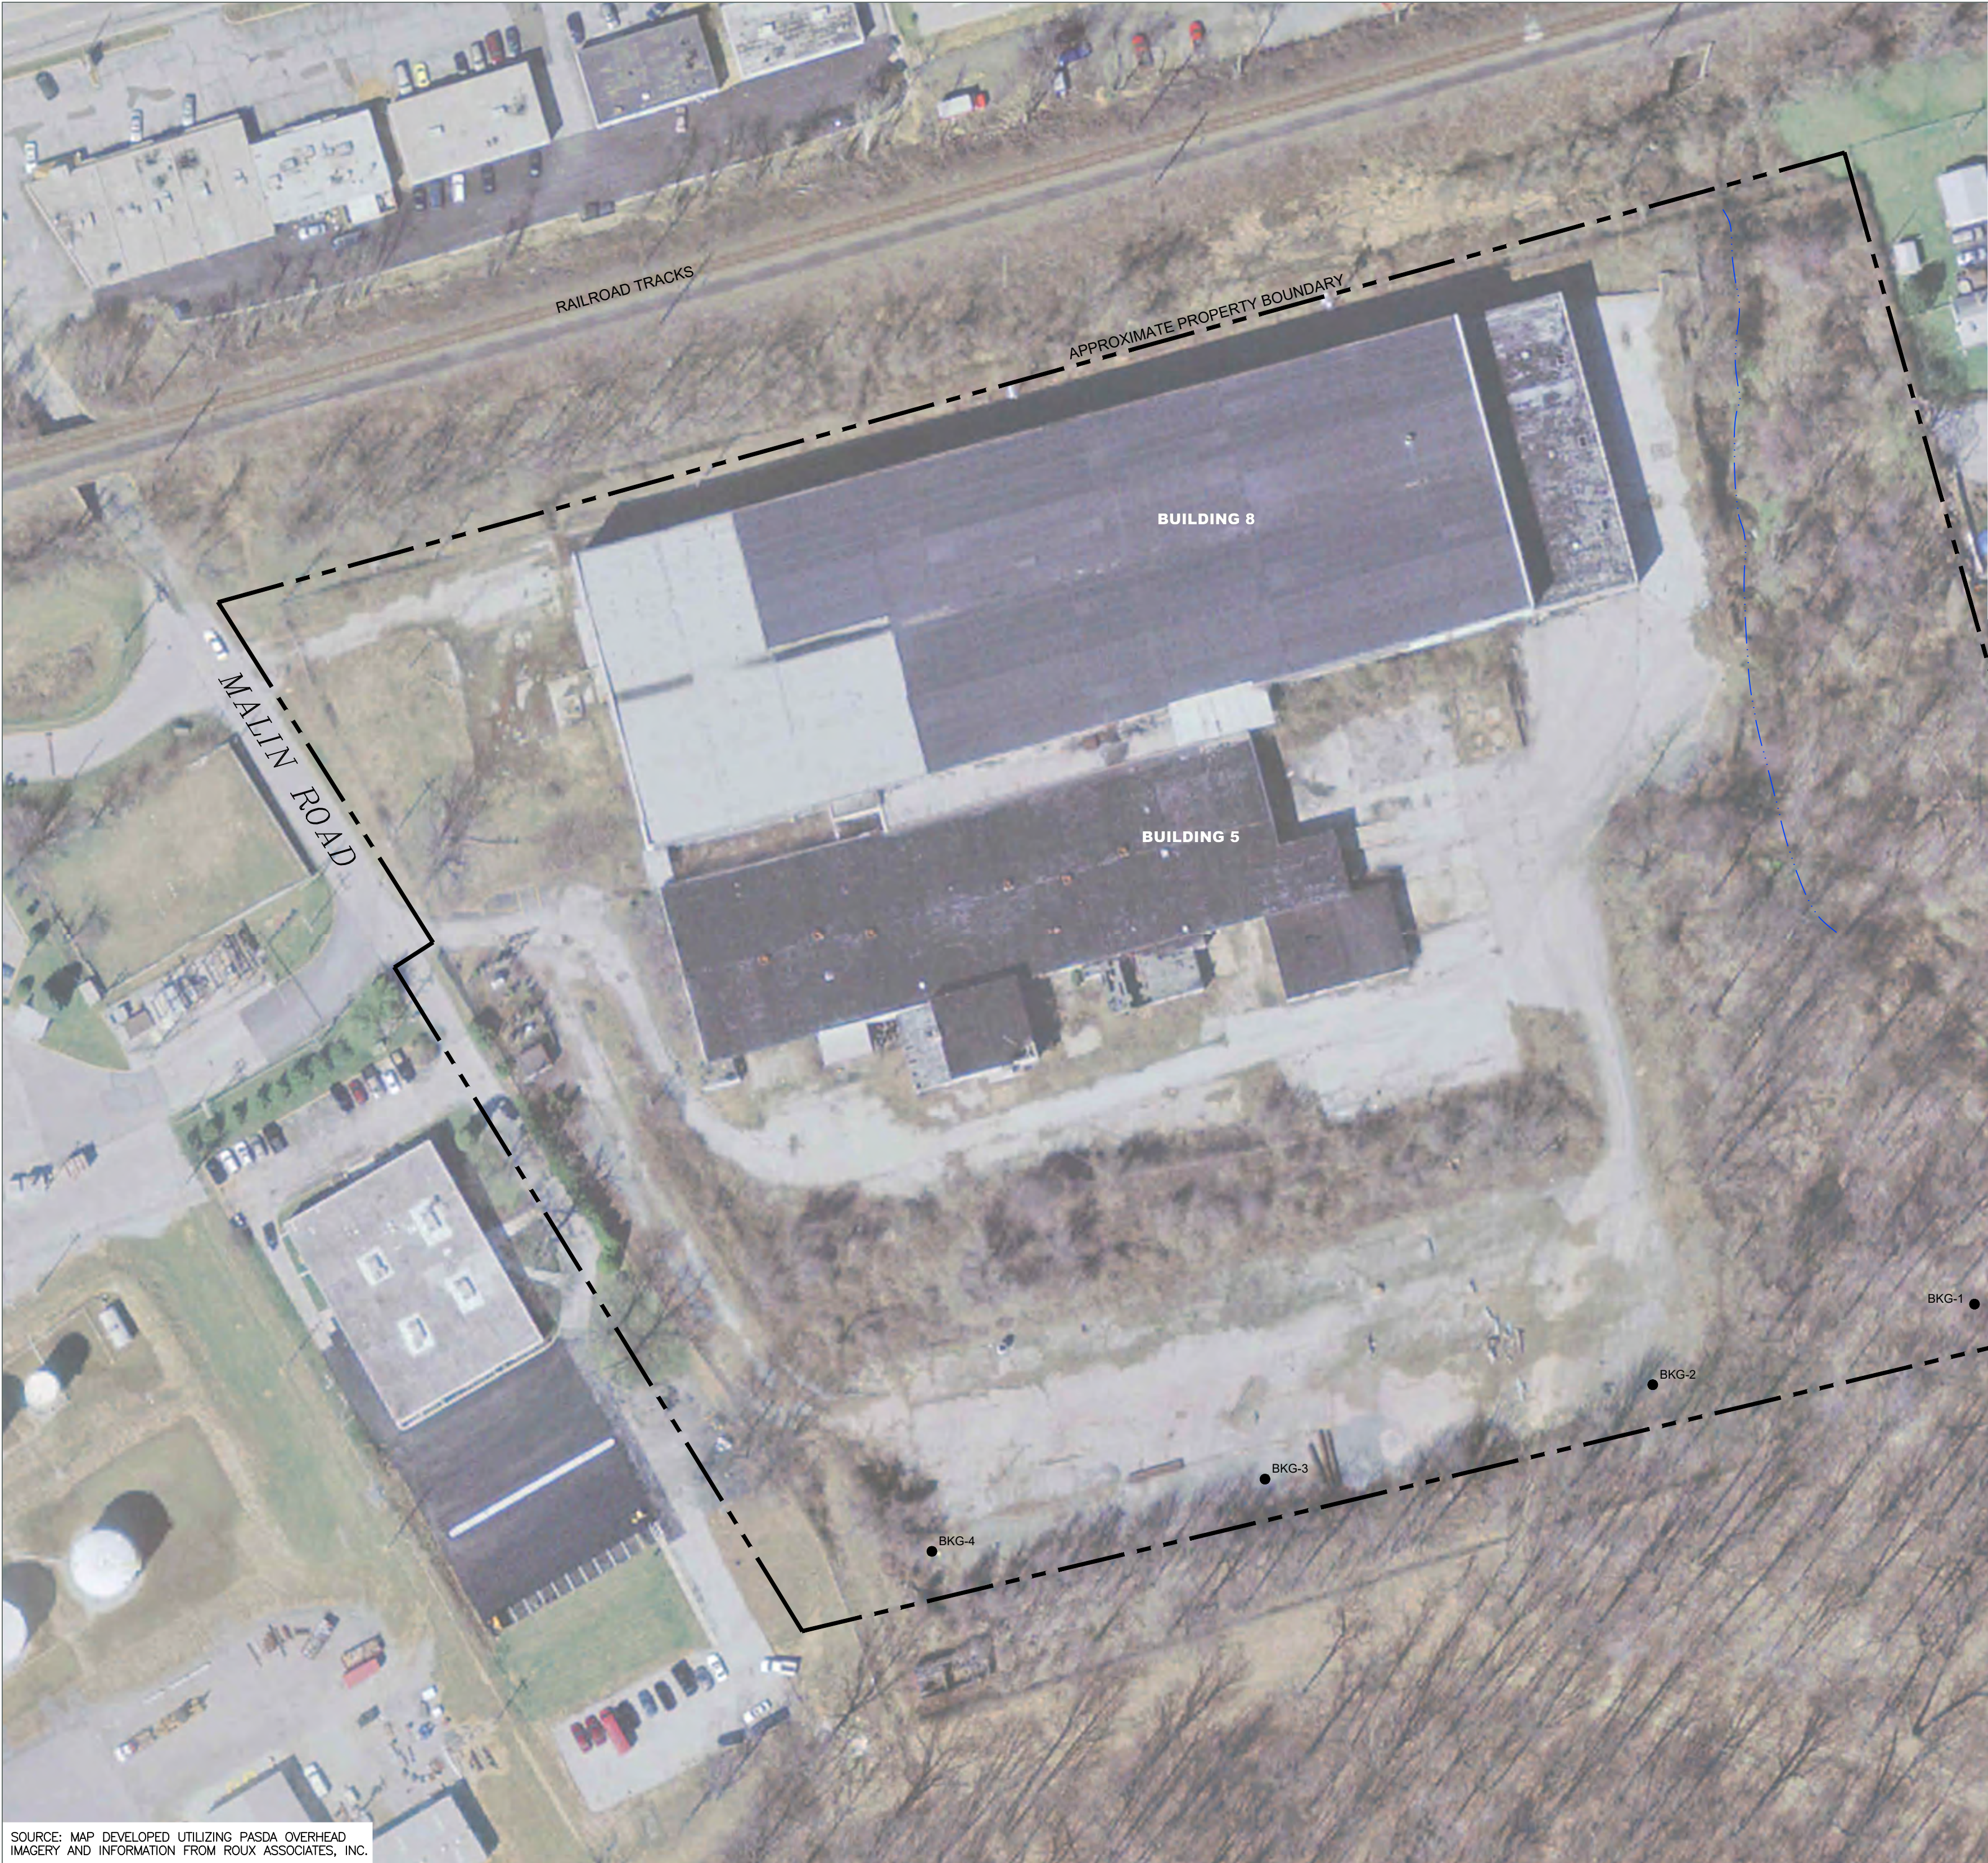
**Figure 5 – Background Soil Sample Location Map**

The limited background soil investigation was conducted near the southern boundary of the source property where no known activities related to the Site operations occurred. On March 5, 2026, GES completed oversight of the advancement of four (4) soil borings to depths ranging from nine (9) to 14 feet bgs to collect soil samples that are believed to be representative of background conditions. The limited background investigation soil borings were logged for lithology and screened using a PID with an 11.7 eV lamp. The composition, color, texture, and moisture content of the soil were recorded on a subsurface log. Additionally, for cores that were to be sampled for fluoride and metals, each one-foot interval of soil was field-screened utilizing XRF technology to evaluate the presence/absence of metals. These readings were also recorded on the subsurface logs for cores where this analysis was conducted. Copies of the soil boring logs for the background soil locations are provided in **Appendix A**.

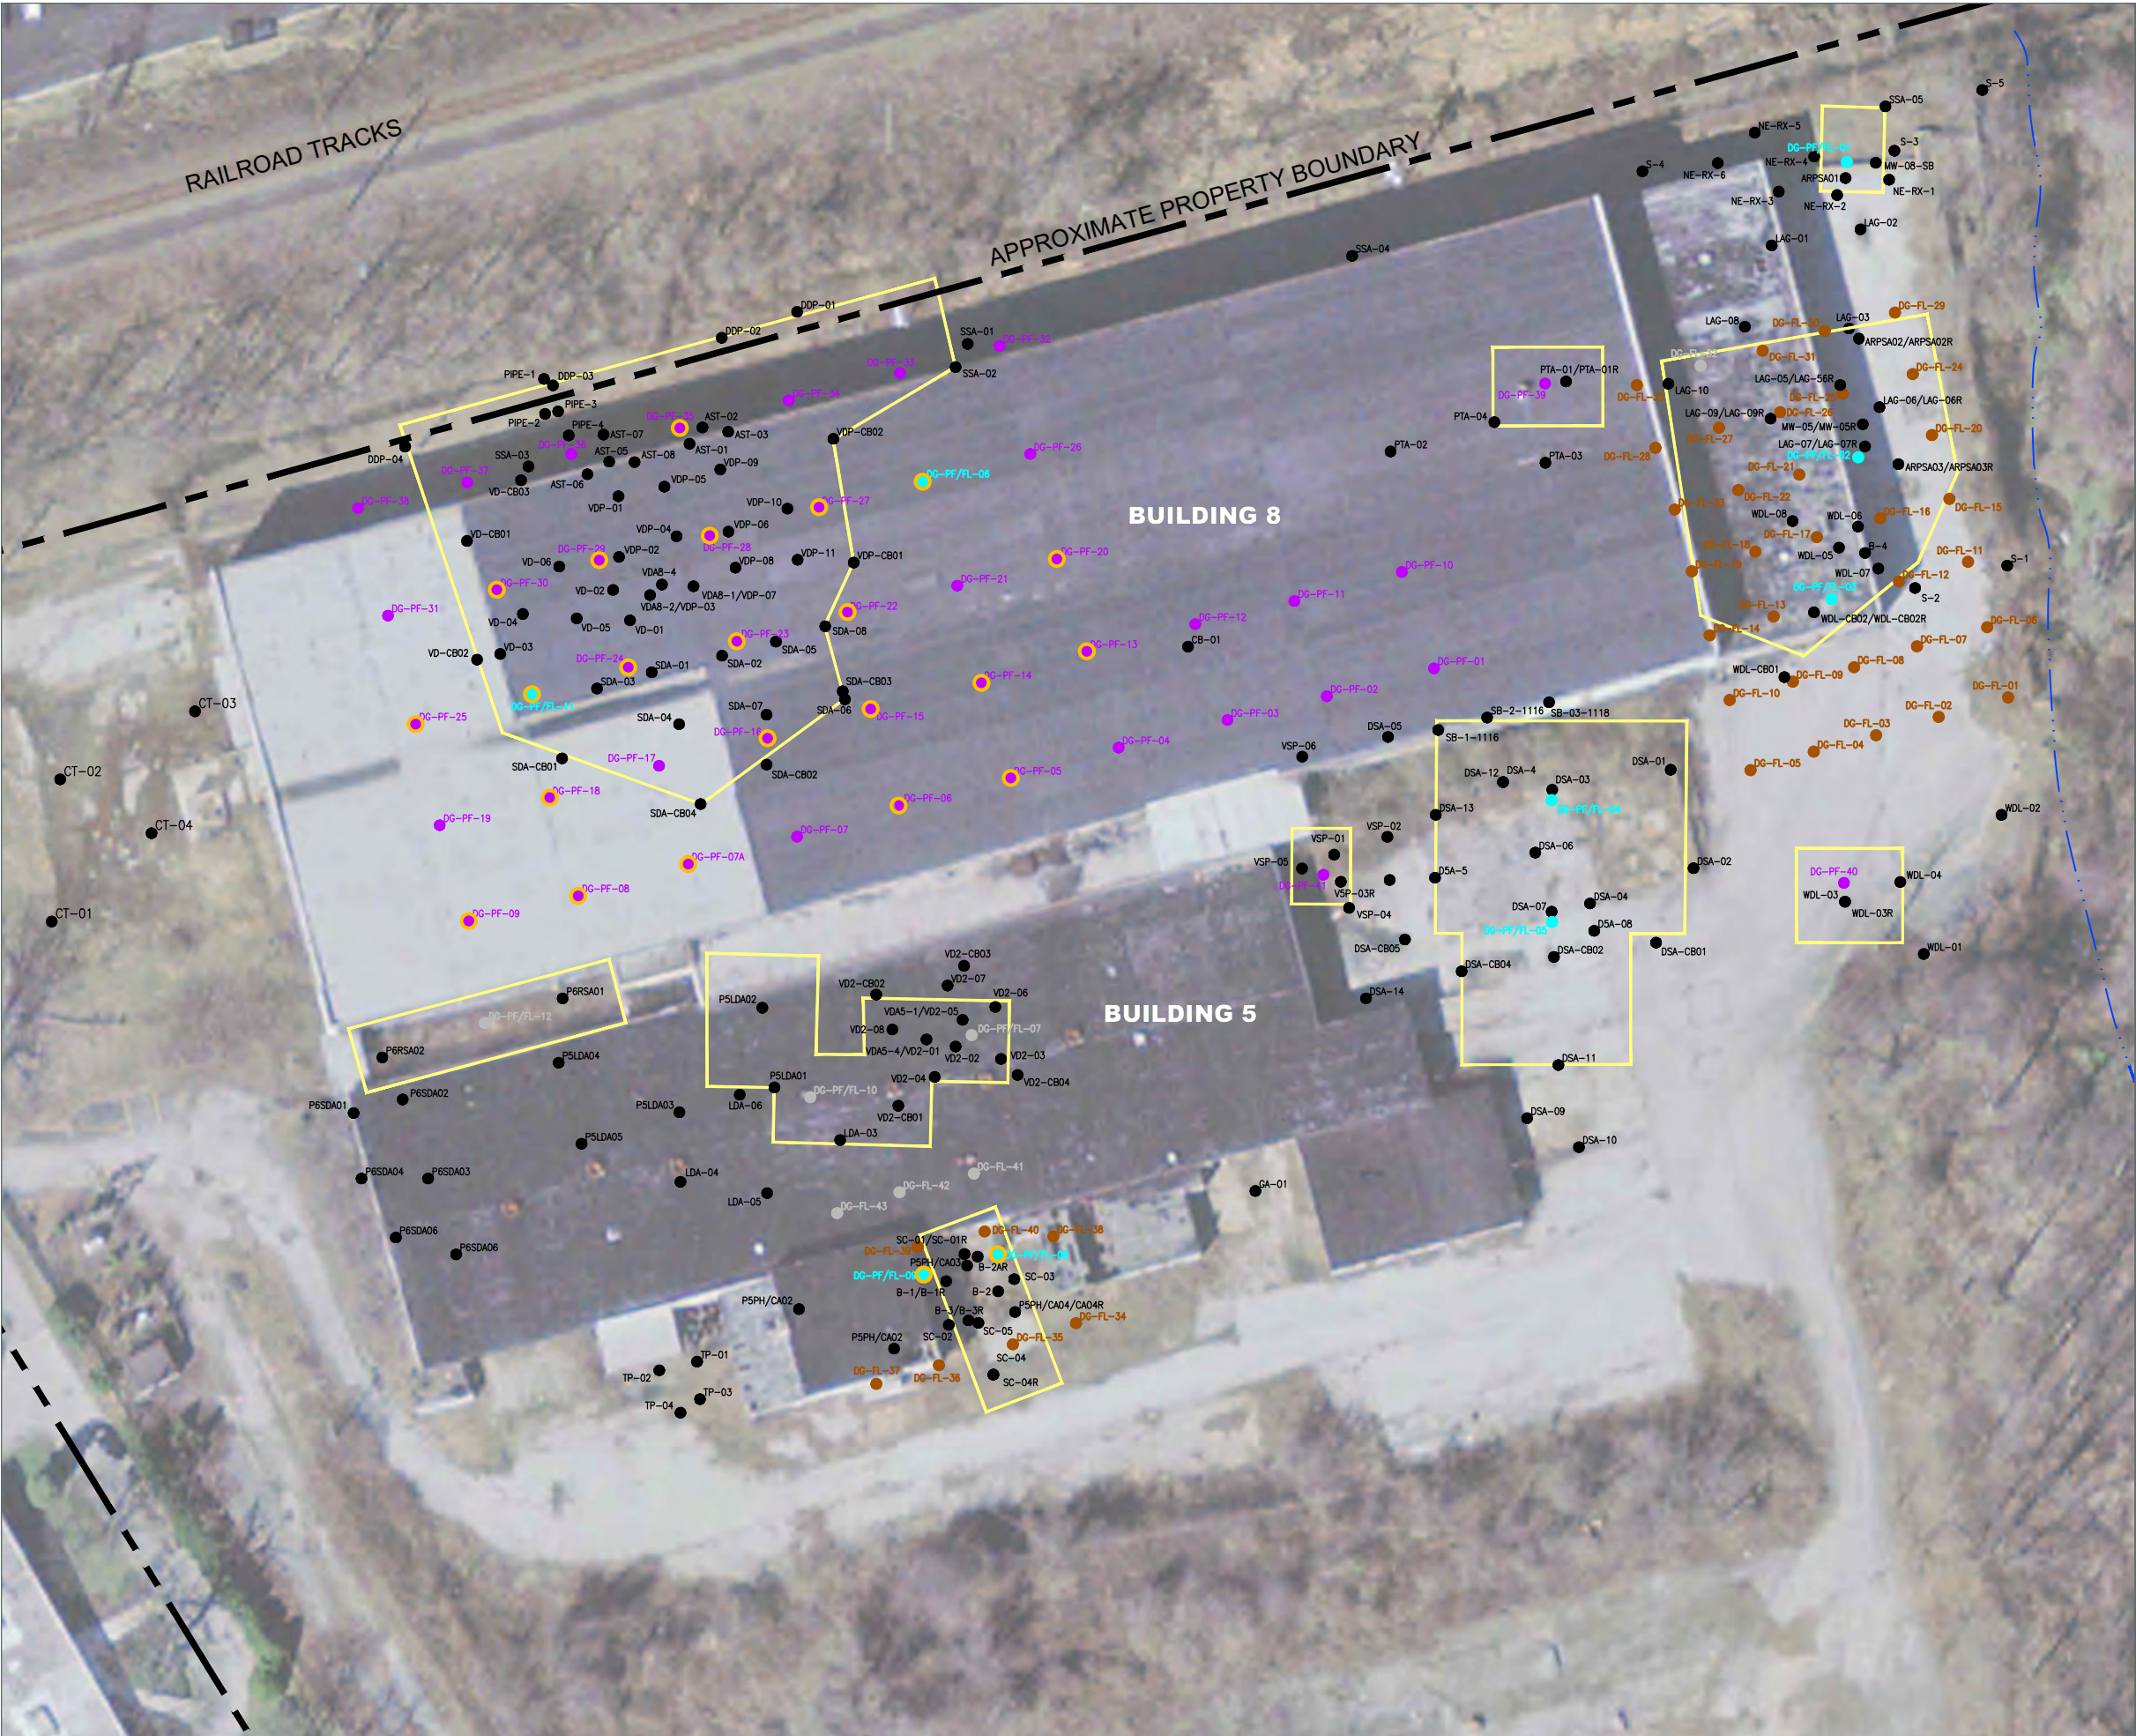
**Figure 6 –Soil Sample PFAS Detection Map (February/March 2026)**

- PROPERTY BOUNDARY (APPROXIMATE)
- STREAM
- HISTORIC SOIL SAMPLE
- SOIL BORING (FLUORIDE)
- SOIL BORING (PFAS)
- SOIL BORING (PFAS/FLUORIDE)
- SOIL BORING (PROPOSED NOT DRILLED)
- NOVEMBER 2020 GES AOC (APPROXIMATE)
- PFAS PERFLUOROALKYL AND POLYFLUOROALKYL SUBSTANCES
- DEP DEPARTMENT OF ENVIRONMENTAL PROTECTION
- MSC MEDIUM-SPECIFIC CONCENTRATIONS
- Concentration was detected for one or more PFAS compounds

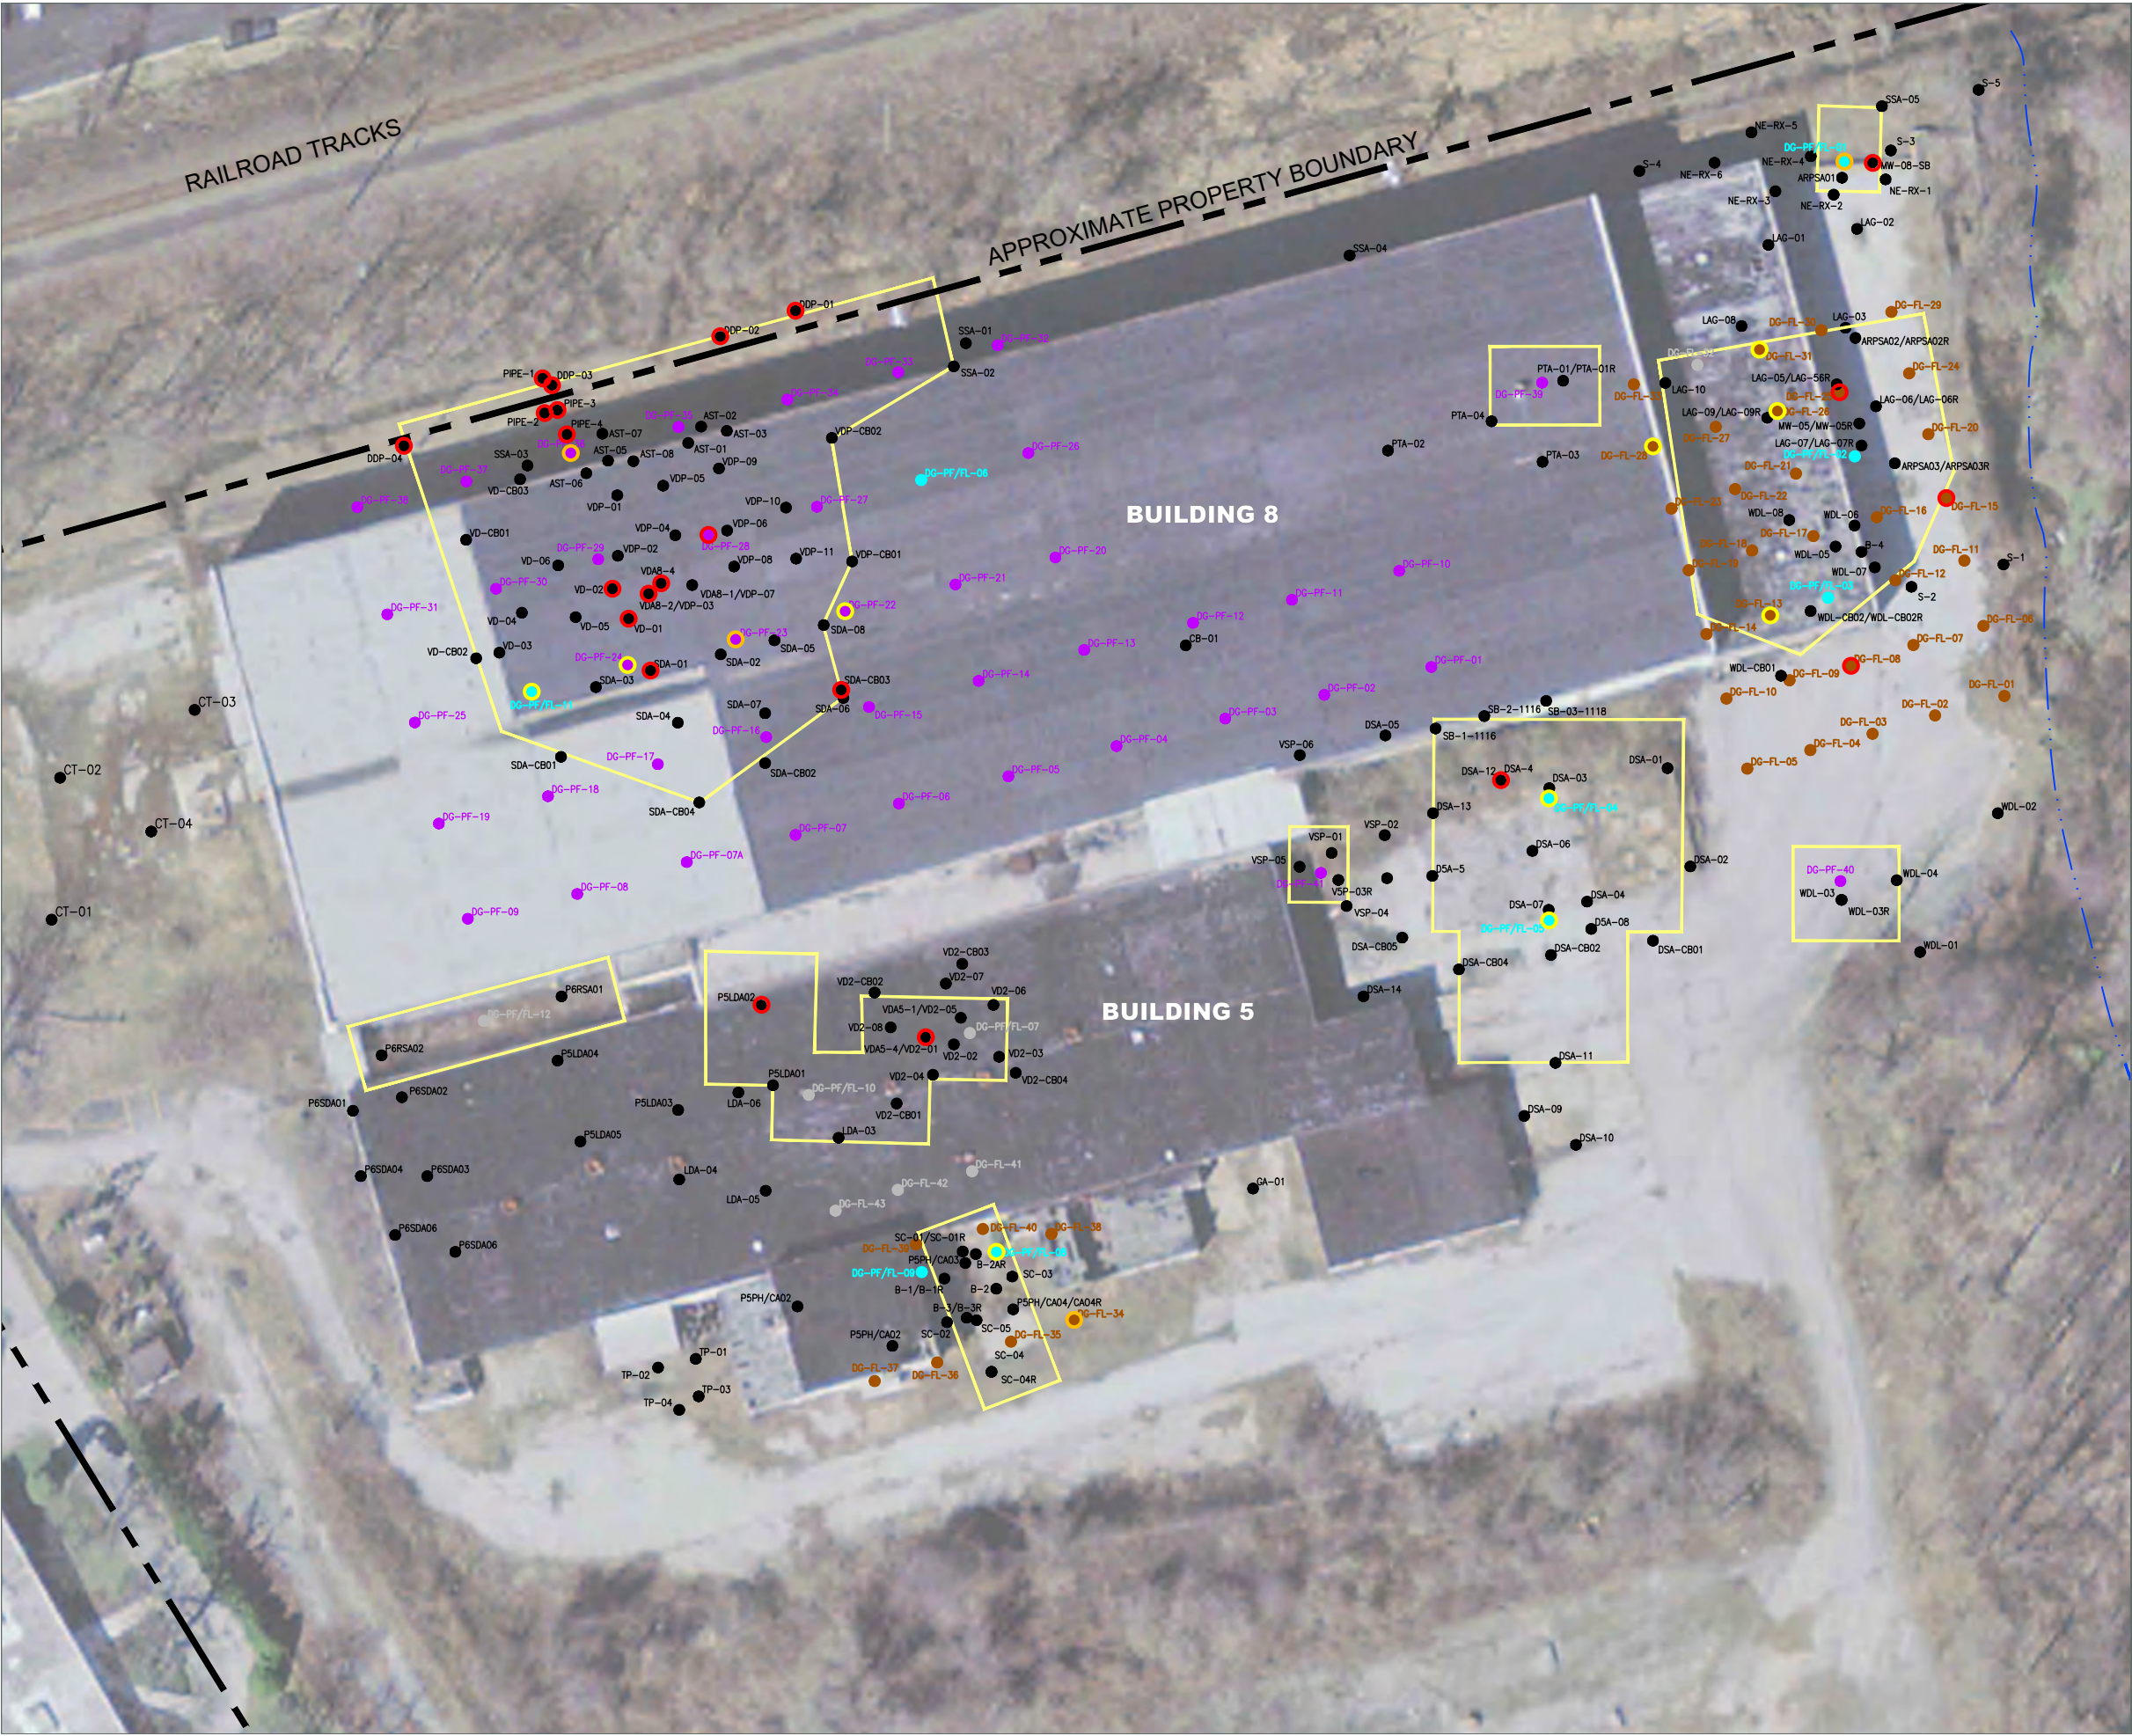
**Figure 8 –Soil Sample Volatile Organic Compounds (VOCs) Detection Map  
(February/March 2026)**

- PROPERTY BOUNDARY (APPROXIMATE)
- STREAM
- HISTORIC SOIL SAMPLE
- SOIL BORING (FLUORIDE)
- SOIL BORING (PFAS)
- SOIL BORING (PFAS/FLUORIDE)
- SOIL BORING (PROPOSED NOT DRILLED)
- NOVEMBER 2020 GES AOC (APPROXIMATE)
- PFAS PERFLUOROALKYL AND POLYFLUOROALKYL SUBSTANCES
- DEP DEPARTMENT OF ENVIRONMENTAL PROTECTION
- MSC MEDIUM-SPECIFIC CONCENTRATIONS
- Concentration of 2026 soil sample was detected below the DEP Act 2 Residential MSCs for one or more volatile organic compounds (VOCs).
- Laboratory reporting limits for 2026 soil boring sample exceed the DEP Act 2 Residential MSCs for one or more VOCs.
- Concentration of 2026 soil sample or historical soil sample was detected above the DEP Act 2 Residential MSCs for one or more VOCs

- No additional data gap pre-design PFAS or fluoride investigation activities are recommended related to soil at the Site, except for installation of eliminated boring locations when Building 5 is deemed safe for work.
- Additional VOC delineation for soil contamination is recommended as part of the OU1 (Operable Unit 1) Remedial Design Investigation (RDI) to further evaluate extent of impacts within AOC 1, 4, 6, and 9. (See **Figure 3.**)
- Additional delineation for soil contamination during the OU1 RDI is recommended in AOCs impacted by inorganic contaminants (including fluoride) to determine the extent of soil contamination in each treatment area.
- During the OU1 RDI, further assessment and/or delineation of Site soil COCs around BKG-1 is recommended.
