# Data Gap Pre-Design Investigation Report Volume 1: Soil

GTAC 8-1-472 – Bishop Tube HSCA Site

1 S. Malin Road, East Whiteland Township, Chester County, Pennsylvania

July 15, 2026

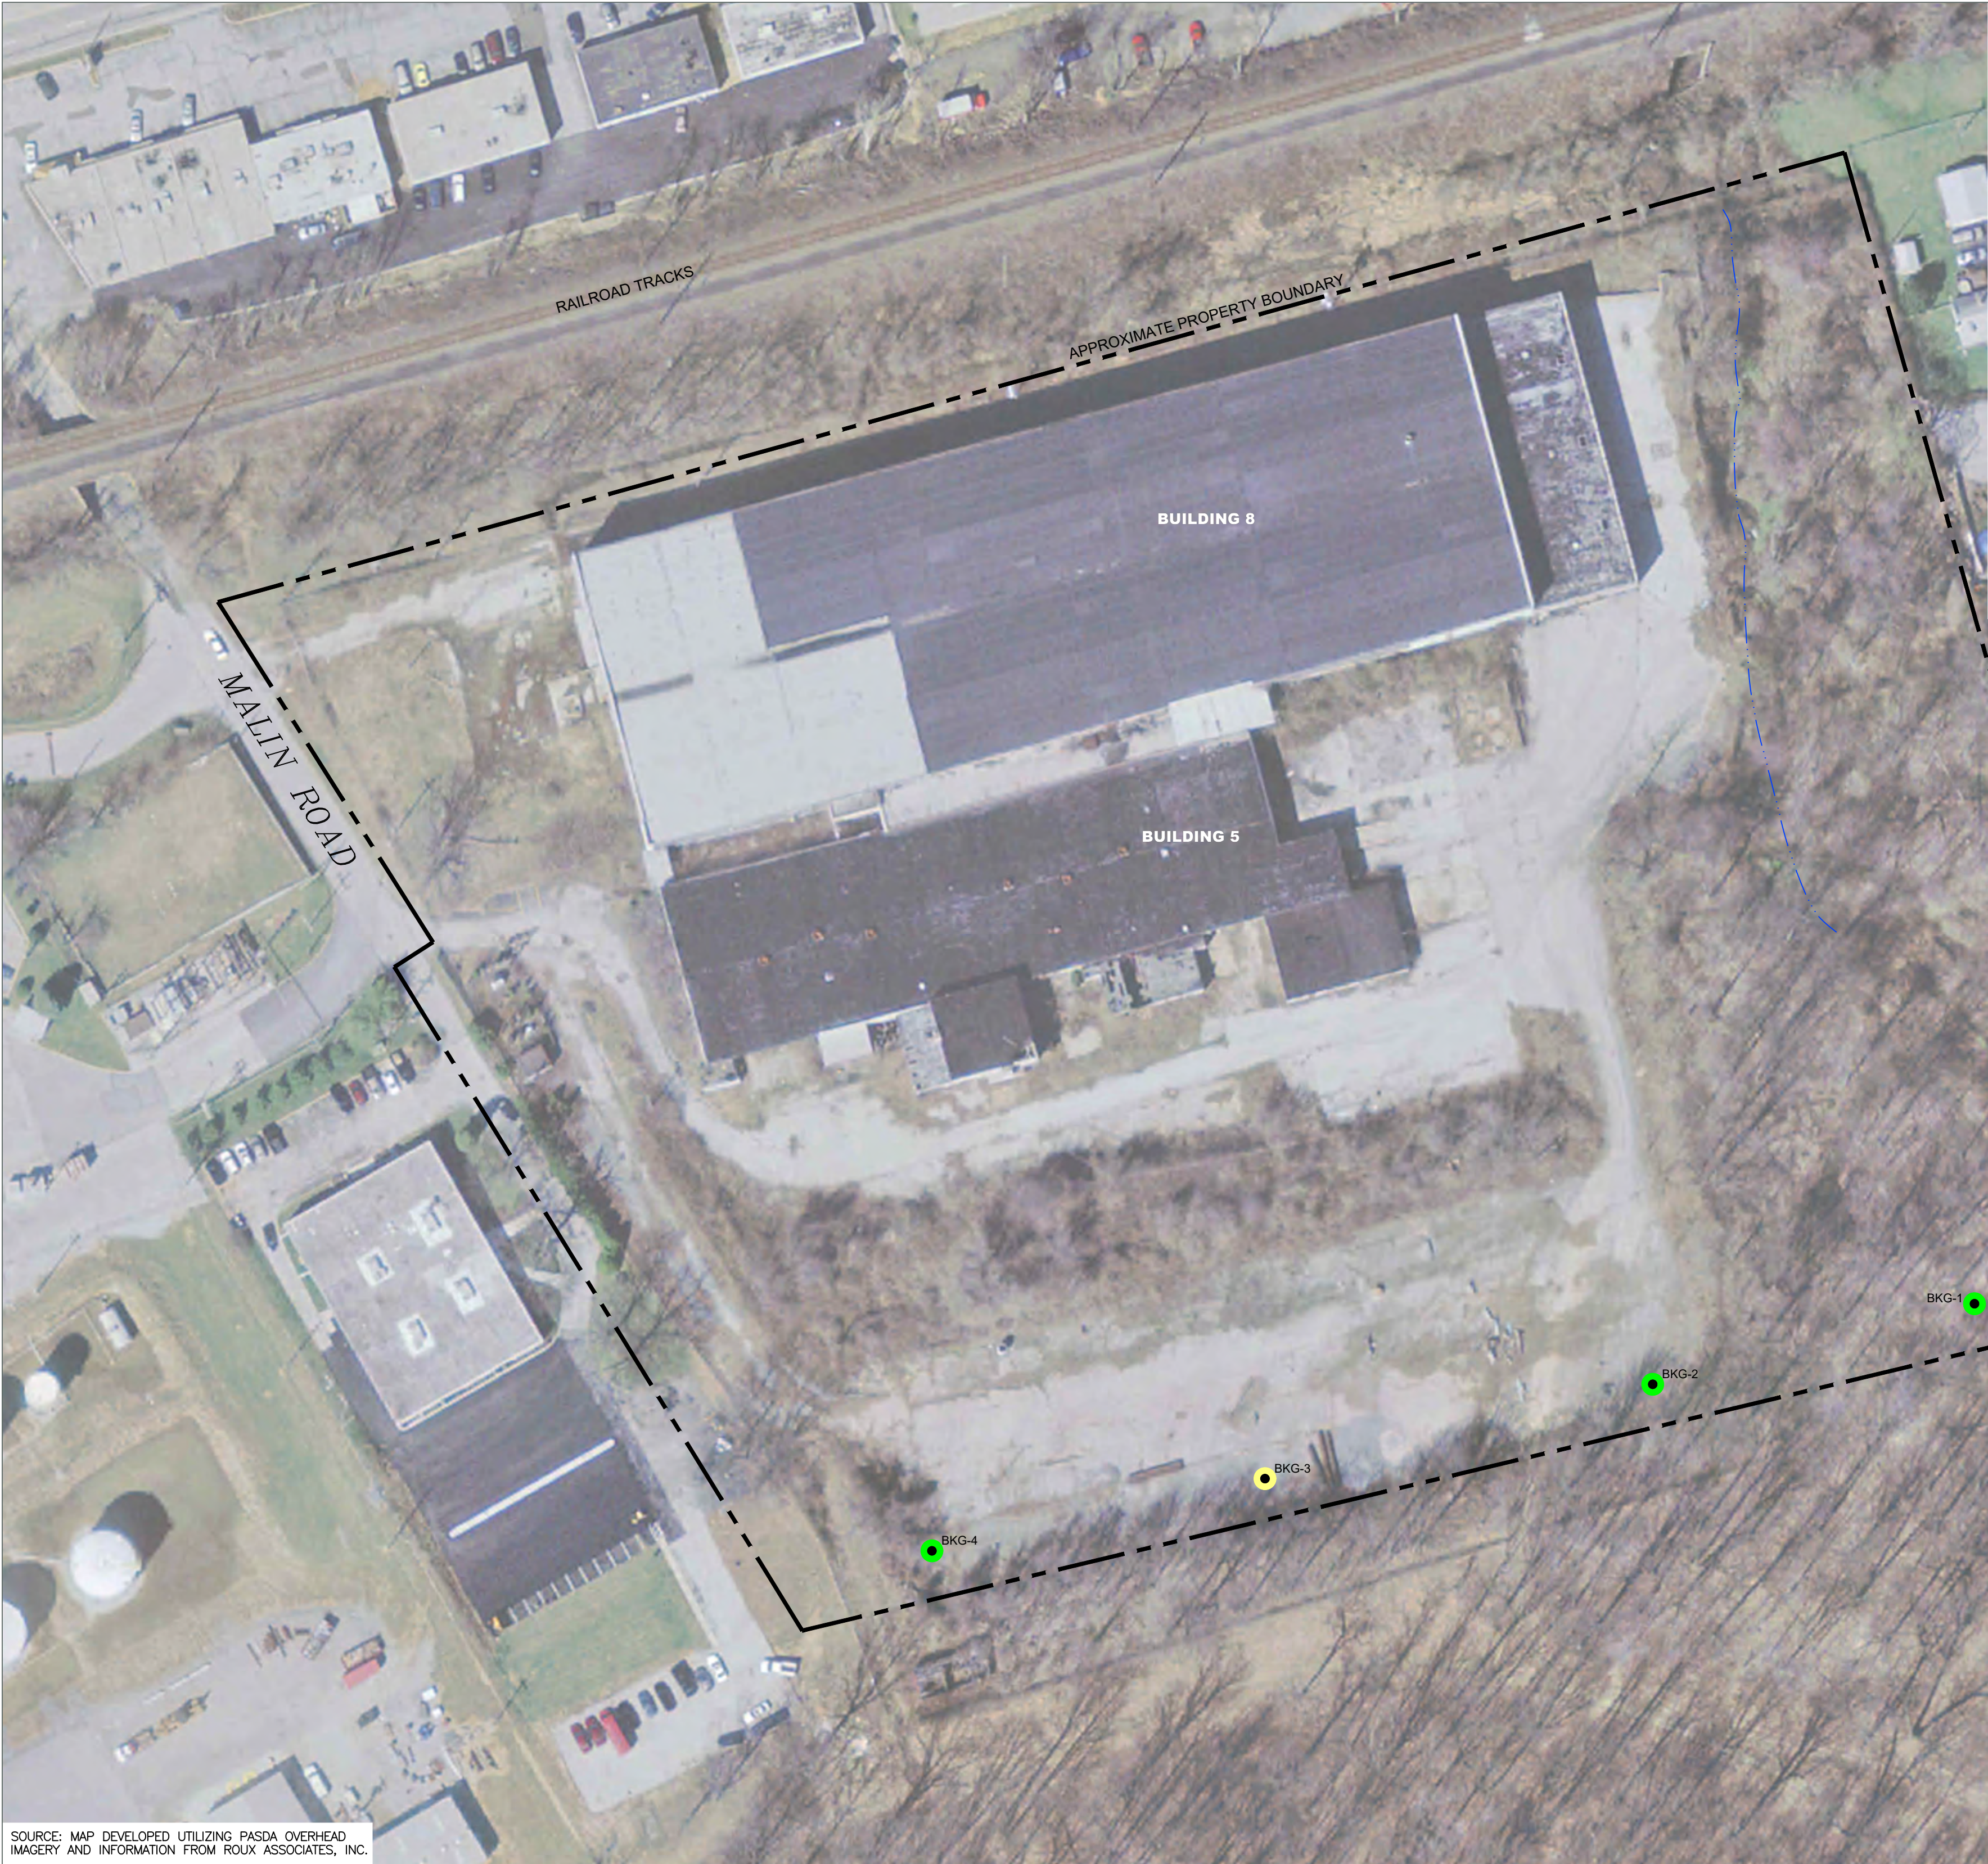
**Figure 9 – PFAS Background Soil Sample Detection Map (March 2026)**

- PROPERTY BOUNDARY (APPROXIMATE)
- STREAM
- SOIL BORING (BACKGROUND)
- DEP PENNSYLVANIA DEPARTMENT OF ENVIRONMENTAL PROTECTION
- MSC MEDIA SPECIFIC CONCENTRATION
- PFAS PERFLUROAKLYL AND POLYFLUROAKLYL SUBSTANCES
- CONCENTRATION WAS DETECTED FOR ONE OR MORE PFAS COMPOUNDS
- LABORATORY REPORTING LIMITS EXCEED THE DEP ACT 2 RESIDENTIAL MSCs FOR ONE OR MORE PFAS COMPOUNDS

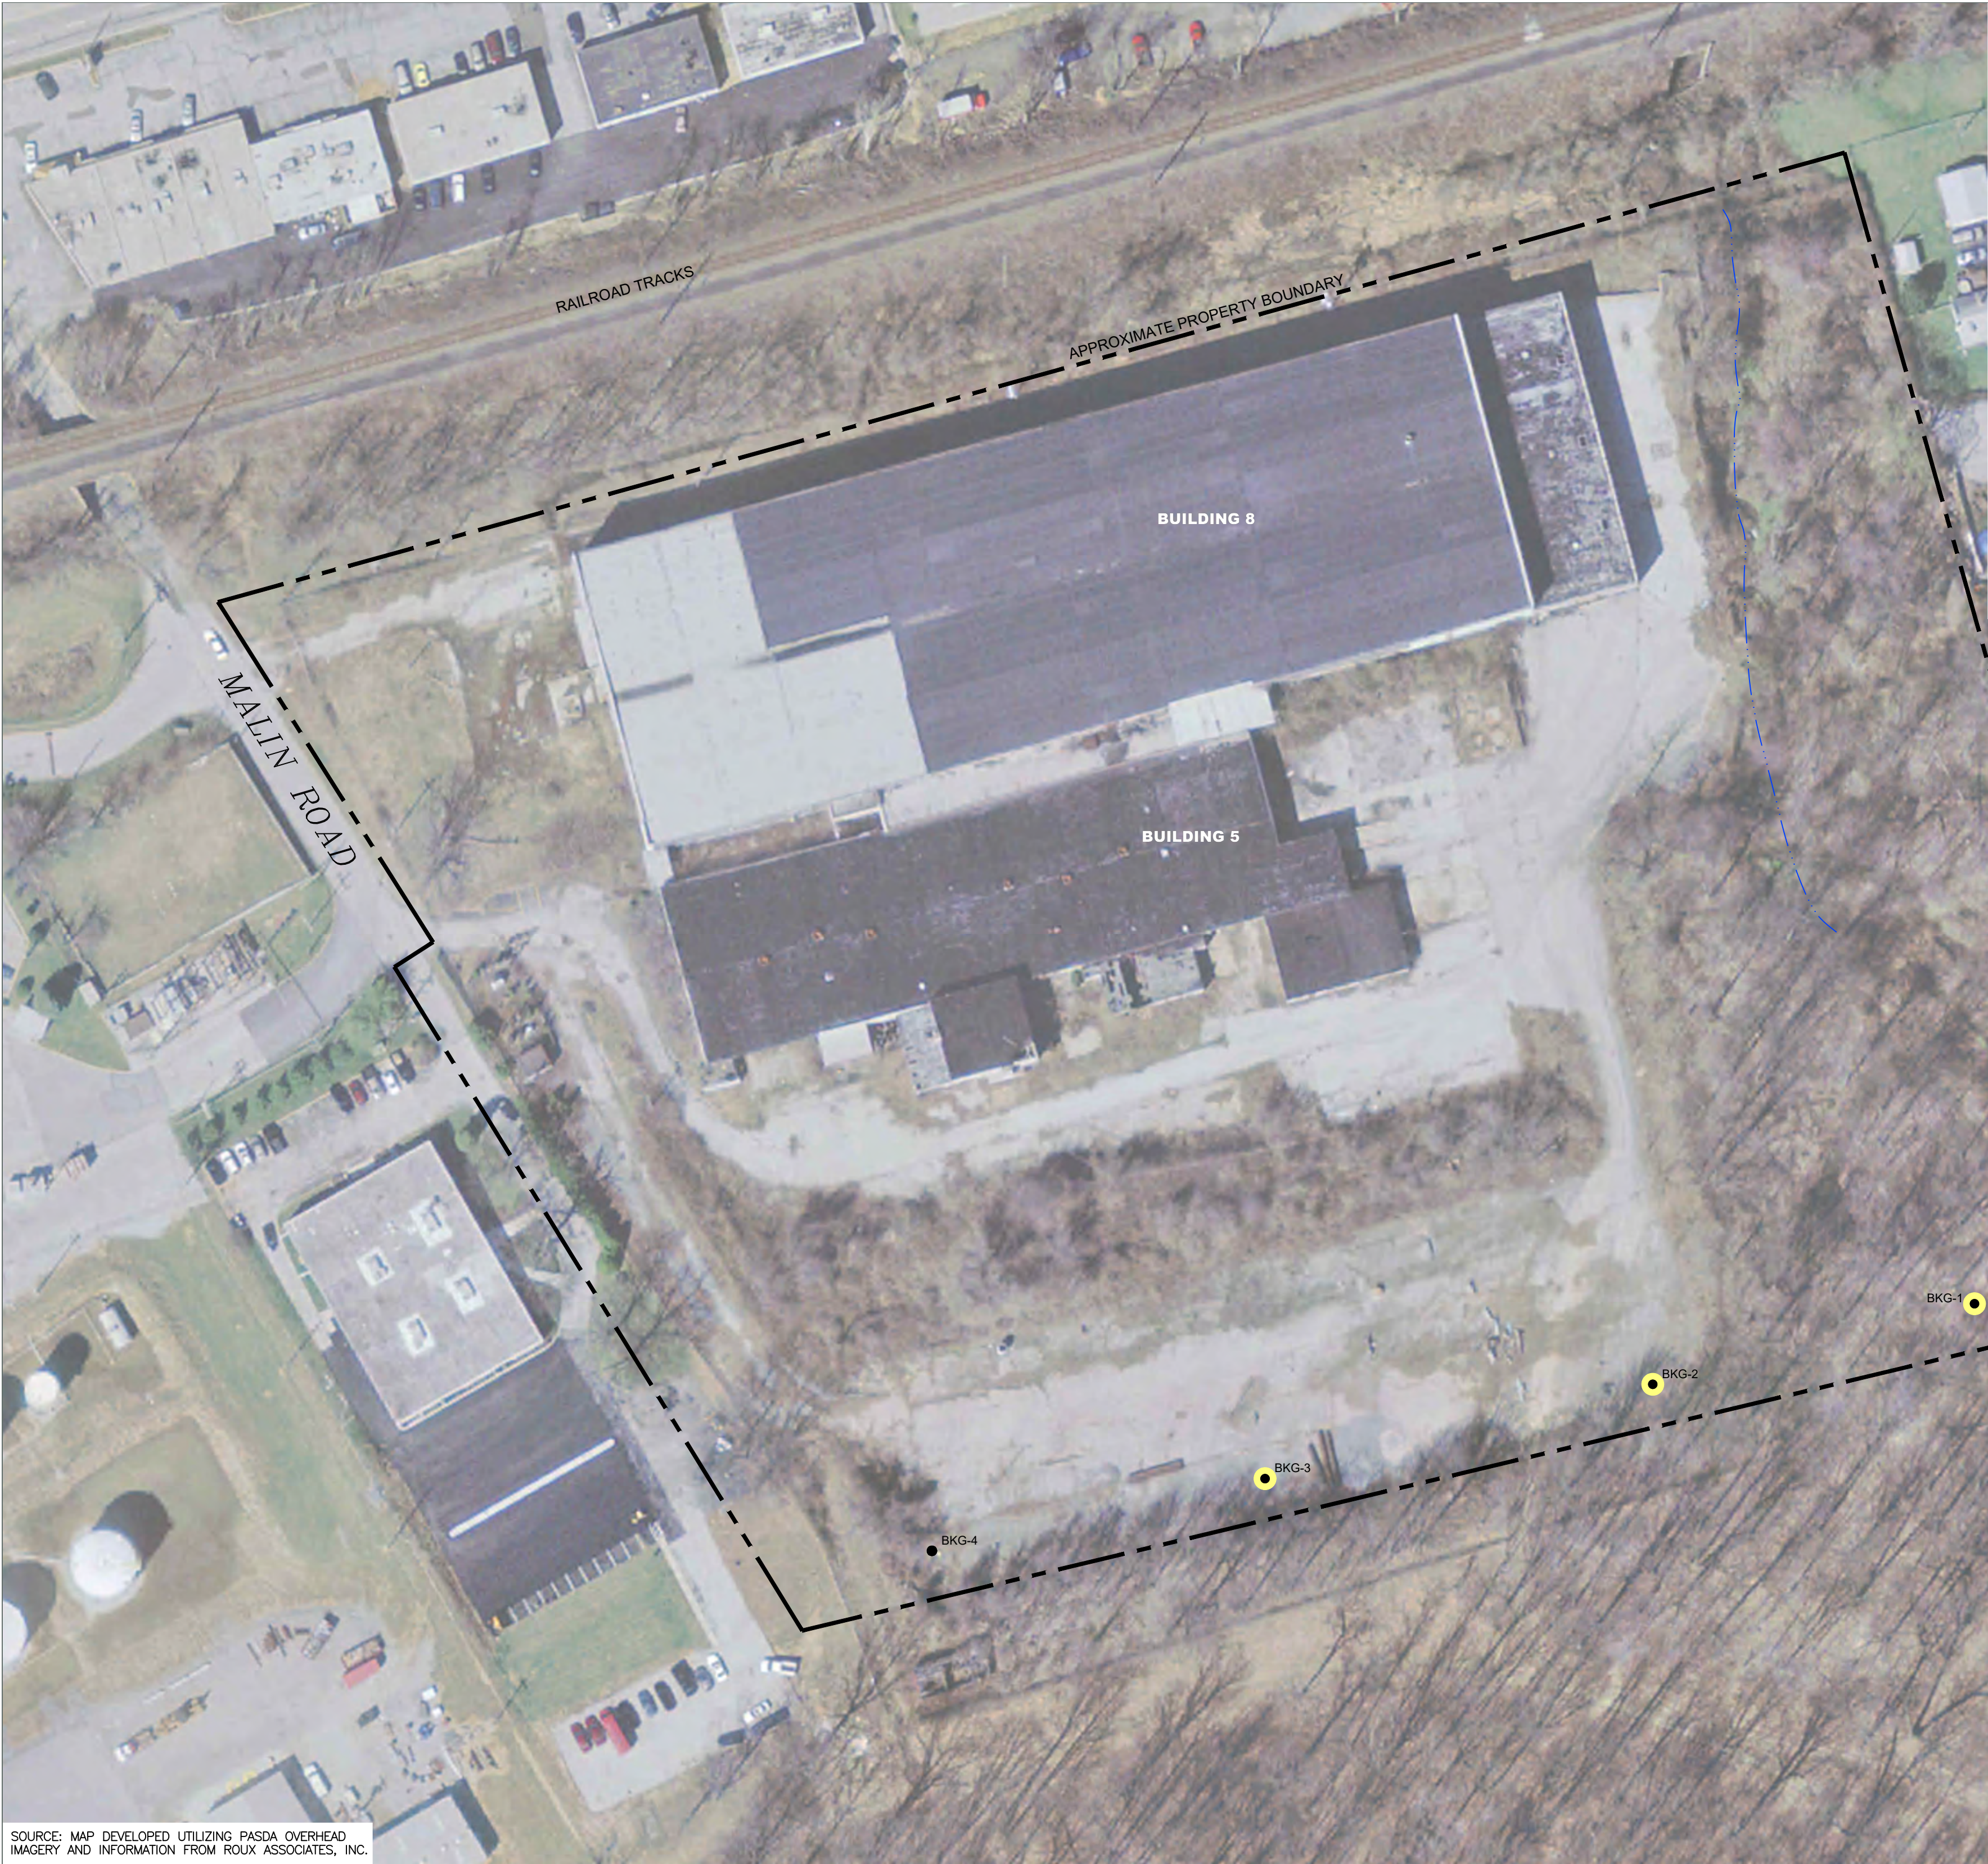
**Figure 10 – Fluoride Background Soil Sample Detection Map (March 2026)**

- LEGEND**
- PROPERTY BOUNDARY (APPROXIMATE)
  - - - - - STREAM
  - SOIL BORING (BACKGROUND)
  - DEP PENNSYLVANIA DEPARTMENT OF ENVIRONMENTAL PROTECTION
  - MSC MEDIA SPECIFIC CONCENTRATION
  - CONCENTRATION WAS DETECTED BELOW THE DEP ACT 2 RESIDENTIAL MSCs FOR FLUORIDE

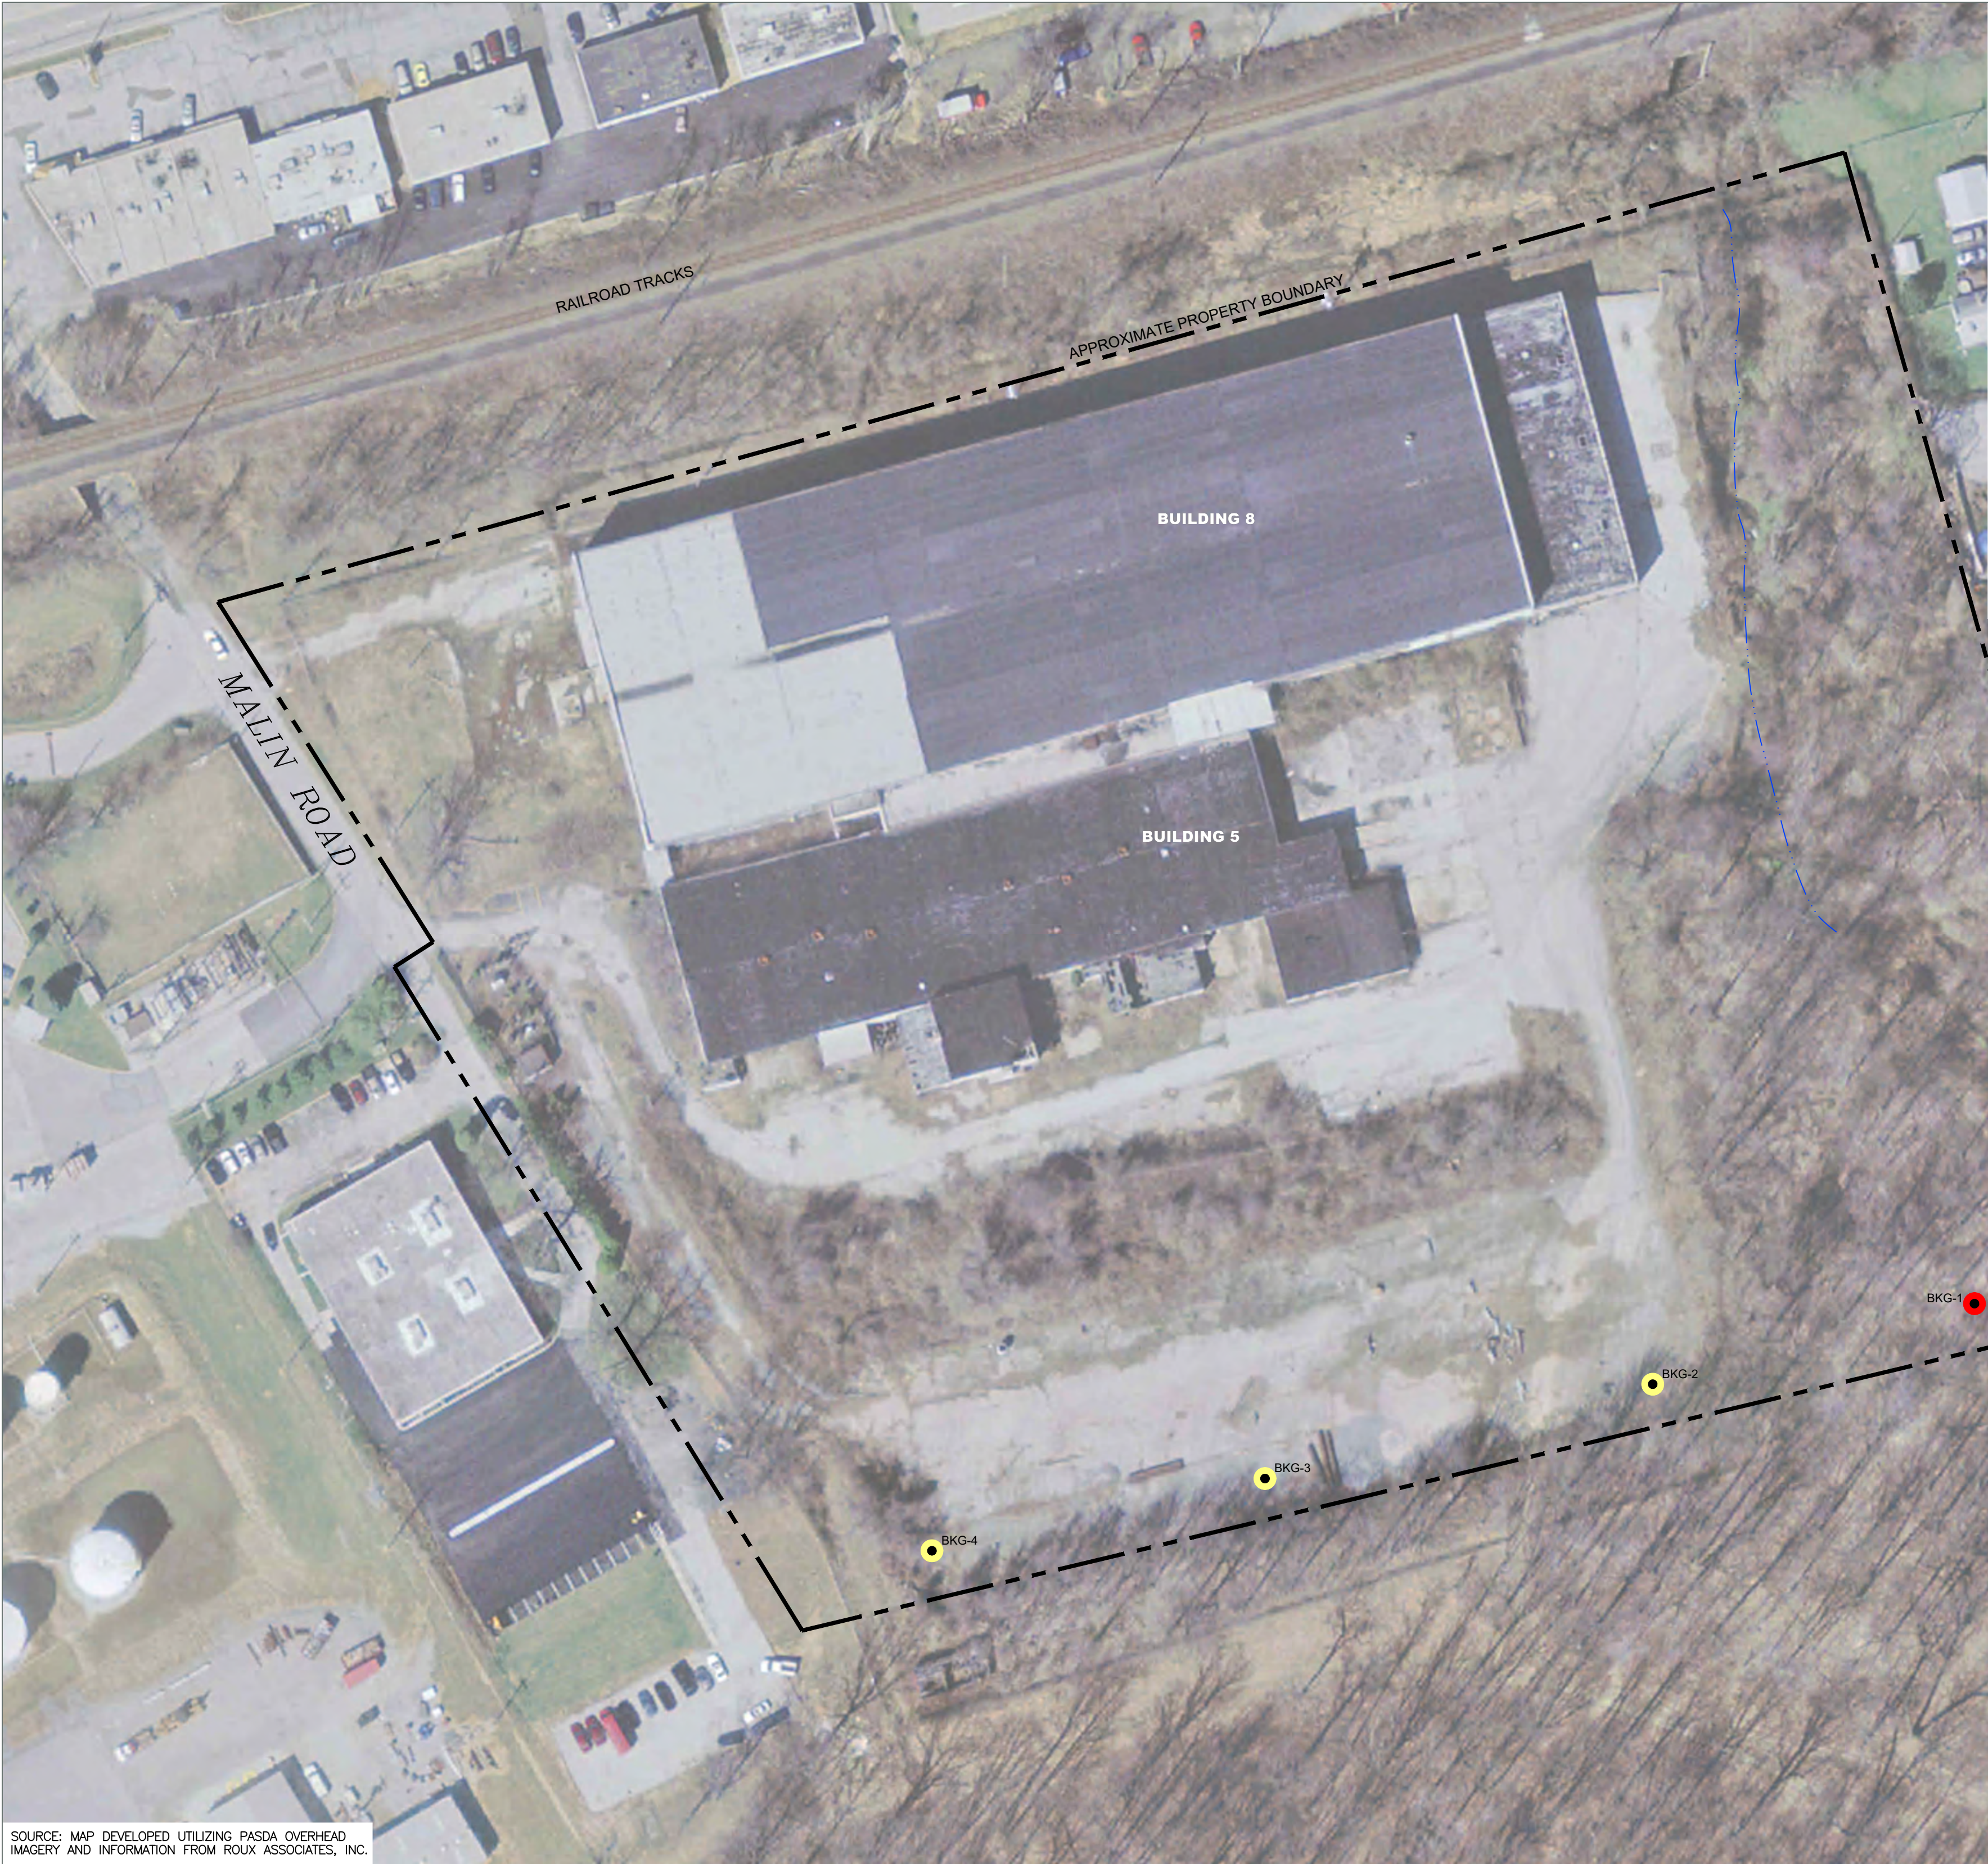
**Figure 11 – Arsenic Background Soil Sample Exceedance Map (March 2026)**

- LEGEND**
- PROPERTY BOUNDARY (APPROXIMATE)
  - - - - - STREAM
  - SOIL BORING (BACKGROUND)
  - DEP PENNSYLVANIA DEPARTMENT OF ENVIRONMENTAL PROTECTION
  - MSC MEDIA SPECIFIC CONCENTRATION
  - CONCENTRATION WAS DETECTED BELOW THE DEP ACT 2 RESIDENTIAL MSCs FOR ARSENIC
  - CONCENTRATION WAS DETECTED ABOVE THE DEP ACT 2 RESIDENTIAL MSCs FOR ARSENIC

- No additional data gap pre-design PFAS or fluoride investigation activities are recommended related to soil at the Site, except for installation of eliminated boring locations when Building 5 is deemed safe for work.
- Additional VOC delineation for soil contamination is recommended as part of the OU1 (Operable Unit 1) Remedial Design Investigation (RDI) to further evaluate extent of impacts within AOC 1, 4, 6, and 9. (See **Figure 3.**)
- Additional delineation for soil contamination during the OU1 RDI is recommended in AOCs impacted by inorganic contaminants (including fluoride) to determine the extent of soil contamination in each treatment area.
- During the OU1 RDI, further assessment and/or delineation of Site soil COCs around BKG-1 is recommended.

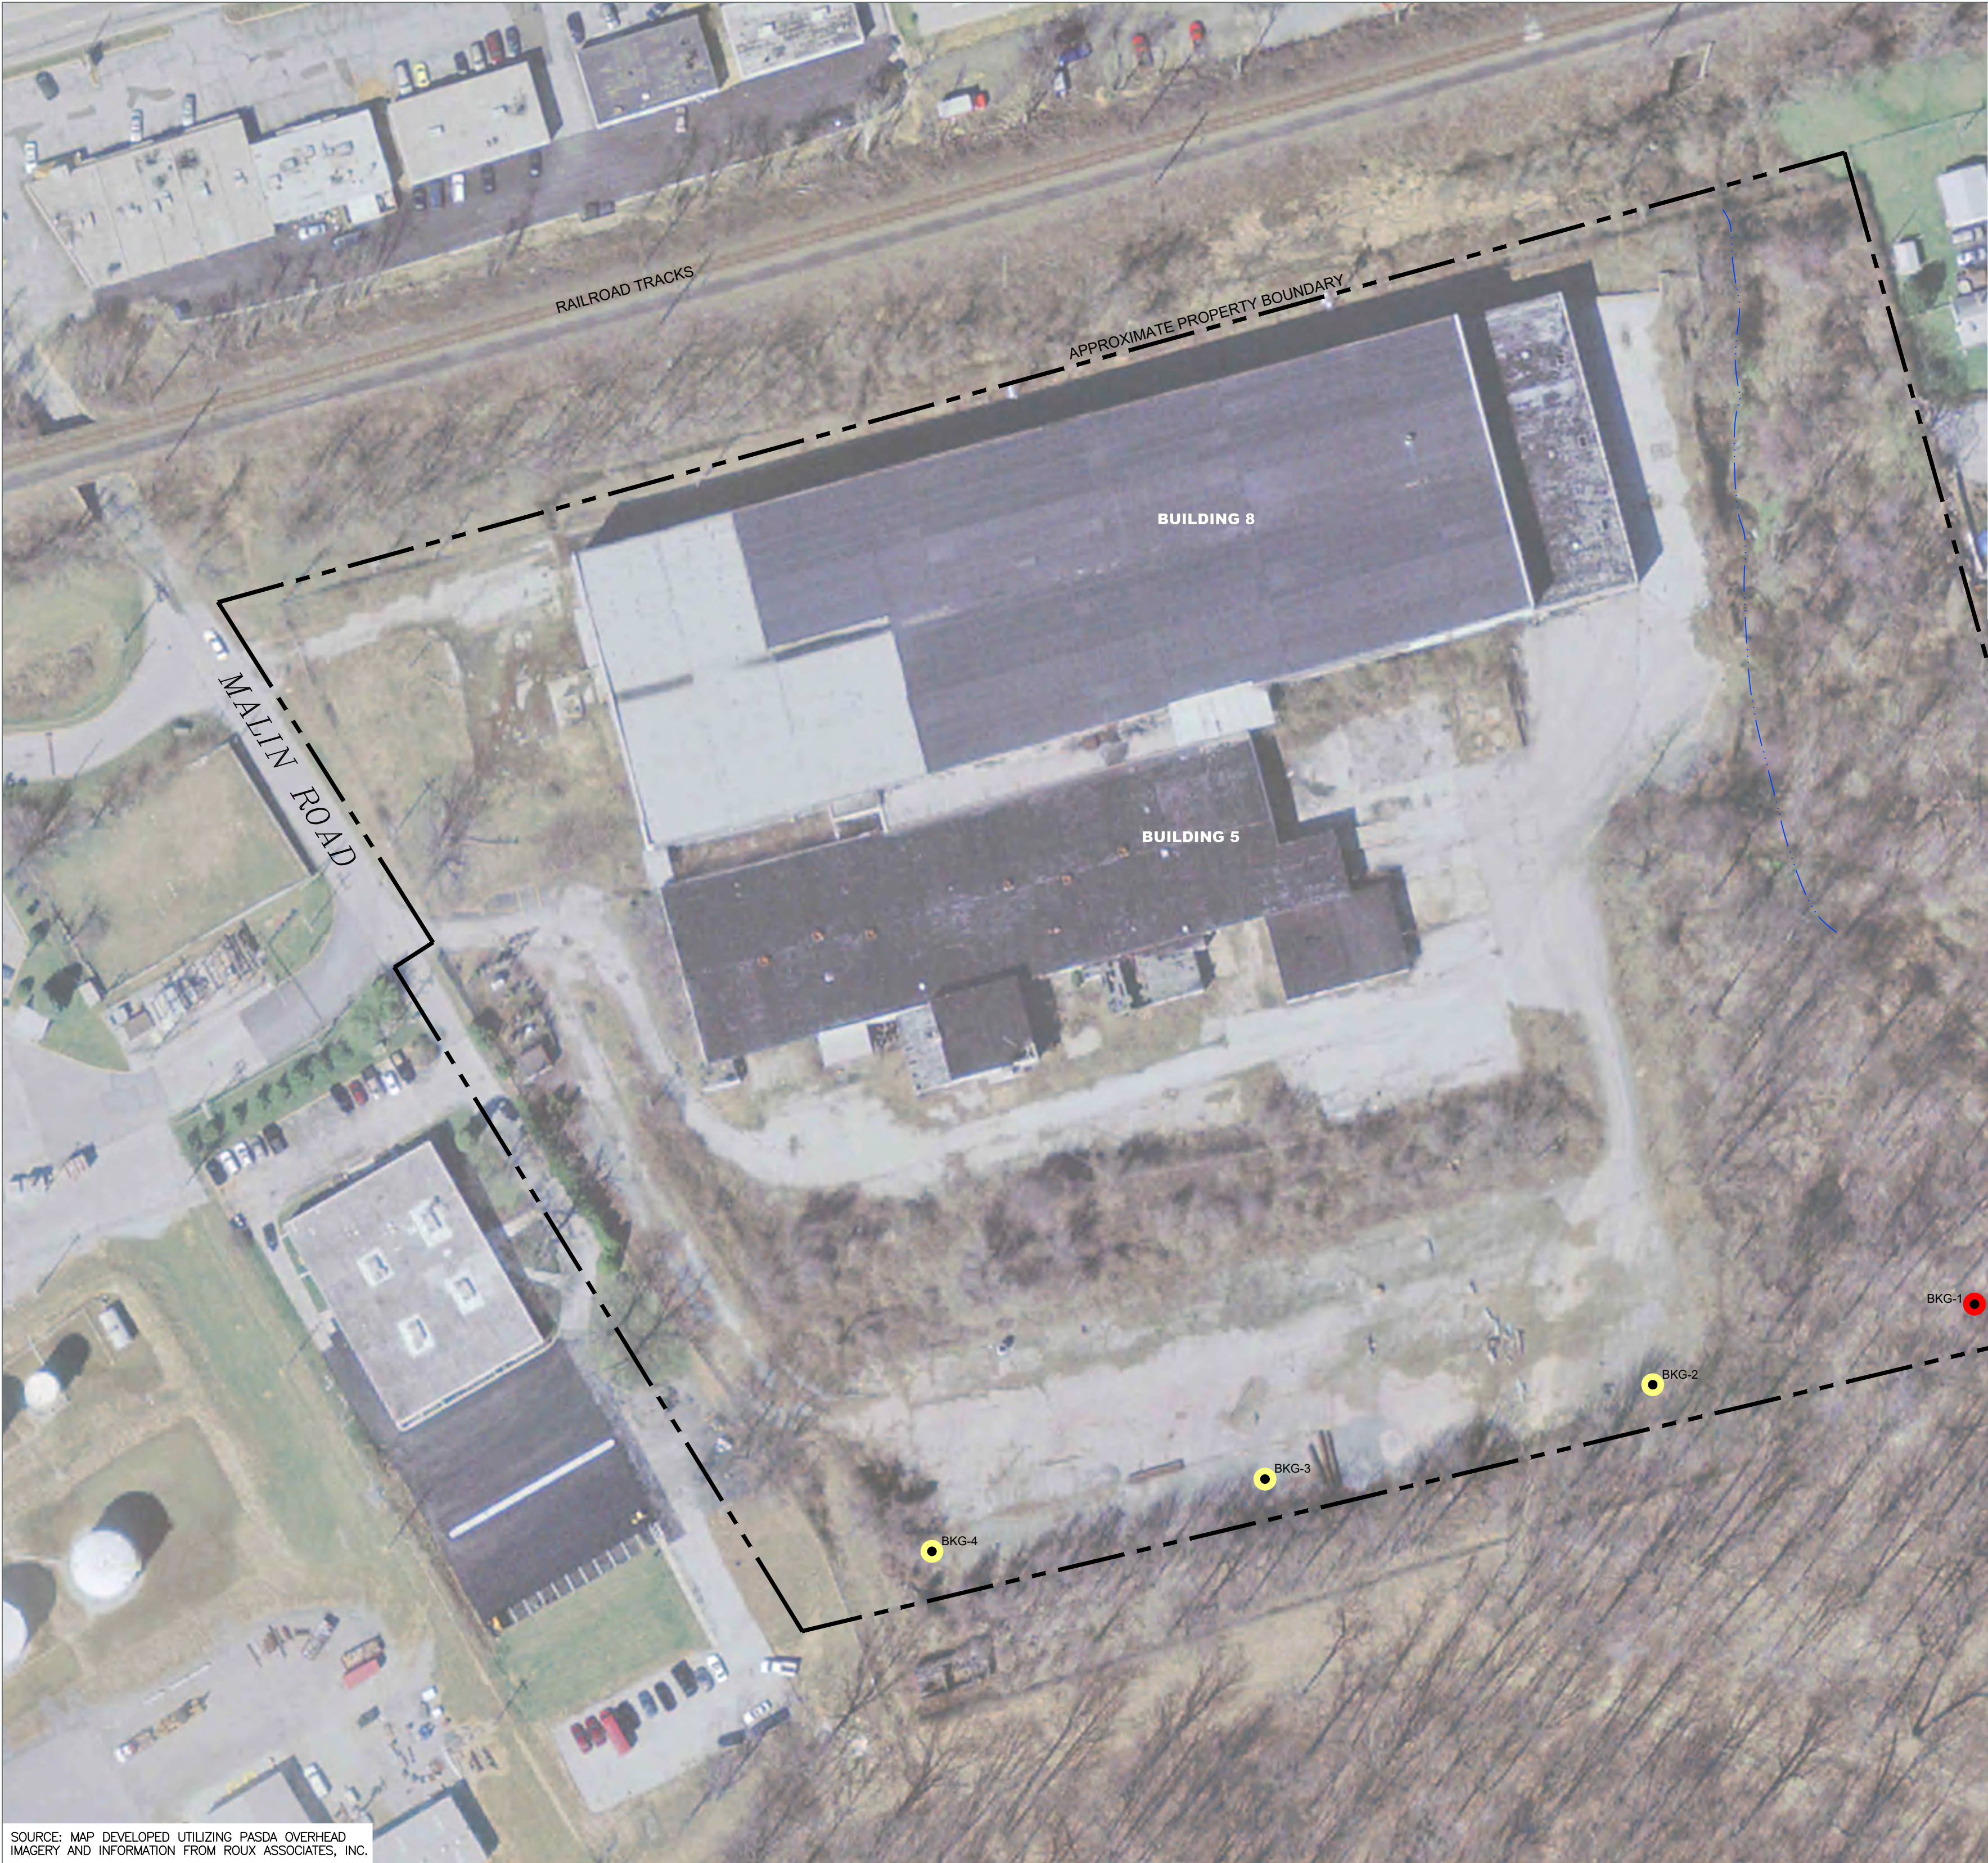
**Figure 12 – Cobalt Background Soil Sample Exceedance Map (March 2026)**

- LEGEND**
- PROPERTY BOUNDARY (APPROXIMATE)
  - - - - - STREAM
  - SOIL BORING (BACKGROUND)
  - DEP PENNSYLVANIA DEPARTMENT OF ENVIRONMENTAL PROTECTION
  - MSC MEDIA SPECIFIC CONCENTRATION
  - CONCENTRATION WAS DETECTED BELOW THE DEP ACT 2 RESIDENTIAL MSCs FOR COBALT
  - CONCENTRATION WAS DETECTED ABOVE THE DEP ACT 2 RESIDENTIAL MSCs FOR COBALT
