**PROJECT INVESTIGATION REPORT
FOR
HOFF VC SITE
NEW HANOVER TOWNSHIP
MONTGOMERY COUNTY
PENNSYLVANIA**

PADEP Requisition Number GTAC5-1-263

Leidos Project 301604.TM.100116

August 2014

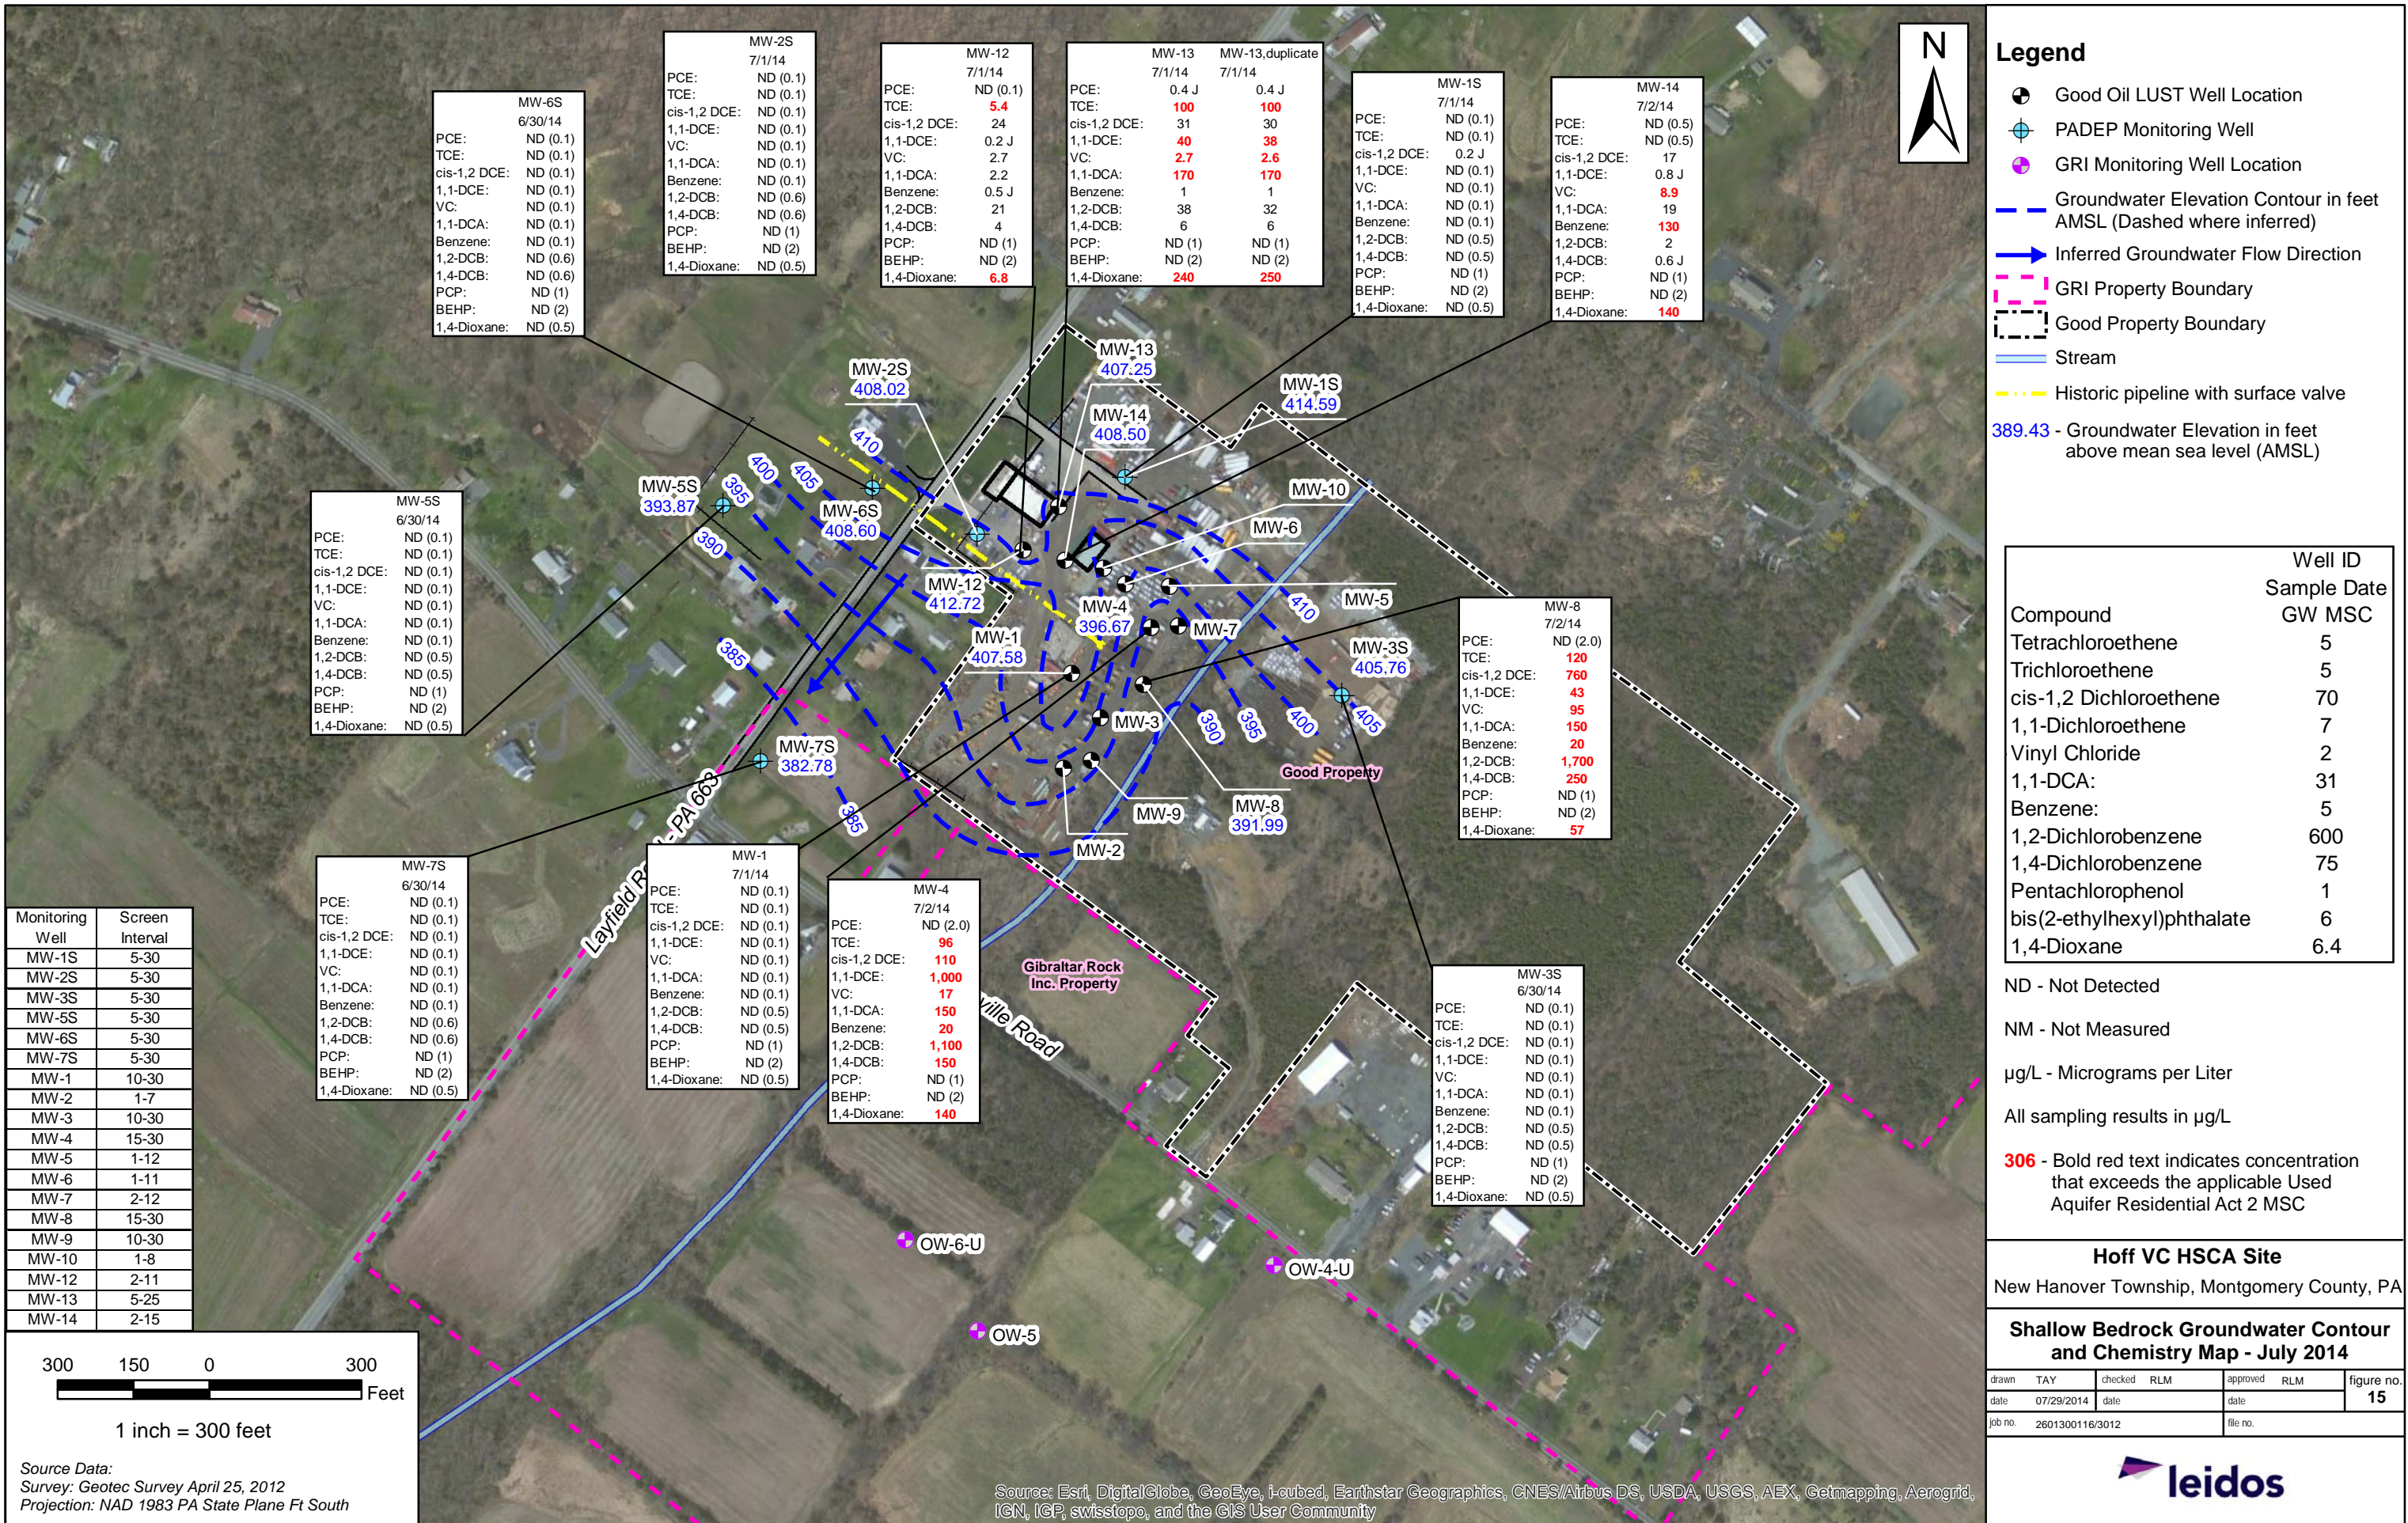
318 Layfield Road

- Structural & Environmental:** Floor Drain, Sub-Slab Floor Drain Piping, Dehumidifier, Window, Stairs, Wall, Shelves with Chemicals & Paints, Bilco Door /Access.
- Equipment & Storage:** Fuel Oil AST, Shelves, Furnace, Refrigerators, Washer & Dryer.
- Utility & Plumbing:** Water Softener, Water Treatment Tanks, Pressure Tank and Water Line In, 4" Sanitary Line Out.
- Monitoring Points:** SVP-1, SVP-2 (indicated by green dots).
