If Interim report, Subject to Change as Additional Information Becomes Available
If Interim Report, this Report is cumulative, containing information from previous reports in addition to new information and may change
SPLP PENNSYLVANIA PIPELINE PROJECT
HORIZONTAL DIRECTIONAL DRILLING – INADVERTENT RETURN REPORT FORM

REPORT DATE:	Current as of 4/20/2021	HDD ALIGNMENT #	PA-CH-100.0000-RD				
PROJECT SITE:	PPP 6 - S3-0290 - Milford Rd./Little Conestoga Rd		HDD COMPANY:	Michels Directional Crossing			
DATE AND TIME WHEN IR WAS INITIALLY DISCOVERED			DATE:	8/10/2020	TIME:	1530	
LOCATION: STREET	427-423 Green Valley Rd, Downingtown, PA 19335		MUNICIPALITY:	Upper Uwchlan	COUNTY:	Chester	
LATITUDE:	40.0794	LONGITUDE:	-75.7104	FROM STATION:	14824+00	TO STATION	14824+00
STREAM NAME:	S-H10 (UNT to Marsh Creek), S-H11 (UNT to Marsh Creek)		POND / LAKE NAME:	Pond H3 (Marsh Creek Reservoir)	WETLAND NAME:	WL-H17 (PEM, PFO)	
DEP PERMIT Nos. (102 AND 105)	E&S Permit # ESG0100015001, Water Obstruction Permit E15-862						
CORPS PERMIT NO.	PASPGP-5 (issued April 12, 2017)						
IR TRACKING ID:	PPP6_PA-CH-0100.0000-RD_MilfordRd_IRInterim_36_042121						
IS AUGUST 8, 2017 ORDER APPLICABLE?	YES	LISTED

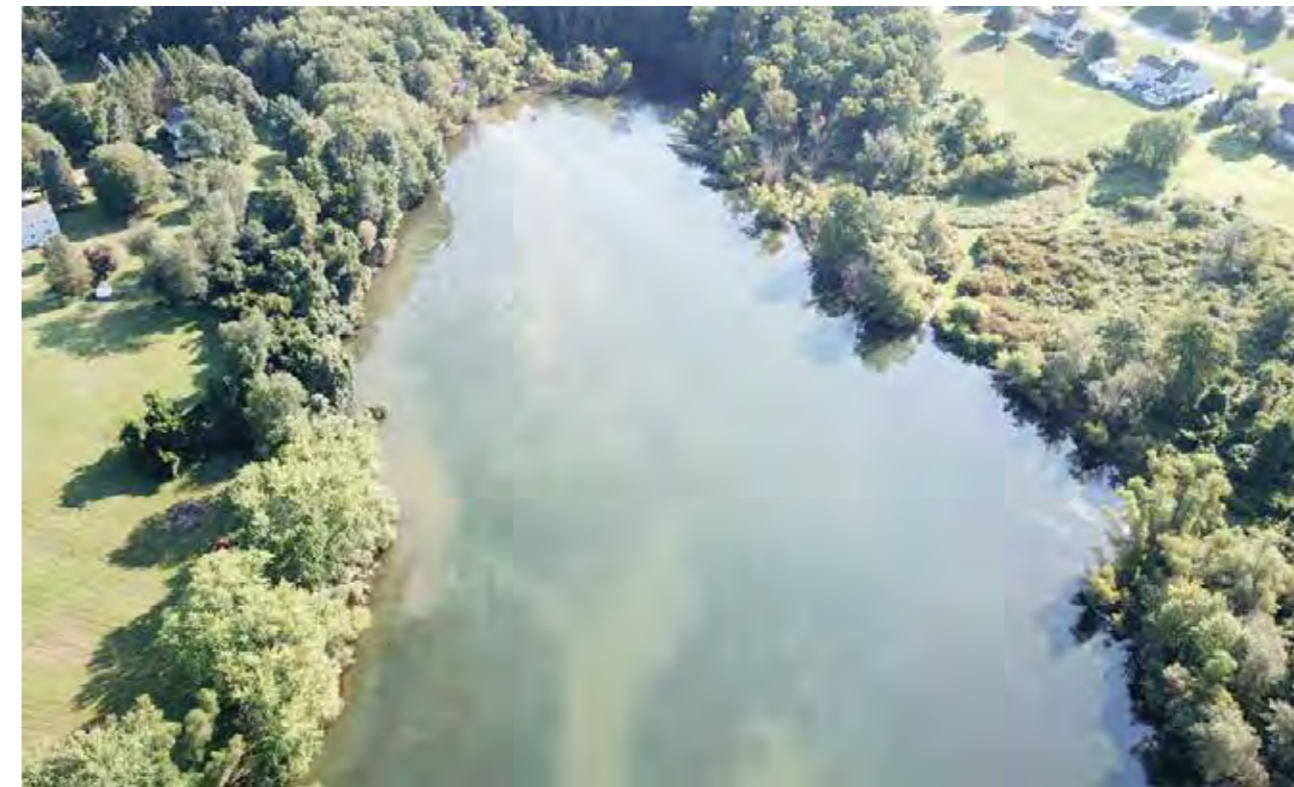
8/17/2020

View of pond H3 (Marsh Creek Reservoir).

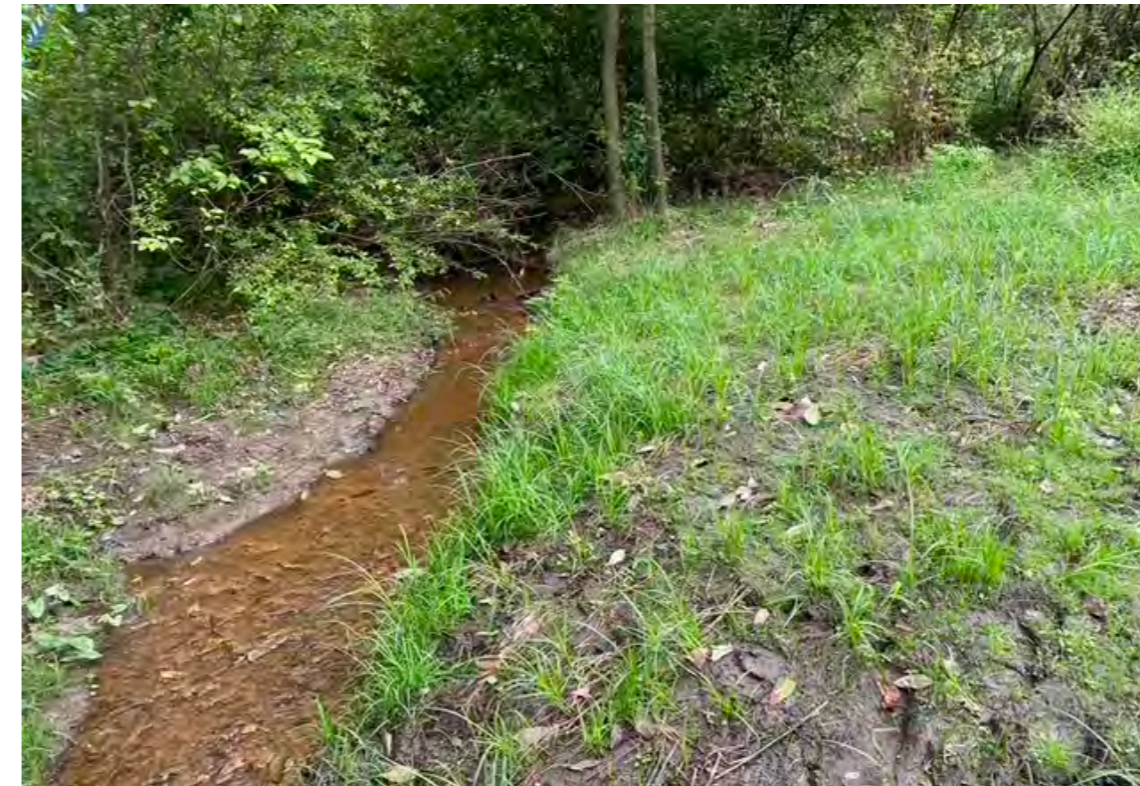
9/14/2020

View of stream S-H10 (UNT to Marsh Creek)

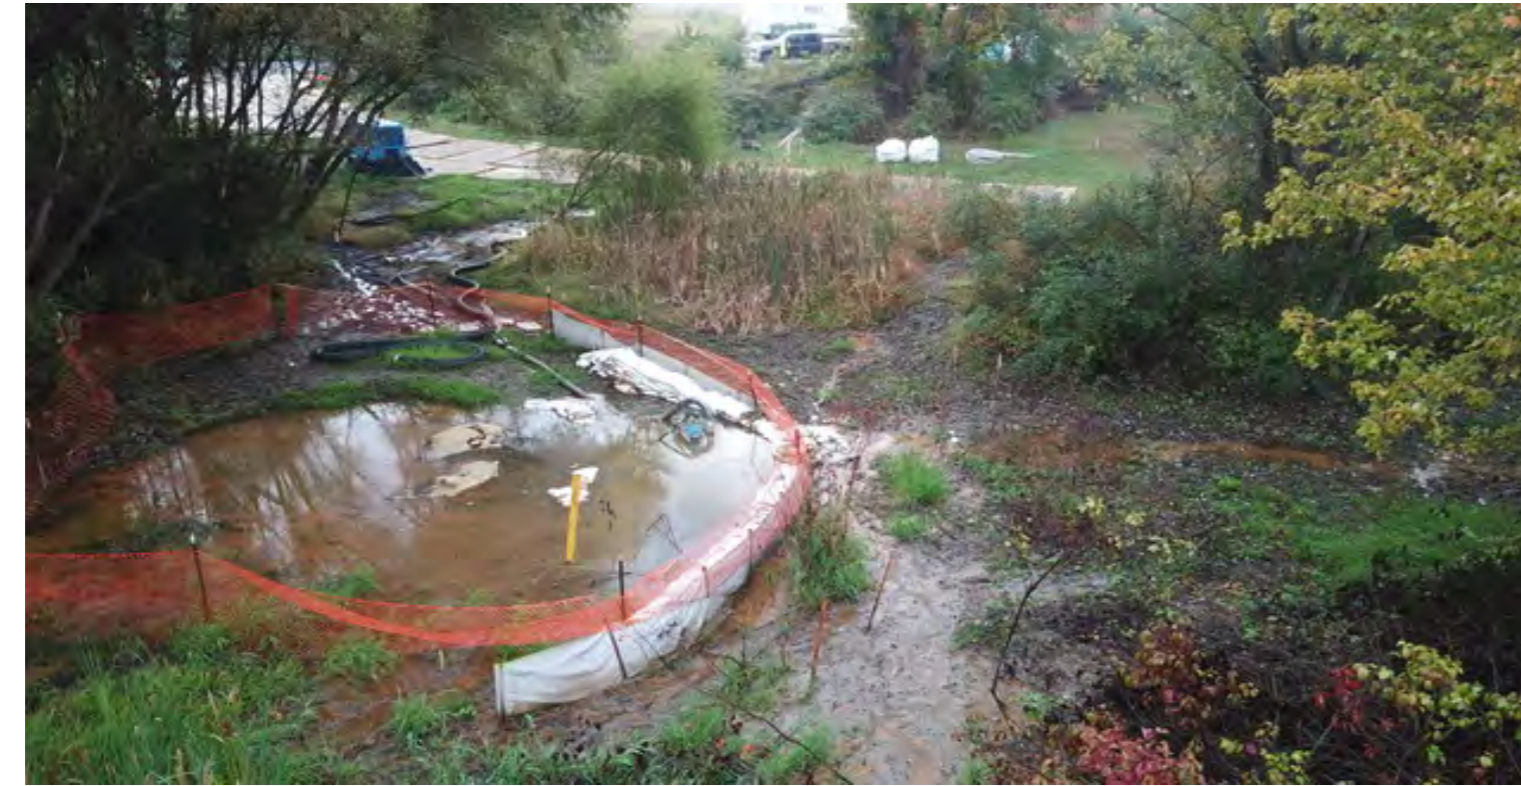
10/5/2020

View of IR release location and containment within WL-H17.

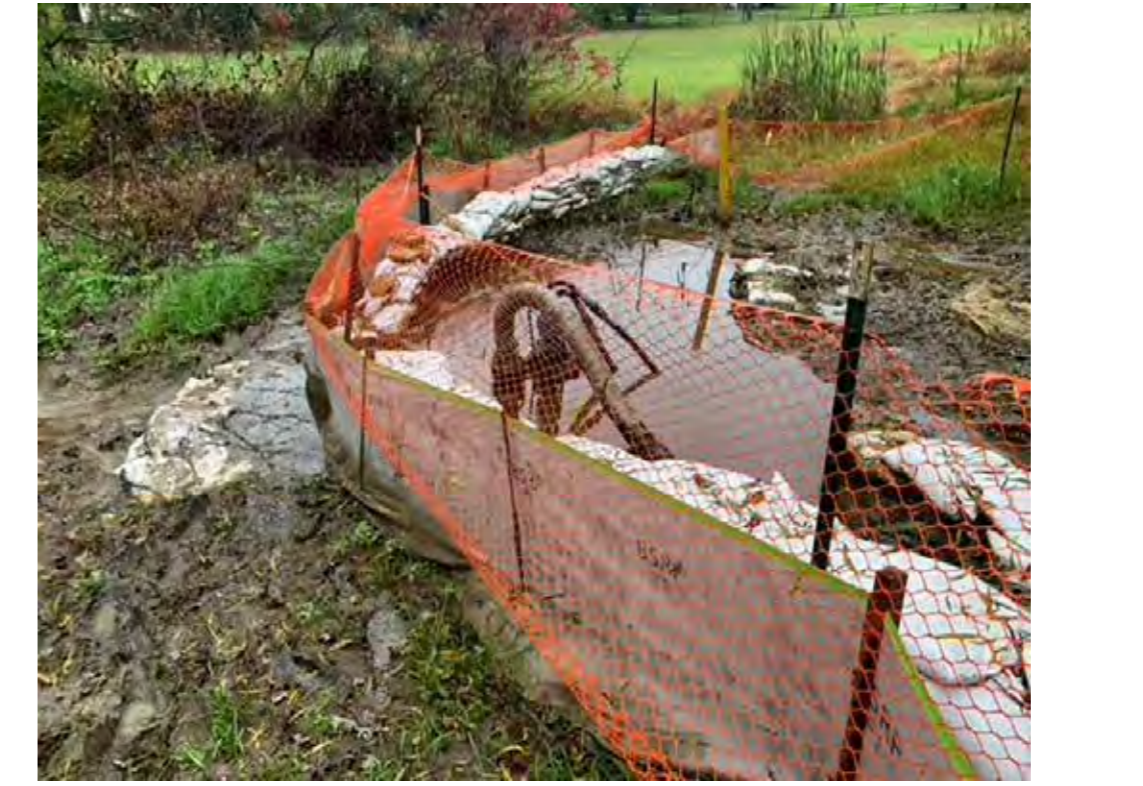
10/12/2020

View of IR release location and containment within WL-H17.

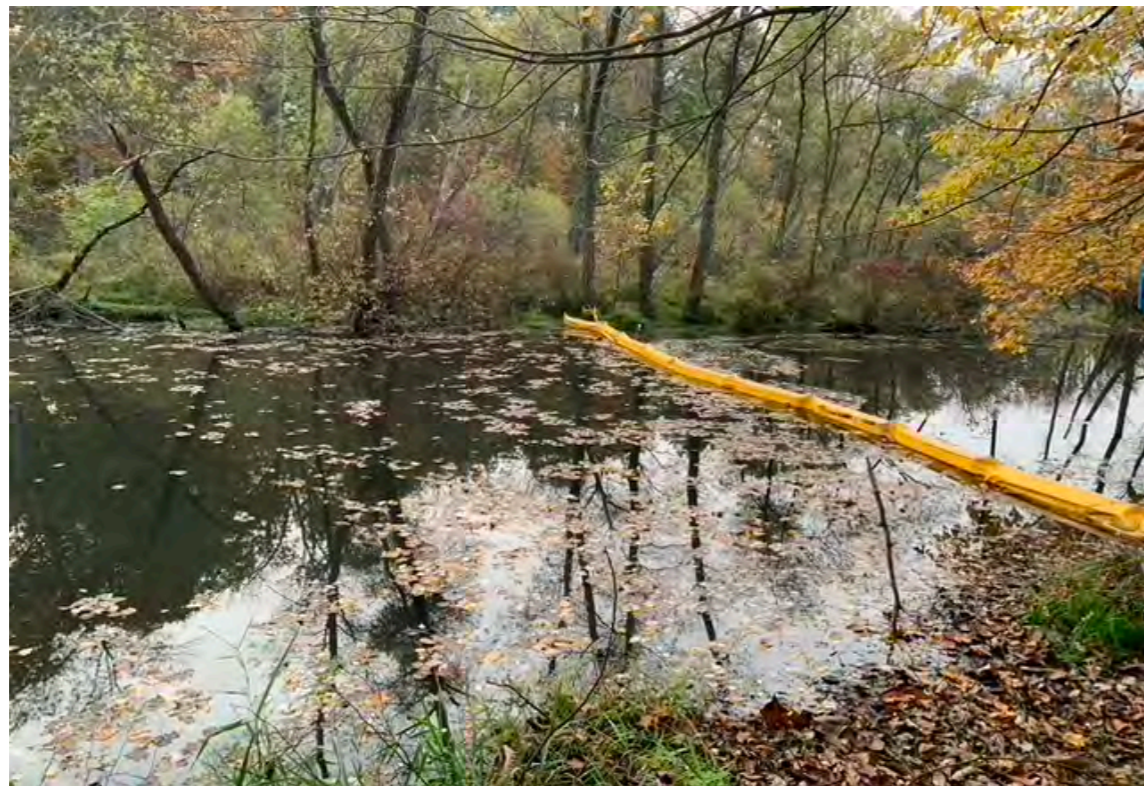
10/19/2020

View of turbidity curtain at the confluence of stream S-H10 (UNT to Marsh Creek) and pond H3 (Marsh Creek Reservoir).

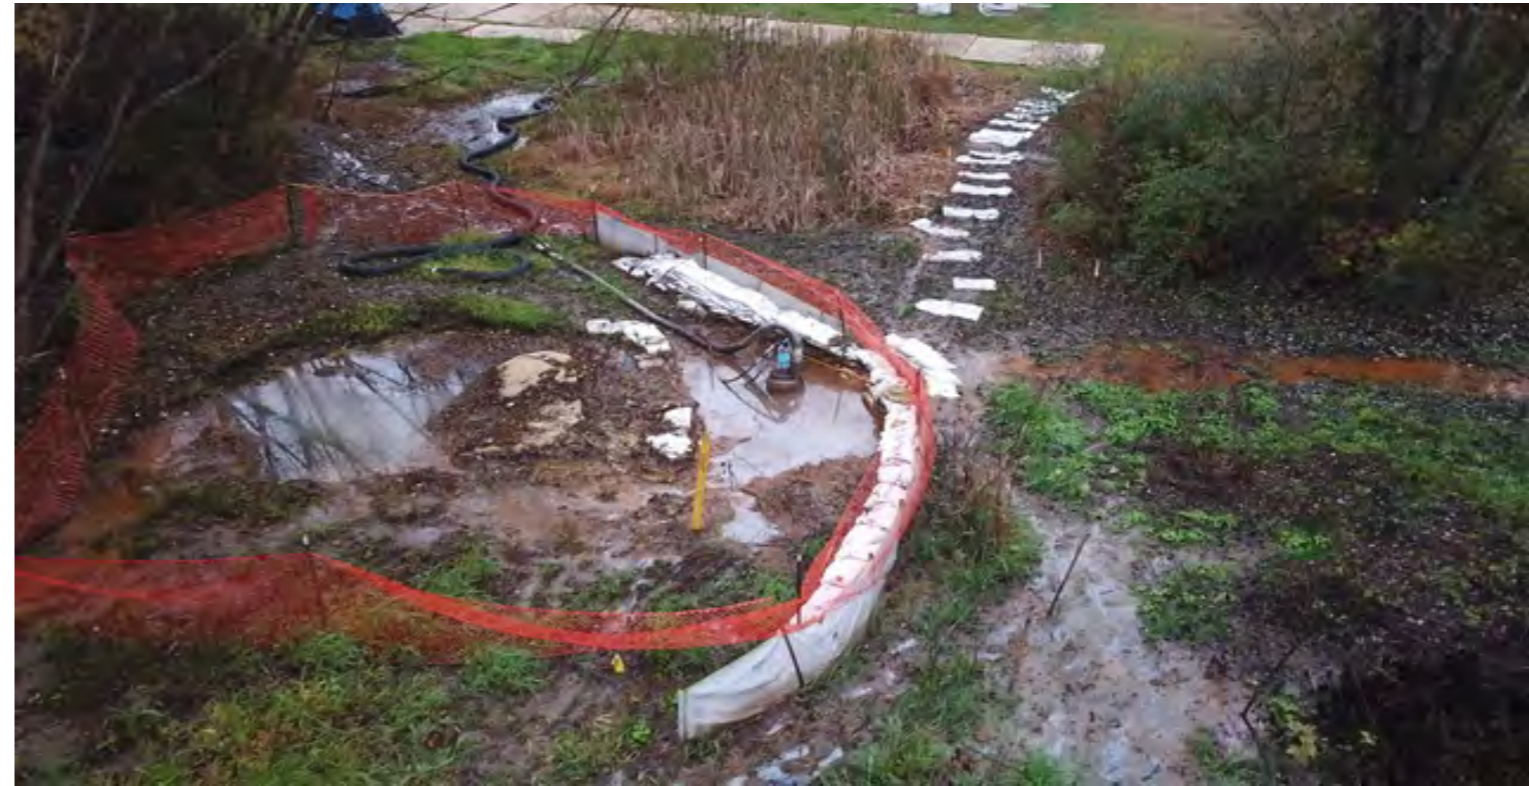
10/26/2020

View of IR release location and containment within WL-H17.

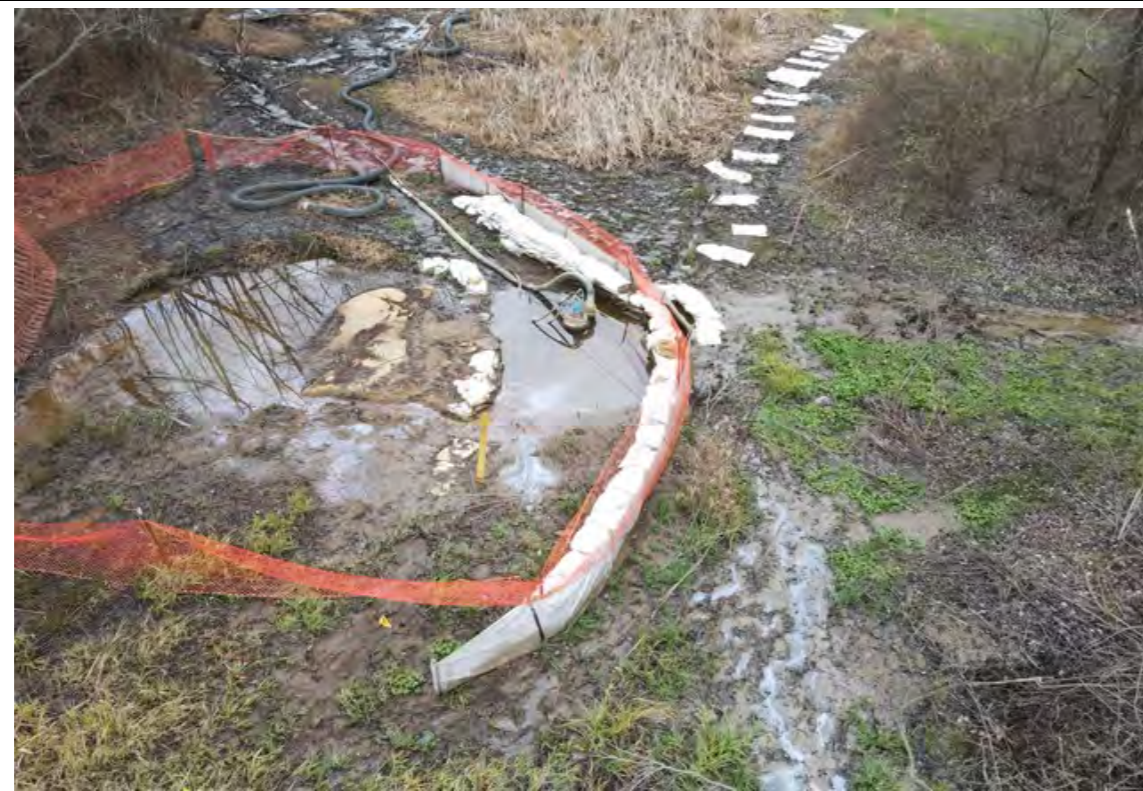
12/1/2020

View of IR release location and containment within WL-H17.

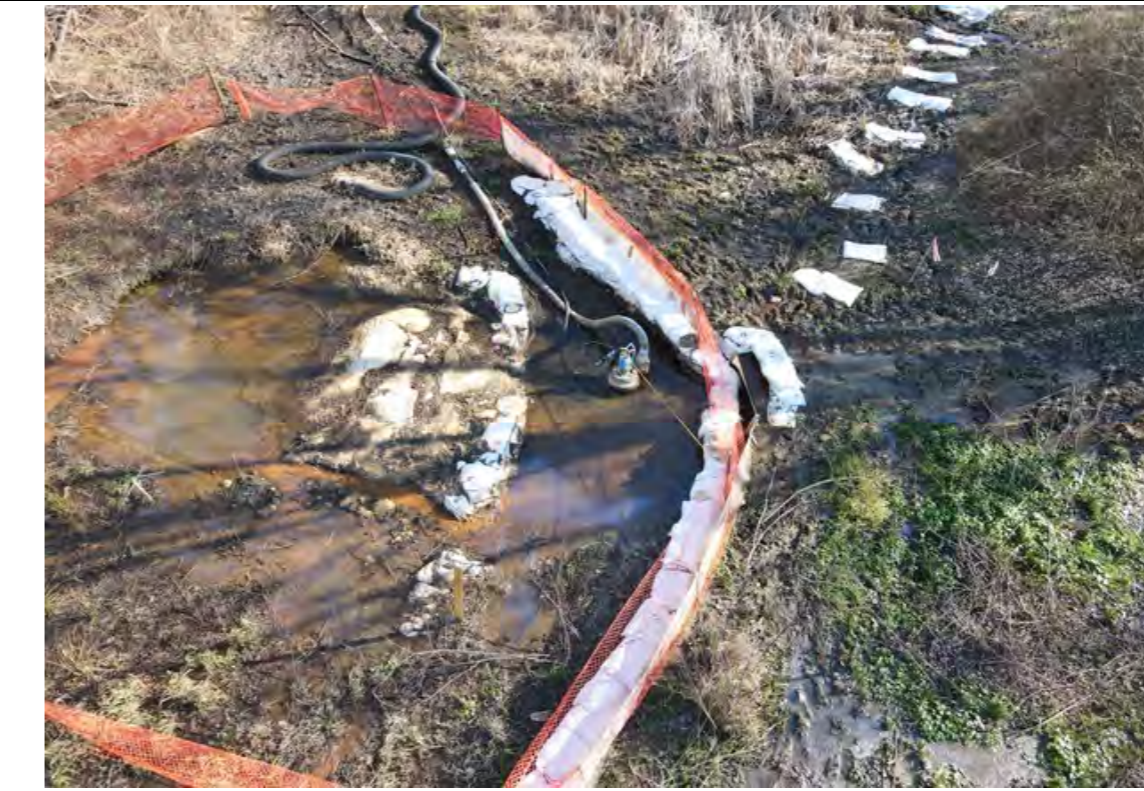
12/8/2020

View of IR release location and containment within WL-H17.

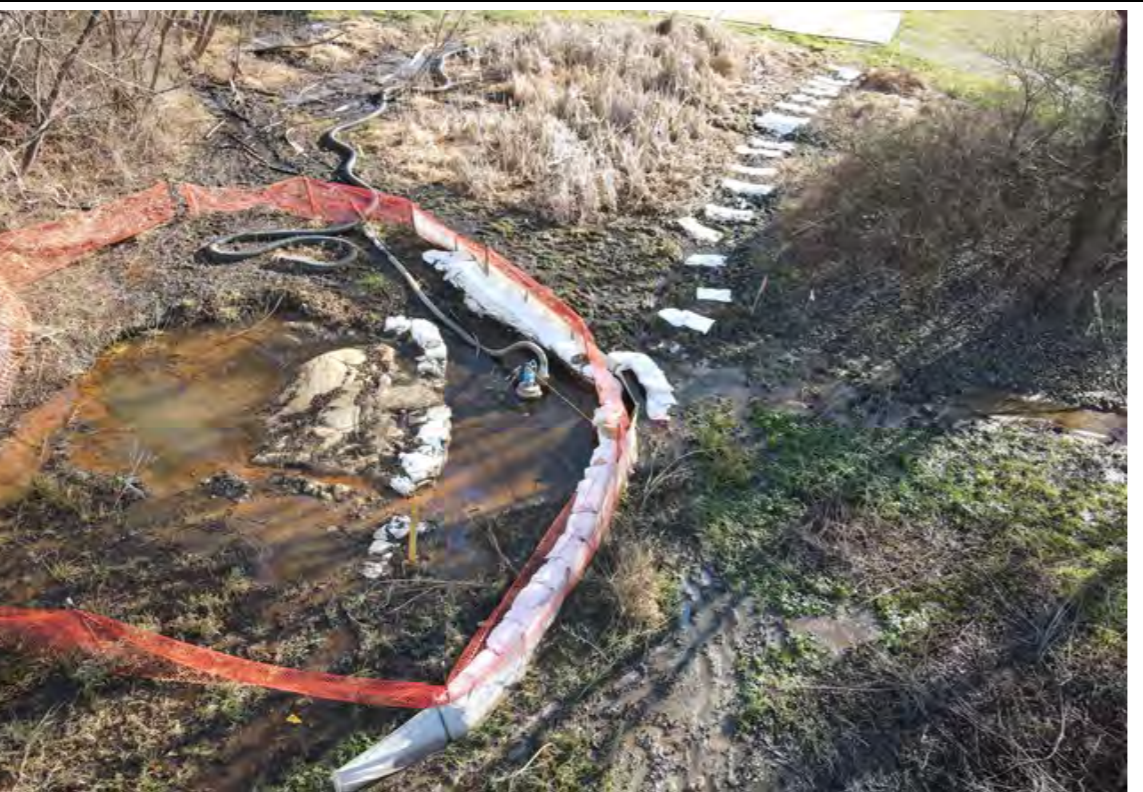
12/15/2020

View of IR release location and containment within WL-H17.

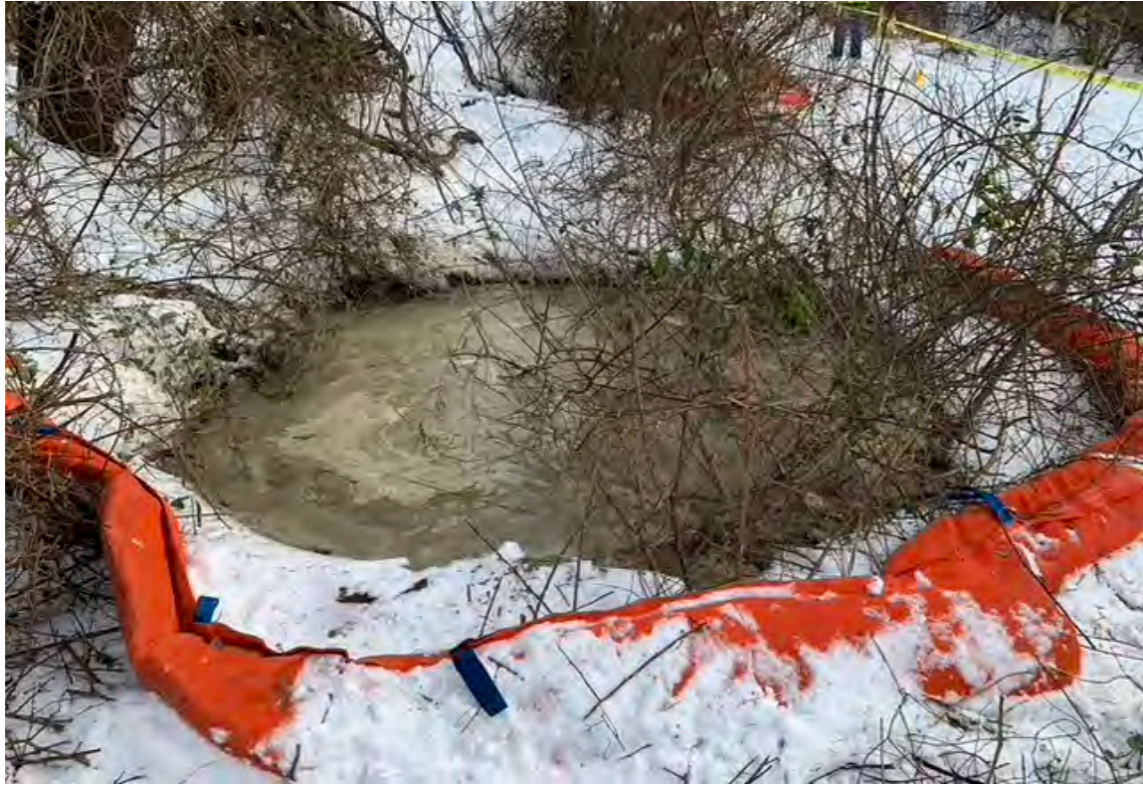
12/19/2020

View of earth feature two filled with 28 cubic yards of flowable fill.

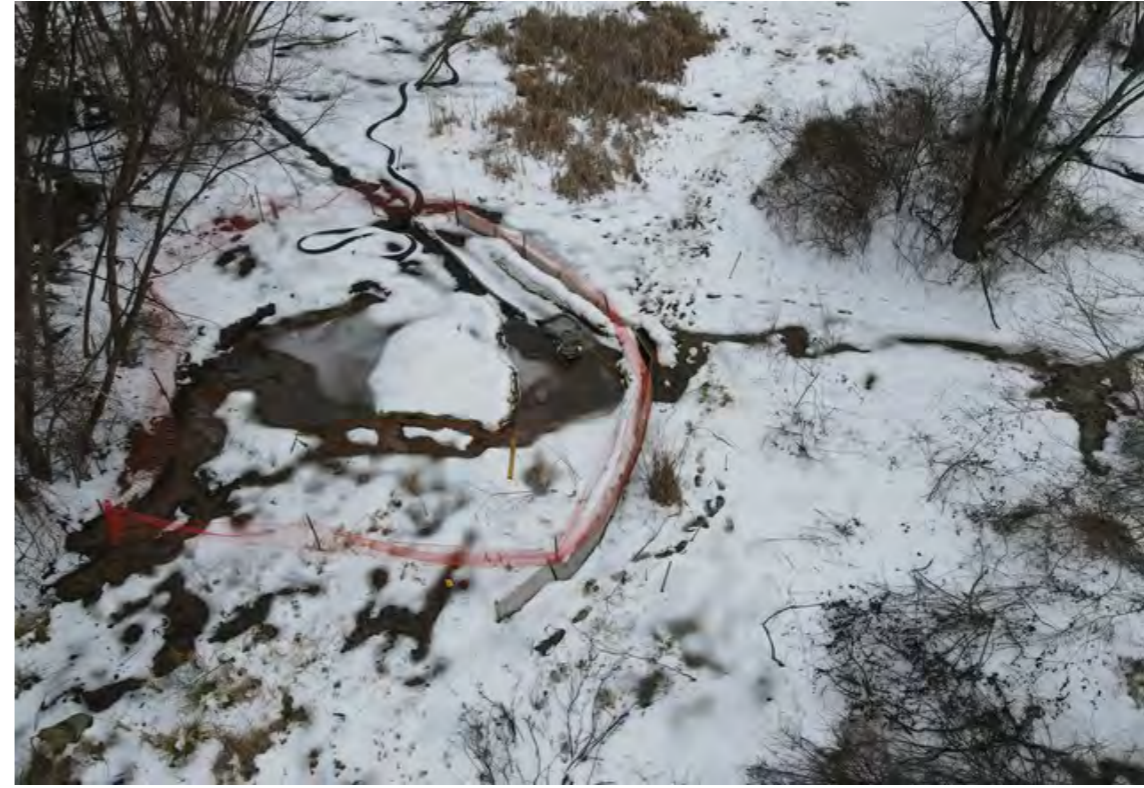
12/21/2020

View of IR release location and containment within WL-H17.

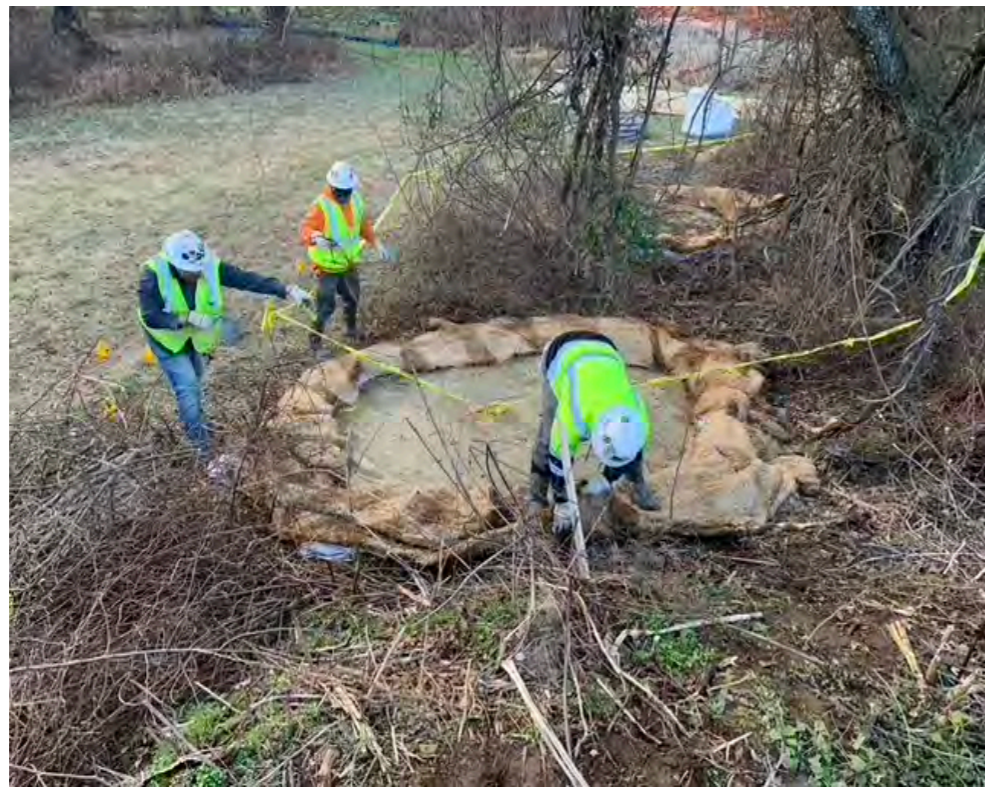
12/28/2020

View of contractor crew members installing erosion control blanket to stabilize earth feature locations.

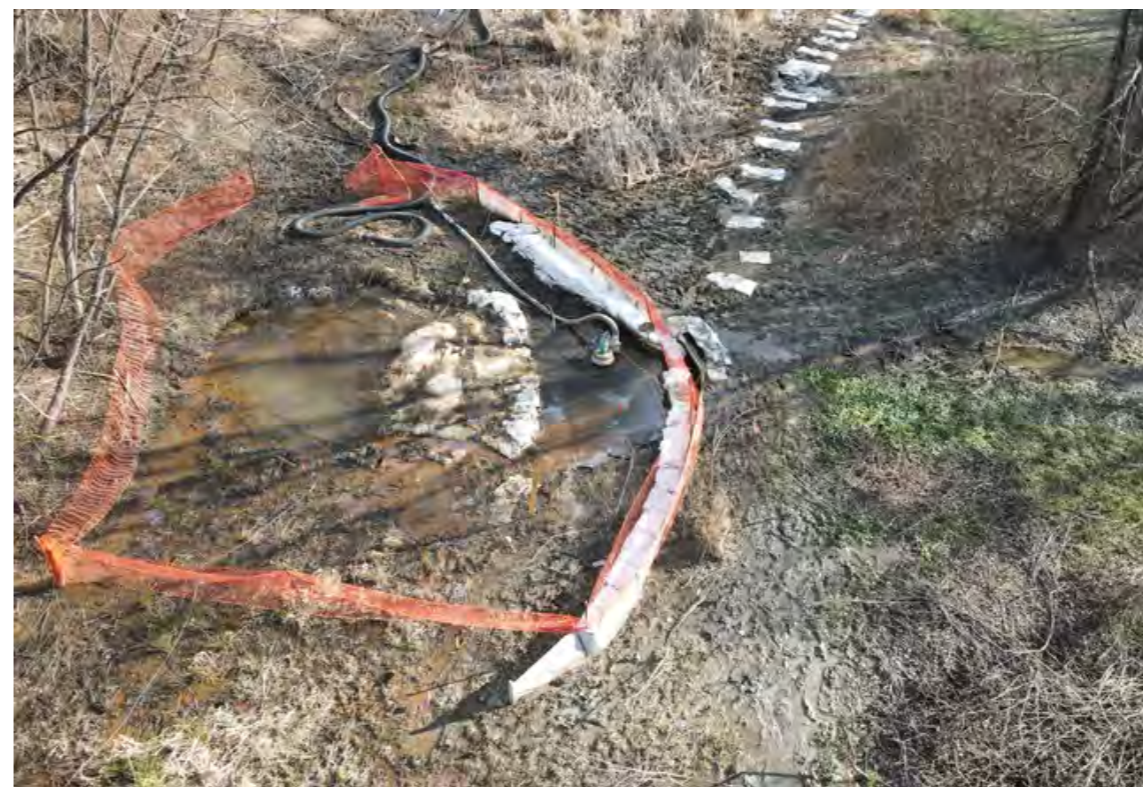
12/29/2020

View of IR release location and containment within WL-H17.

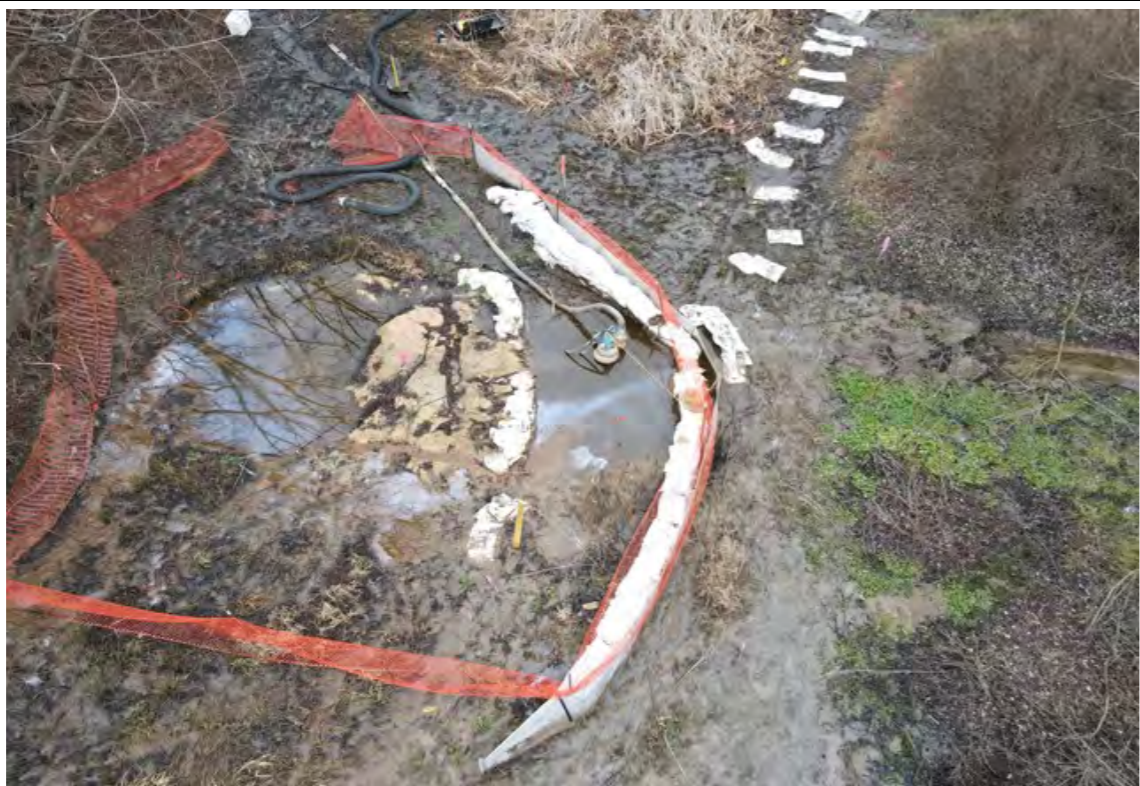
1/5/2021

View of IR release location and containment within WL-H17.

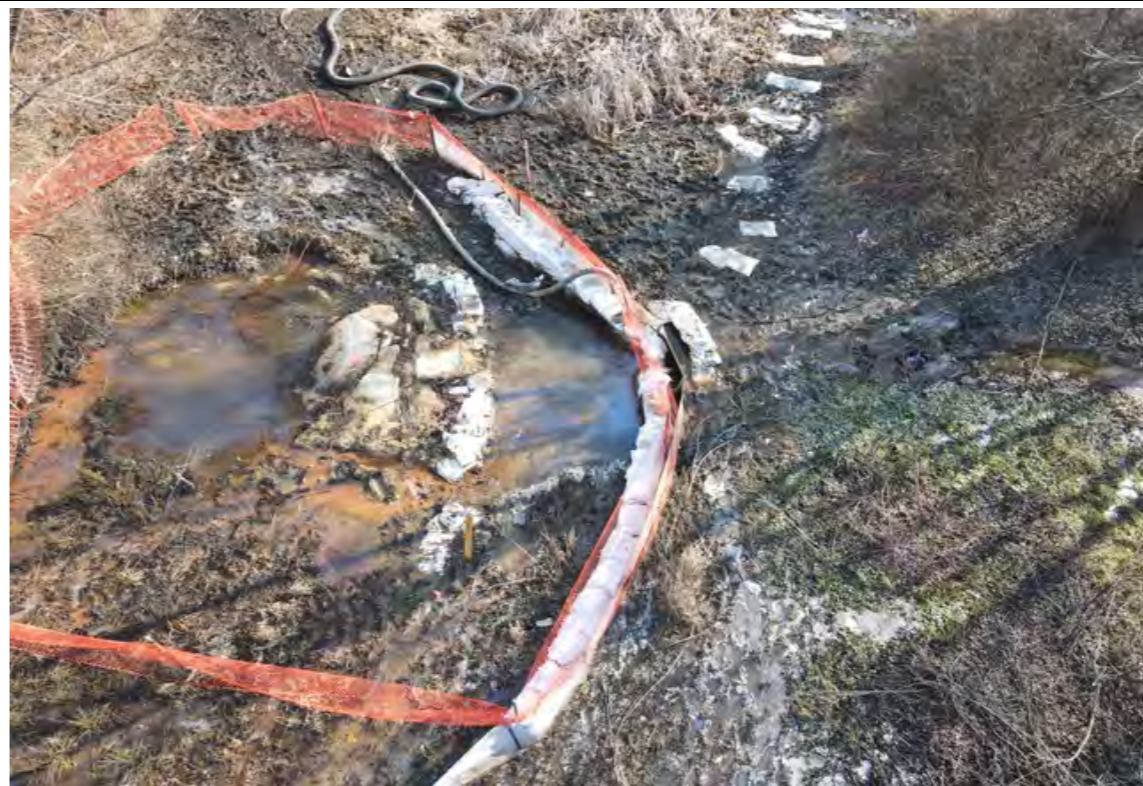
1/12/2021

View of IR release location and containment within WL-H17.

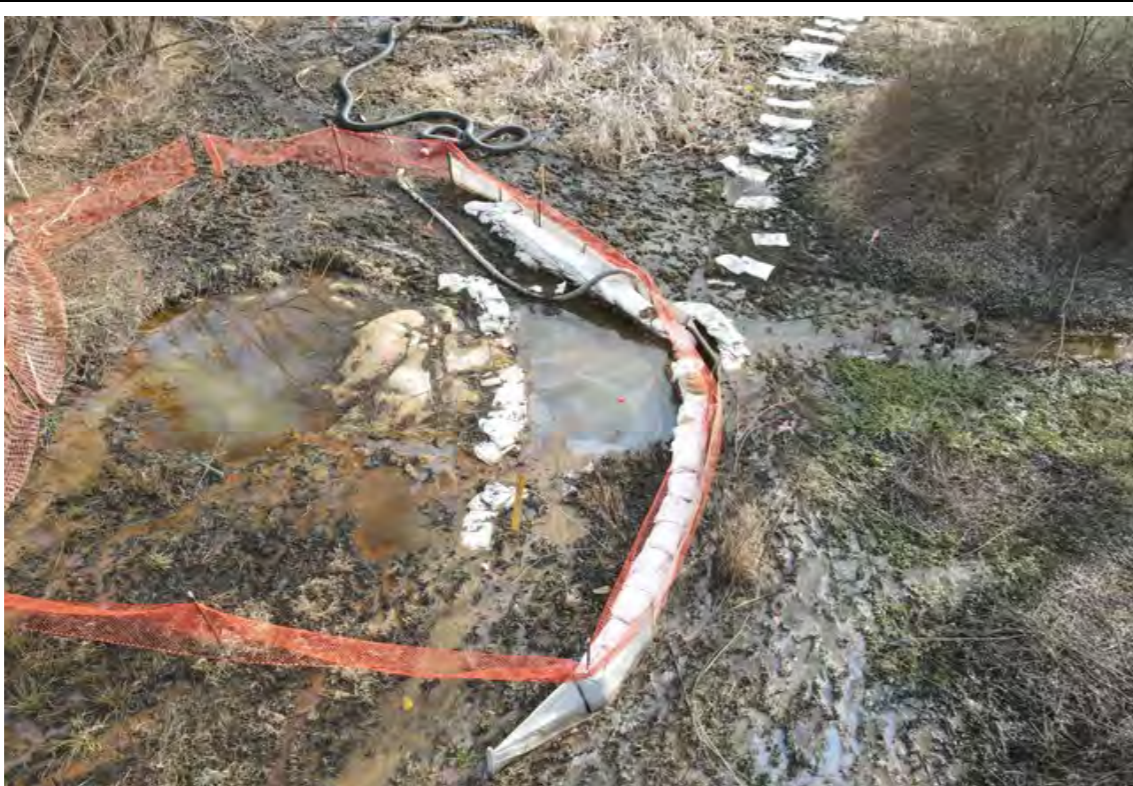
1/19/2021

View of IR release location and containment within WL-H17.

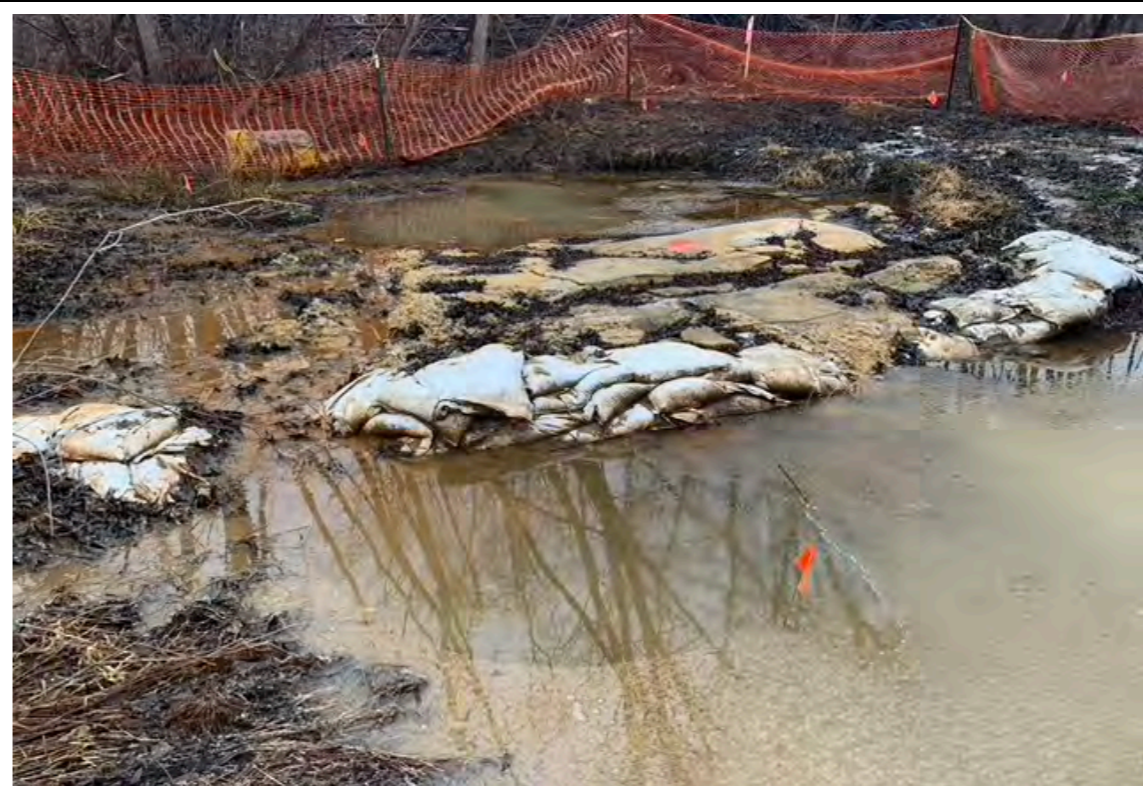
1/26/2021

View of IR release location and containment within WL-H17.

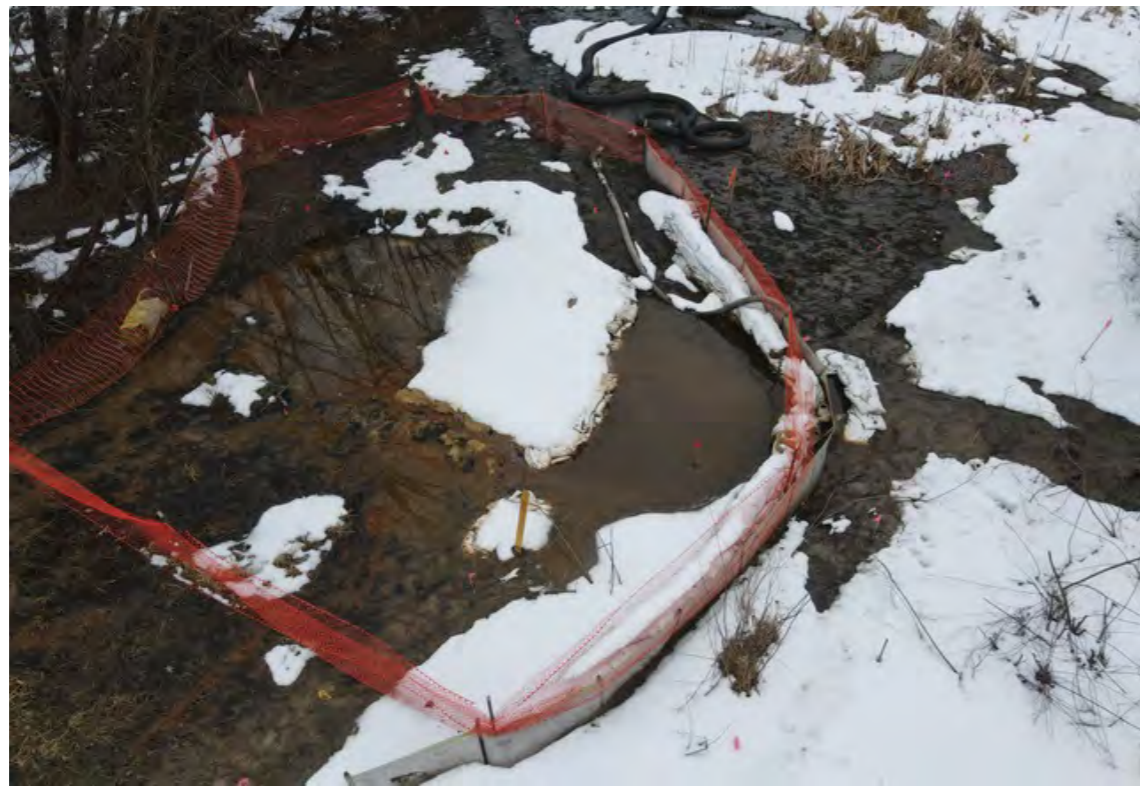
2/16/2021

View of IR release location and containment within WL-H17.

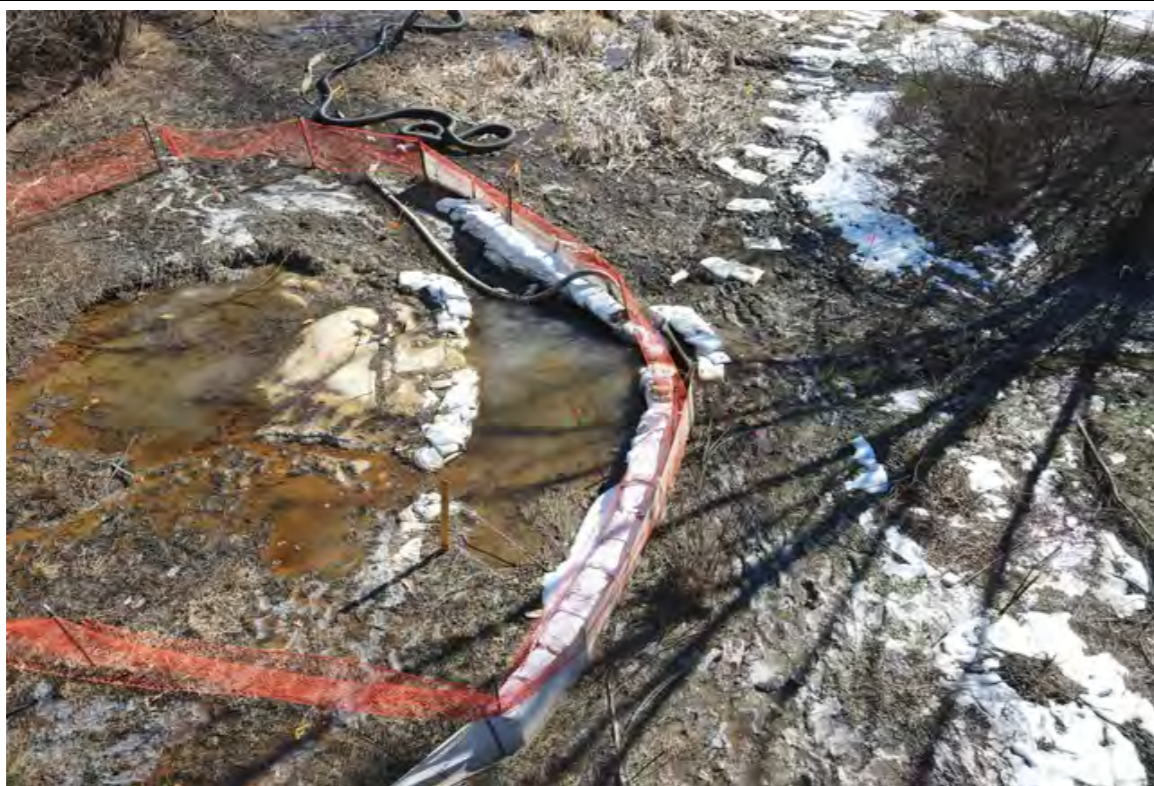
3/2/2021

View of IR release location and containment within WL-H17.

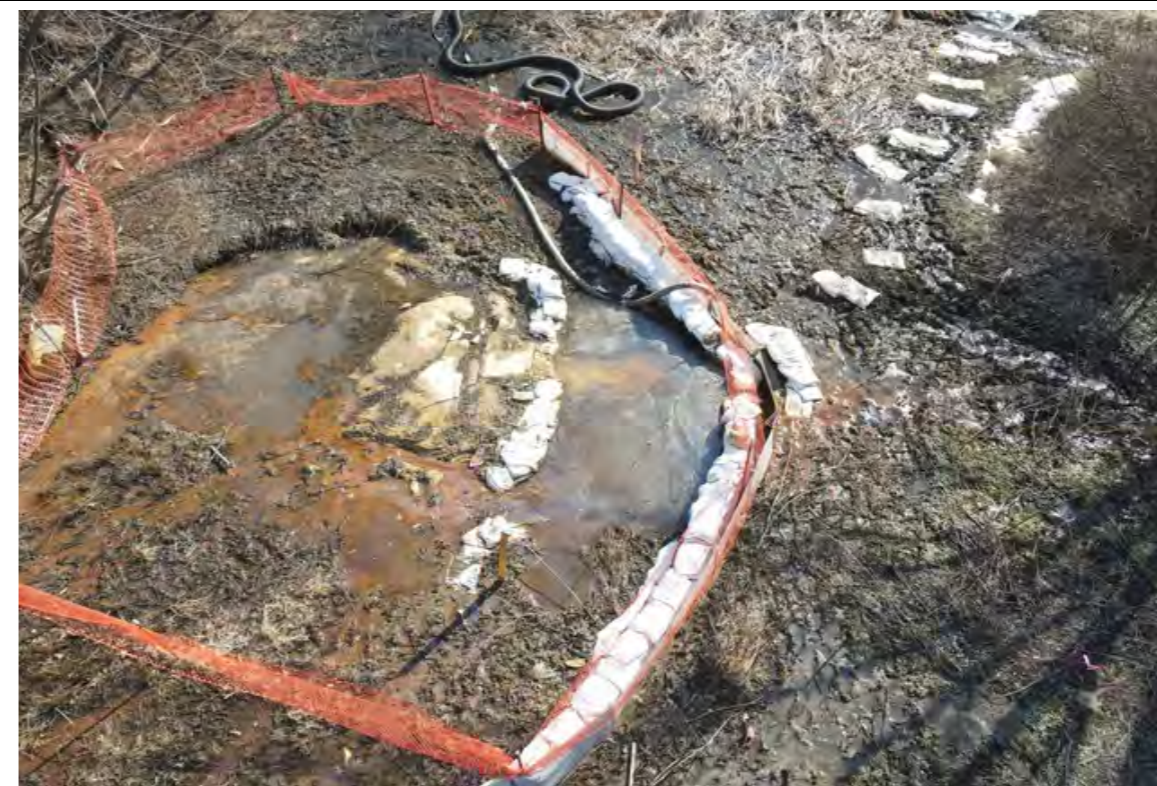
3/9/2021

View of IR release location and containment within WL-H17.

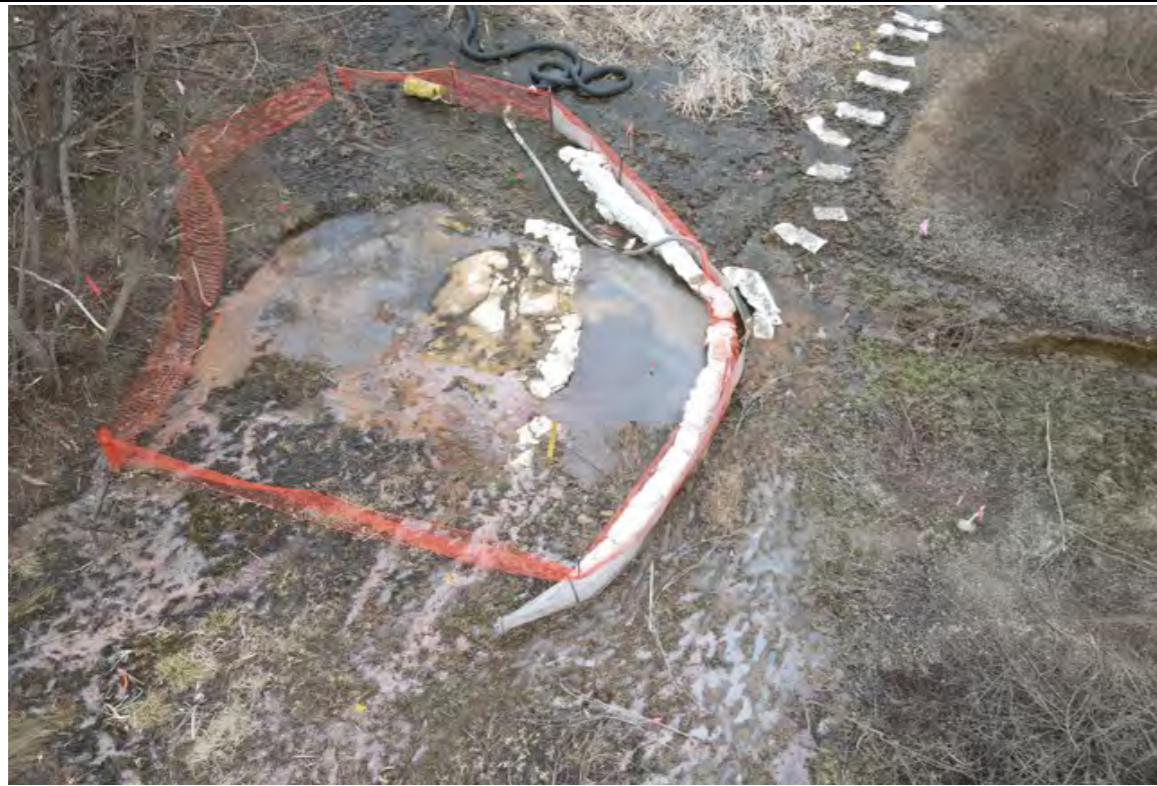
3/16/2021

View of IR release location and containment within WL-H17.

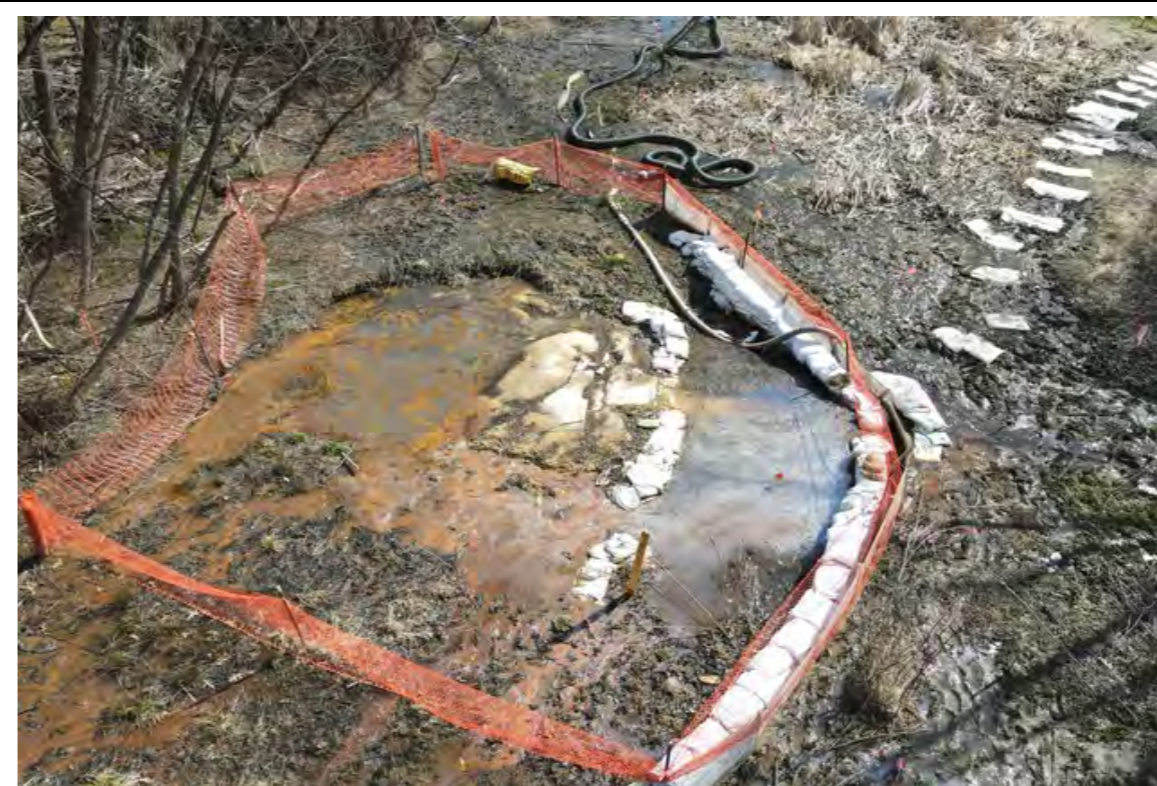
3/23/2021

View of IR release location and containment within WL-H17.

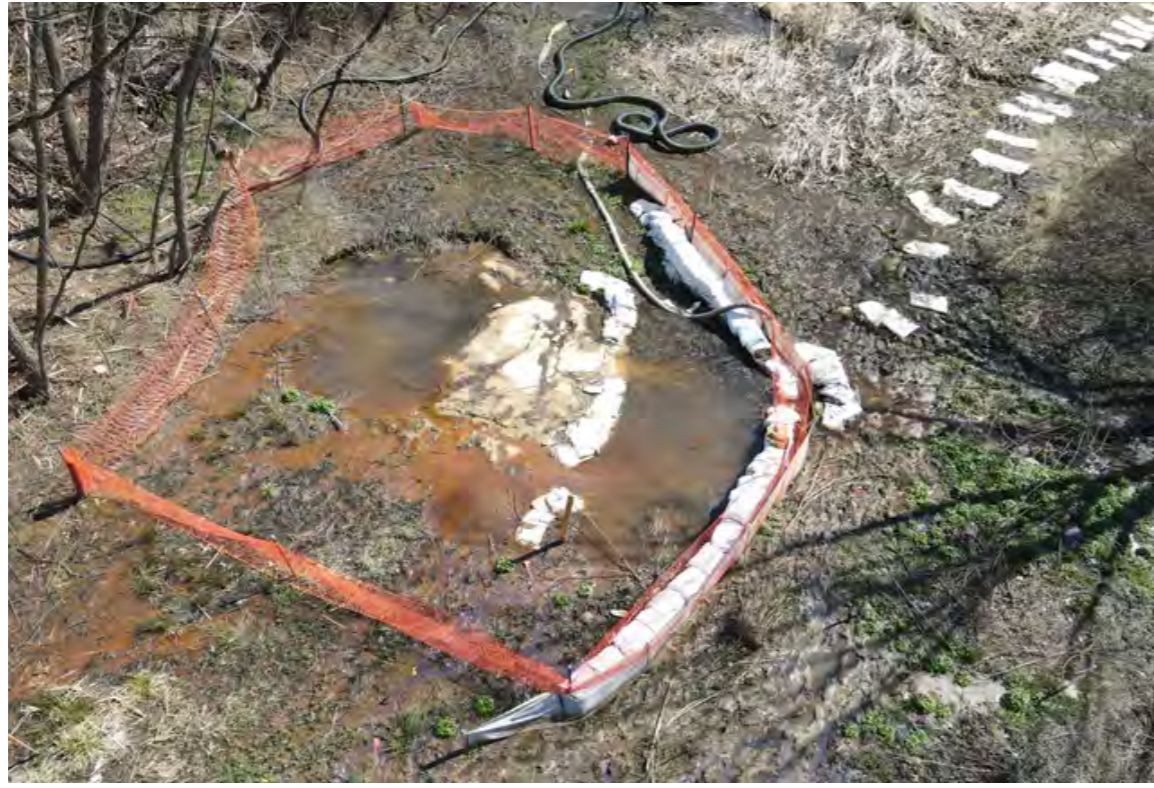
3/30/2021

View of IR release location and containment within WL-H17.

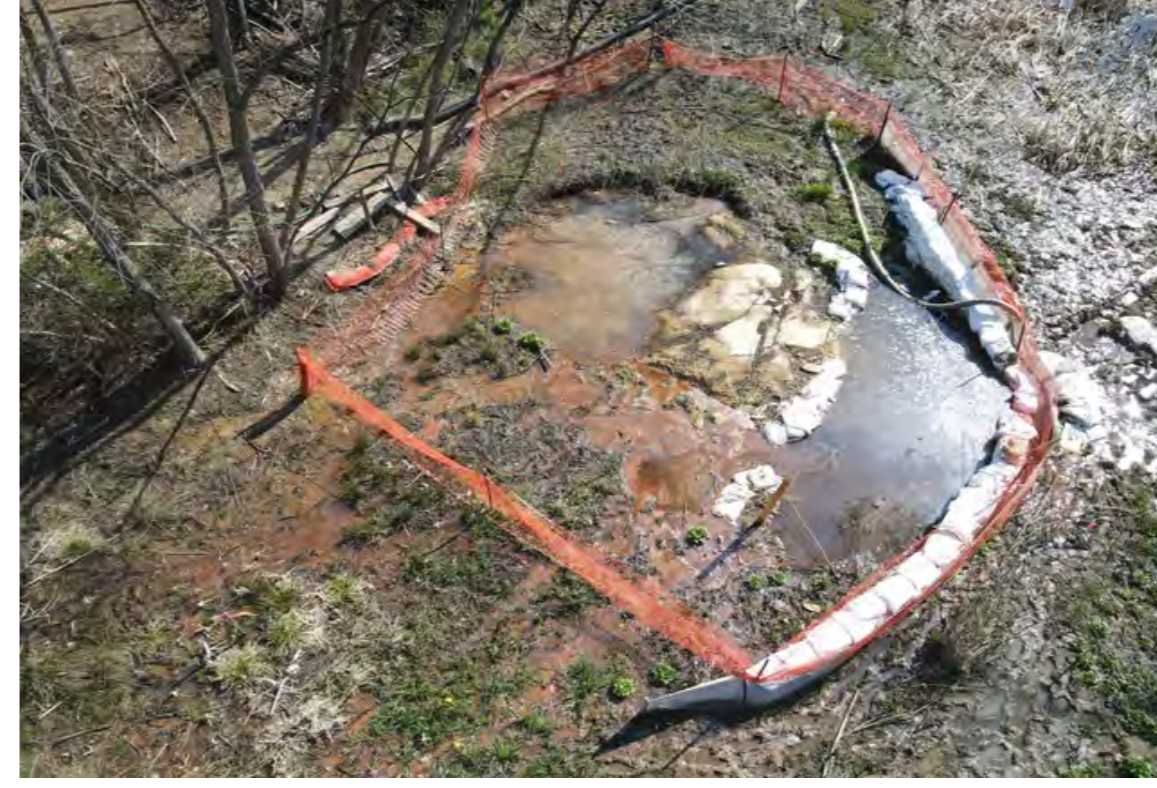
4/6/2021

View of IR release location and containment within WL-H17.
