If Interim report, Subject to Change as Additional Information Becomes Available
If Interim Report, this Report is cumulative, containing information from previous reports in addition to new information and may change
SPLP PENNSYLVANIA PIPELINE PROJECT
HORIZONTAL DIRECTIONAL DRILLING – INADVERTENT RETURN REPORT FORM

REPORT DATE:	Current as of 4/20/2021	HDD ALIGNMENT #	PA-CH-100.0000-RD				
PROJECT SITE:	PPP 6 - S3-0290 - Milford Rd./Little Conestoga Rd		HDD COMPANY:	Michels Directional Crossing			
DATE AND TIME WHEN IR WAS INITIALLY DISCOVERED			DATE:	8/10/2020	TIME:	1530	
LOCATION: STREET	427-423 Green Valley Rd, Downingtown, PA 19335		MUNICIPALITY:	Upper Uwchlan	COUNTY:	Chester	
LATITUDE:	40.0794	LONGITUDE:	-75.7104	FROM STATION:	14824+00	TO STATION	14824+00
STREAM NAME:	S-H10 (UNT to Marsh Creek), S-H11 (UNT to Marsh Creek)		POND / LAKE NAME:	Pond H3 (Marsh Creek Reservoir)	WETLAND NAME:	WL-H17 (PEM, PFO)	
DEP PERMIT Nos. (102 AND 105)	E&S Permit # ESG0100015001, Water Obstruction Permit E15-862						
CORPS PERMIT NO.	PASPGP-5 (issued April 12, 2017)						
IR TRACKING ID:	PPP6_PA-CH-0100.0000-RD_MilfordRd_IRInterim_36_042121						
IS AUGUST 8, 2017 ORDER APPLICABLE?	YES	LISTED

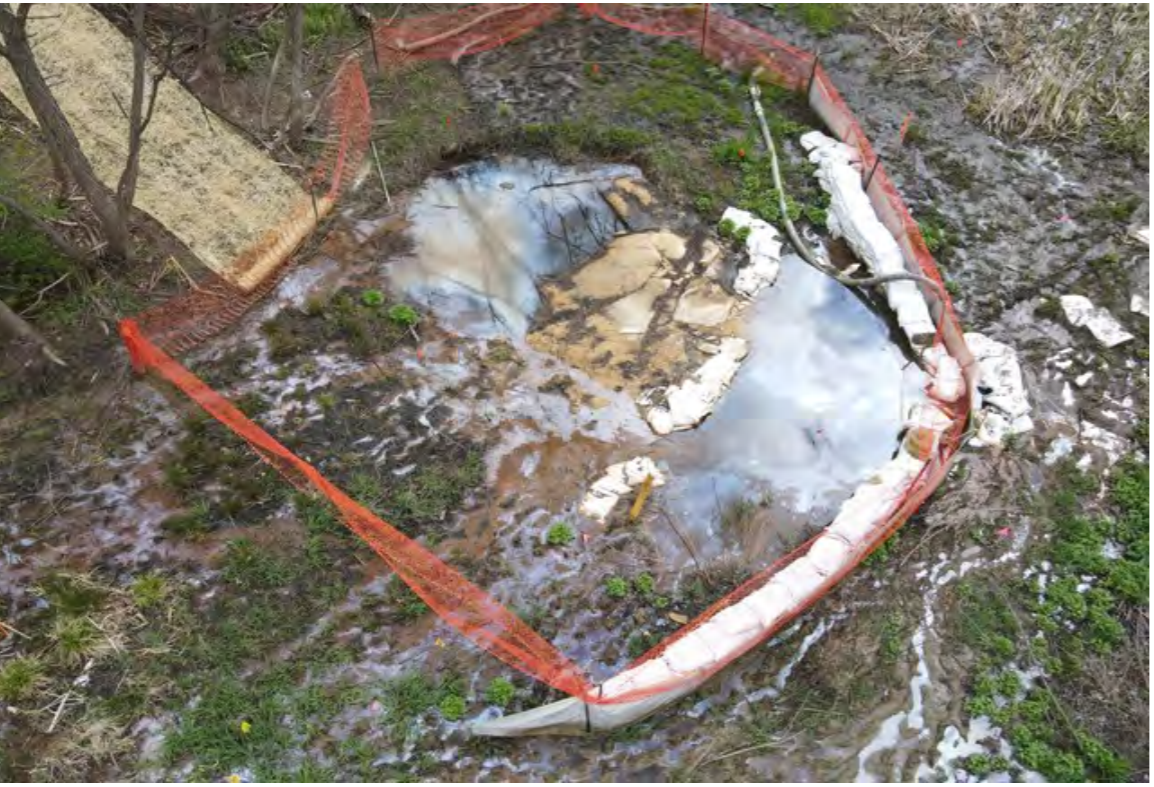
4/13/2021

View of IR release location and containment within WL-H17.

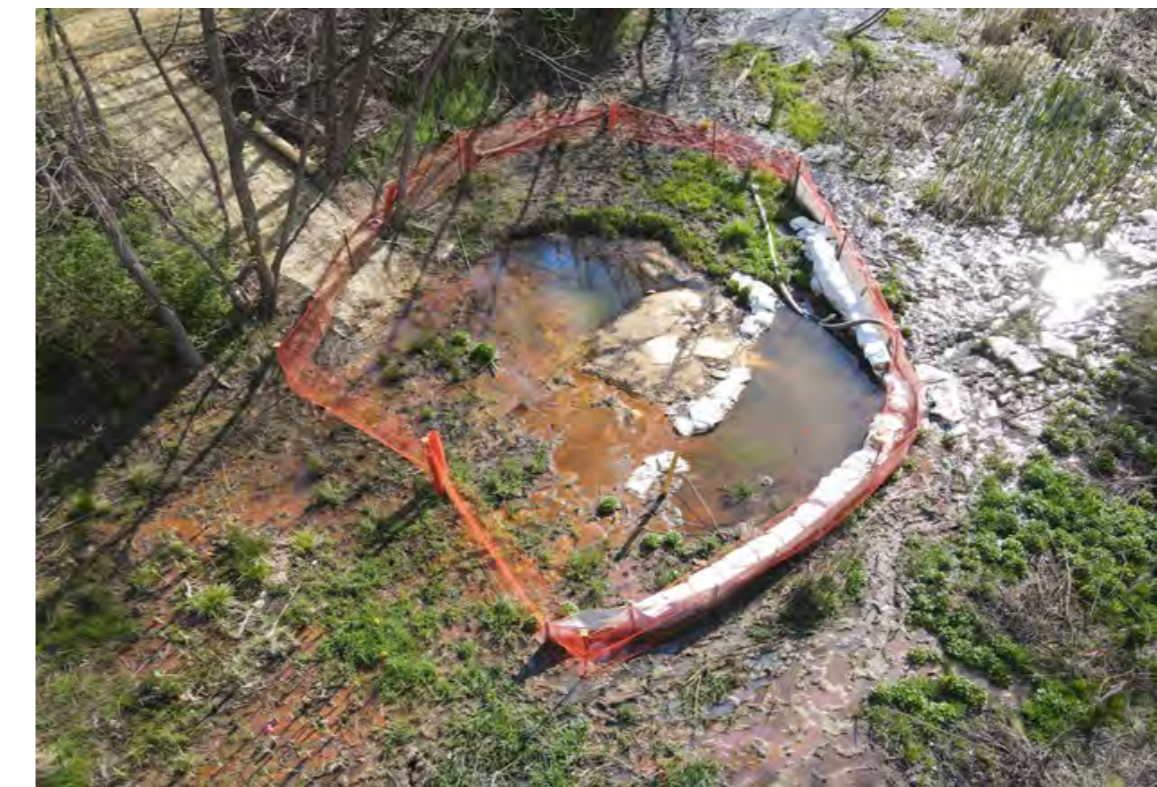
4/20/2021

View of IR release location and containment within WL-H17.
