**If Interim report, Subject to Change as Additional Information Becomes Available**  
**If Interim Report, this Report is cumulative, containing information from previous reports in addition to new information and may change**  
**SPLP PENNSYLVANIA PIPELINE PROJECT**  
**HORIZONTAL DIRECTIONAL DRILLING – INADVERTENT RETURN REPORT FORM**

<b>REPORT DATE:</b>	Current as of 9/7/2020		<b>HDD ALIGNMENT #</b>	PA-CH-100.0000-RD		
<b>PROJECT SITE:</b>	PPP 6 - S3-0290 - Milford Rd./Little Conestoga Rd		<b>HDD COMPANY:</b>	Michels Directional Crossing		
<b>DATE AND TIME WHEN IR WAS INITIALLY DISCOVERED</b>			<b>DATE:</b>	8/10/2020	<b>TIME:</b>	
<b>LOCATION: STREET</b>	427-423 Green Valley Rd, Downingtown, PA 19335		<b>MUNICIPALITY:</b>	Upper Uwchlan	<b>COUNTY:</b>	
<b>LATITUDE:</b>	40.0794	<b>LONGITUDE:</b>	-75.7104	<b>FROM STATION:</b>	14824+00	
<b>STREAM NAME:</b>	S-H10 (UNT to Marsh Creek), S-H11 (UNT to Marsh Creek)		<b>POND / LAKE NAME:</b>	Pond H3 (Marsh Creek Reservoir)	<b>WETLAND NAME:</b>	
<b>DEP PERMIT Nos. (102 AND 105)</b>	E&S Permit # ESG0100015001, Water Obstruction Permit E15-862					
<b>CORPS PERMIT NO.</b>	PASPGP-5 (issued April 12, 2017)					
<b>IR TRACKING ID:</b>	PPP6_PA

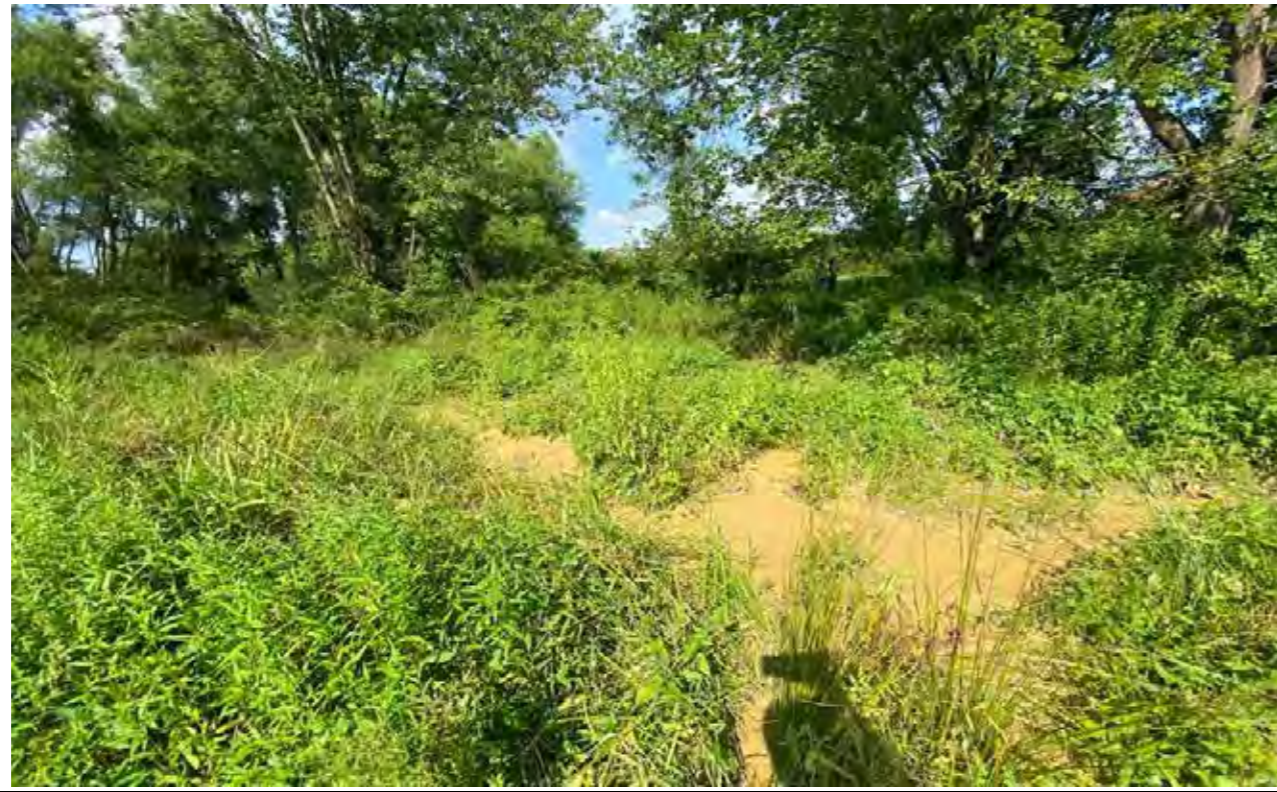
8/10/2020

View of drilling fluid within WL-H17 at location of IR release point.

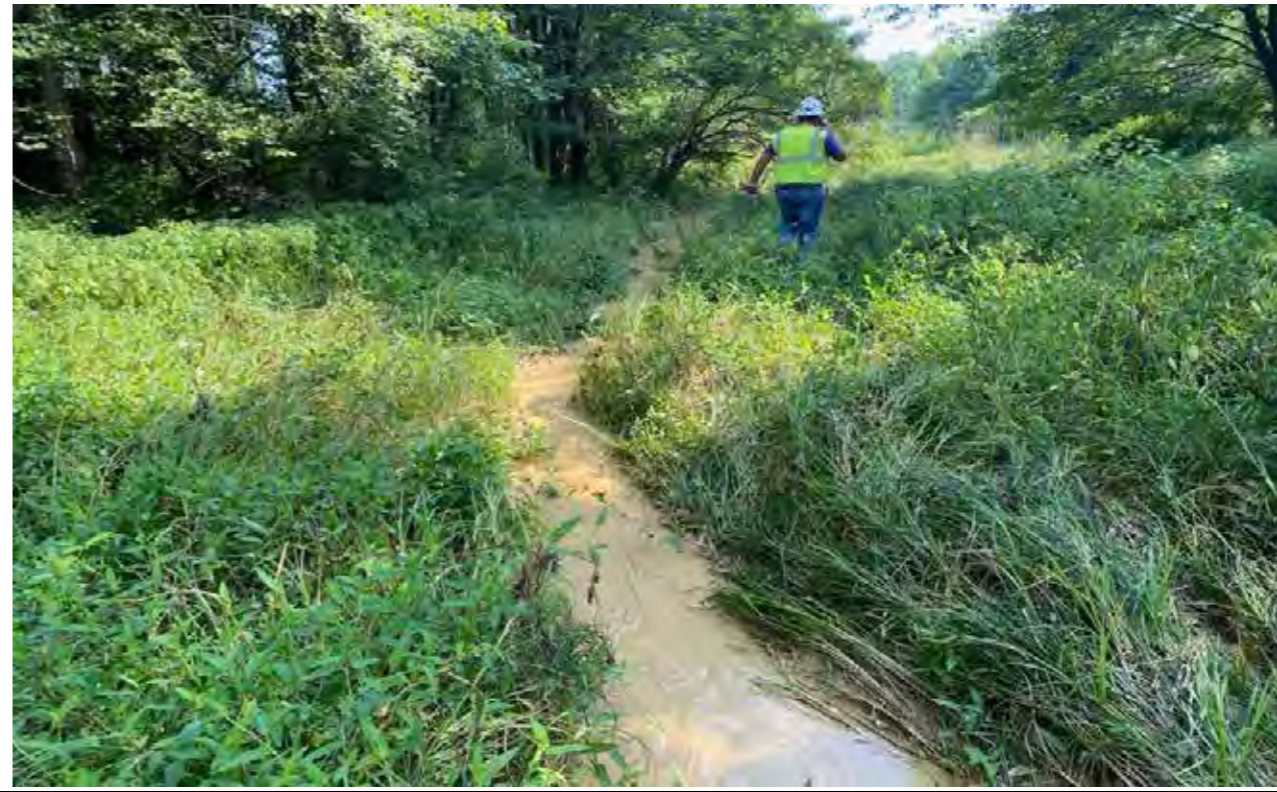
8/10/2020

View of drilling fluid flowing downstream within stream S-H10 (UNT to Marsh Creek).

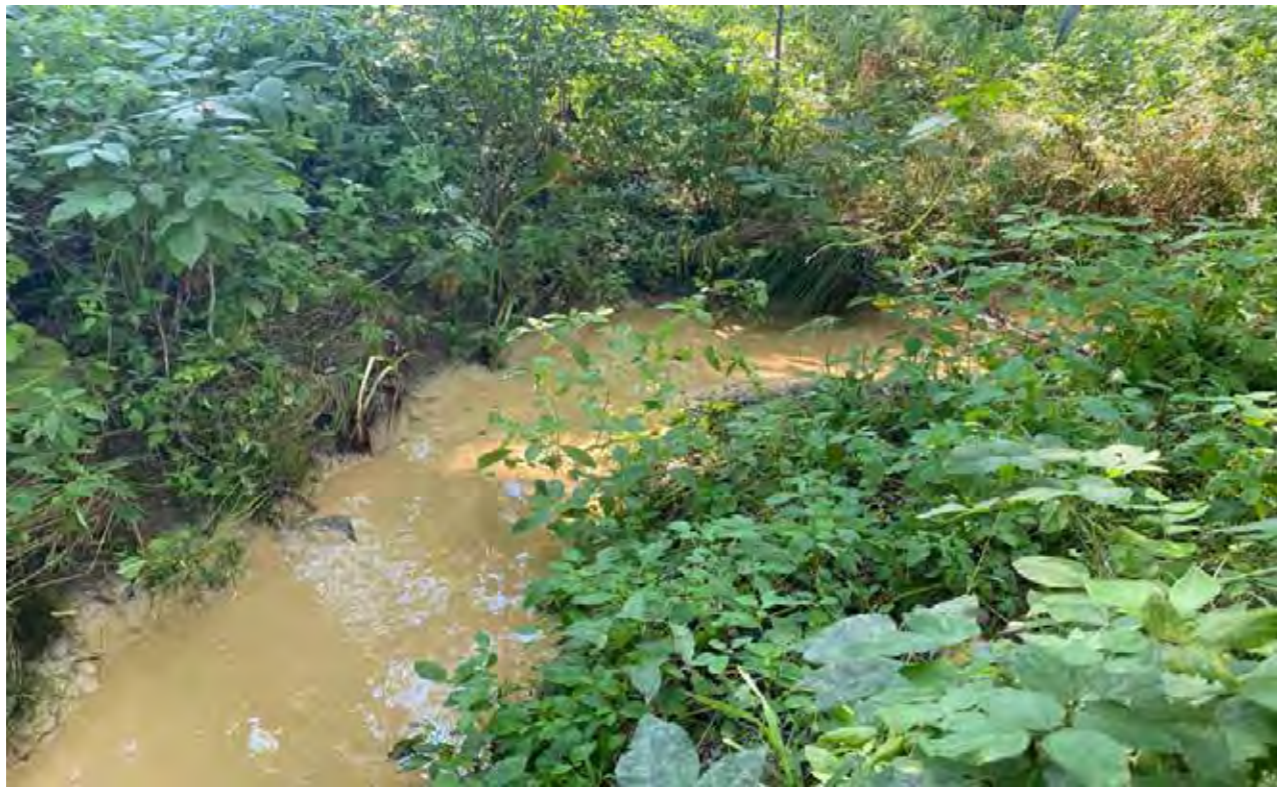
8/10/2020

View of drilling fluid within stream S-H10 (UNT to Marsh Creek).

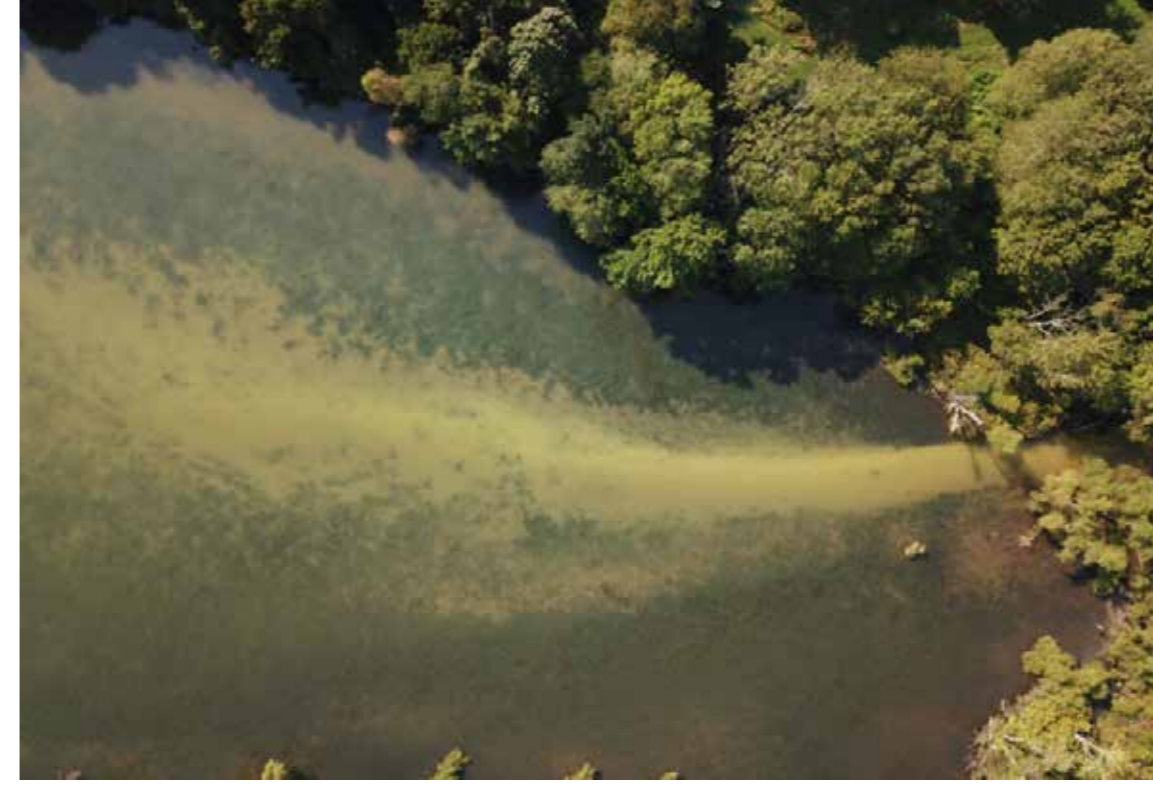
8/10/2020

View of drilling fluid entering pond H3 (Marsh Creek Reservoir).

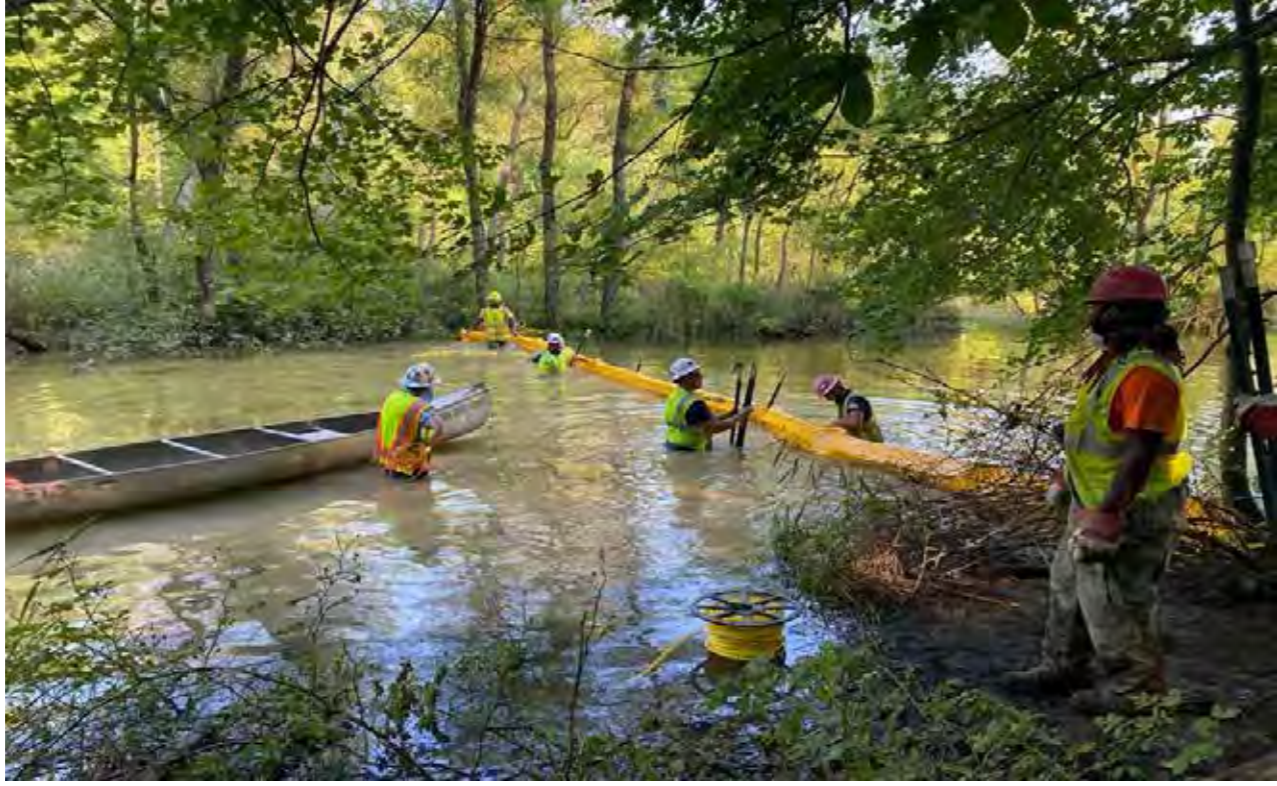
8/10/2020

View of contractor crew members installing two turbidity curtains at the confluence of stream S-H10 (UNT to Marsh Creek) and pond H3 (Marsh Creek Reservoir).

RESOURCE:	POND H3	SURFACE WATER CLASSIFICATION OR WETLAND TYPE:	HQ-TSF	WHAT STEPS HAVE BEEN TAKEN TO ELIMINATE OR MITIGATE THE IMPACTS?	Two turbidity curtains were installed at the confluence of S-H10 and pond H3.				
RESOURCE:		SURFACE WATER CLASSIFICATION OR WETLAND TYPE:		WHAT STEPS HAVE BEEN TAKEN TO ELIMINATE OR MITIGATE THE IMPACTS?					
RESOURCE:		SURFACE WATER CLASSIFICATION OR WETLAND TYPE:		WHAT STEPS HAVE BEEN TAKEN TO ELIMINATE OR MITIGATE THE IMPACTS?					
RESOURCE:		SURFACE WATER CLASSIFICATION OR WETLAND TYPE:		WHAT STEPS HAVE BEEN TAKEN TO ELIMINATE OR MITIGATE THE IMPACTS?					
ADDITIONAL INFORMATION									
IF DRILLING RESUMED DOES IT INVOLVE A CHANGE IN EQUIPMENT, DEPTH OR ALIGNMENT?	NO	NOTE:							
PUBLIC OR PRIVATE WATER SUPPLY - PROXIMITY TO DOWNSTREAM WATER INTAKES?		NOTE:							
PROXIMITY TO PUBLIC OR PRIVATE WATER SUPPLIES AND WELLS?	YES	NOTE:							
LIST AND DESCRIBE MATERIAL(S) RELEASED:	A mixture of bentonite clay and water with native cuttings

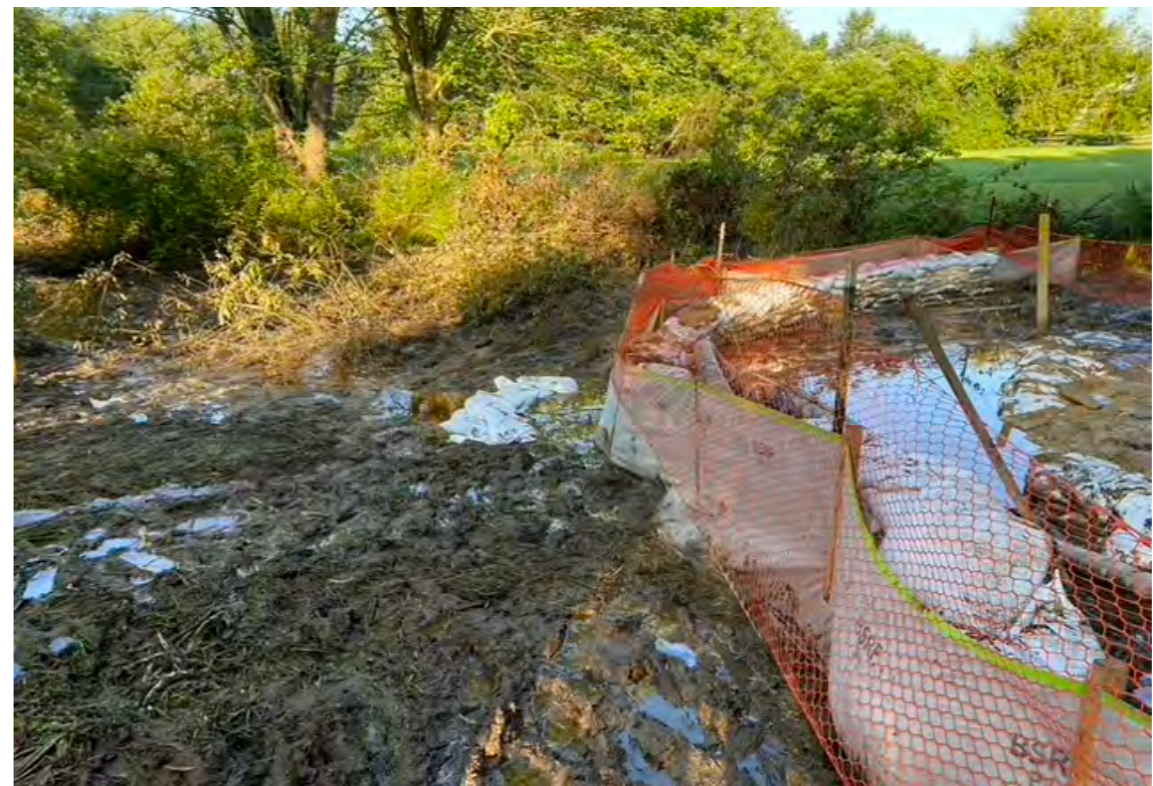
8/17/2020

View of IR release location within WL-H17.

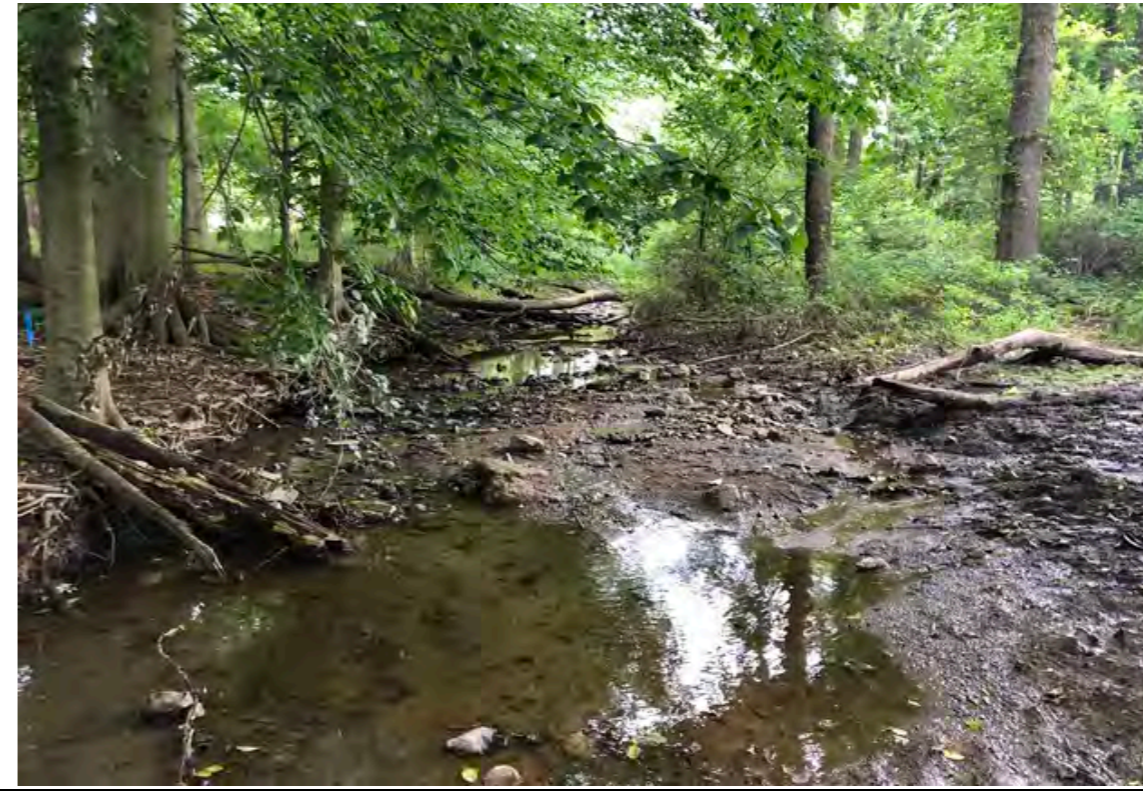
8/31/2020

View of stream S-H10 (UNT to Marsh Creek)

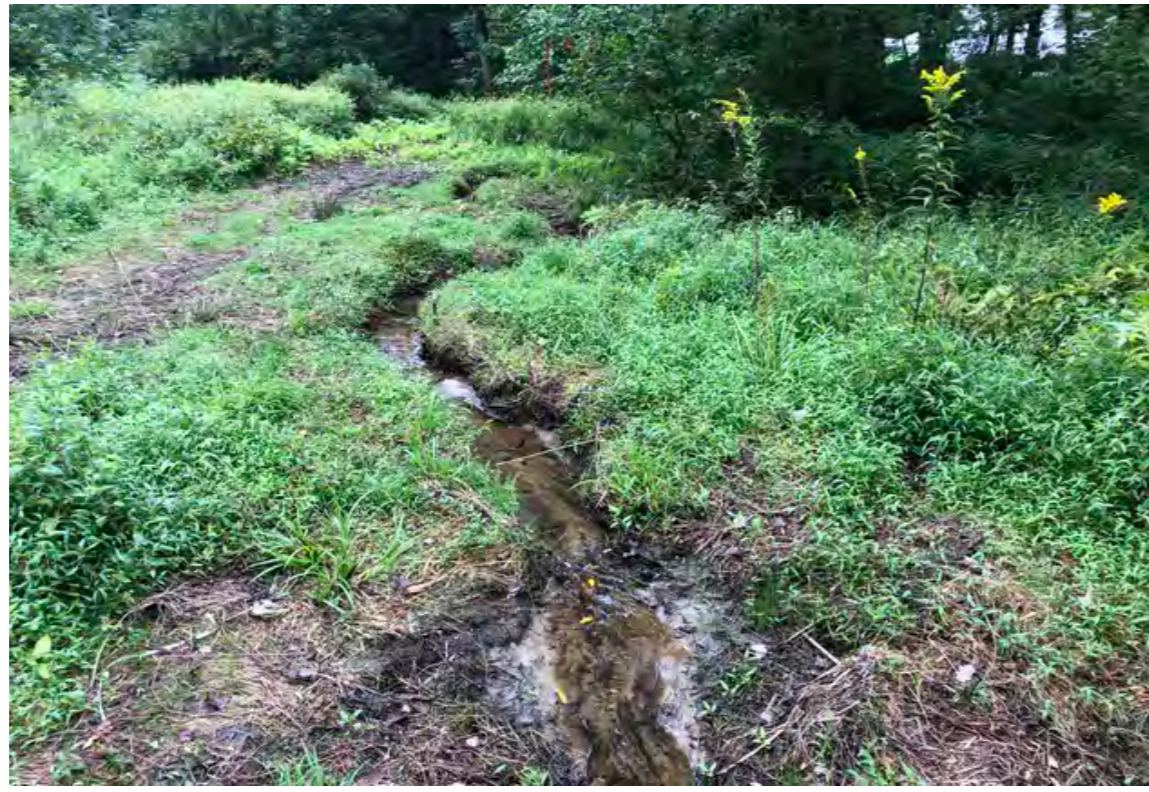
8/31/2020

View of stream S-H10 (UNT to Marsh Creek)

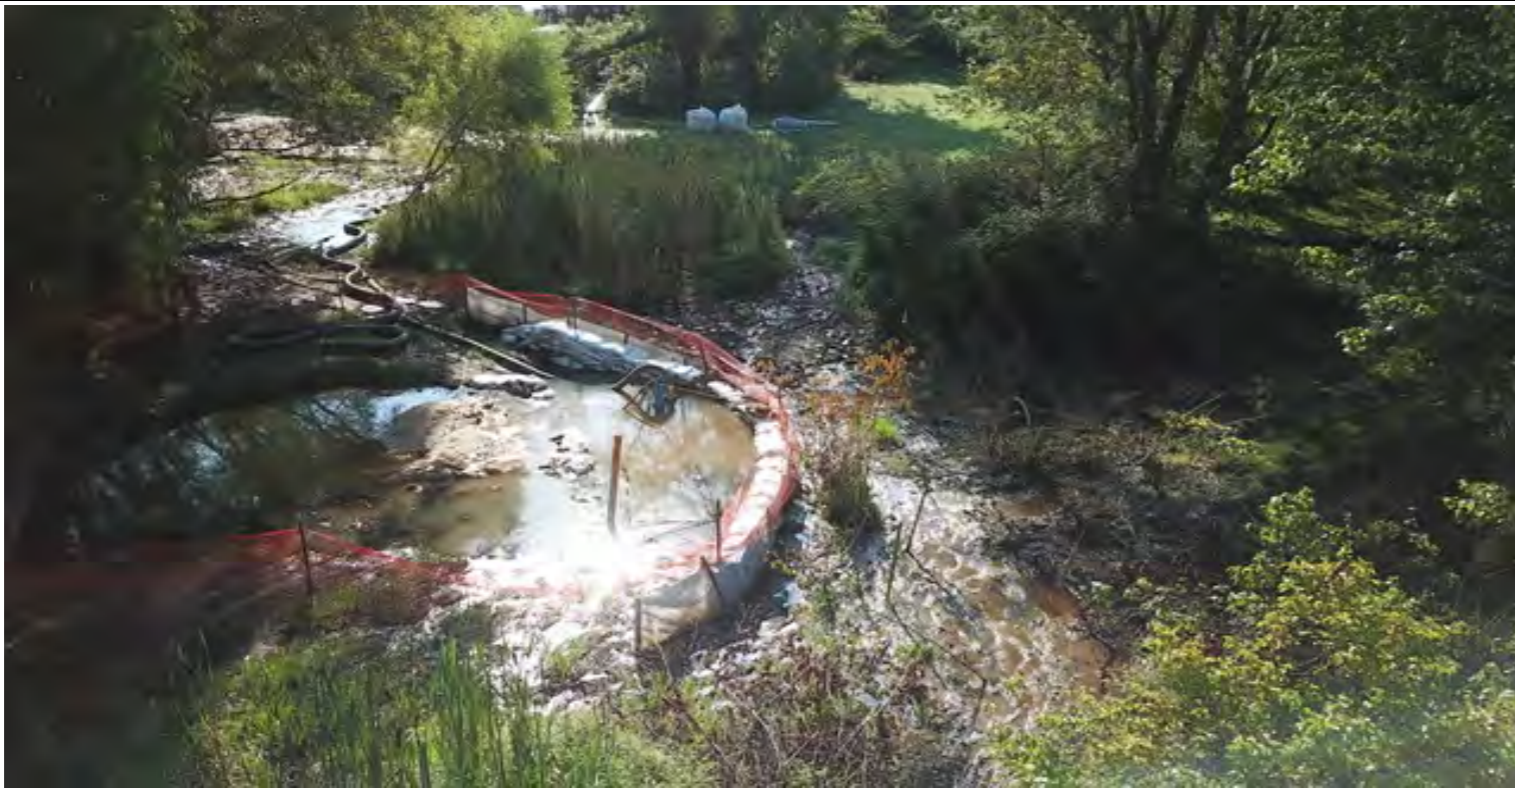
9/4/2020

View of IR release location and containment within WL-H17.

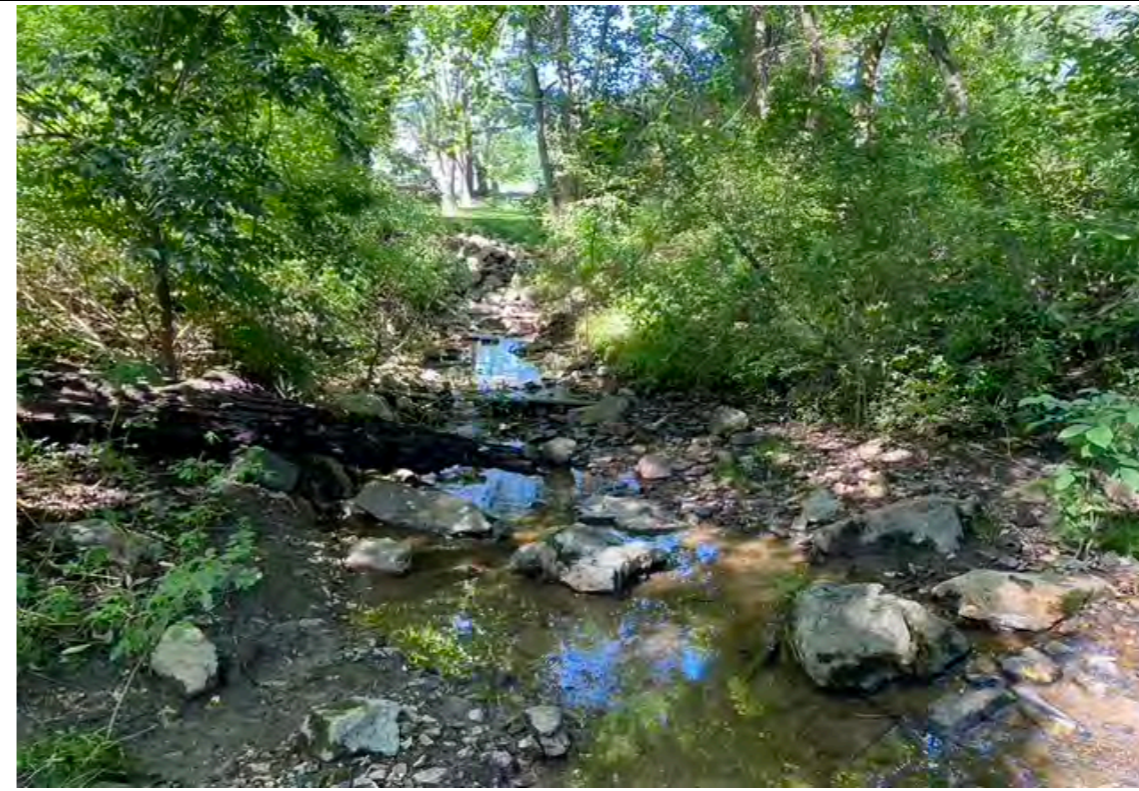
9/5/2020

View of stream S-H10 (UNT to Marsh Creek)
