**SUBJECT: Asbestos Investigation Results  
Rock Hill Quarry Operation  
SMP No. 7974SM1  
East Rockhill Township, Bucks County  
EarthRes Project No. 061003.051**

## FIGURE 1 SAMPLE LOCATION MAP

ROCK HILL QUARRY  
HANSON AGGREGATES PENNSYLVANIA, LLC  
EAST ROCKHILL TOWNSHIP  
BUCKS COUNTY, PENNSYLVANIA

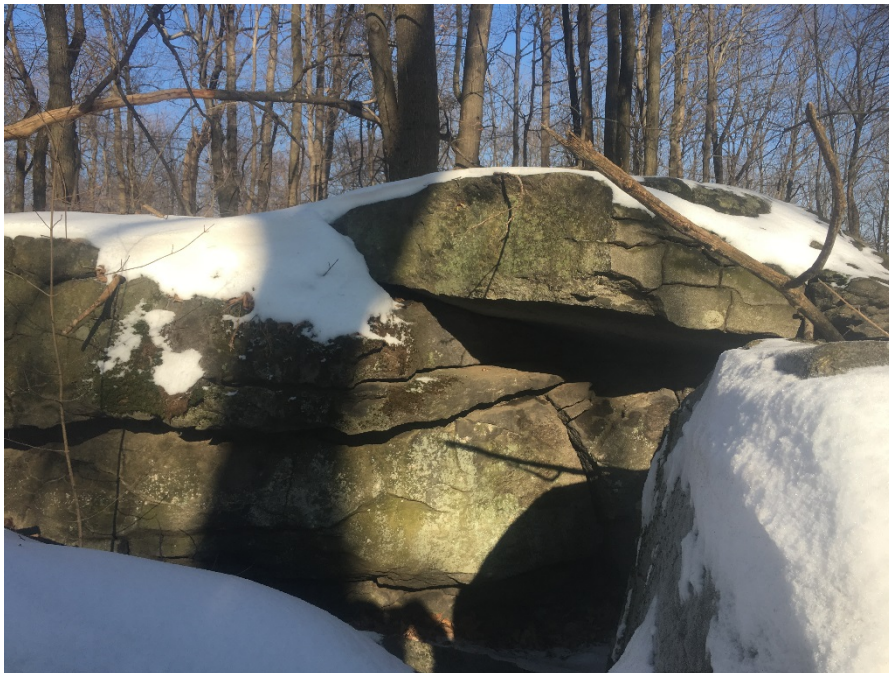
Eastern Hill Top Diabase Outcrop

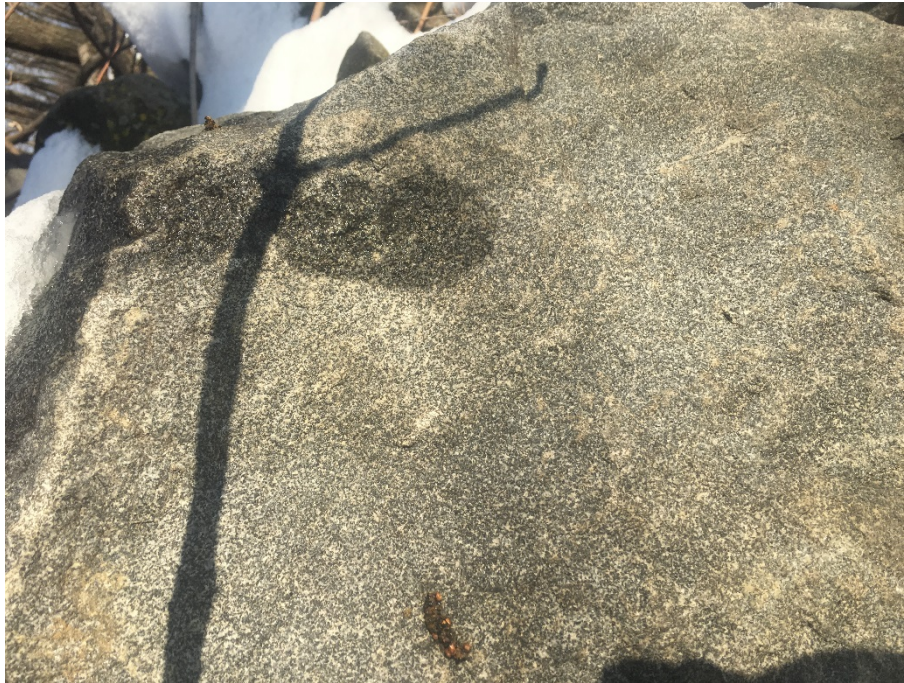
Numerous large boulders were assessed on the southern, northern, and eastern sides of the site. Freshly-broken surfaces were visually inspected to identify the potential presence of naturally occurring asbestos NOA. Each boulder observed consisted of a tightly-massed, fine to medium grained crystalline diabase. Joints were observed to be weathered and typically covered by an oxide, typically manganese or ferric oxide. Mineral veining containing potential NOA was not observed in the examined boulders. Four (4) mineral veins were observed on the southern highwall adjacent to the proposed mining area and were sampled as described in the preceding paragraph.

Typical Diabase Boulder

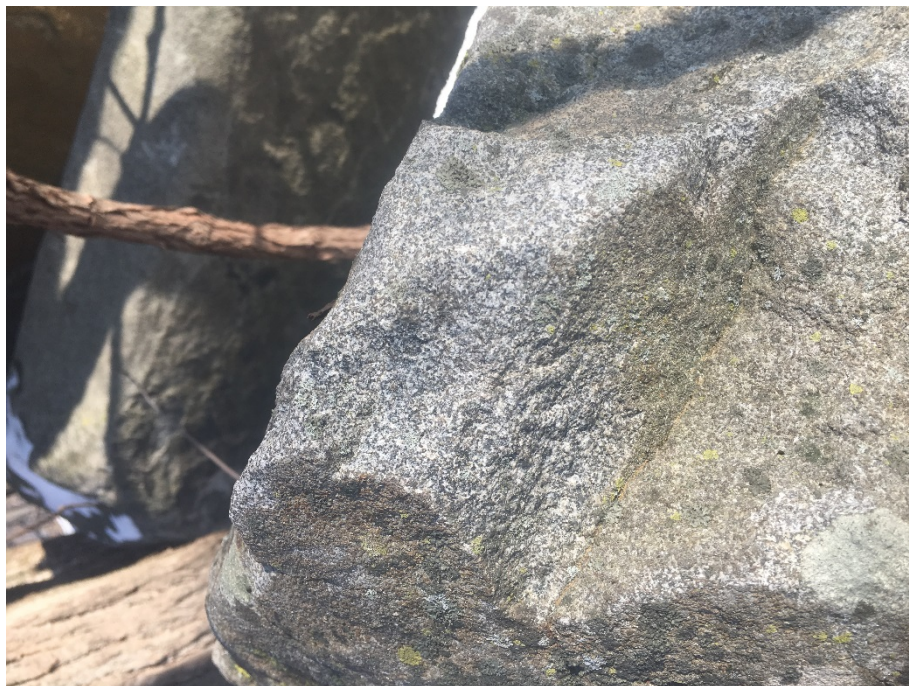
Typical Diabase Boulder

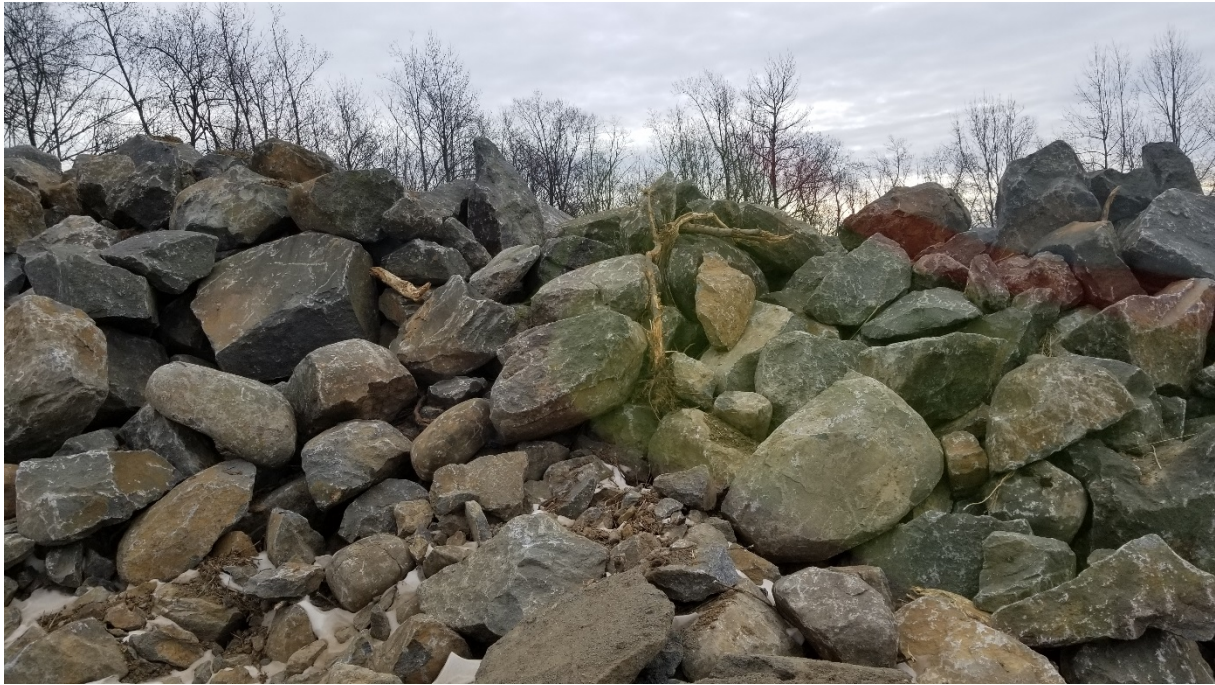
Diabase Boulder Field, south side of southern access road

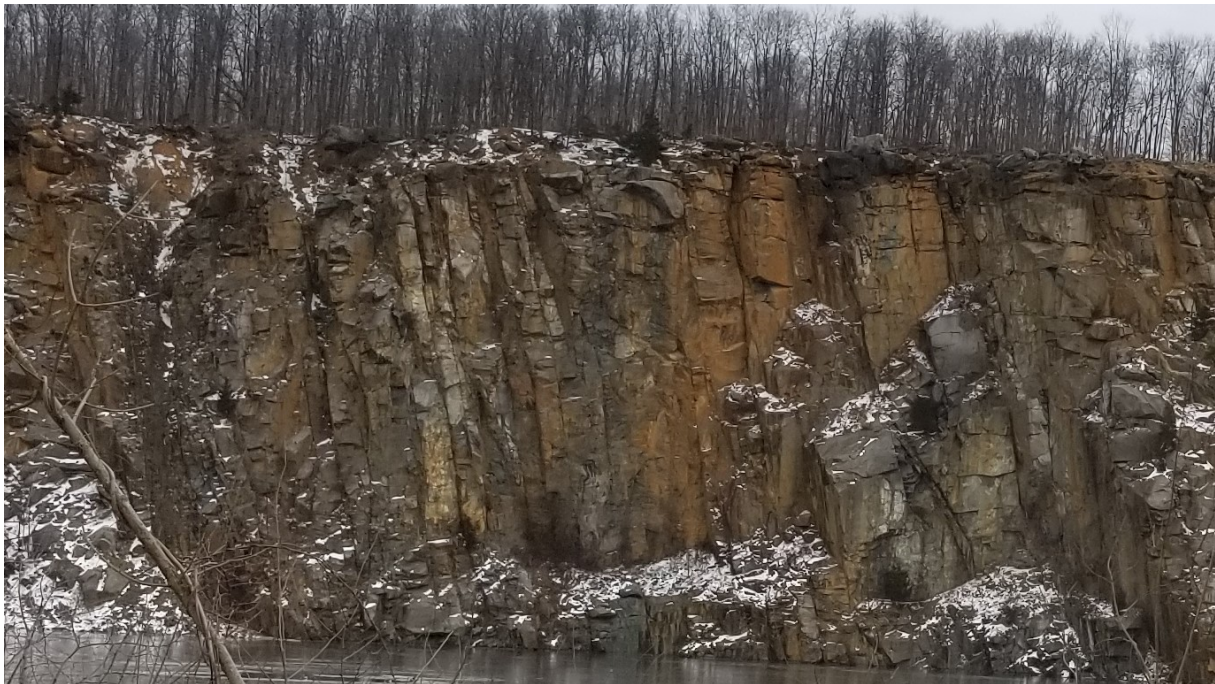
Sedimentary rocks or features (e.g. bedding, folds, cross-beds, etc.) were not visually observed on the highwalls. Near-vertical jointing was observed along much of the eastern highwall. Contacts with sedimentary host rocks were not indicated in the surrounding outcrops or boulder fields. Several photographs taken onsite are included in Appendix C showing field conditions at the time of mapping. The investigation area is indicated to be wholly within the diabase bedrock.

Eastern Highwall Diabase

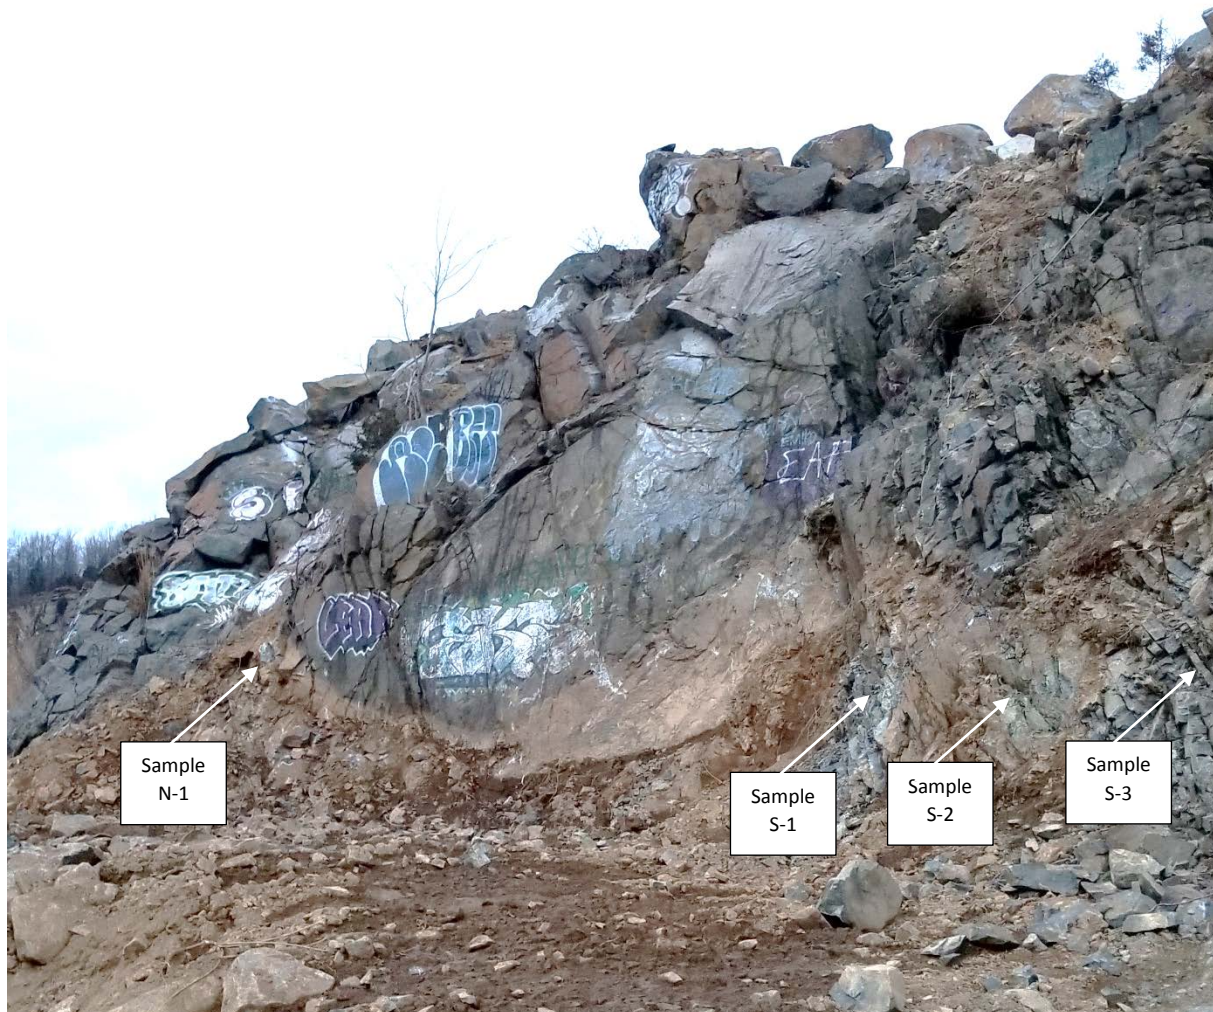
## LOCATION OF SAMPLING

Outcrop hand samples of observed mineral veining from the southern highwall were collected and numbered (from north to south): N-1, S-1, S-2 and S-3, as the highwall in the area of the sampling trends approximately north-south. The general sampling location is shown on the attached Figure in Appendix A. Pictures of the highwall, specific sampling locations and the collected samples are provided in the photographs in Appendix C.

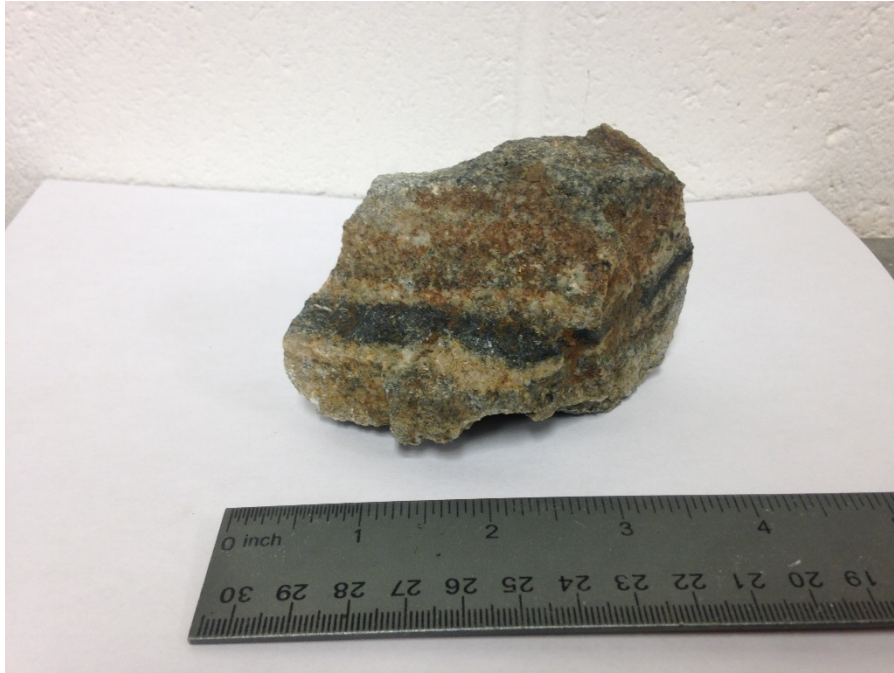
SAMPLE N-1

| Sample | Description | Appearance | Non-Asbestos | | Asbestos |
|---|---|---|---|---|---|
| N-1<br>041800978-0001 | Rock Sample | Gray<br>Non-Fibrous<br>Homogeneous | | 100% Non-fibrous (Other) | None Detected |

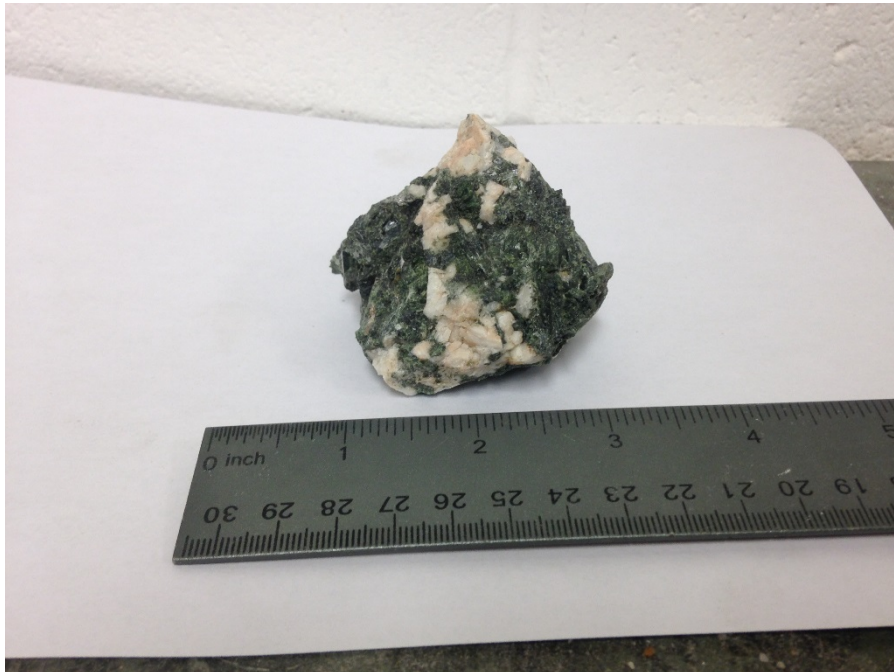
SAMPLE S-1

| Sample | Description | Appearance | Non-Asbestos | | Asbestos |
|---|---|---|---|---|---|
| S-1<br>041800978-0002 | Rock Sample | Gray<br>Non-Fibrous<br>Homogeneous | | 100% Non-fibrous (Other) | None Detected |

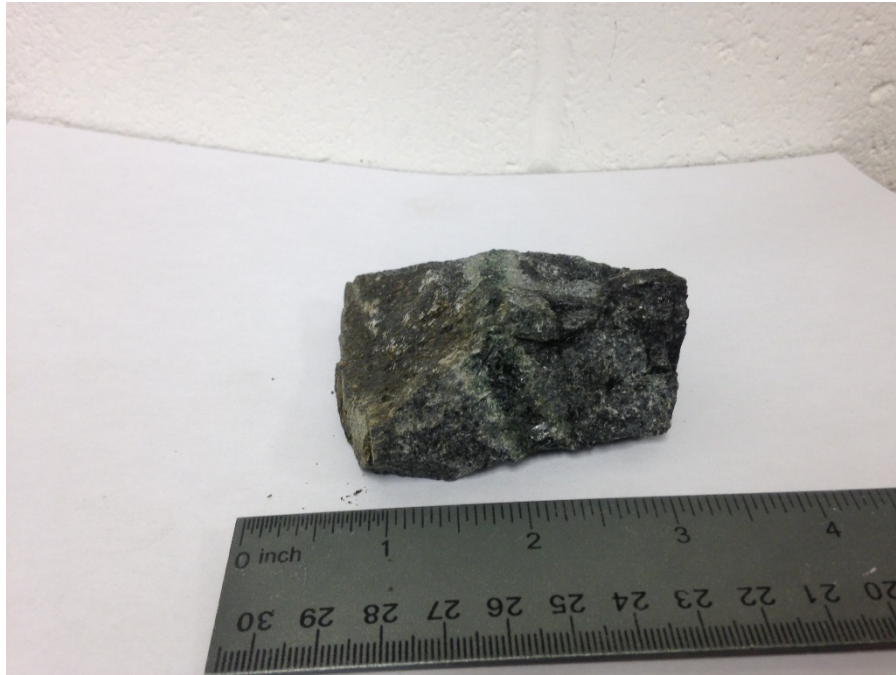
SAMPLE S-2

| Sample | Description | Appearance | Non-Asbestos | | Asbestos |
|---|---|---|---|---|---|
| S-2<br>041800978-0003 | Rock Sample | Gray<br>Non-Fibrous<br>Homogeneous | | 100% Non-fibrous (Other) | None Detected |

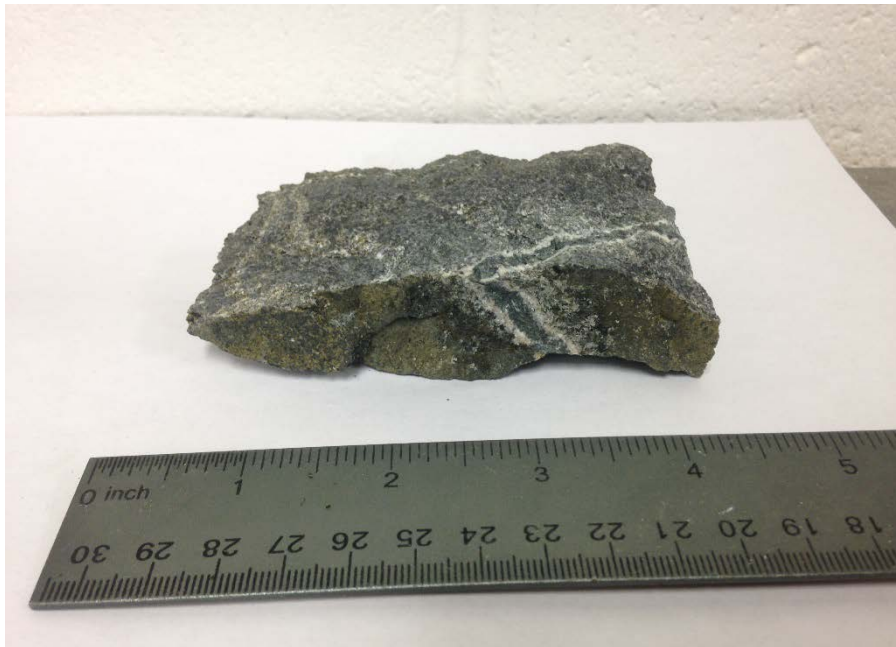
SAMPLE S-3

| Sample | Description | Appearance | Non-Asbestos | | Asbestos |
|---|---|---|---|---|---|
| S-3<br>041800978-0004 | Rock Sample | Gray<br>Non-Fibrous<br>Homogeneous | | 100% Non-fibrous (Other) | None Detected |
