**Re: Limited Activity Based Sampling Data – October 11, 2022 Events 2 & 5
Rock Hill Quarry
Hanson Aggregates Pennsylvania LLC
SMP No. 7974SM1
East Rockhill Township, Bucks County, PA**

RE: Air Sample Analyses
RJ Lee Group Project Number: LLH901997

Attachment 4
CMI Memorandum Re:
Oct. 11, 2022 Sampling Event

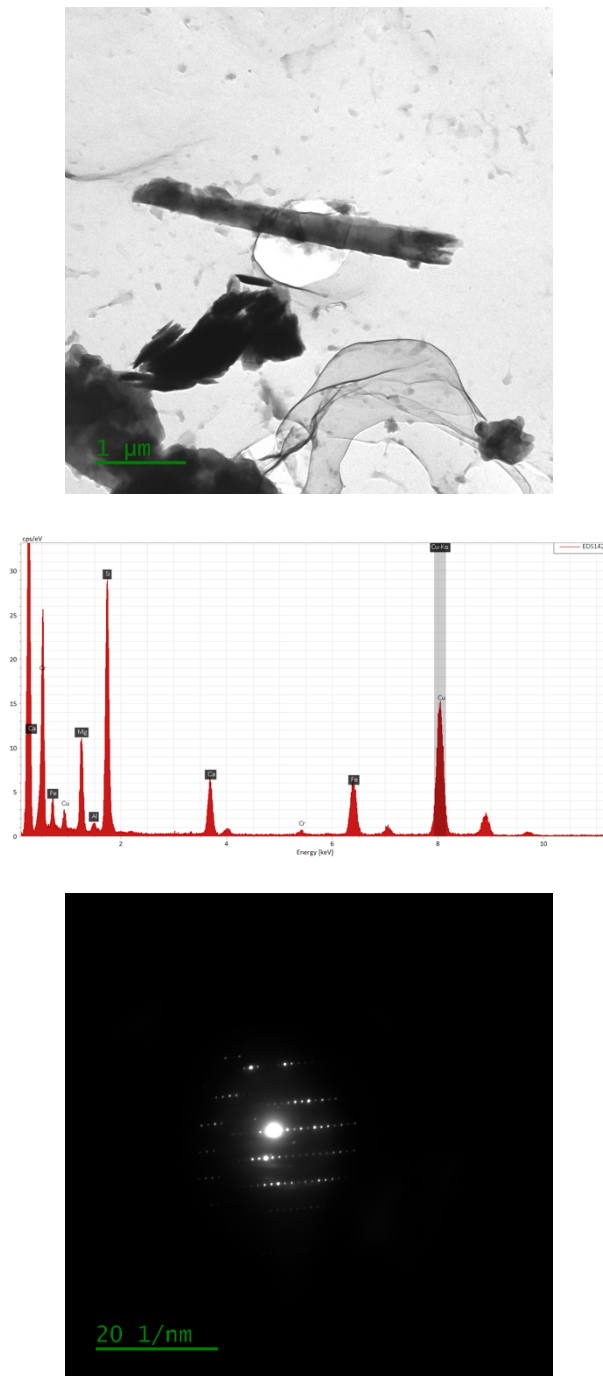
Figure 2. Electron micrograph (top), energy dispersive x-ray spectrum (middle) and selected area electron diffraction pattern (bottom) from actinolite structure observed in sample M6L (3181704) collected at site location M6. The structure measures 3.7 μm long and 0.4 μm wide (aspect ratio 9.25)

Of the eighteen samples analyzed, no countable structures ($\geq 0.5 \mu\text{m}$ long, $\geq 3:1$ aspect ratio) were detected in seventeen of the samples. A single amphibole structure (Figure 2) was observed during the analysis of sample M6L (3181704) collected at site location M6. The structure is $3.7 \mu\text{m}$ long and $0.4 \mu\text{m}$ wide (aspect ratio 9.25) and does not have characteristics of asbestiform morphology. The concentration calculated from this analysis is 0.001 fibers/cc and is 10 times lower than the proposed action limit of 0.01 fibers/cc.
