NARRATIVE REPORT FORM

Facility Name: Glenwood Drive and Walker Road

Primary Facility ID: 881609 _____

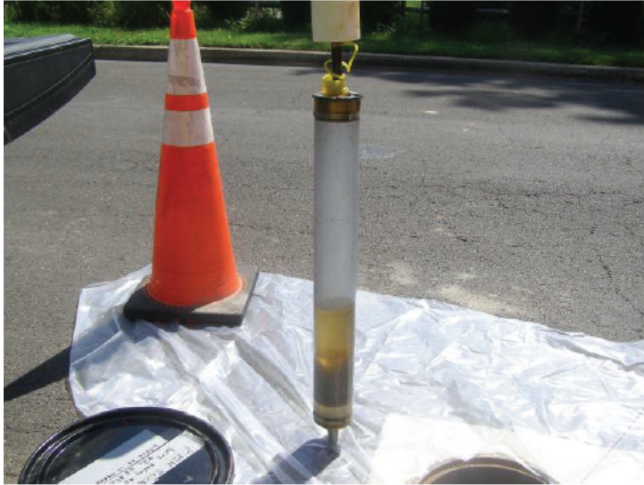
- There was a skimmer installed in the recovery well.
- Depth to water was measured with the skimmer still in the well.
- After the skimmer was pulled out of the recovery well, there was approximately 1L of LNAPL collected.
- A sample of the LNAPL was collected for analysis and poured into a metal bucket.
- Devin stated that they were going to pump out what LNAPL was in recovery wells RW-2 and RW-3 and that it would take several hours.

LNAPL in skimmer pulled from recovery well RW-2
7-21-25 @ 10:34

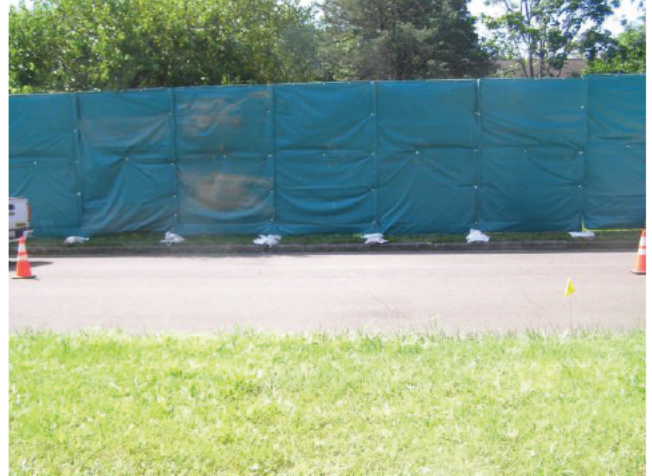
I drove further down Glenwood Drive to where a set of monitoring wells were scheduled to be installed. Upon my arrival, I noticed that sound barriers were set up along between [REDACTED]. There were detour signs and flaggers near the sound barriers for any traffic control issues. Summitt, the drillers, were moving equipment around so that they could soft dig the locations for the shallow and deep wells since the drilling permits still had not been approved.

Sound Barriers in front of [REDACTED]
7-21-25 @ 10:46

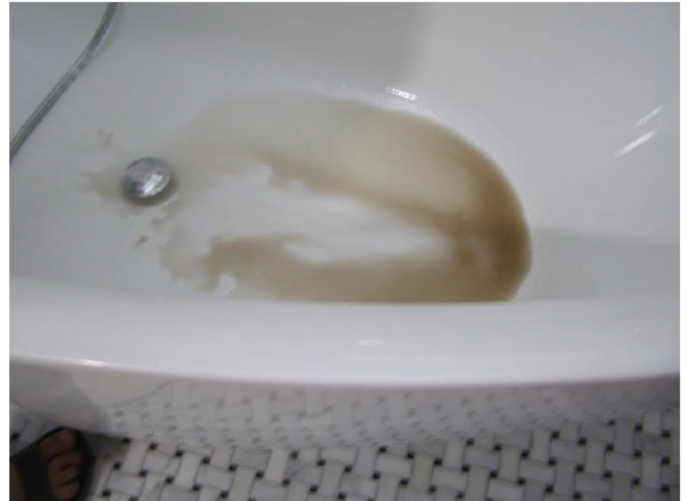
I waited until 13:30 in case the well permit was approved, it was not. I drove to [REDACTED] to speak with the resident who had sent an email to the Department stating that the water coming out of the second-floor sinks was occasionally black. I spoke with the resident. [REDACTED] showed me where the two sinks were that had the black water before. [REDACTED] turned on the cold water in the sinks and bathtub. I noticed that there was some black water that came out briefly, for about 5-10 seconds, then the water ran clear. [REDACTED] turned on the hot water and I did not notice any black water coming out. We checked the sinks in the first-floor powder room and in the kitchen. There was no evidence of any black water coming from either when the cold water was turned on or hot water. I said that I'd go back and talk with my supervisor and others to determine if anyone else has heard of this or seen this and I'd get back to [REDACTED]. I also stated if they had any additional questions they could contact me.

Black water from cold faucet, 2nd floor bathroom on [REDACTED]
7-21-25 @ 13:35
