Escility Name: Glenwood Drive & Walker Poad

COMMONWEALTH OF PENNSYLVANIA DEPARTMENT OF ENVIRONMENTAL PROTECTION BUREAU OF ENVIRONMENTAL CLEANUP AND BROWNFIELDS

NARRATIVE REPORT FORM

racinty Name. Glenwood	Ju Dilve C	x vvalker Rodu			1 minuty 1	definity 1D. <u>001009</u>	
Inspection Date: July 23, 2025		Inspection Time: 11:05 – 12:57		Lat/Long: 40.273661, -74.873306			
Program:	☐ Stor	age Tanks	☐ HSCA			⊠ LRP	
Owner Name: N/A			Inspection ID: N/A		N/A	Site ID: 881609	
Facility Location (911) Address: Glenwood Drive between Walker Road and Spencer Road, Washington Crossing, PA 18977			ington	Municipality: Upper Makefield Township			
				County: Bucks			
Responsible Official Name: Bradford Fish Title: Senior Environmental Specialist, Emergency Response & Remediation				Responsible Official Address: 100 Green Street Marcus Hook, PA 19061			
Responsible Official Telephone: 610-859-6297 Email Address: bradford.fish@energytransfer.com							
Entities Present at Site:							
						er (ET)/Sunoco Pipeline, LP (SPLP) crossing, PA 18977 (the Site, Photo #1).

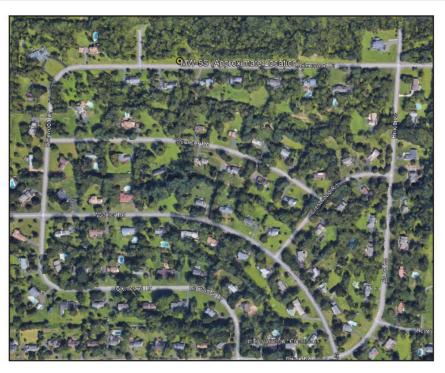
Photo #1
Monitoring well 5S installation location, Washington Crossing, PA

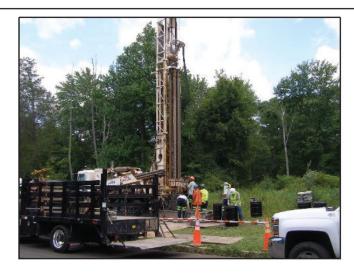
At 11:30, Pete Reichardt (PR) of GES collected a water level measurement from monitoring well 5S, which indicated that only approximately (~) 1 ft of water had entered the borehole over the 45 minutes the team had been on break. PR and CE instructed Summit to advance the borehole to the proposed terminal depth of 35 ft bgs. See Photo #2 for a picture of the drilling area.

Photo #2 Monitoring well 5S drilling area. 7/23/2025 @ 11:55

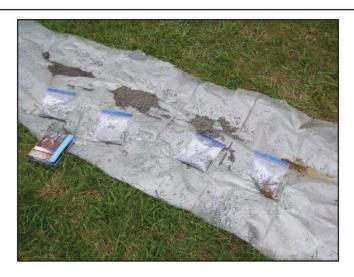
At 11:52, DL reviewed PR's photoionization detector (PID) readings from soil cuttings collected every 5 ft from the borehole. Soil cuttings were first placed in a plastic bag and sealed shut for several minutes to allow for potential volatilization of contaminants, if present. Following this period, the PID intake was sealed within the bag to record headspace readings. PID readings from 5, 10, 15, 20, 25, 30, and 35 ft bgs were 0.3 parts per million (ppm) or less. See Photos #3 and #4 for drilling cuttings.

Photo #3 Monitoring well 5S drilling cuttings, 5 to 20 ft bgs. 7/23/2025 @ 11:53
