## NARRATIVE REPORT FORM

Facility Name: Glenwood Drive & Walker Road

Primary Facility ID: 881609

### Narrative:

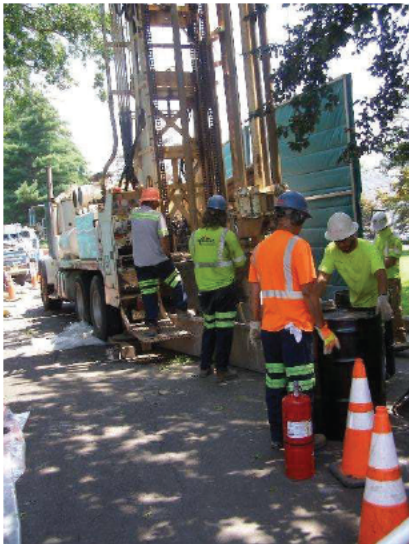
Photo 1: Drilling in progress

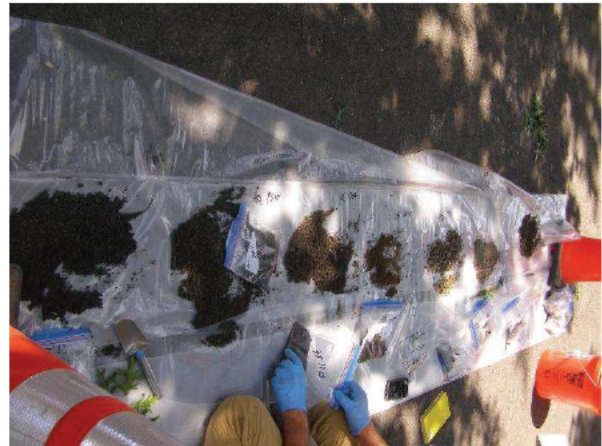
During drilling, small soil cutting piles from five-foot intervals were placed on poly sheet for GES to characterize soils and screen with a PID. Smaller amounts of cuttings were sealed in plastic bags and allowed to sit for several minutes before screening with a PID to allow for potential volatilization (Photo 2). No PID readings greater than 0.3 ppm were detected.

Photo 2: Staging of soil cuttings from 5-foot intervals

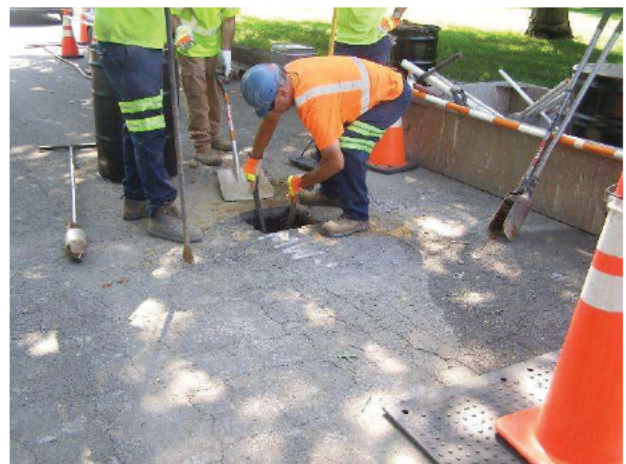
I arrived at the drilling area at 10:20. Upon my arrival Summit Drilling personnel were in the process of hand digging the well location with a hand auger down to 5 feet below ground surface (Photo 4). When they dug down to 5 feet there was a large rock that had to be moved before proceeding with drilling. The drill rig arrived onsite at 11:30 and drilling began at 12:10. The target depth of this well was 40 feet.

Photo 4: Hand digging prior to drilling
