## NARRATIVE REPORT FORM

Facility Name: Glenwood Drive & Walker Road

Primary Facility ID: 881609

The purpose of today's site visit was to observe the installation of monitoring well MW-13D located at the [REDACTED] residence. Entities present at the site included Olivia Budnovitch (DEP), technical staff from Energy Transfer/Sunoco Pipeline, L.P. (SPLP), Groundwater & Environmental Services (GES), Summit Drilling, LLC, and Stantec.

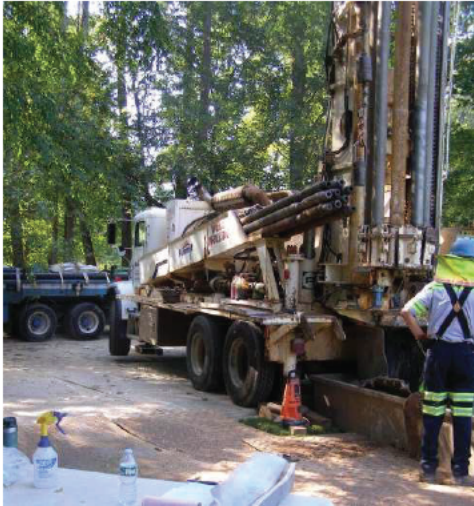
I arrived onsite at 9:45 and equipment was being staged upon my arrival. Sound barriers were placed on both sides of the drilling area against the subject property residence and the neighboring residence (see photo 2). The location of MW-13D is the side yard of the residence. Plastic mats were placed in a pathway from the street to the drilling location to prevent the drill rig from driving over grass. The mats were also staged in the drilling area and areas of highly traveled grass. Stantec was onsite performing air monitoring with summa canisters (photo 4) at locations around the drilling area. Personnel from SPLP was performing noise monitoring with a handheld device.

Photo 1: Drill rig and mat setup

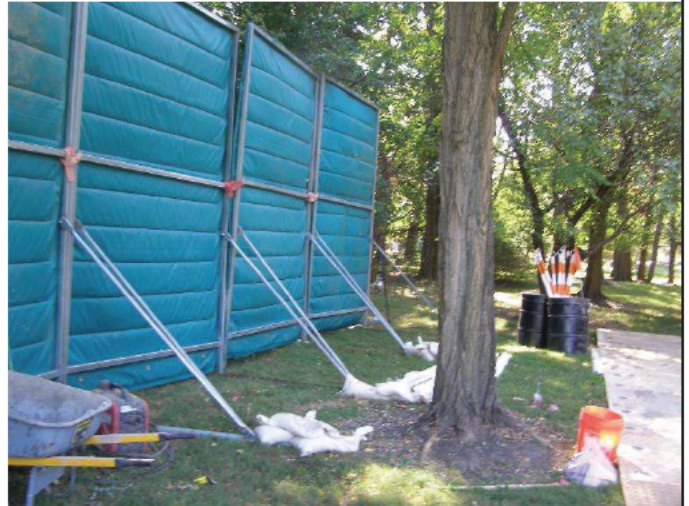
Photo 2: Sound barrier set up

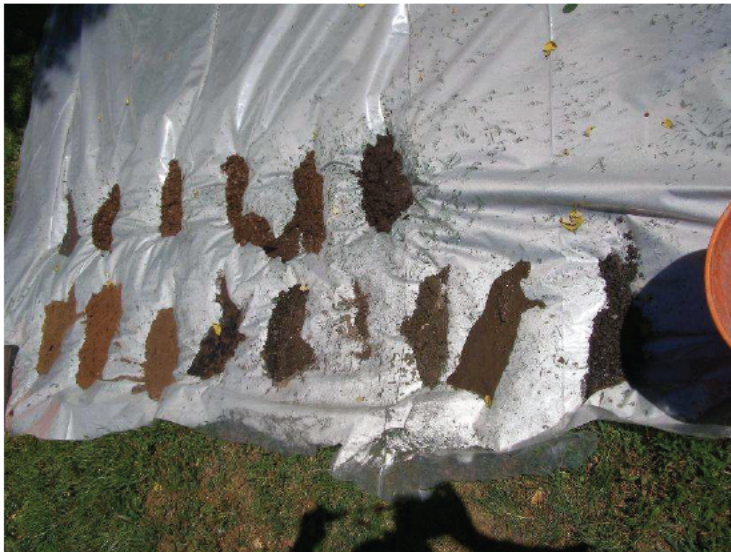
Drilling began at 10:35. The borehole was advanced to 32 feet below ground surface (bgs) before stopping for 20 minutes to allow for groundwater recharge. There was a soft zone at 30 feet bgs so the driller advanced two more feet to avoid collapse. Drilling started again at 11:40. Drilling was finished at 12:30 and the total depth of the borehole was 75 feet bgs. During drilling soil was collected from five-foot intervals and placed on poly sheet for screening and characterization (photo 3).

Photo 3: Soil characterization

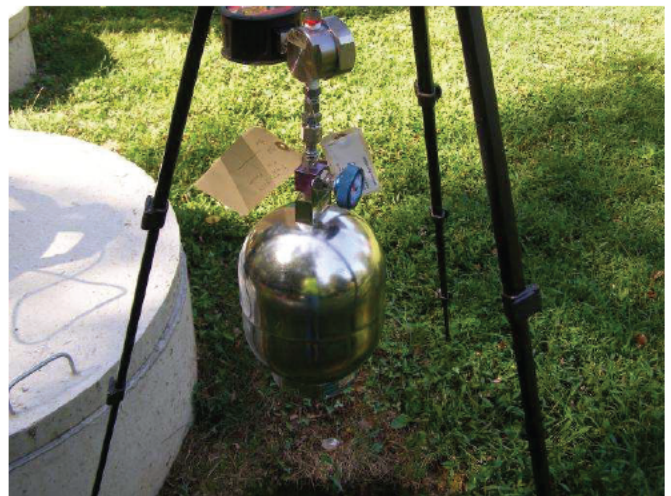
Photo 4: Summa Canister
