## NARRATIVE REPORT FORM

**Facility Name:** Glenwood Drive and Walker Road
**Primary Facility ID:** 881609

| <b>Inspection Date:</b> 10/6/25 | | <b>Inspection Time:</b> 9:00 | | <b>Lat/Long:</b> | |
| <b>Owner Name:</b> Energy Transfer | | | <b>Inspection ID:</b> | | <b>Site ID:</b> |

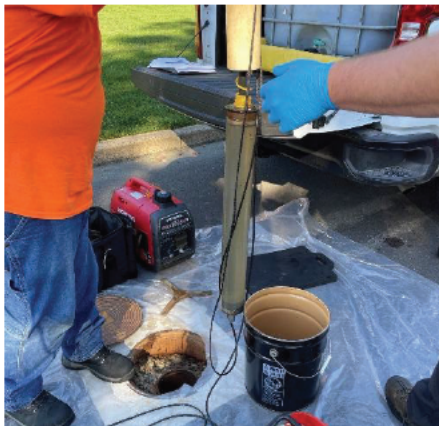
When the passive skimmer system was pulled from the well the containment chamber was 100% filled with product (photo 1). GES collected product samples and emptied the product into a bucket for later disposal. They followed with routine pumping of the recovery well.

Photo 1: Skimmer from RW-2

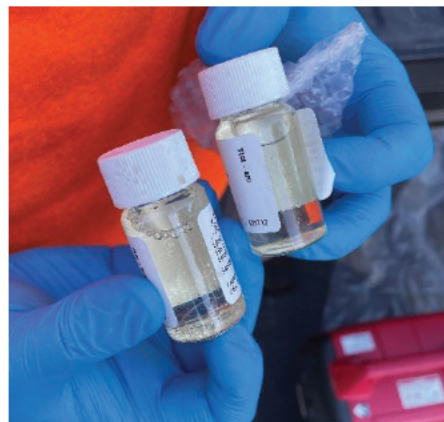
- The interface probe was properly decontaminated between each use.
- PID readings were obtained immediately when the well cap was opened.
- Product samples were collected from the recovery well RW-2 (photo 2).
- There was a RETTEW truck parked at [REDACTED] with a water level meter sitting in the newly installed potable well.
-

Photo 2: Product samples collected from RW-2
