**NARRATIVE REPORT FORM**

Facility Name: Washington Crossing LNAPL \_\_\_\_\_ Primary Facility ID: \_\_\_\_\_

Inspection Date: 2-4-25		Inspection Time:		Lat/Long:	
Program: ECB		<input type="checkbox"/> Storage Tanks		<input type="checkbox"/> HSCA	
				<input checked="" type="checkbox"/> LRP	
Owner Name: Energy Transfer			Inspection ID:		Site ID:
Facility Location (911) Address: 121 Glenwood Drive Washington Crossing, PA 18977				Municipality: Upper Makefield Twp.	
				County: Bucks	
Responsible Official Name:				Responsible Official Address:	
Title:					
Responsible Official Telephone:				Interviewee Name:	
Email Address:				Affiliation:	
				Email Address:

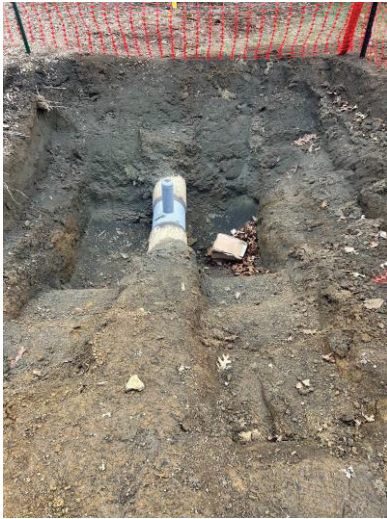
Input for pipe flush - across from 140 Walker Rd.  
2-4-25

We were informed that there were three excavations where the pipeline was accessed to flush it out. The injection point was across from 140 Walker Road, the repaired section at 121 Glenwood Drive, and the collection point across from 140 Glenwood Drive. There was also a high hat installed on the pipeline for the injection of the cleaning liquid on the pipeline across from 140 Walker Road.

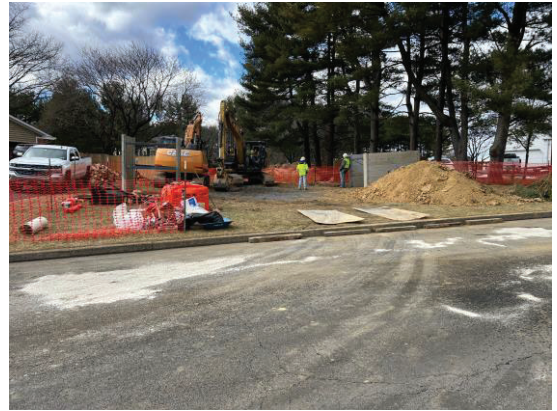
Location of repaired pipe next to 121 Glenwood Ave.  
2-4-25

We arrived at 121 Glenwood Drive at 12:50 to observe where Energy Transfer (Sunoco) had exposed the pipeline where the leak was discovered last Friday January 31, 2025. When we arrived, I noticed trucks with the logo Otis Minnesota Services, who were contracted to perform the excavations. I also detected a moderate petroleum odor in the ambient air. I observed the excavation where the pipeline was exposed, which was about 10-feet below ground surface (bgs). We were told that that's as far as they could go as they had encountered bedrock. The pipeline was at an approximate depth of 9-feet bgs.

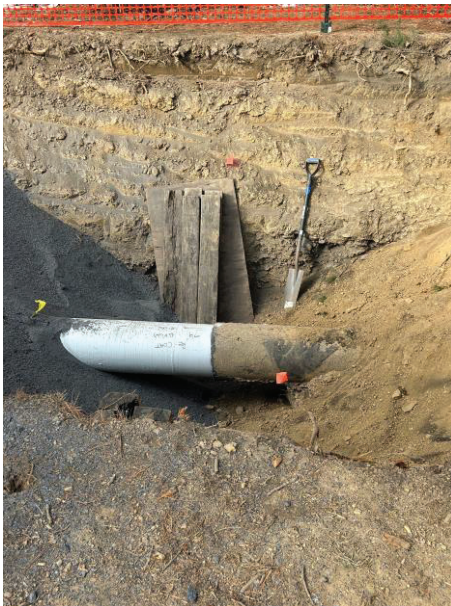
repaired pipeline near 121 Glenwood Ave.  
2-4-25

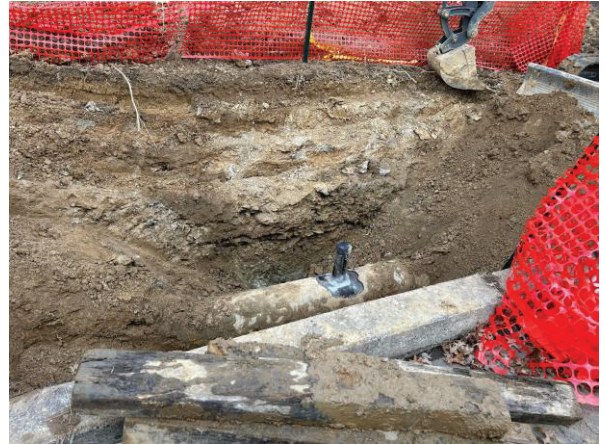
End of pipe flush - across from 140 Glenwood Ave.  
2-4-25

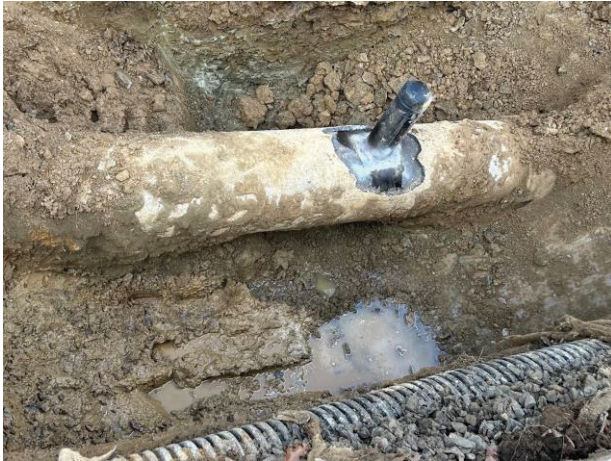
Groundwater in excavation across from 140 Glenwood Dr.  
2-4-25

We went to the excavation near 140 Glenwood Drive. The pipeline was exposed at a little under 4-feet bgs, and the total depth of the excavation was a little over 5-feet bgs. I observed a little groundwater at the bottom of the excavation. We were told by Gary Hopkins (Energy Transfer) that the plan was to re-coat the pipeline, let it cure, and then test the line. If all passed the excavation would be backfilled. There was a high hat installed on the pipeline for the removal of product and venting of the pipeline in support of the repair work.

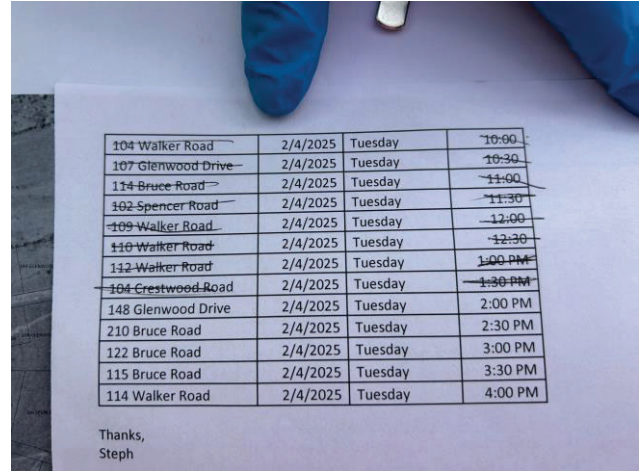
GES List of houses to sample wells  
2-4-25

We noticed that representatives from GES (Alyssa Fetterman and Jason Crone) were at 148 Glenwood Drive, who were sampling potable wells at residences that day. They had a list of thirteen (13) residences to sample for the day. We spoke with the owner of the home and the owner at [REDACTED]. [REDACTED] stated that [REDACTED] have not noticed any taste or smells in [REDACTED] water.
